Inspection Report

Property Address:
1421 Talco Garden Court
League City TX 77573

PROPERTY INSPECTION REPORT

By: Timothy J Hilsher Texas Professional Home Inspector / Hilsher Group LLC 8/13/
2018

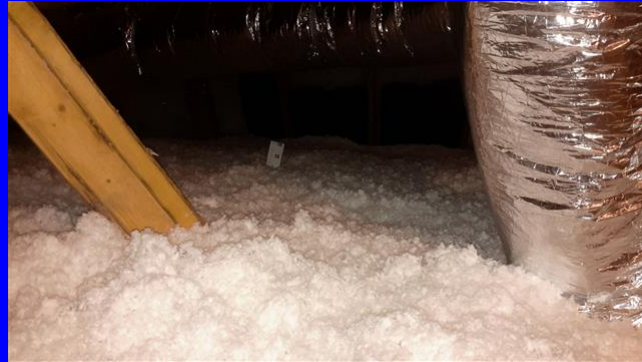
12 inches blown insulation

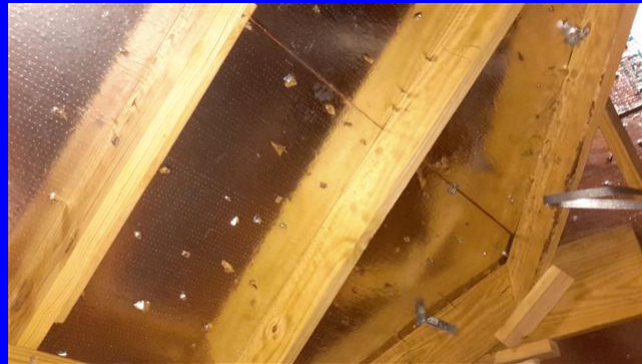
Roof structure stick built 2x6 rafters with radiant barrier decking

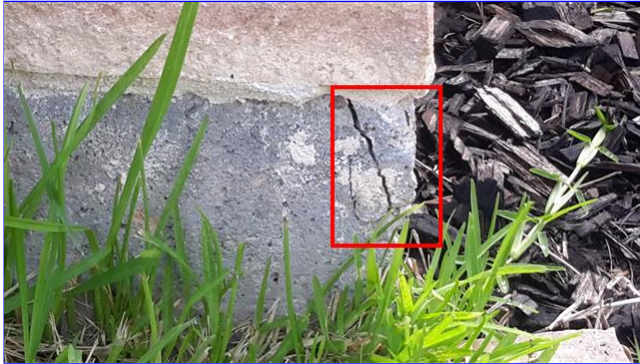
A. Item 1(Picture) Front left corner of home

- (1) This is not an engineering report, but is only an opinion based on observation of conditions known to be related to foundation performance, using the knowledge and experience of the inspector.
- (2) The foundation is poured on grade with post tension cables that appears to be performing as designed.
- (3) The foundation has minor corner pop(s) that are considered cosmetic. Further deterioration may occur if not corrected. I recommend having a qualified person make repairs as needed.

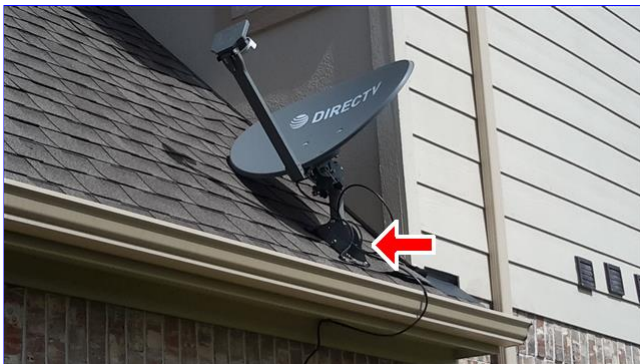
C. Item 1(Picture)

- (1) This inspection does not warrant against roof leaks.
- (2) There is a satellite dish bracket mounted on roof that is screwed directly through roofing surface. This is not considered to be today's standard. I recommend having a qualified person remove and patch roofing as needed. (The area will need periodic maintenance)

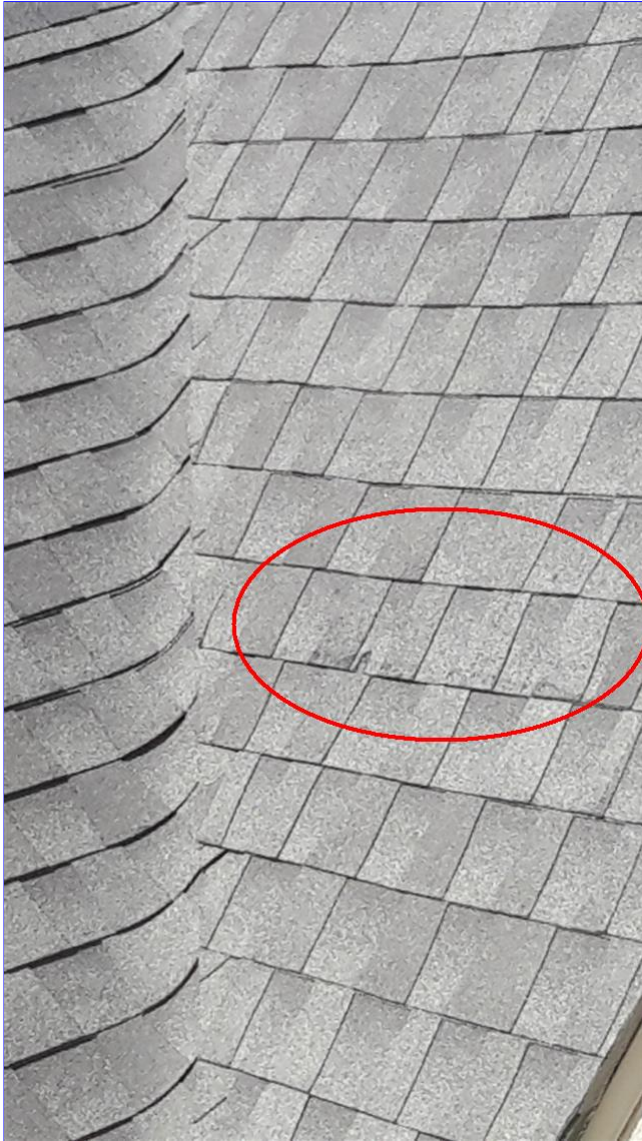
C. Item 2(Picture) Front of home

- (3) The steep pitches in areas of the roof limited the inspection to areas that were safely accessible at the time of inspection.
- (4) The roof covering has some minor damaged in areas. These areas may need replacement and or periodic maintenance. A qualified roofing contractor should inspect and repair as needed.

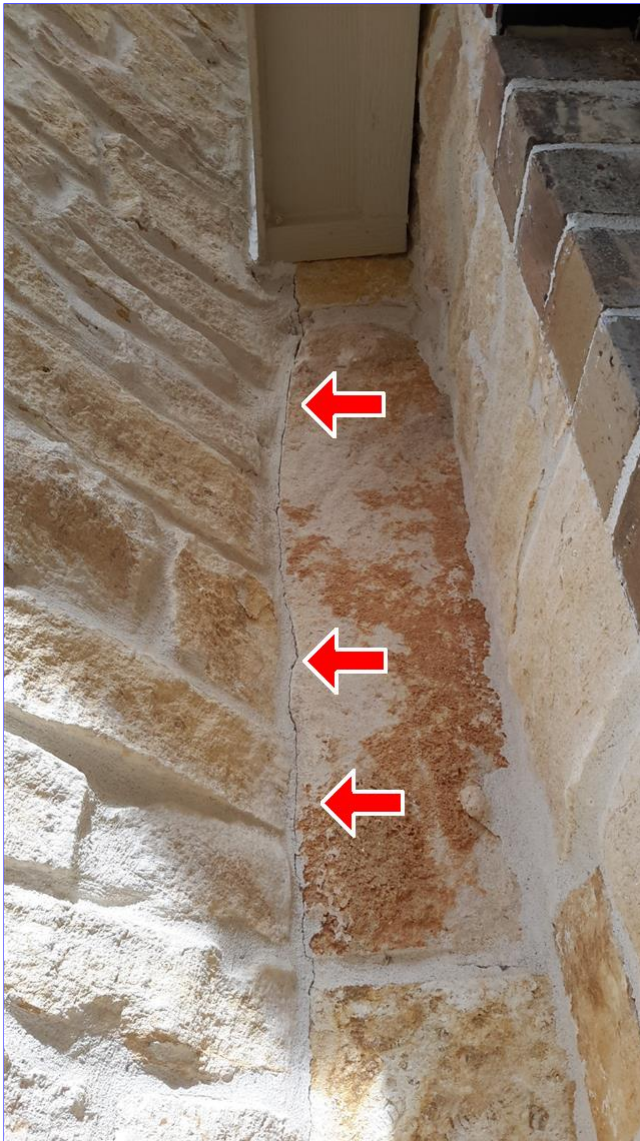
E. Item 1(Picture) Right of main entry

(1) The stone siding has hairline cracks in mortar. Further deterioration can occur if not corrected. A qualified person should repair or replace as needed.

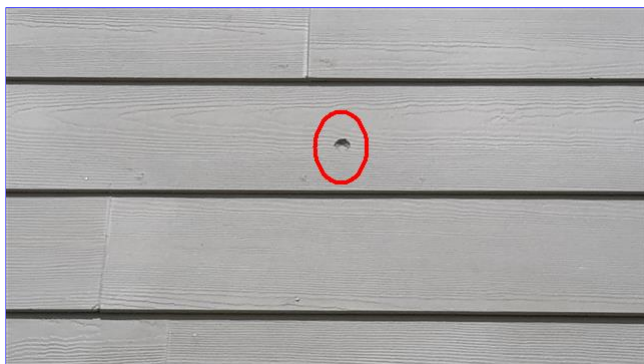
E. Item 2(Picture) Right side of home

(2) The Siding exterior damaged. Further deterioration can occur if not corrected. A qualified person should repair or replace as needed.

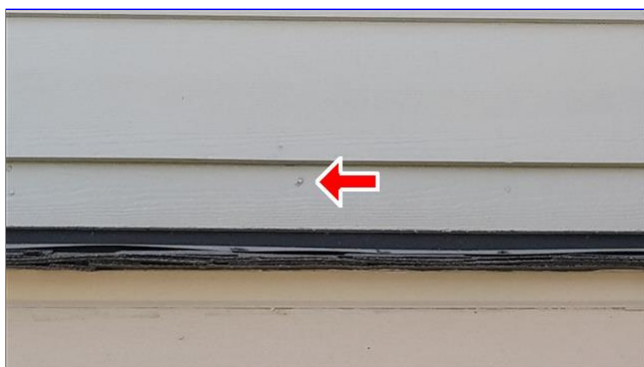
(3) The siding exterior has caulking that is weathered or missing and some lifted nails. Deterioration can eventually occur if not corrected. A qualified person should repair as needed.

E. Item 3(Picture) lifted nail rear of the home

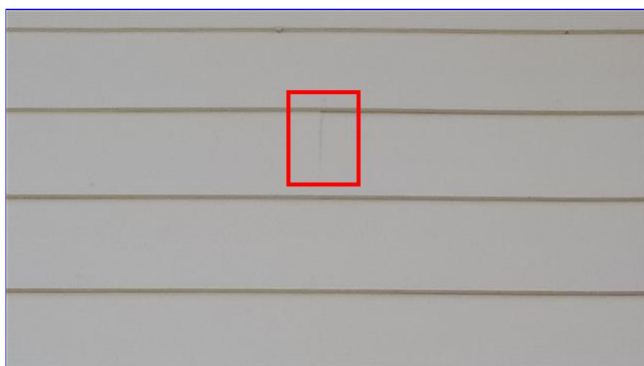
E. Item 4(Picture) deteriorated caulking rear of the home

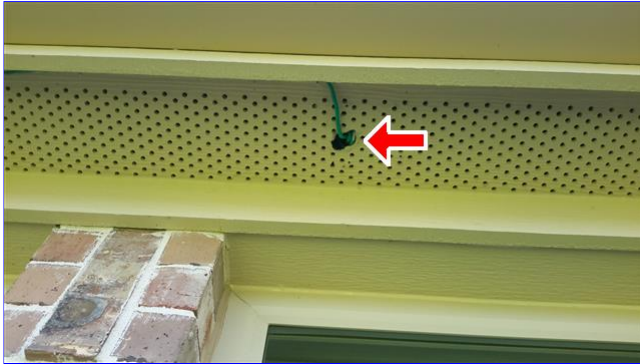
E. Item 5(Picture) left side of home

(4) The soffit panel at eave on the exterior damaged. This is a small repair. A qualified person should repair or replace as needed.

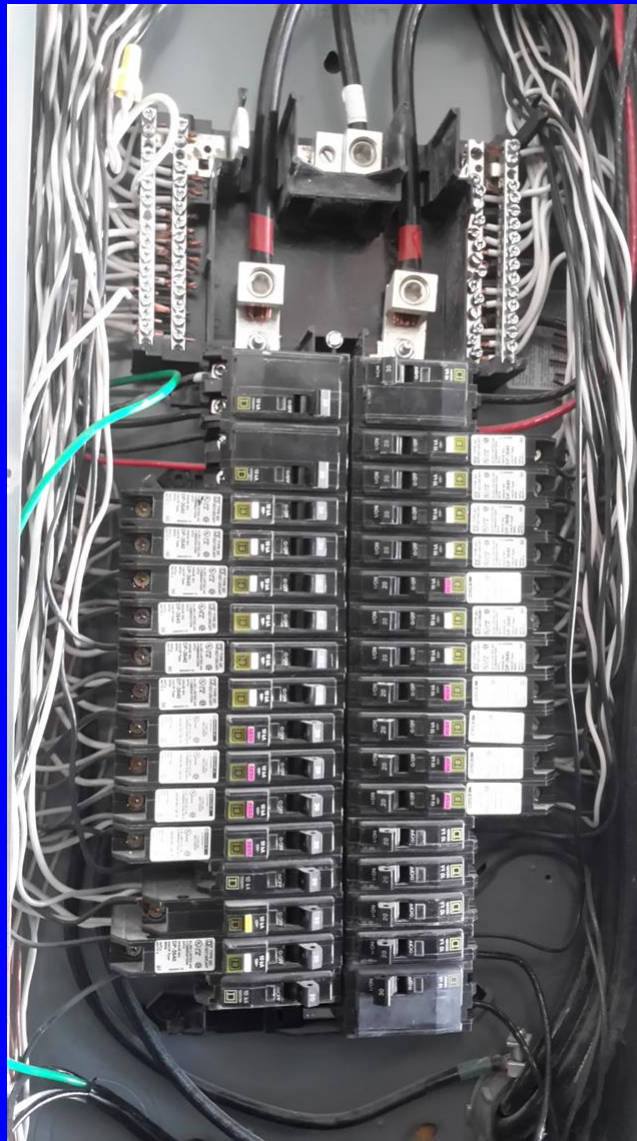
200 amp main panel located in garage

I could not locate the ground wire. The ground wire may not be present or could be hidden from view by construction materials. I recommend an electrical contractor verify or install a ground wire.

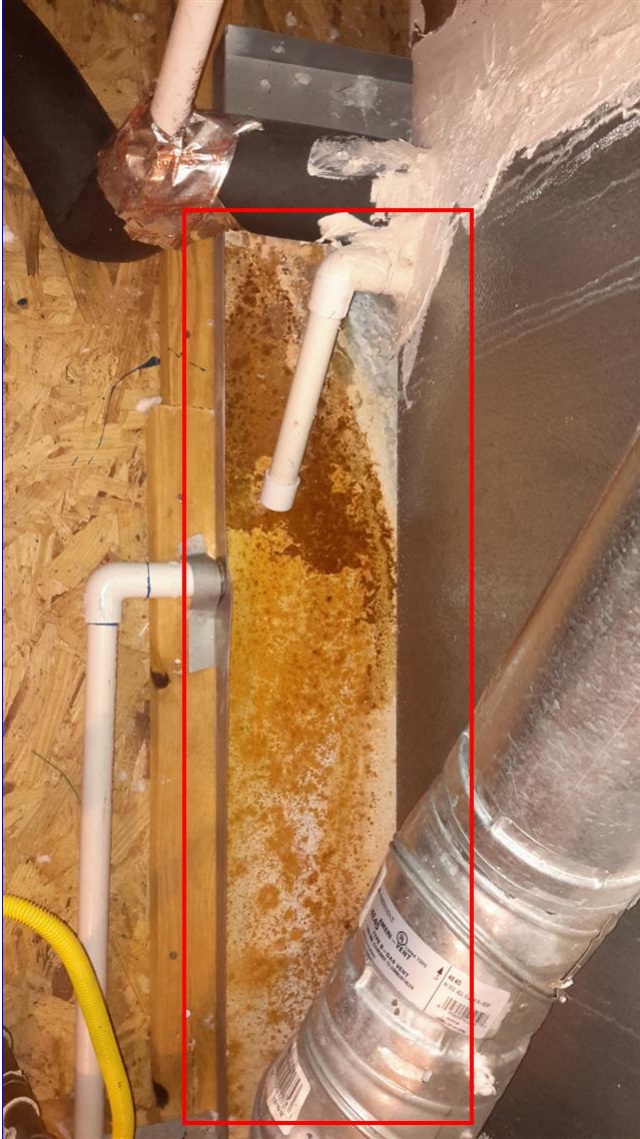
B. Item 1(Picture)

- (1) It is recommended to have HVAC systems serviced annually.
- (2) The ambient air test was performed by using thermometers on the air handler of Air conditioner to determine if the difference in temperatures of the supply and return air are between 14 degrees and 22 degrees which indicates that the unit is cooling as intended. The supply air temperature on your system read 52 degrees, and the return air temperature was 72 degrees. This indicates the range in temperature drop is normal.
- (3) The emergency overflow drain pan for the HVAC system is showing signs of deterioration. Further deterioration may occur if not corrected. I recommend having a qualified person make repairs as needed.

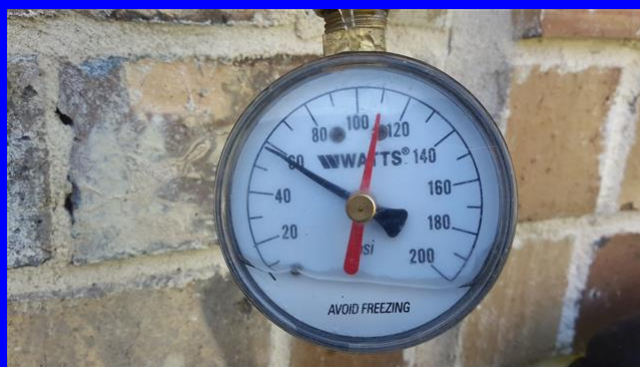
59 psi

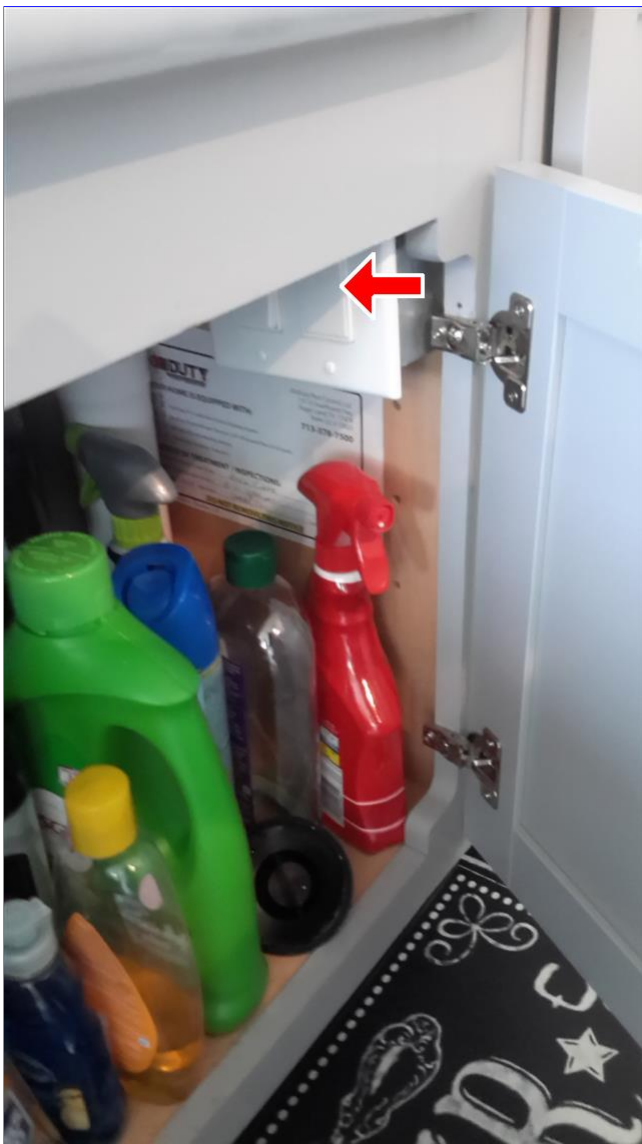
A. Item 1(Picture)

- (1) Tested and working properly at the time of inspection.
- (2) The dishwasher power switch is too low, and does not prevent children from operating. I recommend repair as necessary.

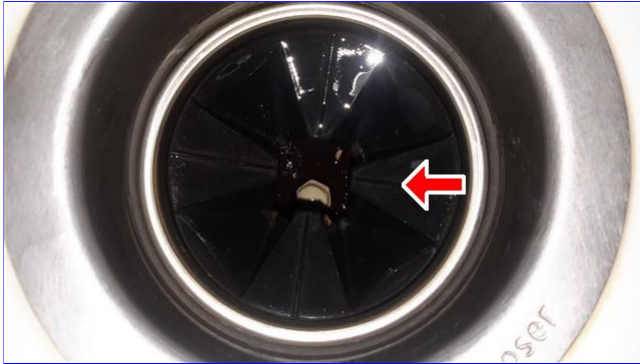
B. Item 1(Picture)

- (1) Tested and working properly at the time of inspection.
- (2) The food disposer is rusted inside at the blades. I recommend repair as needed.

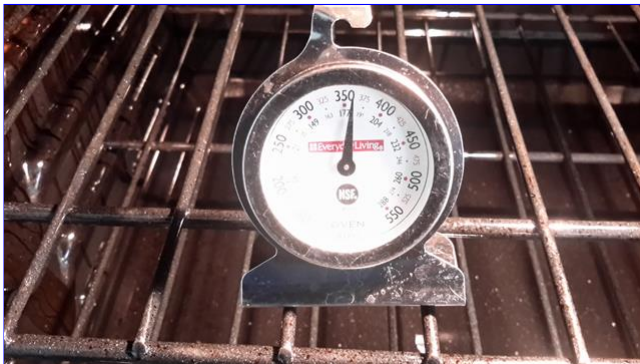
D. Item 2(Picture) Oven tested set at 350 (f) degrees

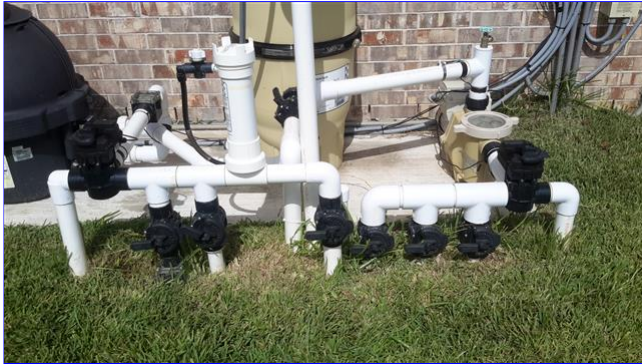
B. Item 1(Picture)

(3) Pool equipment has valves that not clearly marked. I recommend having a pool professional evaluate and mark as needed.
