Pool/Spa Equipment Inspection Report/Inventory

Concerning: 9219 Newburgh Houston, TX. 77095

Inspected By: Rod Scarborough TREC License # 7189 November 6, 2021

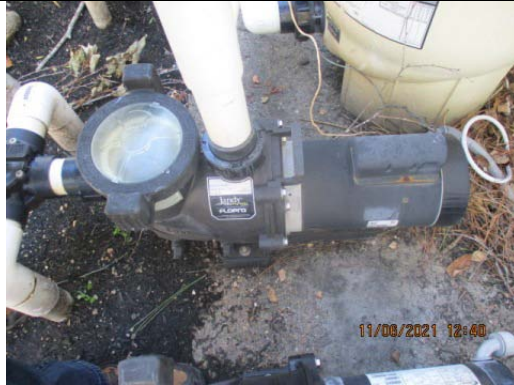
Pump/Motor Condition: Good Fair Poor

Summary/Deficiencies: Pool pump/motor appears to be in fair condition and is functioning as intended however there were deficiencies/items of concern as noted above in yellow.

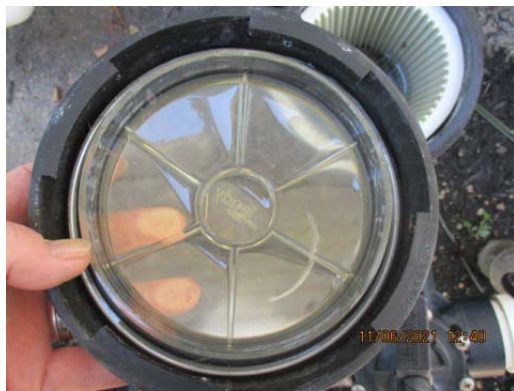
O-Ring Condition:

Yes No This is an indication of a leak on the suction side & should be further evaluated by a qualified pool technician.

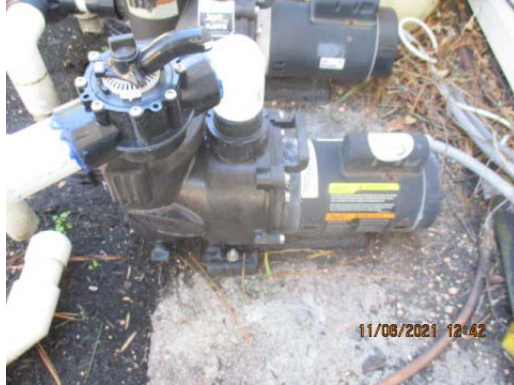
Pump/Motor
Condition:

Summary/Deficiencies: Water feature pump/motor appears to be in fair condition and is functioning as intended however there were deficiencies/items of concern as noted above in yellow.

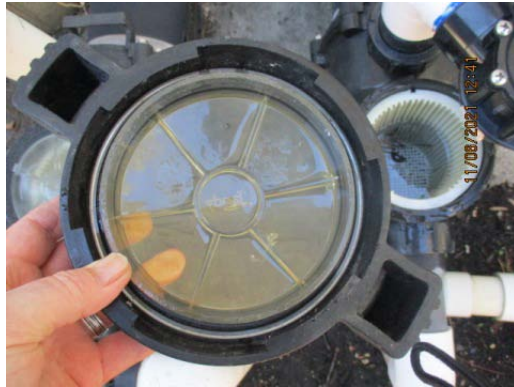
O-Ring Condition:

Are bubbles present
in the pump? Yes No This is an indication of a leak on the suction side & should be further
evaluated by a qualified pool technician.

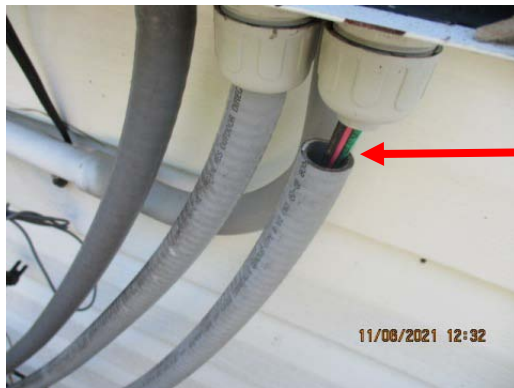
Electrical Condition:

Good Fair Poor (The conduit is not properly secured & sealed below the controller. Recommend securing & sealing to prevent moisture penetration).

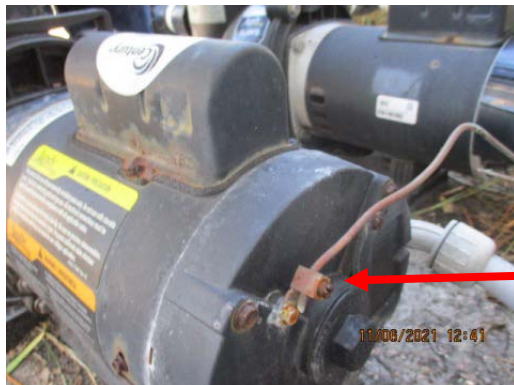
Motor Bonded:

Yes No Appeared to be properly bonded however the inspector is not capable of determining if the bonding conductor is properly connected to the pool rebar.

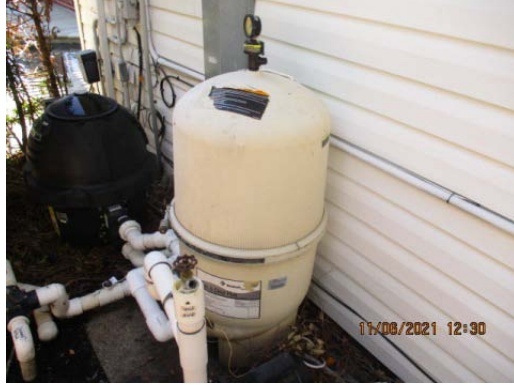
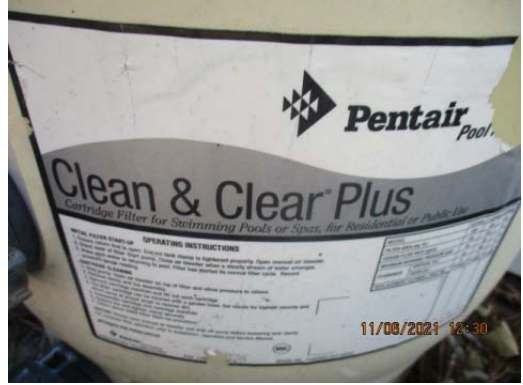
Tank Condition: Good Fair Poor

Summary/Deficiencies: Filter appears to be in fair condition and appeared to be functioning as intended.

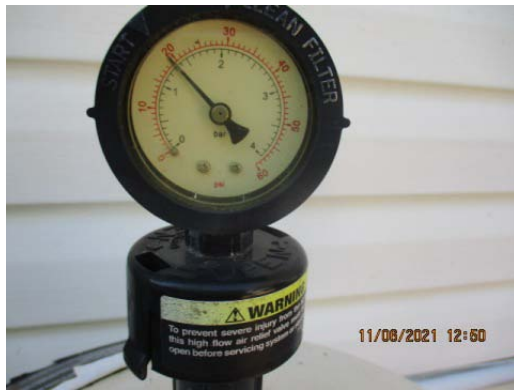
Operating Pressure:

20 PSI

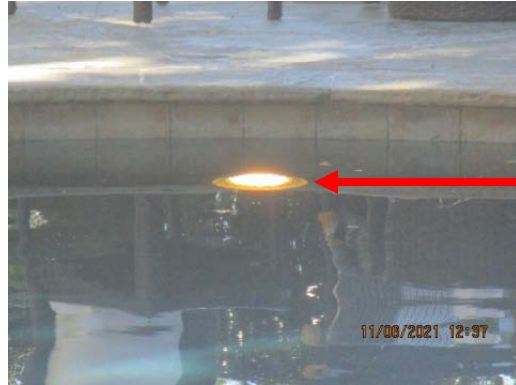
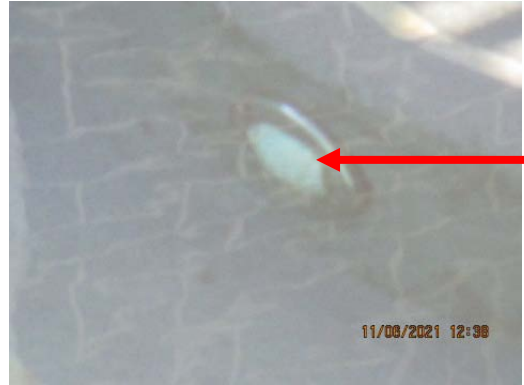
Light Condition:

Good (Deep End) Fair Poor (Shallow End) **The pool light in the shallow end of the pool did not function as intended. Recommend repair.**

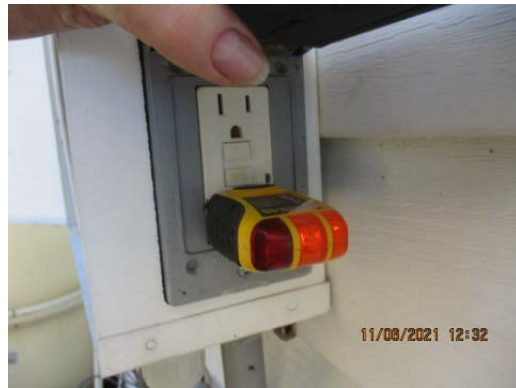
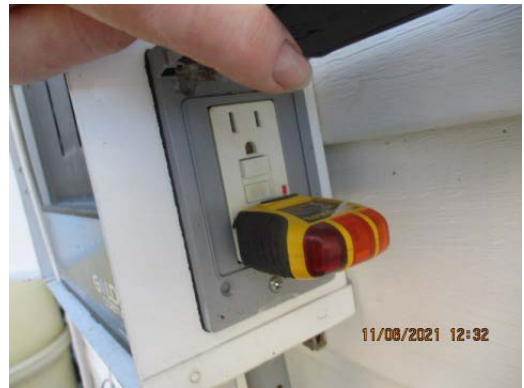
Are Lights GFCI Protected:

Yes No GFCI was tested & functioned as intended. It is recommended that the GFCI protection for the pool be tested on a regular basis to ensure the device is functioning as intended.

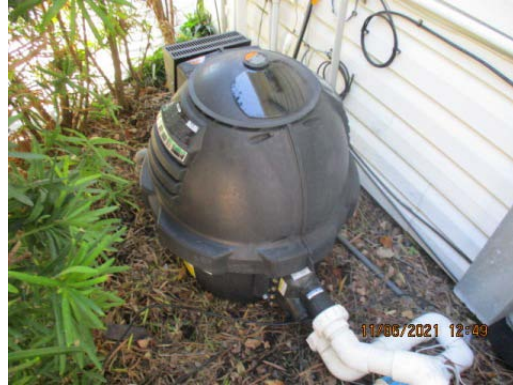
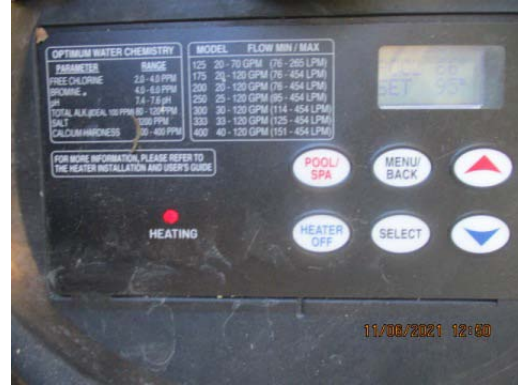
Heater Condition:

Good Fair Poor

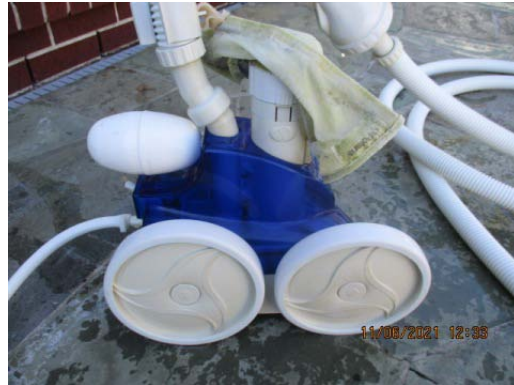
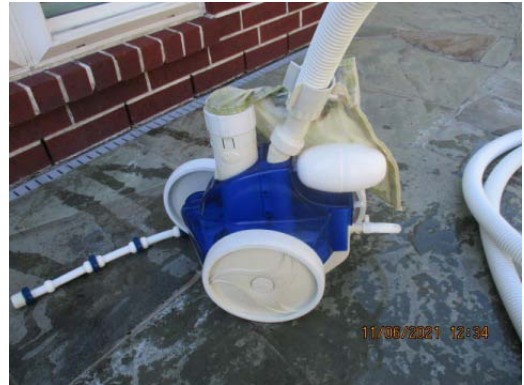
Cleaner Condition:

Summary/ Deficiencies: Pool cleaner appears to be in good condition and appeared to be functioning as intended.

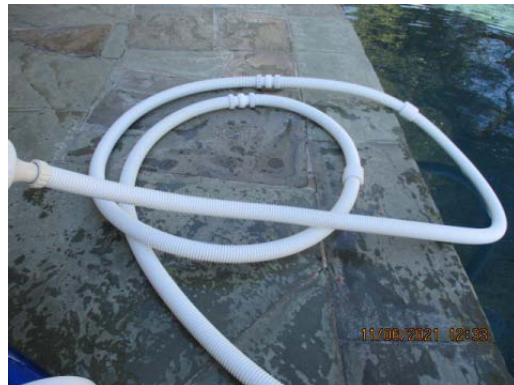
Hose Condition:

Good Fair Poor

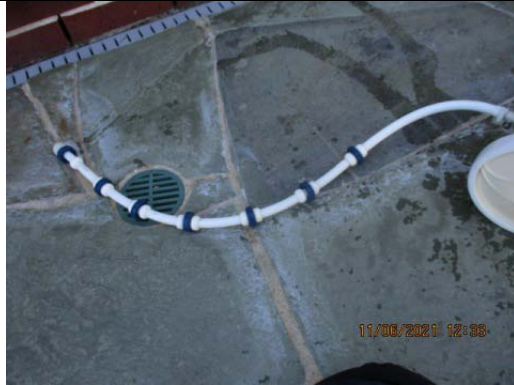
Tail Sweep Condition: Good Fair Poor

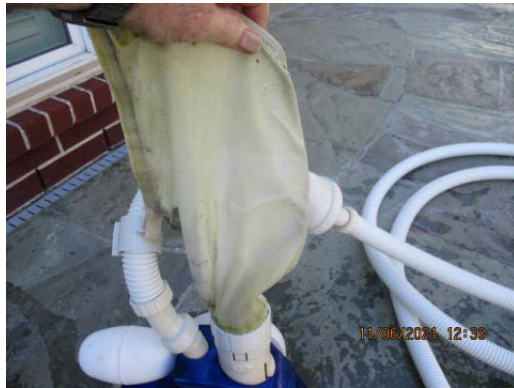
Bag Condition:

Good Fair Poor

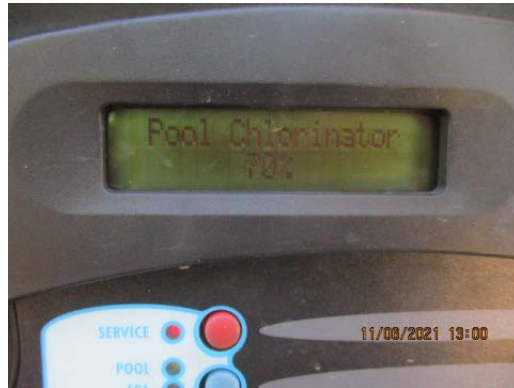
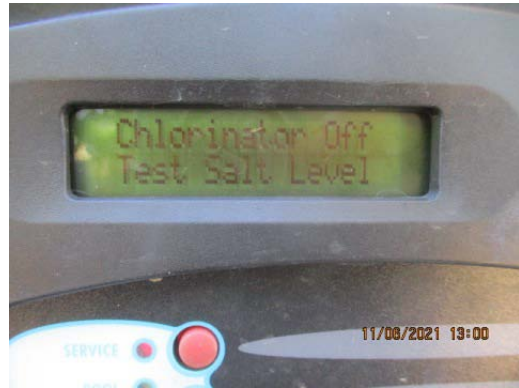
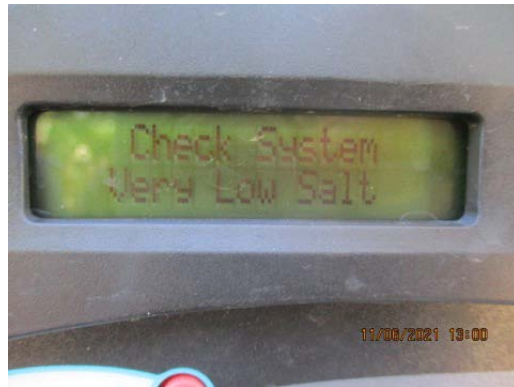
Does the chlorine system appear to be functioning as intended?

Yes No Salt level was very low, chlorinator was off, chlorinator @ 70% & the system was off with a service light lit. Recommend further evaluation by a qualified pool technician.

Summary/Deficiencies: Chlorine system did not appear to be functioning as intended & there were deficiencies/items of concern as noted above in yellow.

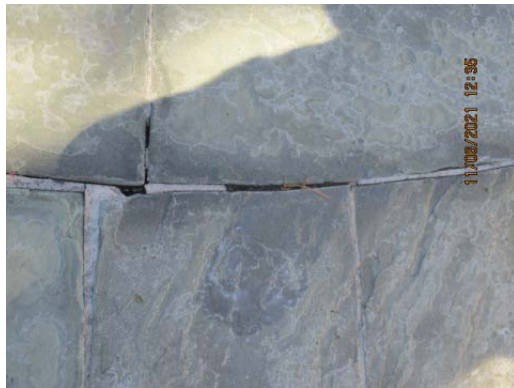
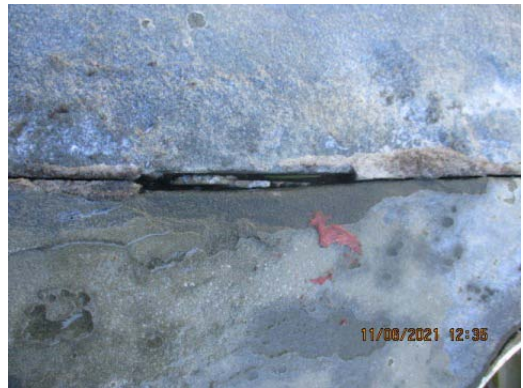
Cracking in the pool decking?

Yes No Recommend sealing the construction joint between the decking & pool coping with a self leveling compound to prevent moisture penetration.

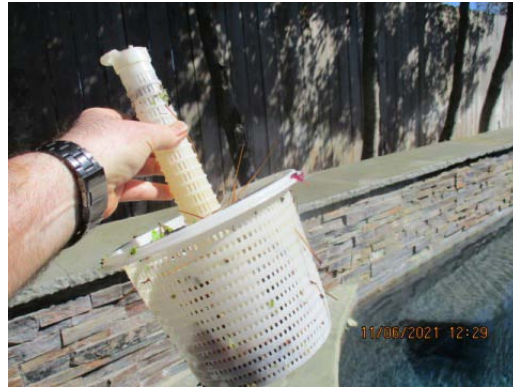
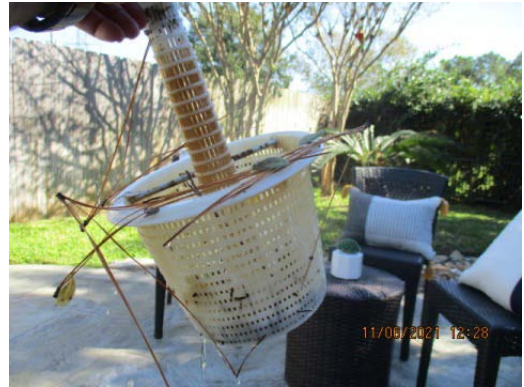
Skimmer Basket Condition:

Weir Condition: Good Fair Poor Missing. The right side weir is missing. Recommend the installation of a weir by a qualified pool contractor as required.

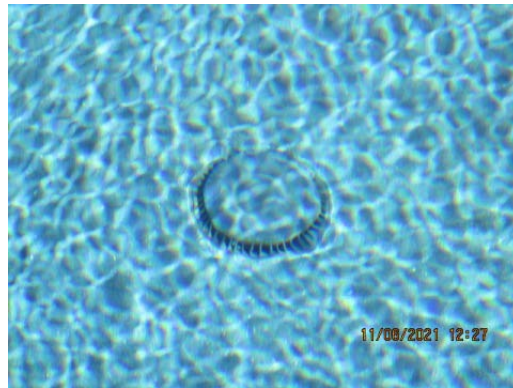
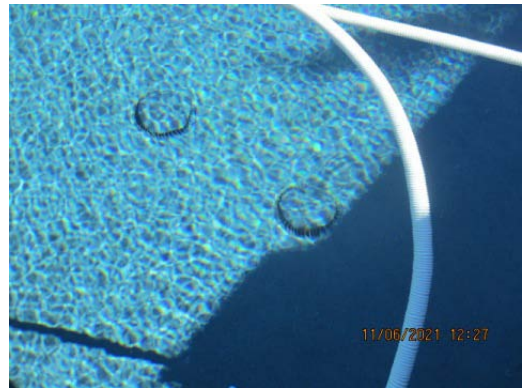
Main Drain Covers VGB Compliant/Anti-Vortex Compliant:

Yes, the drain cover/covers appeared to be VGB/Anti-Vortex Compliant from the pools surface.
