# PROPERTY INSPECTION REPORT

**Concerning: 18634 N Lyford Dr., Katy, TX 77449**

**By: Steve Cochran, Professional Inspector # 6482**

**Date: 11/22/2021**

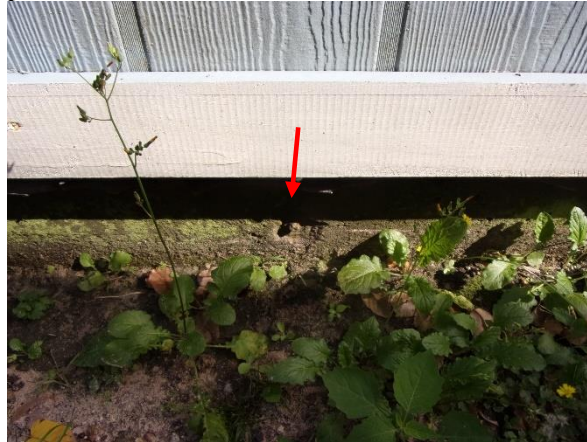
- Foundation: Post tension cable or rebar ends were observed on the exterior of the foundation. If left unattended, the cable can rust and compromise foundation integrity. Minor repair(s) should be undertaken as necessary to prevent corrosion. NOTE: A non-shrink cement mix should be used.

Foundation: Post tension cable or rebar ends were observed on the exterior of the foundation. If left unattended, the cable can rust and compromise foundation integrity. Minor repair(s) should be undertaken as necessary to prevent corrosion. NOTE: A non-shrink cement mix should be used.

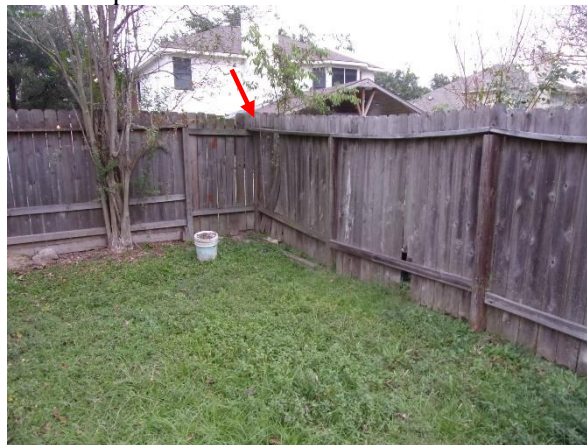
- Exterior: Leaning, damaged or loose sections of fence should be re-secured and/or repaired.

Exterior: Leaning, damaged or loose sections of fence should be re-secured and/or repaired.

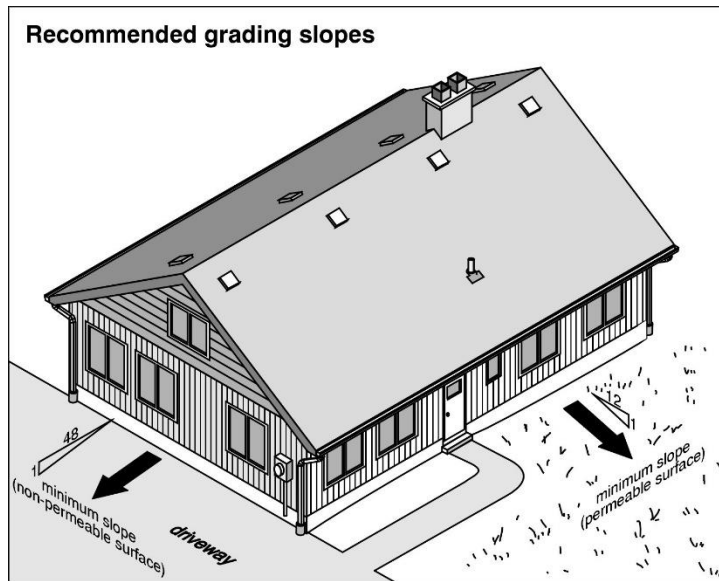
- Exterior: The grading should be improved to promote the flow of storm water away from the house and out of the yard. The ground should slope away from the house at a rate of one inch per foot for at least the first ten feet. NOTE: If re-grading the property is not practical, a drainage system can usually achieve the desired results. Improvements are recommended as needed.

Exterior: The grading should be improved to promote the flow of storm water away from the house and out of the yard. The ground should slope away from the house at a rate of one inch per foot for at least the first ten feet. NOTE: If re-grading the property is not practical, a drainage system can usually achieve the desired results. Improvements are recommended as needed.

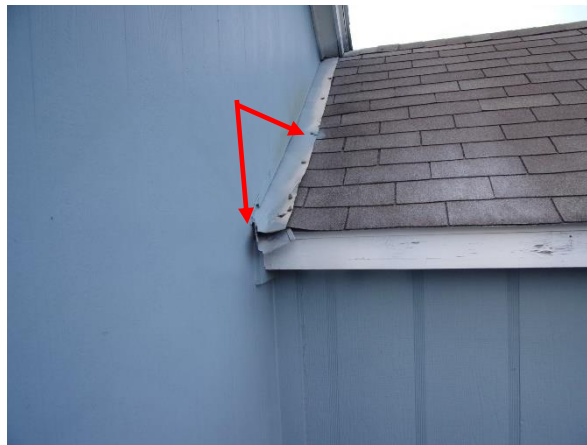
- Roof: The flashing over the dining room does not appear to have been properly installed and a gap is visible between the siding and flashing at the bottom.

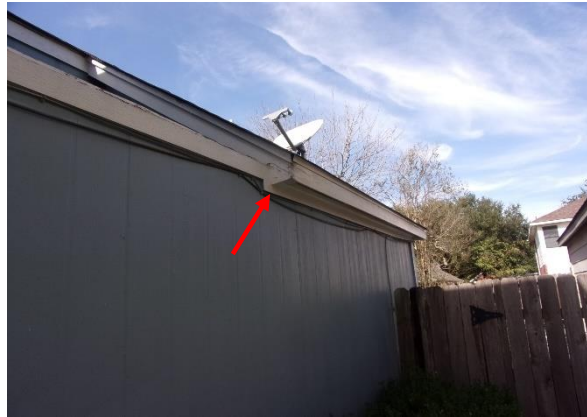
- Exterior: The gutters are rusted, loose, and damaged at various locations.
- Exterior: Rotting or deteriorated soffit / fascia / trim boards were noted in but are not limited to the following areas: right and left elevations. These boards should be repaired or replaced as necessary. NOTE: It is not the intention of this report to point out all such areas.

Exterior: The gutters are rusted, loose, and damaged at various locations.

Exterior: Rotting or deteriorated soffit / fascia / trim boards were noted in but are not limited to the following areas: right and left elevations. These boards should be repaired or replaced as necessary. NOTE: It is not the intention of this report to point out all such areas.

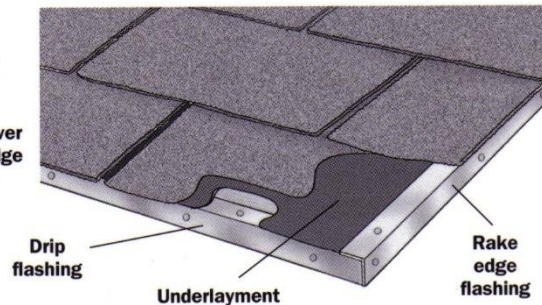
Fig. 47  
Roof Edge Flashing

- Exterior: The drip edge (flashing around the perimeter of the roof) is missing at various locations and should be repaired or replaced as recommended by the Asphalt Roofing Manufacturers Association (ARMA). A qualified roofer should be consulted.

Underlayment laps over  
drip flashing, rake edge  
flashing laps over  
underlayment

Exterior: The drip edge (flashing around the perimeter of the roof) is missing at various locations and should be repaired or replaced as recommended by the Asphalt Roofing Manufacturers Association (ARMA). A qualified roofer should be consulted.

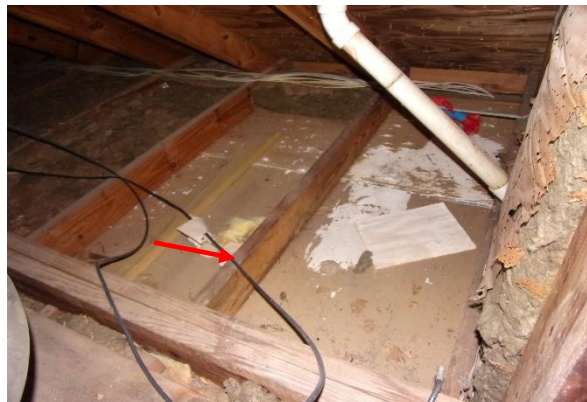
- Attic: Missing insulation in the attic at various locations should be replaced as needed.

Attic: Missing insulation in the attic at various locations should be replaced as needed.

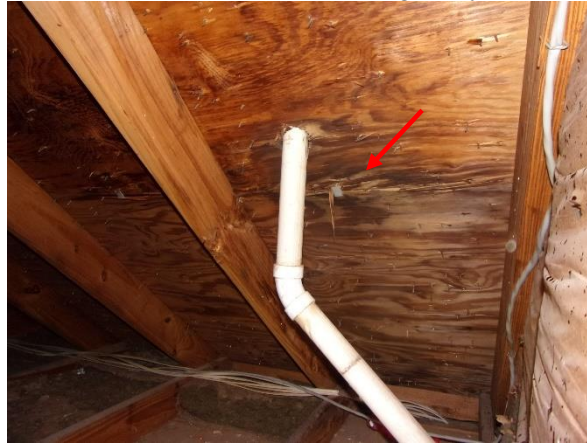
- Attic: Signs of water staining were noted on framing members or decking, indicating previous leakage. Further investigation as to whether the leaks are active and to the amount of damage may be necessary.

Attic: Signs of water staining were noted on framing members or decking, indicating previous leakage. Further investigation as to whether the leaks are active and to the amount of damage may be necessary.

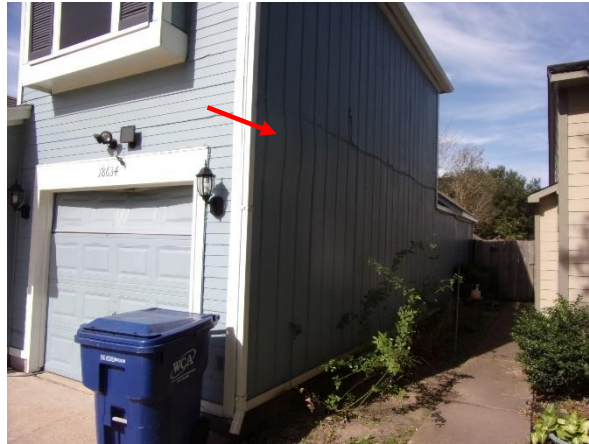
- Exterior: The right elevation siding is bowed outwards at mid height and rotted along the bottom. A qualified contractor should be engaged for repairs. *(picture next page)*

Exterior: The right elevation siding is bowed outwards at mid height and rotted along the bottom. A qualified contractor should be engaged for repairs.

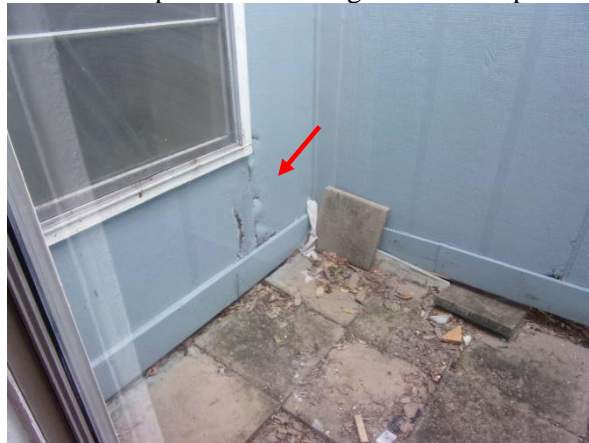
- Exterior: This particular type of wood fiber or laminate siding may be prone premature decomposition due to moisture related problems. Further evaluation in to the brand and its current status is recommended. Decayed or deteriorated portions of siding should be replaced as necessary.

Exterior: This particular type of wood fiber or laminate siding may be prone premature decomposition due to moisture related problems. Further evaluation in to the brand and its current status is recommended. Decayed or deteriorated portions of siding should be replaced as necessary.

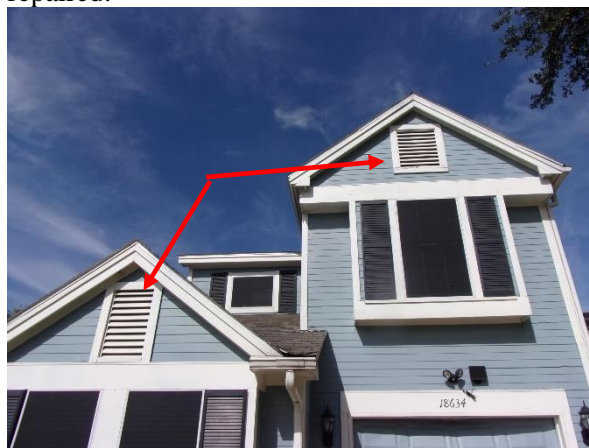
- Exterior: The wood trim around the front louvers is rotted and should be repaired.

Exterior: The wood trim around the front louvers is rotted and should be repaired.

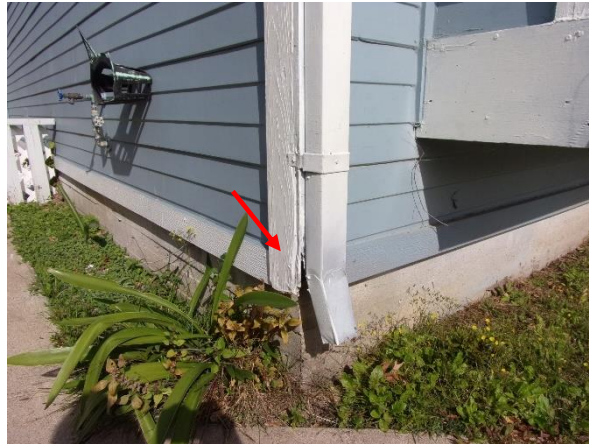
- Exterior: Rotted or deteriorated wood trim at various locations should be repaired.

Exterior: Rotted or deteriorated wood trim at various locations should be repaired.

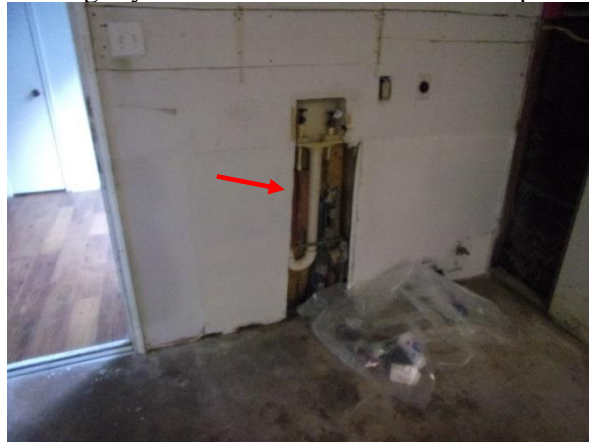
- Garage: The wall between the garage and interior acts as a fire barrier so any missing drywall and insulation should be repaired by a qualified contractor.

Garage: The wall between the garage and interior acts as a fire barrier so any missing drywall and insulation should be repaired by a qualified contractor.

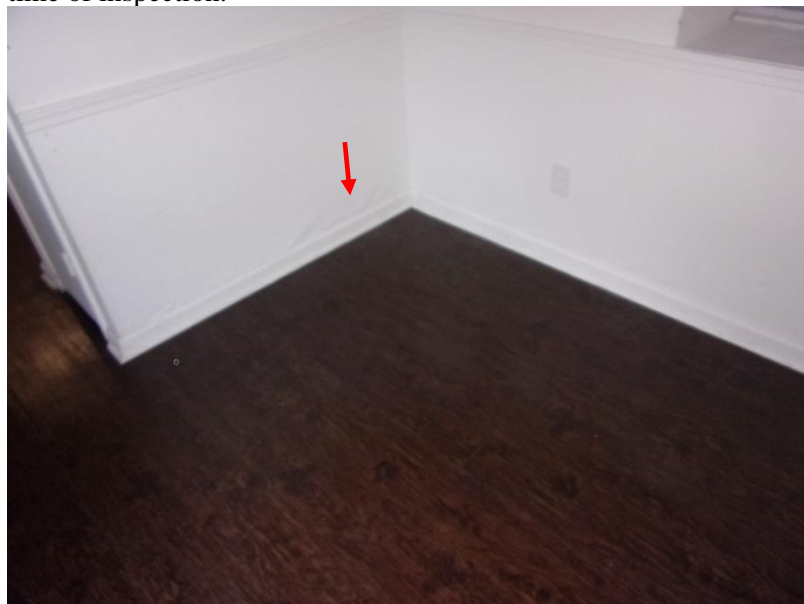
- Interior: The drywall was wrinkled all around the bottom of the dining room suggesting previous moisture damage. No active moisture was detected at time of inspection.

Interior: The drywall was wrinkled all around the bottom of the dining room suggesting previous moisture damage. No active moisture was detected at time of inspection.

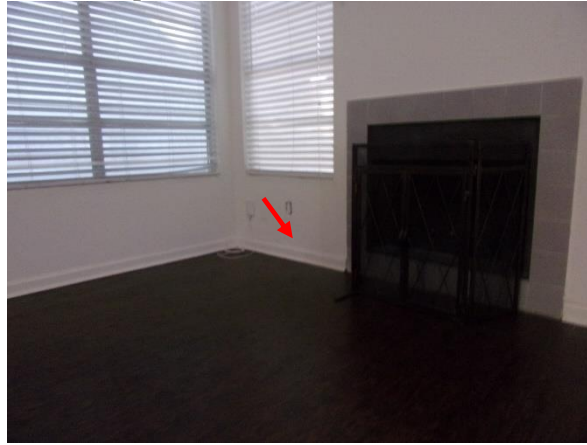
- Interior: The drywall is also wrinkled at the bottom of the wall to the left of the fireplace suggesting previous moisture damage (no active moisture at time of inspection).

Interior: The drywall is also wrinkled at the bottom of the wall to the left of the fireplace suggesting previous moisture damage (no active moisture at time of inspection).

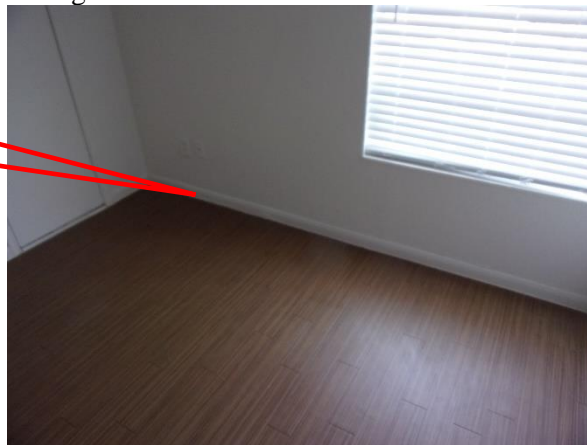
Upstairs  
bedroom

- Interior: Observed rotted or deteriorated baseboard trim in the upstairs right rear bedroom and upstairs hall outside bathroom suggesting moisture damage.

Interior: Observed rotted or deteriorated baseboard trim in the upstairs right rear bedroom and upstairs hall outside bathroom suggesting moisture damage.

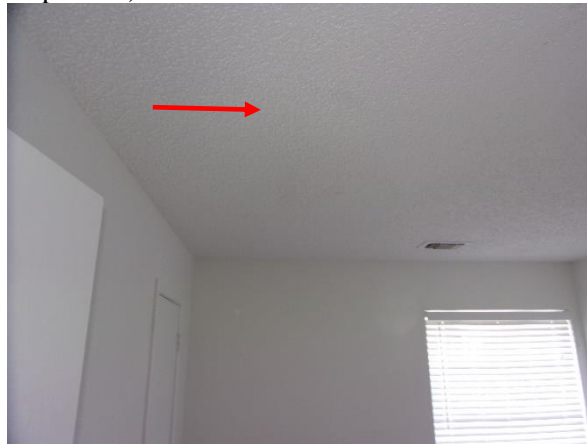
- Interior: Observed drywall paper bubble on the upstairs right rear bedroom ceiling suggesting a previous or current leak (no active moisture at time of inspection). Further evaluation recommended.

Interior: Observed drywall paper bubble on the upstairs right rear bedroom ceiling suggesting a previous or current leak (no active moisture at time of inspection). Further evaluation recommended.

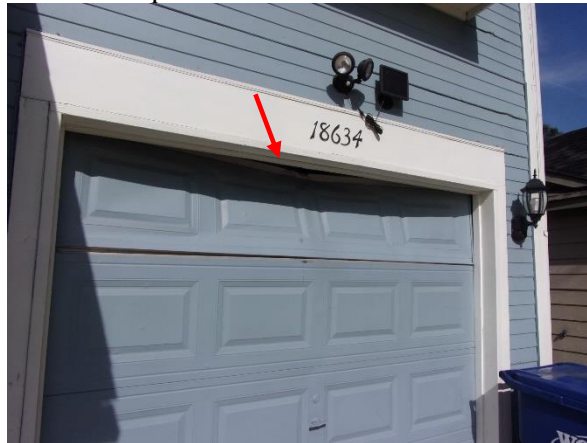
- Exterior: The top panel on the garage is severely bent and damaged and should be replaced.

Exterior: The top panel on the garage is severely bent and damaged and should be replaced.

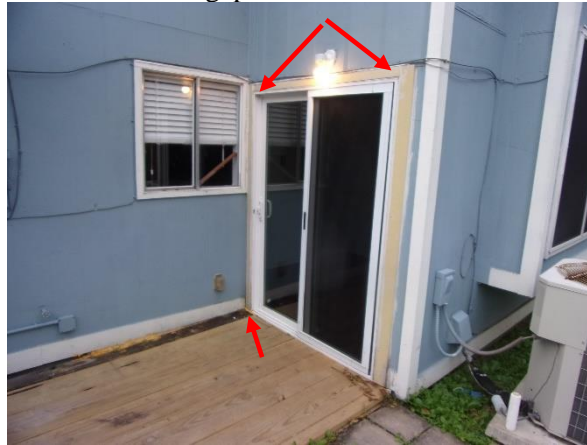
- Exterior: The trim around the rear sliding glass doors does not appear to be well sealed with gaps at various locations.

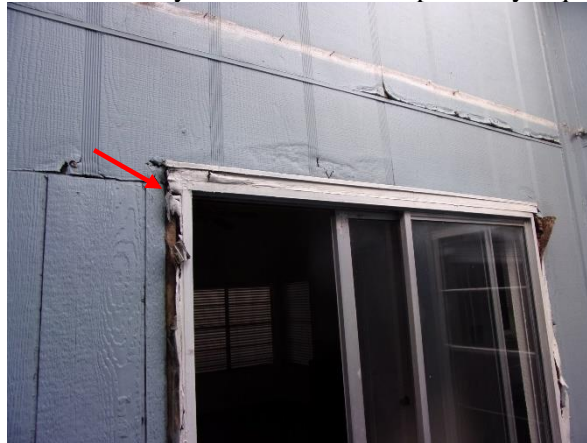
- Exterior: The trim and siding around the right elevation sliding glass doors is tooted or decayed and should be repaired by a qualified contractor.

Exterior: The trim and siding around the right elevation sliding glass doors is tooted or decayed and should be repaired by a qualified contractor.

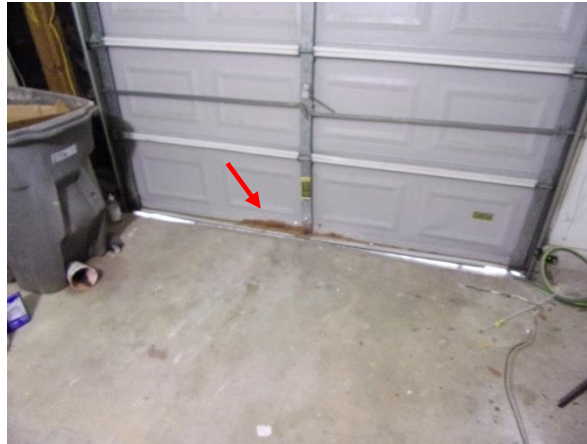
- Exterior: The screen for the sliding glass door is missing and should be replaced.
- Garage: The bottom garage door panel is rusted.

Exterior: The screen for the sliding glass door is missing and should be replaced.

Garage: The bottom garage door panel is rusted.

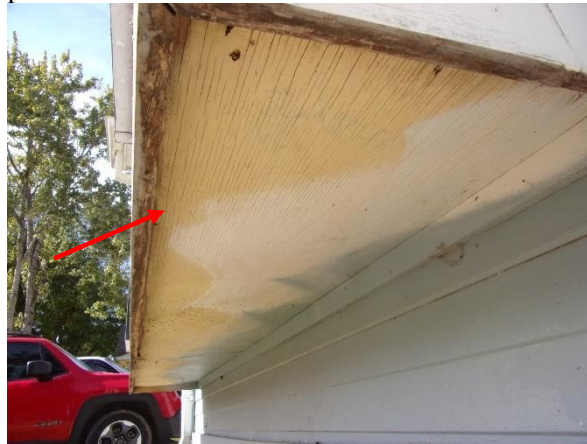
- Exterior: The underside of the front box window should be caulked and painted.

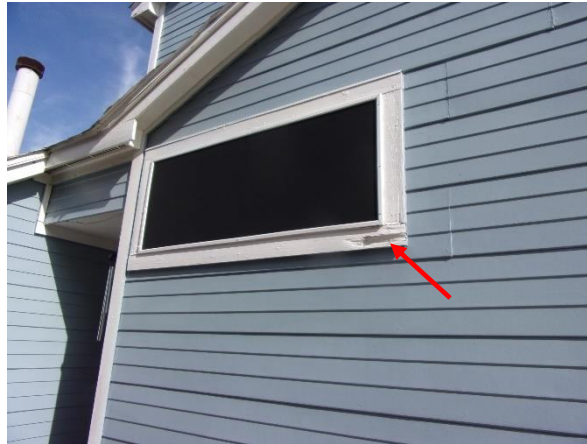
- Exterior: Windows should be caulked and or re-pointed (brick mortar patch) at various exterior locations where gaps or holes are present between window frame or trim and siding to prevent excess moisture and / or insect activity.
- Exterior: It may be desirable to replace window screens where missing and/or damaged. The owner should be consulted regarding any screens that may be in storage.
- Exterior: Rotted or deteriorated window trim should be repaired.

Exterior: Windows should be caulked and or re-pointed (brick mortar patch) at various exterior locations where gaps or holes are present between window frame or trim and siding to prevent excess moisture and / or insect activity.

Exterior: Rotted or deteriorated window trim should be repaired.

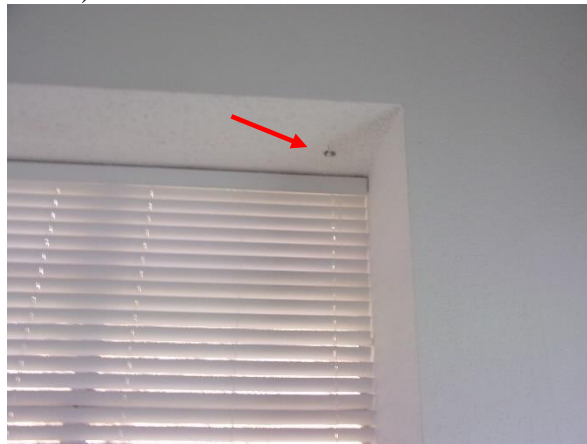
- Interior: Observed what appears to be a previous leak at the rear box window ceiling (no active moisture at time of inspection but it had not recently rained).

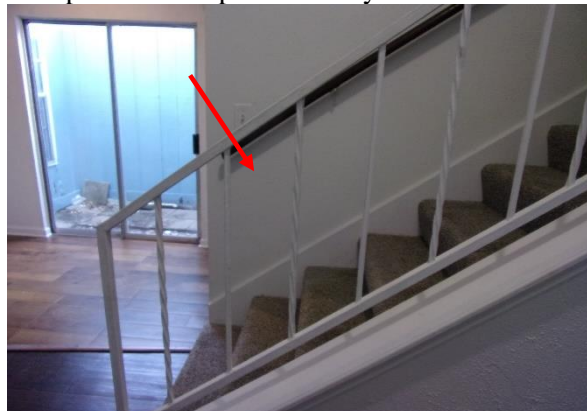
- Interior: The openings in the railing are large enough to allow an object larger than four inches to fall through. It is recommended that this condition be repaired for improved safety.

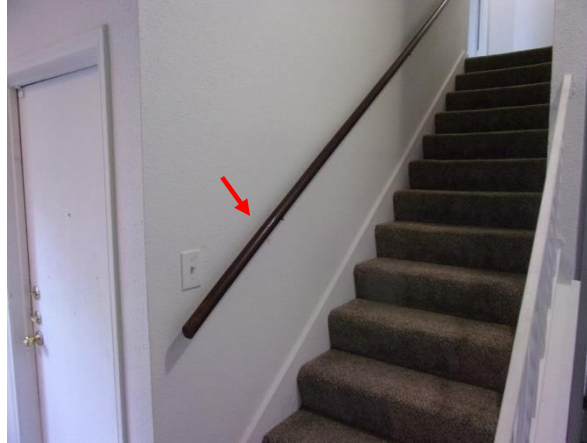
- Interior: The railing is loose and should be repaired for improved safety.

Interior: The railing is loose and should be repaired for improved safety.

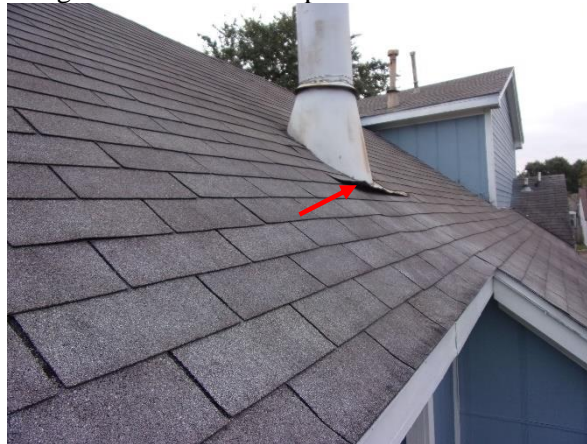
- Roof: The flashing at the bottom of the chimney has curled up off the shingles and should be repaired.

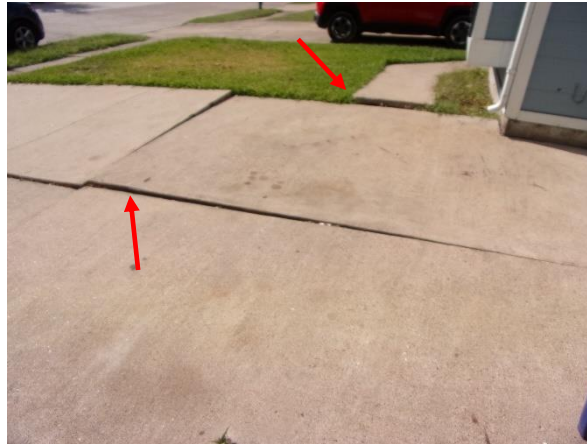
- Exterior: Uneven sections of concrete in the driveway and sidewalk should be corrected as needed.

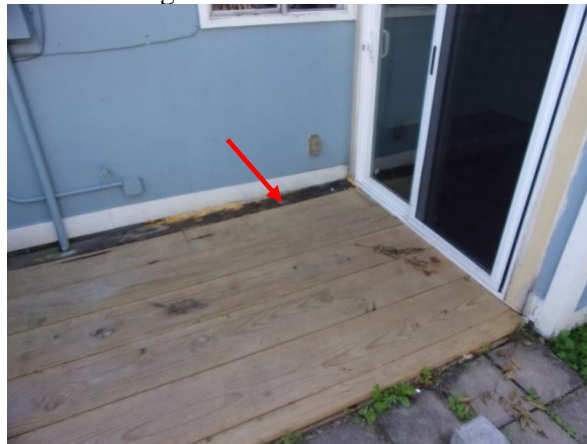
- Exterior: The rear deck has been constructed too high and may aid in rain water wicking below the wall and/or door.

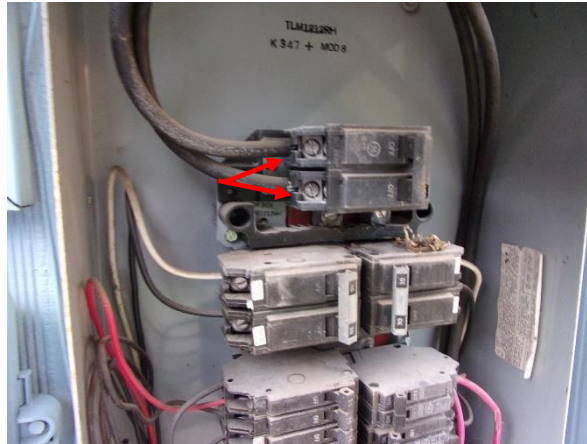
- Main Panel: location(s): Rear exterior
- Main Panel: 100-amp 120/240 volt below ground service.
- Main Panel: An anti-oxidant compound should be used on all exposed aluminum feeder wire terminals. Periodic tightening of the lugs may be necessary due to the expansive nature of aluminum. A licensed electrician should be consulted.

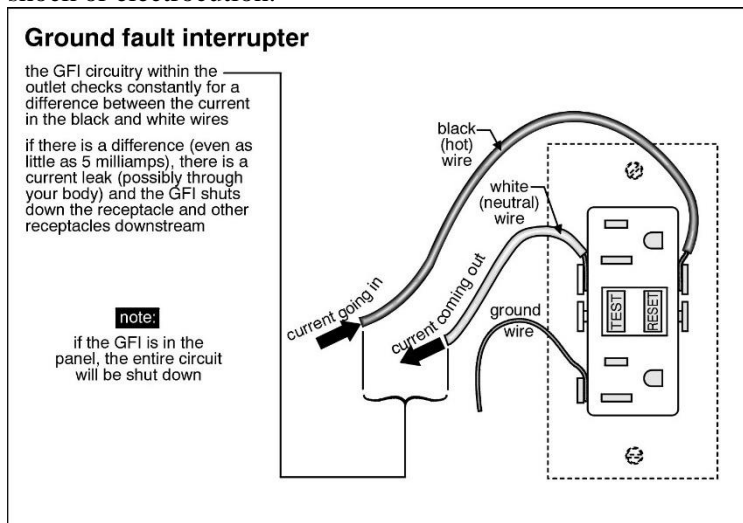
- General: Doorbell did not appear to operate using normal controls.
- General: The installation of a ground fault circuit interrupter (GFCI) is recommended at all bathroom, all kitchen counter top locations, wet bars (counter tops within 6 feet of any sink) and outdoor (including garage) locations. A ground fault circuit interrupter (GFCI) offers protection from shock or electrocution.

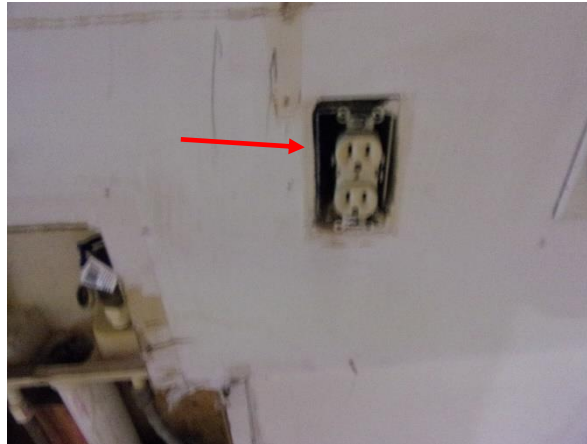
- General: Damaged or missing cover plates over outlets and switches should be replaced as necessary.

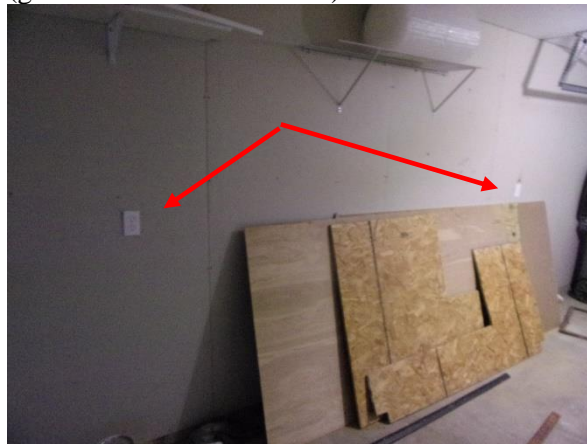
- General: Lights were found to be inoperative. If the bulbs are not blown, the circuit should be investigated.
- General: Wobble in ceiling fans should be corrected.
- General: Loose outlets should be re-secured.
- Garage: The two outlets on the right wall of garage have open grounds (ground wire not connected).

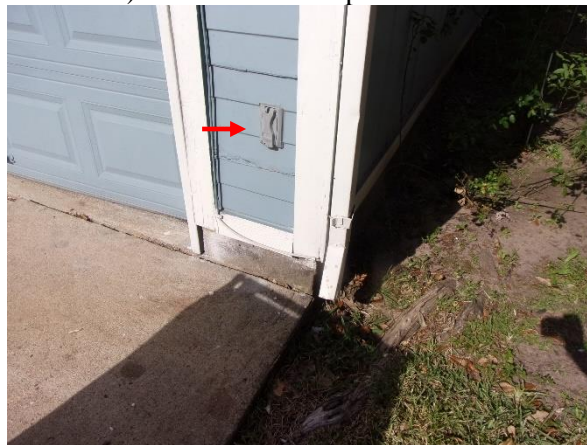
- Exterior: The front right GFCI outlet has an open ground (ground wire not connected) and would not trip when tested.

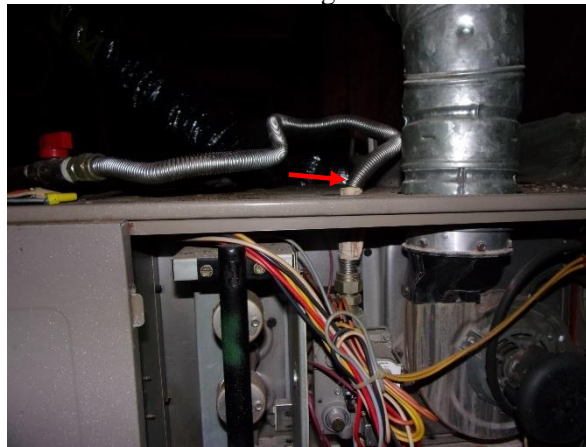
- Attic: The flex gas line should be hard piped at the point of entry at the gas furnace. Vibration against the metal shell of furnace compartment has been known to wear the natural gas flex line.

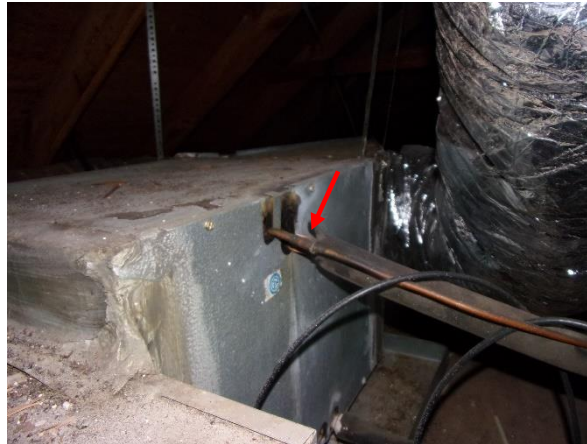
- Attic: Insulation on refrigerant lines should be improved at the evaporator to reduce condensation.

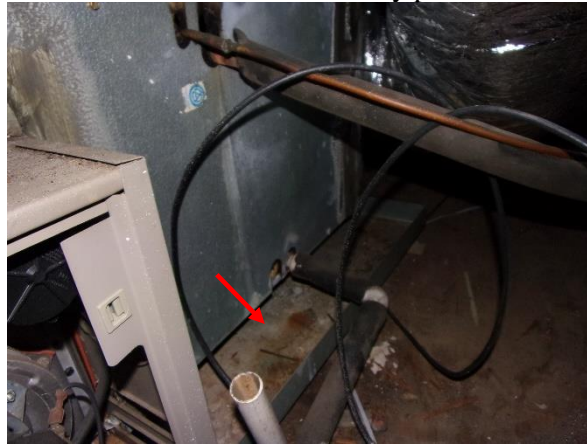
- Attic: Debris inside the secondary pan should be removed.

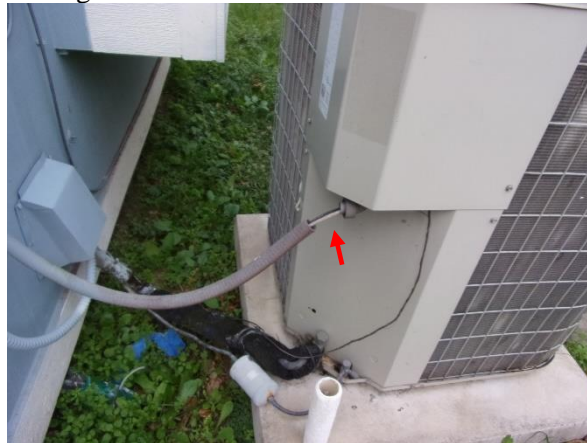
- Exterior: The wiring serving the outdoor unit should be completely enclosed in a rigid conduit.

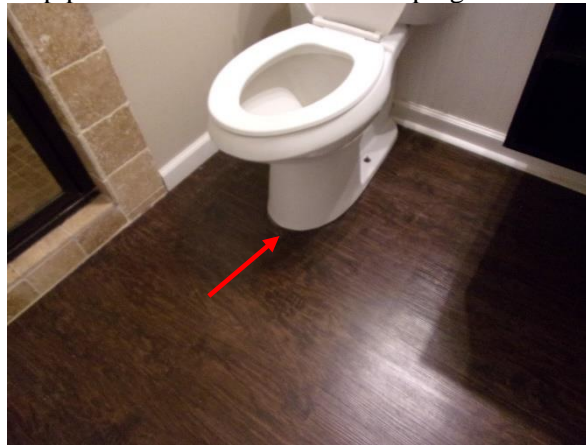
- Bathroom(s): All toilets should be sealed around the bottoms of the floor to help prevent sewer odor from escaping.

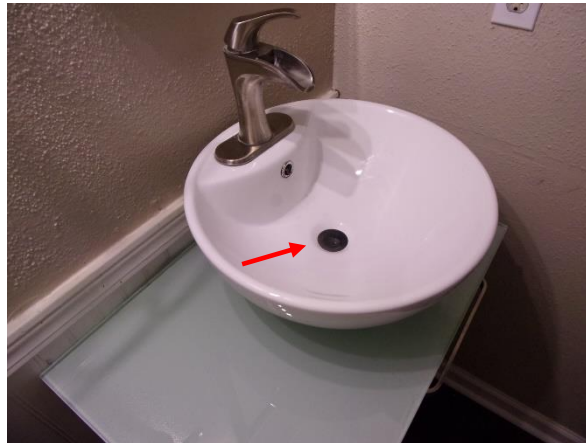
- Bathroom(s): Damaged, non-functioning or missing mechanical drain stoppers (devices that plug sink and tub drains) should be corrected as needed.

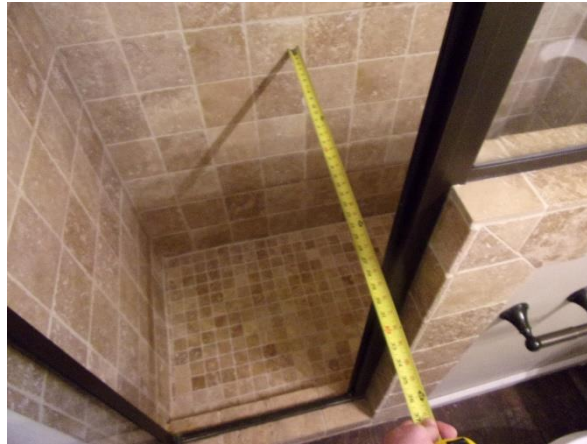
- Bathroom(s): The downstairs shower stall is technically too narrow. The minimum width is 30-inches.

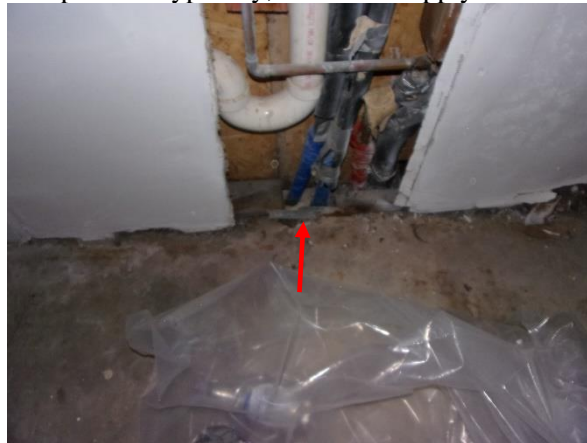
- Bathroom(s): The upstairs toilet is loose and should be re-secured / re-seated as needed.
- Garage: Observed water lines coming up through the foundation at the clothes washing machine. Water supply lines below the slab can be difficult to repair and typically, the water supply lines are not buried below the slab.

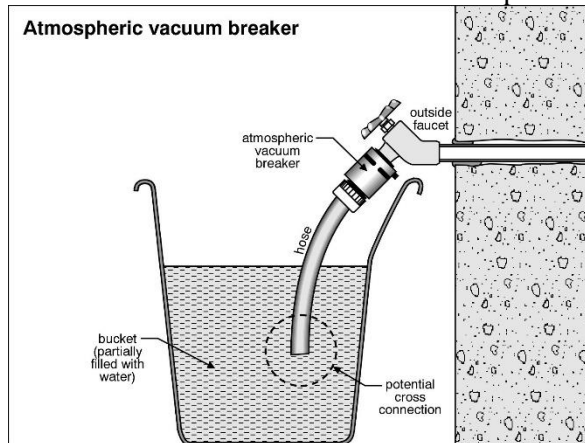
- Exterior: It is recommended that an anti-siphon device (vacuum breaker / backflow preventer) be added to the hose bib(s). This is a small device that attaches to the outside hose connection to prevent water contamination.

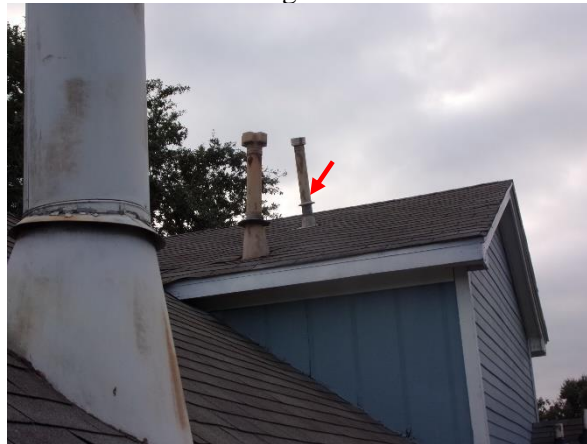
- Roof: The storm collar should be slid down directly over the roof flashing then sealed with a heat grade caulk.

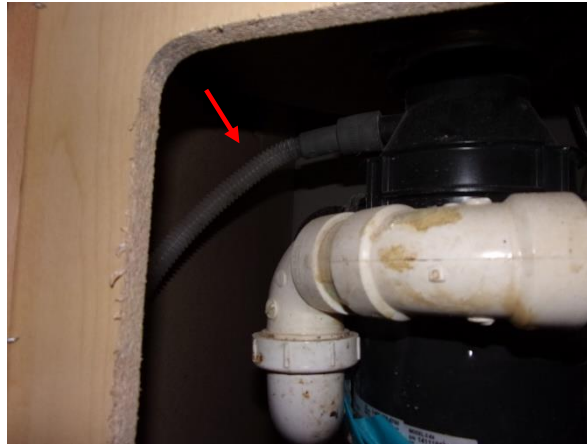
- Kitchen: Loose mounting in the cabinet.
- Kitchen: The flex drain line should be raised as high as possible against the countertop to help prevent back wash into the washer.

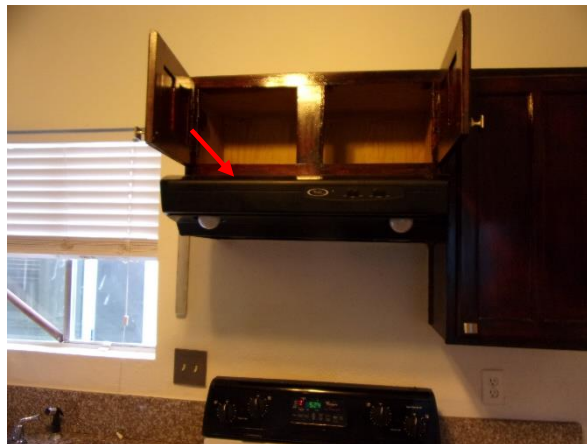
- Kitchen: The fan does not blow out of the top vent and instead just blows the air around in the fan area.

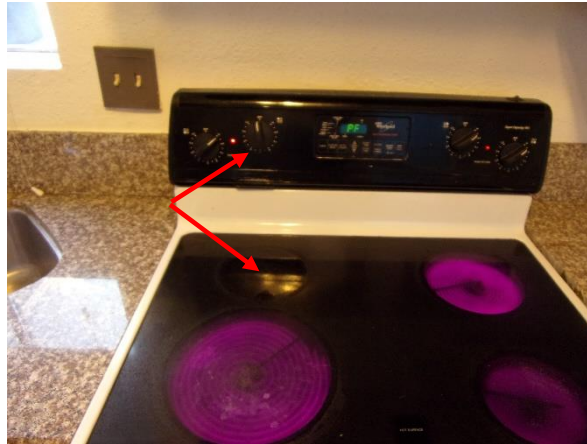
- Kitchen: The knob controlling the left rear burner would not rotate using normal force.

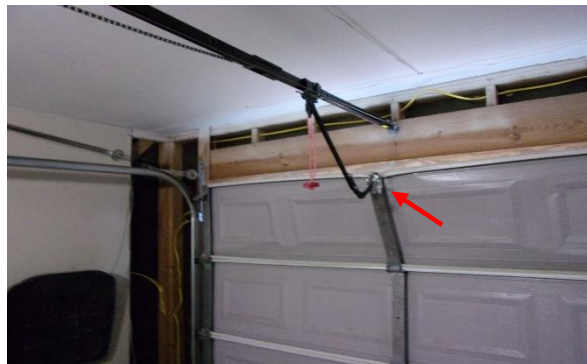
- Garage: The locks for the garage door should be disabled for enhanced safety.
- Garage: The opener could not be tested due to the damaged top panel connection.
