Inspection Report

Property Address:
3600 Jeanetta St
#2712
Houston TX 77063

PROPERTY INSPECTION REPORT

Concerning: 3600 Jeanetta St, #2712, Houston, TX 77063

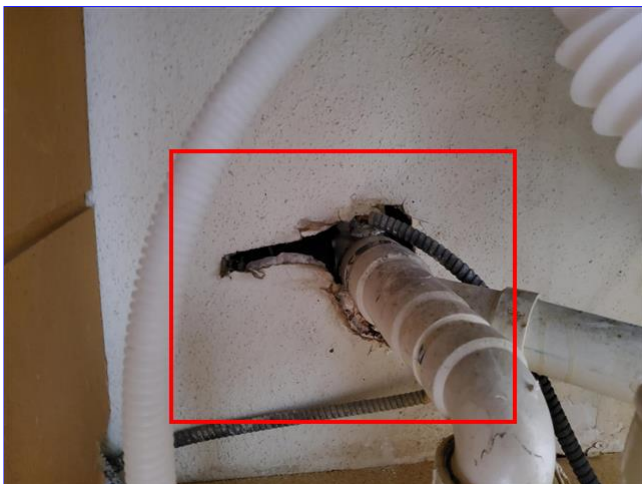
E. Item 1 (Picture) Under kitchen sink

(1) Areas where wiring or piping passes through walls should be sealed. I recommend having a qualified person seal as needed.

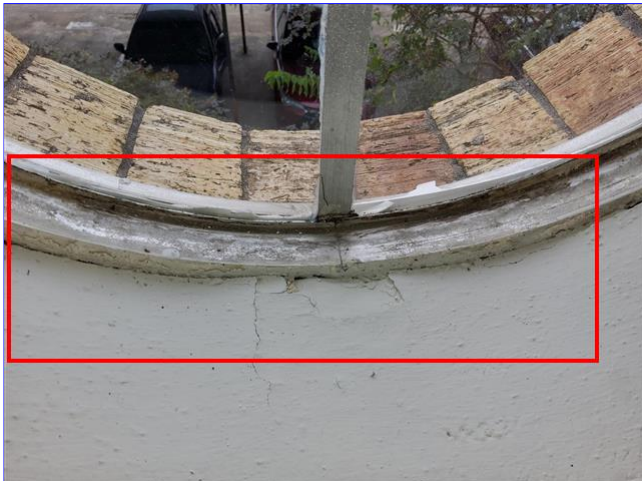
E. Item 6 (Picture) Main entry window

(3) The drywall is damaged in areas of the home. While this damage is cosmetic, it needs to be repaired. A qualified person should repair or replace as needed.

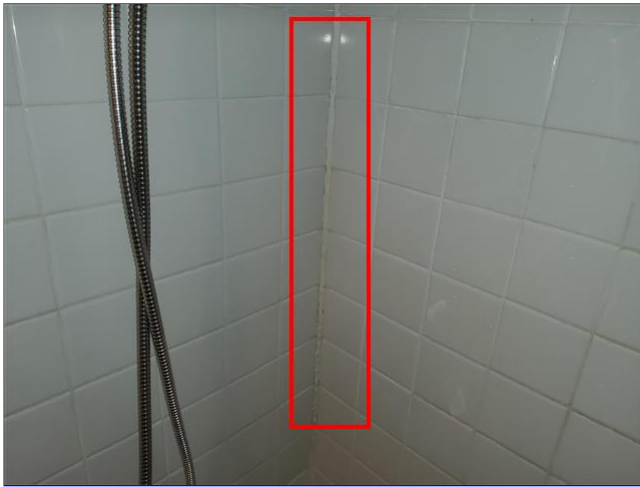
E. Item 9 (Picture)

(5) The Tile surround at bathtub on the wall has been caulked instead of applying grout where obvious at the hall bath. This damage is considered cosmetic. A qualified person should repair or replace as needed.

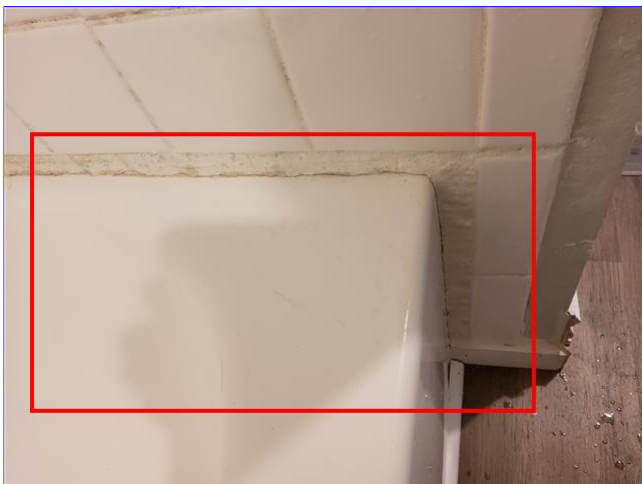
E. Item 10 (Picture)

(6) In the bathroom, there is tile that is cracked and signs of grout beginning to deteriorate. I recommend a qualified person evaluate and repair.

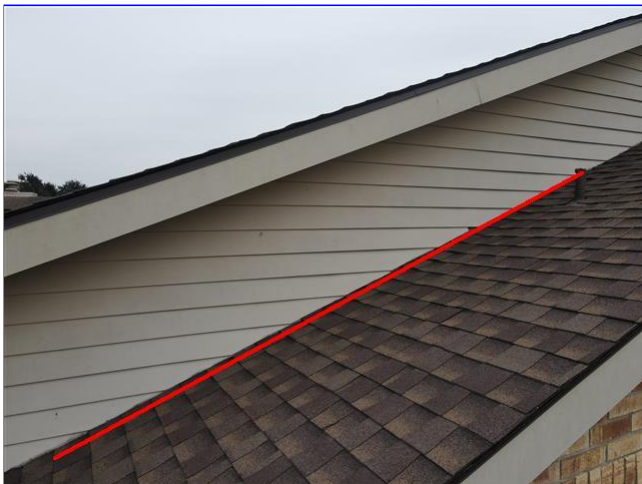
E. Item 12 (Picture)

(7) Siding appears to be in contact with the roof shingles. This can lead to siding deterioration at an accelerated rate. I recommend a qualified person evaluate and correct.

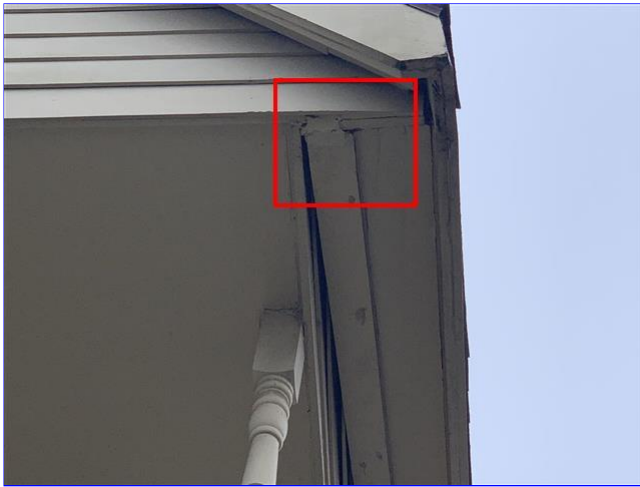
E. Item 13 (Picture) Balcony area

(8) The exterior siding and trim is deteriorated in areas. Further deterioration will occur if not corrected. A qualified contractor should inspect and repair as needed.

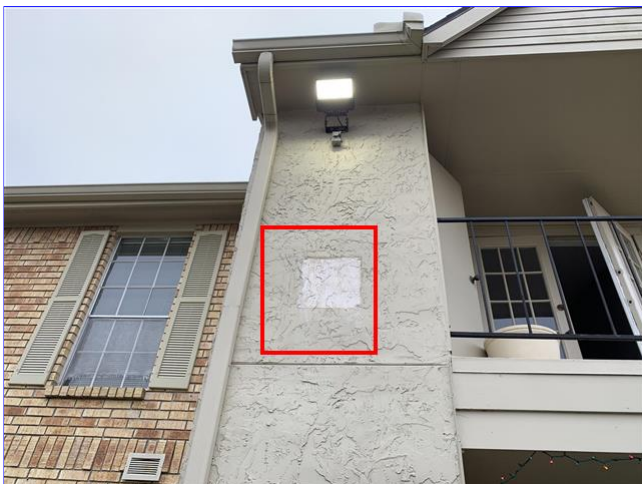
E. Item 15 (Picture)

(9) The stucco at the front of the home is discolored. I am unable to determine if any damage was present. From my vantage point, it appears to be cosmetic. I recommend paint as desired.

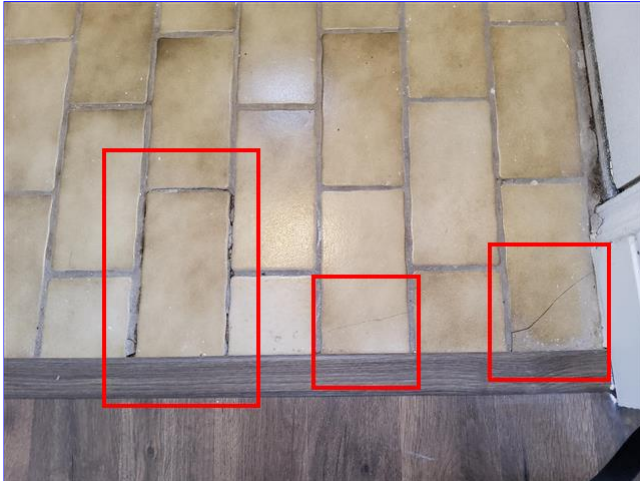
F. Item 1 (Picture) Main entry landing

(1) The tile flooring is cracked/damaged. This damage is considered cosmetic. I recommend repair as desired.

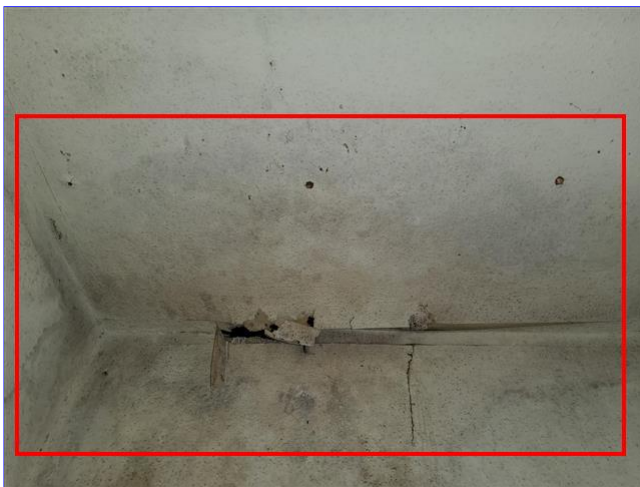
F. Item 4 (Picture)

(2) At the storage space, signs of water damage were visible and appears to have damage in areas of ceiling and walls. I used a moisture meter in this area and found a moisture reading of 0%. I am not able to determine if the area is still susceptible to further water intrusion. I recommend a qualified person evaluate and repair as needed.

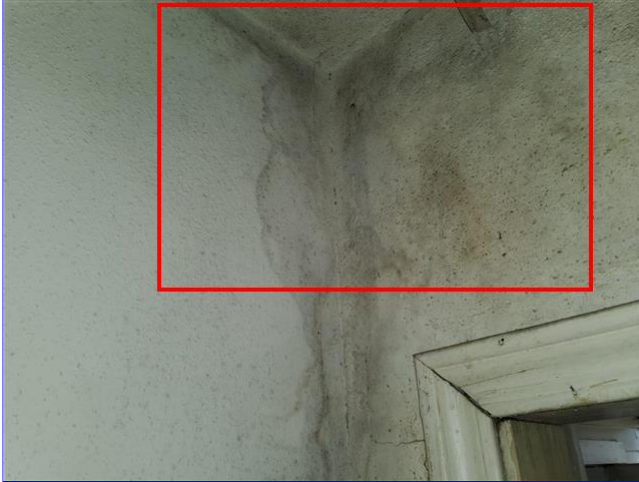
F. Item 5 (Picture) Store area on balcony

(3) Signs of fungi growth are present on ceiling in areas. We did not inspect, test or determine if this growth is or is not a health hazard. The underlying cause is moisture or dampness. I recommend you contact a mold inspector or expert for investigation or correction if needed.

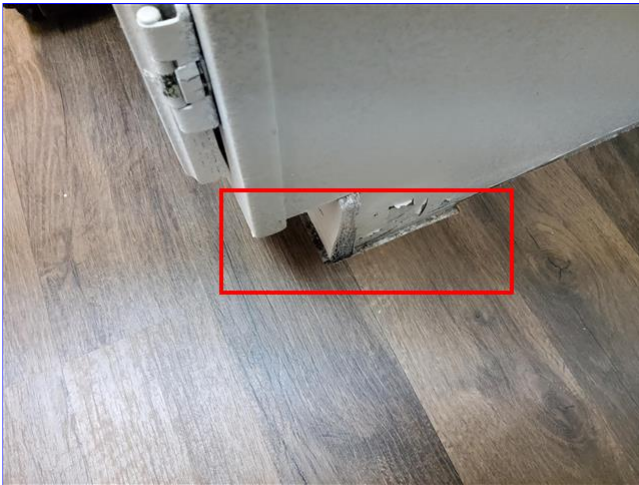
F. Item 6 (Picture) Gaps between flooring and cabinets

(4) The tile flooring is not installed properly. This is considered cosmetic. I recommend repair as desired.

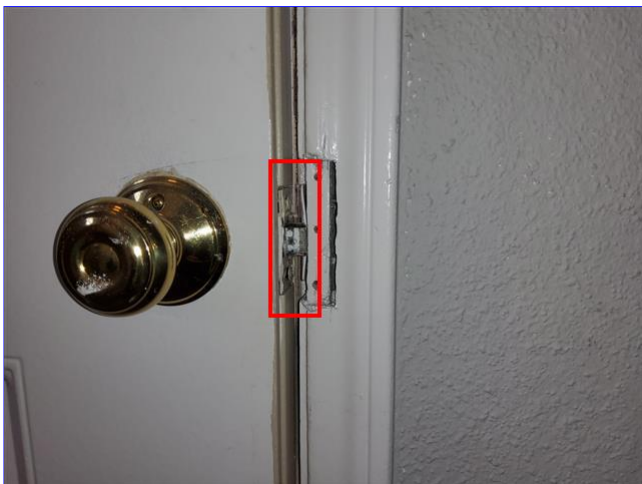
G. Item 1 (Picture) Main entry door.

(1) The interior door does not shut and latch properly. This is a maintenance issue and is for your information. A qualified contractor should inspect and repair as needed.

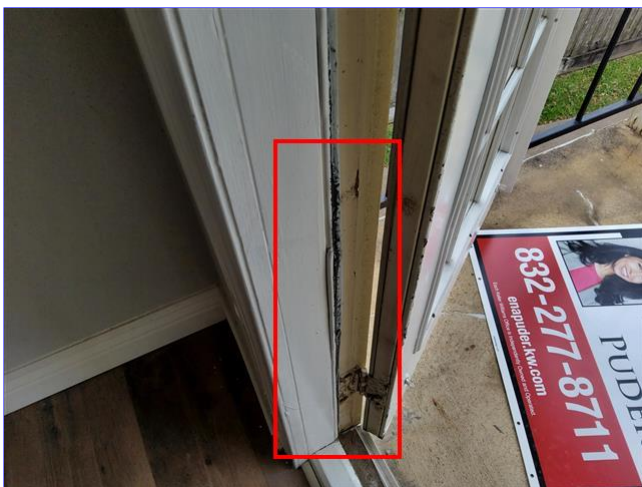
G. Item 2 (Picture)

(2) The weather-stripping at the doors that lead to the balcony were painted over. This caused the door to be painted to the door jamb. I recommend a qualified person evaluate and repair.

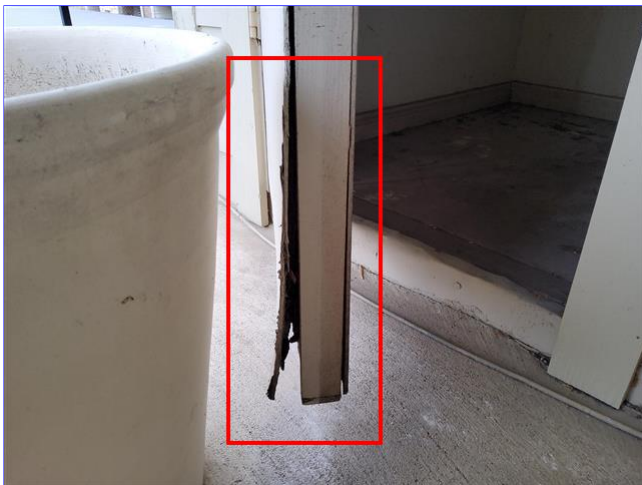
G. Item 4 (Picture)

(3) The covered patio does not shut properly and is delaminated.. This is a maintenance issue and is for your information. A qualified person should repair or replace as needed.

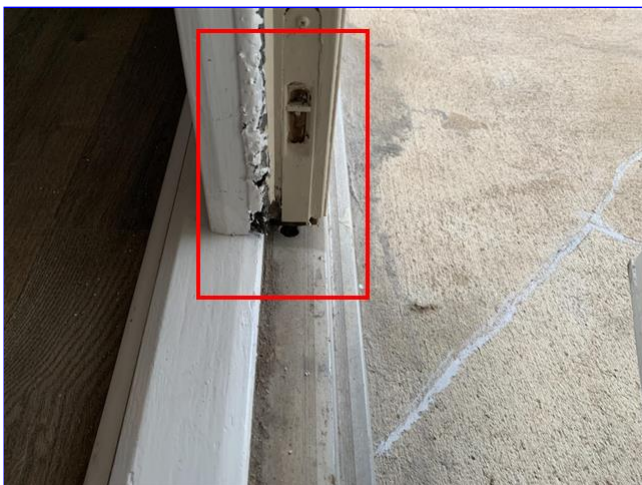
G. Item 5 (Picture)

(4) The door that leads to the balcony does not latch easily. I could not easily get the bottom latch to properly lock. I recommend a qualified person evaluate and repair.

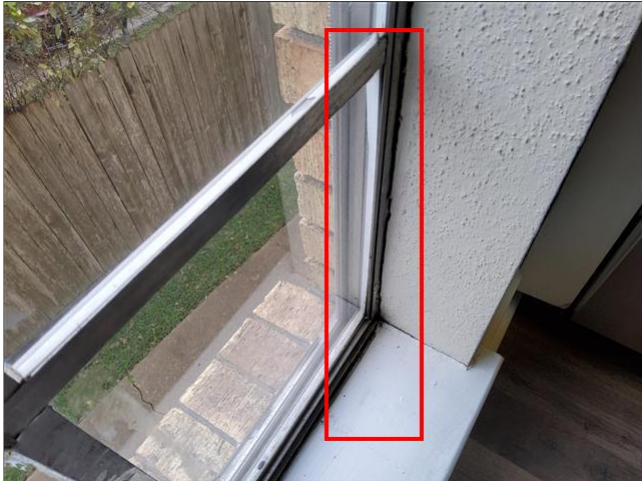
H. Item 1 (Picture) Kitchen window

(1) There are window frames that are not properly sealed. This can cause energy loss. I recommend having a qualified person seal and repair as needed,

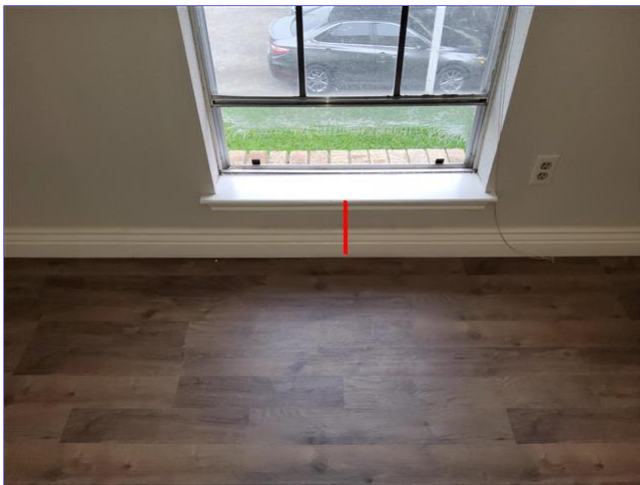
H. Item 5 (Picture)

(3) Window does not have proper clearance from flooring in upstairs bedroom. A fall or injury could occur. This is for your information.

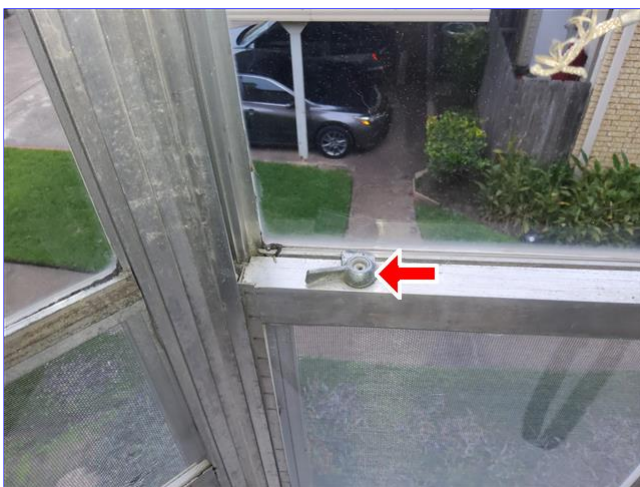
H. Item 8 (Picture)

(4) The windows in the master bedroom do not lock properly. One window is missing a lock, others don't line up properly with the latch. In addition to this, the landing area for the window is showing signs of deterioration. I recommend a qualified person evaluate and repair.

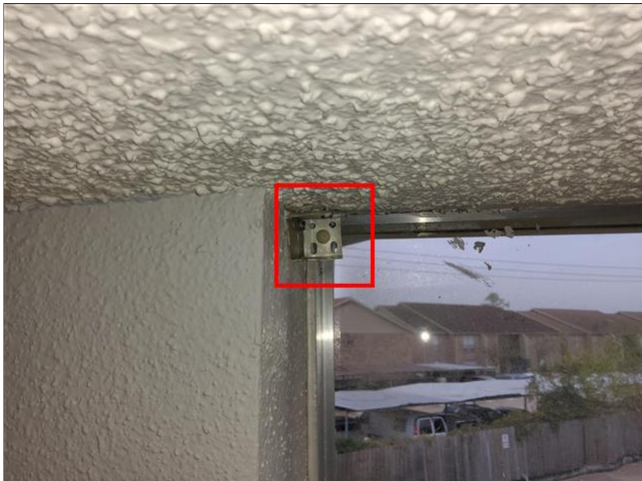
H. Item 9 (Picture)

(5) In the master bedroom, the blinds are not installed properly and can fall when opening. I recommend a qualified person evaluate and repair.

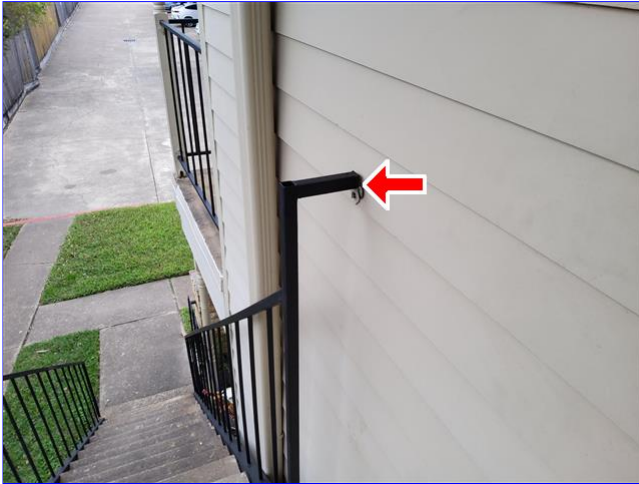
I. Item 1 (Picture)

(1) Bolts on the stairwell are not flush and appear to be mixing required washers. Over time, the bolts can become loose, which can lead to a safety issue. I recommend a qualified person evaluate and repair as needed.

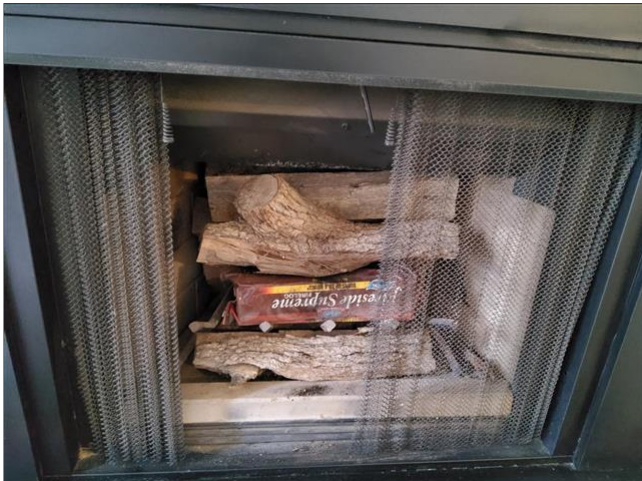
J. Item 1 (Picture)

(1) The fireplace was not tested, nor was the firebox inspected. The firebox was completely full of logs and limited the view of the area. I recommend a qualified person properly clean, inspect and repair as needed.

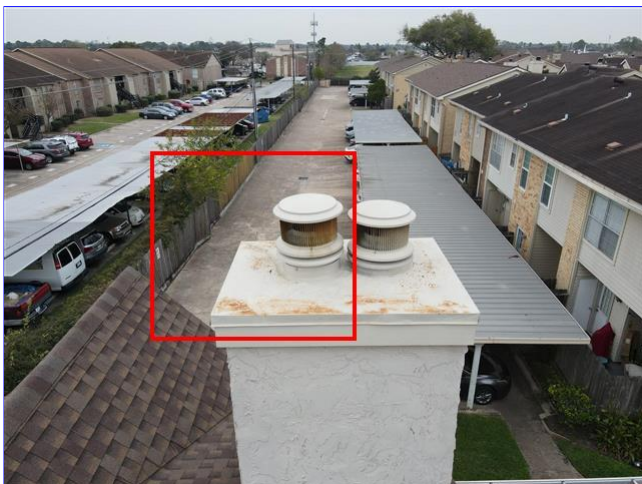
J. Item 3 (Picture)

(2) The damper appears to have signs of rust, however, it did open and close easily. The spark arrestor(screen) was present and moved easily as well. I recommend a qualified person evaluate and repair prior to use. The rain cap shows some minor signs of rust as well.

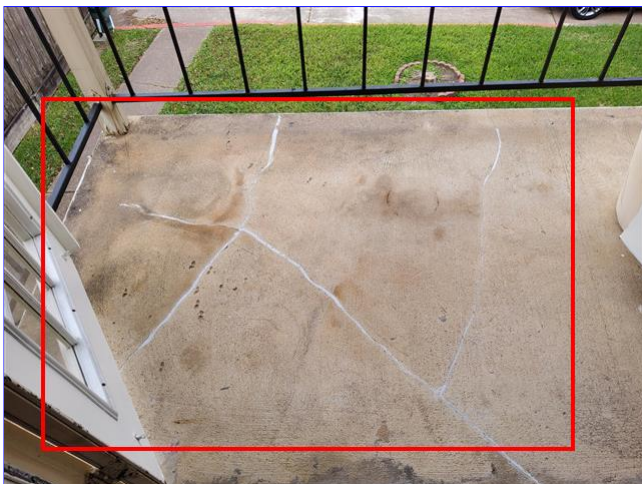
K. Item 1 (Picture)

- (1) The weight load capabilities are not part of this inspection.
- (2) The cement flooring has cracks throughout. It appears prior repair has been made. If deterioration continues, further repair may be needed.

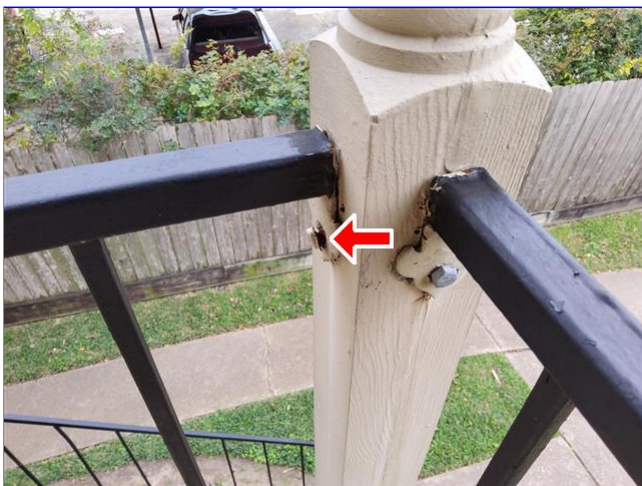
K. Item 3 (Picture)

(3) The handrail is loose, it appears that the bolt securing the railing is backing out. I recommend a qualified person make repairs to help reduce the potential of fall hazard.

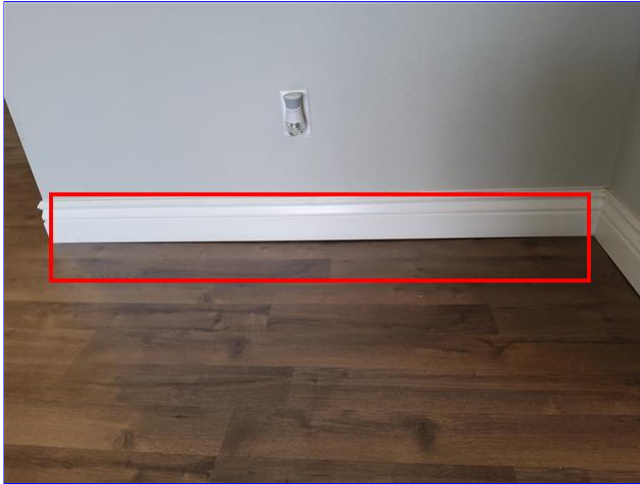
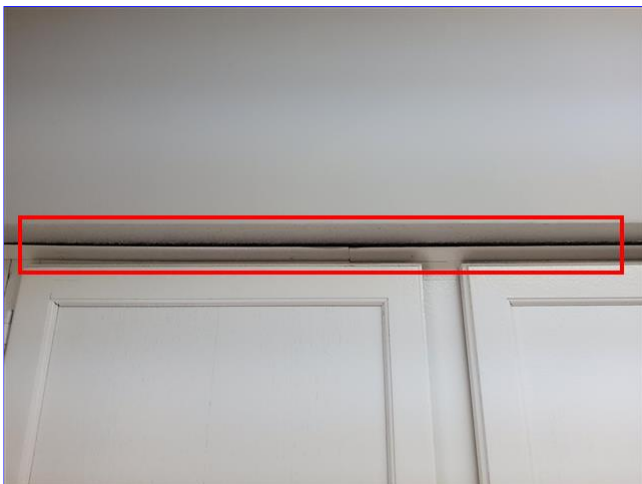
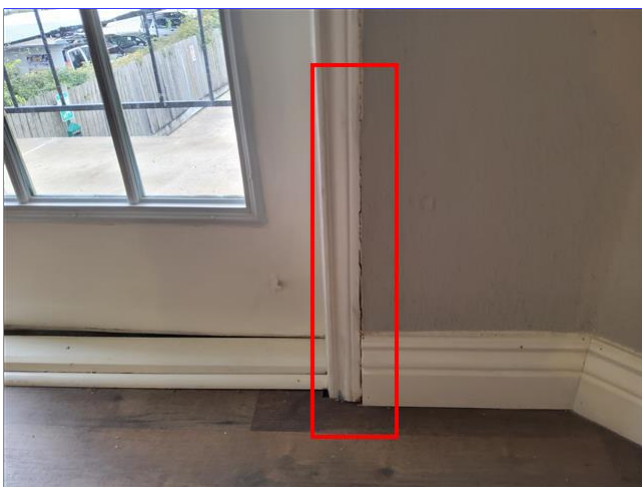
Areas of the home have caulking or grout missing or damaged. Deterioration could occur if not corrected. I recommend having a qualified contractor inspect and make repairs as needed.

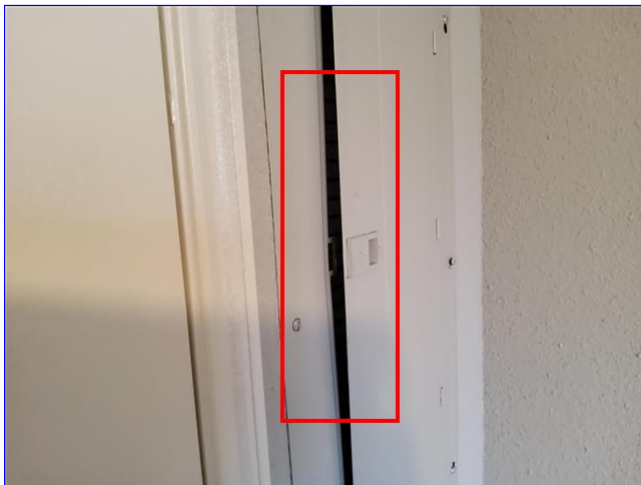
A. Item 2 (Picture)

(2) The service panel door did not latch properly. This can provide easy access to the circuit breakers for children. I recommend a qualified person evaluate and repair.

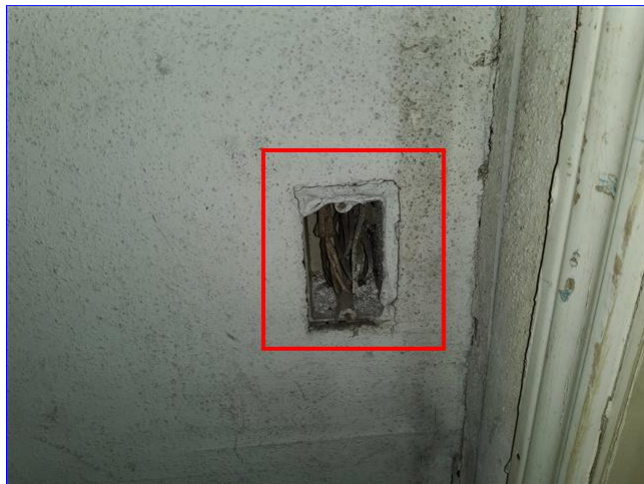
B. Item 1 (Picture)

(3) At the storage space on the balcony, the light fixture was not tested. Exposed wiring revealed where a light switch is to be, and the light bulb was missing. I recommend a licensed electrician evaluate and repair. Exposed wiring is a potential safety issue.

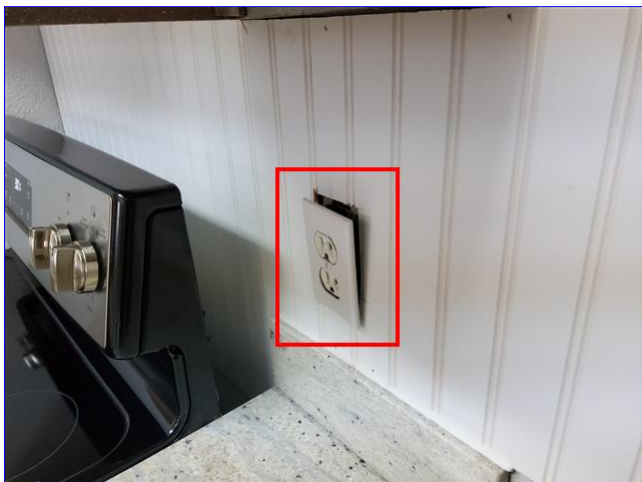
B. Item 3 (Picture)

(4) At least one loose in wall in the kitchen. Electrical issues are considered a hazard until repaired. An injury could occur if not repaired. A qualified licensed electrical contractor should perform repairs that involve wiring.

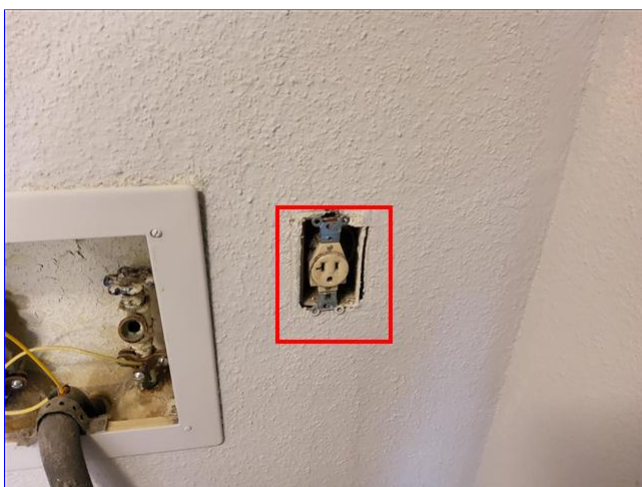
B. Item 4 (Picture) Laundry Room

(5) The outlet cover is damaged/ missing and needs repair or replace. I recommend having a qualified person make repairs as needed.

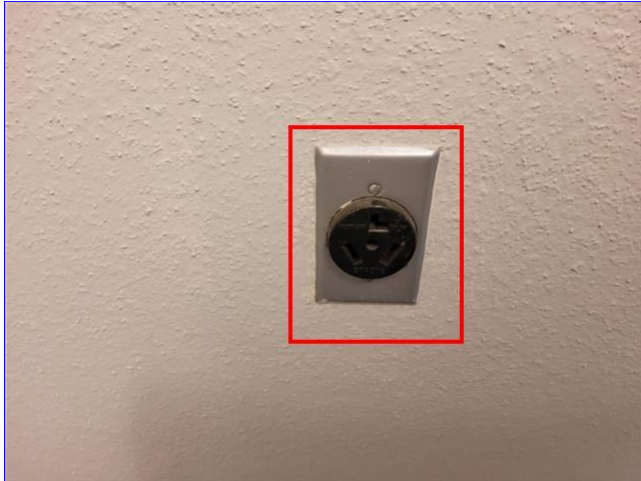
B. Item 5 (Picture)

(6) A three prong outlet for dryer is present in laundry room. This is not considered today's standard. Today's standard requires a four prong outlet be installed. I recommend having a qualified electrician to inspect and make repairs as needed.

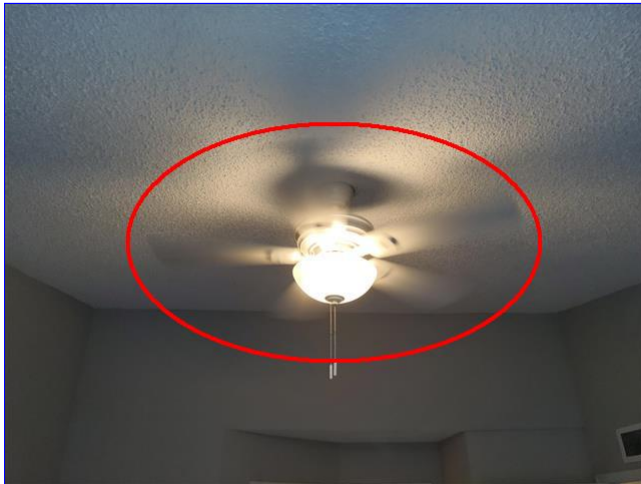
B. Item 6 (Picture)

(7) The ceiling fan "wobbles" in the master bedroom and in the dining room. This is for your information. Some fans that wobble cannot be corrected without replacement. A qualified licensed electrical contractor should perform repairs that involve wiring.

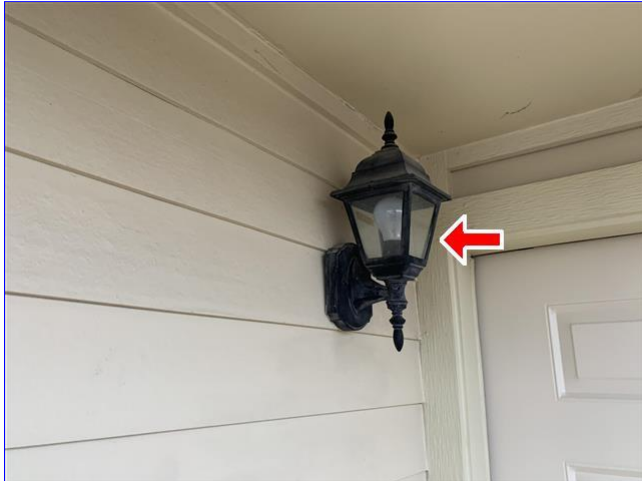
B. Item 7 (Picture)

(8) The light at the main entry did not work. I recommend changing the bulb, if the sockets still does not function, I recommend having a licensed electrician repair.

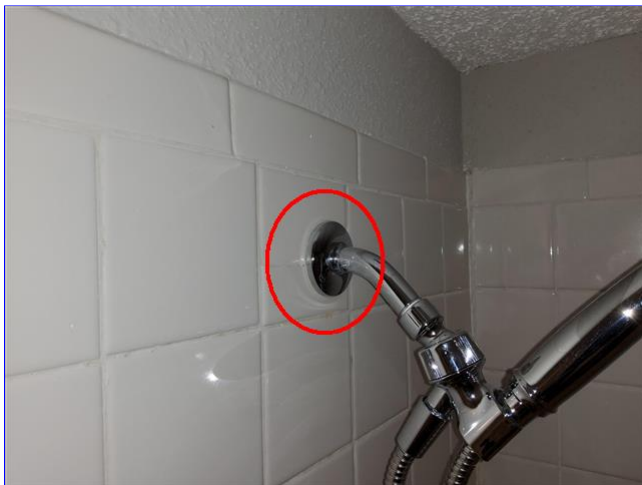
A. Item 2 (Picture)

(2) The shower arm is loose in wall at the hall bath. Repairs are needed This is not considered up to today's standard. A qualified licensed plumber should repair or correct as needed.

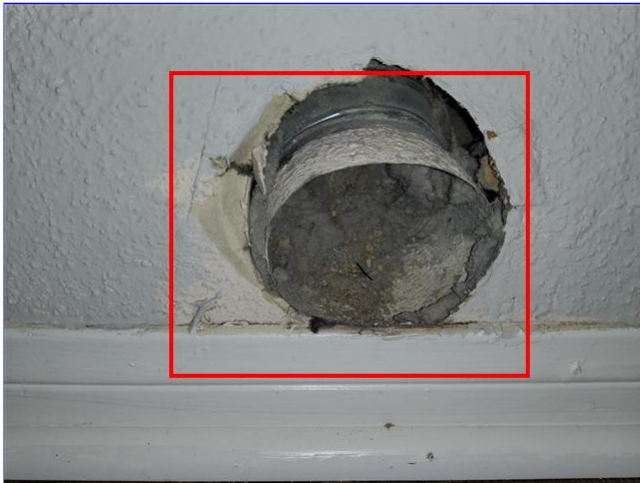
H. Item 1 (Picture)

(2) The dryer vent is full of lint. I recommend a qualified person properly clean prior to use.
