## PROPERTY INSPECTION REPORT

4611 Knoxville Street A, Houston, Texas 77051

Richard Chandler #6803 / Insight Property Inspections

12/10/2021

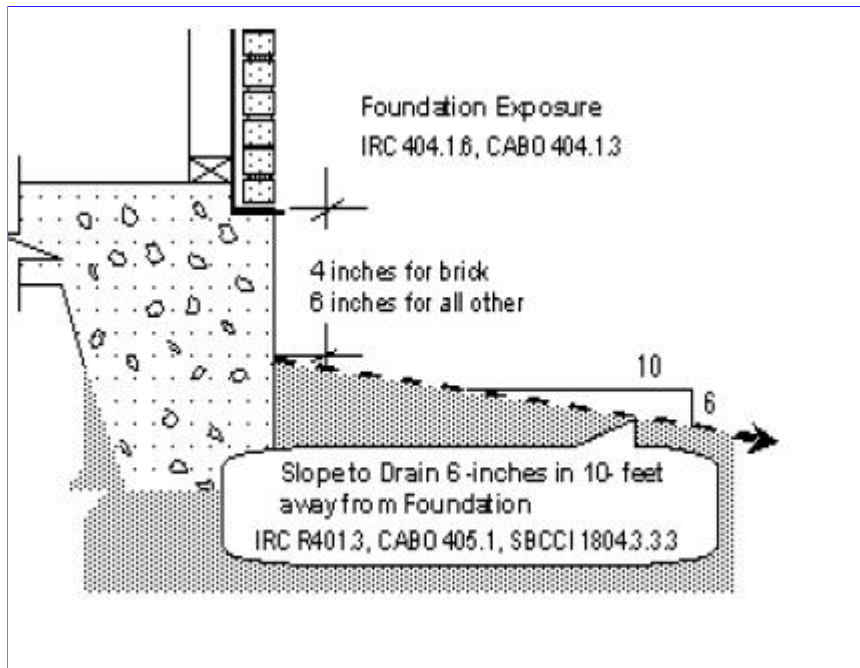
B. Item 1(Picture) grading

Drainage patterns, in the rear of the house, do not appear to properly direct water away from foundation to aid in controlling runoff water and could cause differential movement of the foundation or water penetration during heavy rains. Proper slope away from the foundation is 6 inches in 10 feet. These areas should be regraded to slope away from the foundation.

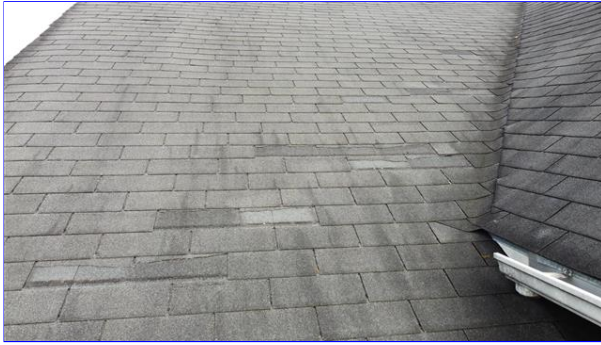
C. Item 1(Picture)

Damaged and missing shingles were observed at the front of the house. Repair is needed.

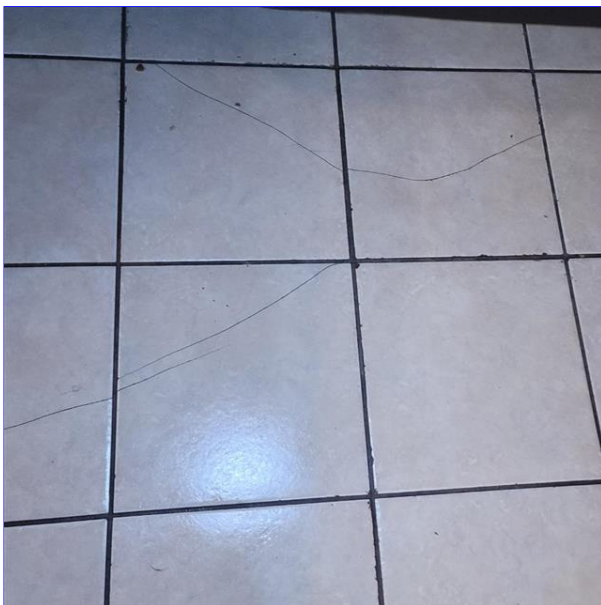
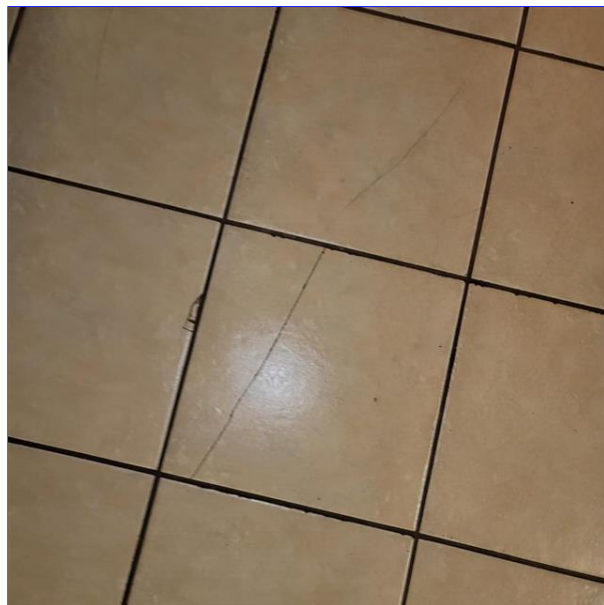
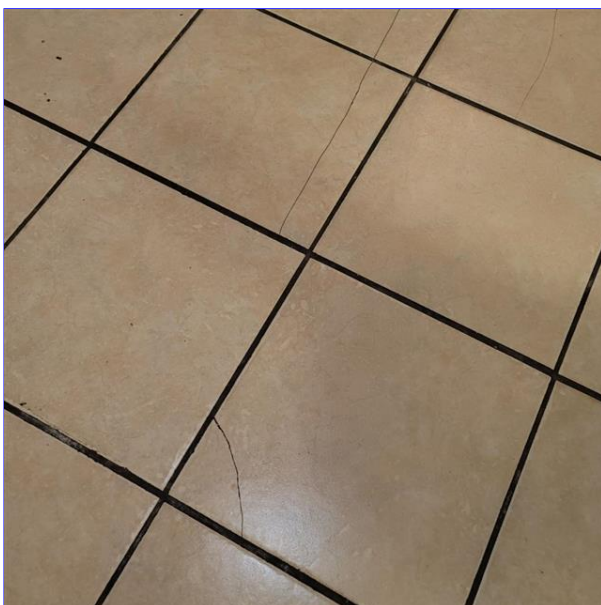
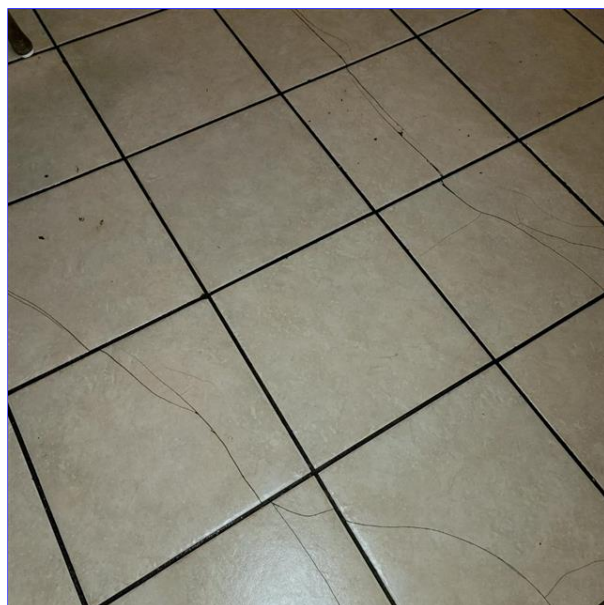
(1) Flooring is damaged at the kitchen and living room floor.

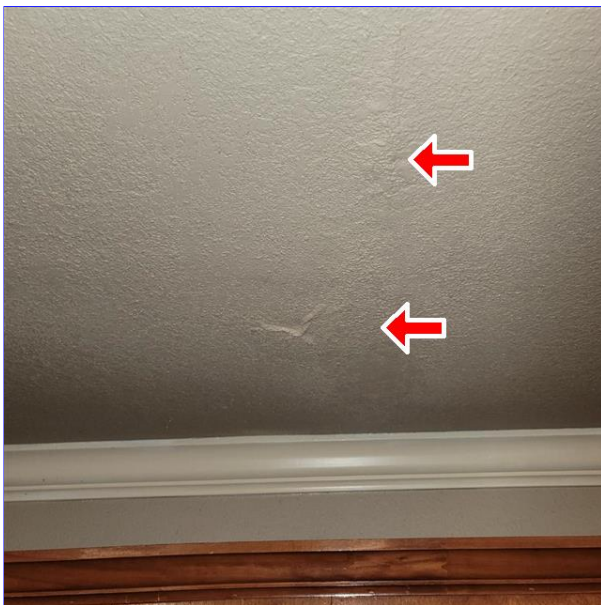
F. Item 5(Picture) Kitchen ceiling

(2) The Drywall on the ceiling reveals damage indicating a leak did or still exists at the Kitchen. The moisture meter was used and it did not indicate an active leak. A qualified contractor should inspect and repair as needed.

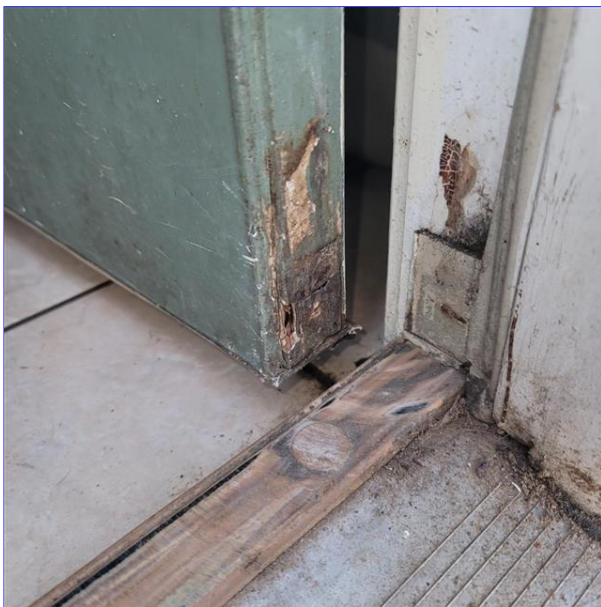
G. Item 1(Picture)

The rear exterior door is damaged at the bottom.

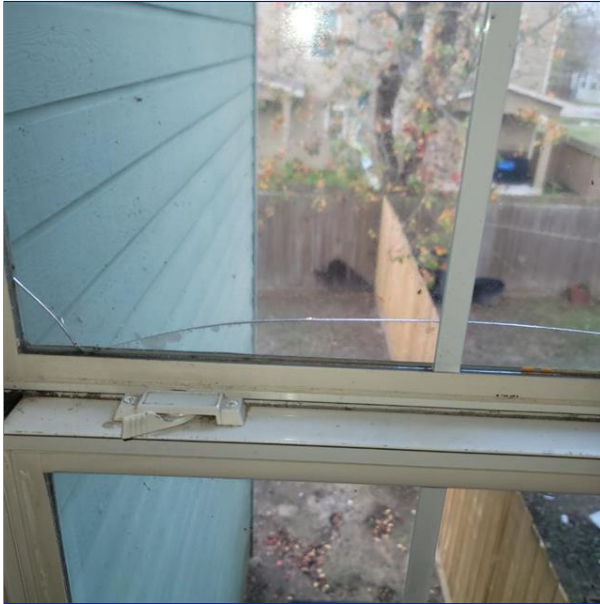
H. Item 1(Picture)

(1) Damaged window (cracked glass) was observed at one of the upstairs rear windows. Double pane

windows should not be repaired by simply replacing the glass. The panes work as a unit and should be replaced as a unit.

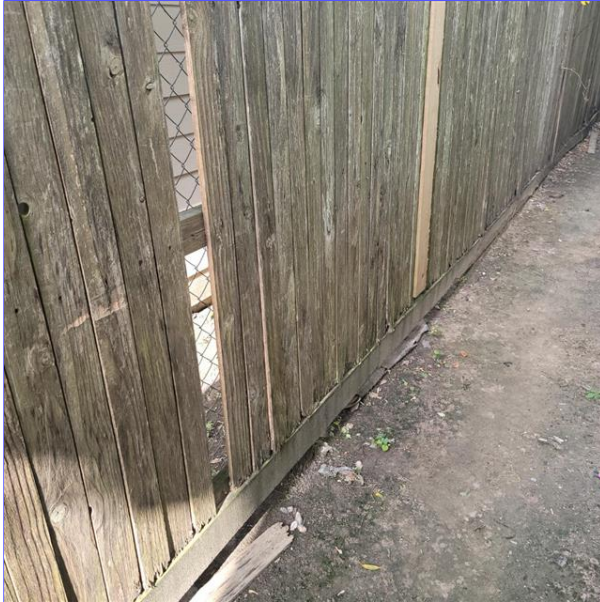
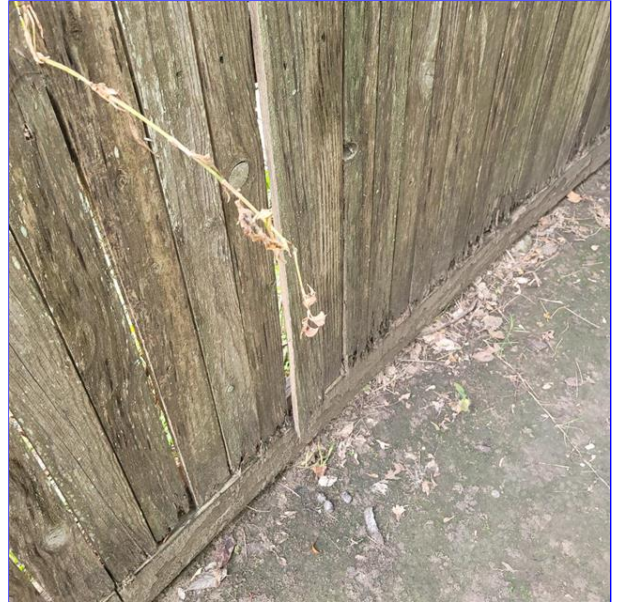
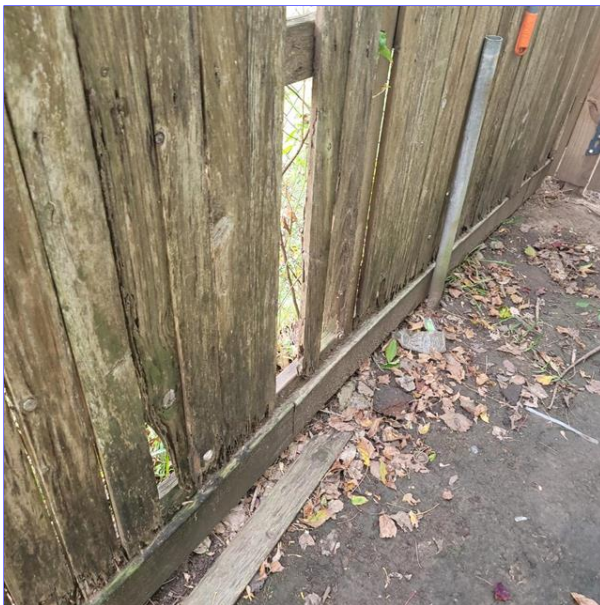
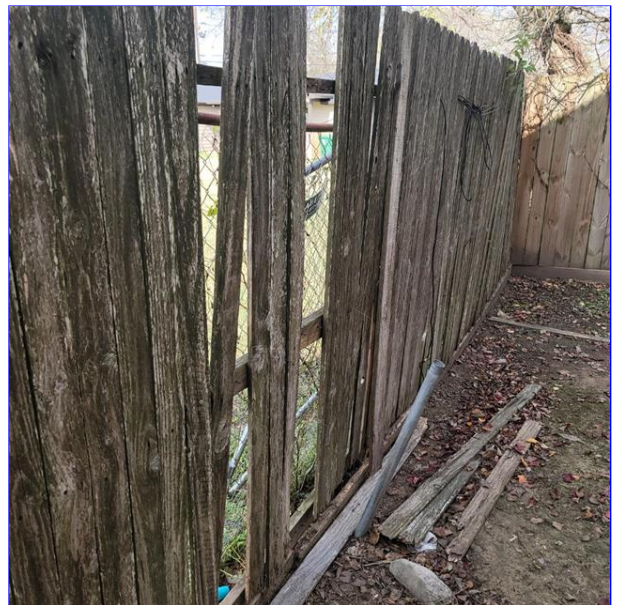
Damaged and loose fence boards were observed in rear of the house

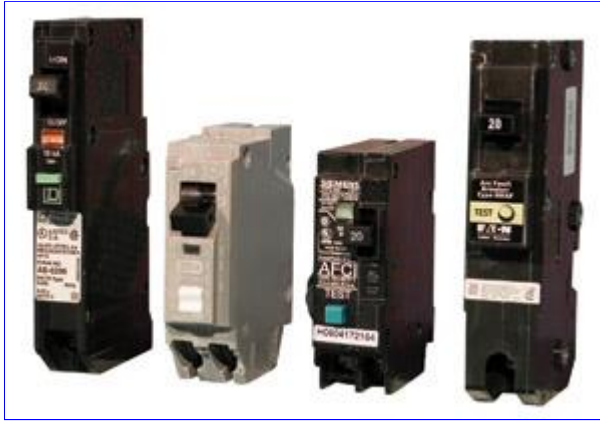
A. Item 1(Picture) AFCI

(1) AFCI devices were not observed in the panel box. AFCI (Arc Fault Circuit Interrupt) device protection, as required by current building standards, for all: family rooms, dining rooms, living rooms, parlors, libraries, dens, bedrooms, sunrooms, recreations rooms, closets, hallways, or similar rooms or areas. AFCI devices are intended to protect against fires caused by electrical arcing faults in the home's wiring. Arc faults are a common cause of residential electrical fires. Arc faults can be created by damaged, deteriorated, or worn electrical plugs, cords, and/or branch circuit conductors. As of September 1, 2008, the State of Texas has adopted the 2005 NEC, which includes this requirement, as the "minimum standard" for all non-exempt electrical work. Homes built prior to 2002, generally were not required to have arc fault protection. However, the current TREC standard of practice requires inspectors to indicate that a hazardous or deficient condition exists if any home does not have this protection, regardless of date the home was constructed.

Note: At the time this home was built AFCI devices were not required

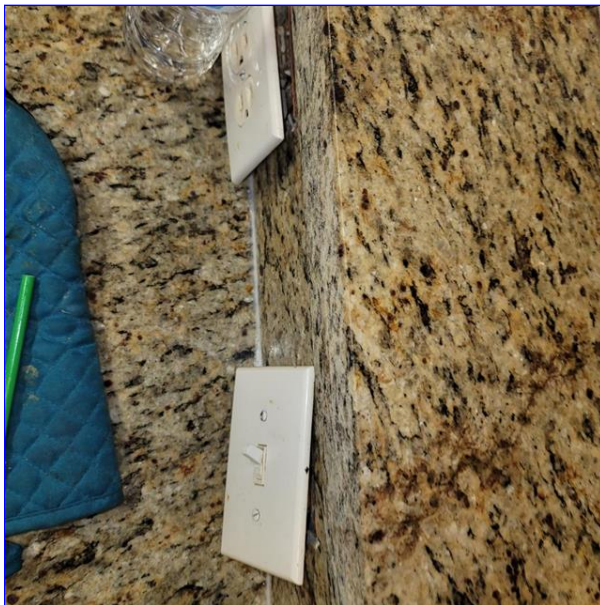
B. Item 1(Picture)

(1) Loose switches and outlets were observed at the Kitchen counter top.

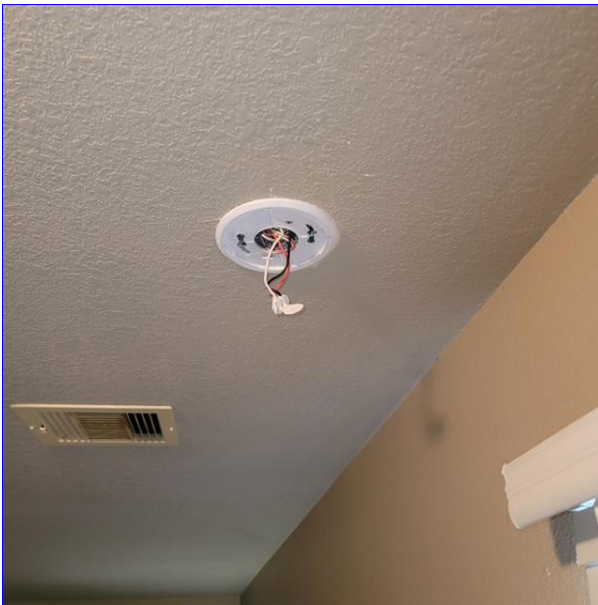
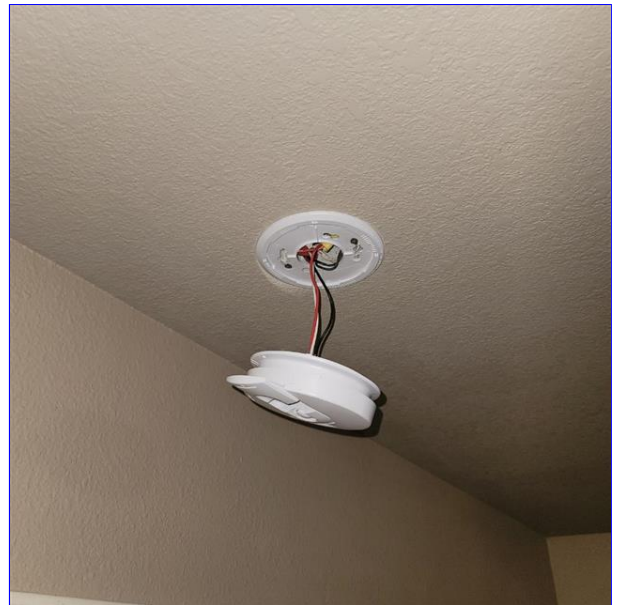
(3) Smoke detectors are missing in several places.

4. Install smoke detectors on each level of the home. Ensure that there is a smoke detector outside all sleeping areas. Replace batteries on any existing smoke detectors and test them. Make a note to replace batteries again in one year.

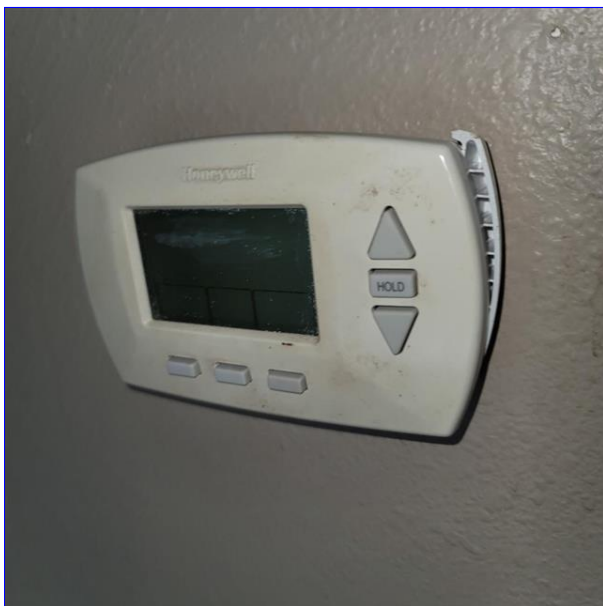
B. Item 1(Picture)

📍 (1) The thermostat and HVAC system were not operational at the time inspection.

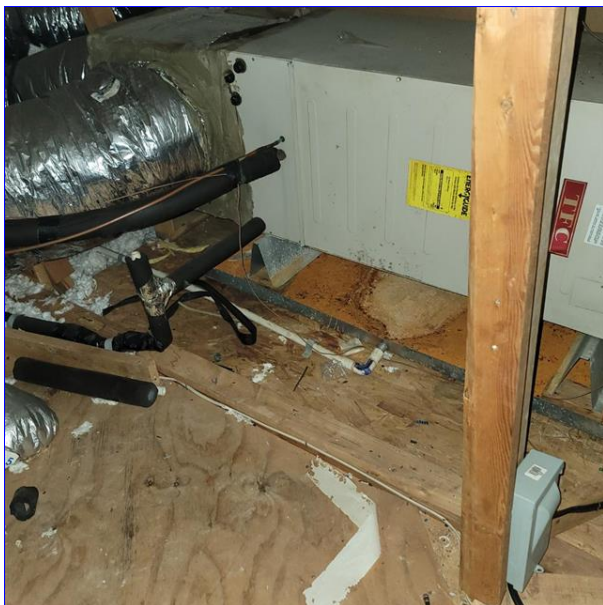
B. Item 2(Picture)

📍 (2) Rust was noted in the safety pan under the evaporator coil in the attic. This should be cleaned professionally by a qualified and licensed HVAC contractor and replaced if the rust has damaged the corrosion resistant coating of the safety pan. After pan has been cleaned and/or replaced, the primary and secondary drain lines should be flow checked and cleaned if necessary plus checked for proper termination..

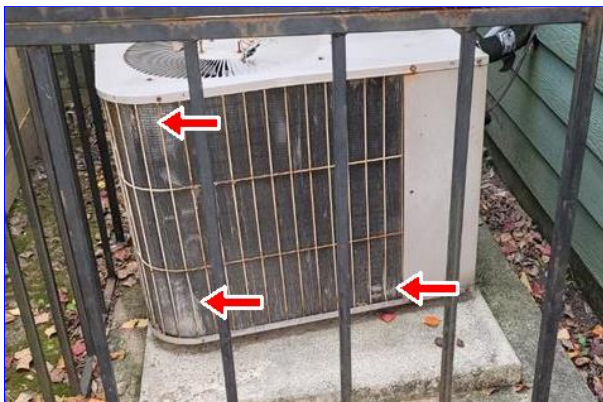
B. Item 3(Picture)

📍 (3) Some of the fins of the condensing unit were observed to be damaged. This condition can reduce the efficiency of the unit.
