S.A.V
On
Home Inspection

Inspection Report

Property Address:
2118 5th St
Hempstead TX 77445

Date: 4/15/2020	Time: 5:35 PM	Report ID:
Property: 2118 5th St Hempstead TX 77445	Customer: Michel Gonzalez	Real Estate Professional: Glenda Diaz

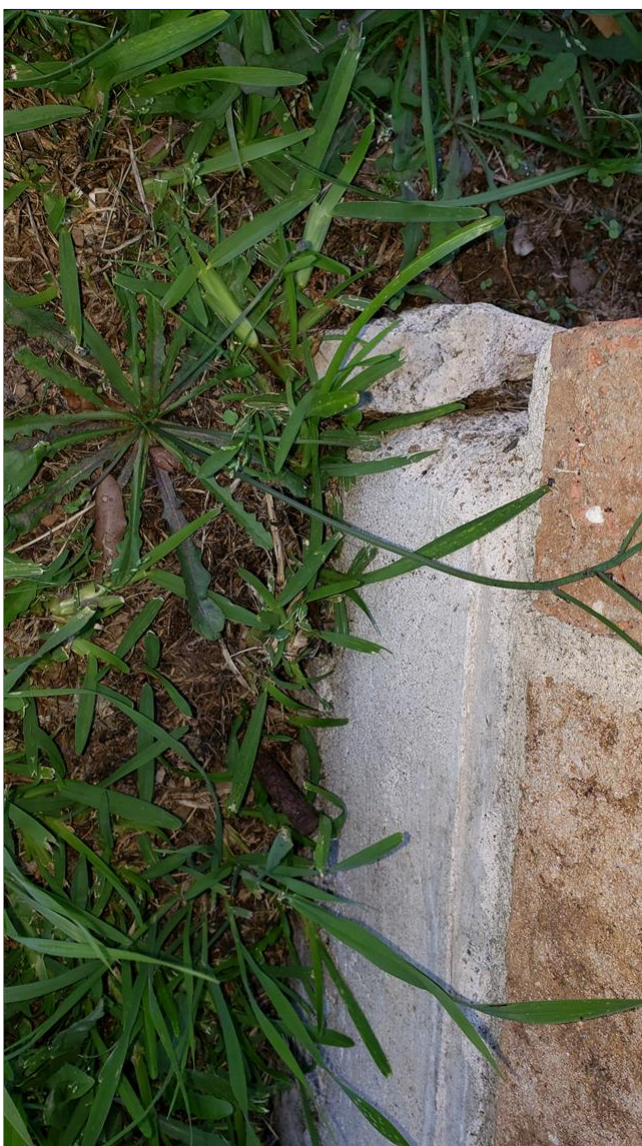
A. Item 1(Picture)

Note: Corner popping on the corner are corners of the foundation edge; does not effect the function of the foundation at the time of inspection.

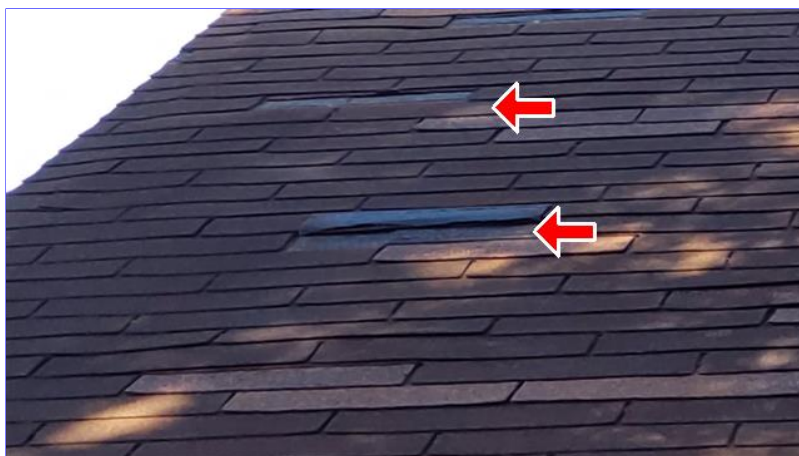
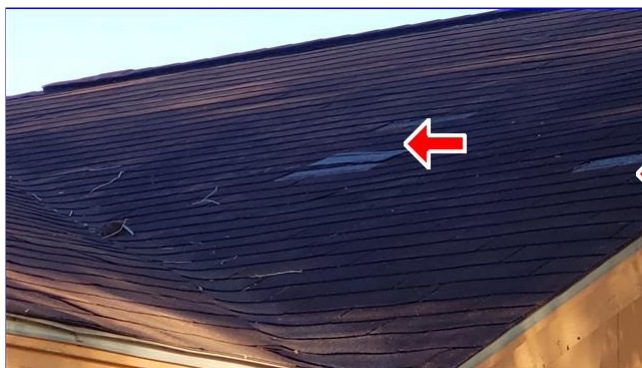
C. Item 1(Picture)

(1) Missing several shingles at the front of the home; recommended a roofing contractor for further evaluation and repairs

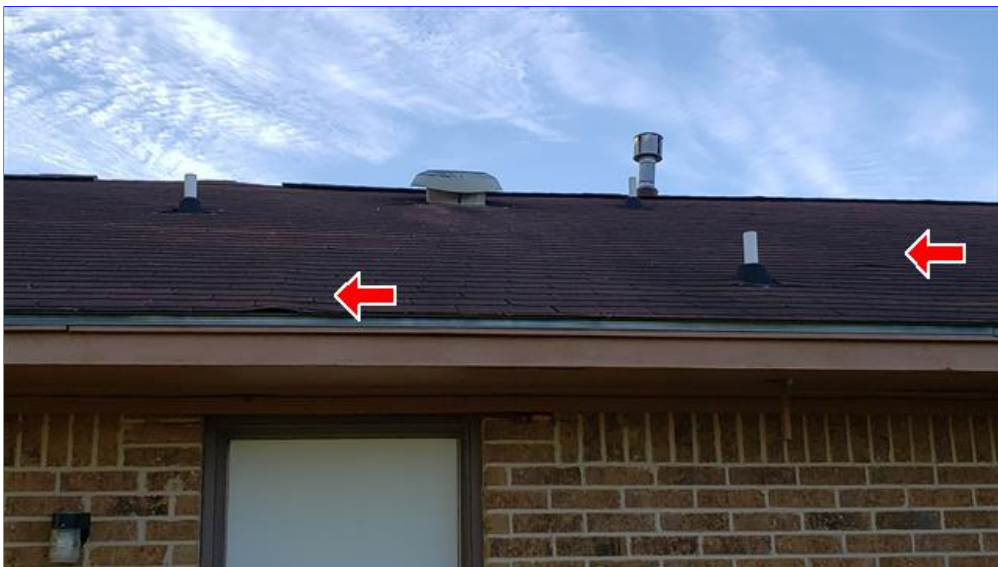
C. Item 3(Picture)

(2) Several shingles lifted by nail heads; recommended roofing contractor for repairs.

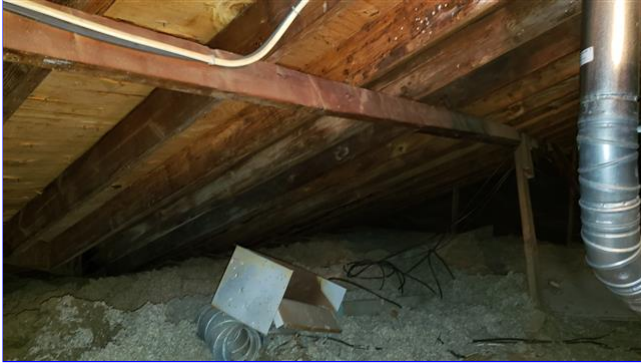
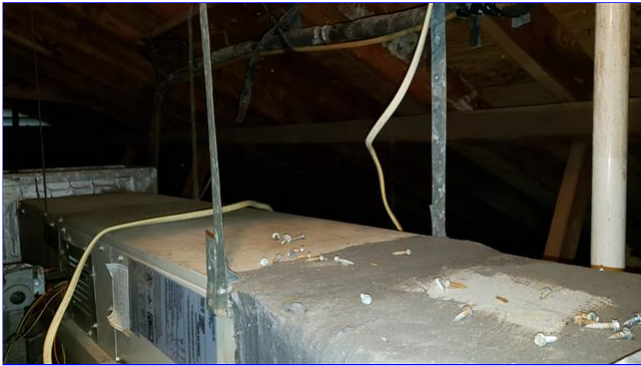
D. Item 1(Picture)

(1) Purling bracing is wrong size; per code purling bracing should be same size at roof rafters. at time of inspection bracing is 2x4 material and rafters are 2x6 material. Note; this is a very common issue in off homes and framing looked solid at time of inspection.

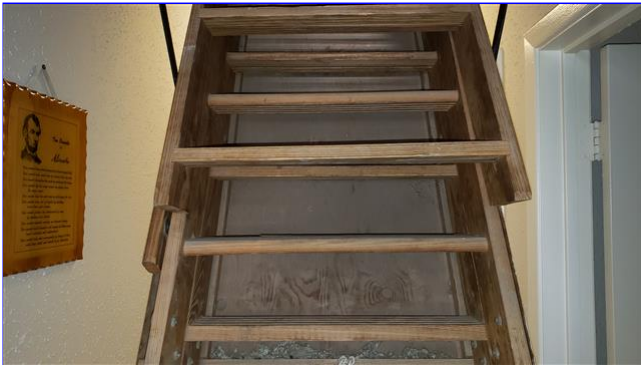
D. Item 3(Picture)

(2) Attic access not insulated at time of inspection.

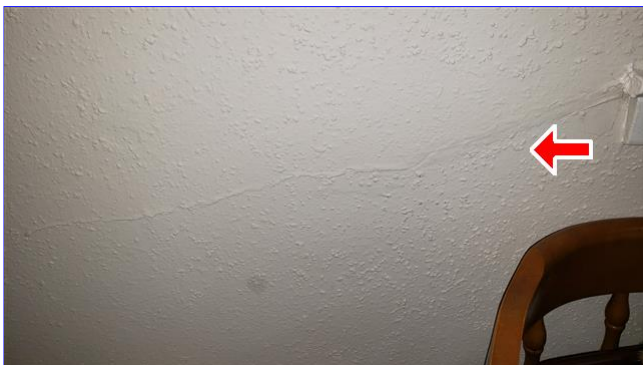
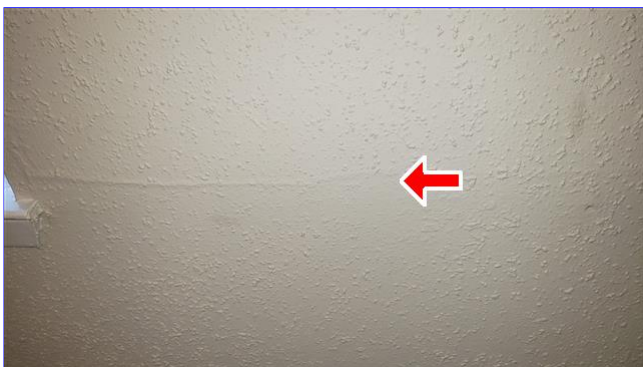
E. Item 1(Picture)

(1) Minor stress cracking on wall in kitchen rear bedroom; appears to be due to minor settlement of the home. No signs of excessive settlement which would suggest foundation issues.

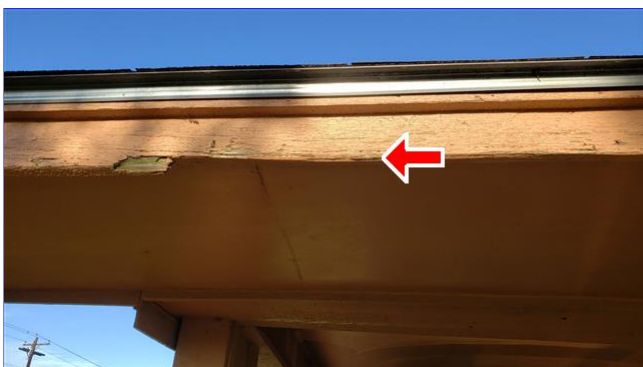
E. Item 3(Picture)

(2) Broken fascia trim at the front of the home in front of the carport.

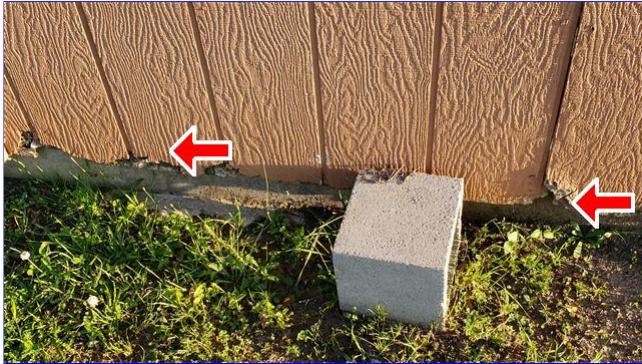
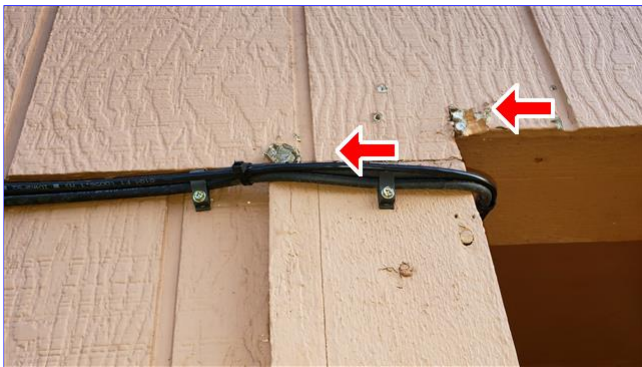
E. Item 4(Picture)

(3) Rotten wood on exterior siding and trim at the left side and rear of the carport toolshed.

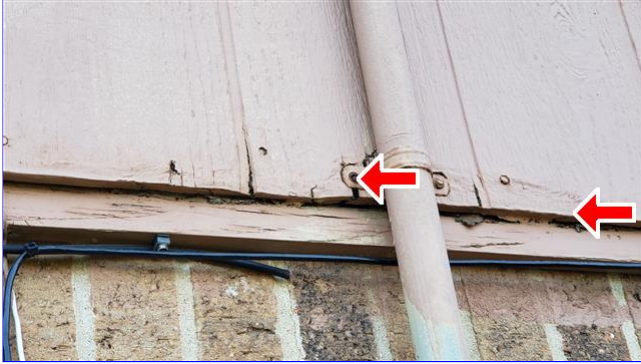
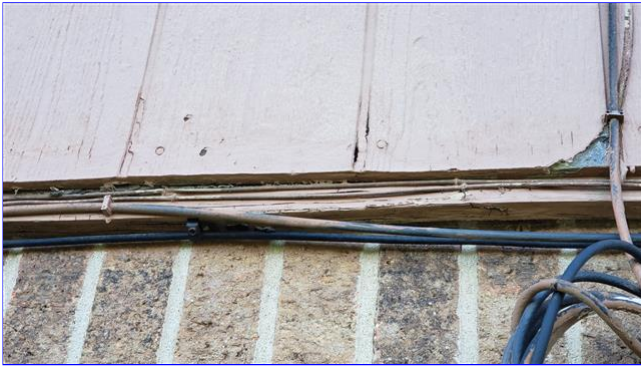
E. Item 7(Picture)

(4) Rotten wood on the bottom of the exterior siding at the rear the home.

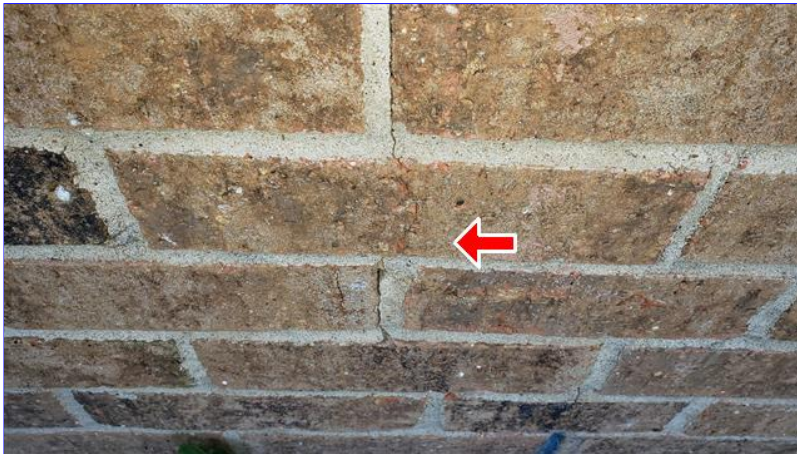
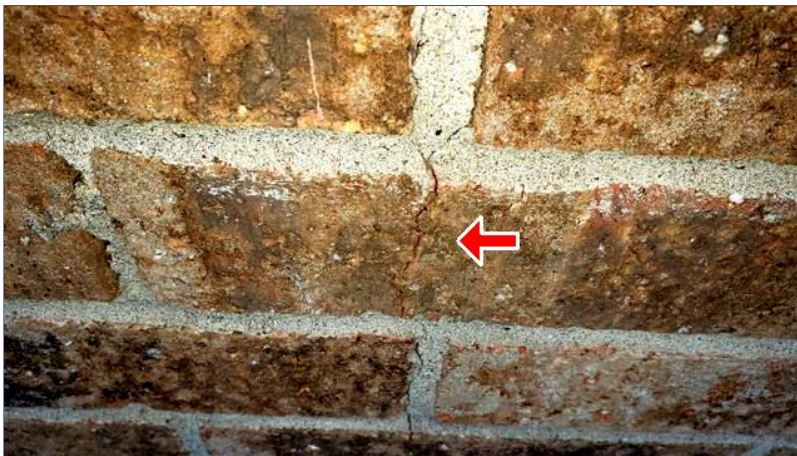
E. Item 9(Picture)

(5) Minor stress cracking on the exterior brick at several areas; appears to be due to normal settlement of the home and does not suggest foundation issues.

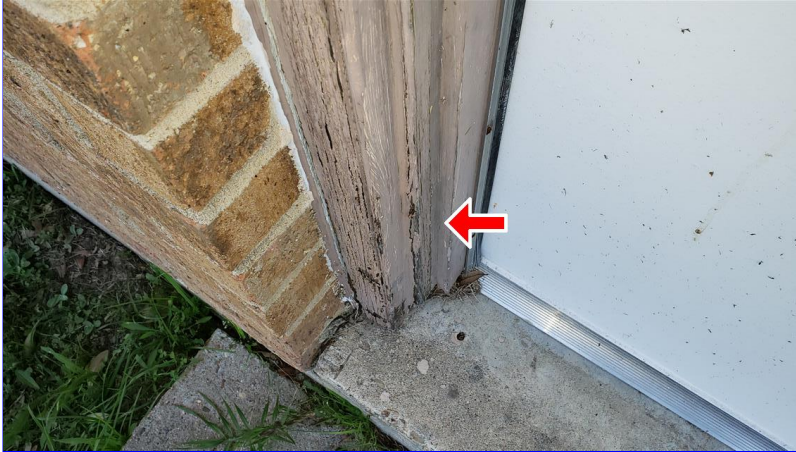
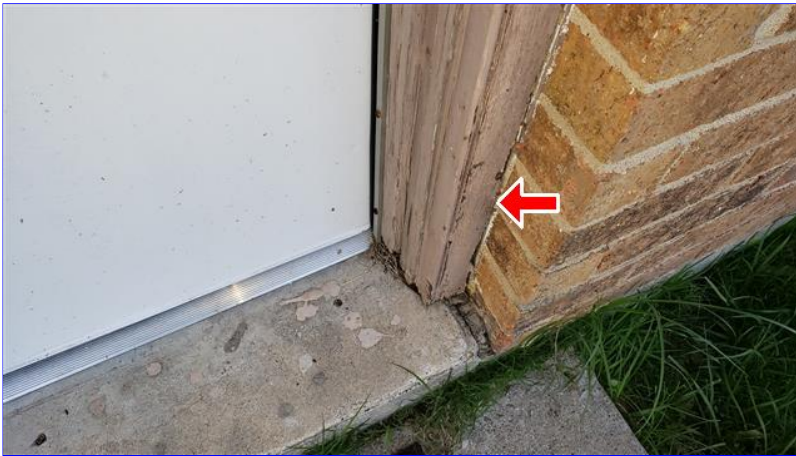
G. Item 1(Picture)

Paint peeling on the exterior side of the side entry door frame.

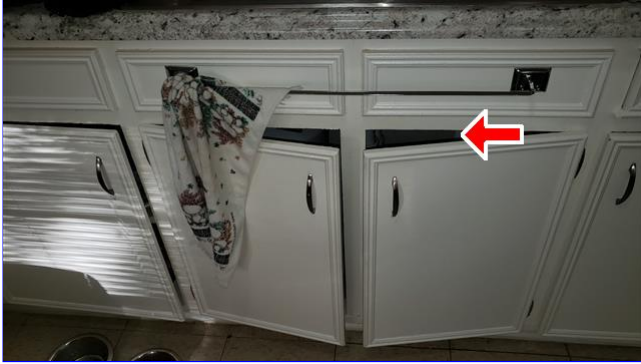
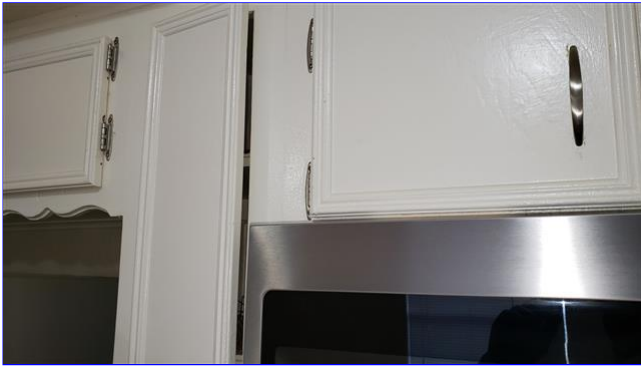
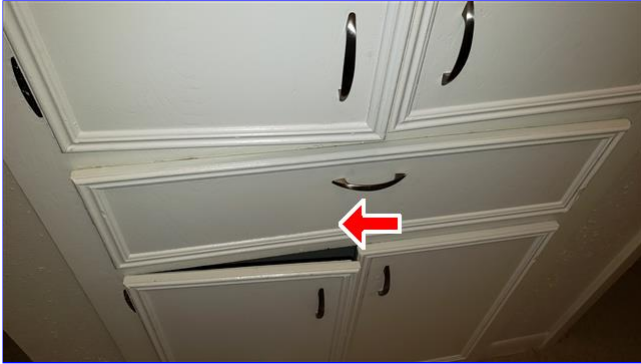
L. Item 1(Picture)

(1) Several of the cabinet doors in kitchen and hallway are not closing properly. Recommend installing latches.

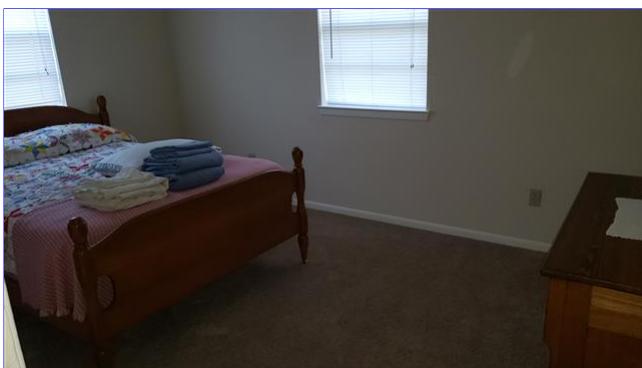
L. Item 10(Picture)

(2) Home is furnished and occupied; could not view all areas of home, inside cabinets, inside closets, all areas of attic and in garage. Obstructed view to these areas.

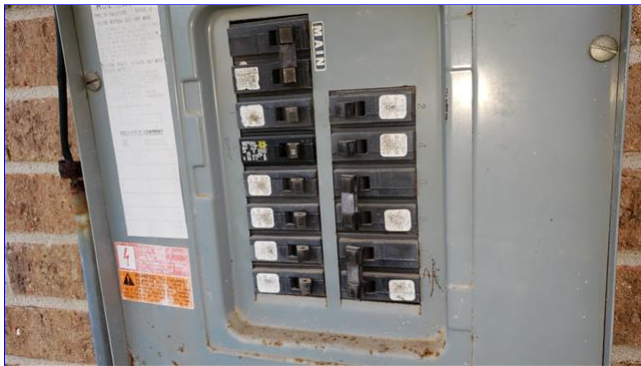
A. Item 1(Picture)

No arc-fault breakers present in electric panel at time of inspection.

Arc-fault circuit interrupters (AFCIs) are special types of electrical receptacles or outlets and circuit breakers designed to detect and respond to potentially dangerous electrical arcs in home branch wiring. All branch circuits that supply 120-volt, single phase, 15 and 20 amp outlets installed in family rooms, dining rooms, living rooms, parlors, libraries, dens, bedrooms, sun rooms, recreation rooms, closets, hallways and similar rooms or areas shall be protected by a combination type arc-fault circuit interrupter installed to provide protection of the branch circuit.

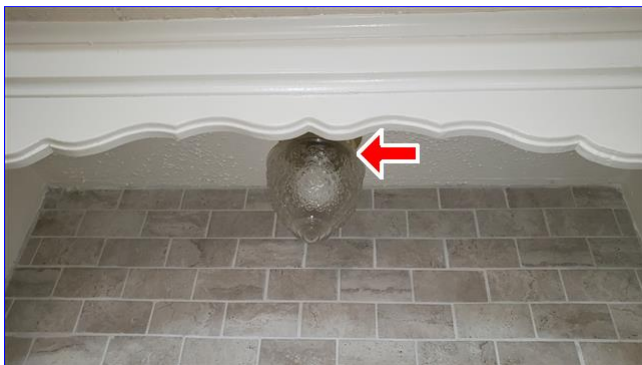
B. Item 1(Picture)

- (1) Light fixture above the sink is not working at time of inspection.
- (2) Outlets in kitchen above counter tops, bathroom, exterior, and garage are not GFCI protected.
- (3) Missing smoke alarms in all bedrooms. Smoke alarms are required in all bedrooms, adjoining hallways, one on each level of the home and should work simultaneously.

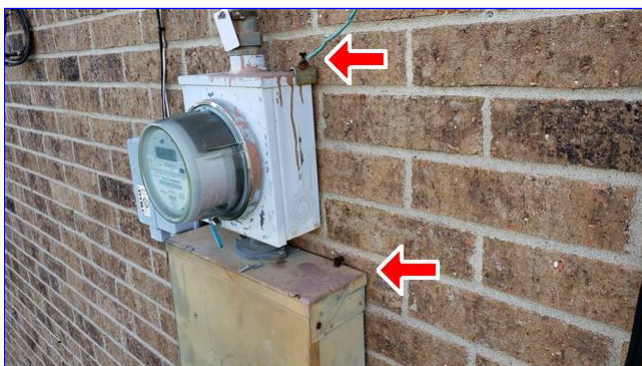
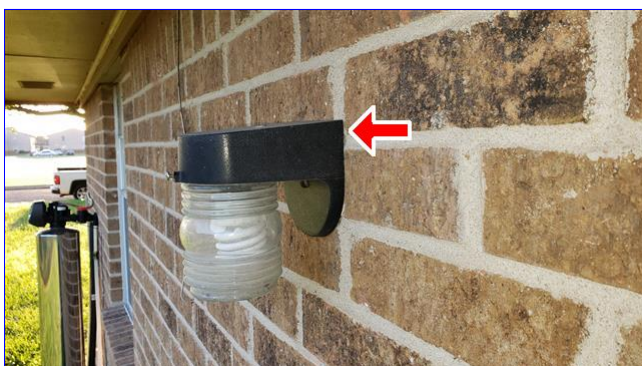
B. Item 2(Picture)

- (4) Need to seal around all exterior electrical items to make water tight against the structure.

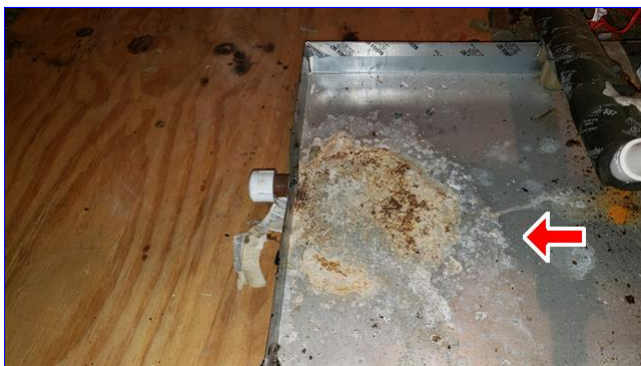
B. Item 1(Picture)

(2) There's no drain line on the A.C secondary pan located in the Attic. Recommend a licensed A.C technician for repairs.

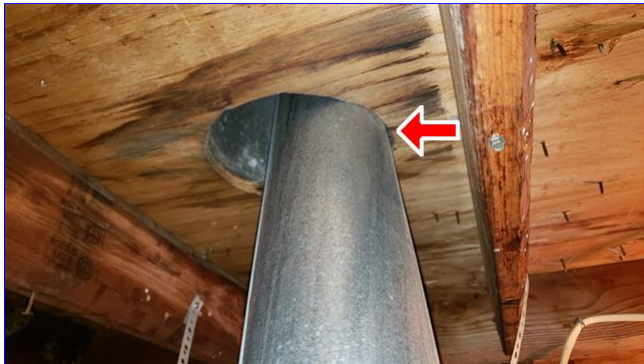
C. Item 1(Picture)

Heater exhaust vent is not strapped in place in attic. Heater vent should be at least one inch away from combustible materials.

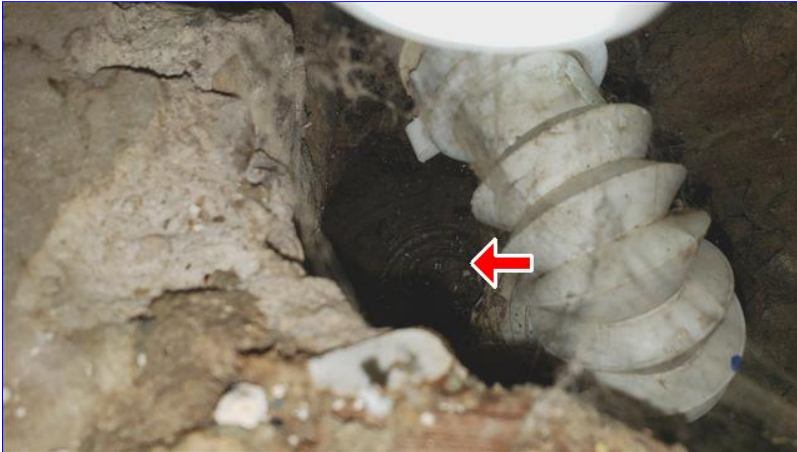
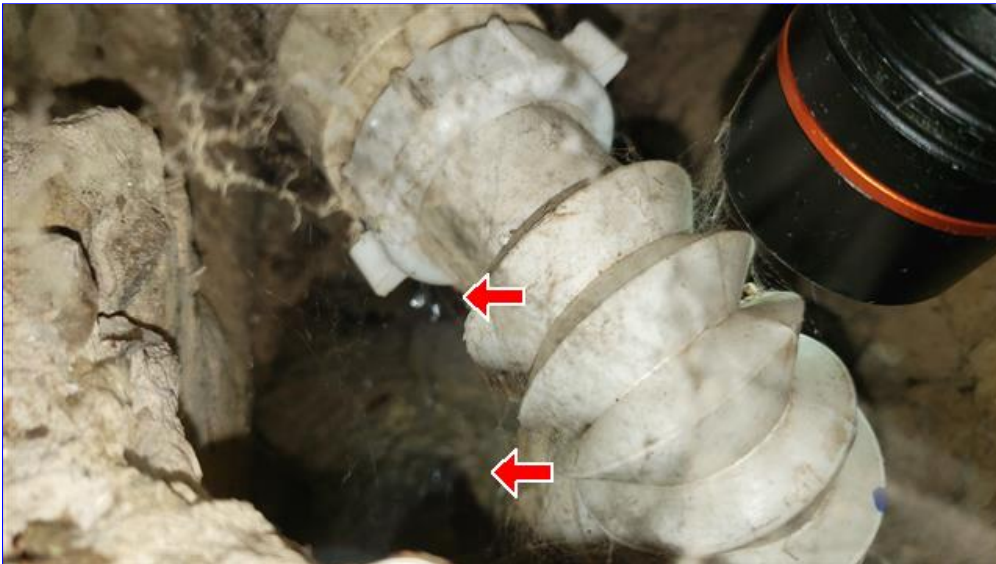
B. Item 1(Picture)

Tub drain leaking in back trap area underneath the tub. Recommend a licensed plumber for repairs.

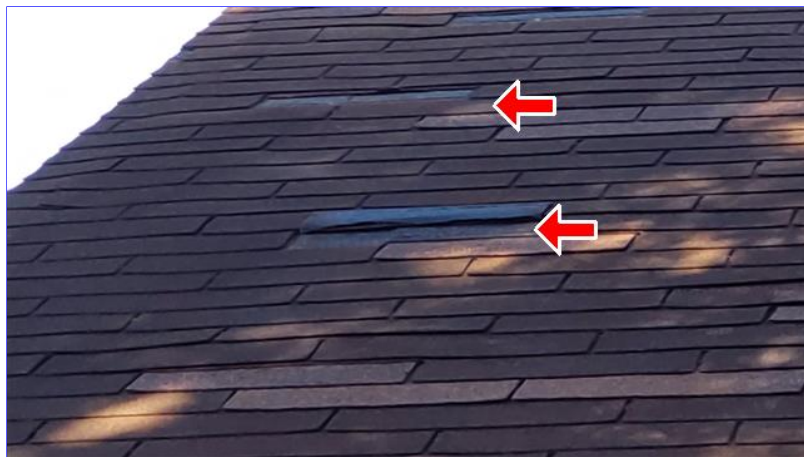
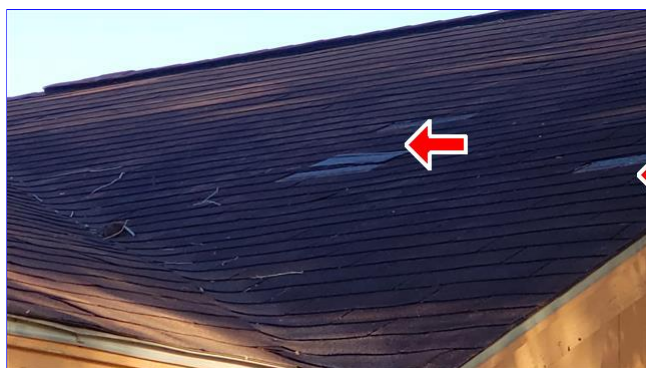
C. Item 1(Picture)

Missing several shingles at the front of the home; recommended a roofing contractor for further evaluation and repairs

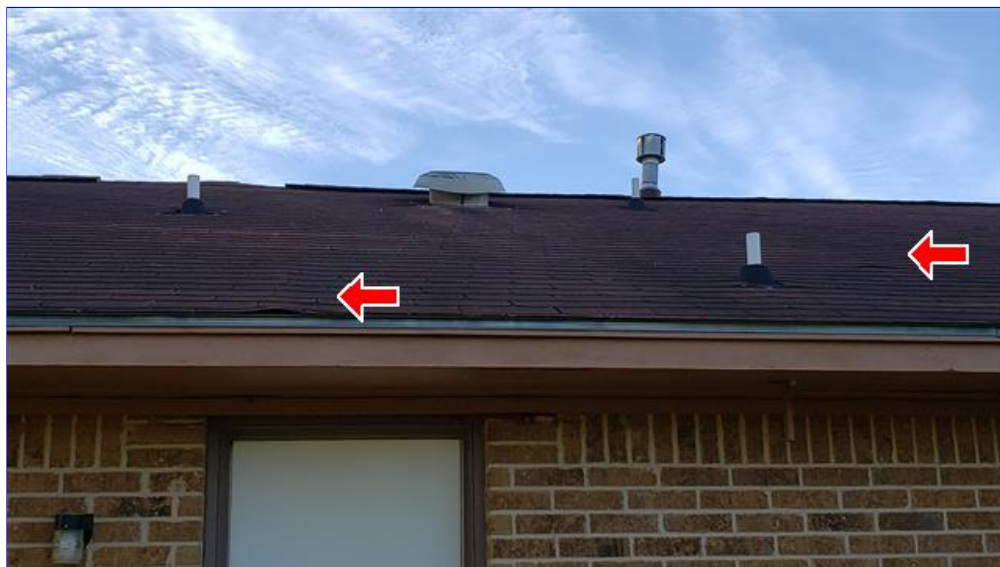
C. Item 3(Picture)

Several shingles lifted by nail heads; recommended roofing contractor for repairs.

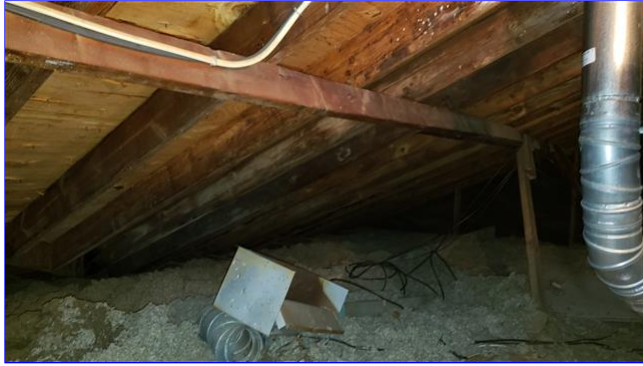
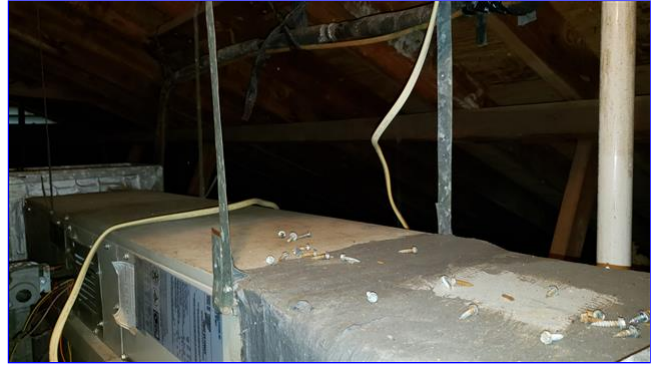
D. Item 1(Picture)

Purling bracing is wrong size; per code purling bracing should be same size at roof rafters. at time of inspection bracing is 2x4 material and rafters are 2x6 material. Note; this is a very common issue in off homes and framing looked solid at time of inspection.

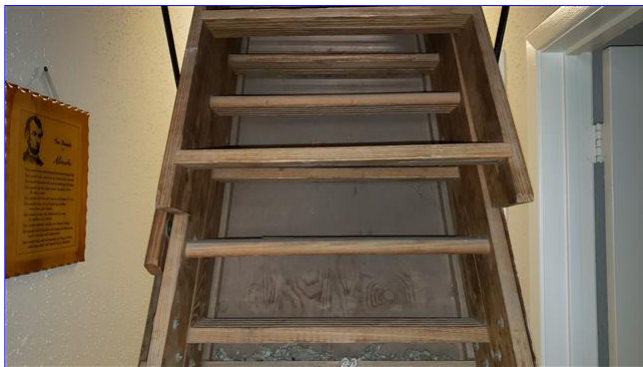
D. Item 3(Picture)

Attic access not insulated at time of inspection.

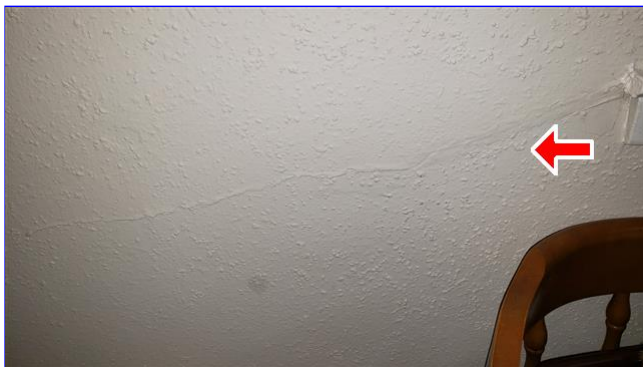
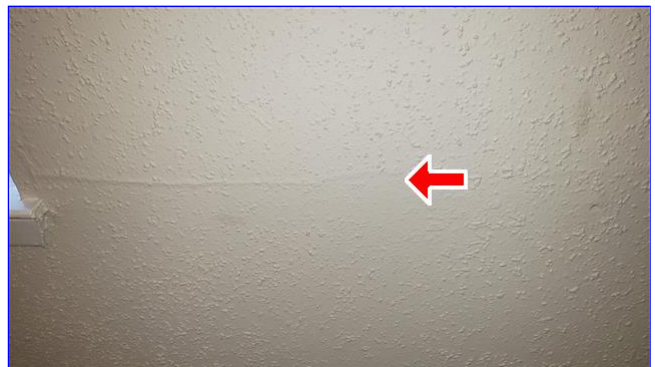
E. Item 1(Picture)

Minor stress cracking on wall in kitchen rea rbed5room; appears to be due to minor settlement of the home. No signs of excessive settlement which would suggest foundation issues.

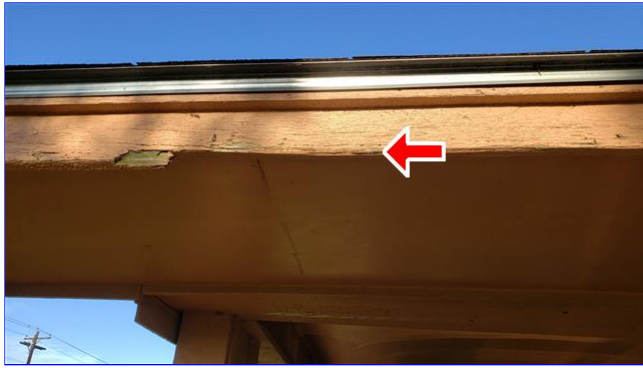
E. Item 3(Picture)

Broken fascia trim at the front of the home in from of the carport.

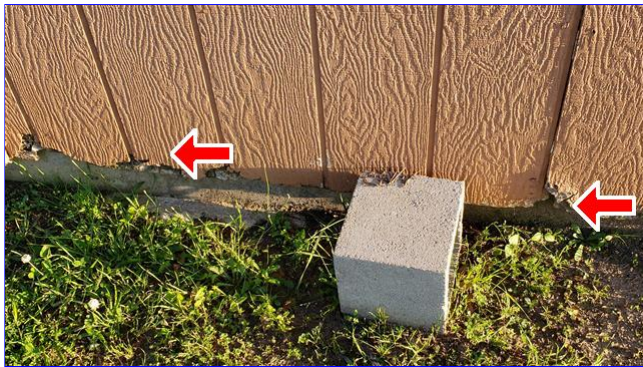
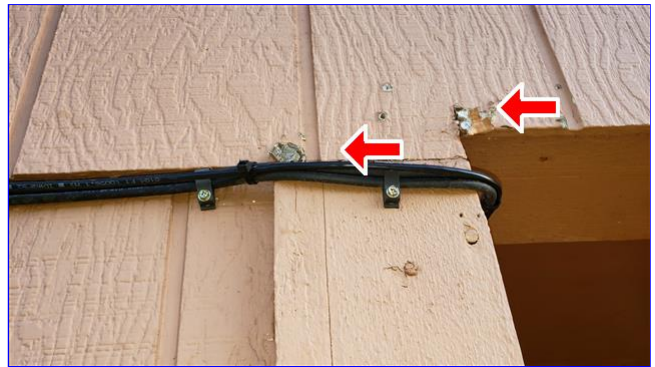
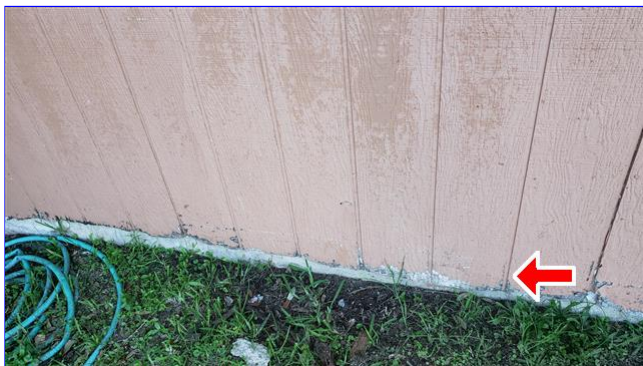
E. Item 4(Picture)

Rotten wood on exterior siding and trim at the left side and rear of the carport toolshed.

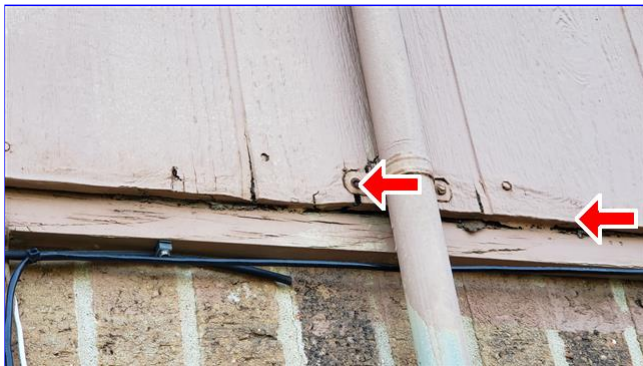
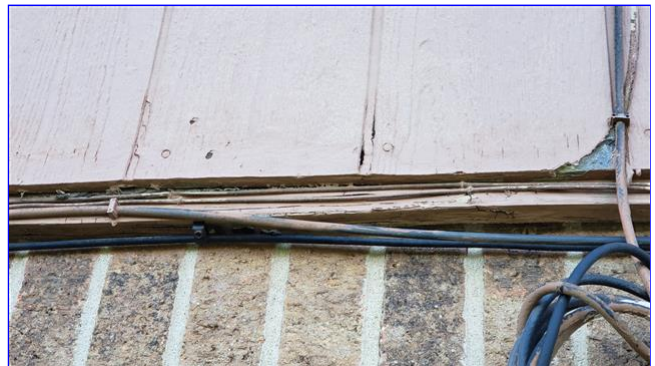
E. Item 7(Picture)

Rotten wood on the bottom of the exterior siding at the rear the home.

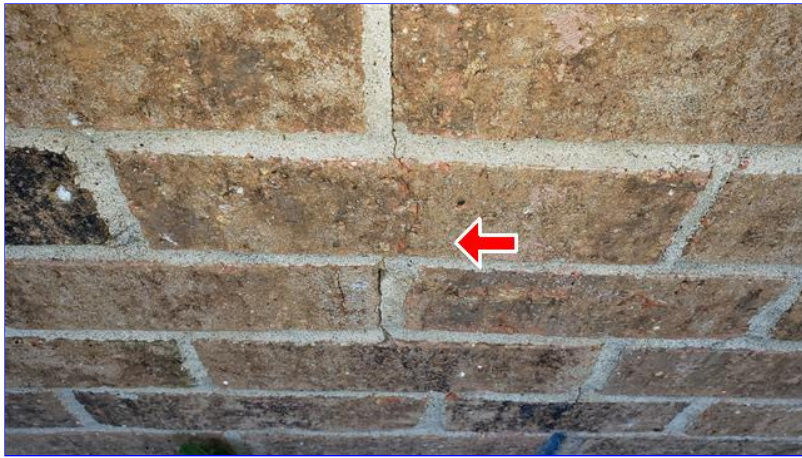
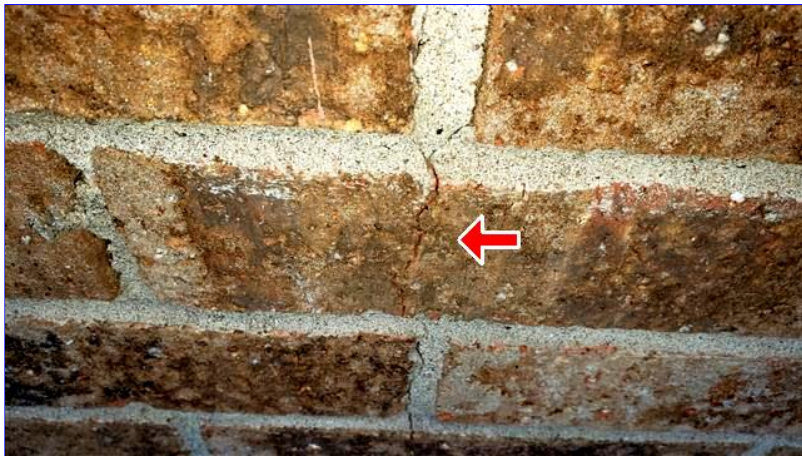
E. Item 9(Picture)

Minor stress cracking on the exterior brick at several areas; appears to be due to normal settlement of the home and does not suggest foundation issues.

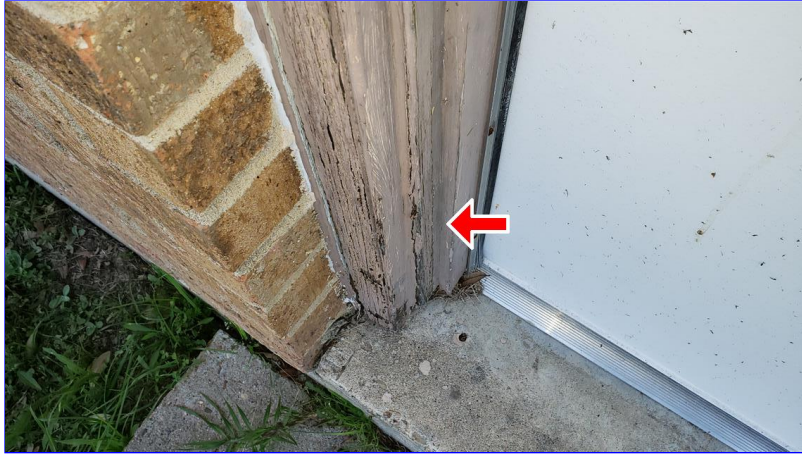
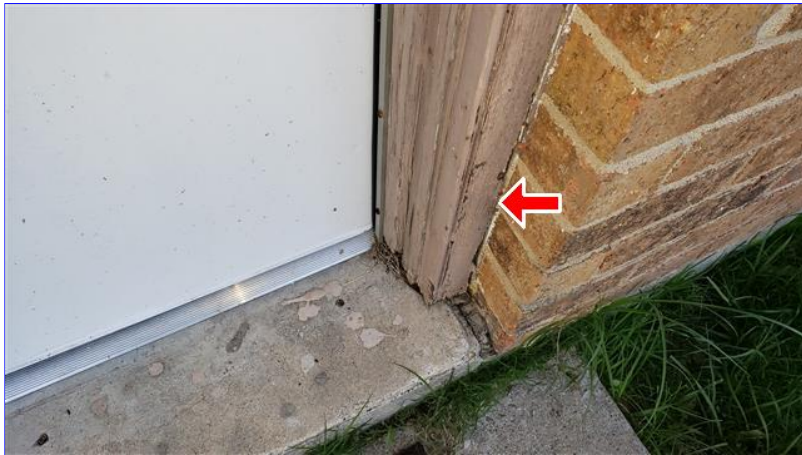
G. Item 1(Picture)

Paint peeling on the exterior side of the side entry door frame.

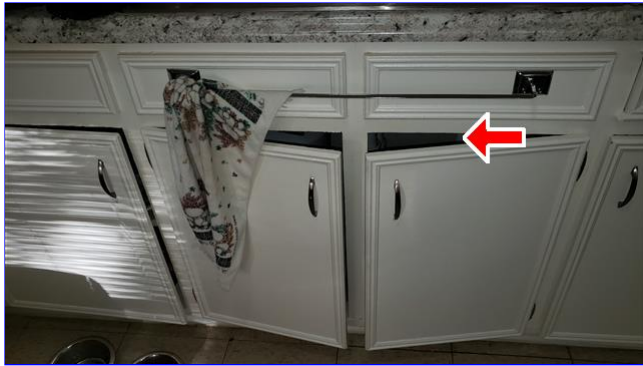
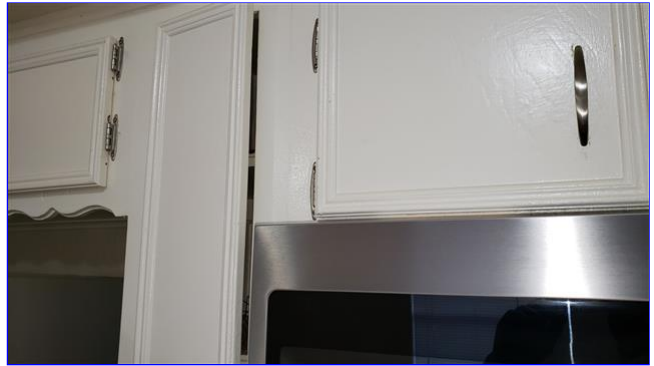
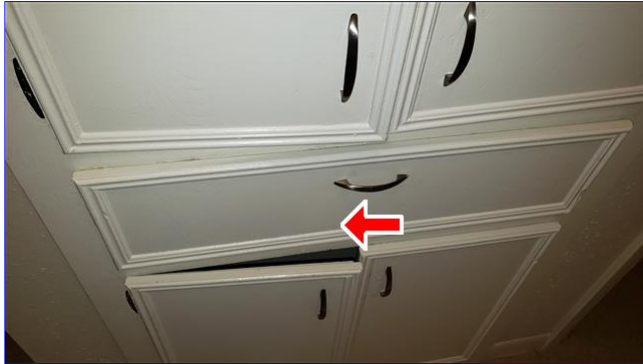
L. Item 1(Picture)

Several of the cabinet doors in kitchen and hallway are not closing properly. Recommend installing latches.
(2)

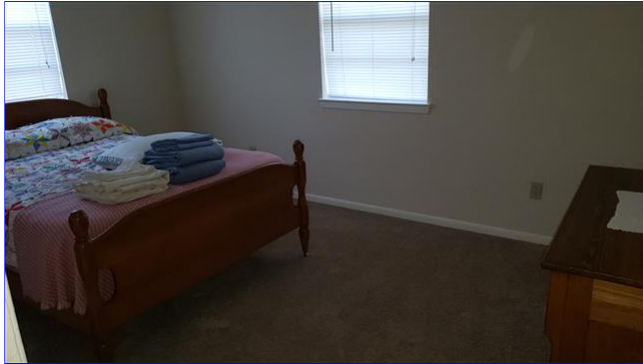
L. Item 10(Picture)

Home is furnished and occupied; could not view all areas of home, inside cabinets, inside closets, all areas of attic and in garage. Obstructed view to these areas.

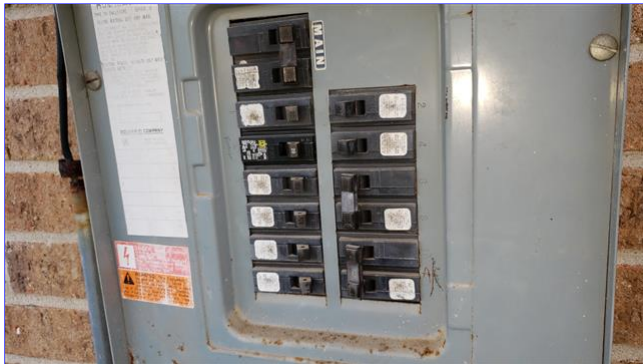
A. Item 1(Picture)

No arc-fault breakers present in electric panel at time of inspection.

Arc-fault circuit interrupters (AFCIs) are special types of electrical receptacles or outlets and circuit breakers designed to detect and respond to potentially dangerous electrical arcs in home branch wiring. All branch circuits that supply 120-volt, single phase, 15 and 20 amp outlets installed in family rooms, dining rooms, living rooms, parlors, libraries, dens, bedrooms, sun rooms, recreation rooms, closets, hallways and similar rooms or areas shall be protected by a combination type arc-fault circuit interrupter installed to provide protection of the branch circuit.

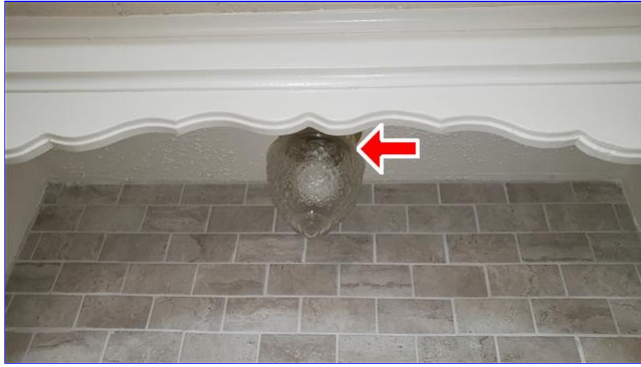
B. Item 1(Picture)

Light fixture above the sink is not working at time of inspection.

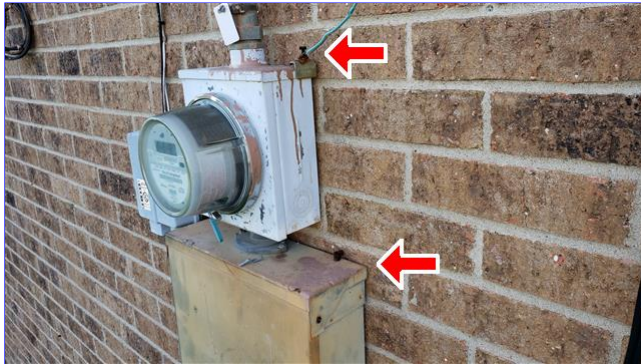
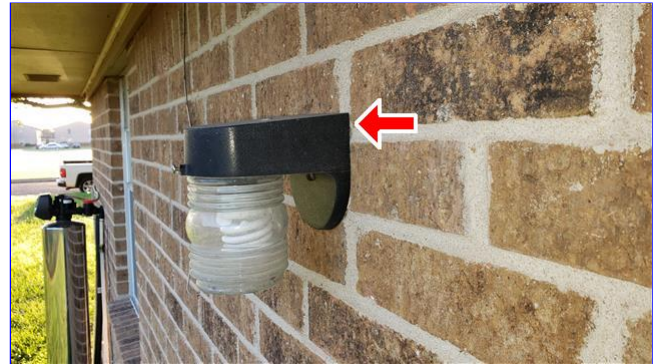
B. Item 2(Picture)

Need to seal around all exterior electrical items to make water tight against the structure.

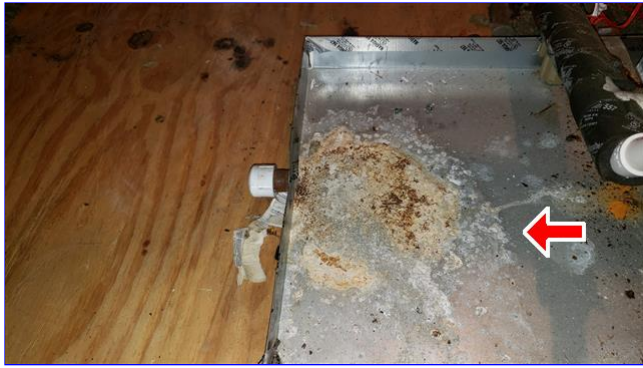
B. Item 1(Picture)

There's no drain line on the A.C secondary pan located in the Attic. Recommend a licensed A.C technician for repairs.

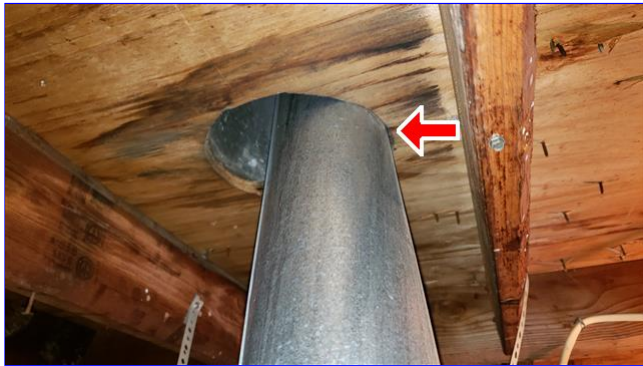
C. Item 1(Picture)

Heater exhaust vent is not strapped in place in attic. Heater vent should be at least one inch away from combustible materials.

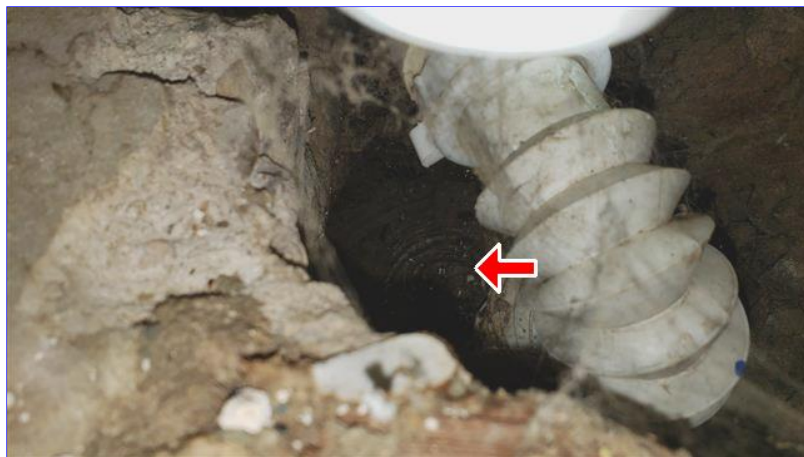
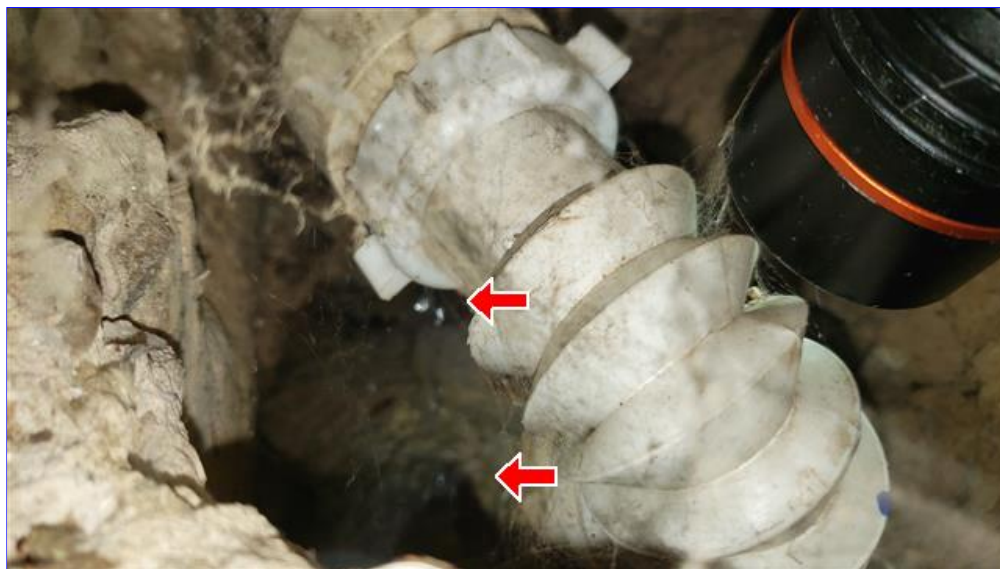
B. Item 1(Picture)

Tub drain leaking in back trap area underneath the tub. Recommend a licensed plumber for repairs.
