HITE TECH INSPECTIONS

1525 Nagle St  
Houston TX 77003

# PROPERTY INSPECTION REPORT

**Concerning:** 1525 Nagle St, Houston TX 77003  
(Address or Other Identification of Inspected Property)

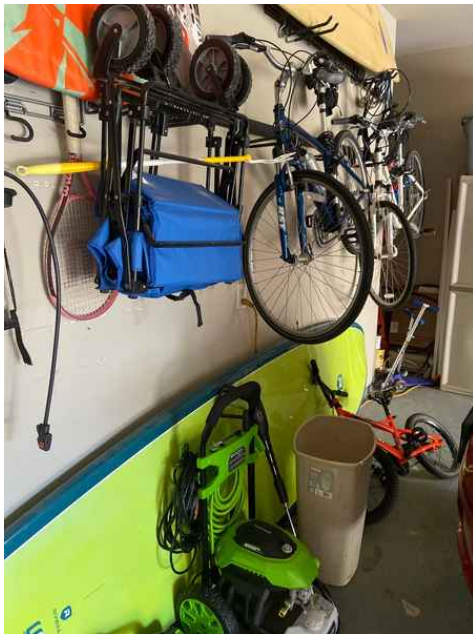
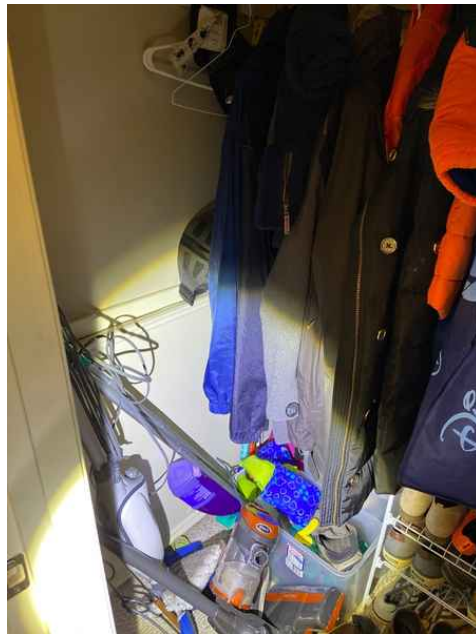
*The structure is occupied and has a large amount of personal belongings being stored. :*

Personal belongings can block items from being seen, and therefore will limit the scope of the inspection.

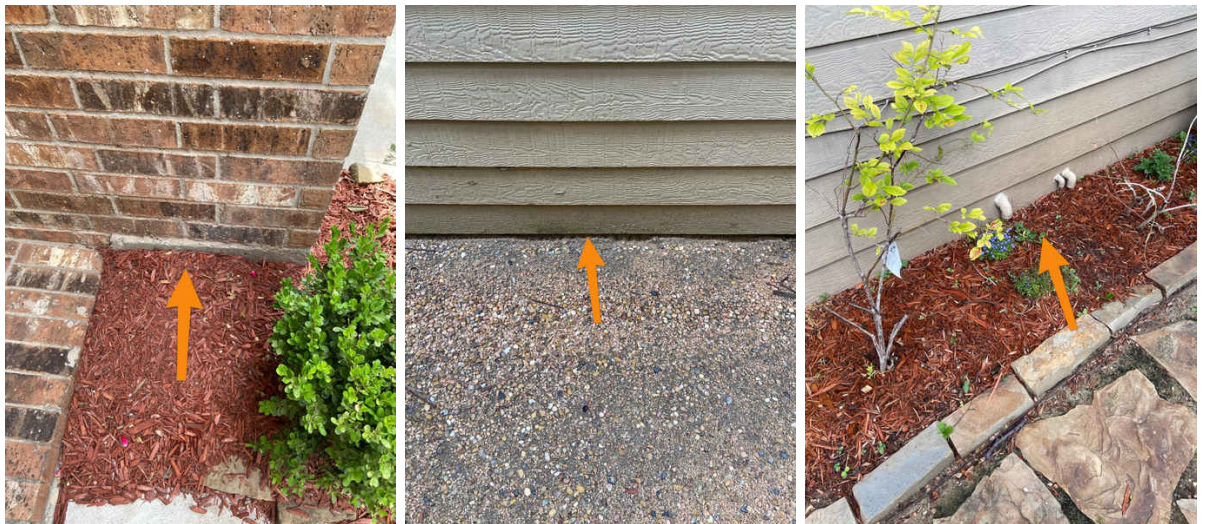
**2: Foundation needs to be exposed around perimeter of home**

The foundation wall should be exposed at least 4 inches this allows observation of the foundation wall for cracks and pest intrusions.

Recommendation: Contact a qualified grading contractor.

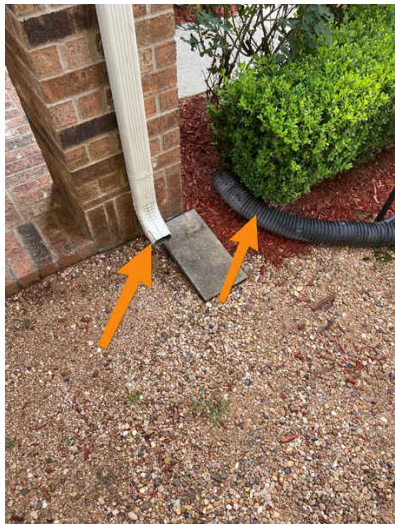
**1: Downspout extension is missing**

The gutter extension helps direct water away from the foundation. Uneven moisture around a foundation can cause it to move. Recommend installation of extension.

Extension needs to be reattached.

Recommendation: Contact a handyman or DIY project

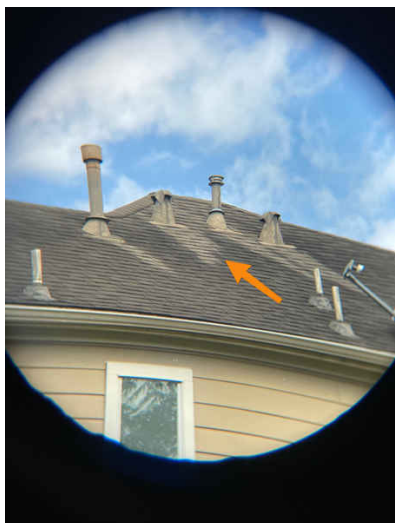
Roof shingles were discolored, which can be caused by moisture, rust or soot. Recommend a qualified roofing contractor evaluate and remedy with a roof cleaning or repair.

Recommendation: Contact a qualified roofing professional.

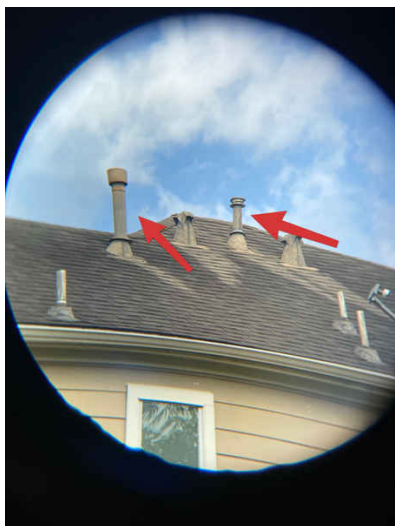
**3: Furnace/Water Heater exhaust vent is too short or uses improper cover**

Furnace exhaust vents are required to be 3 feet from any surface and water heaters 2 feet from any surface on the roof to the vent opening. This is to help exhaust products draft, and protect materials from being exposed to the high temperatures that can result in shorting of the lifespan of the materials and possibly lead to a fire.

Recommendation: Contact a qualified professional.

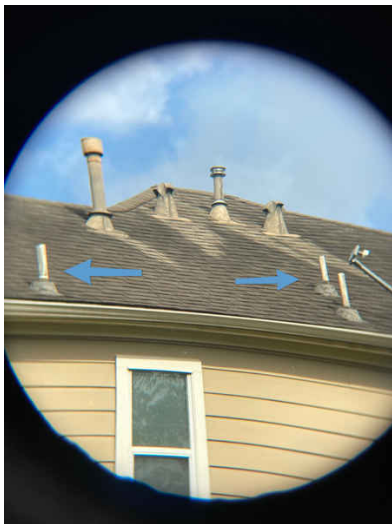
PVC will deteriorate when exposed to sunlight, which will shorten the lifespan of the material. PVC should be painted or covered to avoid damage.

Recommendation: Contact a handyman or DIY project

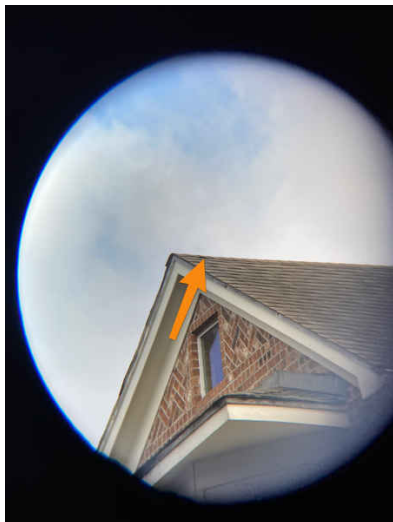
**7: Raised shingles**

Recommendation: Contact a qualified professional.

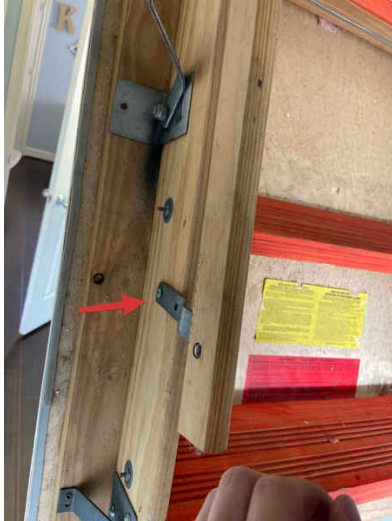
**2: Attic entry is not properly secured**

Attic entries need to be secured with 16d nails or lag screws. Most attic entries have labels giving instruction on how to properly install the entry. entrance ladder must be secured directly onto the framing without gaps.

Recommendation: Contact a qualified professional.

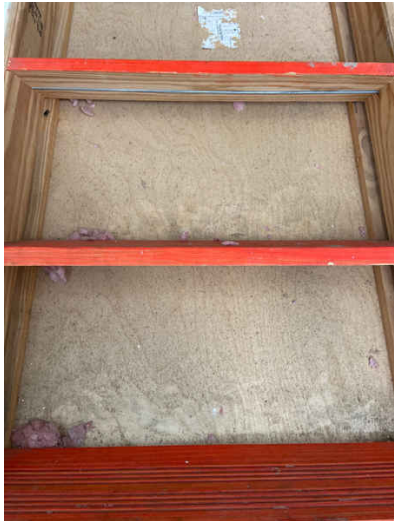
An uninsulated and unsealed attic entry will cause a loss in HVAC.

Recommendation: Contact a qualified professional.

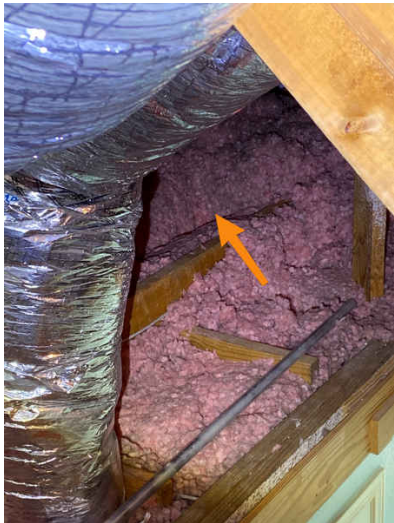
**4: Insulation is low in some areas**

Install insulation to bring level to 12 or more inches to increase HVAC efficiency.

Recommendation: Contact a qualified insulation contractor.

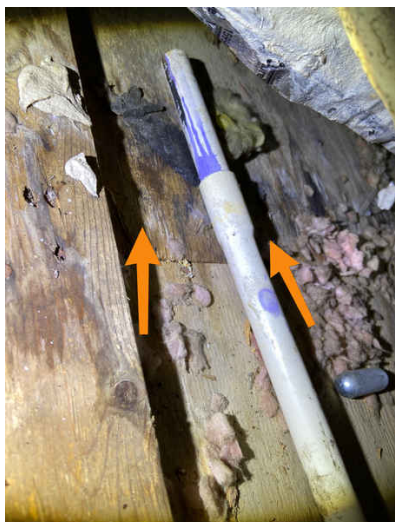
**5: Water damage or staining**

Damage or staining indicates a leak in the roof. Determine if the leak is active and have repaired by a qualified roofing contractor.

Recommendation: Contact a qualified professional.

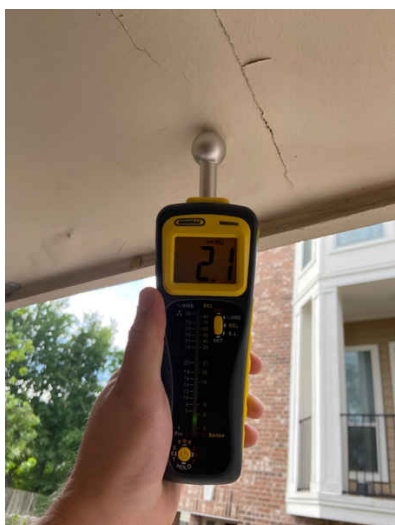
In front of garage.

**1: Evidence of previous water intrusion**

These places had evidence of previous moisture, but were dry at the time of the inspection. They can change with the weather and should be monitored for further change. If further changes occur have moisture source identified, and corrected.

Recommendation: Contact a qualified professional.

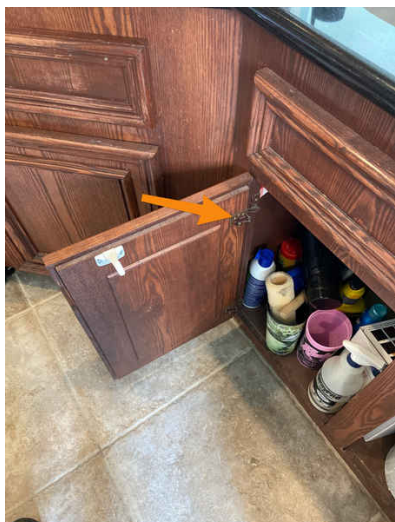
**2: Cabinet hinges are loose**

Loose hinges will not allow the doors to operate properly and doors could come off of cabinets if allowed to continue to loosen.

Recommendation: Contact a qualified professional.

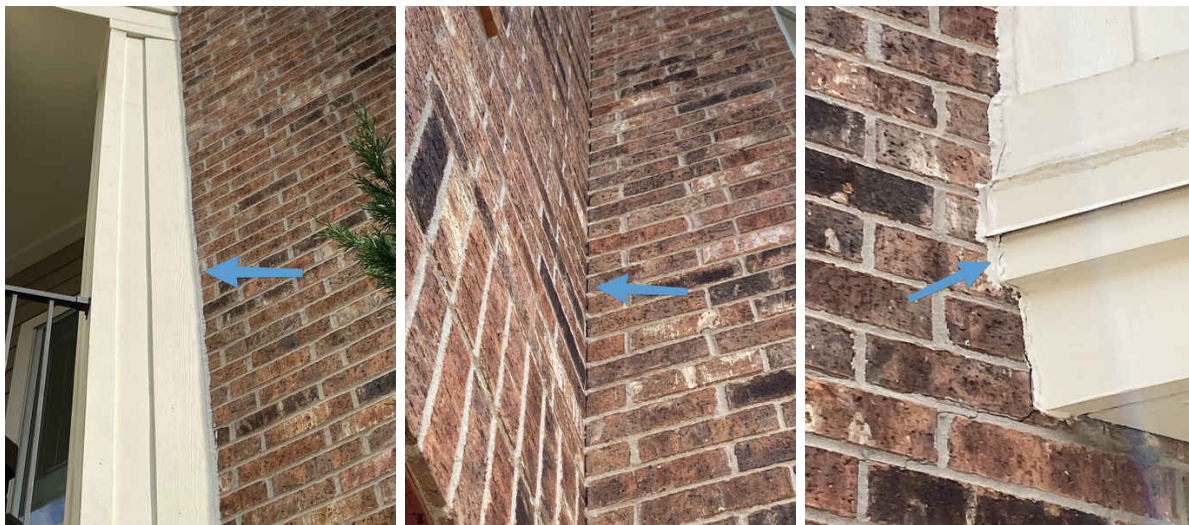
**3: Caulking/sealant is deteriorated or missing.**

Gaps in the caulking/sealant let insects and water penetrate the structure. When caulking starts to separate or crack it is time to replace it.

Recommendation: Contact a handyman or DIY project

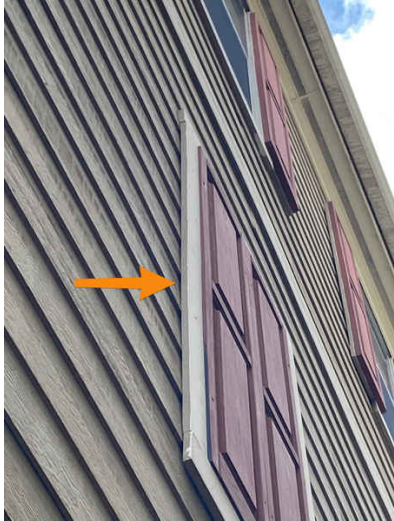
**4: Cement board is not installed properly**

Recommendation: Contact a qualified siding specialist.

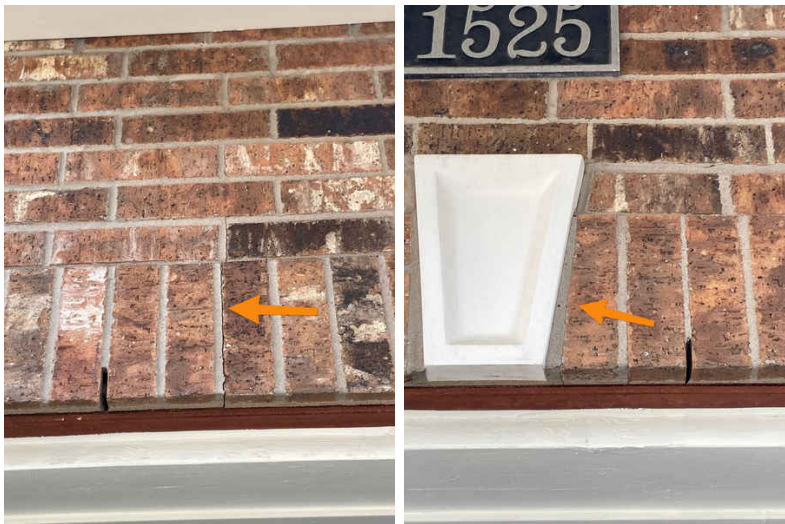
**5: Cracks through mortar**

These can be caused by age as well as rusted lintels. These are not necessarily a sign of foundation movement. All cracks should be sealed to prevent water penetration.

Recommendation: Contact a qualified professional.

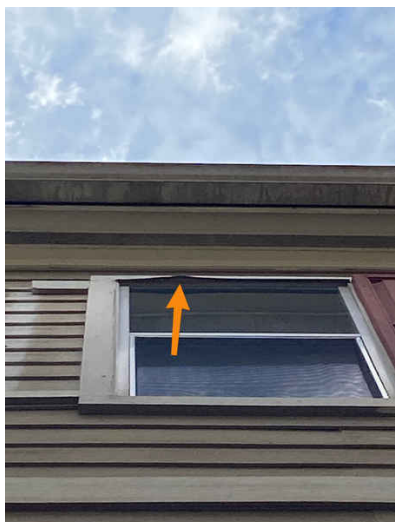
**6: Flashing has gaps, is damaged, or missing**

Recommendation: Contact a qualified professional.

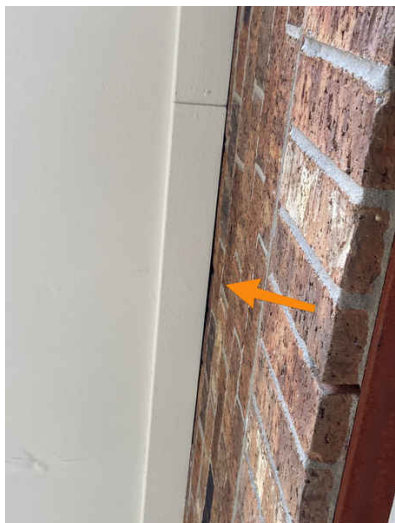
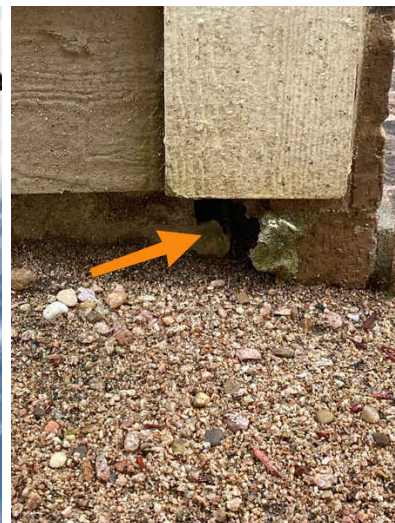
**7: Gaps in Siding**

Gaps in the siding allow water and insects to penetrate the structure. All gaps should be sealed to prevent damage from interior structural components.

Recommendation: Contact a qualified siding specialist.

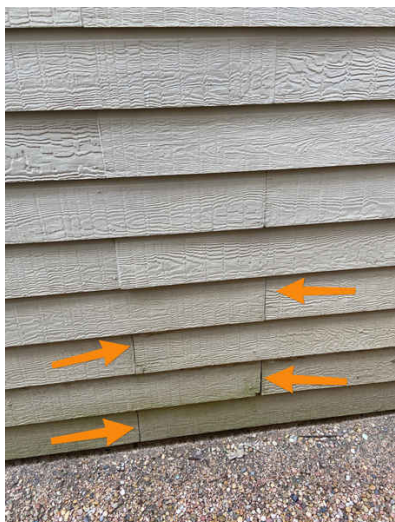
**8: Joints are separating in siding**

Siding should be sealed at all joints. Reason for separation should be determined in order to assess if repairs are needed to structure.

Recommendation: Contact a qualified professional.

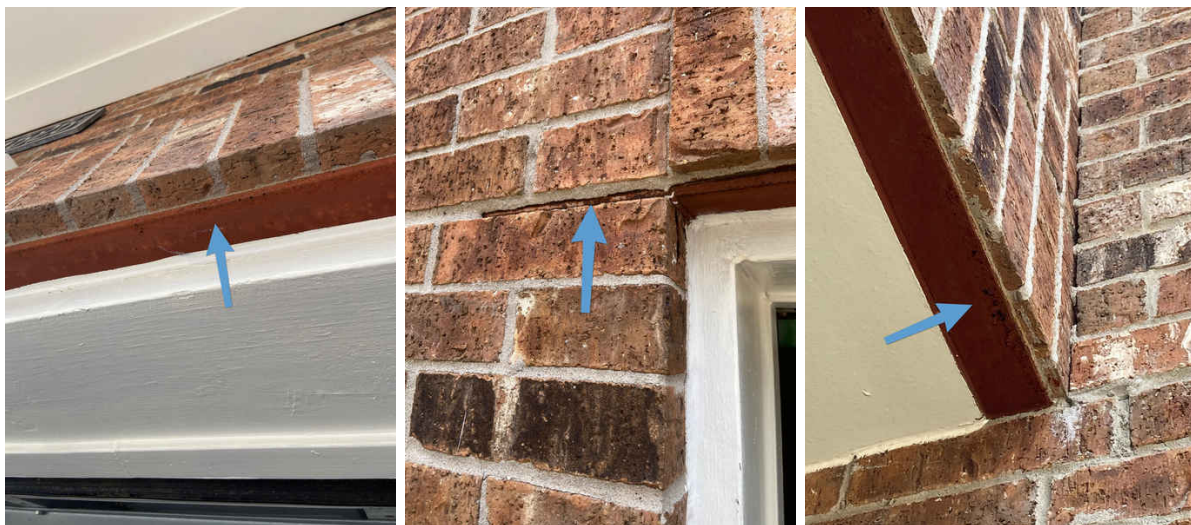
**9: Lintel is rusted**

Lintels are metal plates that support the brick above them it is important to keep these painted and sealed to prevent rusting. Rust will expand and crack the brick and mortar. In extreme cases, the lintel will not be able to support the brick and will need to be replaced.

Recommendation: Contact a qualified professional.

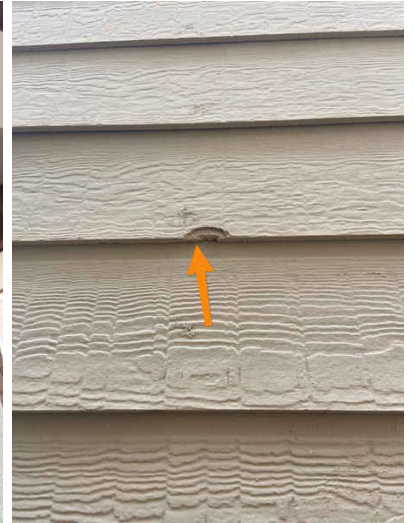
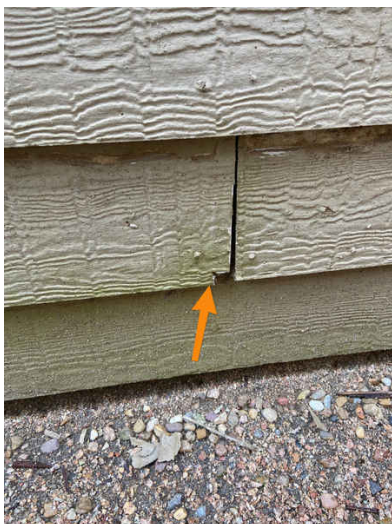
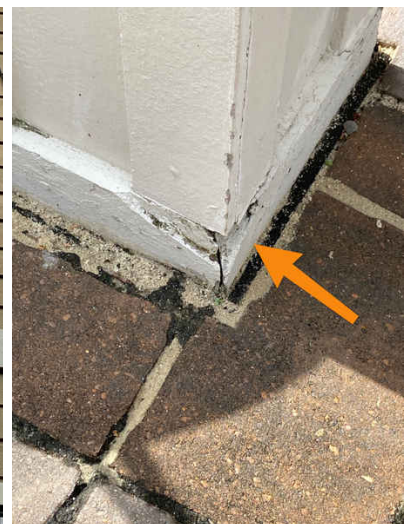
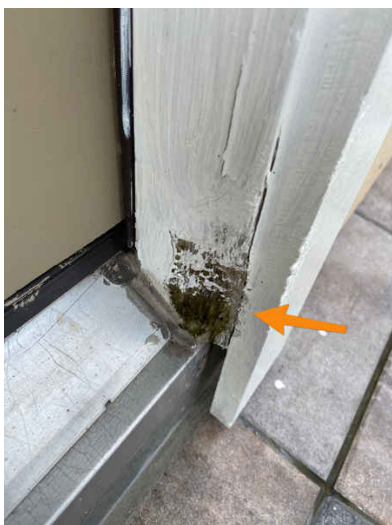
Damaged or deteriorated siding and trim can allow access to water and insects into the home. Have damaged or deteriorated areas replaced.

Recommendation: Contact a qualified siding specialist.

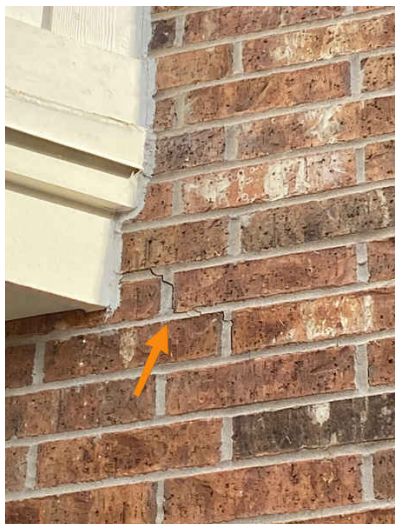
Step cracks in brick indicates some movement or shifting has happened. Seal the cracks with caulk, and monitor for further movement. This may be an indication of foundation movement, and should be combined with other indicators before making a determination. Step cracking alone is not usually an indicator of foundation movement. Alone, it is normally an indication of a failure in the siding system.

Recommendation: Contact a qualified siding specialist.

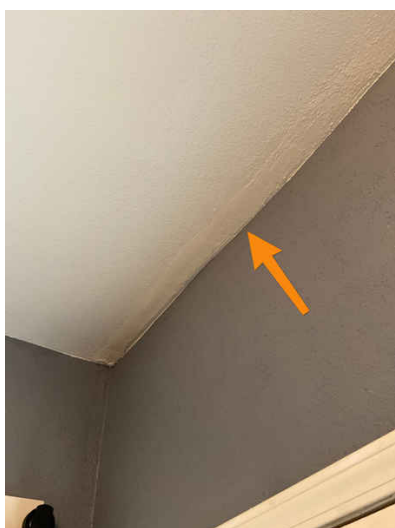
**1: Evidence of previous repair**

Reason for previous repairs cannot be determined, and can cover latent defects.

Recommendation: Contact a qualified professional.

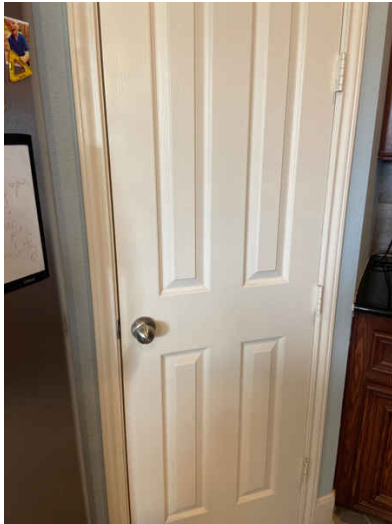
**1: Door does not latch**

Door doesn't latch properly. Recommend handyman repair latch and/or strike plate.

Recommendation: Contact a qualified handyman.

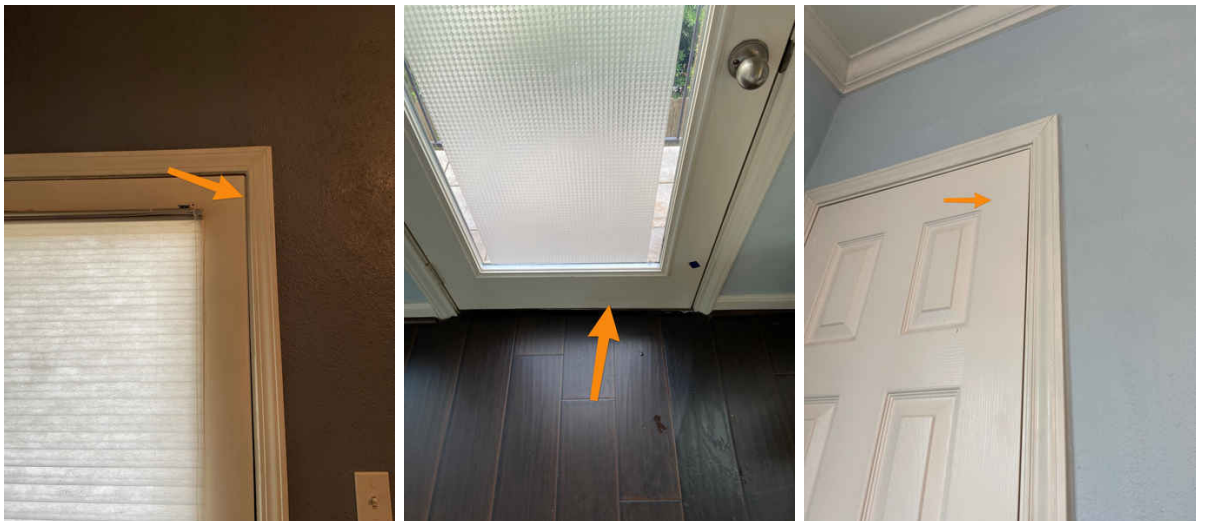
## 2: Door Is binding

Door may need to be adjusted or reinstalled in order to operate correctly.

Recommendation: Recommended DIY Project

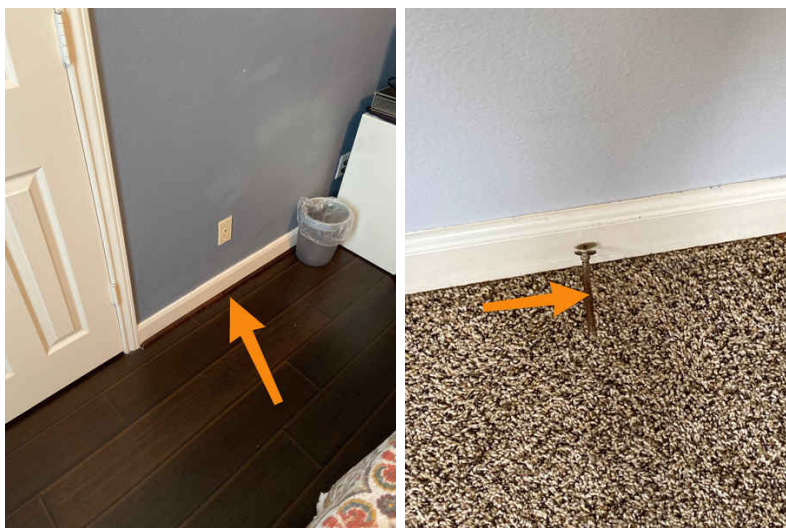
## 3: Doorstop missing or damaged

This can cause damage to walls or objects which the door comes into contact. Install or replace the door stop.

Recommendation: Contact a handyman or DIY project

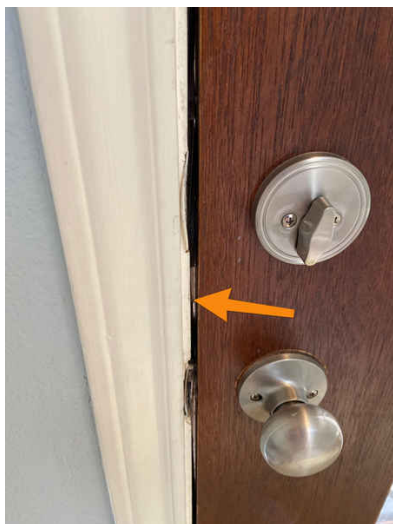
#### **4: Noticeable Gap**

One or more gaps could result in energy loss. Recommend handyman or door contractor evaluate.

Recommendation: Contact a qualified door repair/installation contractor.

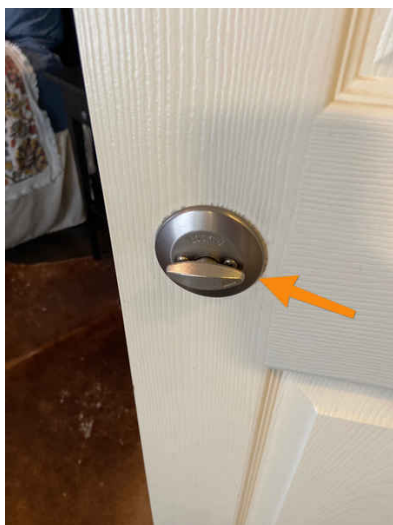
**6: Door knob missing**

The door will be more difficult to open without a proper knob.

3rd Bedroom, knobs are replaced with dead bolts.

Recommendation: Contact a qualified door repair/installation contractor.

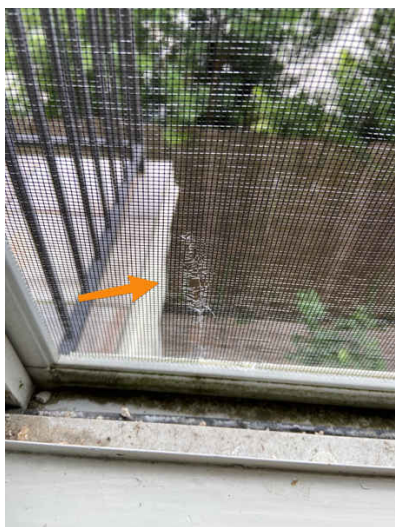
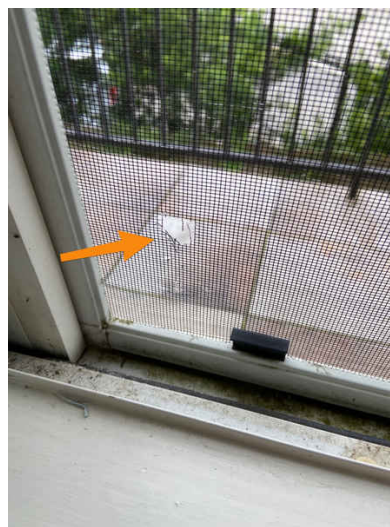
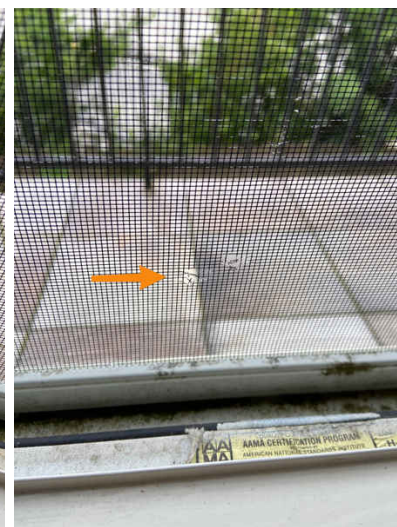
Damaged screens will let insects enter home when the window is open.

Recommendation: Contact a qualified professional.

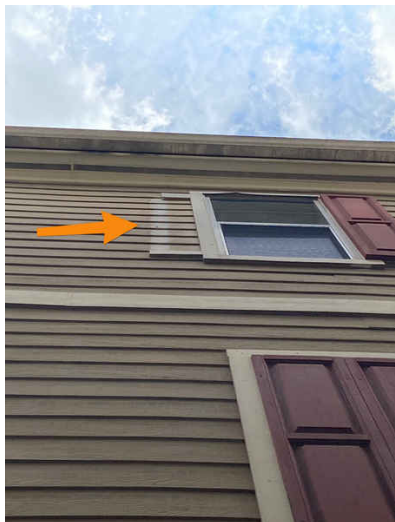
**4: Window is incorrect height or size**

In sleeping rooms windows cannot exceed 44" and must have an opening of not less than 5.7 feet. This is so that children or the elderly can get out of the window in an emergency. On upper stories, windows must be a minimum of 24" inches from the floor to protect children from accidentally falling through the window.

Recommendation: Contact a qualified professional.

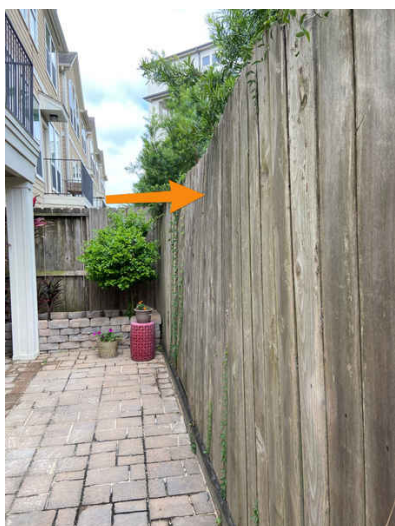
Fence moves when pressure is applied, noting posts were not installed deep enough, or cement was not used to secure posts

Recommendation: Contact a qualified professional.

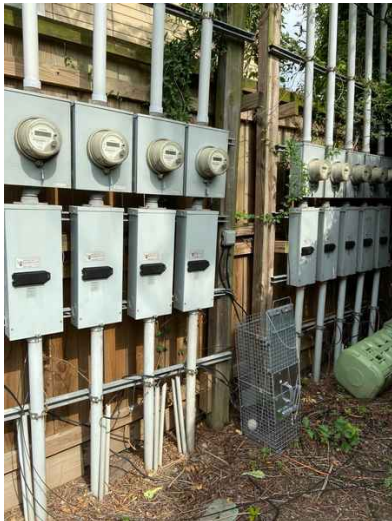
Main panels are not labeled.

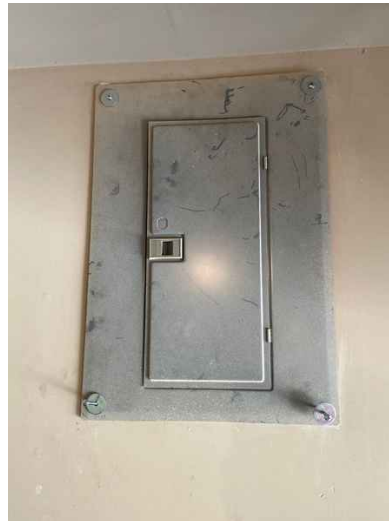
Panel is used as junction box.

Recommendation: Contact a qualified electrical contractor.

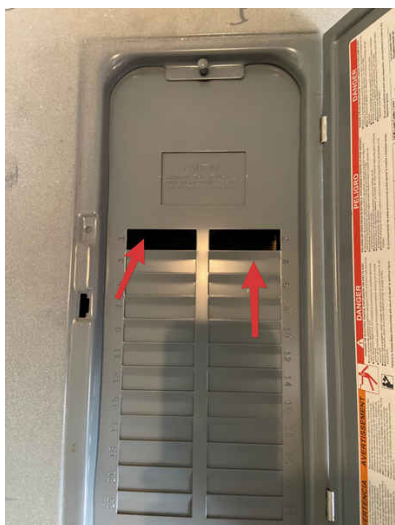
#### **4: Knockouts are open**

Recommendation: Contact a qualified professional.

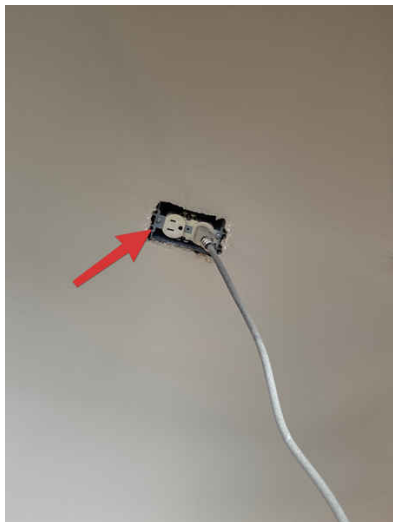
**5: Light Inoperable**

One or more lights are not operating. Test the light by replacing the light bulb.

Recommendation: Contact a qualified electrical contractor.

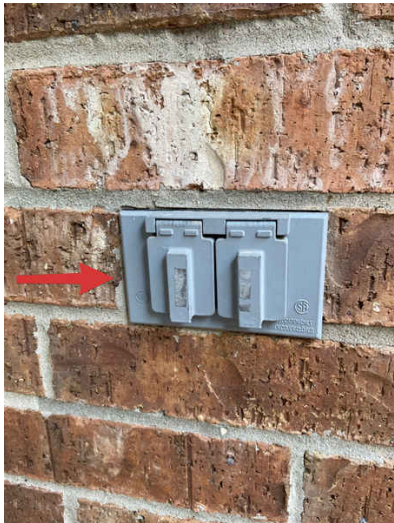
**9: Outlets, switches or electrical components have paint or combustibile material on them**

Paint as well as any combustibile materials should not cover outlets.

Recommendation: Contact a qualified electrical contractor.

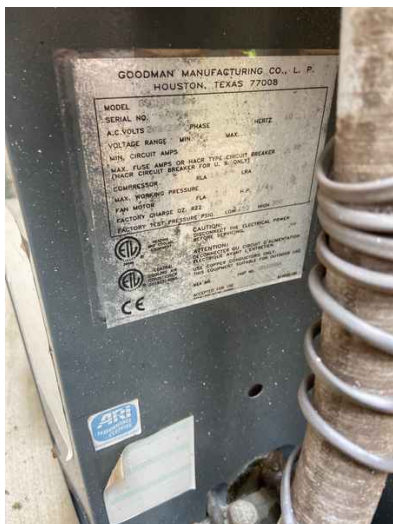
*Manufacturer data plate:*

*Type of Systems:* Central Air Conditioner

*AC condenser max breaker rating:* 30 - amps

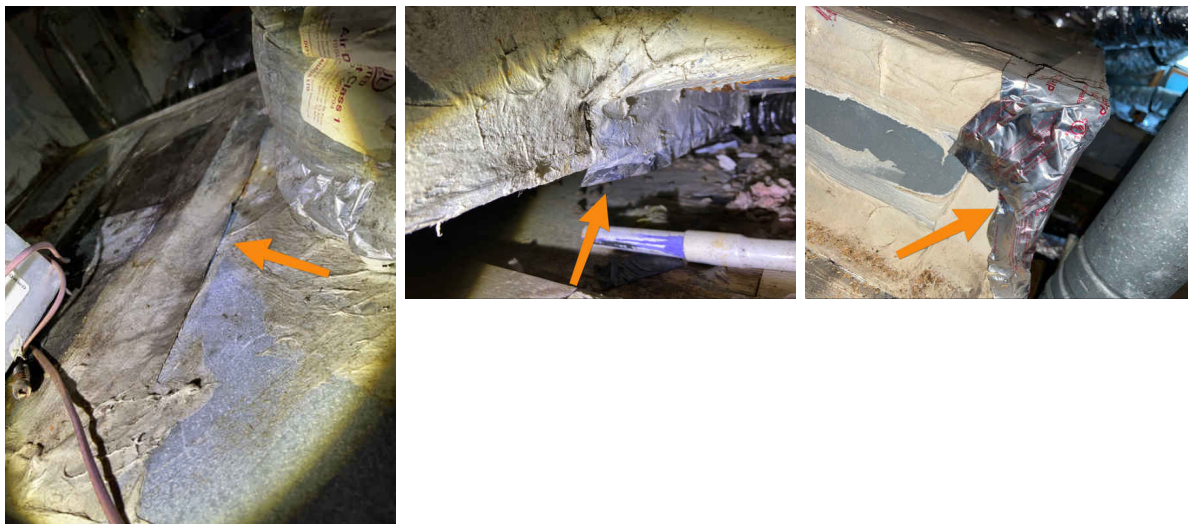
**2: Casing is leaking and/or damaged**

Recommendation: Contact a qualified professional.

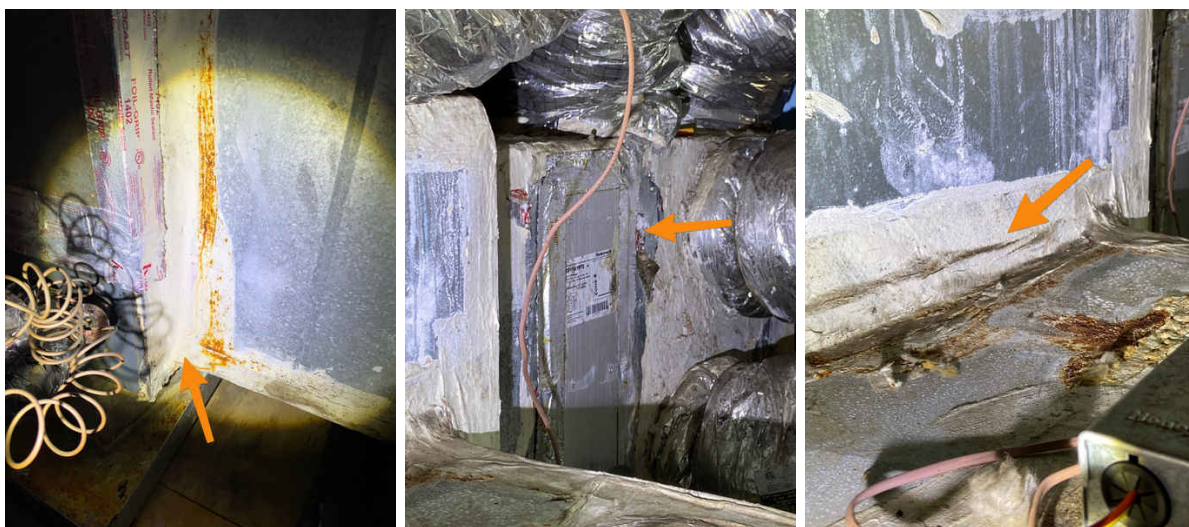
**3: Condensation on unit casing**

Recommendation: Contact a qualified professional.

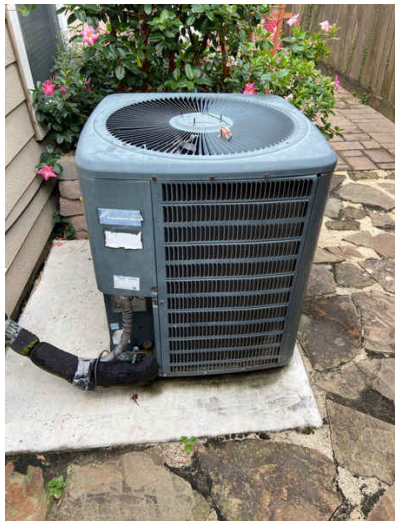
**4: Condenser unit is not secured or level**

Recommendation: Contact a qualified HVAC professional.

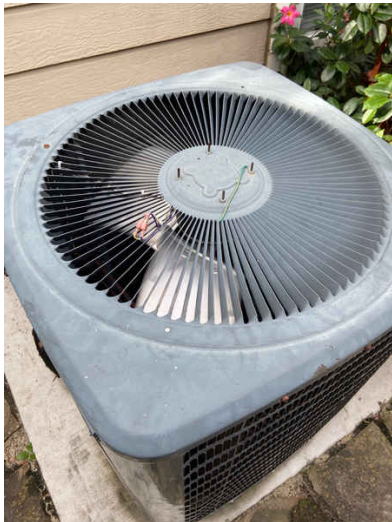
The condenser fan is out of balance. With use the condition will worsen and cause damage to the unit. It also decreased the efficiency of the unit.

Recommendation: Contact a qualified HVAC professional.

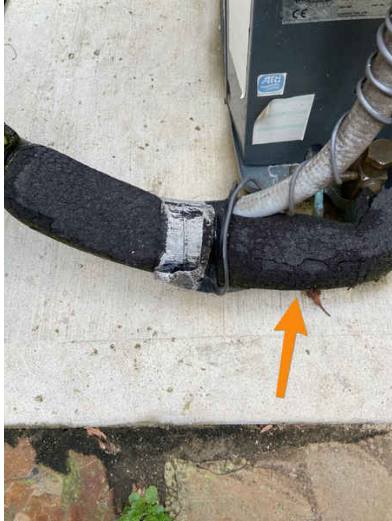
**7: Insulation Missing or Damaged**

Missing or damaged insulation on refrigerant line can cause energy loss and condensation.

Recommendation: Contact a qualified HVAC professional.

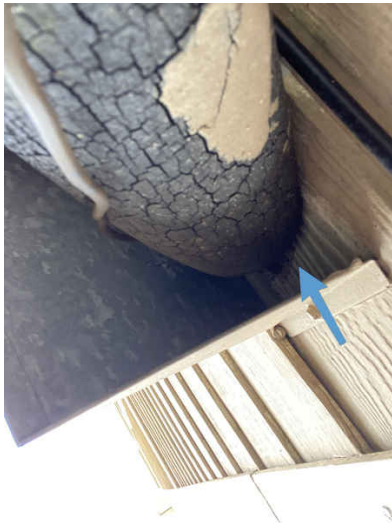
**8: Refrigerant lines need to be sealed or resealed at entrance into the home**

Penetrations into the home need to be sealed to keep pests and water out.

Recommendation: Contact a qualified professional.

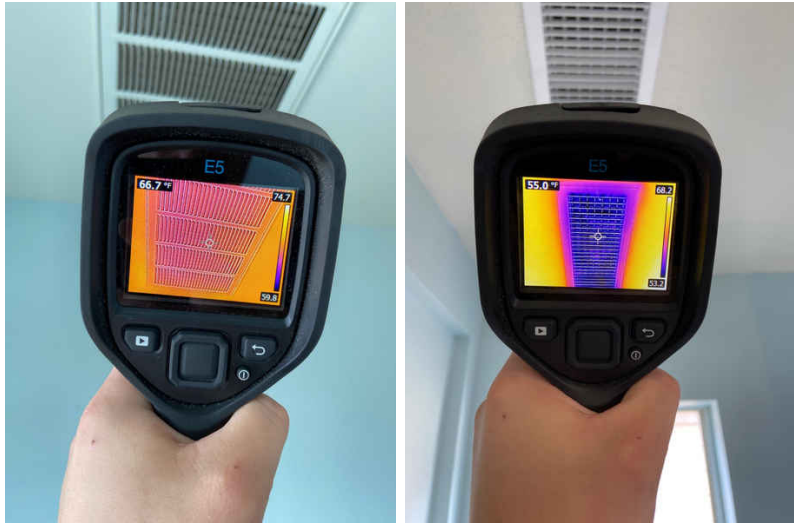
**9: Register did not produce sufficient differentials to properly cool the house**

The air conditioner was running but did not produce air within the 14+ degree range needed to cool the home at all registers. Recommend licensed HVAC contractor evaluate.

Recommendation: Contact a qualified HVAC professional.

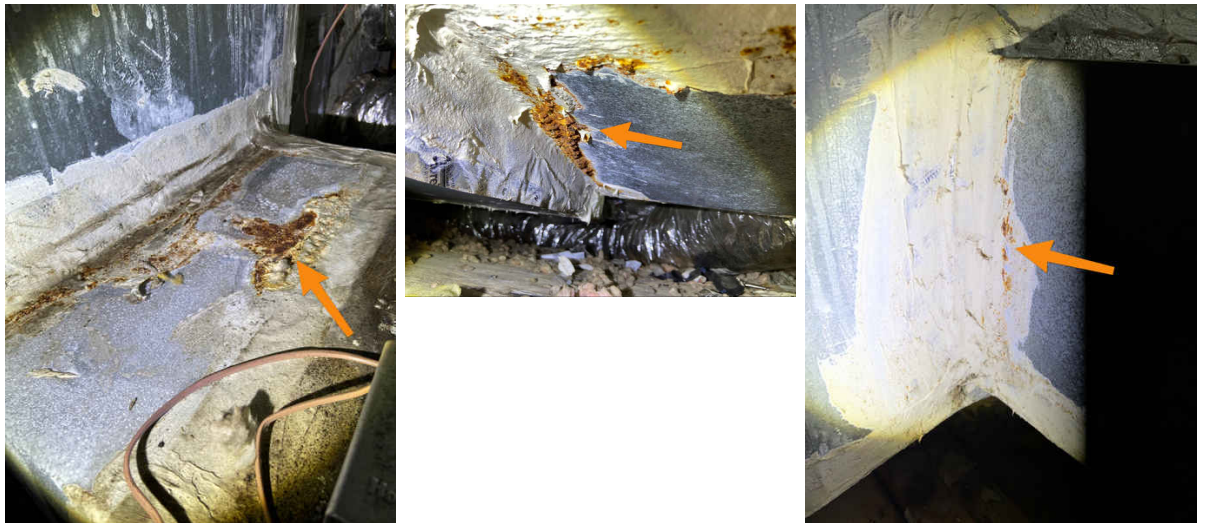
**10: Rusted casing**

Recommendation: Contact a qualified professional.

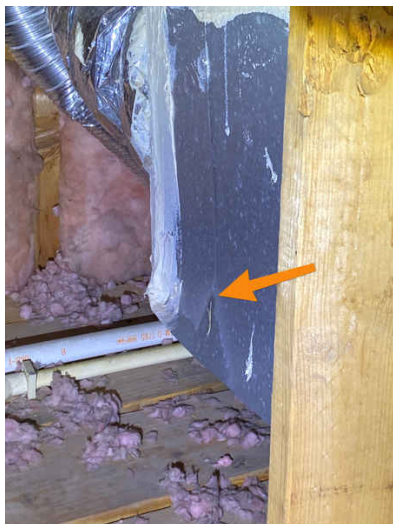
**1: Duct Damaged or leaking**

Air supply duct was leaking or damaged. Recommend a qualified HVAC contractor repair.

Recommendation: Contact a qualified HVAC professional.

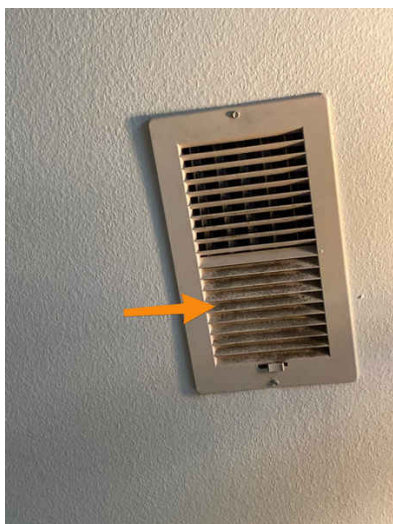
**2: Register is dirty with possible bio growth**

Recommendation: Contact a qualified professional.

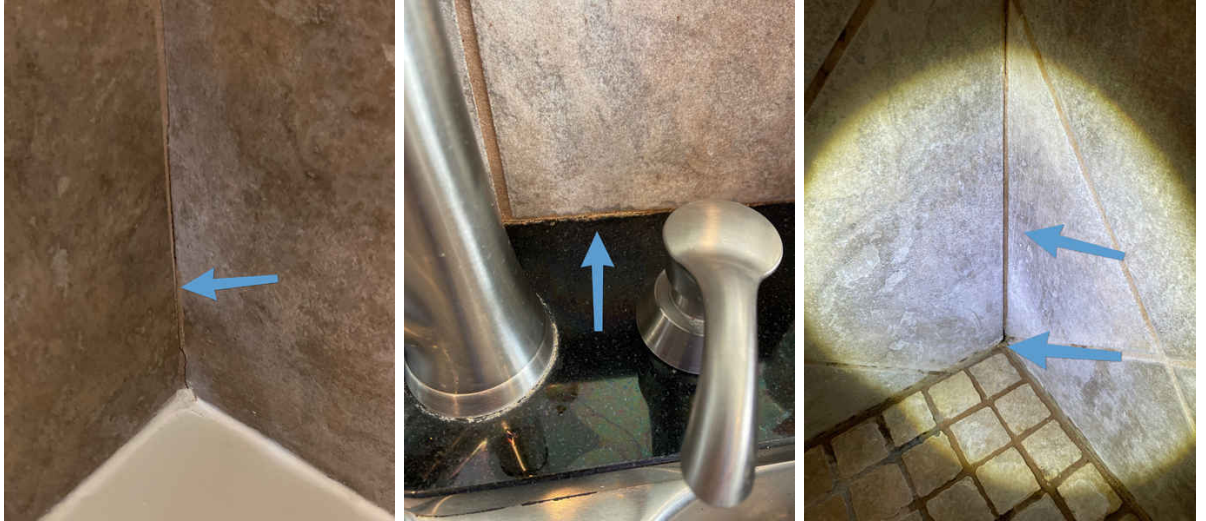
**1: Caulking is missing or deteriorated**

Caulking, while inexpensive is an important part of the home. Caulking around plumbing fixtures and at joints protects finishes and structural members from water damage.

Recommendation: Contact a handyman or DIY project

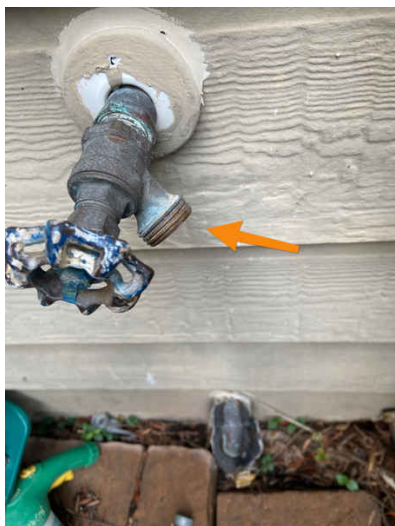
**4: Hose bib needs anti-siphon device**

Recommendation: Contact a qualified professional.

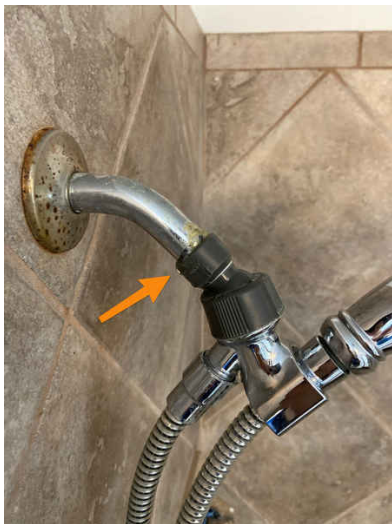
**6: Shower head is leaking from connection joint**

Recommendation: Contact a qualified professional.

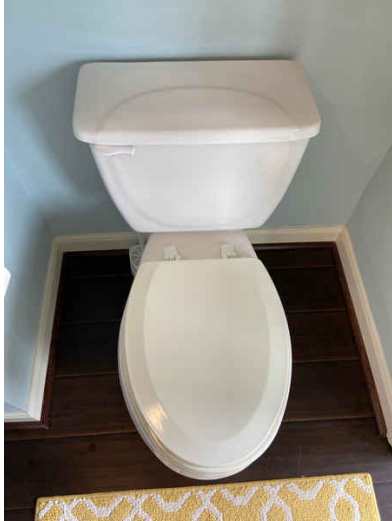
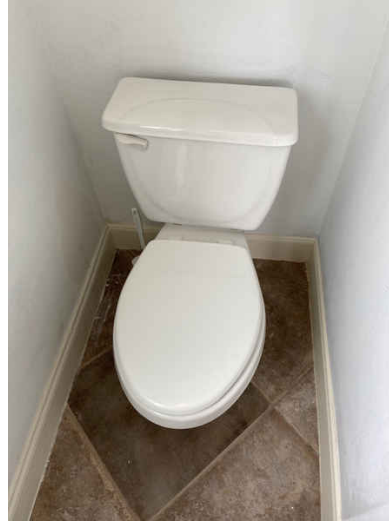
**7: Toilet is loose from floor**

Toilets have a wax ring that seals the connection of the toilet to the floor. If the seal is broken water and sewer gases can escape.

Recommendation: Contact a qualified professional.

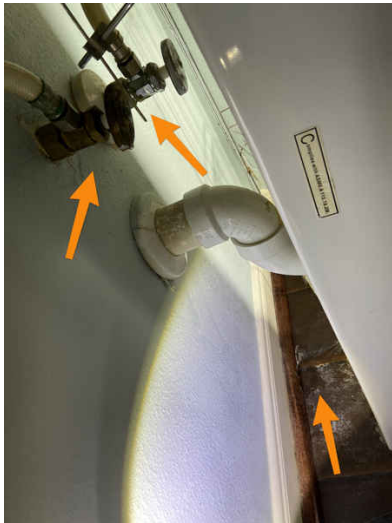
**8: Water line or valve leaking**

Water line or valve leaking. Recommend qualified plumber repair leak.

Recommendation: Contact a qualified plumbing contractor.

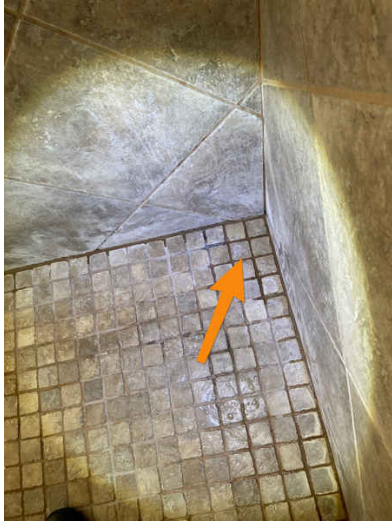
**9: Shower floor is not properly sloped for drainage**

Shower floors should be sloped towards the drain to keep the floor from deteriorating from standing water.

Recommendation: Contact a qualified general contractor.

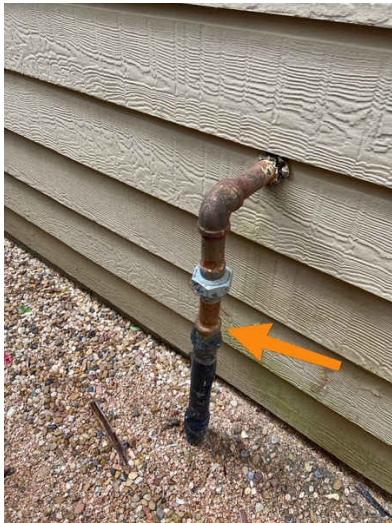
**10: Gas line is corroded/rusted**

Monitor the gas line for further corrosion or leaks. Have repaired as needed.

Recommendation: Contact a qualified plumbing contractor.

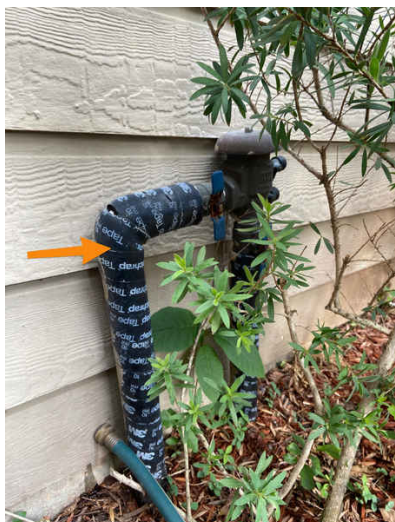
**11: Antisiphon device for sprinkler system needs to be supported.**

Left unsupported, the anti-siphon device could be impacted and caused pipes to break or leak

Recommendation: Contact a handyman or DIY project

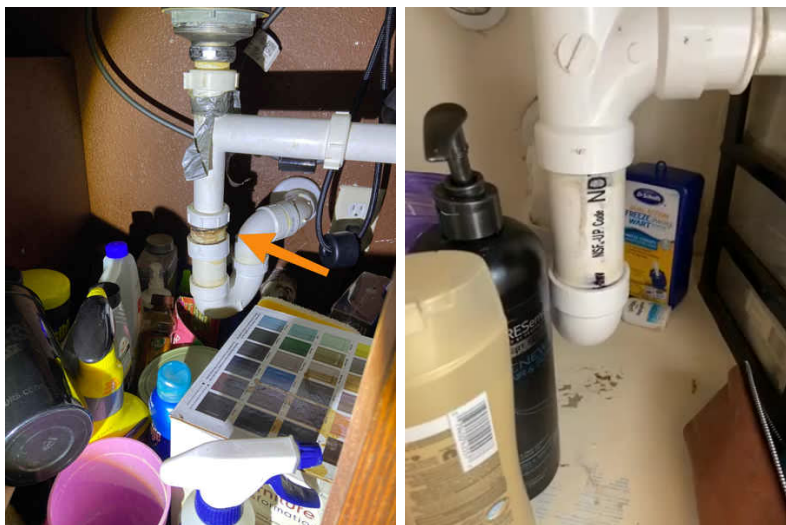
**1: Leaking**

Recommendation: Contact a qualified plumbing contractor.

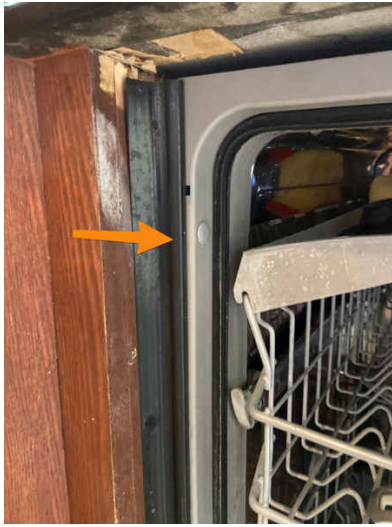
Fasteners are loose

Recommendation: Contact a handyman or DIY project

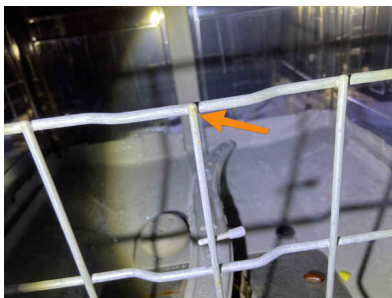
**2: Dishwasher racks are damaged or rusted**

Dishwasher racks might not hold dishes properly and could cause stains if the racks are damaged or rusted.

Recommendation: Contact a qualified professional.

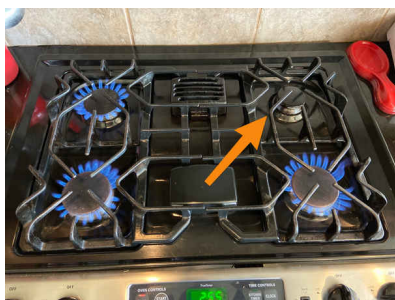
**1: Burner Not Working**

One or more heating elements did not heat up or heat up fully when turned on. Recommend qualified professional evaluate & repair.

Recommendation: Contact a qualified appliance repair professional.

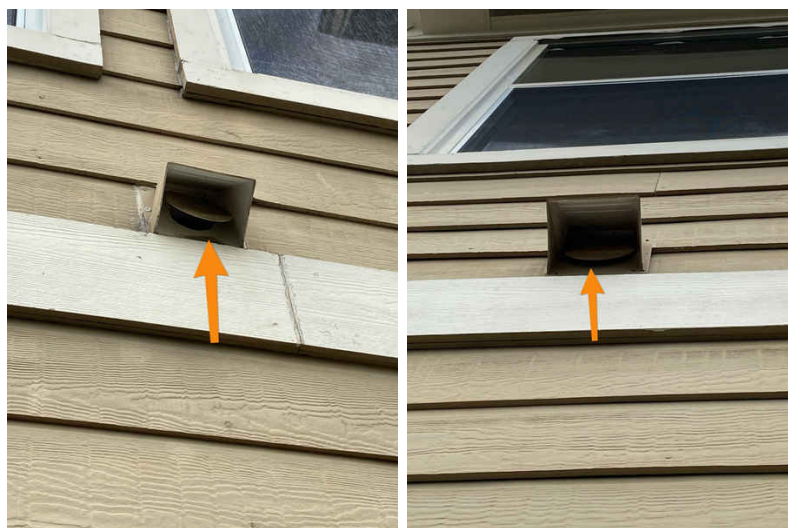
The damper on an exhaust vent should close when it is not in use to protect the structure from water and pest intrusion.

Recommendation: Contact a qualified general contractor.

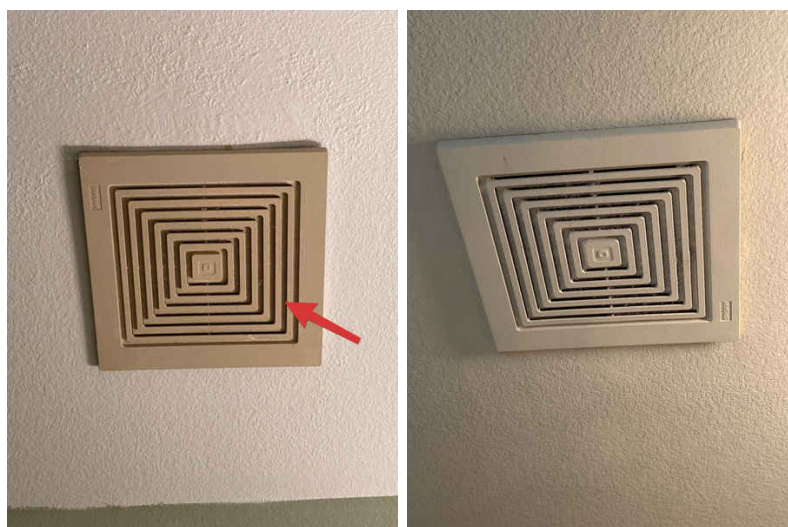
**2: Dirty**

Recommendation: Contact a qualified professional.
