Wood Destroying Insect Report

Inspection Performed by Juan Mireles TPCL #838092 7/12/2021

13515 St Mary's Ln.

TEXAS OFFICIAL WOOD DESTROYING INSECT REPORT

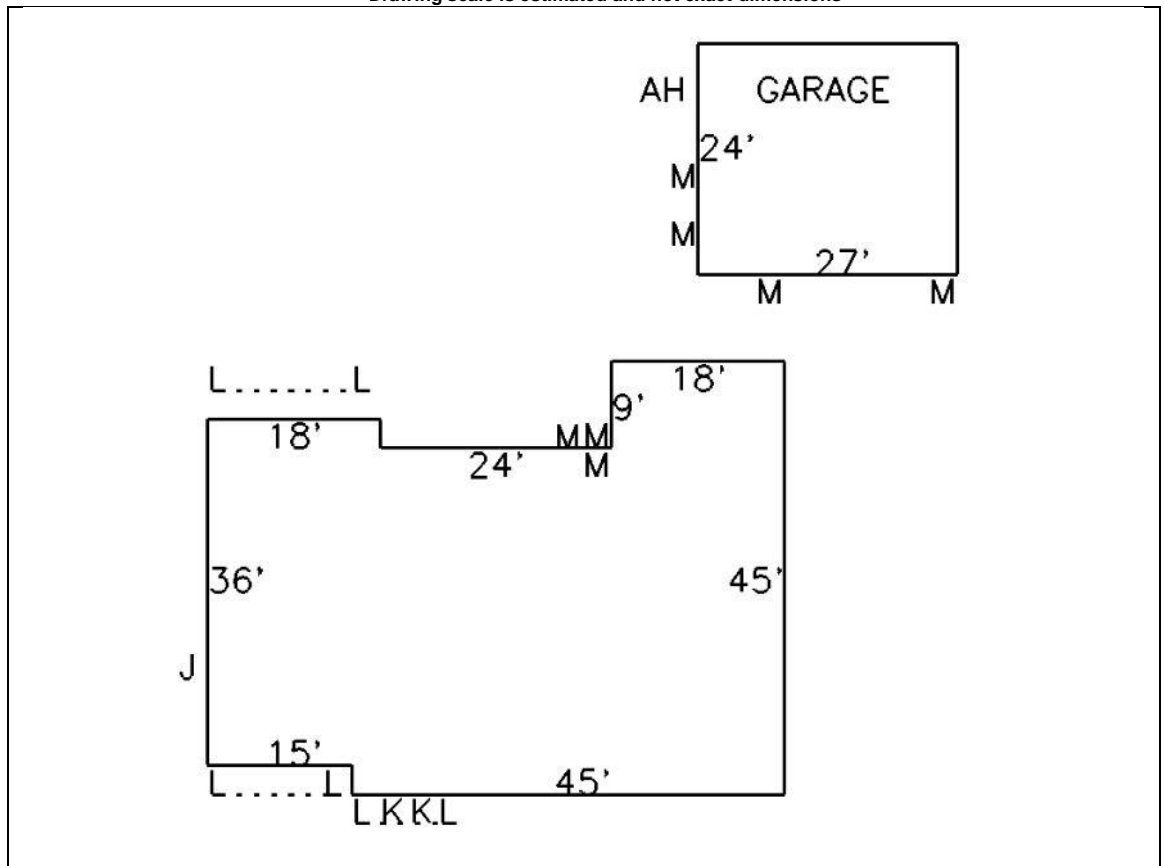
Diagram of Structure(s) Inspected

The inspector must draw a diagram including approximate perimeter measurements and indicate active or previous infestation and type of insect by using the following codes: E - Evidence of Infestation, A-Active; P-Previous; D-Drywood Termites; S-Subterranean Termites; F-Formosan Termites; C-Conducive Conditions; B-Wood Boring Beetles; H-Carpenter Ants; Other(s) - Specify:

Drawing scale is estimated and not exact dimensions

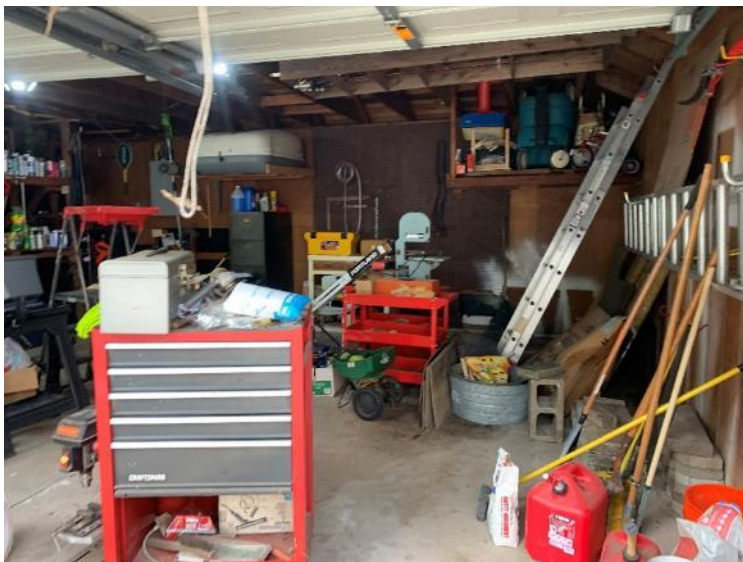
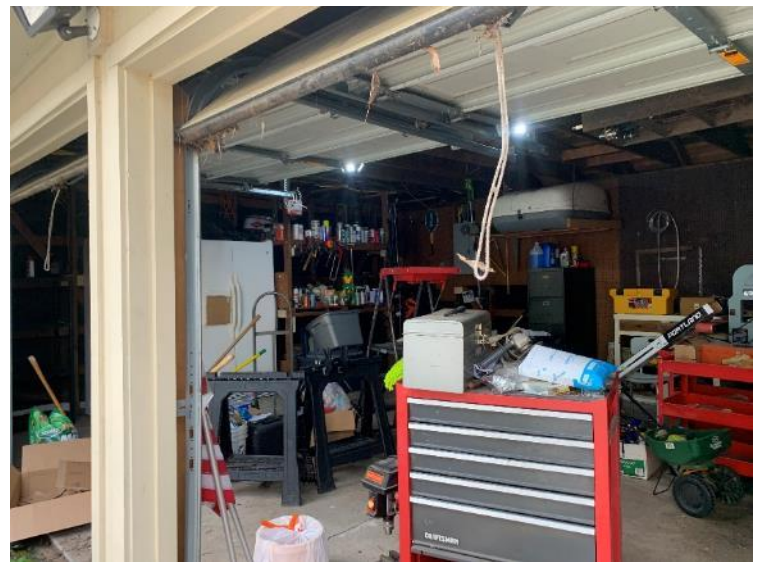
Obstructed View

Items stored in the garage obstructing view

Conducive conditions obstruct visibility and limit the inspection for wood destroying insects. It is recommended that all conducive conditions be corrected and the obstructed areas be reinspected once the work is complete.

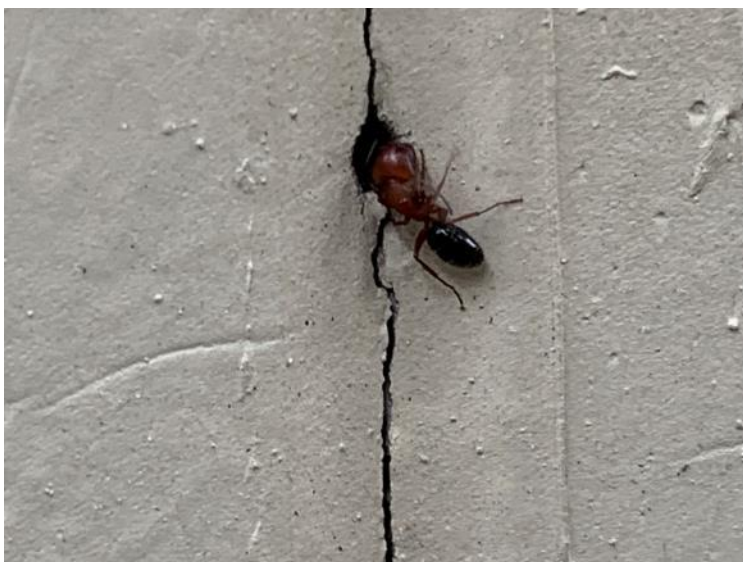
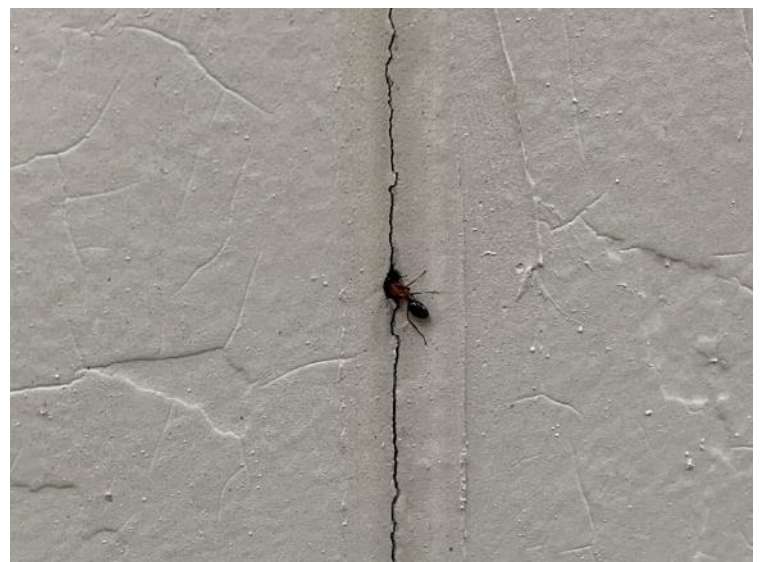
Evidence of Wood Destroying Insects

11G. Visible evidence of: **Carpenter Ants** has been observed in the following areas: **Outer left side of the garage.**

(AH) Carpenter Ants - Evidence of an active infestation - Treatment is recommended.

Evidence of carpenter ants

**Treated with follow-up
See Chem-Tech Invoice**

INVOICE NOTES: Treated right and rear walls and soffits of the home. Treated all interior roof joists and interior soffits of the garage, treated perimeter, soffit and roof line also. Added residual dust at back, right corner of the garage, area of primary activity. Also added bait around the perimeter of the garage. Carpenter ants appear to be originating from the tree in your neighbors yard. The use of bait and non repellent materials will have a broad effect. We will treat again in 1 week.

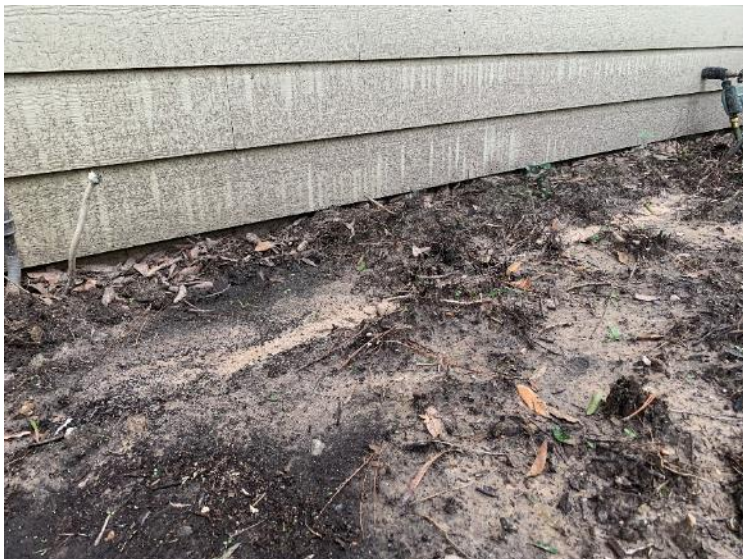
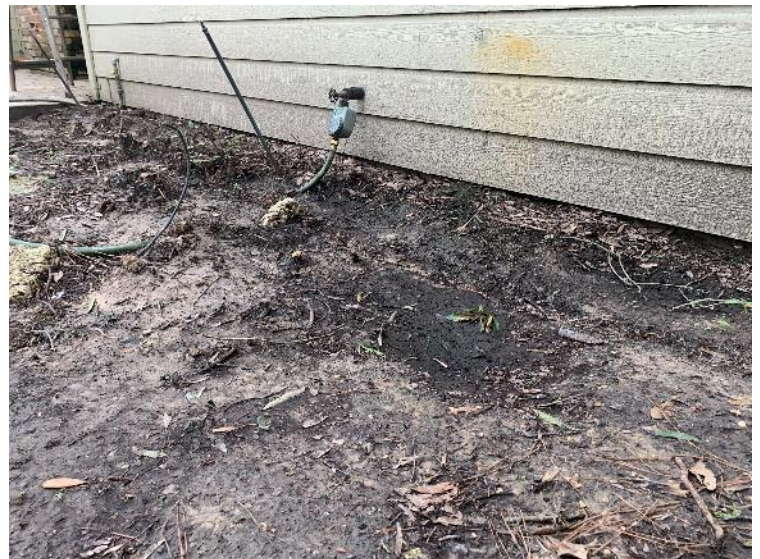
Debris observed near the structure and should be removed

(K) Debris - Debris should be cleared from around the structure.
