## INSPECTION REPORT

655 S Rivershire Dr  
Conroe TX 77304

# PROPERTY INSPECTION REPORT

Concerning: 655 S Rivershire Dr, Conroe TX 77304

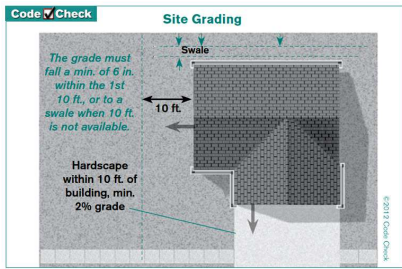
**1: High Soil Levels**

High soil levels detected at exterior. Soil levels should be lowered to provide the suggested 4 inches of clearance between soil and exterior wall cladding (brick, stucco, siding).

Recommendation: Contact a qualified professional.

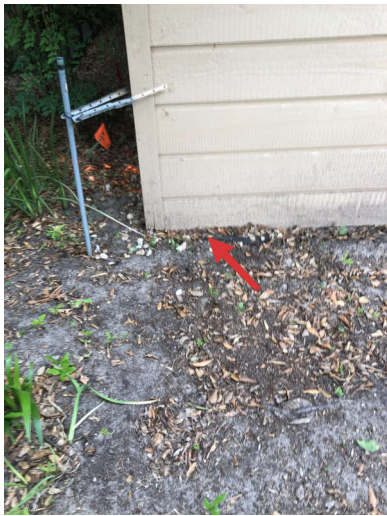
**2: Trim Foliage**

Detached Garage

Foliage touching the home can trap moisture or provide access to the home for bugs. Touching foliage can allow damage to structure in times of wind and storm.

Recommendation: Contact a handyman or DIY project

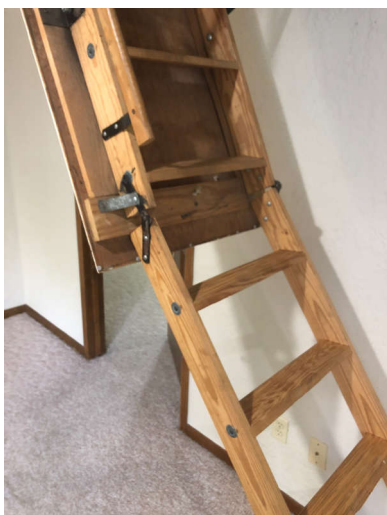
**1: Loose/Damaged/Missing Hardware on Attic Access Ladder**

Loose/Damaged hardware on access ladder can be a safety hazard.

Recommendation: Contact a qualified professional.

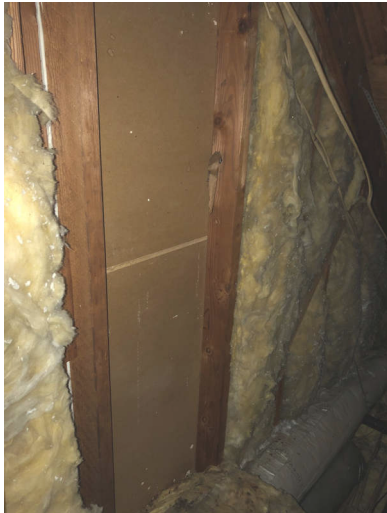
## 2: Gaps/Missing Insulation

Gaps in the insulation envelope should be improved. Any holes will reduce the effectiveness of the the insulation. Current standards are R38(or 12-14 inches of loose fill).

Recommendation: Contact a qualified insulation contractor.

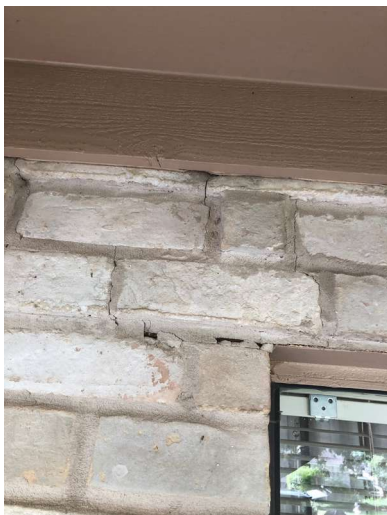
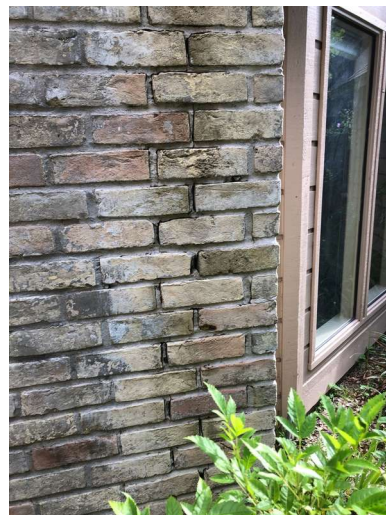
Minor cracks were noted on the exterior. At the time of the inspection, these cracks did not warrant any type of repair.

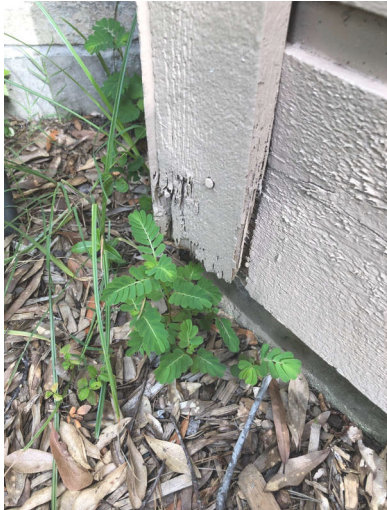
## 1: Wood Damage

Damaged wood should be repaired or replaced to maintain the integrity of the weather envelope provided by the wall coverings.

Recommendation: Contact a qualified general contractor.

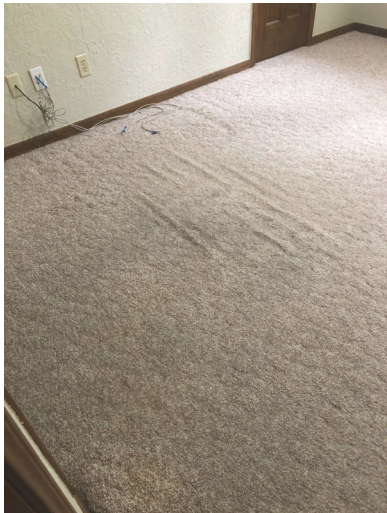
**1: Damaged/Loose Carpet**

Damaged/Loose carpet can be a trip hazard. In many cases carpets can be stretched.

2nd Floor

Recommendation: Contact a qualified professional.

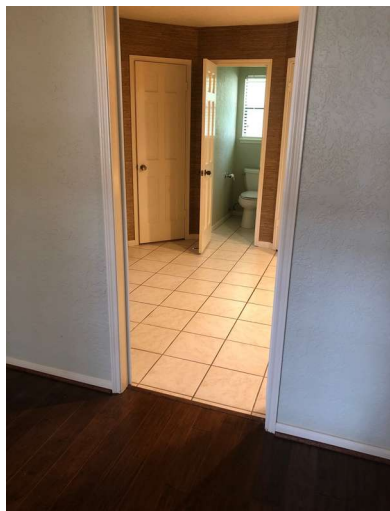
Walk in closet/storage attic is open to regular attic. Suggest weatherstripping closet door to prevent heat transfer

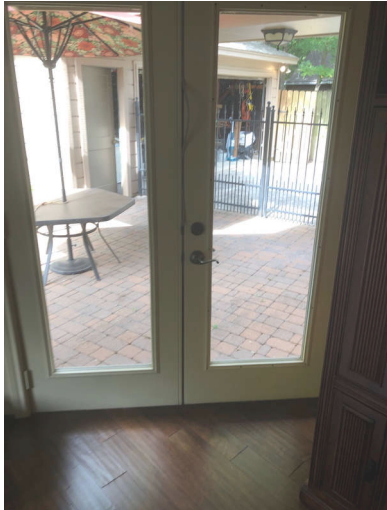
**1: Door Sticks**

Door sticks and is tough to open. Recommend sanding down offending sides.

Inoperable-could not open

Recommendation: Recommended DIY Project

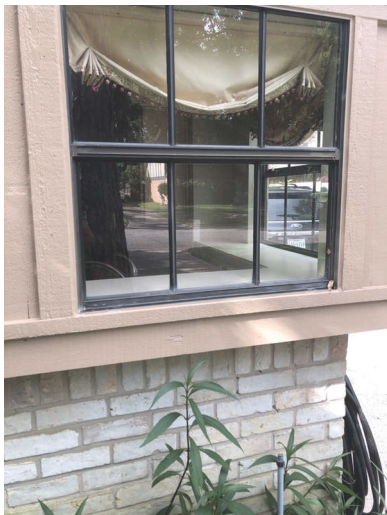
**1: Missing Screen(s)**

One or more windows are missing a screen. Recommend replacement.

Recommendation: Contact a qualified window repair/installation contractor.

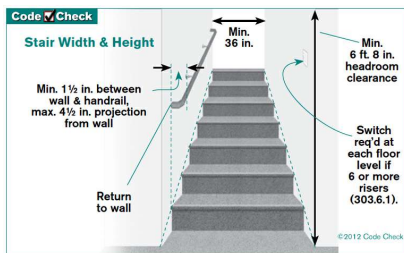
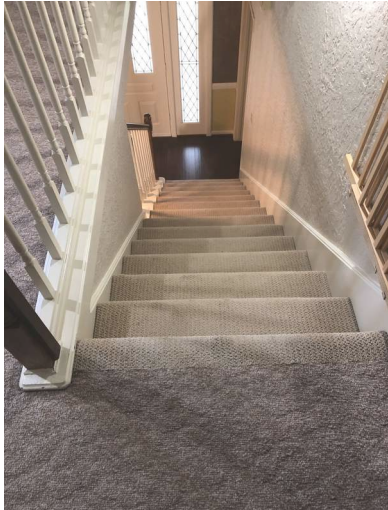
### 1: Improper Handrail Installation

Current building practices require the handrail to return into the wall at top and bottom to prevent injury.

No hand rail at top section

Recommendation: Contact a qualified professional.

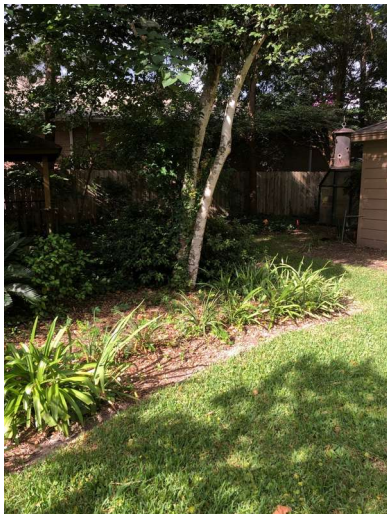
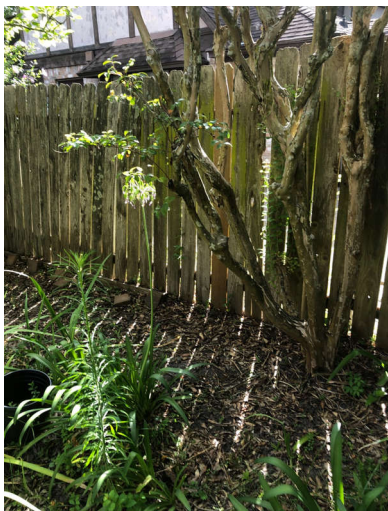
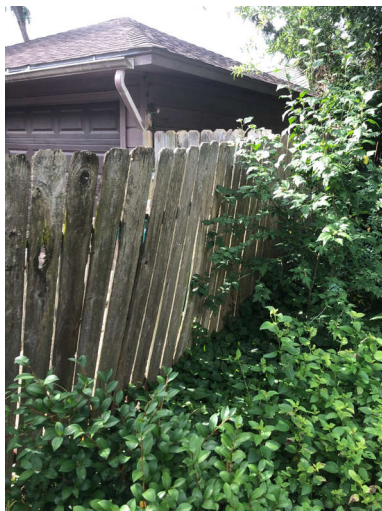
**1: General Repair**

Loose/ damaged fence posts

Loose/ damaged fence planks

Recommendation: Contact a qualified professional.

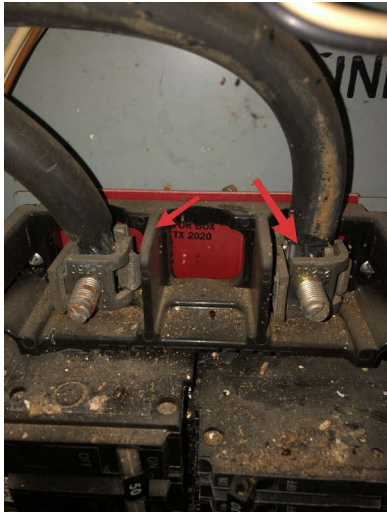
**1: Anti-oxidant Paste**

Aluminum service wires are accepted however may require anti-oxidant paste to help control temperature.

Recommendation: Contact a qualified professional.

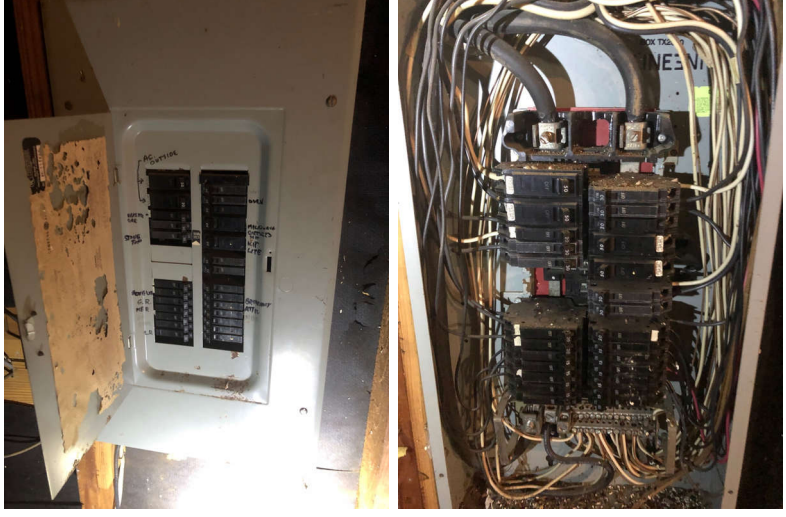
**3: No main disconnect**

Should be able to turn electricity off to home in less than 6 throws.

Recommendation: Contact a qualified professional.

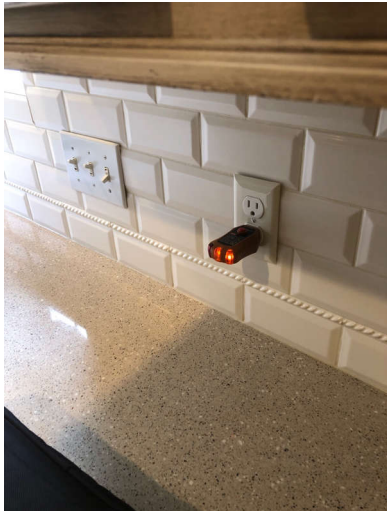
Kitchen

No GFCI protection present in all locations. Recommend licensed electrician upgrade by installing ground fault receptacles in all locations.

Recommendation: Contact a qualified electrical contractor.

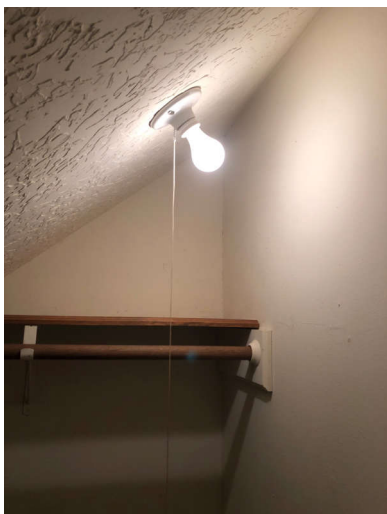
**3: Exposed Bulbs in Closets**

Exposed bulbs in closets may pose a risk of fire if the bulb is damaged.

Recommendation: Contact a qualified handyman.

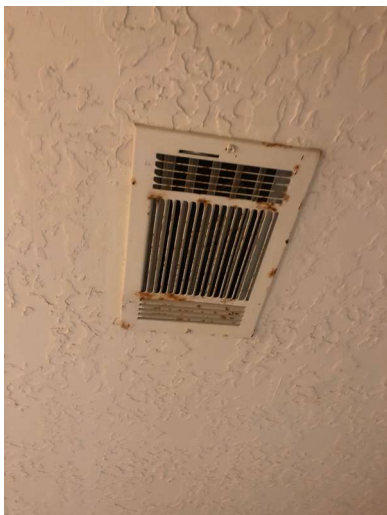
**1: Rusted Registers**

Master Bathroom: most likely from lack of venting

Replace or refinish as necessary

Recommendation: Contact a qualified heating and cooling contractor

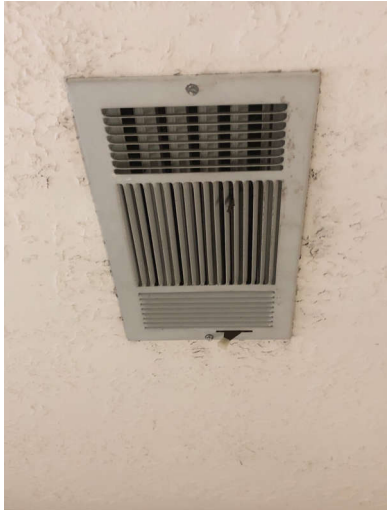
**2: Soil at Registers**

Soil at registers typically indicate dirty ducts

Recommendation: Contact a qualified professional.

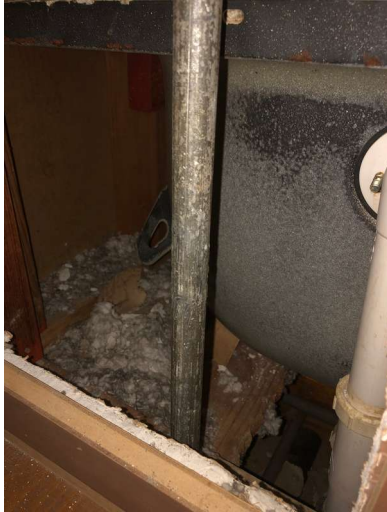
Determination of condition is difficult because galvanized pipe corrodes from the inside.

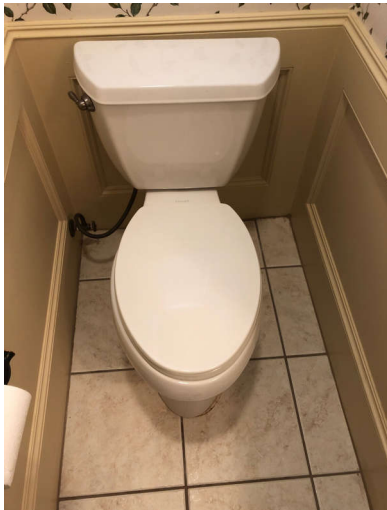
**1: Loose Commode**

Check for loose or unsecured mounting bolts or worn out wax ring.

1st Floor 1/2 bath

Recommendation: Contact a qualified plumbing contractor.

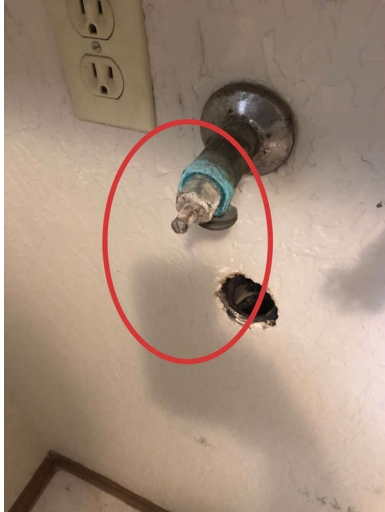
**2: Damaged Plumbing Fixture**

Missing handle at washer connection

Repair or Replace

Recommendation: Contact a qualified professional.

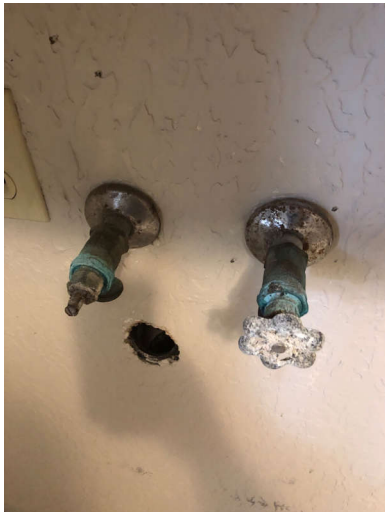
**3: Excessive Corrosion Noted at Plumbing Fittings**

Corrosion appears to be from previous leaking and may leak again if corrosion is cleaned from the fittings

Recommendation: Contact a qualified professional.

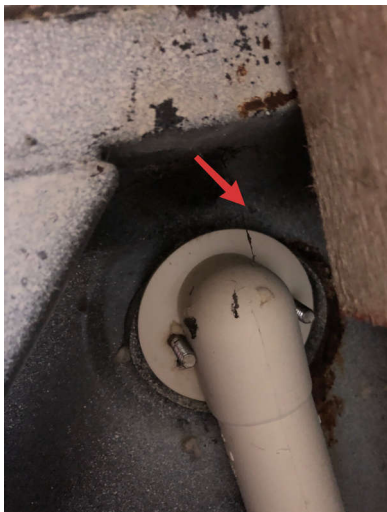
Master Bathroom

*Note: overflow gasket slightly damaged:*

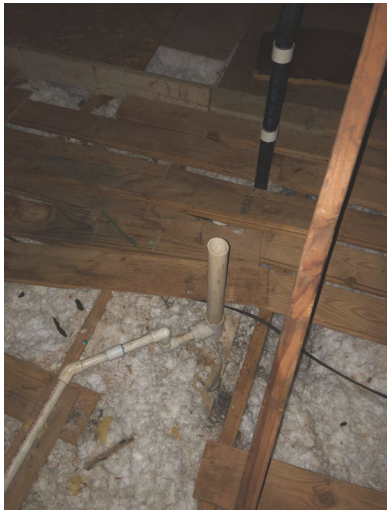
**1: Improper Venting**

Plumbing vent should terminate at exterior.

Recommendation: Contact a qualified professional.

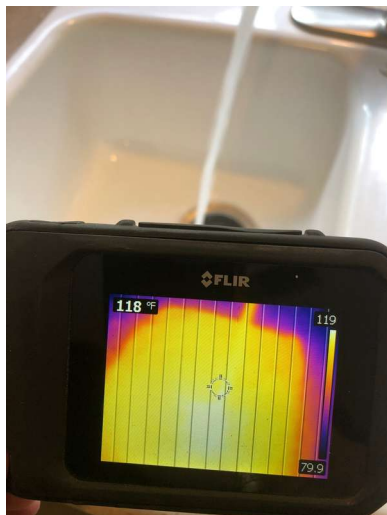
Fuel gas connection Lin may need to be upgraded when new water heater is installed

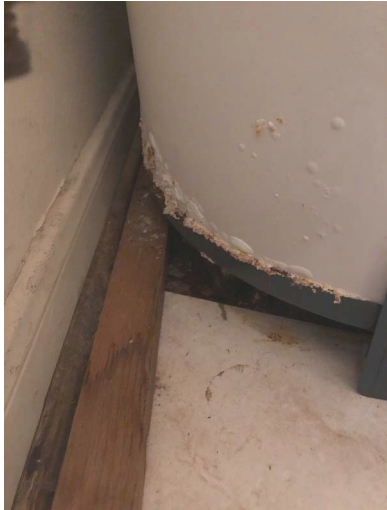
**1: Rust at Base of Tank**

Observations:: Poor Condition

Recommendation: Contact a qualified professional.

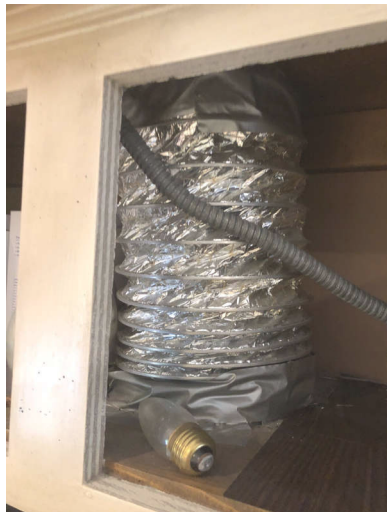
**1: Improper Duct Material**

Installed corrugated flex pipe should be replaced with smooth wall duct piping.

Recommendation: Contact a qualified professional.

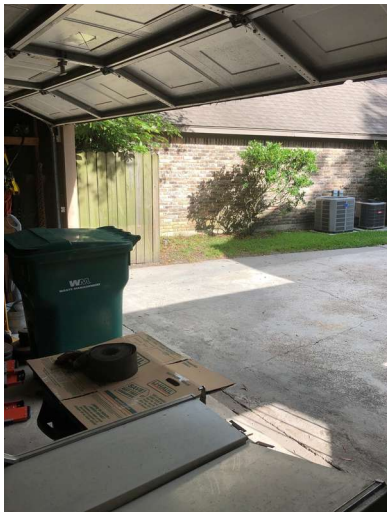
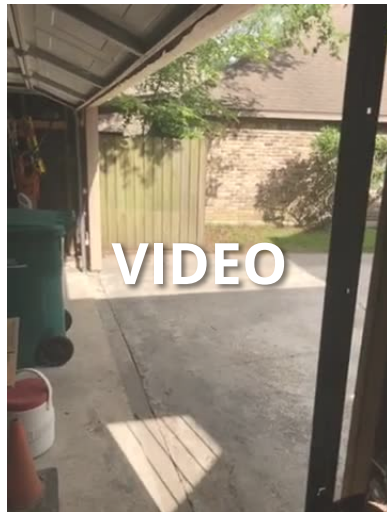
**1: Auto Reverse Sensor Not Working**

The auto reverse sensor was not responding at time of inspection. This is a safety hazard to children and pets. Recommend a qualified garage door contractor evaluate and repair/replace.

Recommendation: Contact a qualified garage door contractor.
