# PROPERTY INSPECTION REPORT

Concerning: 655 S Rivershire Dr, Conroe TX 77304  
(Address or Other Identification of Inspected Property)

By: Richard Kinder - Trec #21699 11/17/2021 9:00 am  
(Name and License Number of Inspector) (Date)

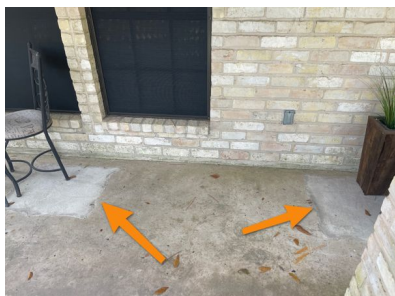
**2: Evidence Of Foundation Repair**

Evidence of previous repairs to the foundation were observed. The homeowner should be consulted on the previous foundation work performed and possible warranty information that may apply. The effectiveness of the foundation repair is not determined.

Recommendation: Contact a foundation contractor.

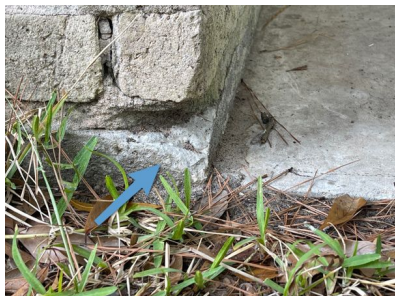
**3: Corner Pops**

Foundation corners cracked and/or sheared off (Corner pops) were observed. This condition does not adversely affect the performance of the foundation, however cosmetic improvements may be necessary.

Recommendation: Contact a foundation contractor.

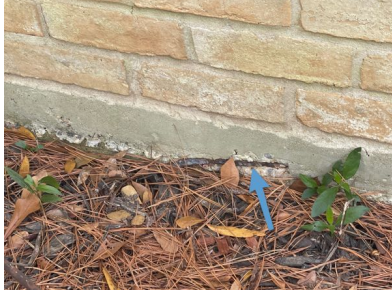
Exposed rebar in the foundation was observed. Exposed rebar if left untreated can cause extensive structure damage and may cause the rebar to break away.

Recommendation: Contact a foundation contractor.

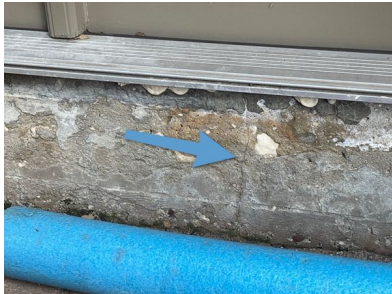
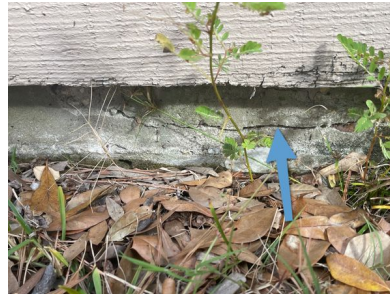
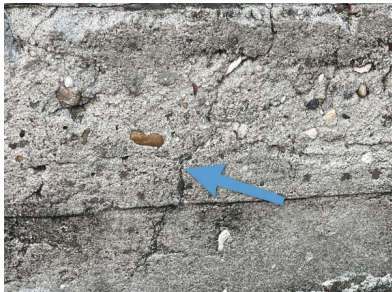
### 6: Foundation Slab Cracks/Fractures

Cracks/fractures were observed in the foundation slab at the time of the inspection.

Recommendation: Contact a foundation contractor.

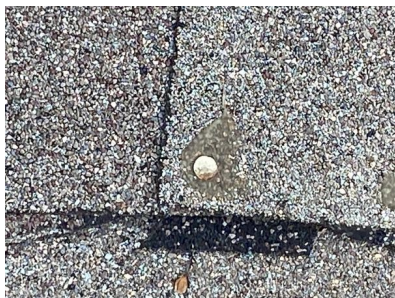
Exposed fasteners such as staples and/or nails located on the roof surface should be properly sealed.

Recommendation: Contact a qualified roofing professional.

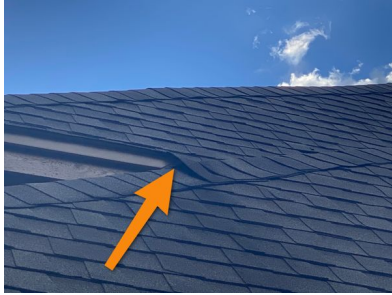
## 3: Raised Shingles

Raised/lifted shingles were observed.

Recommendation: Contact a qualified roofing professional.

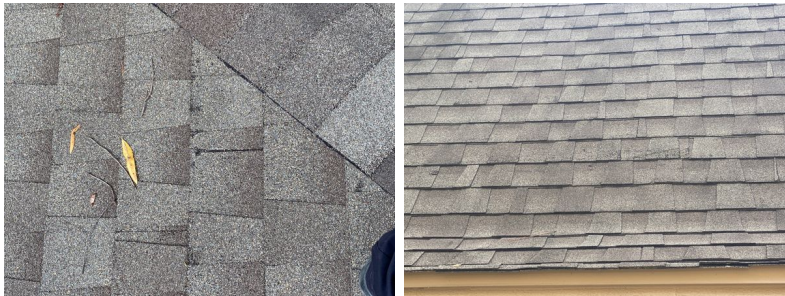
#### **4: Granule Loss**

Some wear and granule loss was observed on areas of the shingles. Granule loss is a sign of wear and could shorten the life span of the roof covering materials. Replacement of shingles with excessive granule loss may be necessary.

Recommendation: Contact a qualified roofing professional.

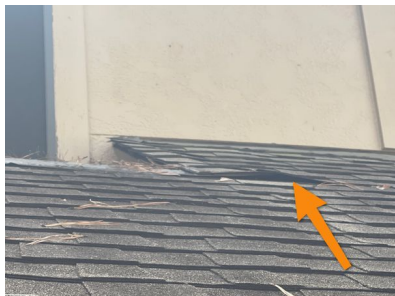
Raised/lifted areas of flashing were observed.

Recommendation: Contact a qualified roofing professional.

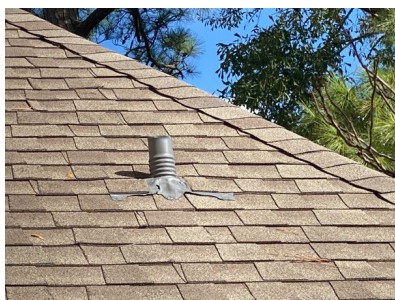
**8: Damaged Flashing**

Damaged flashing was observed on the roof surface.

Recommendation: Contact a qualified roofing professional.

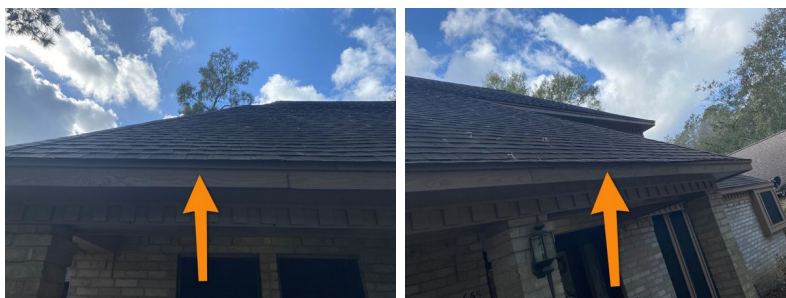
**9: Drip Edge Flashing Missing**

Missing drip edge flashing was noted along areas of the roof surface perimeter.

Recommendation: Contact a qualified roofing professional.

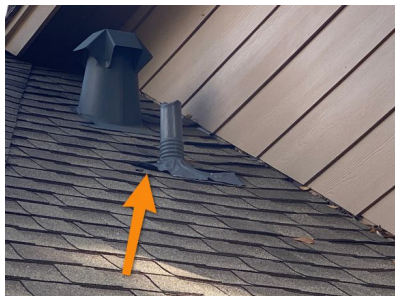
**10: Penetration Flashing Raised/Lifted**

Raised/lifted flashing around one or more roof penetrations was observed.

Recommendation: Contact a qualified roofing professional.

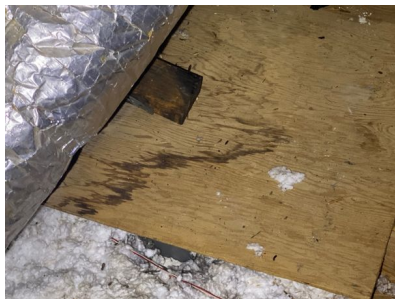
**2: Platform Decking: Moisture Staining/Damage**

The attic platform/decking to the mechanical equipment was observed to have moisture staining/damage at the time of the inspection.

Recommendation: Contact a qualified professional.

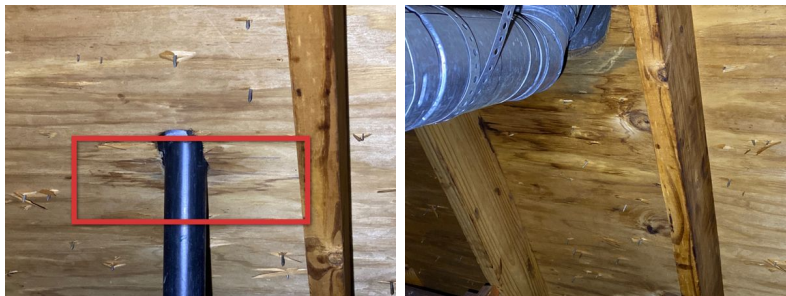
**4: Roof Decking Moisture Staining/Damage**

Moisture staining/damage was observed on areas of the roof structure. This indicates a previous/present leak has occurred in the roof.

Recommendation: Contact a qualified professional.

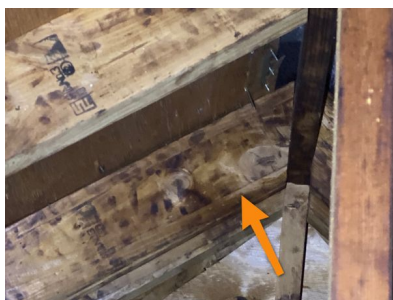
### 6: Rafters Cracked/Damaged

Cracked/damaged rafters were observed.

Recommendation: Contact a qualified professional.

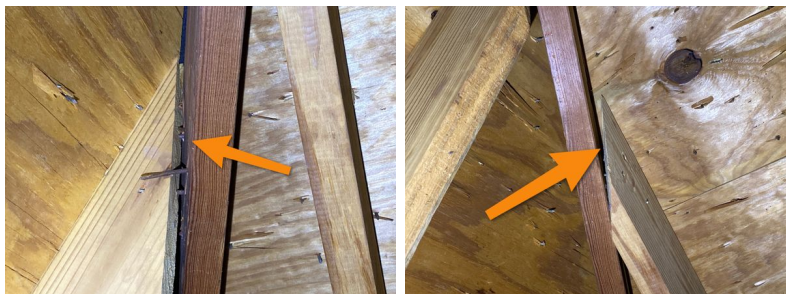
### 7: Rafters Poorly Cut

Various rafters were observed to be poorly cut and were separated from the ridge board. The rafters should make full contact with the ridge board to insure the load is properly transferred.

Recommendation: Contact a qualified professional.

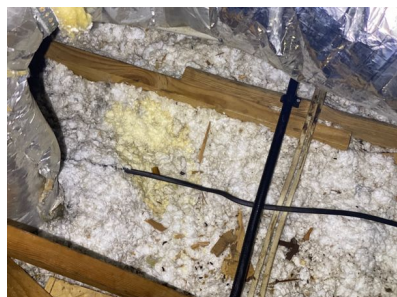
**11: Insulation Staining**

Staining was observed on one or more sections of insulation at the time of the inspection.

Recommendation: Contact a qualified professional.

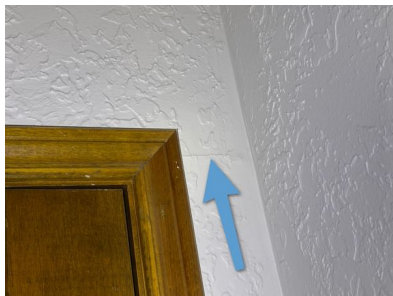
**1: Interior Wall Cracks/Fractures**

Interior wall cracks/fractures were observed.

Recommendation: Contact a qualified professional.

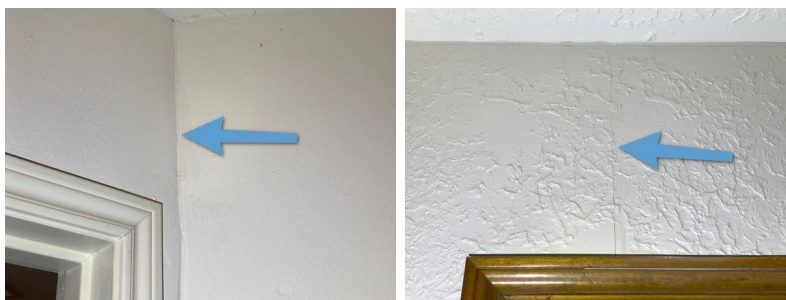
## 2: Drywall Joint Separation

Drywall joint separation cracks were observed. These cracks are mainly cosmetic.

Recommendation: Contact a qualified professional.

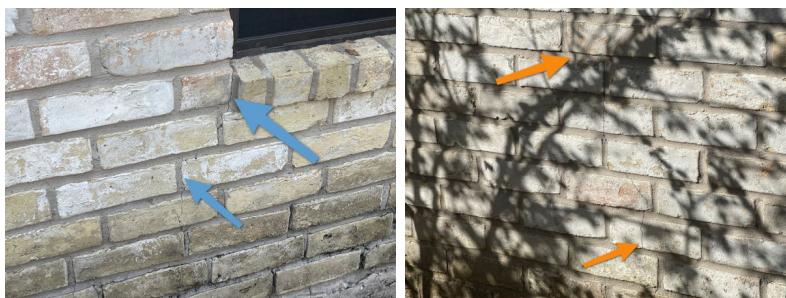
## 3: Exterior Wall Cracks/Fractures

Exterior wall cracks/fractures were observed.

Recommendation: Contact a qualified professional.

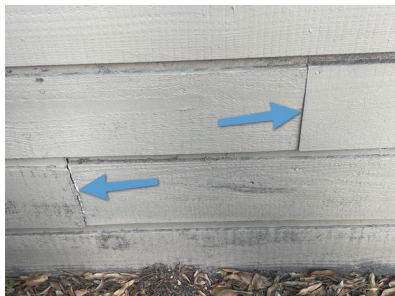
## 4: Deficient Exterior Wall Connection Joint Sealant

Cracking, deteriorated, and/or missing sealant was observed around exterior wall connection joints. It is recommended all joints be properly sealed to prevent moisture intrusion.

Recommendation: Contact a qualified professional.

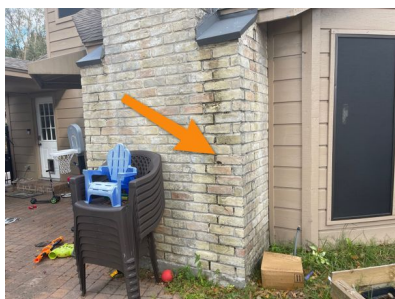
### 5: Roof Run-Off Stains

Stains were observed on areas of the exterior walls of the home. The stains appeared to be where moisture is discharging from the roof down the exterior walls. We recommend the areas be cleaned and that improvements be undertaken to promote moisture away from the walls of the home.

Recommendation: Contact a qualified professional.

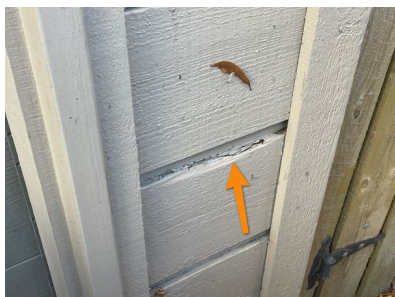
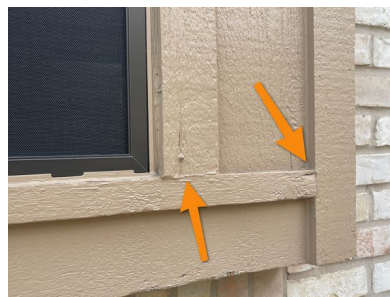
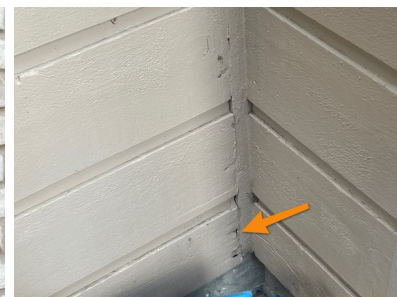
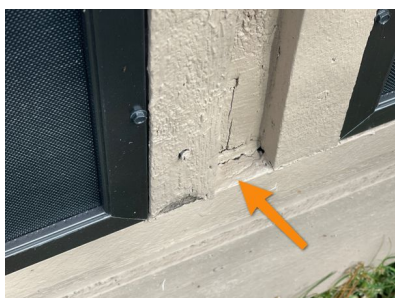
### 6: Siding/Trim Damaged/Rotted

Areas of the exterior siding/trim were observed to be damaged/rotted.

Recommendation: Contact a qualified professional.

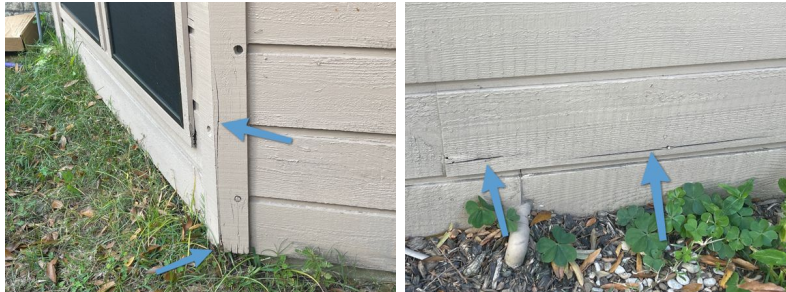
### 7: Siding/Trim Damaged

Areas of the exterior siding/trim were observed to be damaged.

Recommendation: Contact a qualified professional.

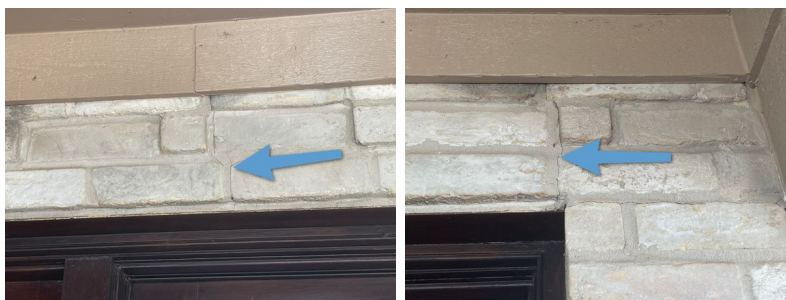
### 8: Cracks/Fractures Above Steel Lintels

Cracks/fractures were observed above steel lintels.

Recommendation: Contact a qualified professional.

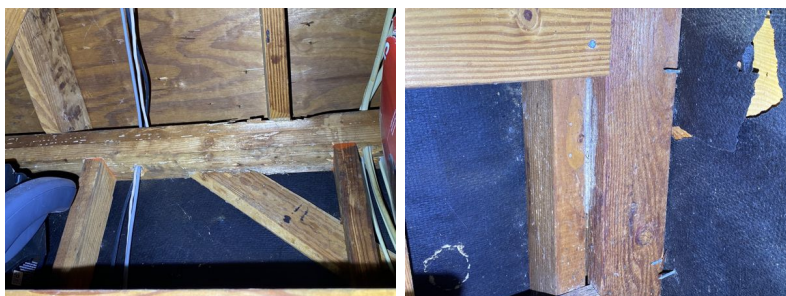
### 10: Damaged Wall Studs

Damaged to the wall studs on the interior of the garage was observed.

Recommendation: Contact a qualified professional.

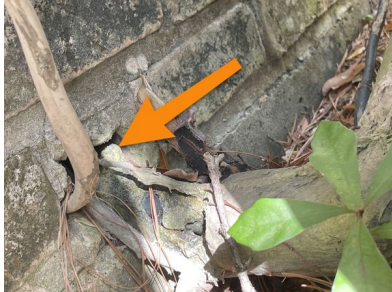
It is recommended the area of the wall where the cooling system utilities penetrate the exterior wall be properly flashed and/or sealed.

Recommendation: Contact a qualified professional.

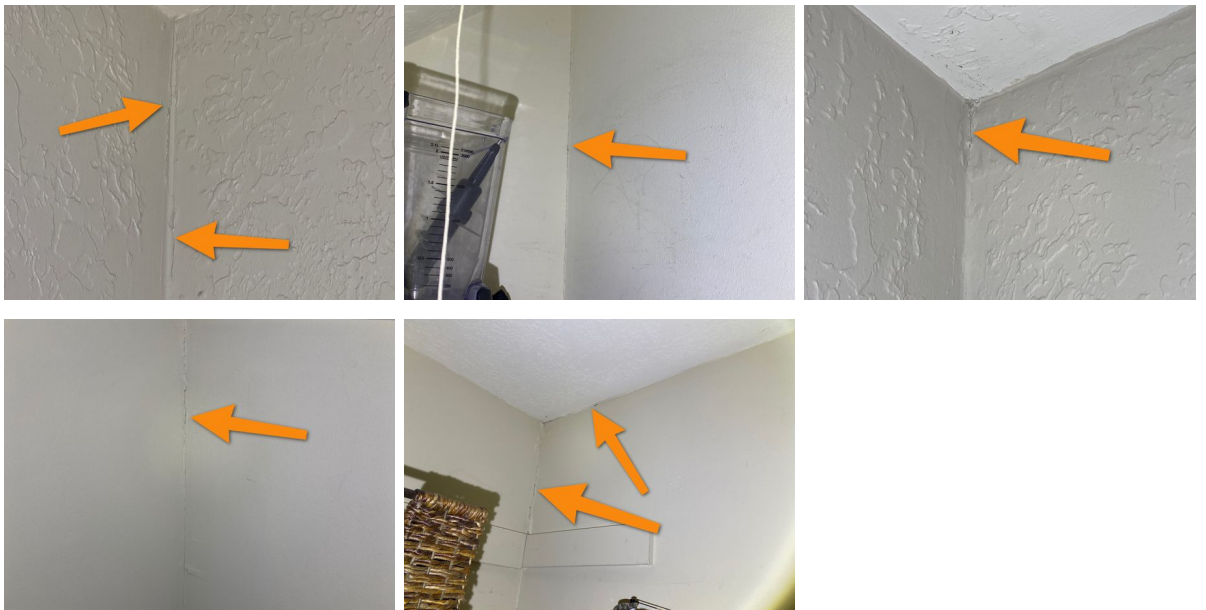
### 12: Cracking/Separation

Cracking/separation was noted at one or more intersections on the interior of the home at the time of the inspection.

Recommendation: Contact a qualified professional.

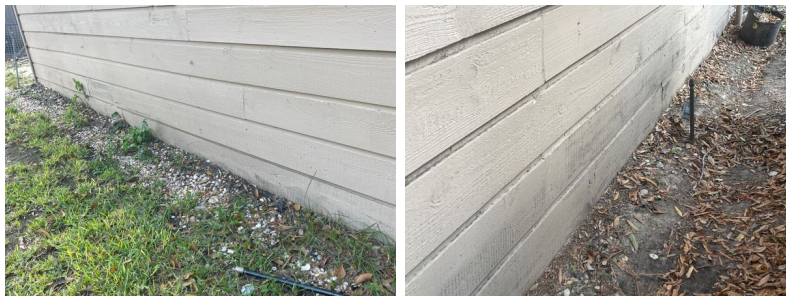
### 13: Siding/Wood To Ground Contact

Siding/wood to ground contact was noted around the garage at the time of the inspection. This condition is conducive for moisture and wood destroying insects.

Recommendation: Contact a qualified professional.

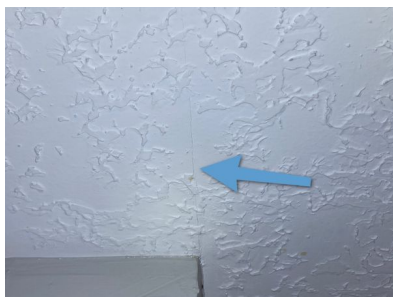
**1: Ceiling Cracks/Fractures**

Interior ceiling cracks/fractures were observed.

Recommendation: Contact a qualified professional.

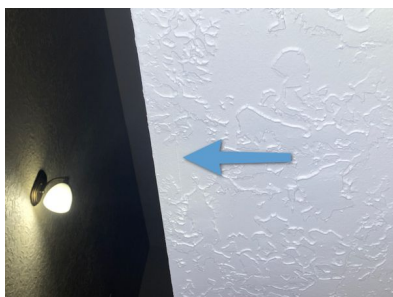
**2: Ceilings: Drywall Joint Separation Cracks**

Drywall joint separation cracks were observed.

Recommendation: Contact a qualified professional.

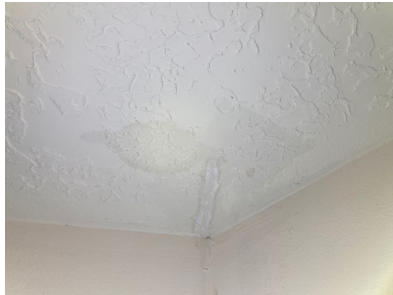
Master Closet

**3: Ceilings: Moisture Stains**

What appeared to be moisture staining/damage was observed on areas of the ceiling.

Recommendation: Contact a qualified professional.

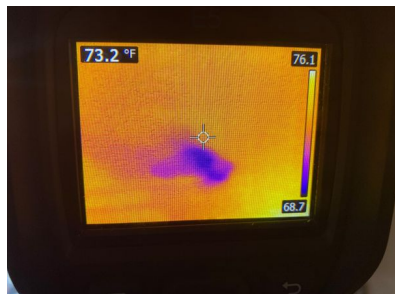
Living Room , Active

Thermal anomalies were observed at the time of the inspection. These areas were tested with a moisture meter and showed elevated signs of moisture.

Recommendation: Contact a qualified professional.

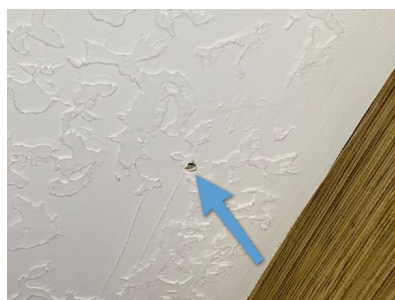
Nail pops were observed on the interior ceilings.

Recommendation: Contact a qualified professional.

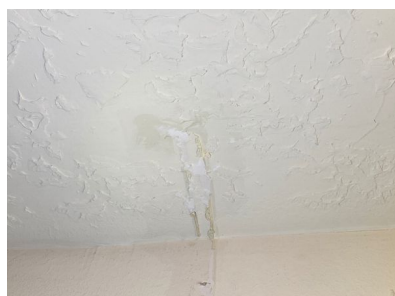
Master Closet

Unknown stains were observed on areas of the ceiling. The stains and source of the stains were unable to be identified. Further investigation may be necessary.

Recommendation: Contact a qualified professional.

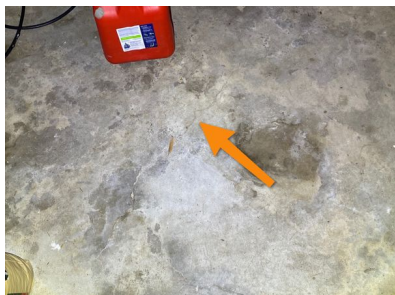
Fractures/Cracks were observed in the garage slab.

Recommendation: Contact a qualified professional.

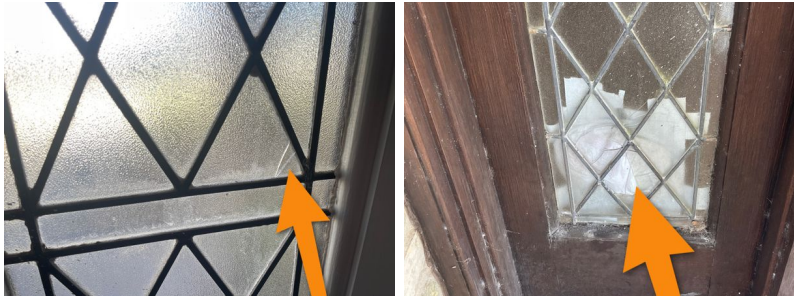
Entry

**2: Cracked/Damaged Glazing**

Cracked/damaged window glazing was observed.

Recommendation: Contact a qualified window repair/installation contractor.

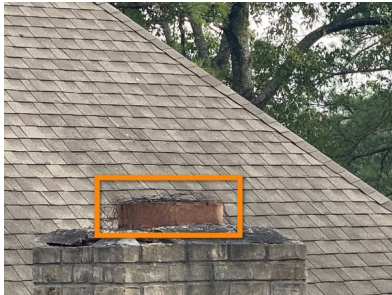
The chimney did not have a spark arrestor/cap installed.

Recommendation: Contact a qualified professional.

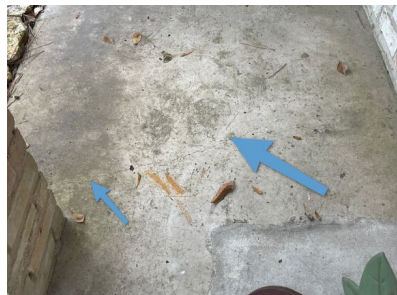
Cracking/damage was noted at the porch slab.

Recommendation: Contact a qualified professional.

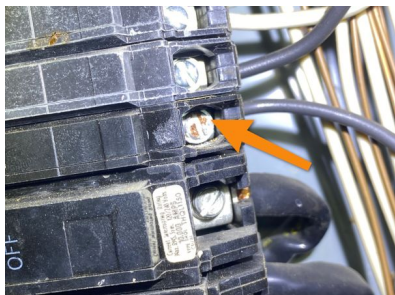
Rust was observed on components on the interior of the panel.

Recommendation: Contact a qualified electrical contractor.

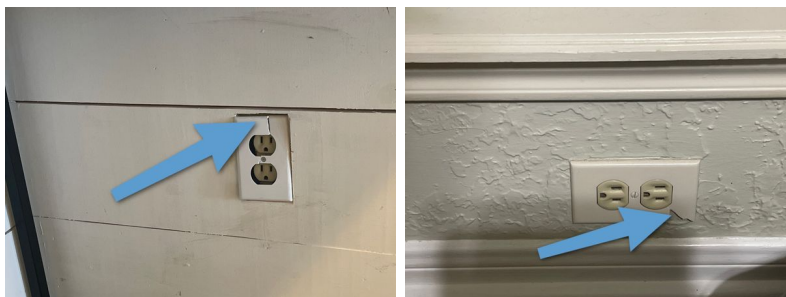
Cracked/damaged cover plates were observed.

Recommendation: Contact a qualified electrical contractor.

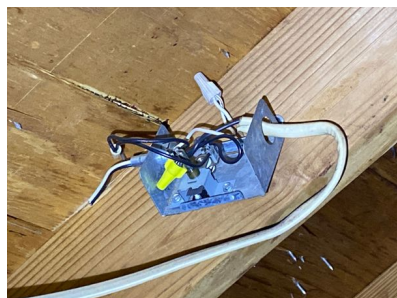
Improperly terminated and/or loose electrical conductors were observed. Conductors should be properly secured and terminated in a junction box with a cover installed to protect against potential shock.

Recommendation: Contact a qualified professional.

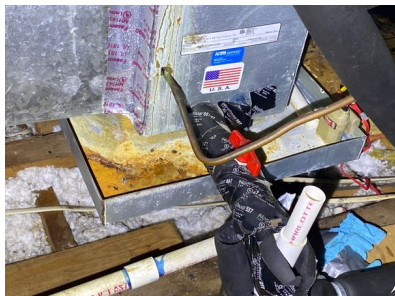
Rust, evidence of previous moisture, and/or discoloration/staining was observed in the secondary drain pan under the evaporator coil/air handler. This indicates a previous/present issue exist(ed) with the cooling system. Replacement of the drain pan may be necessary.

Recommendation: Contact a qualified HVAC professional.

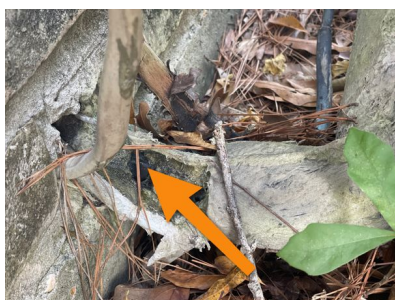
Cracking, deteriorated, damaged, and/or missing insulation was observed on the cooling system refrigerant line.

Recommendation: Contact a qualified professional.

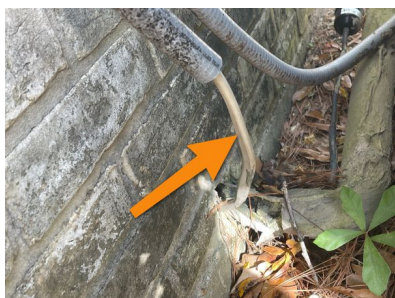
The flexible electrical conduit at the condenser was observed to be loose/damaged

Recommendation: Contact a qualified professional.

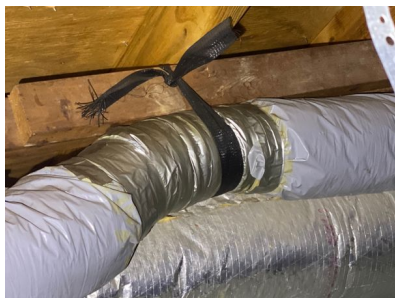
Duct tape was observed on areas of the duct system. Duct tape is not an approved building material and should not be used to seal ducts.

Recommendation: Contact a qualified HVAC professional.

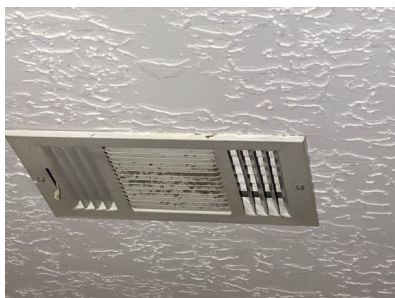
What appeared to be organic growth was observed on various output registers.

Recommendation: Contact a qualified professional.

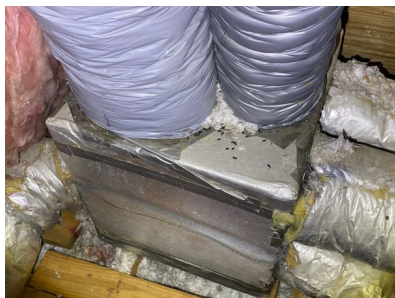
**9: Duct Tape On Plenum**

Duct tape was noted on the plenum at the time of the inspection. Duct tape is not an approved building material. Correction is recommended.

Recommendation: Contact a qualified professional.

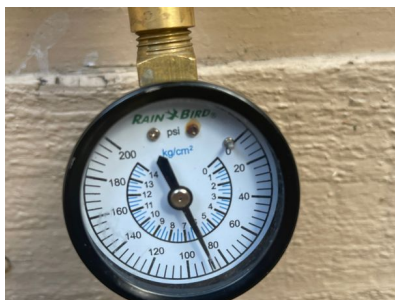
Static Water Pressure Reading: 80-90 PSI

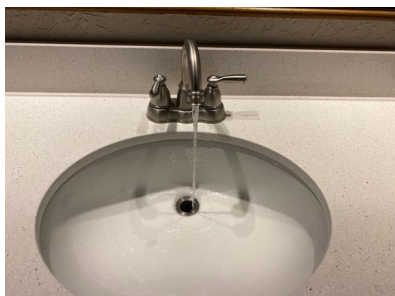
2nd Floor Bathroom #1 , Hot Water Side

Low water flow was observed at one or more plumbing fixtures at the time of the inspection.

Recommendation: Contact a qualified plumbing contractor.

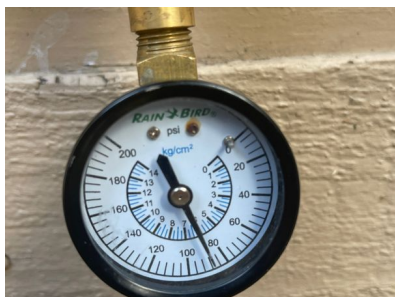
The static water pressure reading to the home was observed to be higher than what is considered typical. Normal static water pressure reading should range between 40 and 80 PSI.

Recommendation: Contact a qualified plumbing contractor.

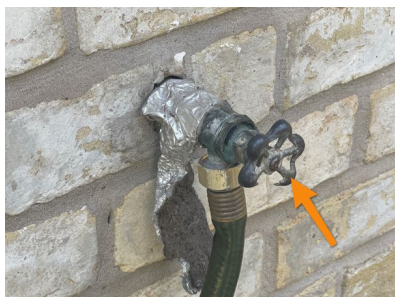
Right Exterior

One or more exterior faucet handles were observed to be broken/missing. These faucets were unable to be tested/operated.

Recommendation: Contact a qualified professional.

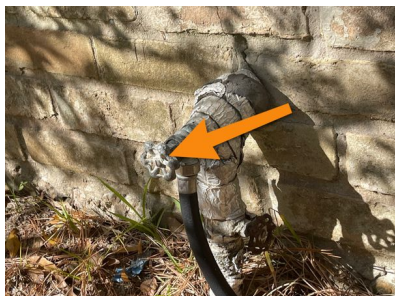
Left Exterior

Leaking was observed at exterior faucets when operated at the time of the inspection.

Recommendation: Contact a qualified plumbing contractor.

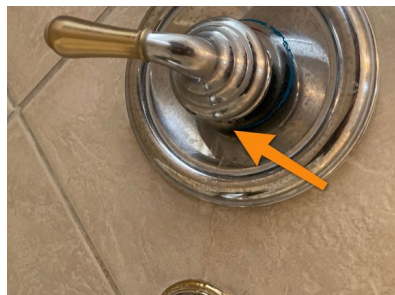
Master Bathroom

Leaks were observed at bathtub/shower fixture components when operated.

Recommendation: Contact a qualified plumbing contractor.

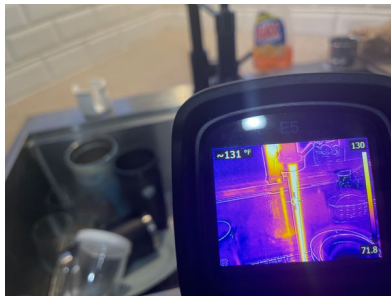
The water heater was observed to be functioning as intended. Adjust the water temperature as needed.

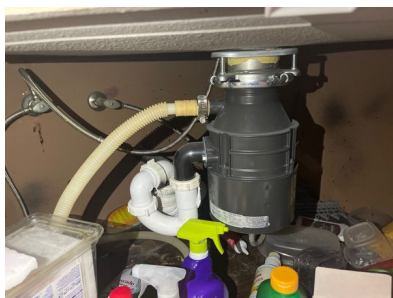
The food waste disposer was operated and appeared to be functioning.

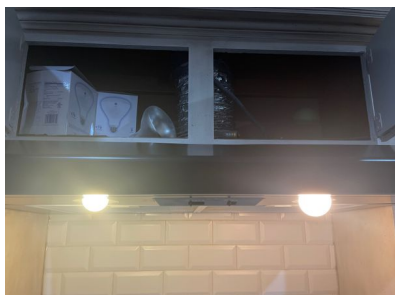
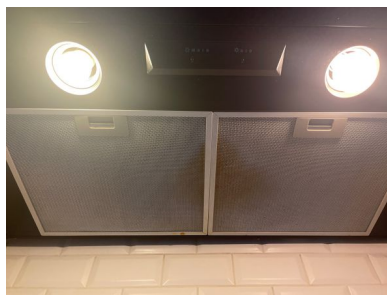
Duct tape was observed on the range hood vent. Duct tape is not an approved building material and should not be used to seal the vent.

Recommendation: Contact a qualified appliance repair professional.

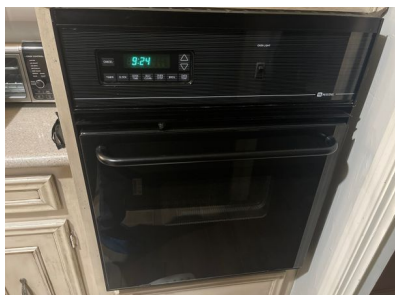
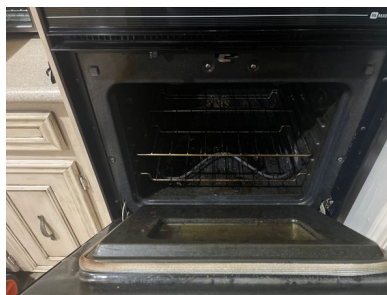
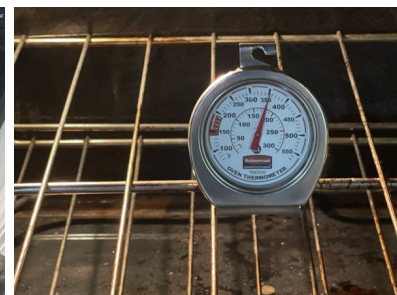
The oven was tested at 350 degrees and read within the acceptable 25 degree range, in my opinion the oven appeared to be functioning as intended.

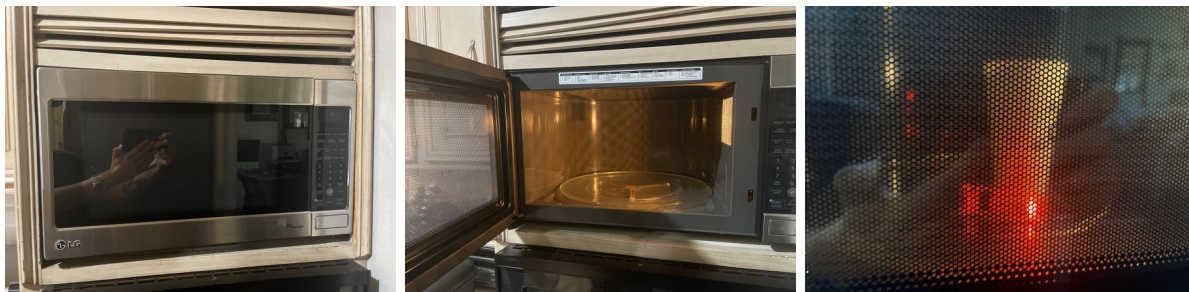
The microwave was operated and appeared to be functioning.
