RESIDENTIAL INSPECTION REPORT

16707 Promenade Park
Cypress, TX 77429

PROPERTY INSPECTION REPORT

Concerning: 16707 Promenade Park, Cypress, TX 77429
(Address or Other Identification of Inspected Property)

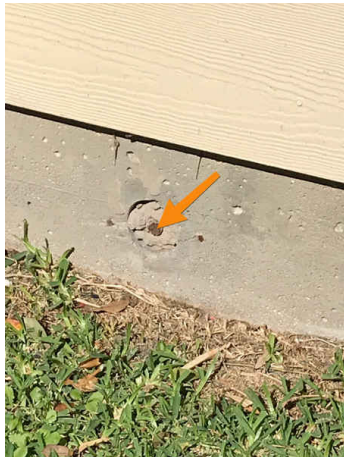
Post tension cable(s) exposed along the perimeter of the foundation. Remedy as needed.

Recommendation: Contact a qualified professional.

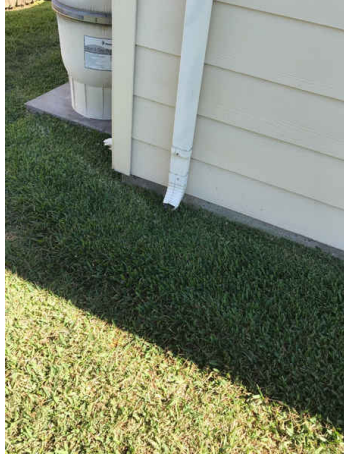
1: Gutters & Downspouts: Missing Splash Blocks

A splash block placed beneath the downspout elbow helps to disperse water away from the foundation and to prevent soil erosion. Remedy as needed.

Recommendation: Recommended DIY Project

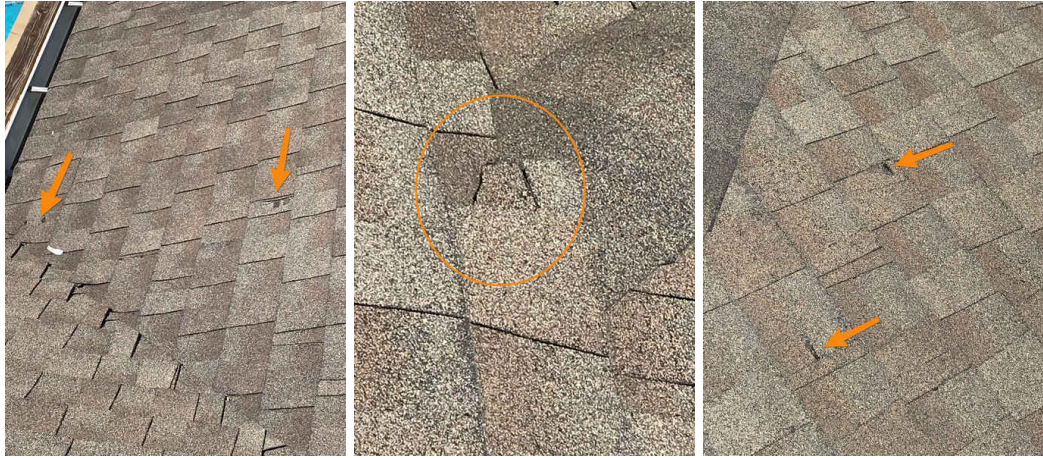
2: Shingles: Damaged/Torn/Missing

Roof shingle material was missing, damaged, or torn in areas. Evaluation and/or repair by a qualified roofing professional is recommended.

Recommendation: Contact a qualified roofing professional.

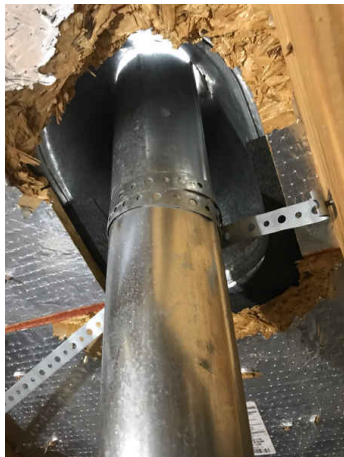
3: Flashing: Daylight visible

Daylight was visible in the attic around vent jacks or flashings. This can indicate poor weatherproofing and should be investigated further by a qualified roofing professional.

Recommendation: Contact a qualified roofing professional.

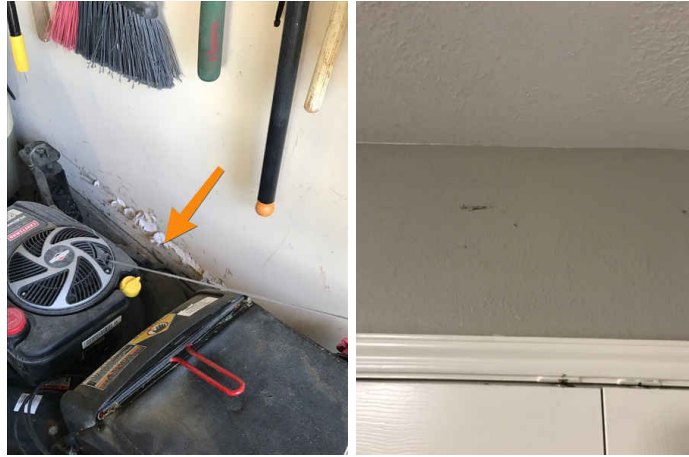
5: Interior: Damaged Drywall (or other wall covering)

Damaged Drywall (or other wall covering) was observed. Remedy as needed to prevent pest intrusion and energy loss.

Recommendation: Contact a qualified professional.

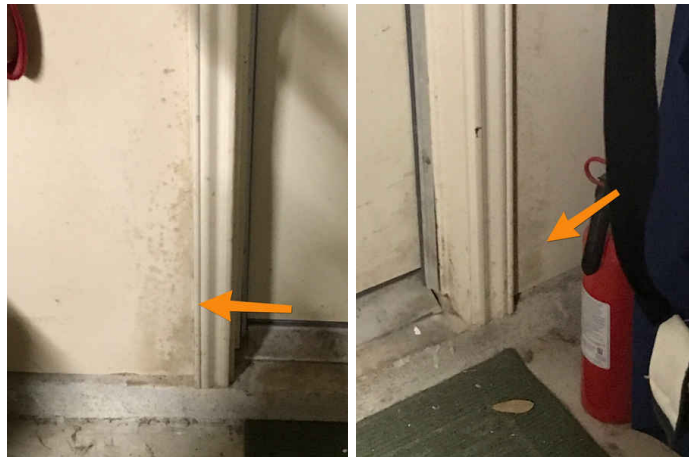
6: Interior: Possible Microbial Growth

Observed signs of possible microbial growth indicating prior moisture intrusion. It is recommended that the source of any moisture intrusion be identified, and the issue remediated.

Recommendation: Contact a qualified professional.

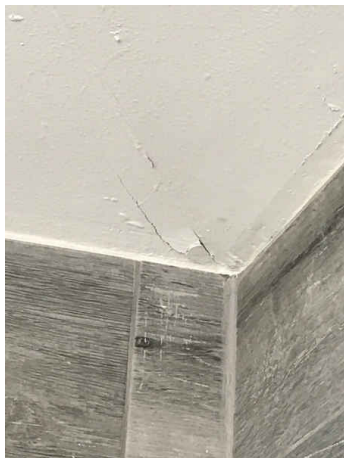
1: Ceiling: Damage

Ceiling damage was present. Evaluation and repair by a qualified drywall or licensed structural engineer is recommended.

Recommendation: Contact a qualified professional.

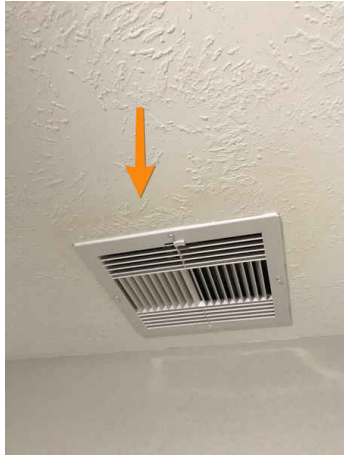
2: Ceiling: Evidence of Previous Moisture Contact

Wall structure showed signs of previous water intrusion. Tested negative for moisture at the time of the inspection. Evaluate and remedy as needed.

Recommendation: Contact a qualified professional.

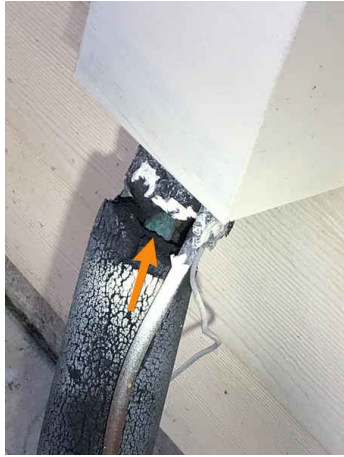
1: Condenser: Insulation Missing or Damaged on Refrigerant Lines

Missing or damaged insulation on refrigerant line can cause energy loss and condensation. Remedy as needed.

Recommendation: Contact a qualified HVAC professional.

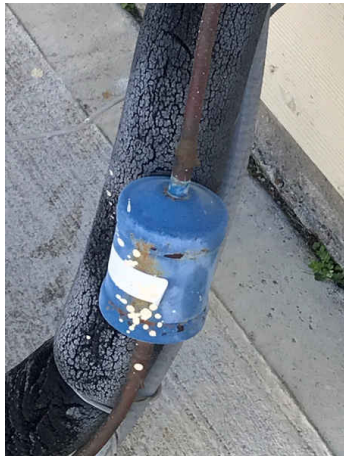
2: Condenser: Rusted Filter Drier

The filter drier was rusted. Evaluation and remediation by a licensed HVAC contractor is recommended.

Recommendation: Contact a qualified HVAC professional.

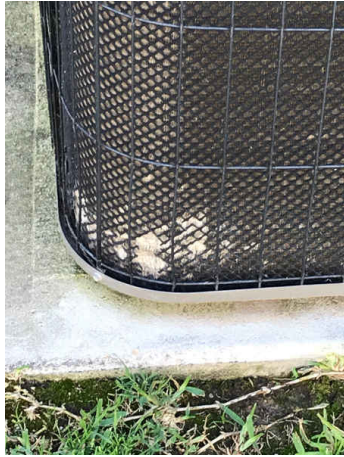
3: Condenser: Damaged Fins

External fins on the condensing unit were damaged. Evaluation and remediation by a licensed HVAC contractor is recommended.

Recommendation: Contact a qualified HVAC professional.

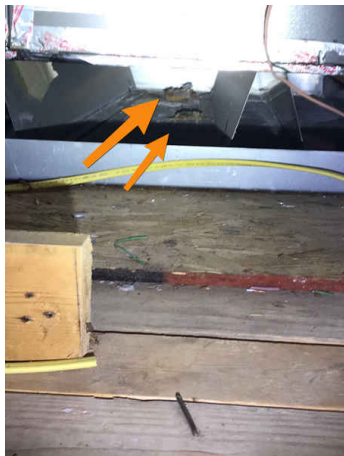
4: Condensate system: Debris in emergency pan

Debris was in the emergency overflow pan which will prevent proper drainage. Remedy as needed.

Recommendation: Contact a qualified HVAC professional.

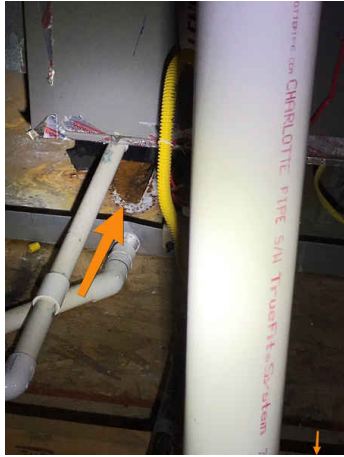
5: Condensate system: Rusted Emergency pan

The emergency overflow pan is rusted. Further evaluation by an HVAC professional is recommended.

Recommendation: Contact a qualified HVAC professional.

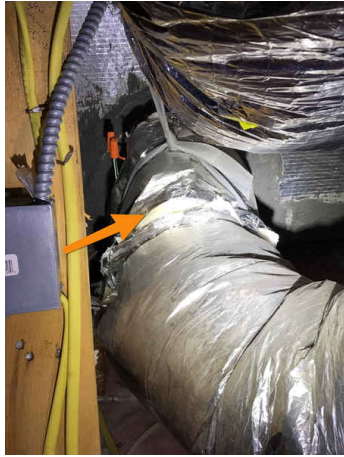
2: Ducts: Damaged

The air supply duct was damaged. Evaluation and remediation by a licensed HVAC contractor is recommended.

Recommendation: Contact a qualified HVAC professional.

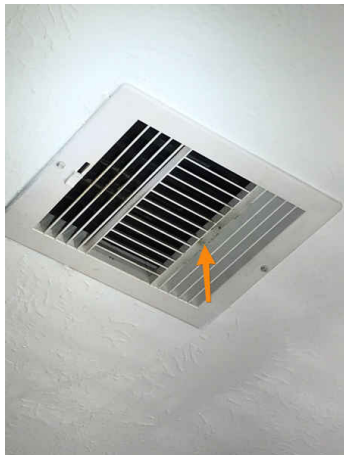
3: Visible substance observed on Supply Register

A dark substance was observed on an air supply register in the home. This is typically dust that has collected upon condensation which has developed on supply registers. Servicing and cleaning of the system by a qualified HVAC contractor is recommended, as this can be a result of excessive water vapor/humidity in the conditioned air.

Recommendation: Contact a qualified HVAC professional.

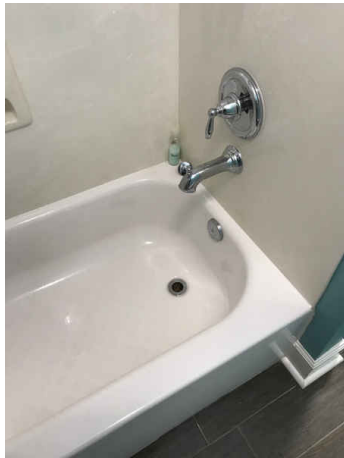
2: Fixture: Drain Stops Missing or Ineffective

Drain stops had issues that prevented them from working properly (holding water). Remedy as needed.

Recommendation: Contact a qualified plumbing contractor.

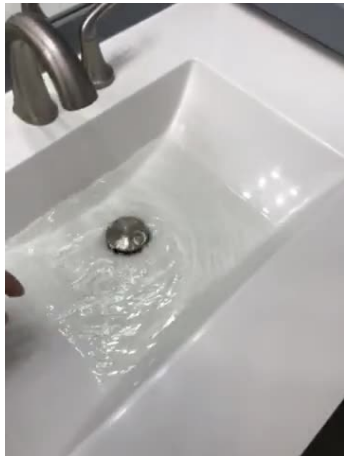
Poor/slow drainage was observed at time of inspection. Evaluation and/or remediation by a licensed plumber is recommended.

Recommendation: Contact a qualified plumbing contractor.

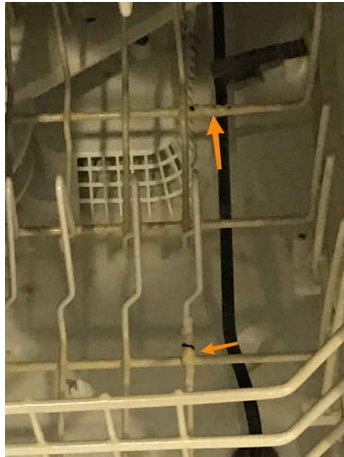
1: Rusted Dish Racks

There is evidence of rust on dishwasher racks. Evaluate and remedy as needed.

Recommendation: Contact a qualified professional.
