Home Inspection Report

675 County Road 3141
Cleveland, Texas 77327

PROPERTY INSPECTION REPORT

Inspection Date: 1/6/2021

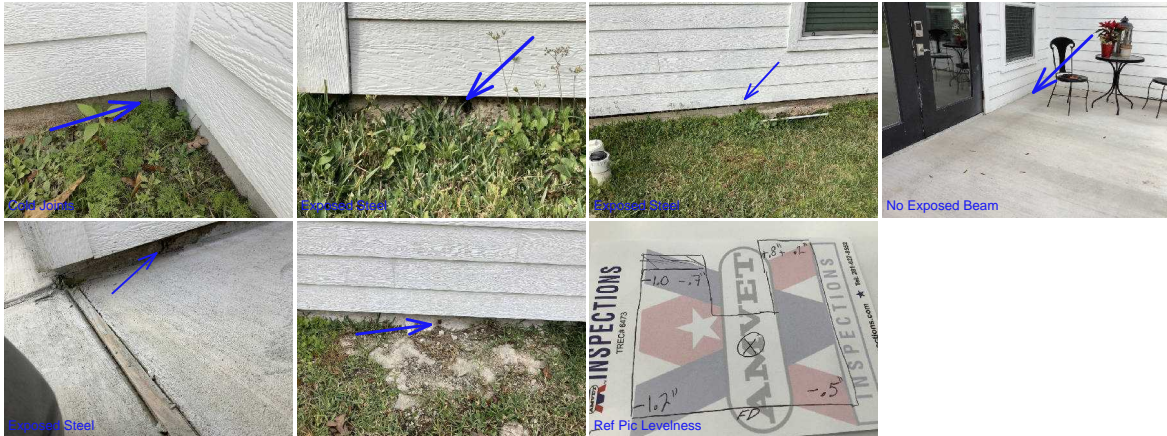
☒☐☐☒ A. Foundations

1. Cold joints present, those are a conducive condition for termites.
2. A few pieces of exposed steel at the grade beams, those should be covered to prevent further rusting of the components.
3. Back patio pad was placed against the main slab with no exposed grade beam. Otherwise, I measured for levelness and found the slab to be in good order and within reasonable limits to be considered level.

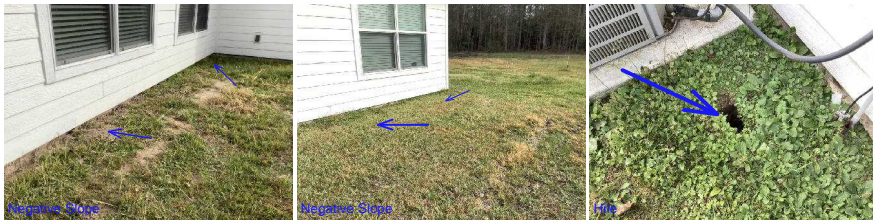
☒☐☐☒ B. Grading and Drainage - Comments:

1. A few areas around the slab that had negative slope toward the house. Those areas would tend to hold water.
2. Open hole right side yard, Otherwise the property was a rural lot with flat areas that would tend to pond, but the general slope was to drain as designed.

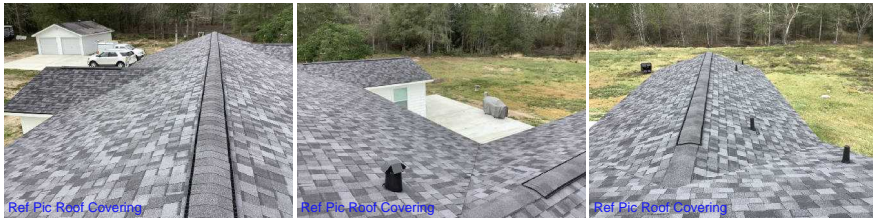
☒☐☐☐ C. Roof Covering Materials

The roof was disclosed as being 2-3 years old and it presented as such. It was in good order and performing well at the time of the inspection.

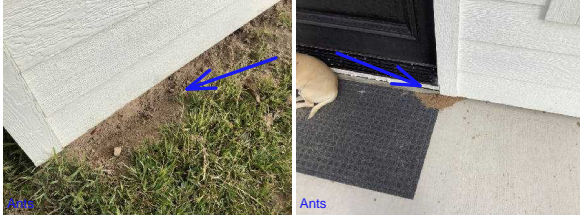
L. Other - Comments:

1. Large active ant mounds in the yard and against the slab of the house.

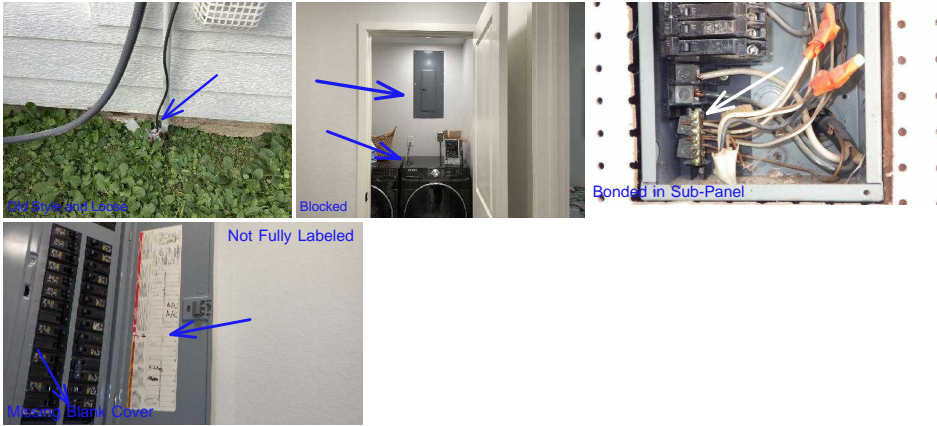
A. Service Entrance and Panels - Comments:

1. The ground clamp was the old type pipe clamp not the newer style acorn clamp and the clamp was loose on ground rod.
2. Grounds and neutrals bonded in garage sub-panel. Modern standards have them unbounded in sub-panels.
3. The main panel was located in the laundry room, it was blocked by the laundry machines, which limited access. The panel did not conform to the required clearance standards.
4. The panel was not fully and clearly labeled.
5. Missing one blank cover in the panel face. A licensed electrician is recommend to evaluate the panel and system for repairs of deficiencies listed herein and any others that they may find.

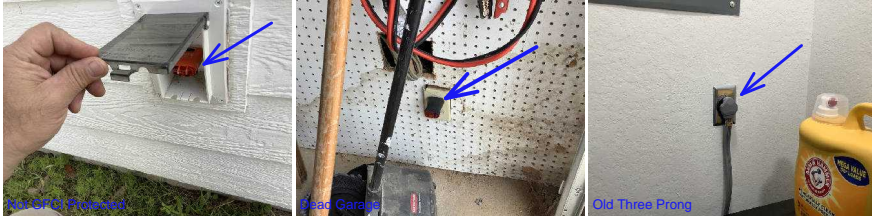
B. Branch Circuits, Connected Devices, and Fixtures (continued)

1. Missing GFCI protection for outlets in required locations, all exterior.
2. Receptacle circuit in garage dead, not connected to power.
3. Old three prong 250V receptacle for the dryer circuit outlet.
4. During operation, the electric water heater would surge making the lights in the hall way flicker. Im not certain why. Recommend a licensed professional electrician evaluate system and repair deficiencies listed herein and any others they may find.

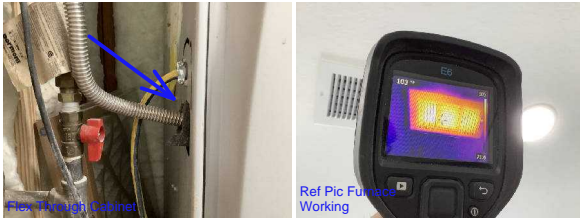
A. Heating Equipment

- 1. Flex gas line through the cabinet, it should be a hard pipe, Otherwise the furnace was working well.

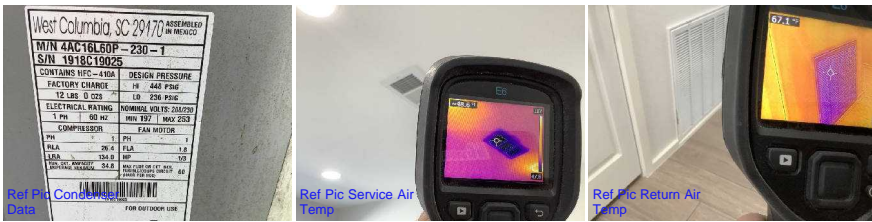
B. Cooling Equipment

Comments: Ducane 2018 R-410A Differential 19F Degrees

In good order and working well at the time of the inspection.

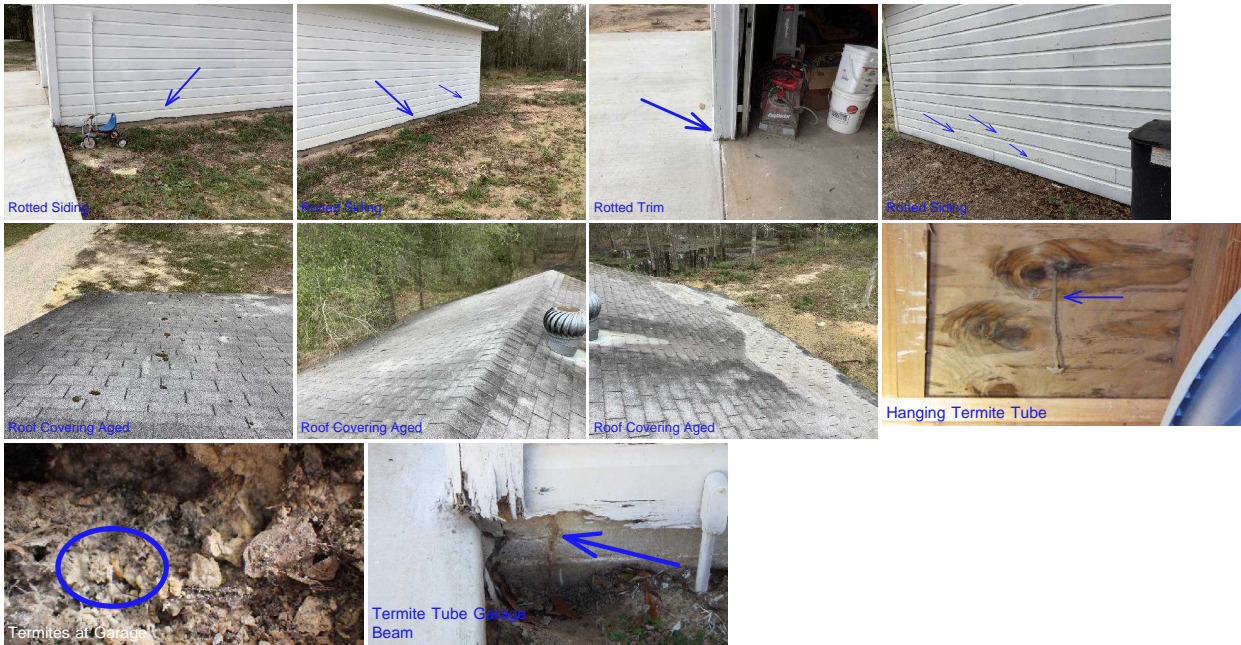
☒☐☐☒ C. Outbuildings - Comments:

1. Garage siding and trim was rotted in many areas.
2. The roof covering on the garage was aged and in poor condition, it had aggregate lose. The covering was performing, but it was at the latter part of its useful life Note, insurance may not cover the roof for full replacement value due to the age and condition. I recommend checking with your insurance company before assuming it will be covered for full replacement value.
3. Active Termites at the garage.

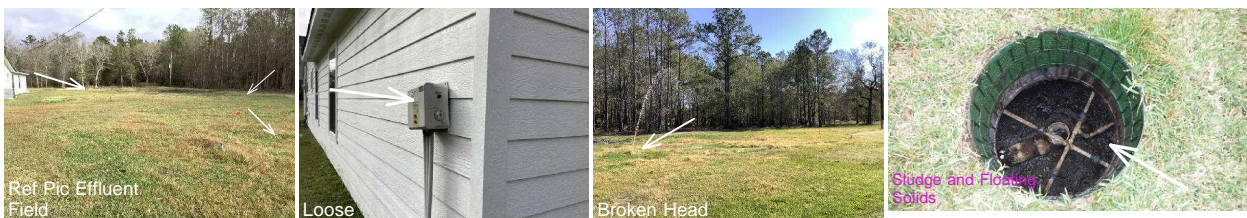
☒☐☐☒ E. Private Sewage Disposal (Septic) Systems

1. The control panel for the system was loose on the wall. It should be mounted firmly.
2. There was floating sludge and some built-up solids in the solids tank, not overly built up, but from normal use. If there are no records of the tank being pumped out in the last 2-3 years then a periodic maintenance pumping and system cleaning is recommended.
4. Broken sprinkler head, repairs required.
5. No chlorine in the dispenser.
6. I do recommend buyer attain all relevant documents for the system ie. service records, diagrams and anything else the sellers can provide. Otherwise the system was working well, effluent tank was low, float switches responded to manual activation.

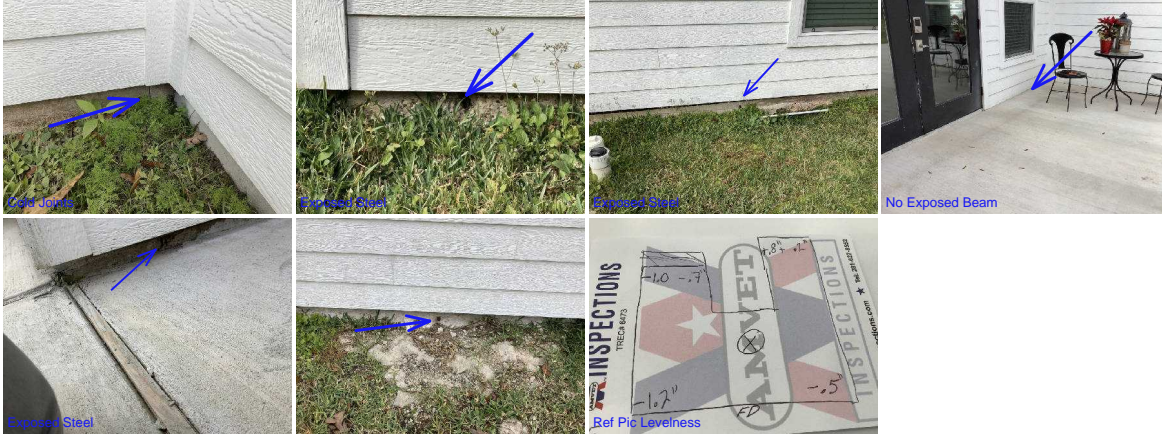
A. Foundations

1. Cold joints present, those are a conducive condition for termites.
2. A few pieces of exposed steel at the grade beams, those should be covered to prevent further rusting of the components.
3. Back patio pad was placed against the main slab with no exposed grade beam. Otherwise, I measured for levelness and found the slab to be in good order and within reasonable limits to be considered level.

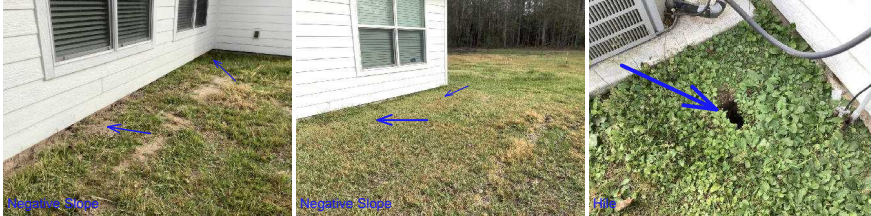
B. Grading and Drainage

1. A few areas around the slab that had negative slope toward the house. Those areas would tend to hold water.
2. Open hole right side yard, Otherwise the property was a rural lot with flat areas that would tend to pond, but the general slope was to drain as designed.

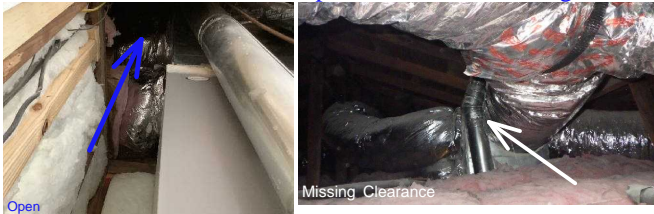
D. Roof Structures and Attics

1. The floor of the attic was not fully fire-blocked from the story below, it was open around the updraft air handler unit.
2. Missing 1 inch clearance from combustibles for the furnace exhaust duct. The duct was touching HVAC ducts in the attic. Otherwise the accessible part of the attic was in good order. The access was limited.

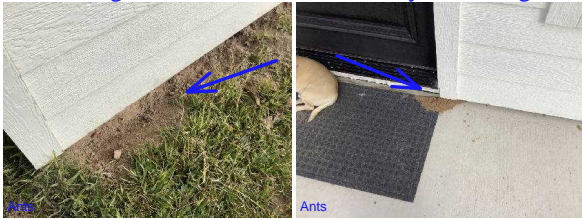
L. Other

1. Large active ant mounds in the yard and against the slab of the house.

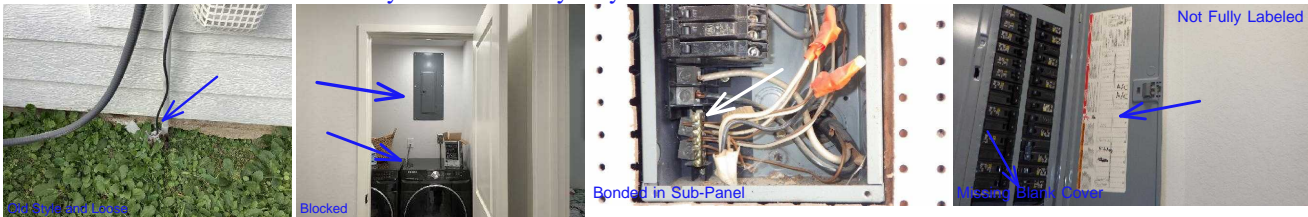
A. Service Entrance and Panels

1. The ground clamp was the old type pipe clamp not the newer style acorn clamp and the clamp was loose on ground rod.
2. Grounds and neutrals bonded in garage sub-panel. Modern standards have them unbounded in sub-panels.
3. The main panel was located in the laundry room, it was blocked by the laundry machines, which limited access. The panel did not conform to the required clearance standards.
4. The panel was not fully and clearly labeled.
5. Missing one blank cover in the panel face. A licensed electrician is recommend to evaluate the panel and system for repairs of deficiencies listed herein and any others that they may find.

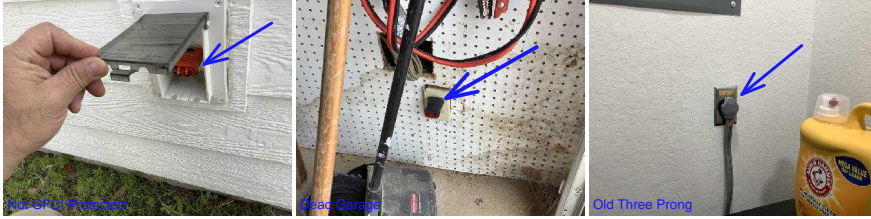
B. Branch Circuits, Connected Devices, and Fixtures (continued)

1. Missing GFCI protection for outlets in required locations, all exterior.
2. Receptacle circuit in garage dead, not connected to power.
3. Old three prong 250V receptacle for the dryer circuit outlet.
4. During operation, the electric water heater would surge making the lights in the hall way flicker. Im not certain why. Recommend a licensed professional electrician evaluate system and repair deficiencies listed herein and any others they may find.

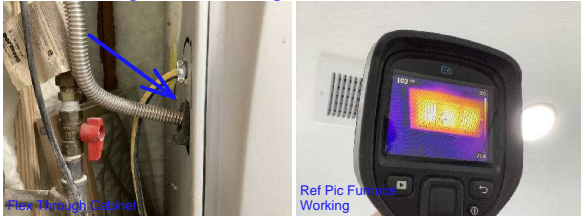
A. Heating Equipment

1. Flex gas line through the cabinet, it should be a hard pipe, Otherwise the furnace was working well.

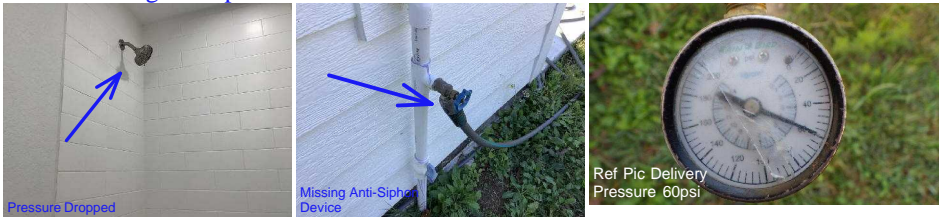
A. Plumbing Supply, Distribution Systems and Fixtures CPVC,

1. Hot water side of service had low delivery pressure. Cold side was good at 60 psi. The drop on the hot side could possibly be associated with the on-demand water heater.
2. Missing ant-siphon devices from exterior hose bibs.

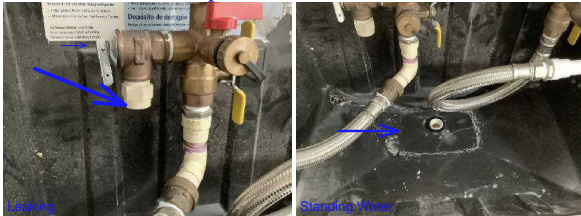
C. Water Heating Equipment ExoSmart,

1. The Temperature and Pressure relief valve was leaking at the time of the inspection. Otherwise the unit was working, but there was issue with pressure on the hot water side of the system down stream of the unit.

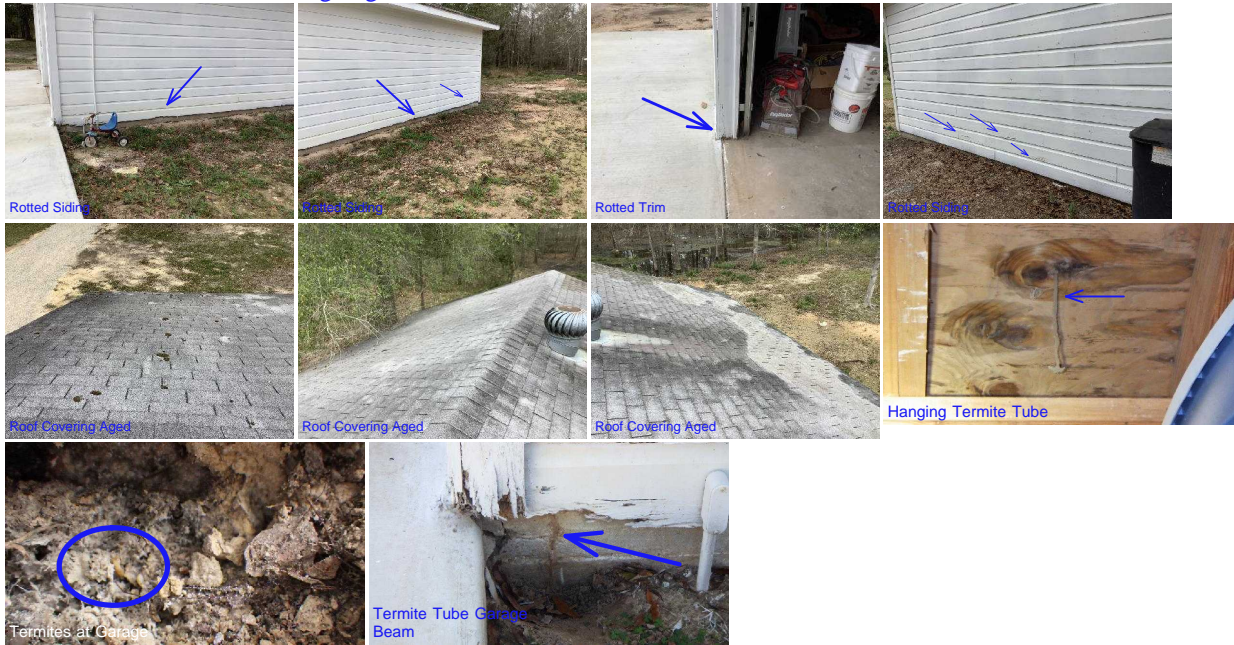
C. Outbuildings

- 1. Garage siding and trim was rotted in many areas.
- 2. The roof covering on the garage was aged and in poor condition, it had aggregate lose. The covering was performing, but it was at the latter part of its useful life Note, insurance may not cover the roof for full replacement value due to the age and condition. I recommend checking with your insurance company before assuming it will be covered for full replacement value.
- 3. Active Termites at the garage.

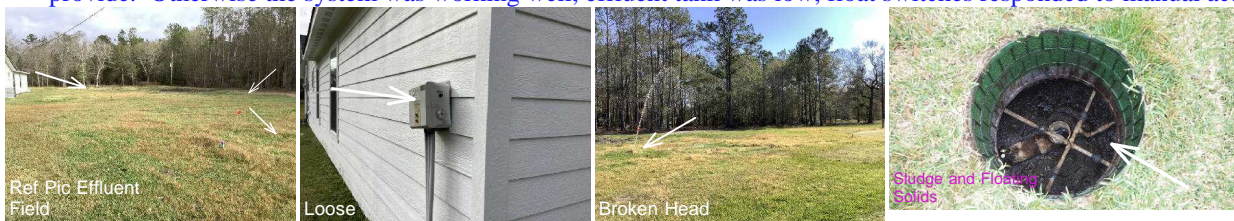
E. Private Sewage Disposal (Septic) Systems

- 1. The control panel for the system was loose on the wall. It should be mounted firmly.
- 2. There was floating sludge and some built-up solids in the solids tank, not overly built up, but from normal use. If there are no records of the tank being pumped out in the last 2-3 years then a periodic maintenance pumping and system cleaning is recommended.
- 4. Broken sprinkler head, repairs required.
- 5. No chlorine in the dispenser.
- 6. I do recommend buyer attain all relevant documents for the system ie. service records, diagrams and anything else the sellers can provide. Otherwise the system was working well, effluent tank was low, float switches responded to manual activation.
