Inspection for Property located at 23943 Prairie Dust Dr
10/16/2021
Prepared for : Ebony Williams

PROPERTY INSPECTION REPORT

Concerning: 23943 Prairie Dust Dr, Hockley, TX 77447
(Address or Other Identification of Inspected Property)

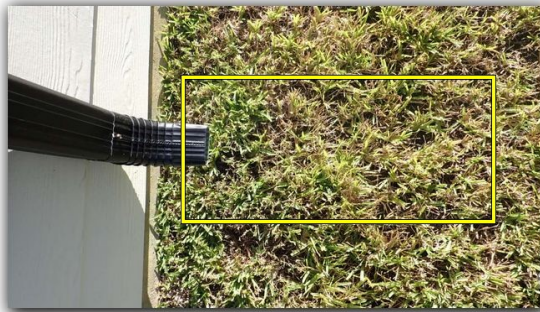
B. Grading and Drainage

Comments: Downspouts need splash blocks at bottoms to prevent soil erosion.

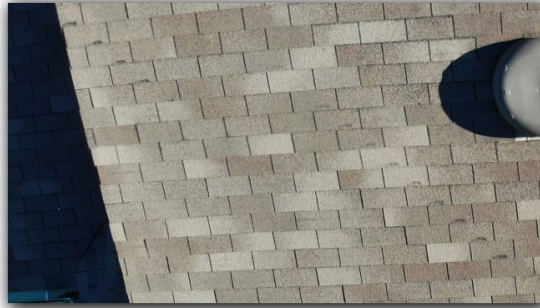
C. Roof Covering Materials

Comments: Observed scuffed / damaged shingles . Probably due to foot traffic. Scuffing the mineral surface off of a composition shingle exposes the asphalt to ultraviolet light which causes it to deteriorate and can greatly reduce the life of the shingle. Replace scuffed shingles.

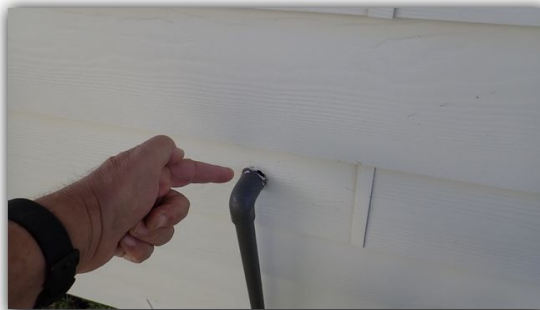
E. Walls (Interior and Exterior)

Comments: Need sealing / caulking around all holes and exterior siding penetrations on top and both sides, (leave bottom open) to prevent water entry. Including but not limited to dryer, bath and range top vents, light fixtures, etc.

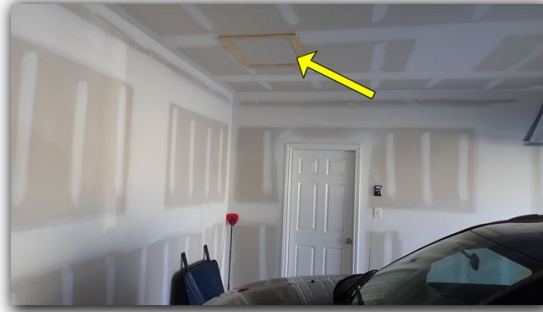
F. Ceilings and Floors

Comments: Access holes / openings in garage walls and / or ceiling need to have fireproof covers to serve as fire stopping to comply with current code and help protect house. Doors to openings should be 20 minute fire rated. 2012 R302.5.1

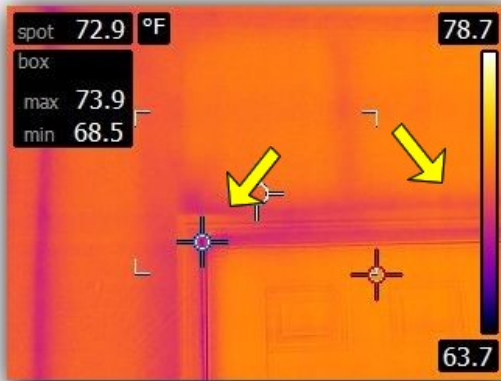
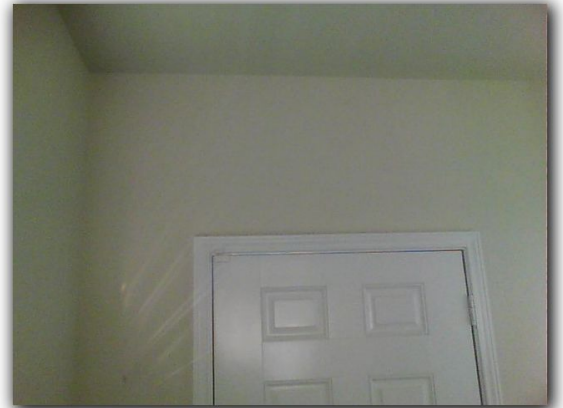
G. Doors (Interior and Exterior)

Comments: The upper trim at one or more exterior doors is not caulked. This condition allows unconditioned exterior air to enter the house.

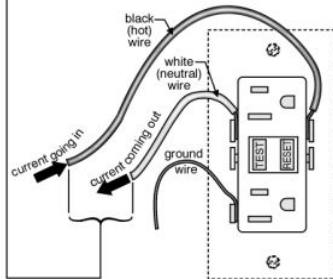
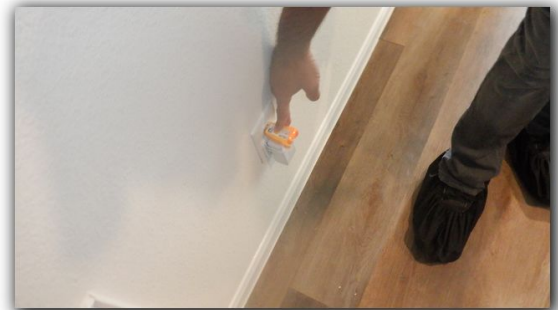
B. Branch Circuits, Connected Devices, and Fixtures

Comments: Did not observe GFCI protection of all outlets in required locations, including but not limited to the location marked below. This condition is a recognized safety hazard and is in need of repair.

| <input type="checkbox"/> All bathrooms | <input checked="" type="checkbox"/> All kitchen outlets |

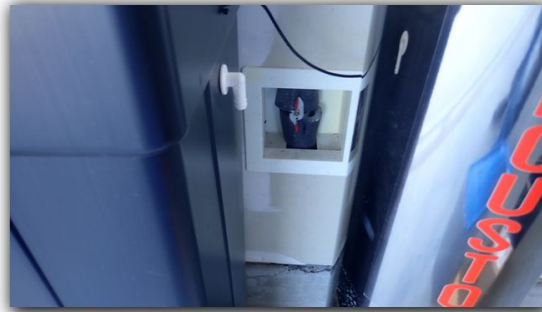
Static water pressure reading:
45 psi

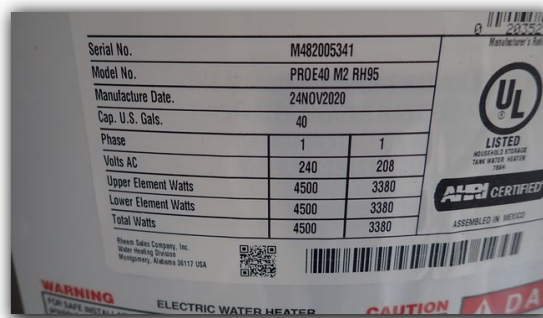
B. Water Heating Equipment

Comments: The water heater data-plate indicates the unit was manufactured in 2020

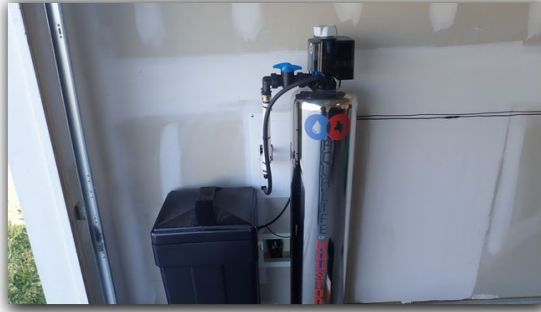
C. Other

Comments: The water softener/filter systems were not checked. Suggest checking with the sellers to obtain user manual and maintenance schedule.

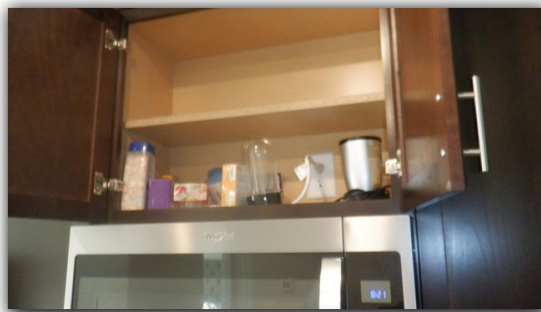
C. Range Hood and Exhaust Systems

Comments: The range hood is integrated in the microwave oven mounted above the range. The hood relies on filter screens to remove particles and grease from the cooking fumes. IT DOES NOT VENT OUTSIDE. Regular cleaning and/or replacement of the filter screens is necessary for proper and effective operation.

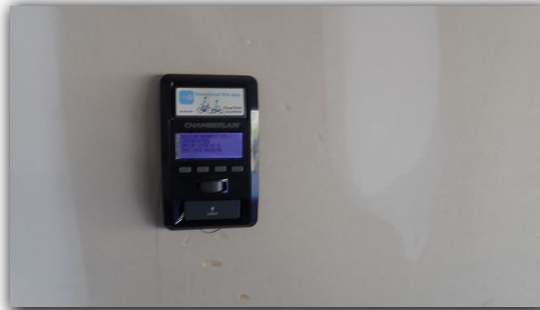
G. Garage Door Operators

Comments: Missing required safety sticker / decal next to operator button.

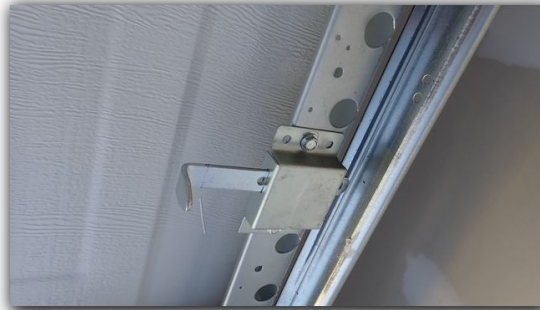
Locks should be made non-operational on garage doors equipped with openers.

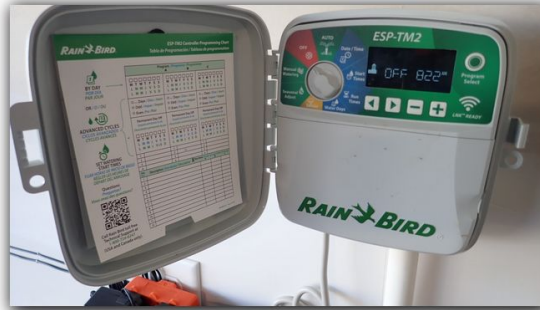
A. Landscape Irrigation (Sprinkler) Systems

Comments: The sprinkler controller was off at the time of inspection. We turned the controller on for testing and then returned it to off before the inspection was completed.

Sprinkler stations/zones were not labeled or listed.
