Date & Property Address : 3-10-2022 915 Willow West

PROPERTY INSPECTION REPORT

915 Willow West

Houston, Texas

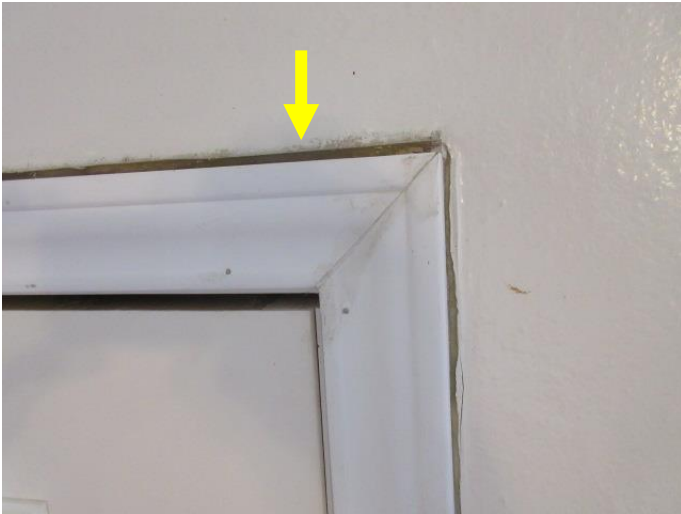
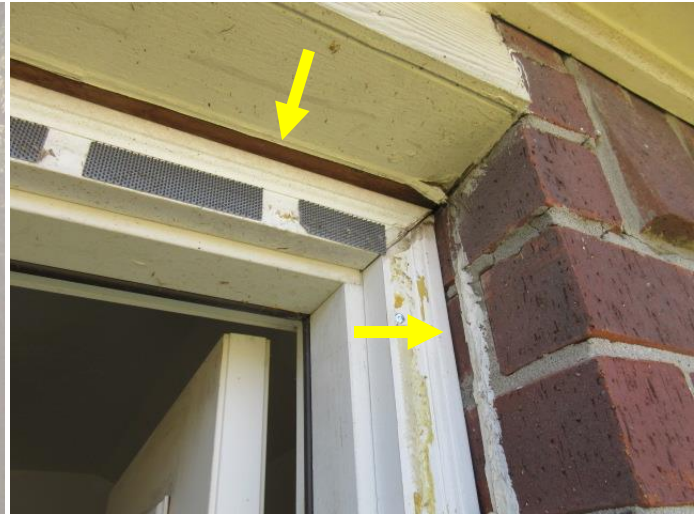
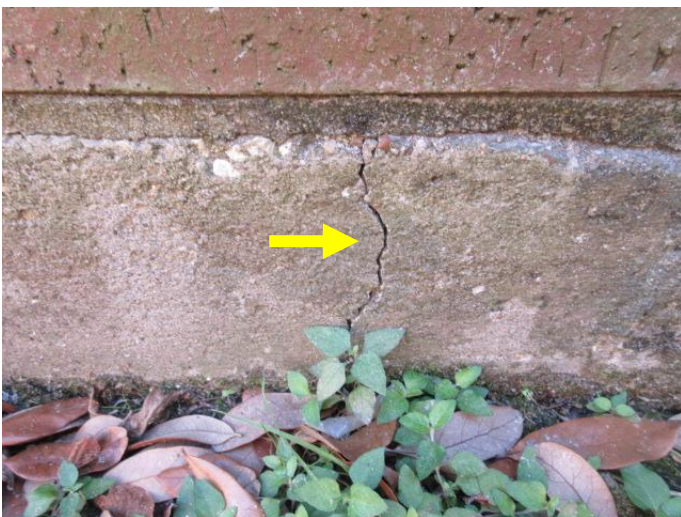
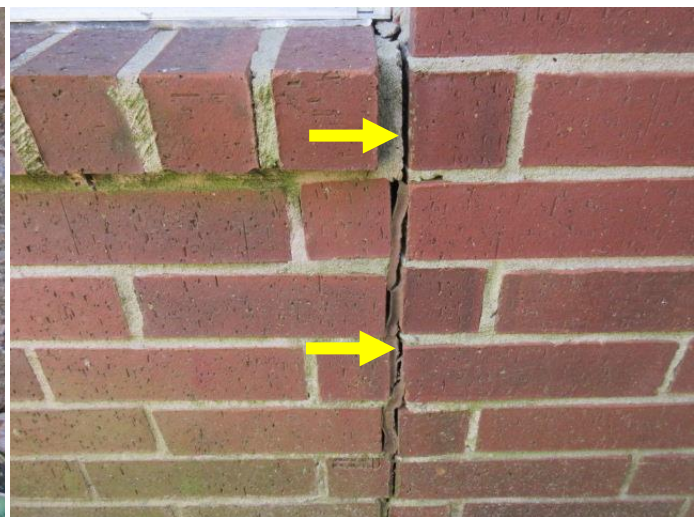
- Contact a foundation expert to evaluate for repairs. Evidence of movement observed through: stress cracks around fireplace, stress crack in kitchen, separation around door frames & window frames, stress crack on left exterior foundation wall, etc.
- Every property owner should conduct a yearly survey of the foundation and perform any preventative maintenance necessary to improve drainage and minimize the effects of landscaping and existing vegetation on the foundation. Conditions can change yearly for the life of the foundation.
- Stress crack = kitchen interior wall.

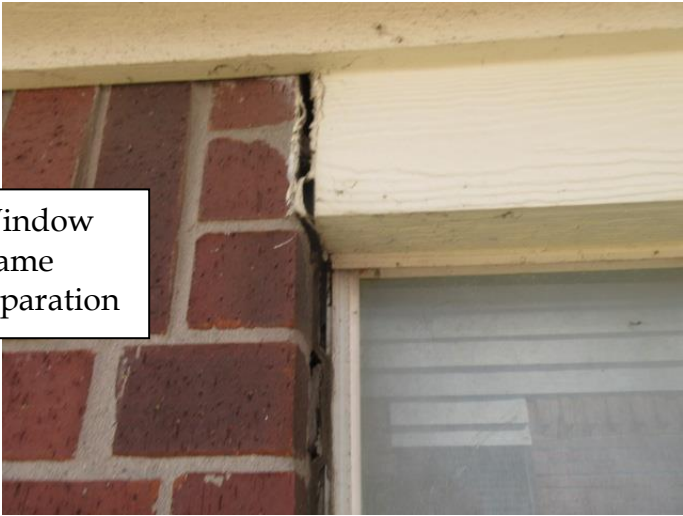
Window frame separation

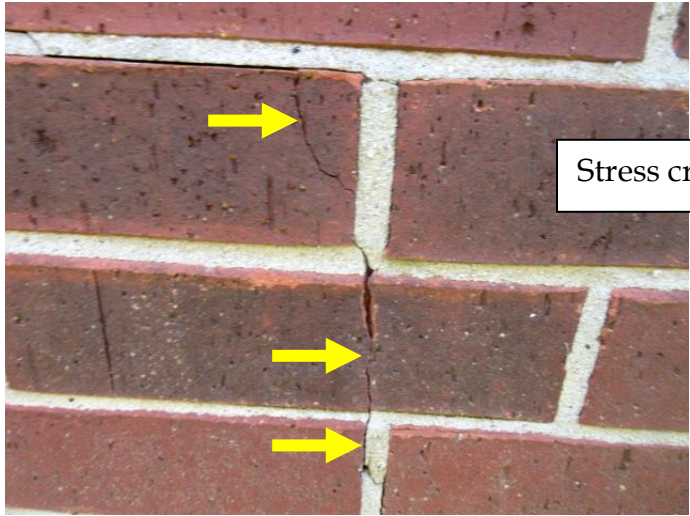
Stress crack

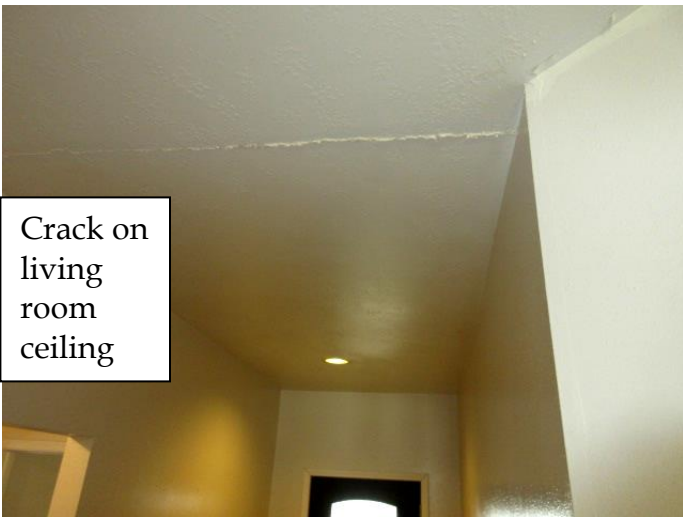
Crack on living room ceiling

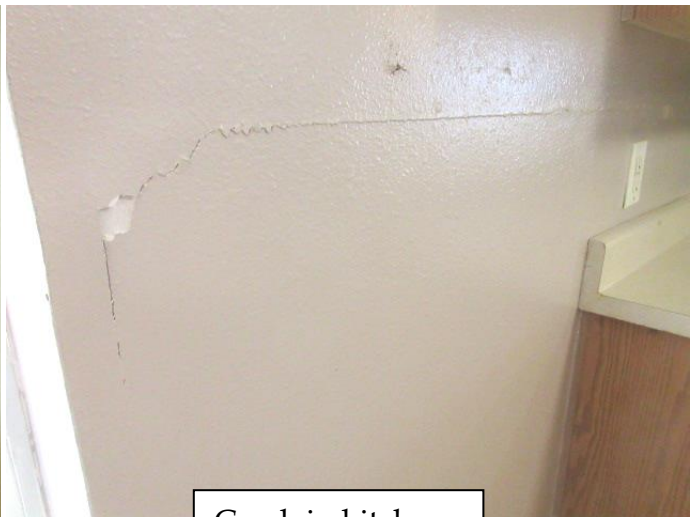
Crack in kitchen

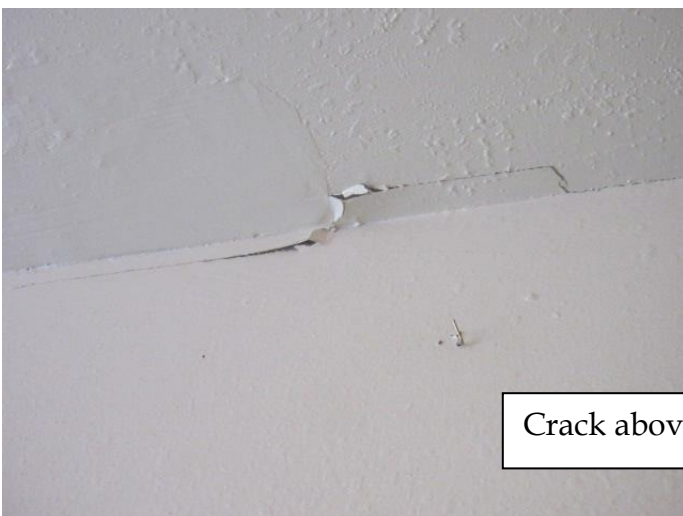
Crack above fireplace

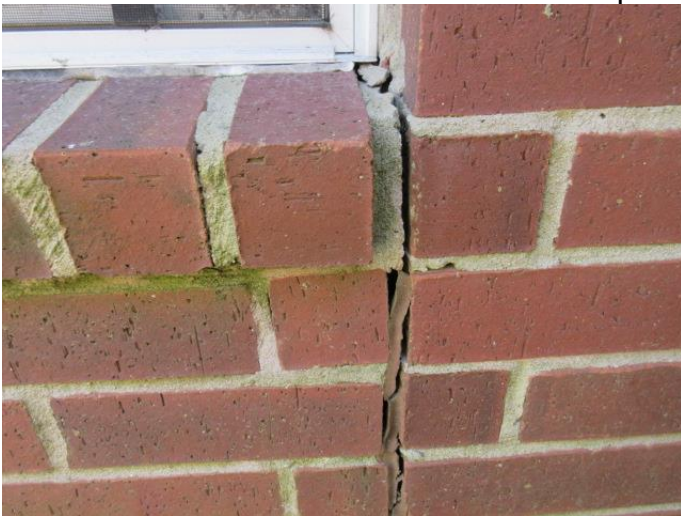
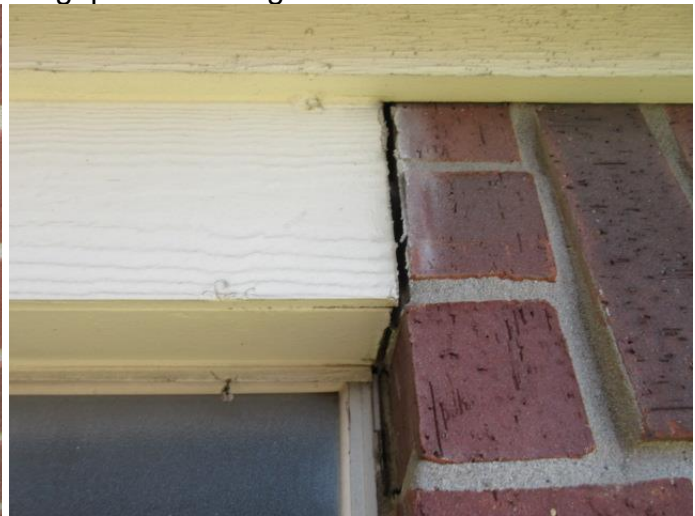
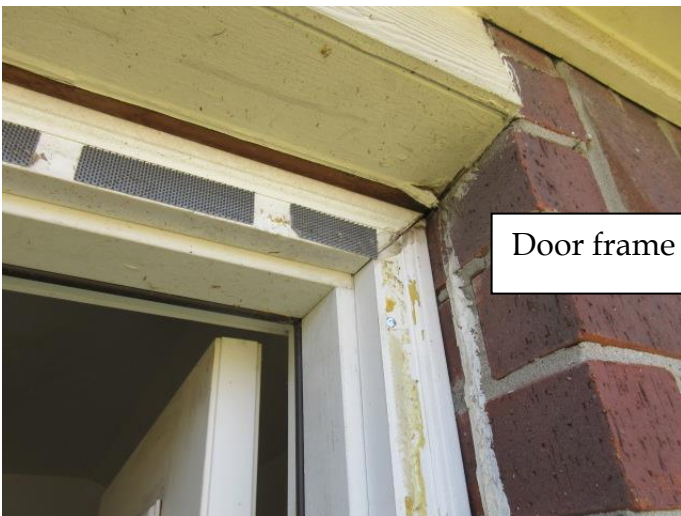
Door frame separating from wall

- Reduce soil grade to expose at least 4" of the concrete slab. Create positive drainage away from the structure
- Caulk around windows and doors, where the previous application of caulk has dried and cracked over time.
- Caulk around the base of all exterior light fixtures. This will help prevent rain water from entering the electrical junction box in wall.
- Seal all gaps in the exterior walls (trim, fascia, etc) to prevent water intrusion.
- Re-caulk vertical expansion gaps in left & right brick walls.

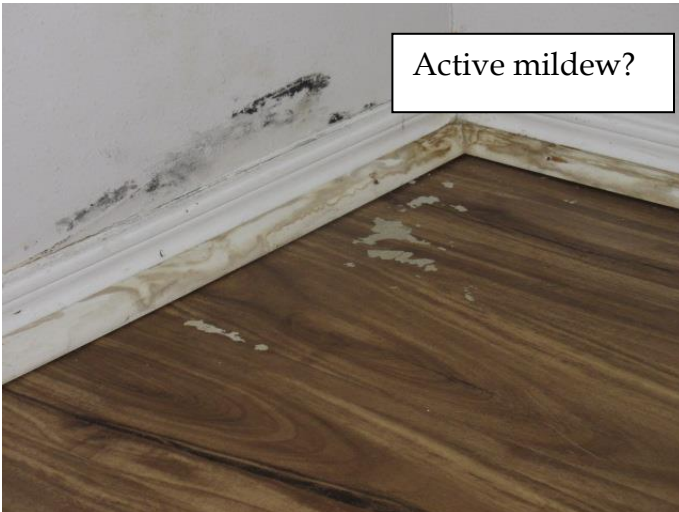
- Cosmetic damage (nail holes, scratches, craters, etc) observed around house interior, from prior Residents.
- Rear guest bedroom closet = Observed possible micro-organism growth on interior wall which may be a concern due to increased awareness of environmental issues associated with molds.
- Damaged kitchen counter tops/cabinets.
- Damaged kitchen drawer.
- Replace damaged/missing quarter round in laundry room.
- Damaged shelves in laundry room.
- Water damaged wall trim = outside middle guest bedroom.
- Water damaged wall trim = outside rear guest bedroom.
- Secure loose clothes rods to their wall brackets. Ex. Front coat closet, front guest bedroom closet, rear guest bedroom closet, master bedroom closet.
- Master bathroom = damaged drawer.

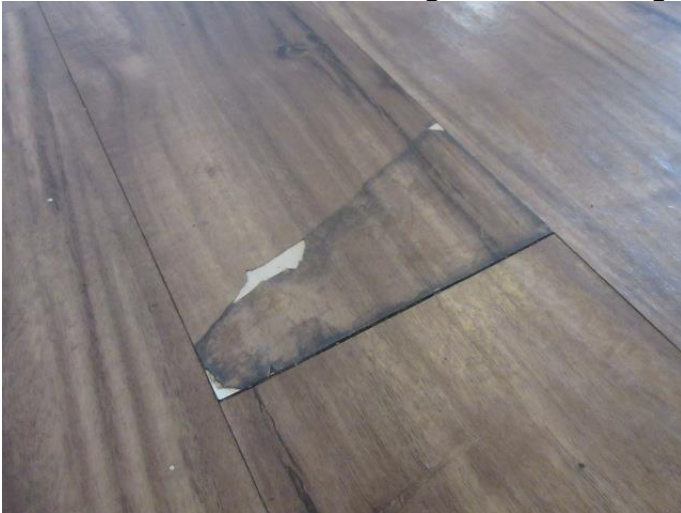
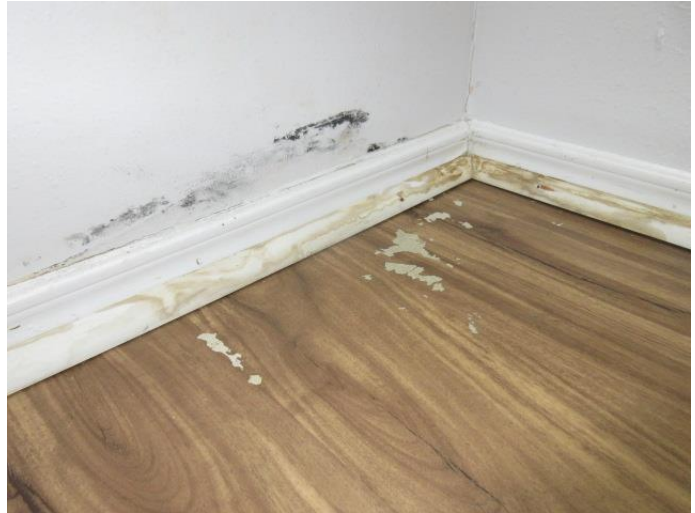
- Damaged flooring observed throughout common rooms of house (peeling, tears, gaps, etc)
- Front door = the threshold under door is loose / not properly supported. Threshold flexes and bends when stepped on (damaging caulk and causing gaps along edges).
- Damaged floor = front door threshold area.
- Damaged floor = rear guest bedroom closet.

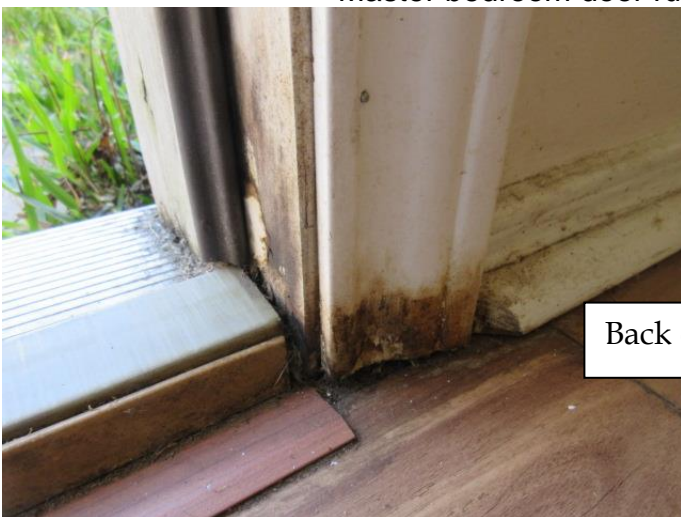
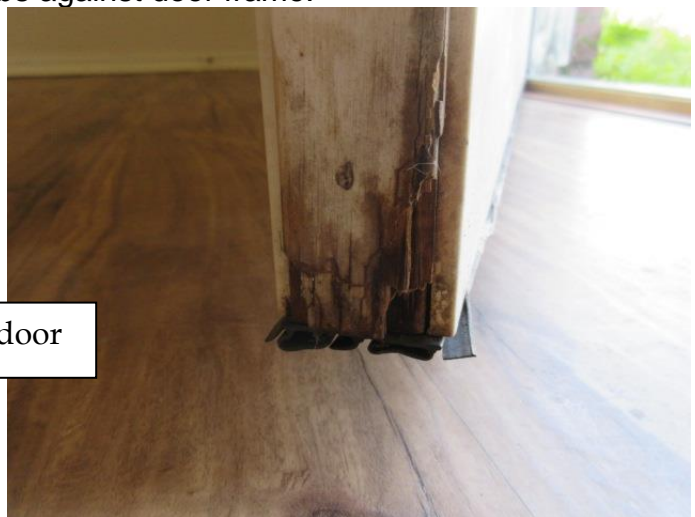
- Install door stops behind all interior doors to prevent damage to walls.
- Back door = water damaged corner of door & water damaged door trim/frame.
- Back door = large amounts of separation observed around door frame.
- Garage door = rust damage observed along bottom of door.
- Garage interior door = replace missing self closing door hinge.
- Crater in laundry room door.
- Middle guest bedroom = adjust the strike plate so the door can be secured shut.
- Master bedroom door rubs against door frame.

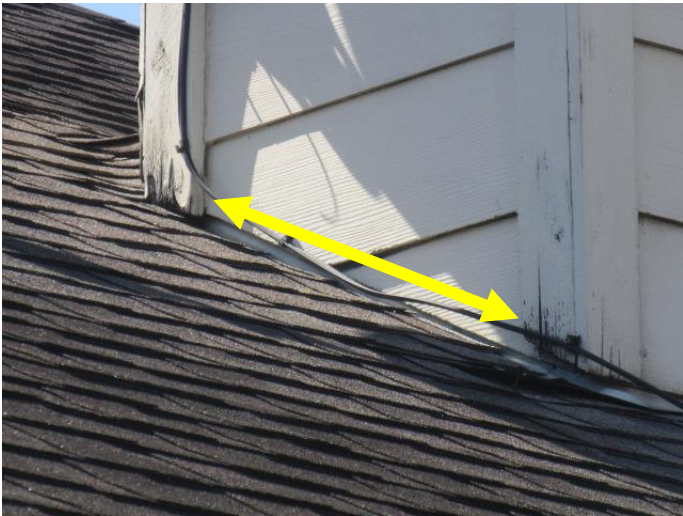
- Replace missing hearth cover.
- Gas fireplaces must have a dampner stop, to prevent the flue dampner from being completely closed (carbon monoxide hazard)
- Functional.
- Missing grout in tile hearth area.
- Wood rot observed on chimney exterior.

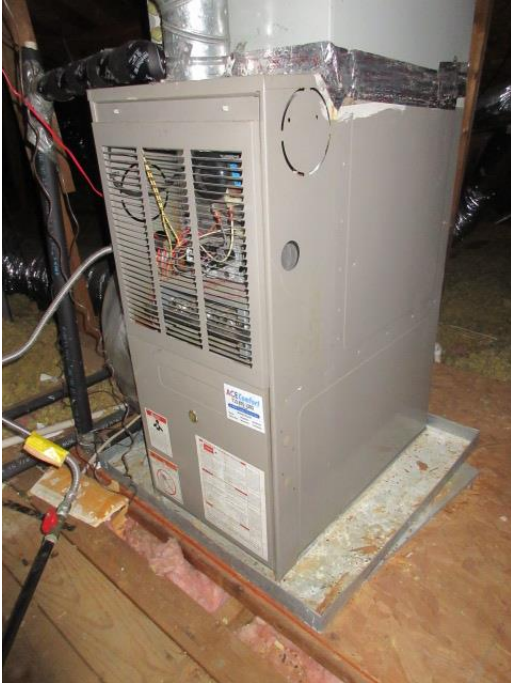
A. Heating Equipment: Comments: Functional
Type and Energy Source: Vertical gas attic unit
Year and Brand: 1999 Unknown

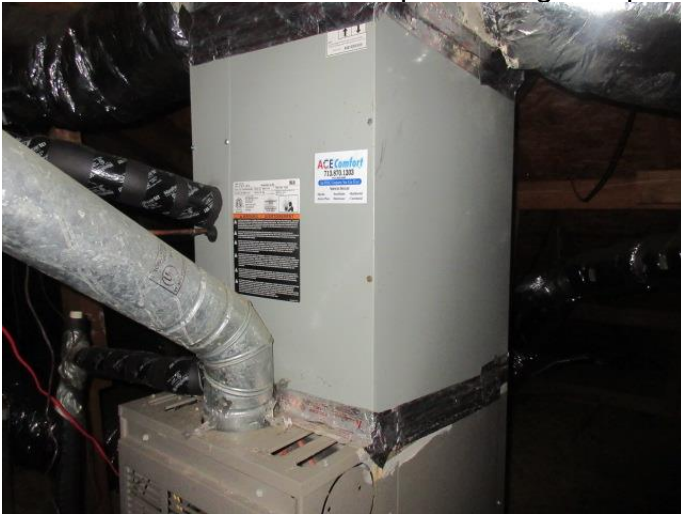
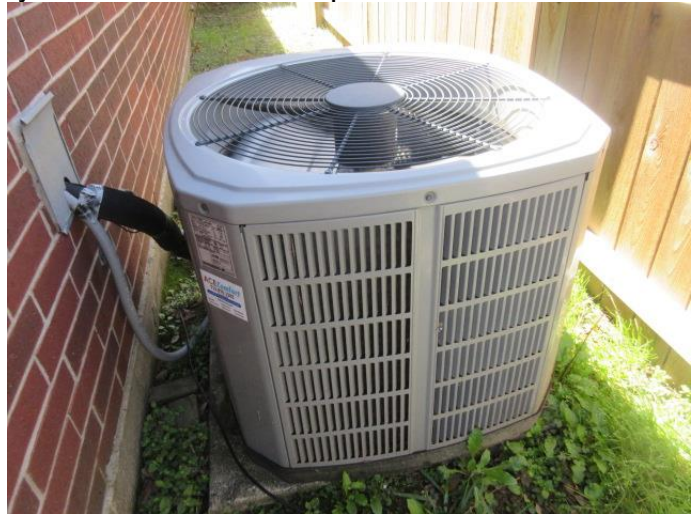
B. Cooling Equipment: (Delta Cooling = Difference between the air return and the a/c vents, typically 16-22 degrees) Comments: Functional
Type and Energy Source: 3.5 ton Condensing Unit
Delta Cooling: 16 degrees delta
Year and Brand: 2015 American Standard

- The evaporator coil in attic area is circa 2016
- The AC system was cooling with an acceptable temperature differential and performing adequately at the time of the inspection.

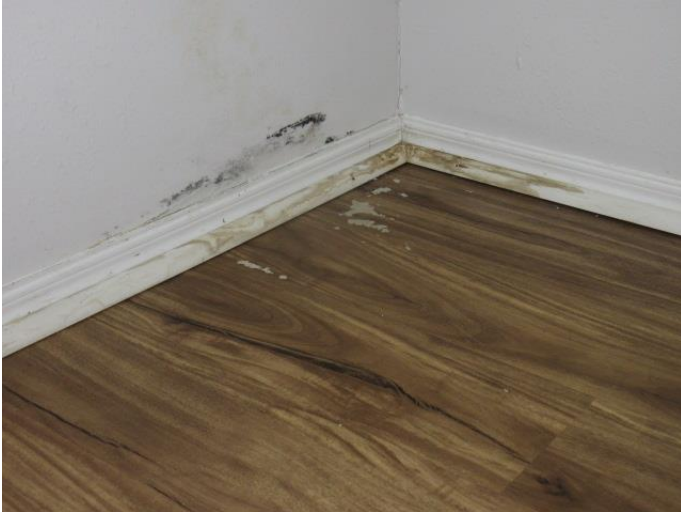
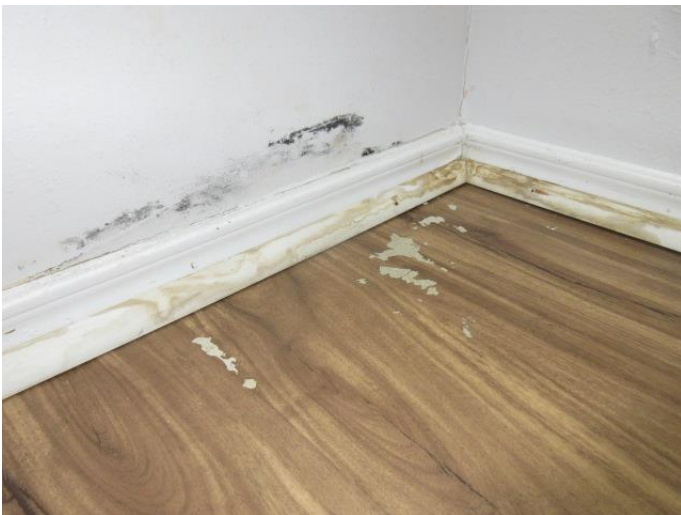
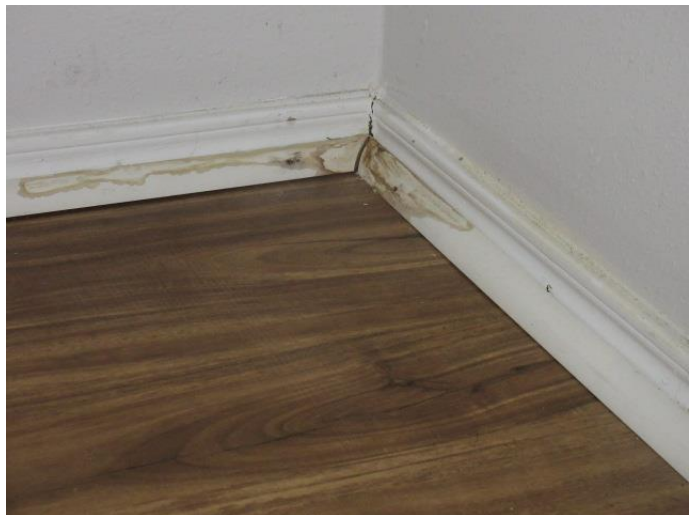
- Master bathtub drains too slowly!
- Suspected leak from drain line under guest bathtub! Water stains & mildew observed on wall behind tub. Install an access behind tub to evaluate the drain line further.

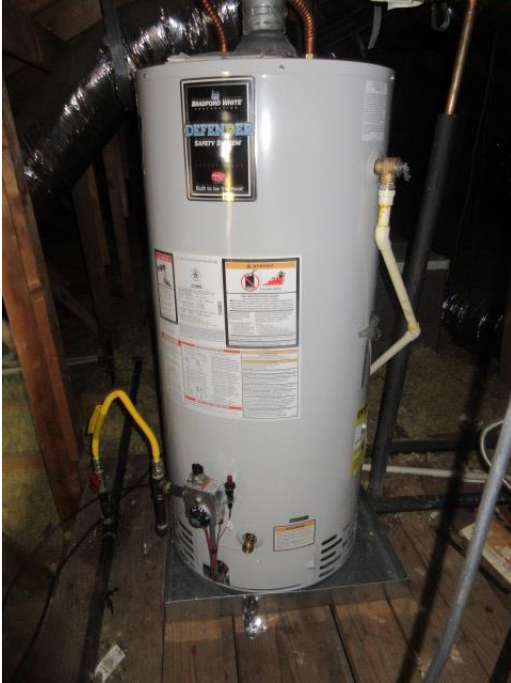
- C. Water Heating Equipment** Comments: Functional
Energy Source: Natural Gas
Year and Brand: 2019 Bradford White
Capacity: 40 gallon
