# PROPERTY INSPECTION REPORT

Concerning: 1122 Autrey St. Unit 3, Houston, TX 77006

By: Brett Finch - TREC #22635

01/27/2022 9:00 am

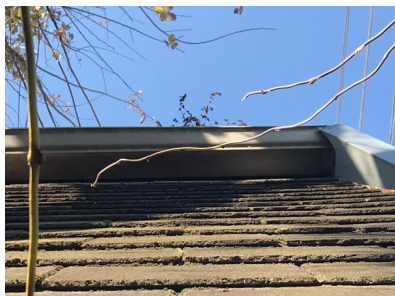
Recommend clearing gutters of debris to improve drainage. Debris in the gutters gutters can cause water to back up under the roof covering and cause damage to the home.

Recommendation: Contact a handyman or DIY project

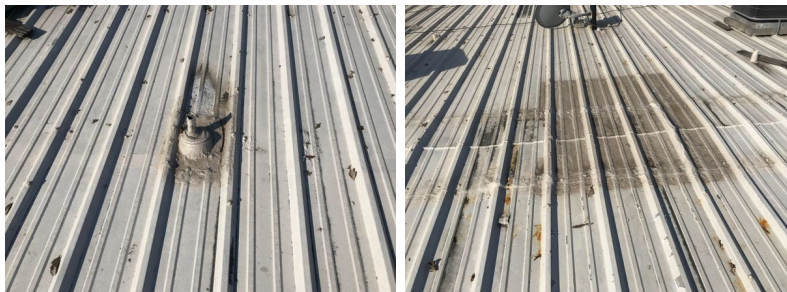
*Signs of Previous Repair:*

Note: Signs of previous repairs observed on the roof covering at the time of inspection. Recommend consulting with the seller to determine any previous issues and scope of previous repairs. No signs of active water intrusion were observed, recommend continued monitoring of these areas.

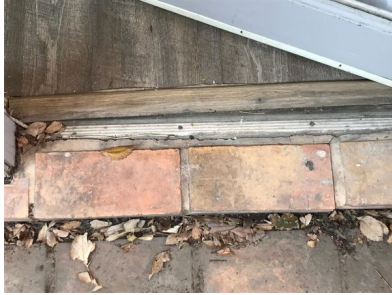
**1: Masonry: Minor cracks/Maintenance Recommended**

Minor cracks were observed in the masonry walls and/or mortar lines around the home. These conditions appear related to typical or normal settlement. Recommend you consider correction to avoid further deterioration and for cosmetic reasons.

Recommendation: Contact a qualified masonry professional.

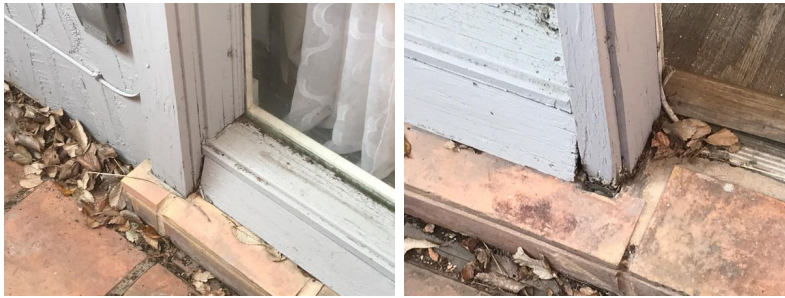
## 2: Siding: Minor Damage/Maintenance Recommended

The siding displayed sections with minor damage or maintenance issues. Common maintenance items include: minor damage, separation at joints and trim, finishes that are worn, etc. While these conditions do not appear to be contributing to any larger issues, recommend you consider correction to avoid further deterioration and as part of normal maintenance.

Recommendation: Contact a qualified handyman.

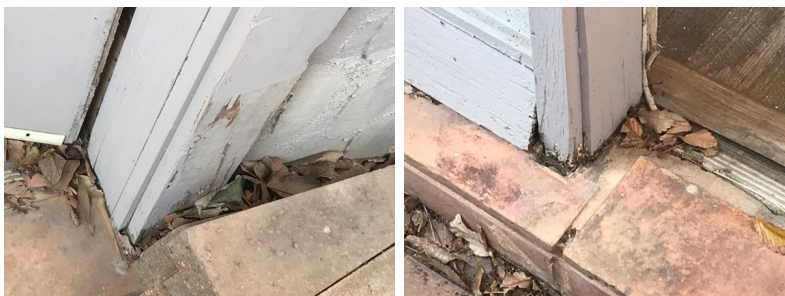
## 3: Siding: Wood Rot/Moisture Issues

Moisture penetration was observed to the wooden trim, fascia boards and siding at multiple locations around the home. Repair as needed to prevent further deterioration.

Recommendation: Contact a qualified professional.

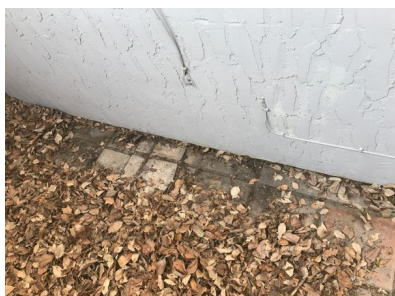
### 5: Stucco: No Weep Screed

No weep screed was observed at the base of the Stucco finish at multiple locations. Recommend further evaluation and repair as these allow any moisture that accumulates behind the veneer to wick out.

Recommendation: Contact a qualified professional.

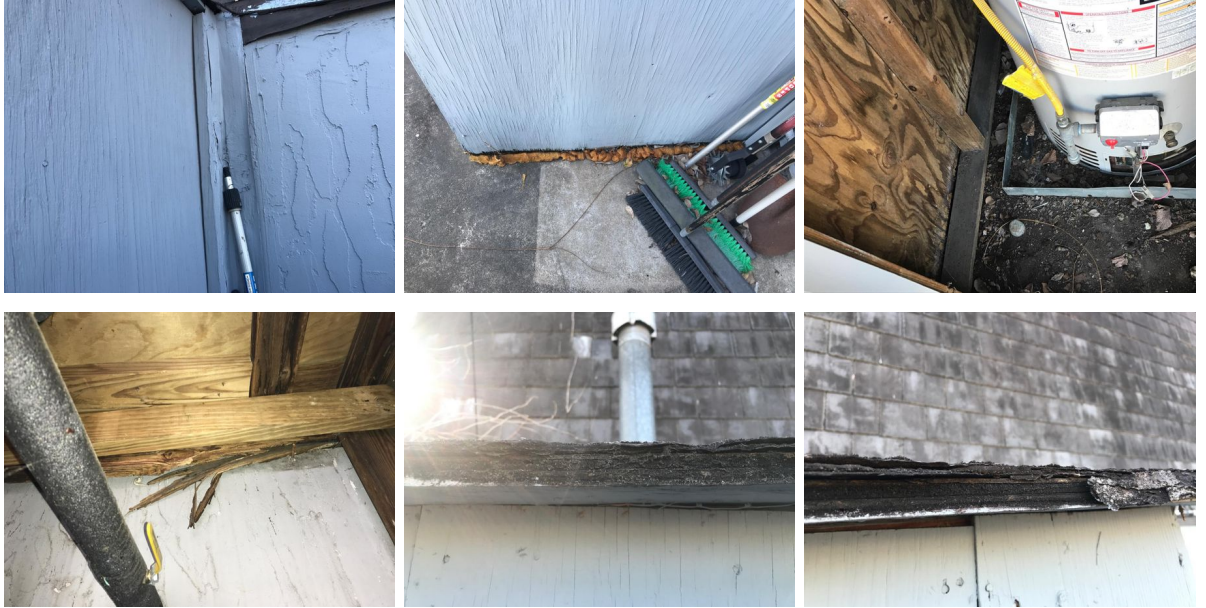
### 6: Wood exterior closet: multiple issues

The wood exterior closet which protects the water heater has multiple issues. There is no back wall to the small closet. It is backed up against the building and there is moisture damage to the boards. There's moisture staining on the interior on the siding. The exterior paint is failing and there are areas where caulking is needed. The shingles are deteriorating. I recommend evaluation by a contractor and make necessary repairs.

Recommendation: Contact a qualified professional.

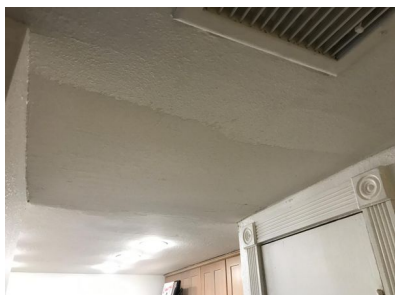
*Previous Repairs:*

Previous repairs were noted. Recommend obtaining all repair documents or further evaluation of repairs.

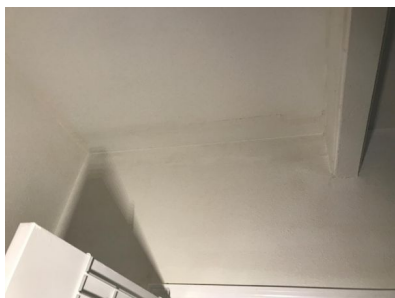
**1: Ceiling: Cracked Tape Joints**

Cracked taped joints and other cosmetic issues were observed on the ceiling finish at multiple locations. These cracks and cosmetic issues may be due to typical settlement of the foundation. I recommend repair as needed to prevent further deterioration and monitoring for additional movement.

Recommendation: Contact a qualified painting contractor.

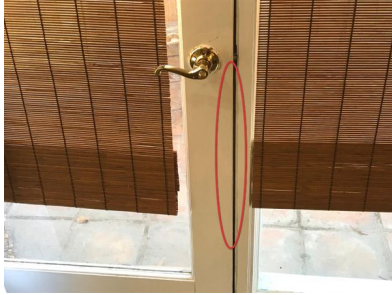
**1: Exterior Door: Gaps in Weather Seals**

Gaps were observed in the weather seal around the exterior doors. Repair as needed to prevent moisture, pest, and air intrusion.

Recommendation: Contact a qualified professional.

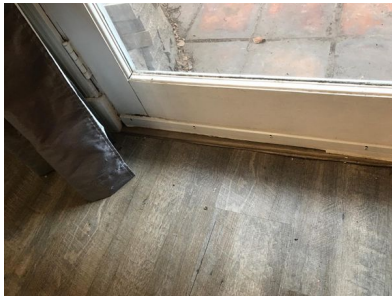
## **2: Exterior Door: Weatherstripping Missing or Damaged**

Multiple exterior doors showed damage or were missing its weatherstripping. Recommend installation or repair of standard weatherstripping to prevent energy loss and/or moisture intrusion.

Recommendation: Contact a qualified professional.

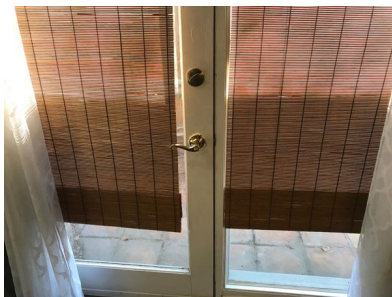
## **3: Door: Not Latching Securely**

One or more doors do not latch securely or have broken hardware. Recommend to repair or adjust as needed.

Recommendation: Contact a handyman or DIY project

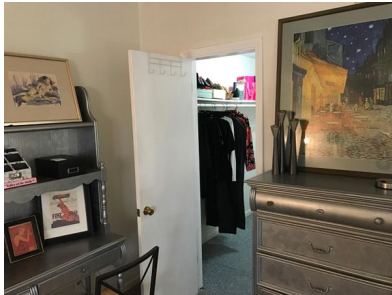
## **4: Interior Door: Catches/Rubs on Floor**

The door at above stated locations would catch/rub on the floor. Adjustment to the door frame is recommended to prevent damage to the flooring material.

Recommendation: Contact a qualified professional.

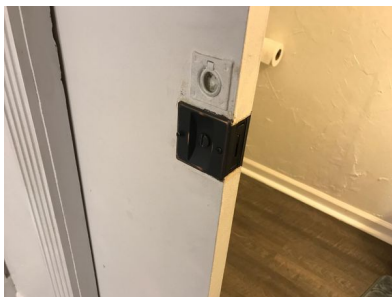
**5: Interior Door: Loose Hardware**

The door knob hardware at multiple doors around the home was observed to be loose. Recommend tightening to allow for easier operation of the doors.

Recommendation: Contact a qualified professional.

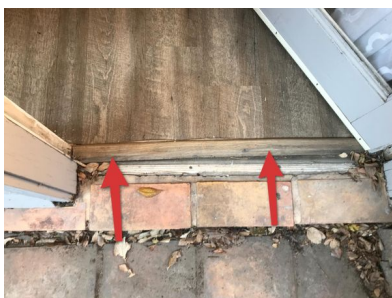
**6: Threshold: wood threshold unpainted**

The wood threshold at the back door is not painted or sealed. I recommend sealing to prevent moisture intrusion and deterioration.

Recommendation: Contact a qualified professional.

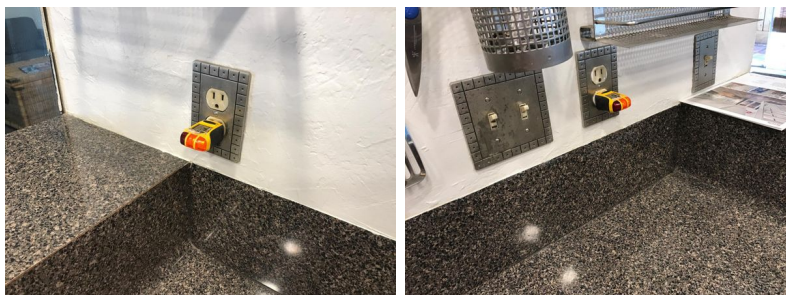
**1: Outlets: GFCI Protection Inadequate**

Multiple outlets throughout the homes wet locations were in need of GFCI protection. GFCI outlets weren't required when the home was built but updating to GFCI would avoid safety hazards.

Recommendation: Contact a qualified professional.

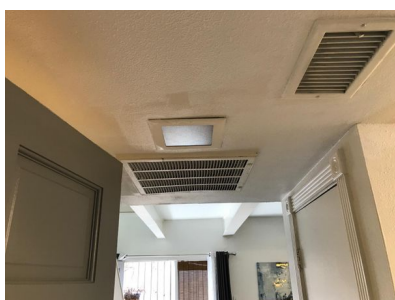
## 2: Light: Inoperable

One or more light fixtures around the home did not function, possibly bulb related. Correct as needed.

Recommendation: Contact a qualified electrical contractor.

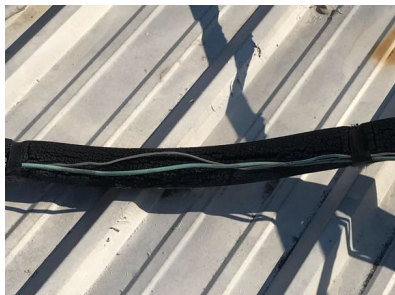
Missing or damaged insulation on refrigerant line can cause energy loss and condensation. Recommend correction.

Recommendation: Contact a qualified HVAC professional.

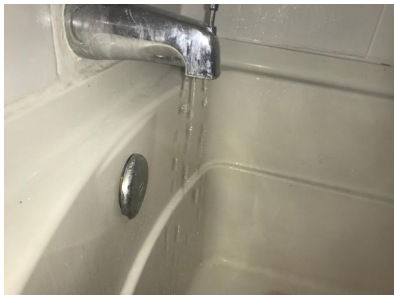
The tub diverters were observed to not function properly when the pin was pulled. I Re**co**mmend further evaluation by a plumbing contractor.

Recommendation: Contact a qualified plumbing contractor.

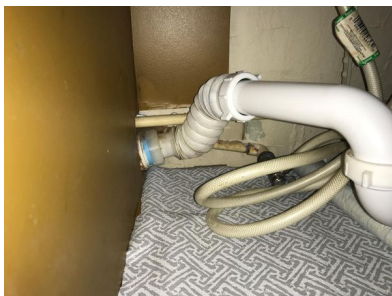
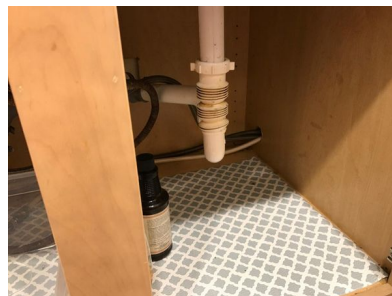
**1: Drains: Accordion Pipe**

Accordion drain pipe was observed to be in use under the kitchen and upstairs bathroom locations. This type of pipe is known to accumulate debris within the ridges and clog. Recommend repair.

Recommendation: Contact a qualified professional.

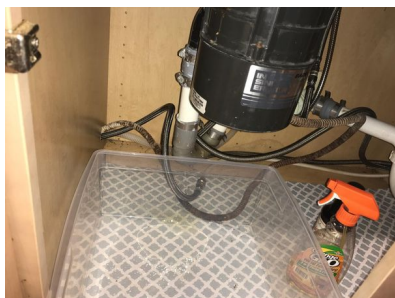
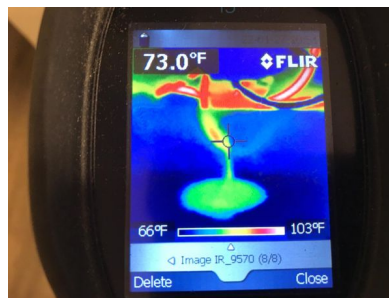
Garbage disposal was inoperable at the time of inspection. Recommend qualified handyman repair.

Waste disposal was leaking at the time of the inspection. Further evaluation by a plumbing contractor is recommended.

Recommendation: Contact a qualified handyman.

Recommendation: Contact a qualified professional.

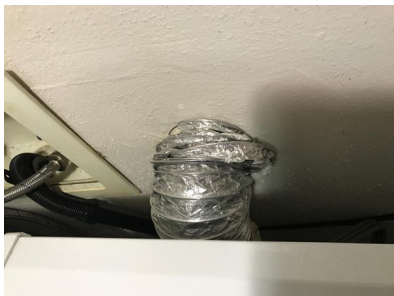
The dryer is installed therefore unable to view the dryer vent. I recommend cleaning before use.
