TEXAS OFFICIAL WOOD DESTROYING INSECT REPORT

8205 Arrowhead Lane

5A. Single Family Residence
List structure(s) inspected that may include residence, detached garages and other structures on the property. (Refer to Part A, Scope of Inspection)

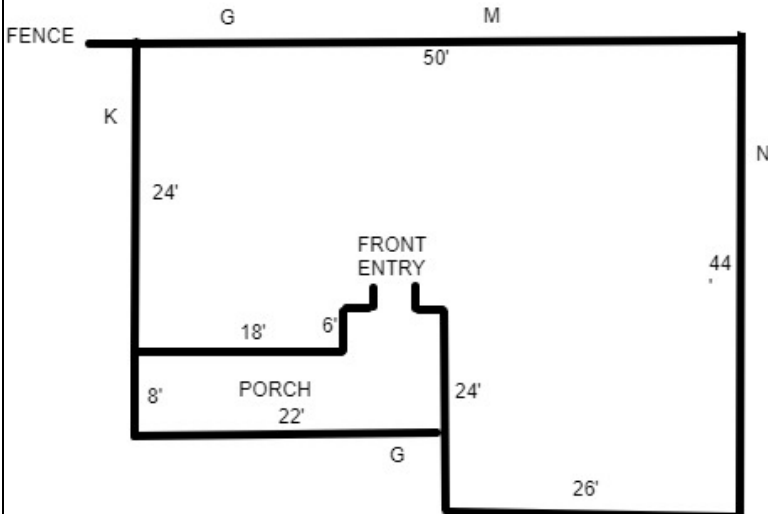
Diagram of Structure(s) Inspected

The inspector must draw a diagram including approximate perimeter measurements and indicate active or previous infestation and type of insect by using the following codes: E- Evidence of Infestation, A-Active; P-Previous; D-Drywood Termites; S-Subterranean Termites; F-Formosan Termites; C-Conductive Conditions; B-Wood Boring Beetles; H- Carpenter Ants; Other(s) - Specify N/A

G - WOOD TO GROUND CONTACT
 K - WOOD DEBRIS AROUND OR UNDER STRUCTURE
 M - WOOD ROT

12B. A preventive treatment and/or correction of conducive conditions as identified in 10A & 10B is recommended as follows: Yes No

Specify reason: Wood to Ground Contact (G), Debris under or around structure (K), Wood Rot (M)
