RESIDENTIAL INSPECTION REPORT

21134 Stoney Haven Dr
Katy, TX 77449

PROPERTY INSPECTION REPORT

Concerning: 21134 Stoney Haven Dr, Katy, TX 77449

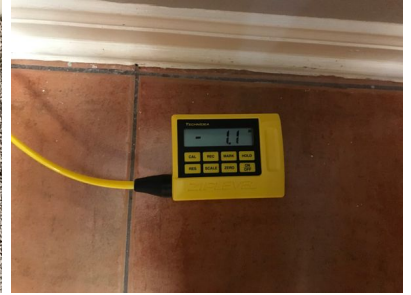
1: Slab: Minor Surface Irregularities

Note: These conditions are typically cosmetic and not associated with structural movement.

Recommendation: Recommend monitoring.

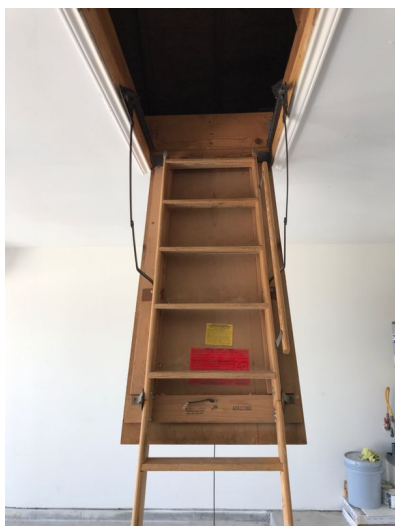
1: Pulldown stairs/ladder: Not fire rated in garage

The pull-down attic ladder located in the garage was not fire-rated **Note:** This is a newer building standard.

Recommendation: Contact a qualified professional.

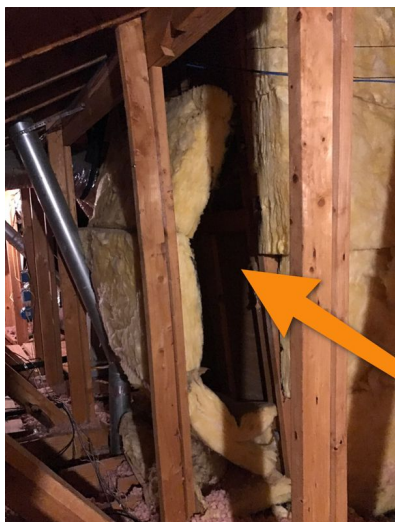
2: Insulation: Fallen wall insulation

Fallen wall insulation should be re-hung or replaced if needed. Remedy as needed.

Recommendation: Contact a qualified insulation contractor.

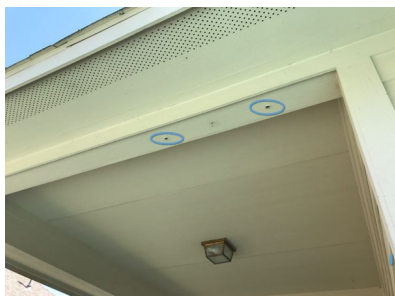
For Example: rear patio

1: Exterior: Seal Wall Fixtures

Fixtures/Electrical boxes were not properly sealed. Remedy as needed.

Note: Modern building practices recommend sealing around components that are mounted on or pass through the exterior wall to limit moisture intrusion.

Recommendation: Recommended DIY Project

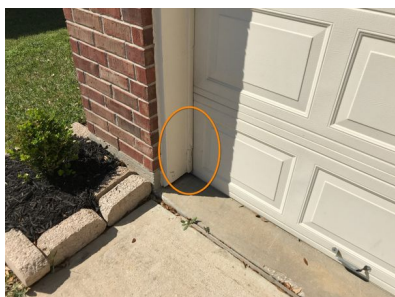
For Example: add garage door

3: Exterior-Fascia/soffits/eaves/siding : Evidence of Wood Rot

Wood rot/deterioration was observed. Evaluate and remedy as needed.

Recommendation: Contact a qualified professional.

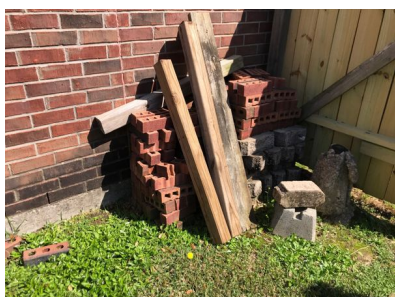
4: Debris up against exterior wall

Debris up against exterior wall

Debris can retain moisture, it can also hide the entrance of wood destroying insect's

Recommend storing debris away from structure

Recommendation: Contact a qualified professional.

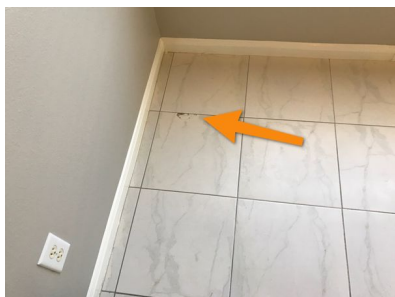
For Example: Front dining area

1: Flooring: Tiles Cracked/Chipped

Floor tiles were cracked or chipped.

Recommendation: Contact a qualified professional.

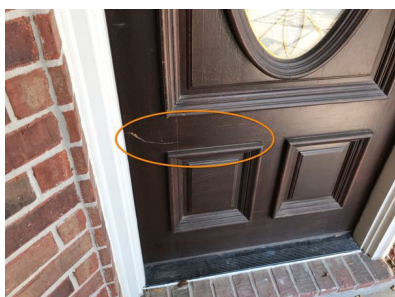
For Example: Front door

1: Door: Damaged

Evaluated and remedy as needed

Recommendation: Contact a qualified door repair/installation contractor.

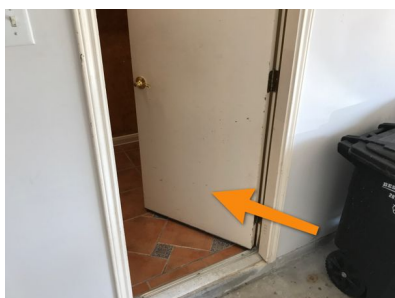
2: Garage Door into Living Space: Self-Closing Mechanism not Present/Operable

Entry door between the garage and living space should have a functioning self-closing mechanism.

Recommendation: Contact a qualified professional.

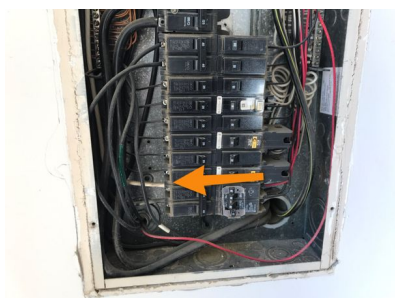
White wires connected to breakers are not marked with black or red electrical tape to indicate that they are "hot". Remedy as needed.

Recommendation: Contact a qualified electrical contractor.

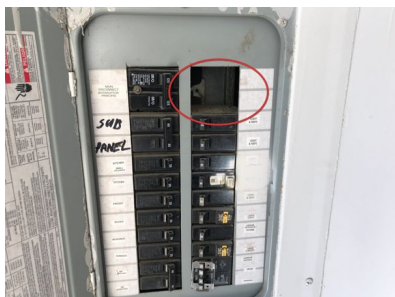
3: Missing Knockouts

Safety "knockouts" were missing from the panel cover. Evaluation and/or remediation by a licensed electrician is recommended.

Recommendation: Contact a qualified electrical contractor.

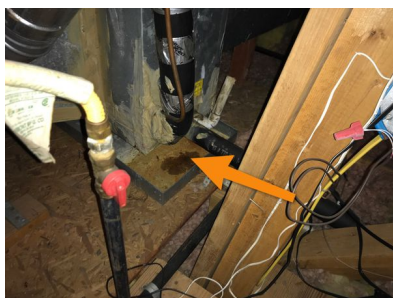
3: Condensate system: Rusted Emergency pan

The emergency overflow pan is rusted. Further evaluation by an HVAC professional is recommended.

Recommendation: Contact a qualified HVAC professional.

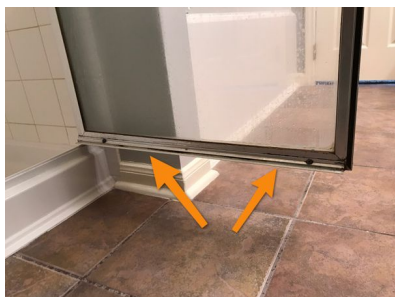
For Example: Master bathroom

1: Shower: Door Missing/Damaged Seal

The seal (also known as a gasket or floor sweep) at the shower door was missing or damaged. Remedy as needed.

Recommendation: Contact a qualified professional.

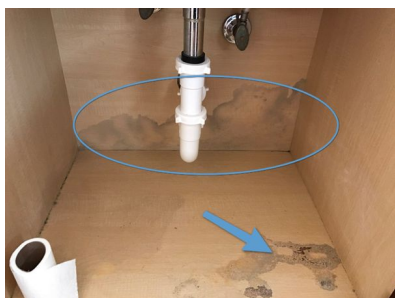
Hall Bathroom

1: Note: Evidence of Previous Leak

Note: Evidence of a previous leak was noted under the sink. No leaking occurred at time of inspection and the area remained dry.

Recommendation: Recommend monitoring.

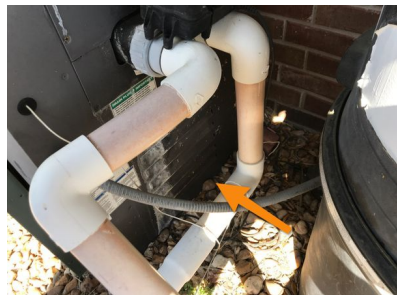
3: Bonding Connection Missing

A bonding connection is missing at the pool equipment.

Heater is not connected to bonding

Recommendation: Contact a qualified electrical contractor.

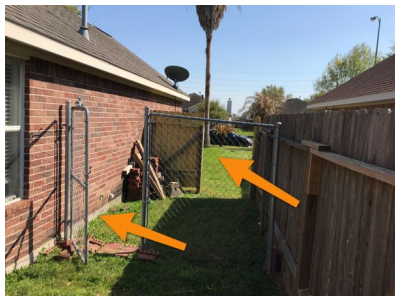
7: Inadequate Perimeter Gates

The perimeter gates that provide access to the pool/spa area should be self-closing, self-latching, and open away from the pool area.

Recommendation: Contact a qualified professional.

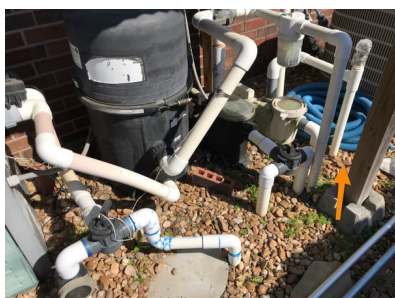
PVC piping was not painted. PVC can be damaged by sunlight and should be painted or coated for UV protection.

Recommendation: Contact a handyman or DIY project
