REDSTAR PROFESSIONAL HOME INSPECTION, INC

REDSTAR RESIDENTIAL INSPECTION REI 7-6

2000 Bagby St 7434
Houston, TX 77002

PROPERTY INSPECTION REPORT FORM

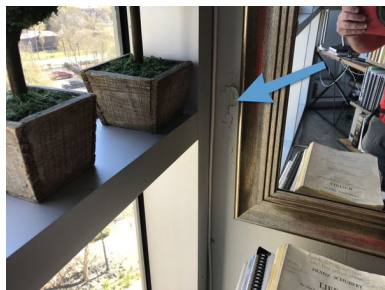
Rear Right

Paint finish damaged or worn -

The above stated issues were observed at the home at time of inspection. These items are related to cosmetic issues or maintenance due to expected wear and tear. Recommend you budget for repair of these issues for cosmetic reasons, or to avoid further deterioration.

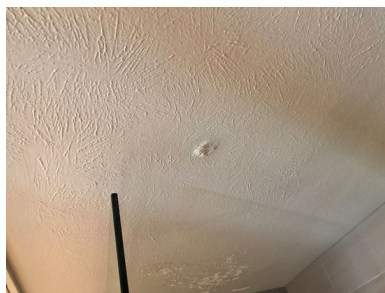
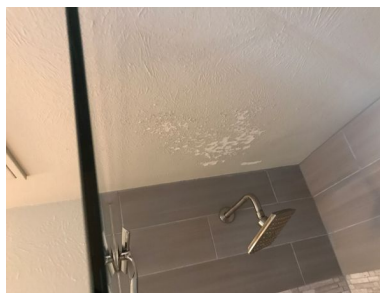
2nd Floor Bathroom Multiple Locations

1: Ceiling: Moisture Damage/ Water Mark

Water staining observed at the interior of the home at the ceiling. Thermal imaging revealed no signs of active moisture at these locations, and it appears these stains are related to a previous issue. Recommend consulting with the seller to determine any previous issues at these locations, and recommend cosmetic repair and further monitoring to help ensure no leaking is present.

Recommendation: Contact a qualified professional.

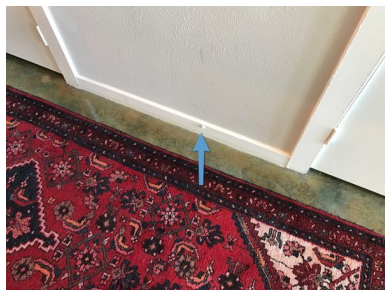
Front Hall

1: Interior Door Hardware: Missing Door Stops

One or more door stops were observed to be missing. Recommend adding door stops to prevent damage to drywall finish.

Recommendation: Contact a qualified professional.

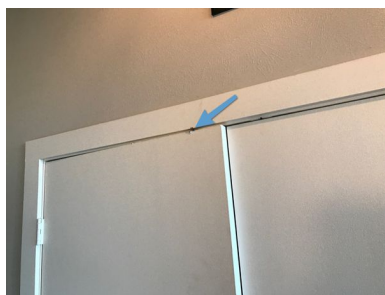
Front Left Closet

2: Interior Door Hardware: Ball Hardware Damaged

The ball hardware for the door was damaged. Repair as needed to allow the door to close properly.

Recommendation: Contact a handyman or DIY project

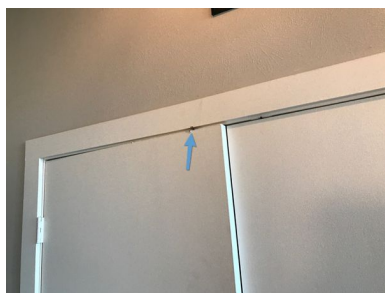
3: Door: Damaged

Observed front hall closet with minor damaged at door. Evaluate and remedy as needed.

Recommendation: Contact a qualified professional.

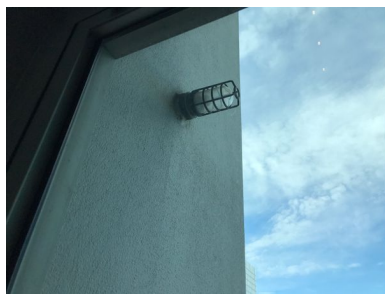
1: Electrical Fixture Issues

Lights out

Recommendation: Contact a qualified professional.

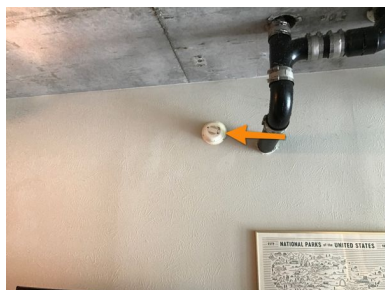
2nd Floor Bedroom

2: Smoke Detectors: Old/Past Life Expectancy

The smoke detectors in the home appeared to be more than 10 years old. It is recommended they be replaced every 10 years to ensure they will operate properly. Repair as needed.

Recommendation: Contact a qualified electrical contractor.

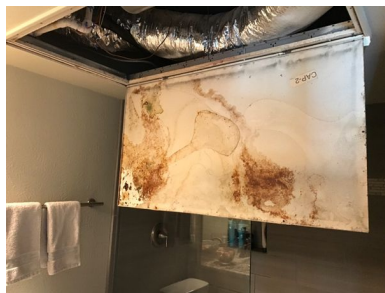
2nd Floor Bathroom

1: Rust: Condenser Panel

Rusting observed at the exterior of the condenser panel. Recommend further evaluation by a licensed HVAC tech.

Recommendation: Contact a qualified HVAC professional.

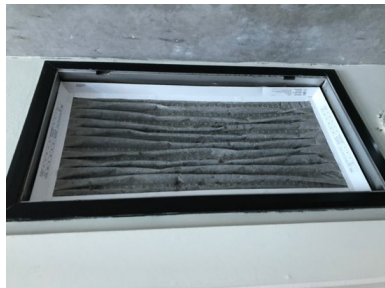
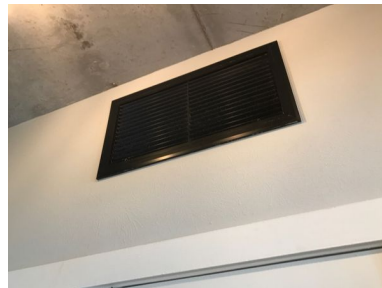
1: Filters: Dirty

The return air filters at the return air registers were observed to be dirty. Correct as needed to allow the equipment to operate properly.

Recommendation: Contact a qualified professional.

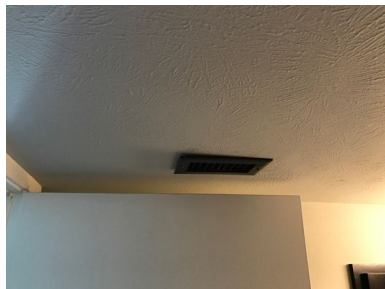
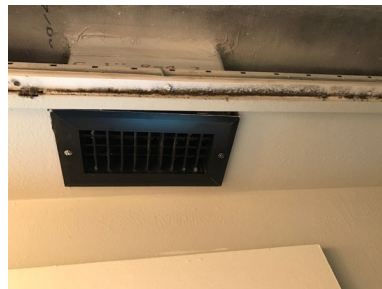
2: Register: Loose

Supply air registers were loose at multiple locations. Remedy as needed.

Recommendation: Contact a qualified professional.

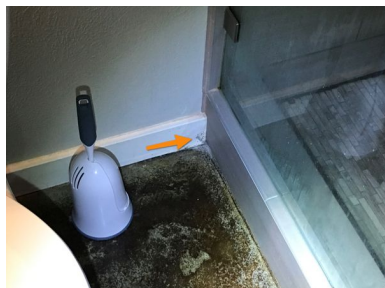
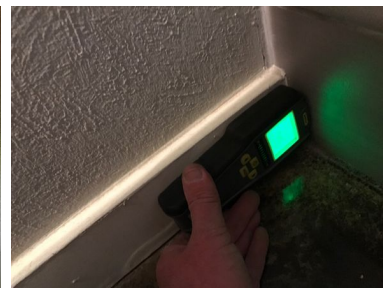
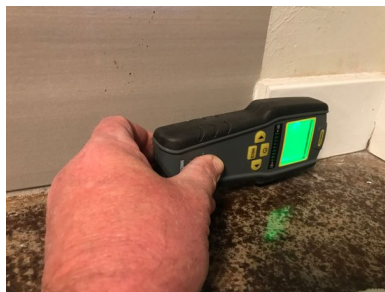
2nd Floor Bathroom

2: Shower: Evidence of Moisture Leaking Outside Enclosure

The inspector observed evidence of moisture leaking to the outside of the shower enclosure. The cause could not be determined at the time of the inspection. Recommend further evaluation by a general contractor.

Recommendation: Contact a qualified general contractor.

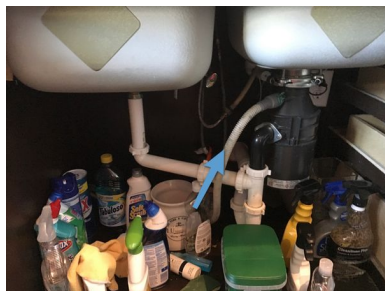
1: Missing Anti-Siphon Loop

There should be an anti-siphon loop or an air gap in the dishwasher drain line to prevent backwash from the waste disposal. Correct as needed.

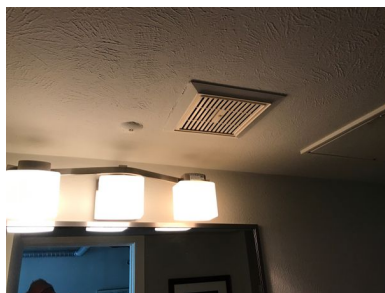
2nd Floor Bathroom

1: Noisy Vent Fan

One or more exhaust vent fans were observed to be noisy. Recommend to have a contractor evaluate for remedy.

Recommendation: Contact a qualified professional.

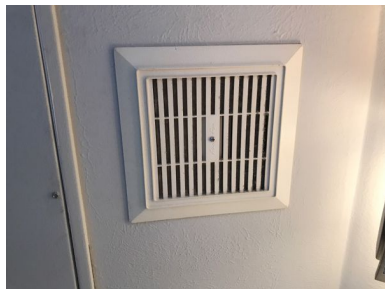
1st Floor Bathroom

2: Dirty Vent Cover

One or more vent covers were observed to be dirty. Recommend to clean as needed.

Recommendation: Contact a qualified professional.
