TREC REI 7-6 (BBI MASTER)

1729 Airline Dr
Houston, TX 77009

PROPERTY INSPECTION REPORT FORM

Nathan Roberts <i>Name of Client</i>	04/19/2022 2:00 pm <i>Date of Inspection</i>
1729 Airline Dr, Houston, TX 77009 <i>Address of Inspected Property</i>	
Javier Garcia <i>Name of Inspector</i>	TREC# 21439 <i>TREC License #</i>
<i>Name of Sponsor (if applicable)</i>	<i>TREC License #</i>

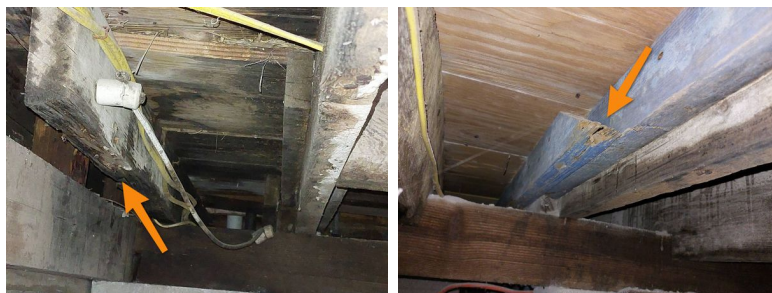
2: Crawlspace: Wood Rot on Structural Components

Wood rot was observed on exposed beams/joists under the home. Further evaluation by a licensed structural engineer is recommended.

Recommendation: Contact a qualified structural engineer.

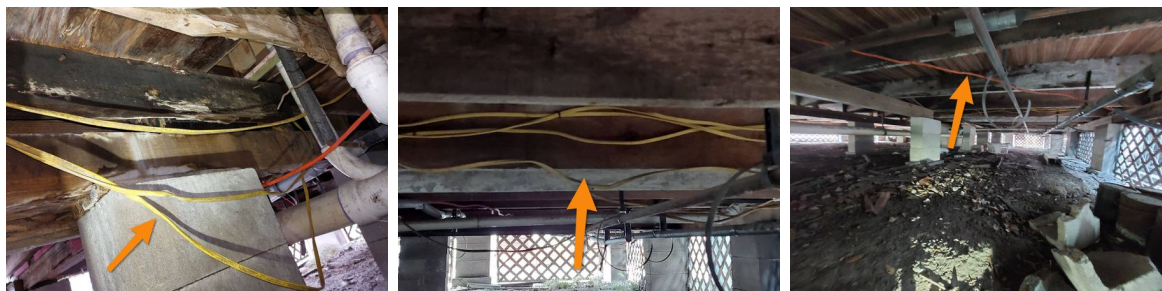
6: Loose Wires.

There were loose wires at the time of the inspection. Evaluate and remedy as needed.

Recommendation: Contact a qualified professional.

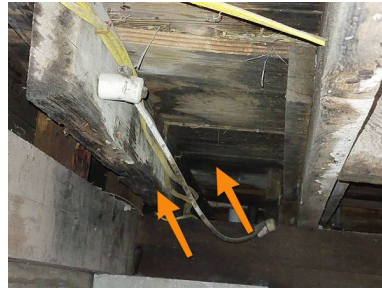
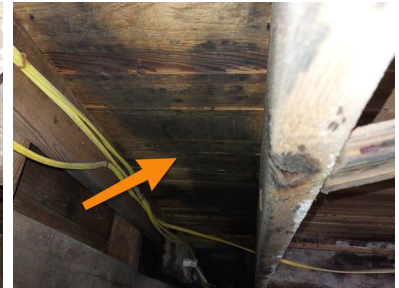
7: Evidence of Prior Moisture.

Evidence of previous moisture was observed at the time of the inspection. Evaluate and remedy as needed.

Recommendation: Contact a qualified professional.

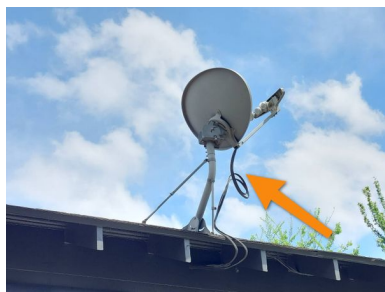
Equipment was mounted to the roof, including, but not limited to satellite dishes, solar panels and HVAC equipment. The inspector was unable to determine if the equipment was installed per manufacturer's specifications. Further evaluation is recommended.

Recommendation: Contact a qualified roofing professional.

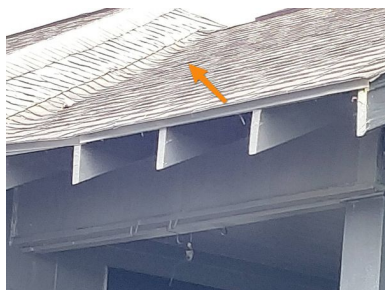
2: Popped up nails

Popped up nail heads were observed. Evaluation and remediation is recommended.

Recommendation: Contact a qualified professional.

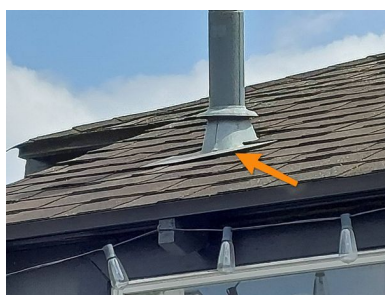
3: Flashing Deficiencies

Deficiencies with the flashings were present at the time of inspection. Evaluation and remediation is recommended.

Recommendation: Contact your builder.

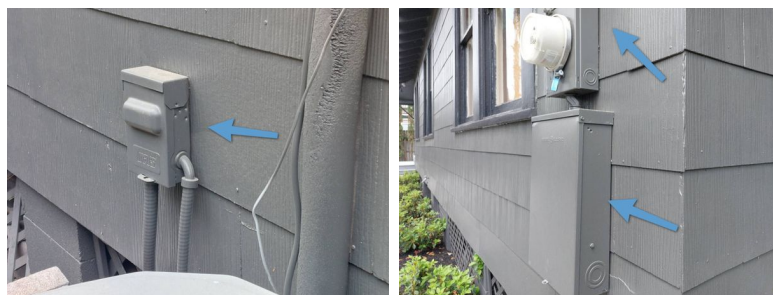
1: Exterior: Seal Wall Fixtures

Note: Modern building practices recommend sealing around components that are mounted on or pass through the exterior wall to limit moisture intrusion.

Recommendation: Recommended DIY Project

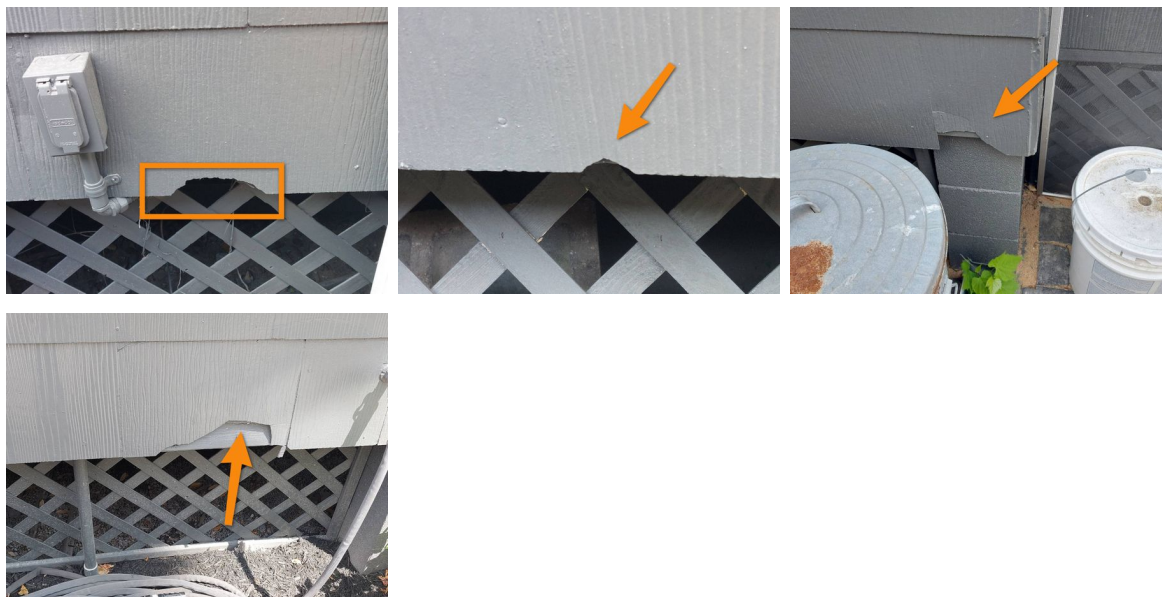
2: Exterior- Siding: Siding Damage

There was damage to exterior siding. Evaluation and remediation is recommended.

Recommendation: Contact a qualified professional.

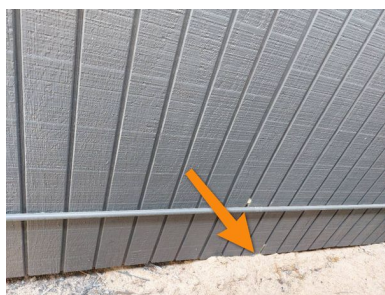
3: Exterior: Siding or brick is too close to grade

Siding should be a minimum of 6 inches above finished grade. Brick and stone should be a minimum of 4" above grade. Evaluation and remediation is recommended.

Recommendation: Contact a qualified professional.

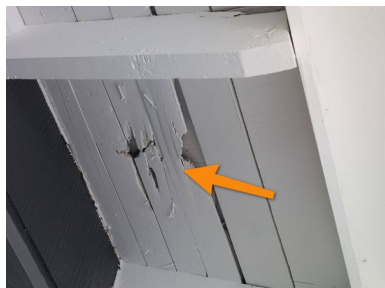
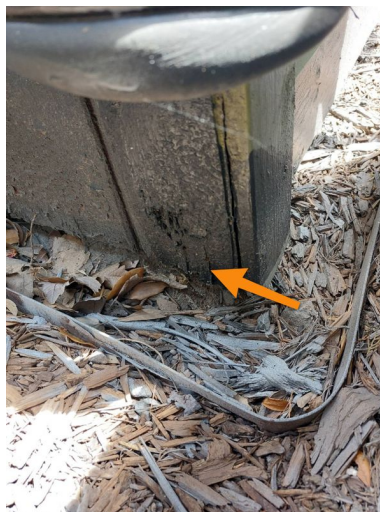
4: Exterior: Evidence of Wood Rot

Wood rot/deterioration was observed. Evaluate and remedy as needed.

Recommendation: Contact a qualified professional.

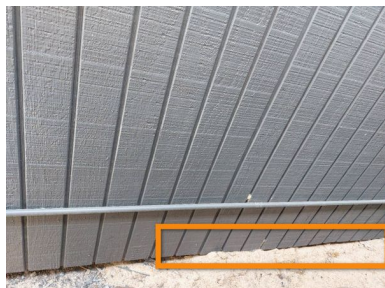
6: Exterior: High Soil

A high soil level was observed. The foundation should have at least 4 inches of exposure. Evaluation and remediation is recommended.

Recommendation: Contact a qualified landscaping contractor

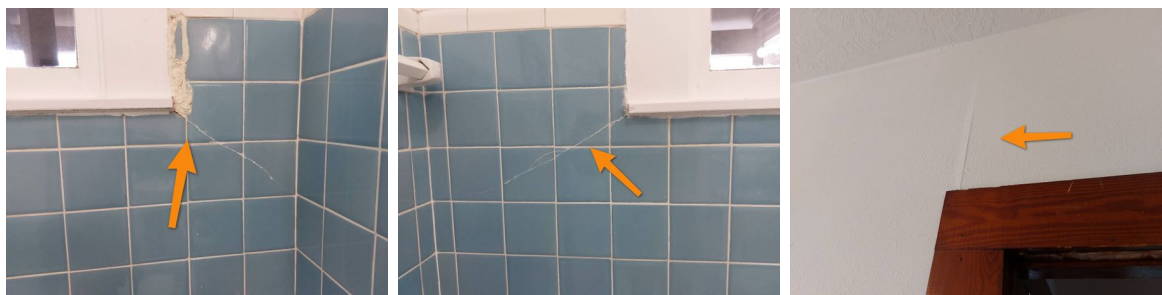
7: Interior: Stress Cracks in Drywall

Stress cracks are observed in the interior drywall. This is consistent with structural movement of the home. Evaluation and remediation is recommended.

Recommendation: Contact a qualified professional.

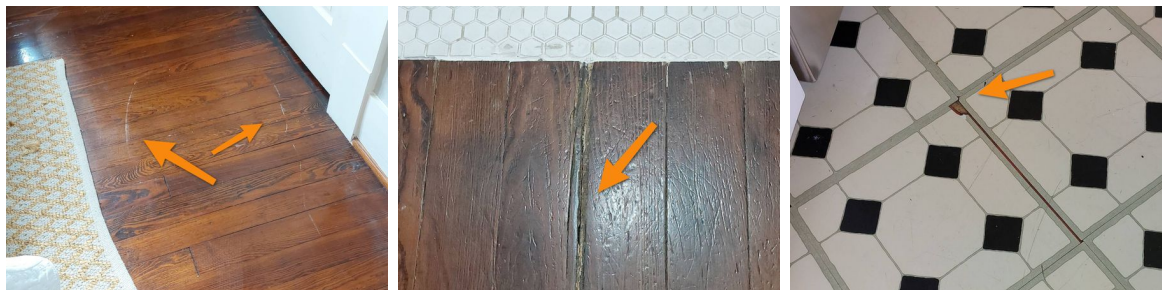
1: Flooring: Damaged

Flooring had damage visible at the time of the inspection. Evaluation by a qualified flooring contractor is recommended.

Recommendation: Contact a qualified professional.

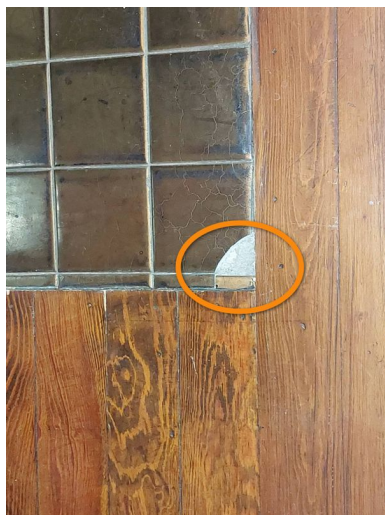
2: Flooring: Tiles Cracked/Chipped

Floor tiles were cracked or chipped. Evaluation and remediation is recommended.

Recommendation: Contact a qualified professional.

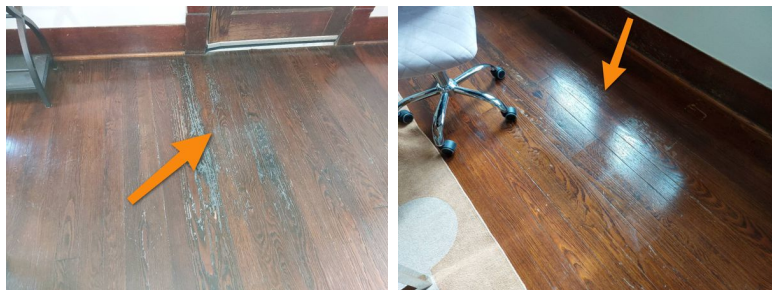
4: Flooring: Squeaky Subflooring

Squeaky subflooring is not uncommon and is usually caused by wood subflooring that isn't properly attached to the joists. These can generally be repaired by a flooring contractor. Evaluation and remediation is recommended.

Recommendation: Contact a qualified flooring contractor

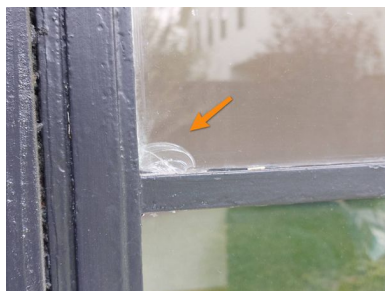
2: Cracked/Broken Glass Panes

Cracked or broken glass panes were present. Evaluation and remediation is recommended.

Recommendation: Contact a qualified window repair/installation contractor.

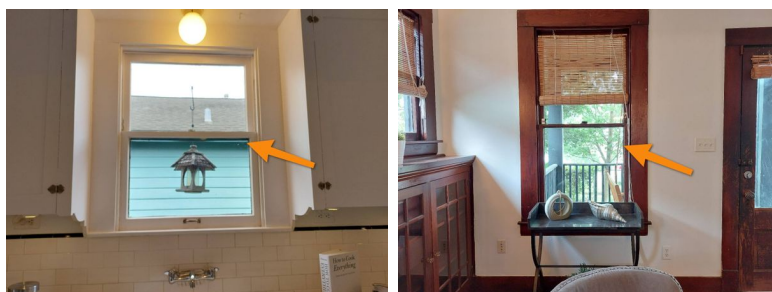
3: Difficult Operation

Windows were not operating properly. Evaluation and remediation by a window professional is recommended.

Recommendation: Contact a qualified window repair/installation contractor.

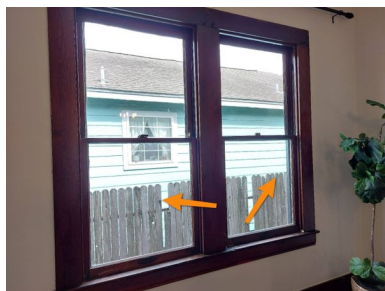
5: Painted Shut

One or more windows were painted shut. Restoration of window functionality is recommended.

Recommendation: Contact a qualified window repair/installation contractor.

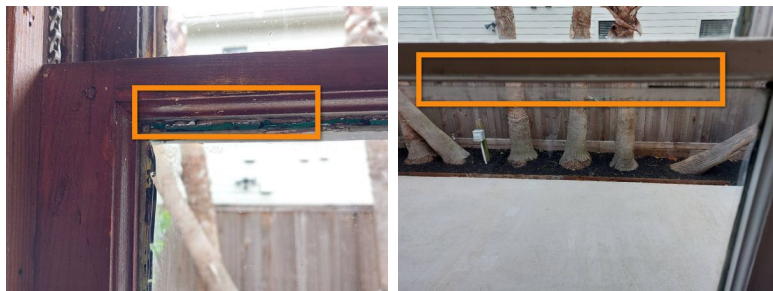
6: Caulking: Missing/Damaged

Caulking around window frames was missing or deteriorated. Caulking around window frames is an important barrier to moisture and air intrusion. Most exterior sealants have a lifespan of 5 to 8 years and should be regularly maintained with that lifespan in mind. Evaluate and remedy as needed.

Recommendation: Contact a qualified professional.

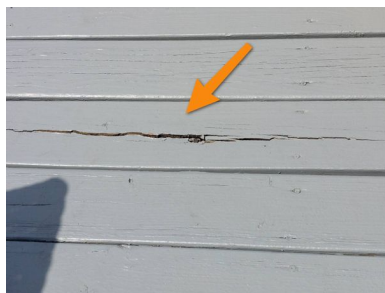
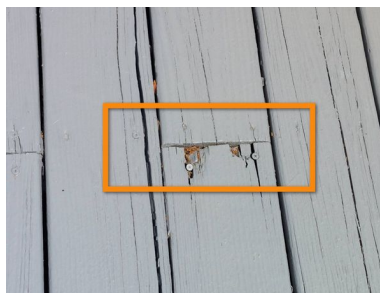
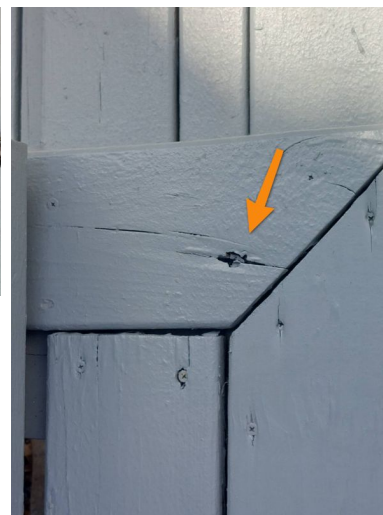
One or more deck boards are rotted. Evaluation and/or repair by a qualified deck contractor is recommended.

Recommendation: Contact a qualified deck contractor.

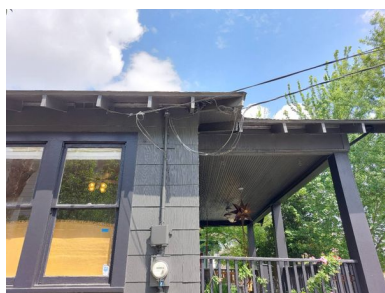
Service size: 100 Amps

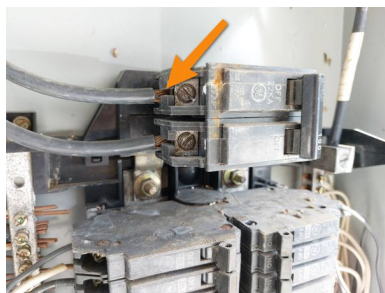
Antioxidant paste was not present at service conductor connection to main (aluminum) lugs in the distribution panel. Paste is recommended to prevent oxidation. Evaluation and remediation is recommended.

Recommendation: Contact a qualified professional.

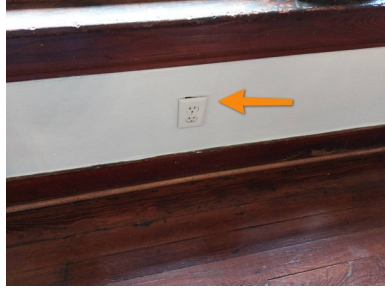
1: Receptacles: Loose

One or more receptacles were loose at the time of inspection. Evaluate and remedy as needed.

Recommendation: Contact a qualified professional.

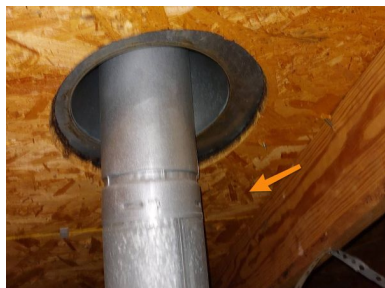
1: Venting system: Missing/loose ceiling collar

The collar was missing/loose where the flue passes through the ceiling. Evaluate and remedy as needed.

Recommendation: Contact a qualified professional.

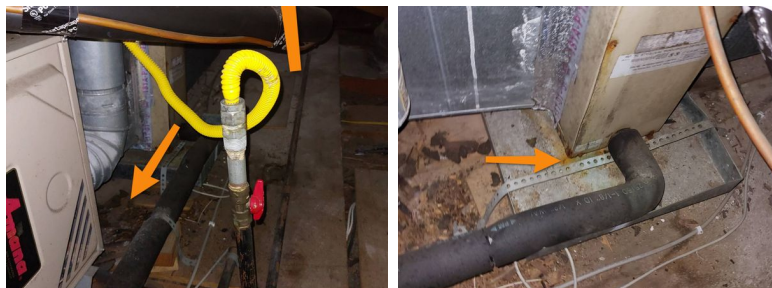
1: Condensate system: Rusted Emergency pan

The emergency overflow pan is rusted. Further evaluation by an HVAC professional is recommended.

Recommendation: Contact a qualified HVAC professional.

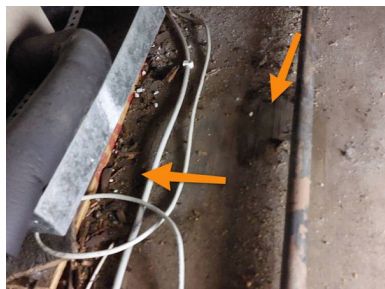
2: Condensate System: Discoloration Under or Around HVAC Equipment

Discoloration under or around HVAC equipment indicates prior moisture contact. Cause was not determined. Evaluation and remediation is recommended.

Recommendation: Contact a qualified HVAC professional.

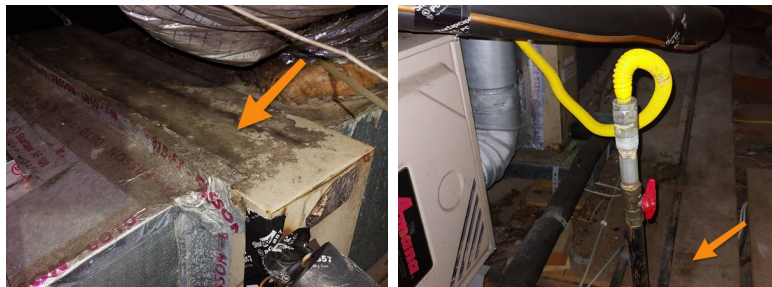
Signs of microbial growth were observed indicating prior moisture contact or condensation issues. Evaluation and remediation is recommended.

Recommendation: Contact a qualified HVAC professional.

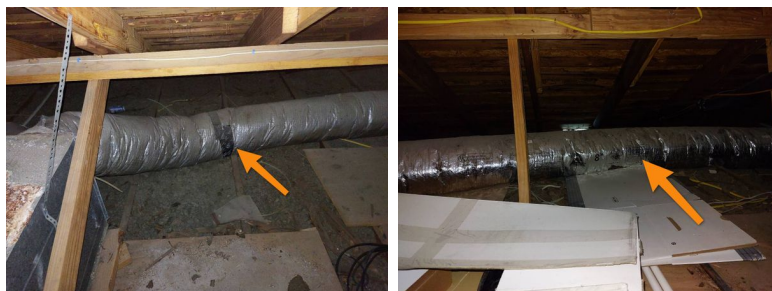
Sections of ducting were resting on the attic floor. Evaluate and remedy as needed.

Recommendation: Contact a qualified HVAC professional.

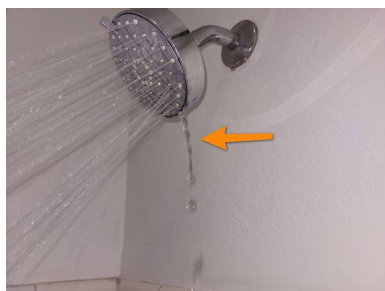
1: Shower: Showerhead leaks/sprays

Water leaked/sprayed around the showerhead during operation. Evaluation and remediation is recommended.

Recommendation: Contact a qualified plumbing contractor.

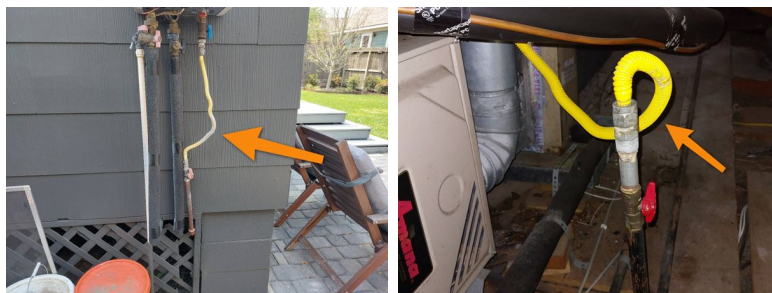
1: Missing Sediment Trap (Drip Leg)

Sediment traps are installed to help prevent sediment in the gas piping from getting into the gas valve or burner area of an appliance and causing problems. Evaluation and remediation is recommended.

Recommendation: Contact a qualified professional.

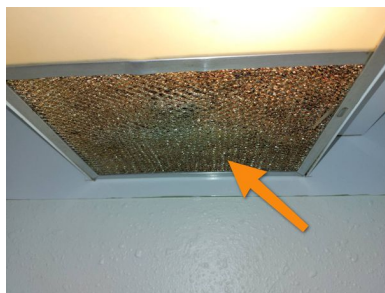
Kitchen exhaust filter had excessive grease build-up. Clean and/or replace as needed.

Recommendation: Contact a qualified professional.

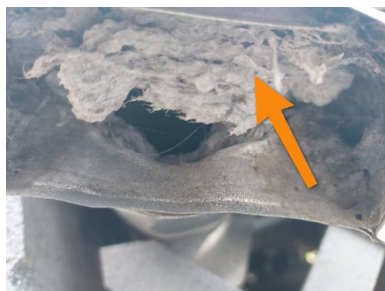
The dryer vent was be clogged. For safety purposes, dryer venting should be free of obstruction. Lint is a fire hazard. Evaluation and remediation is recommended.

Recommendation: Contact a qualified professional.
