PROPERTY INSPECTION REPORT

Concerning: 407 W 26th St C, Houston, TX 77008
(Address or Other Identification of Inspected Property)

By: Marcinkowska - TREC Professional Inspector License #23833 01/13/2020 8:00 am
(Name and License Number of Inspector) (Date)

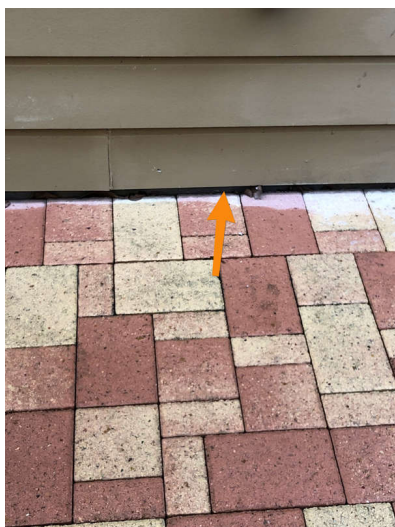
1: Foundation needs to be exposed around perimeter of home

The foundation wall should be exposed at least 4 inches this allows observation of the foundation wall for cracks and pest intrusions.

Recommendation: Contact a qualified grading contractor.

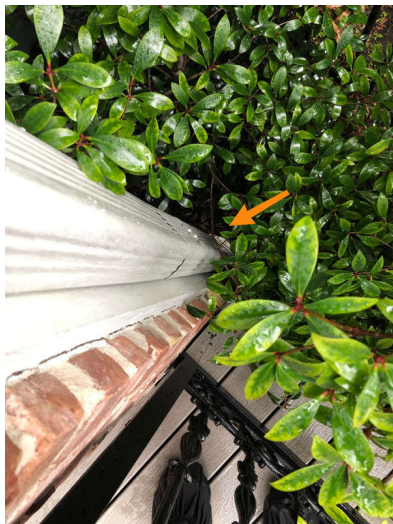
The downspout drain termination should direct water away from the home. This cannot be confirmed without being able to see the termination.

Recommendation: Contact a qualified gutter contractor

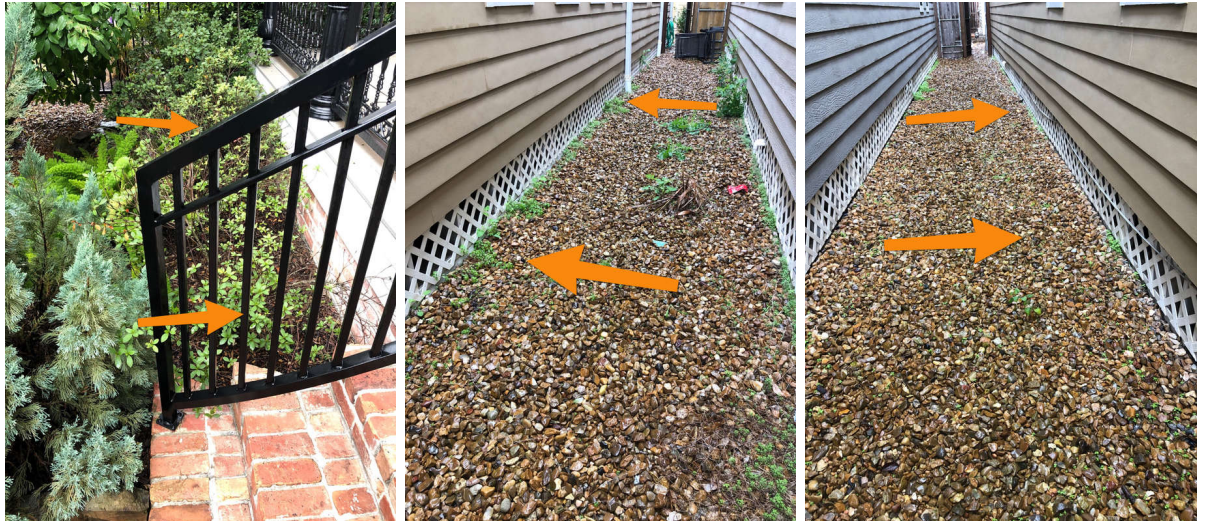
2: Negative Grading

Grading is sloping towards the home in some areas. This could lead to water intrusion and foundation issues. Recommend qualified landscaper or foundation contractor regrade so water flows away from home.

Recommendation: Contact a qualified landscaping contractor

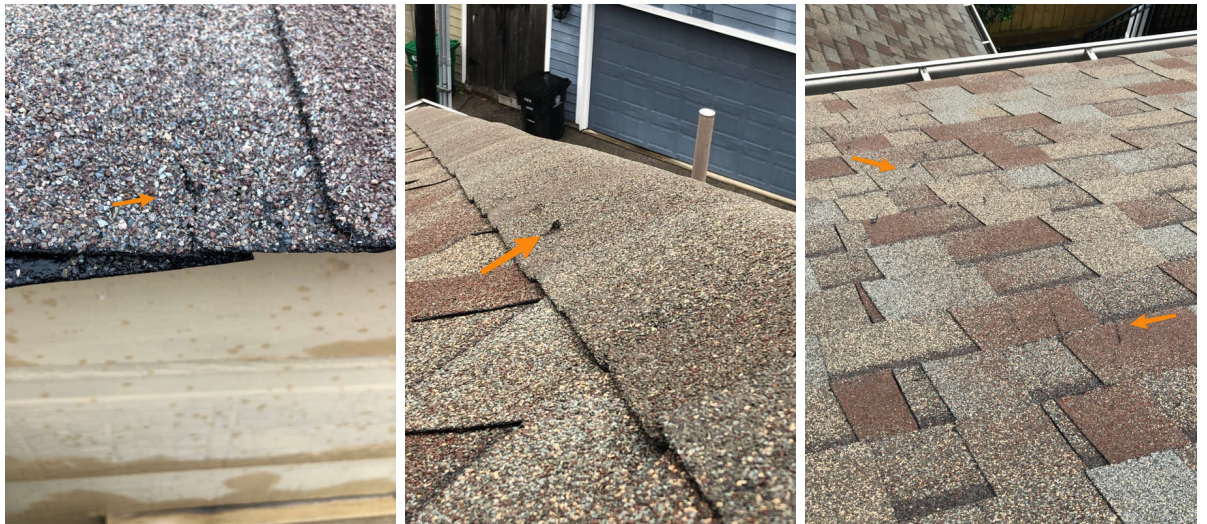
1: Damaged Coverings

Roof coverings exhibited general damage that could affect performance. Recommend a qualified roofer evaluate and repair.

Recommendation: Contact a qualified roofing professional.

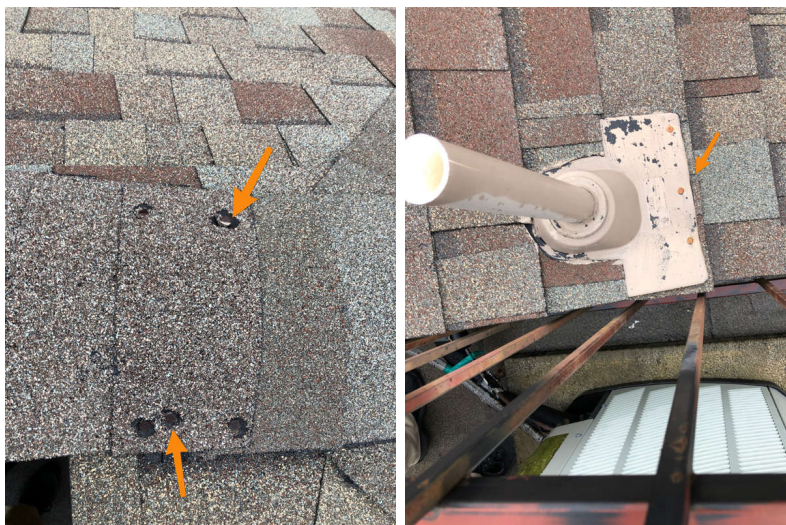
2: Exposed Nails

Under-driven or exposed nails were found in one or more roof coverings. Recommend a qualified roofer evaluate and correct. Unsealed nails will rust and create gaps where water can gain access to components

that come become water damaged.

Recommendation: Contact a qualified roofing professional.

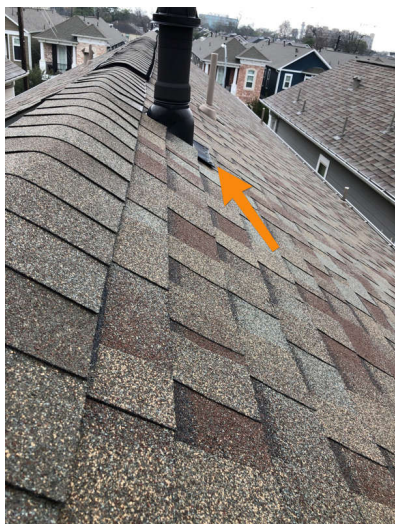
3: Flashings has gaps

Wind driven rain can make its way into these gaps, allowing water to damage to the underlying components leading to expensive repairs. It also allow animals and insects access to the interior space of the home.

Recommendation: Contact a qualified roofing professional.

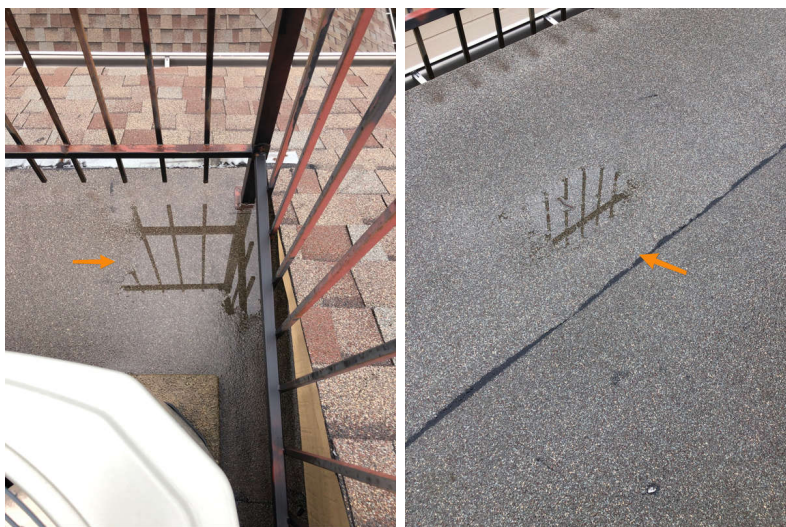
Observed ponding in one or more areas of roof. Ponding can lead to accelerated erosion and deterioration. Recommend a qualified roofing contractor evaluate and repair.

Recommendation: Contact a qualified roofing professional.

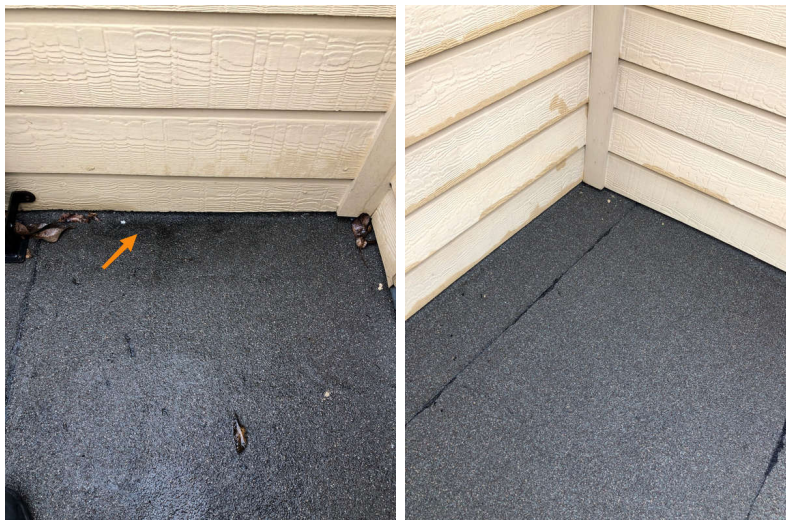
6: Siding is too close to roofing material

Siding should be 2 inches from the surface of the roof to avoid water penetration and deterioration of the siding material.

Recommendation: Contact a qualified professional.

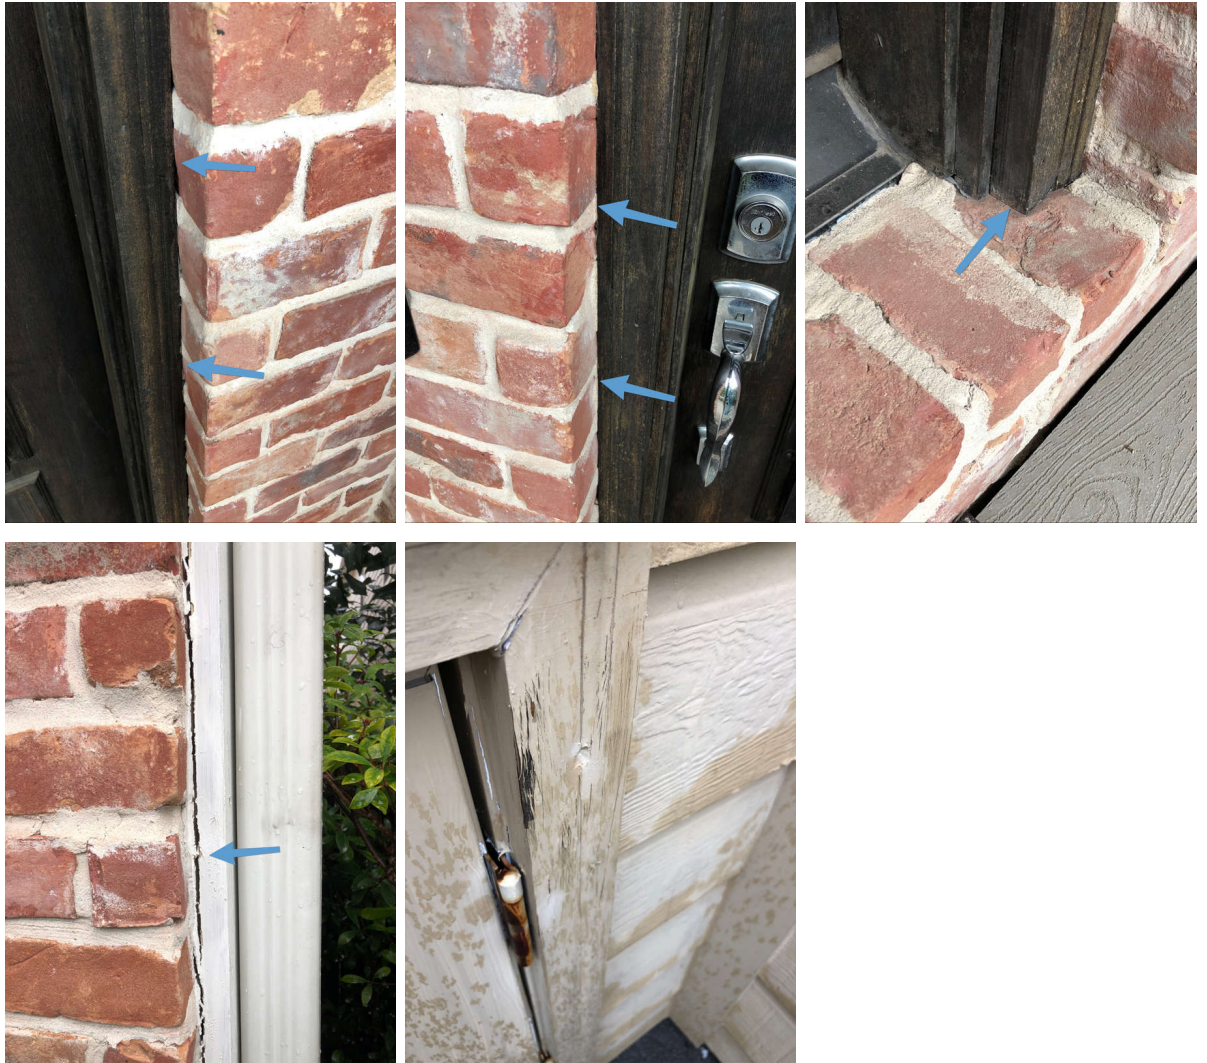
1: Caulking/sealant is deteriorated or missing.

Gaps in the caulking/sealant let insects and water penetrate the structure. When caulking starts to separate or crack it is time to replace it.

Recommendation: Contact a handyman or DIY project

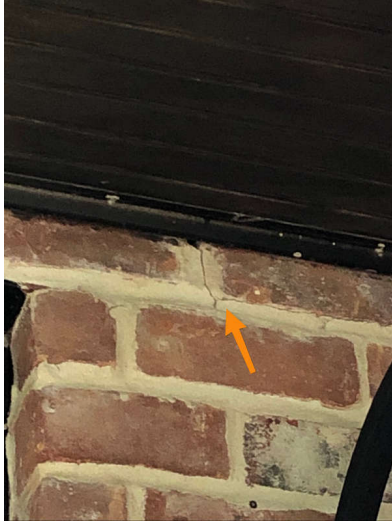
3: Evidence of Water Intrusion

Wall structure showed signs of water intrusion, which could lead to more serious structural damage. Recommend a qualified contractor identify source of moisture and remedy.

Recommendation: Contact a qualified structural engineer.

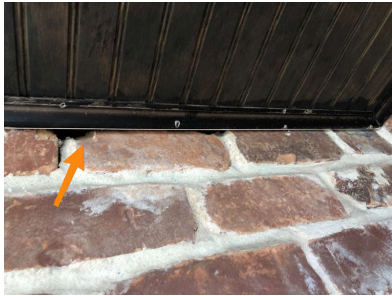
Gaps in the siding allow water and insects to penetrate the structure. All gaps should be sealed to prevent damage from interior structural components.

Recommendation: Contact a qualified siding specialist.

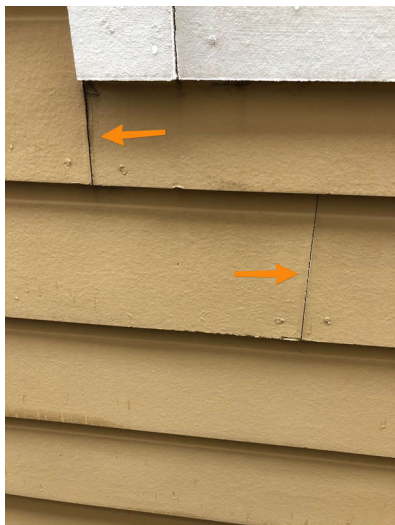
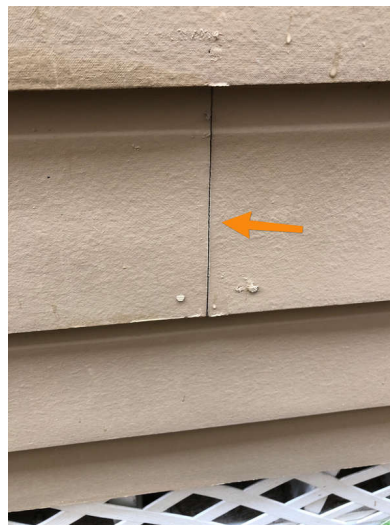
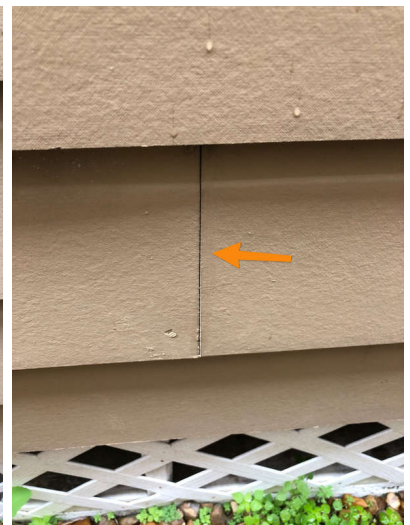
5: Joints are separating in siding

Siding should be sealed at all joints. Reason for separation should be determined in order to assess if repairs are needed to structure.

Recommendation: Contact a qualified professional.

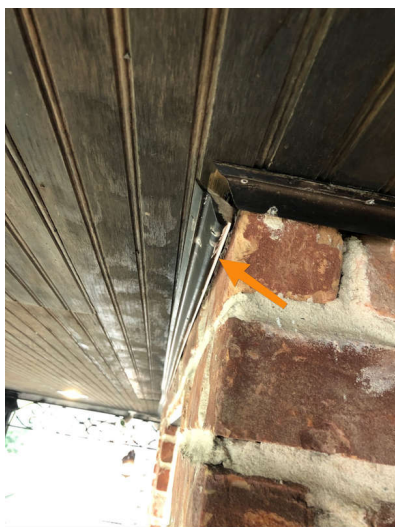
7: Loose/missing trim or siding

Loose/missing trim and siding will not properly protect the building from moisture. Reinstall for proper protection.

Recommendation: Contact a qualified professional.

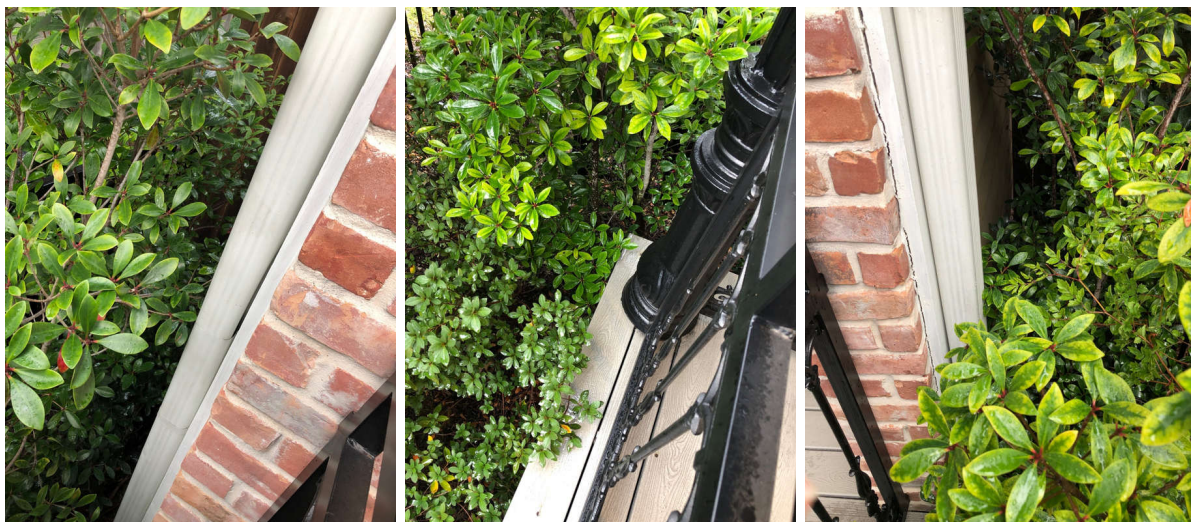
8: Plants in contact with home

Plants hold moisture against the siding causing deterioration to accelerate.

Recommendation: Contact a handyman or DIY project

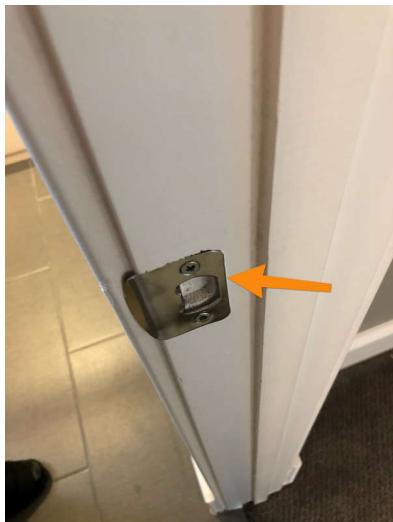
Strike plate needs an adjustment.

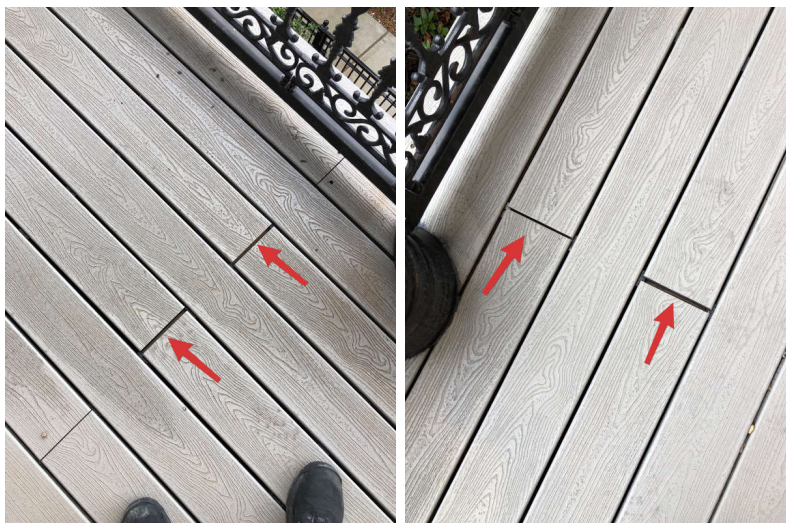
Fasteners are missing.

Recommendation: Contact a qualified deck contractor.

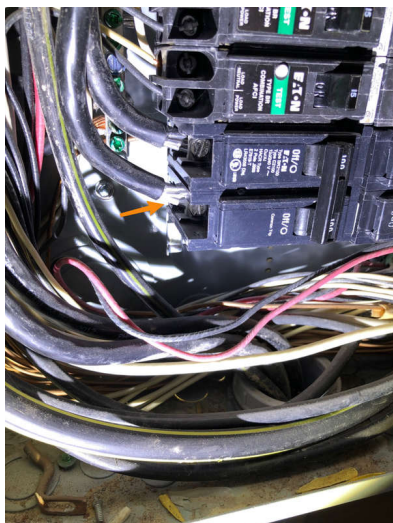
2: Anti-oxidant paste missing from service conductors

Anti-oxidant paste keeps the aluminum service conductors from oxidizing and moving in their terminals, which is known to cause arcing.

Recommendation: Contact a qualified electrical contractor.

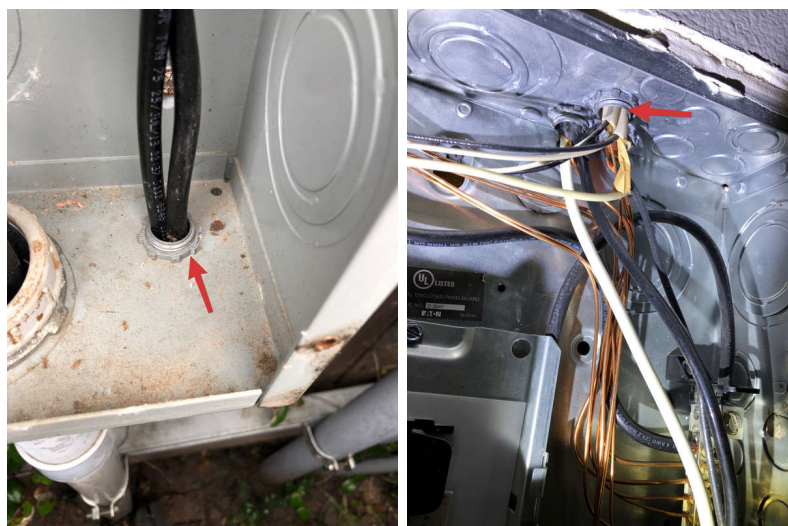
Bushings are installed to protect wires from abrasion when entering the panel box. Without them, the insulation around the wiring can be cut by the sharp metal in the entrance to the panel. This could cause arcing leading to electrical shock or fire.

Recommendation: Contact a qualified professional.

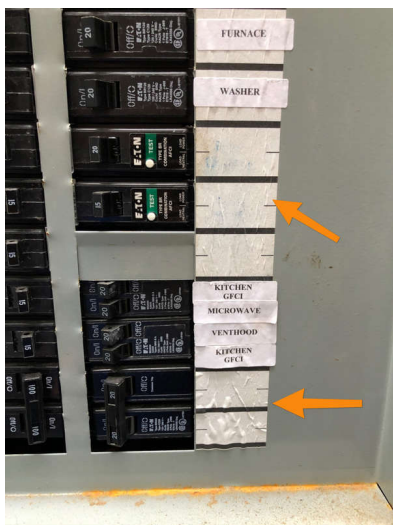
6: Panel Missing Labels

Electrical panel does not have labels. Recommend a qualified electrician test and properly label all switches. Without proper labeling, the breakers cannot be identified for usage.

Recommendation: Contact a qualified electrical contractor.

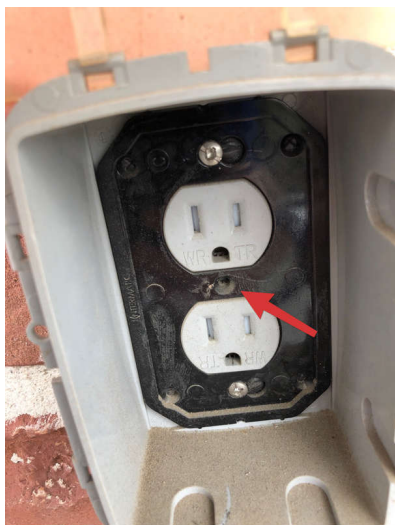
One or more receptacles have a damaged cover plate. Recommend replacement.

Recommendation: Contact a qualified electrical contractor.

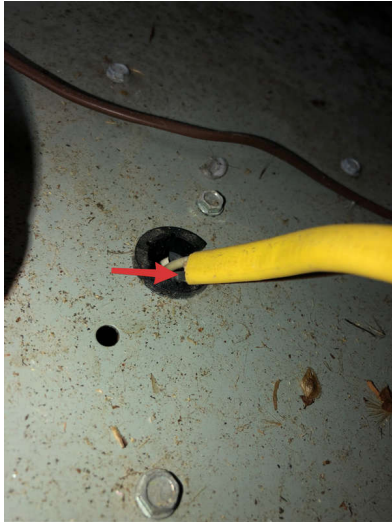
Insulation on wiring is designed to protect people from getting shocked when handling the wire. The insulation also protects the wire from damaged.

Recommendation: Contact a qualified electrical contractor.

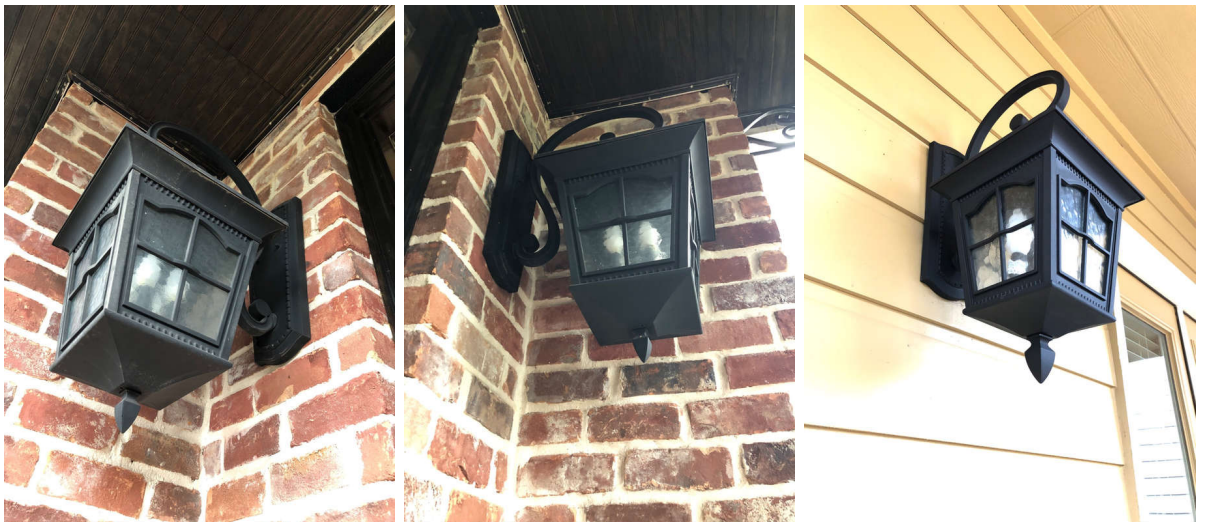
4: Fixture not secured to building

Fixtures need to be properly secured to building to protect from falling and seal against moisture and insect intrusion.

Recommendation: Contact a qualified professional.

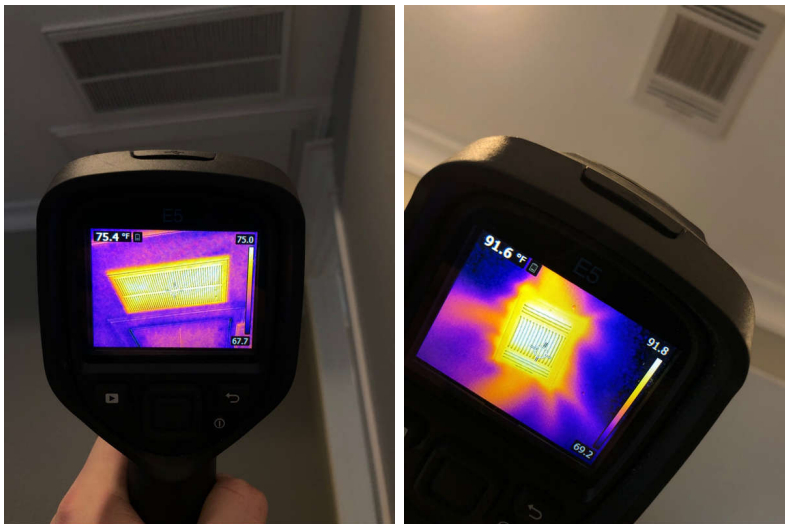
Furnaces should get 30-40 degree differentials from return register to the supply registers. Have a HVAC professional inspect and repair the system as needed.

Recommendation: Contact a qualified heating and cooling contractor

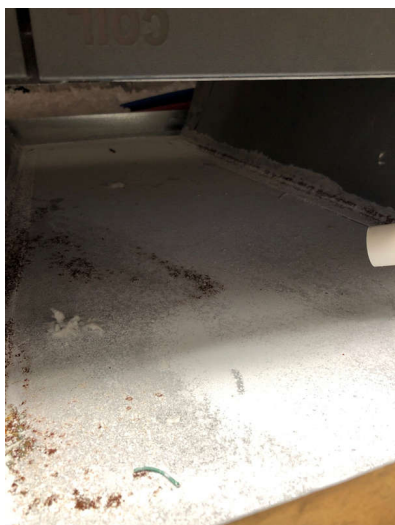
3: Pan is not angled towards drain

The pan should be angled towards the drain so that it will drain out and condensation will not build up or spill over the pan.

Recommendation: Contact a qualified professional.

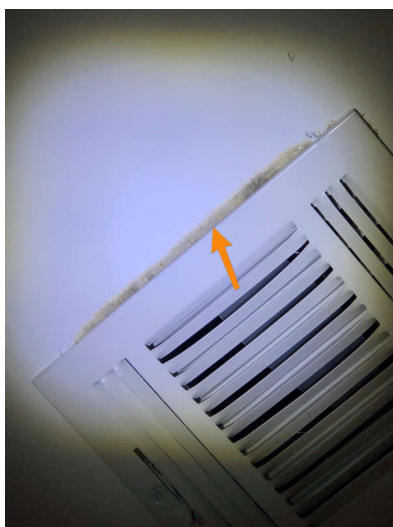
2: Register is rusted

Resting on registers is normally a product of previous condensation on the register. Source of condensation should be determined and repaired.

Recommendation: Contact a qualified professional.

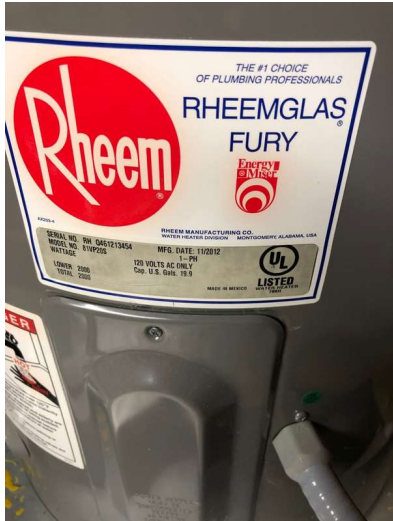
1: Corrosion on water line, indicating possible water leak

Corrosion on the water line could mean a leak. Monitor this for moisture, and repair as needed.
