Inspection Report

Property Address:
19711 Arroyo Colorado Court
Cypress TX 77433

HG HOME INSPECTION

PROPERTY INSPECTION REPORT

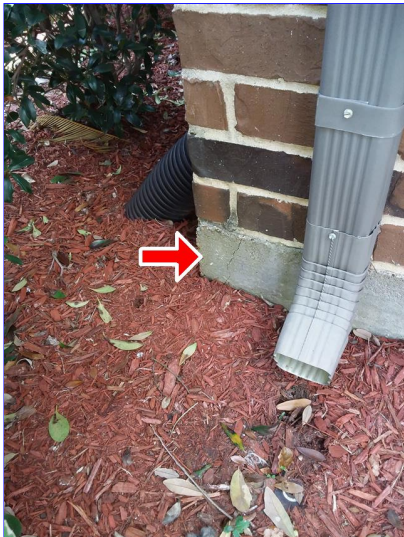
A. Item 1(Picture) front

(4) The foundation wall appears to be showing signs of flaking and deterioration. I recommend having a qualified person make repairs as needed.

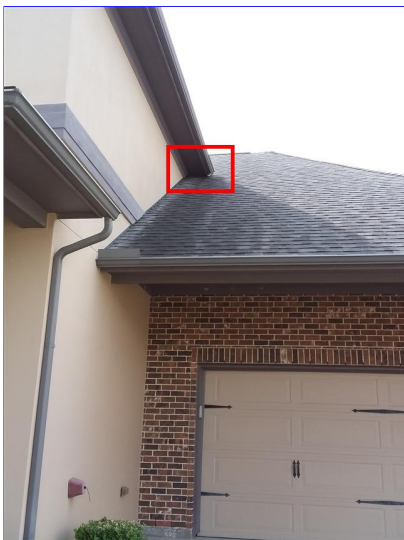
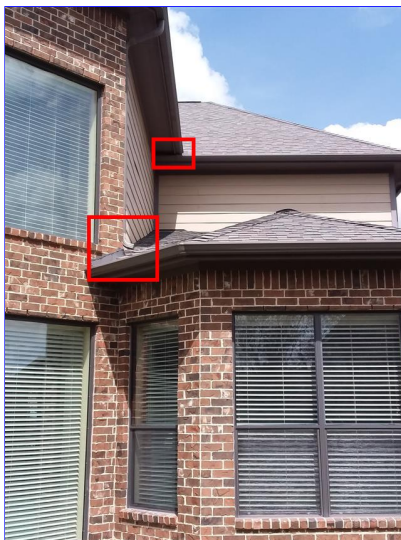
B. Item 1(Picture) front

(1) Downspouts discharges onto roofing surface in areas of the roof. Deterioration could occur if not corrected. I recommend having a qualified contractor make repairs as needed.

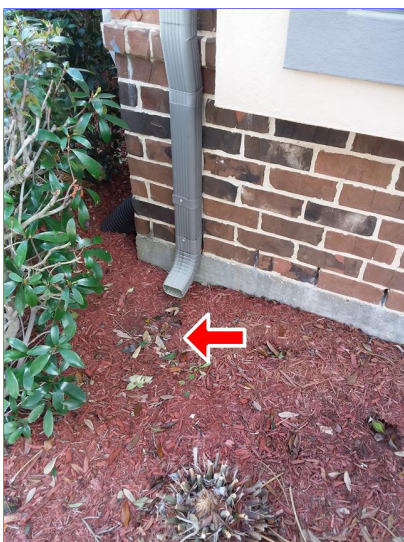
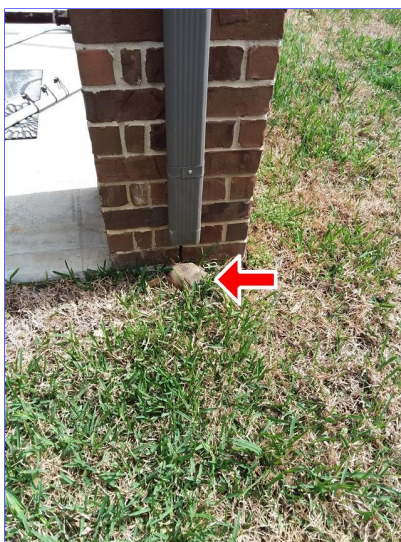
B. Item 3(Picture) front

(2) The gutter downspout(s) are missing deflector(s) at the exterior. Erosion can continue or become worse if not corrected. A qualified contractor should inspect and replace as needed.

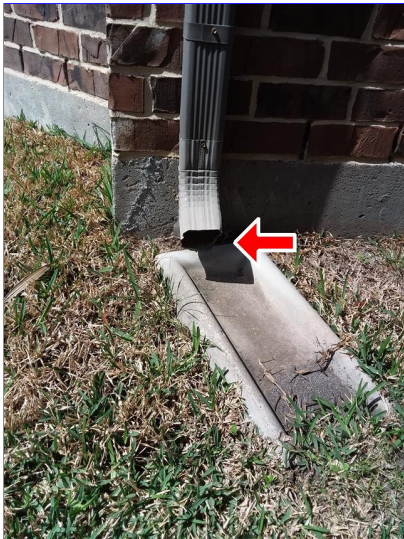
B. Item 5(Picture) rear left

(3) The gutter is damaged at the exterior. Gutters that drain poorly or clogged can lead to many costly problems such as deterioration of fascia, soffit or roof edge. It can also cause gutters to pull loose and lead to possible water intrusion. A qualified person should repair or replace as needed.

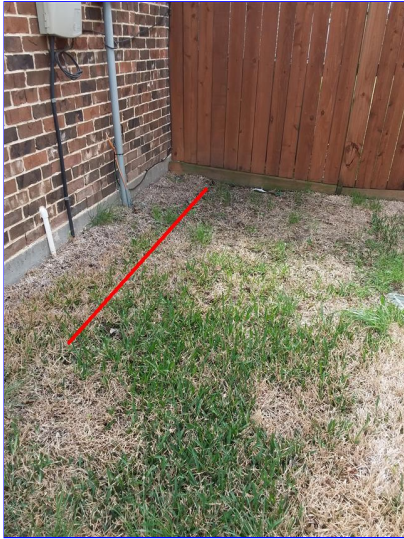
B. Item 9(Picture) right

(4) There is a negative slope at the exterior areas and can cause or contribute to water intrusion or deterioration. I recommend correcting landscape to drain water away from home.

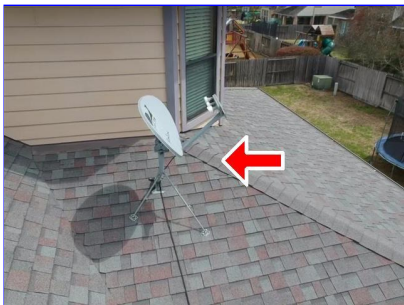
C. Item 1(Picture) rear right

not considered to be today's standard. I recommend having a qualified person remove and patch roofing as needed. (The area will need periodic maintenance)

Re-inspected 04/19/2021 **The repairs do NOT appear to be adequate. The repair is either incomplete or has not been done according to standard workmanlike practice. It is recommended after a proper repair is performed that you obtain a copy of the repair contract from the seller(s). Our company does not guarantee repairs from contractors. We only re-inspect to determine whether or not repairs were performed.**

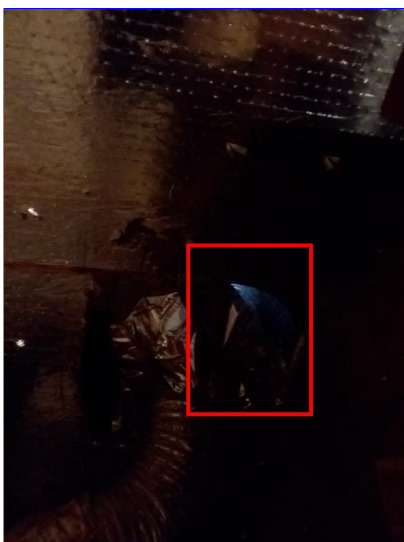
D. Item 4(Picture) front left

(4) Visible daylight in areas of attic space. This is not considered today's standard. Further deterioration can occur if not corrected. I recommend having a qualified contractor inspect and make repairs as needed.

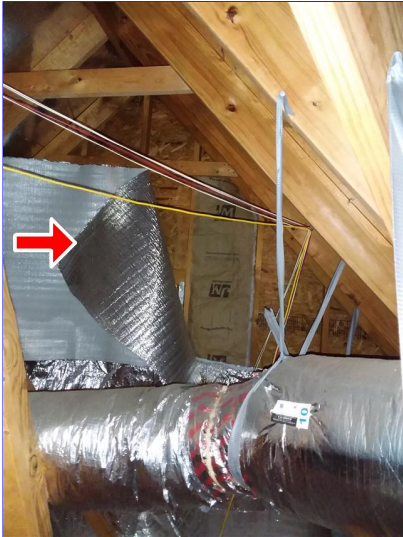
D. Item 5(Picture) front right

(5) The thermal barrier in the attic area is loose. This is a maintenance issue. I recommend repair as needed.

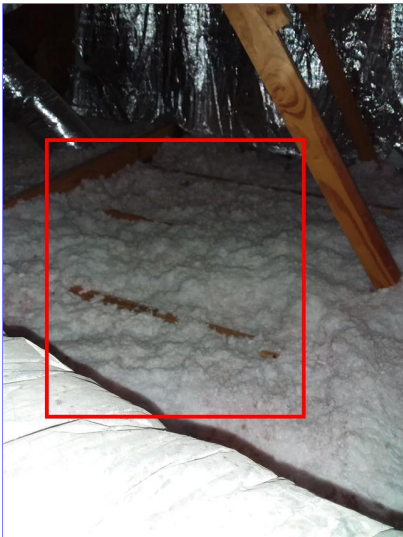
D. Item 6(Picture) front right

(6) The attic space has areas of thin insulation. This is causing energy loss and is not today's standard. I recommend having a qualified person evaluate and add insulation as needed.

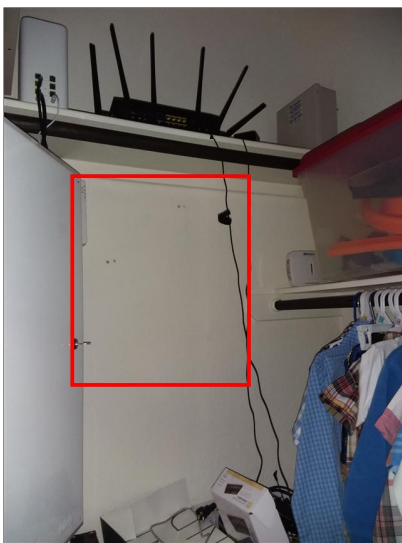
E. Item 2(Picture) closet rear left bedroom

(2) The drywall on the wall is damaged. While this damage is cosmetic, it needs to be repaired. A qualified person should repair or replace as needed.

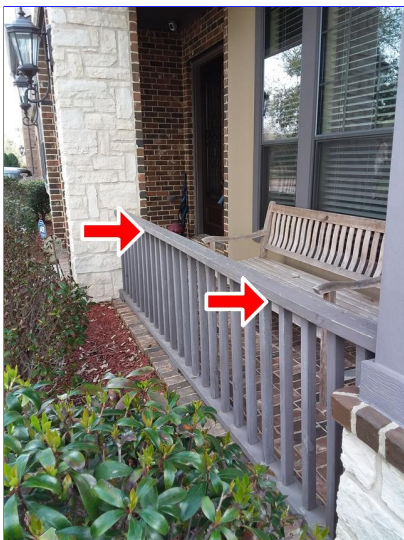
E. Item 3(Picture) front

(3) The paint is failing. I recommend prep and paint at the exterior.

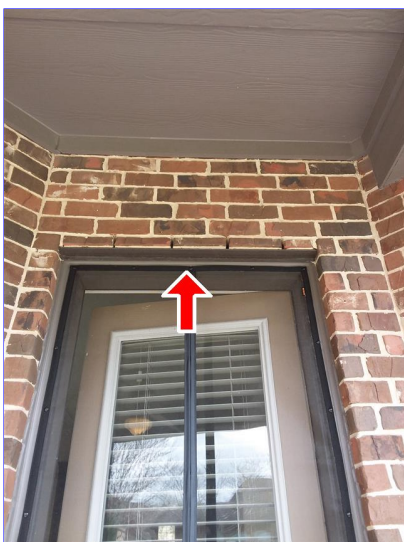
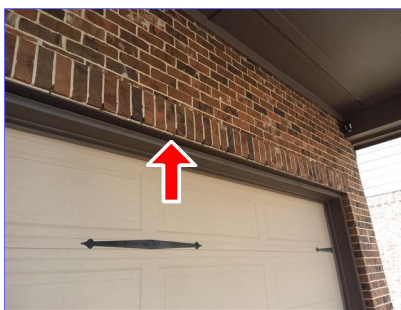
E. Item 4(Picture) rear

(4) Lintels above exterior doors are showing signs of deterioration. Further deterioration may occur if lintels are not primed and painted. A qualified person should repair as needed.

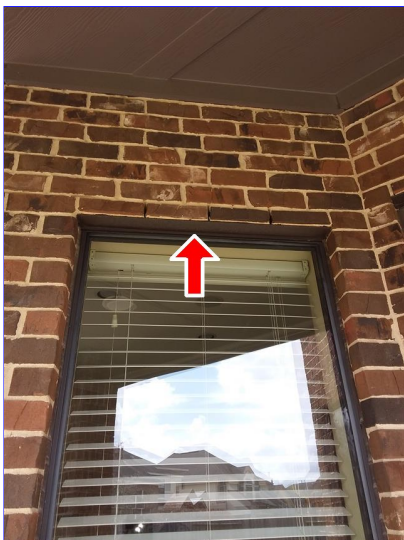
E. Item 6(Picture) rear

(5) Lintels above windows are showing signs of deterioration in areas. Further deterioration may occur if lintels are not primed and painted. A qualified person should repair as needed.

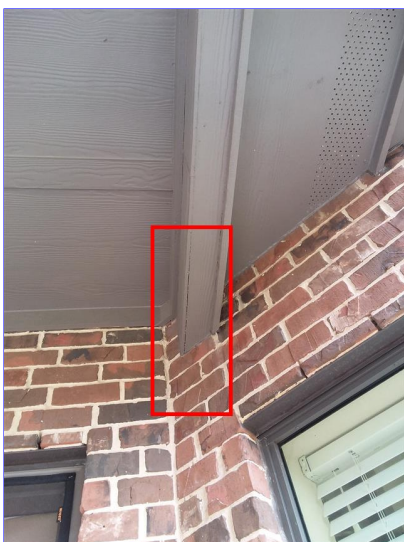
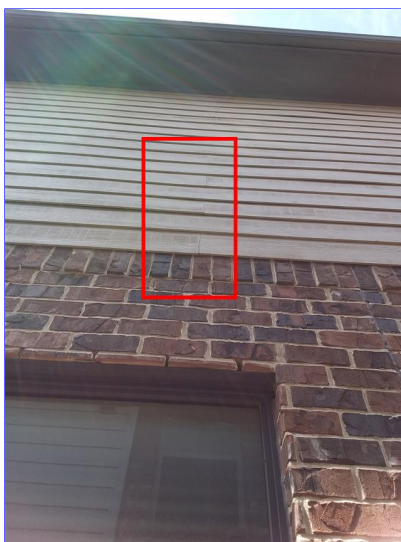
E. Item 7(Picture) rear

(6) The siding exterior has caulking that is weathered or missing and some lifted nails. Deterioration can eventually occur if not corrected. A qualified person should repair as needed.

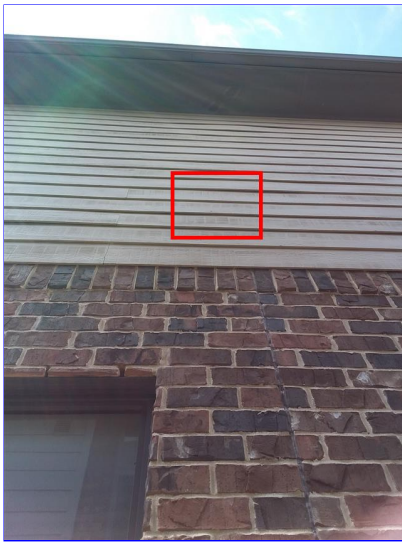
E. Item 10(Picture) left

(8) The cement board exterior is damaged. Deterioration can eventually occur if not corrected. A qualified person should repair or replace as needed.

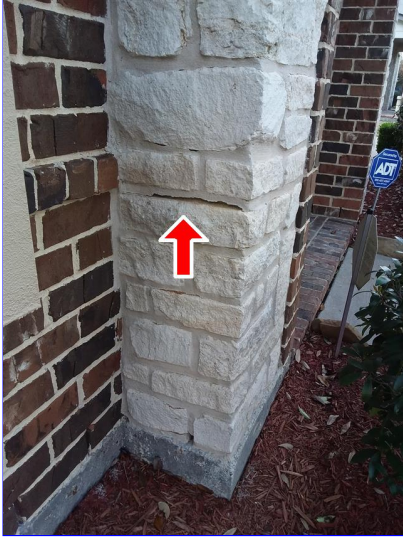
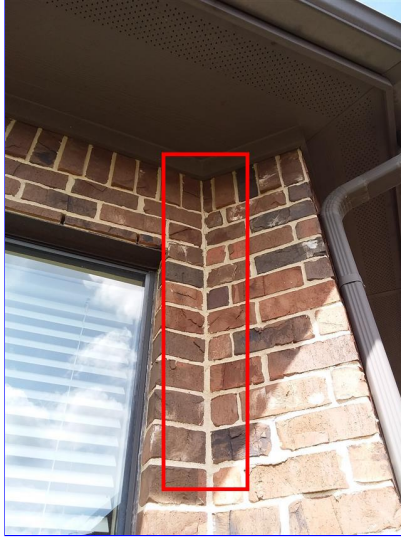
E. Item 11(Picture) entry left

(9) The brick mortar at the exterior has hairline cracks. Deterioration can eventually occur if not corrected. A qualified contractor should inspect and repair as needed.

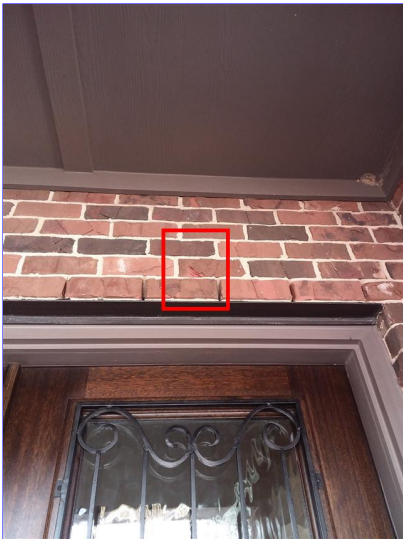
E. Item 13(Picture) entry

(10) The brick siding exterior is damaged. Further deterioration can occur if not corrected. A qualified person should repair or replace as needed.

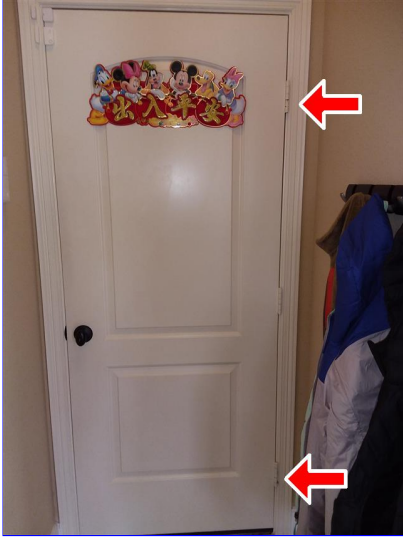
G. Item 1(Picture)

(1) The interior garage door does not have the required self closing hinge. This is not considered to be today's standard. I recommend having a qualified person make repairs as needed.

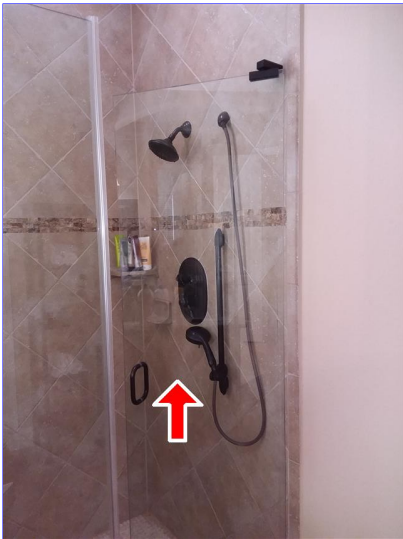
G. Item 2(Picture) primary bath

(2) The shower door swings in and not out in areas. This is considered unsafe and needs correcting. A qualified person should repair or replace as needed.

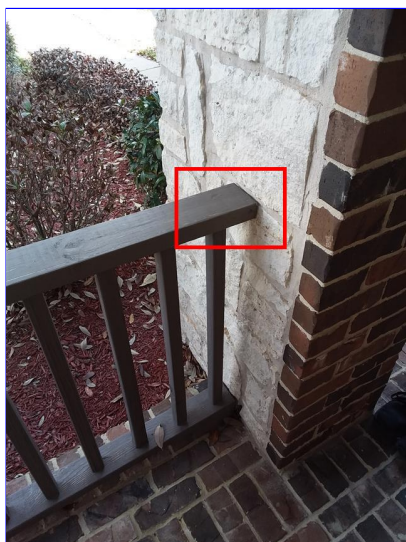
K. Item 1(Picture)

- (1) The weight load capabilities are not part of this inspection.
- (2) The hand/guard rail for the front porch is loose. This is a maintenance issue that can prevent further deterioration. A qualified contractor should repair or replace as needed.

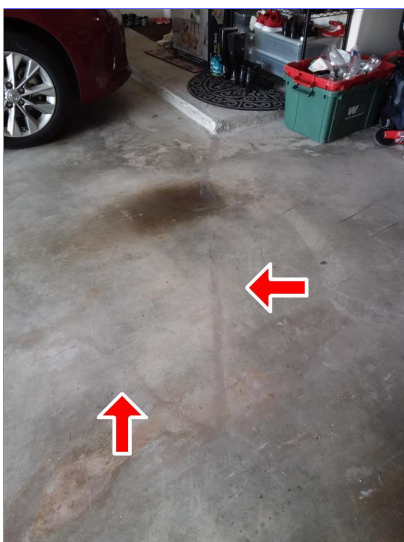
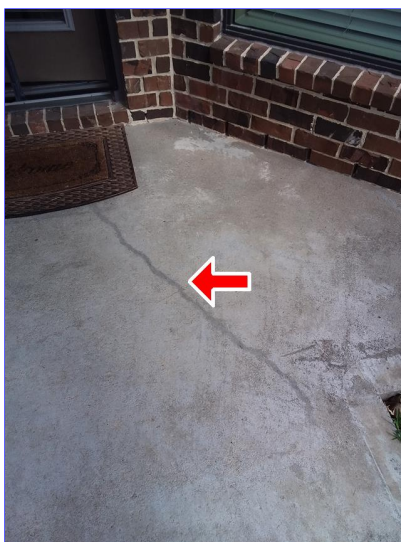
L. Item 3(Picture) garage

(2) The concrete walkway at the exterior areas has settlement cracks. Further deterioration can occur if not repaired. A qualified person should repair or replace as needed.

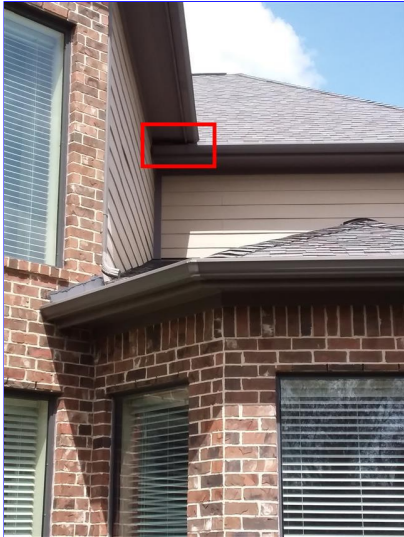
L. Item 5(Picture) rear left

(3) Bird nest observed. I recommend having a qualified person remove and correct condition as needed.

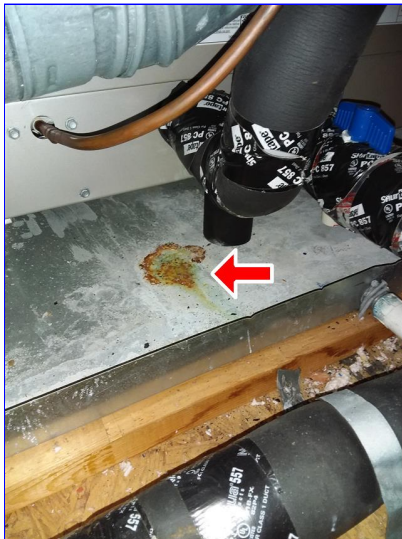
B. Item 5(Picture) rear unit

(3) The emergency overflow drain pan for the HVAC system is showing signs of deterioration. Further deterioration may occur if not corrected. I recommend having a qualified person make repairs as needed.

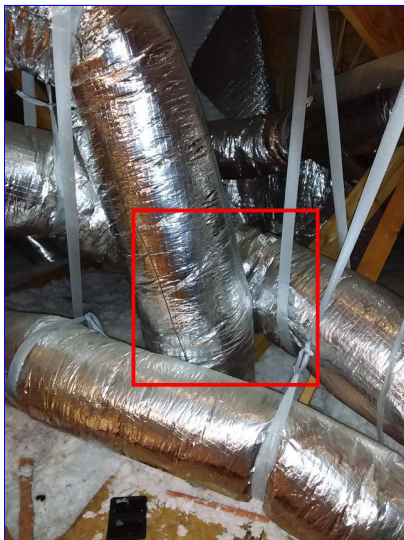
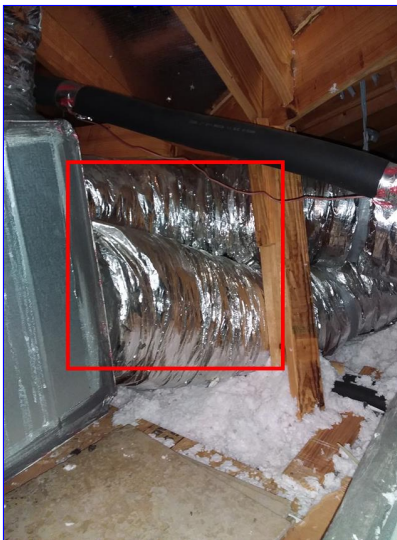
C. Item 1(Picture) front right

not corrected. I recommend having a qualified HVAC contractor further evaluate and make repairs as needed.

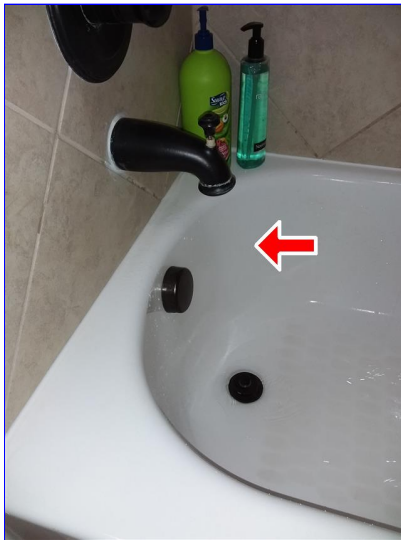
A. Item 1(Picture) shared bath

Tub spout leaks when shower is in use. This is not considered today's standard. I recommend having a qualified person make repairs as needed.

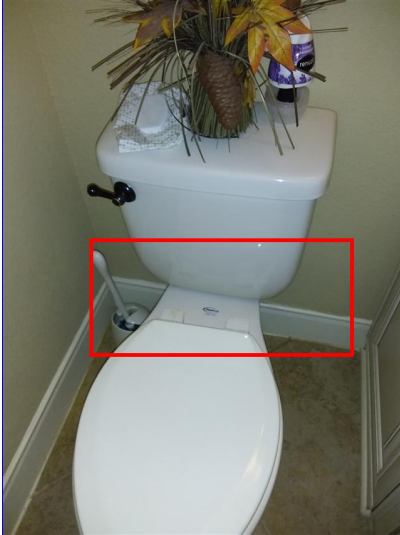
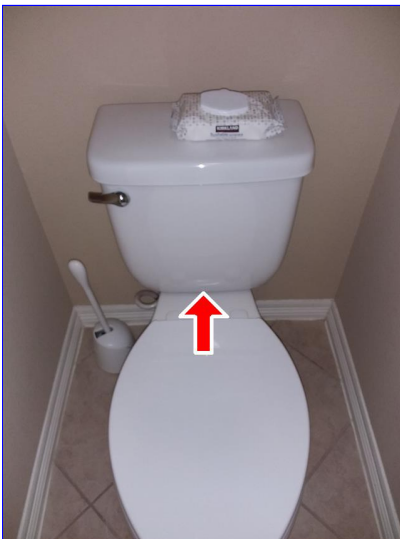
B. Item 1(Picture) half bath

(1) The toilet is loose at the tank mount at the bath areas. This is not considered up to today's standard. A qualified person should repair as necessary.

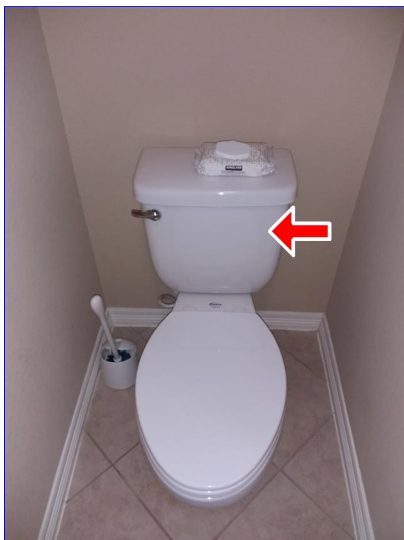
B. Item 4(Picture)

(2) The toilet at the shared bath takes an extremely long time for the tank to refill. I recommend further investigation by licensed plumber.

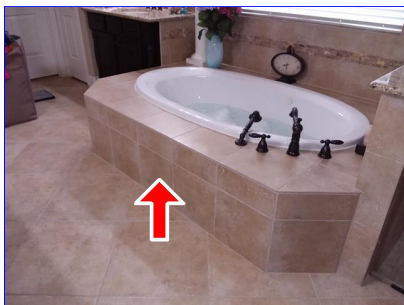
D. Item 2(Picture)

(2) The jetted tub is missing access panel. I recommend adding access panel.

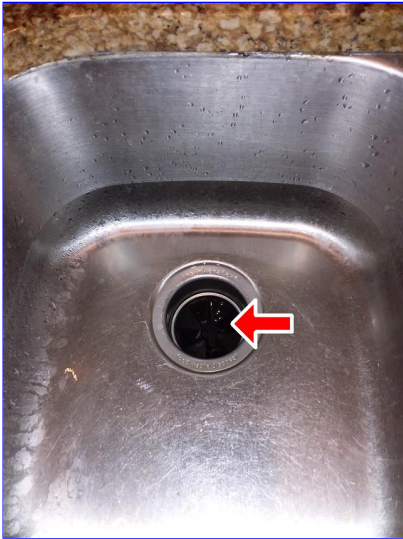
B. Item 1(Picture)

(2) The food disposer is rusted inside at the blades. I recommend repair as needed.

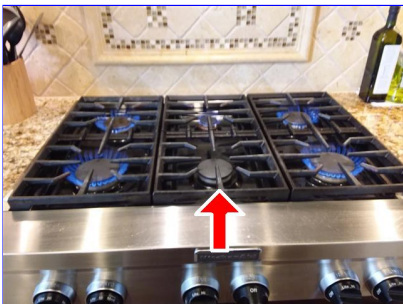
D. Item 1(Picture)

(2) The front burner (on cook top) did not work when tested. I recommend repair as needed.

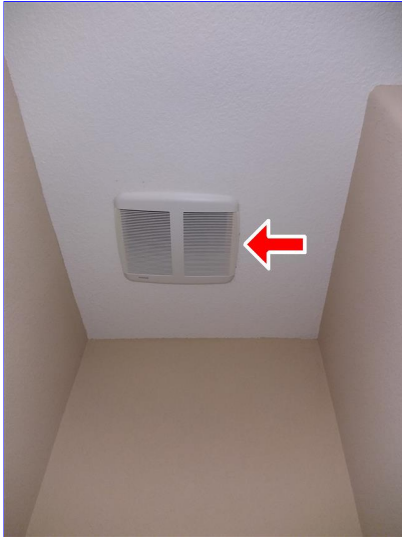
F. Item 1(Picture) shared bath

(2) The exhaust fan is noisy at the hall bath. This is for informational purpose to you. A qualified person should repair or replace as needed.

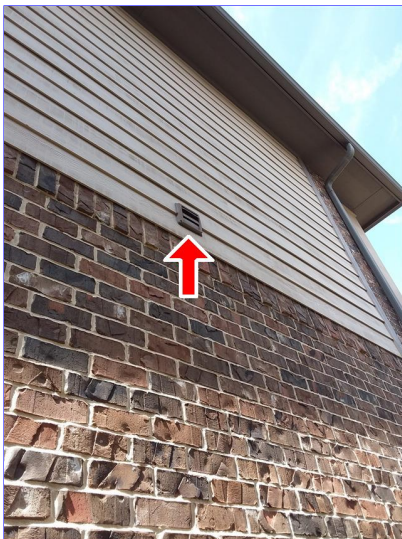
F. Item 2(Picture) left

(3) The exhaust fan has a damaged vent cover outside. This may allow insects or critters to enter home. A qualified person should repair or replace as needed.

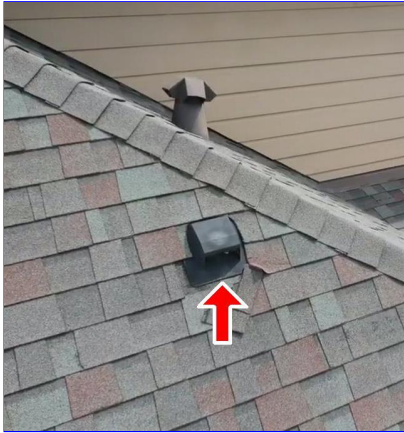
H. Item 1(Picture) lint present

The dryer vent piping is long and vertical which can trap lint at elbow. Vent pipes should be cleaned regularly if they are longer than normal (10 feet or more) or vented vertically. I recommend repair as needed.
