**ENVIRONMENTAL SITE ASSESSMENT  
PHASE I**

***Site Name:*** Vacant Lot  
***Site Address:*** 0 Hanna Road  
Spring, Montgomery County, Texas 77389

November 25, 2019

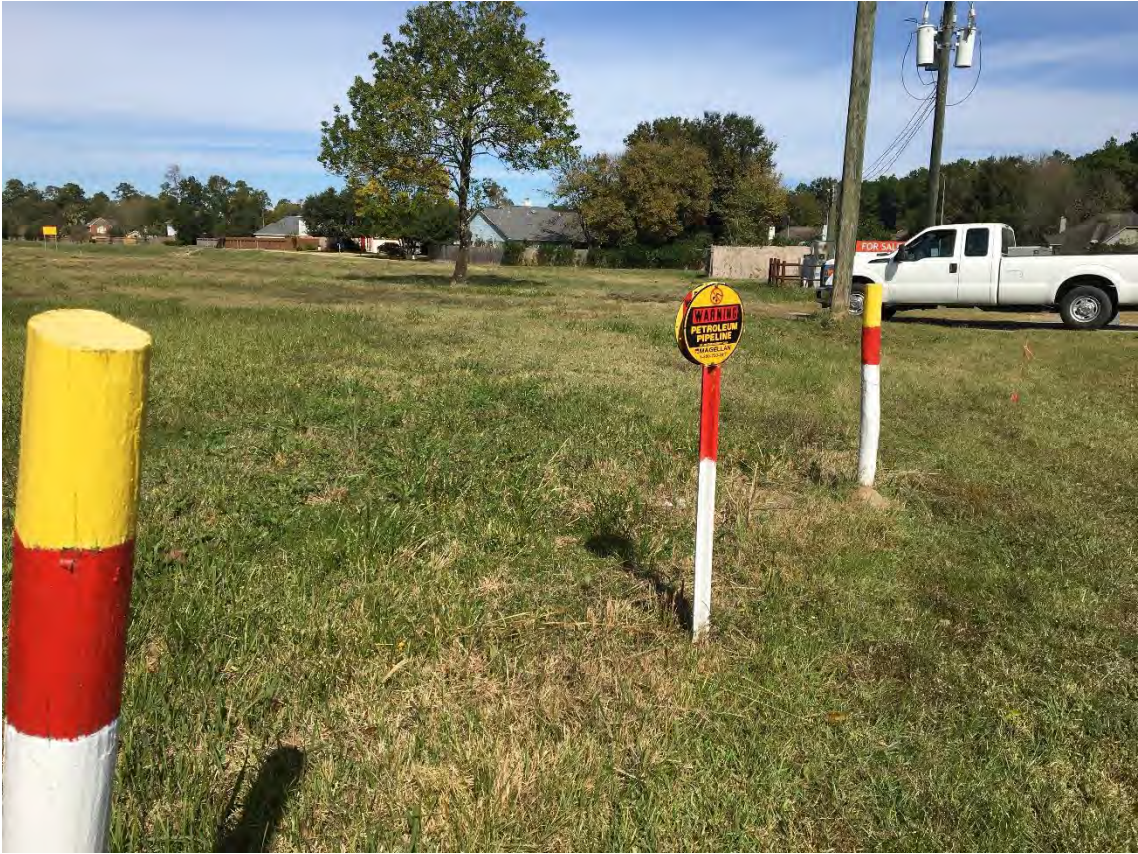
1. A northwestward view of the subject site from the southeastern corner of the site, and a view of the refined liquid product pipeline marker.

- An active refined liquid product transmission pipeline easement was observed running northwest to southeast through the western portion of the subject site. The presence of the pipeline poses a “Material Threat” to the subject site; however, the land appeared to be in good condition, and the RRC has stated that the pipeline easement has no reported spills, violations, or environmental incidents.

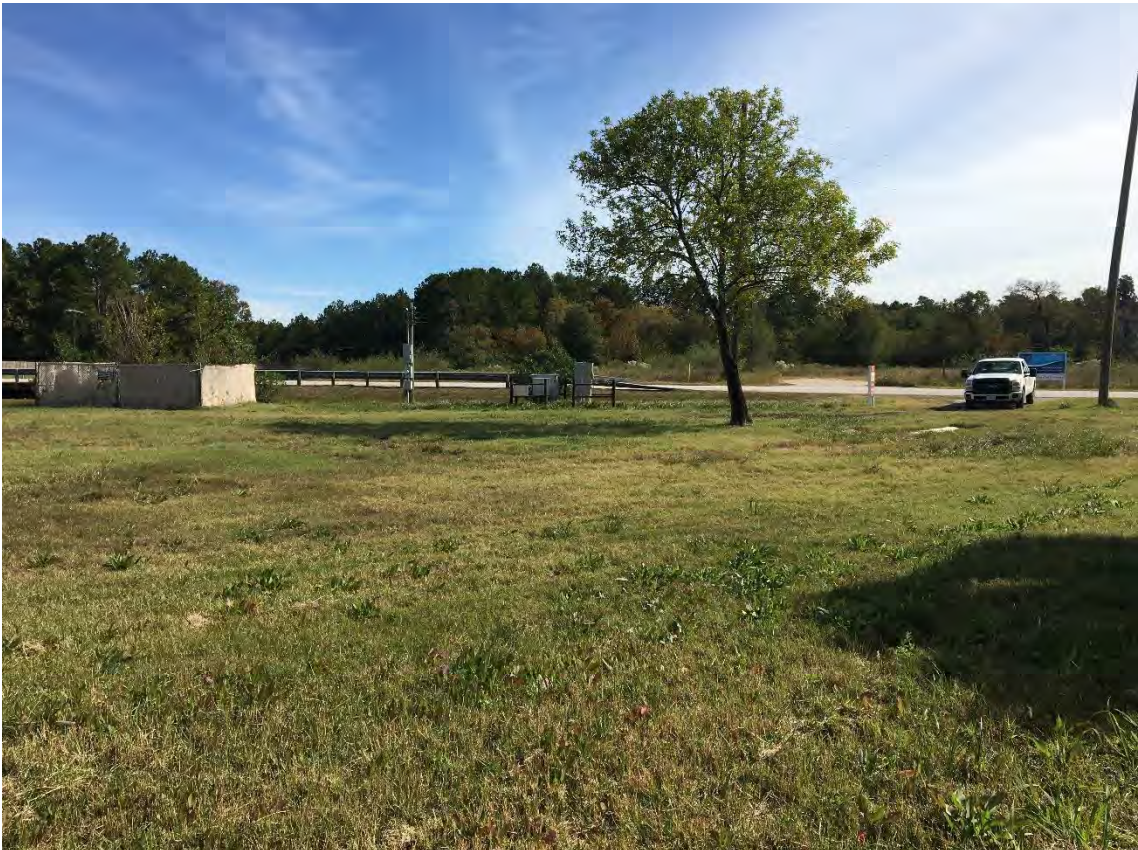
2. A southeastward view of the subject site from the northwestern corner of the site.

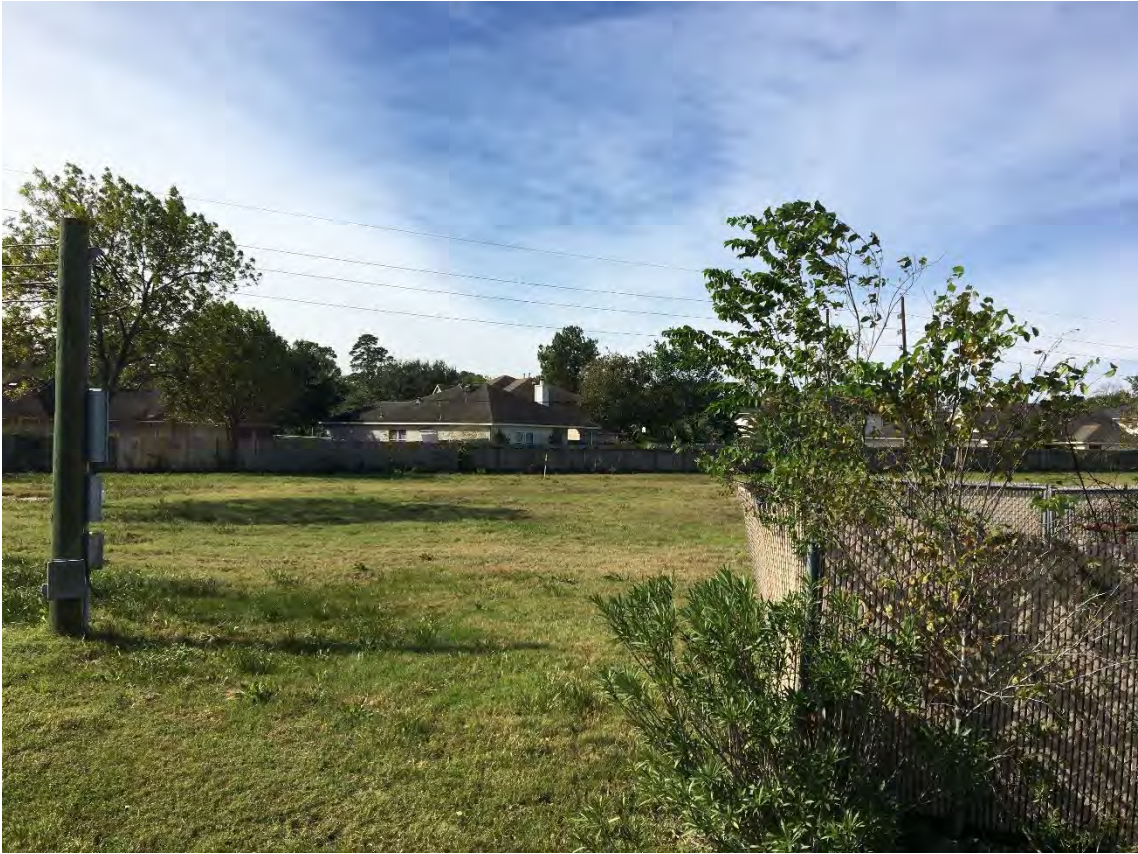
3. A southwestward view of the subject site from the northeastern corner of the site.

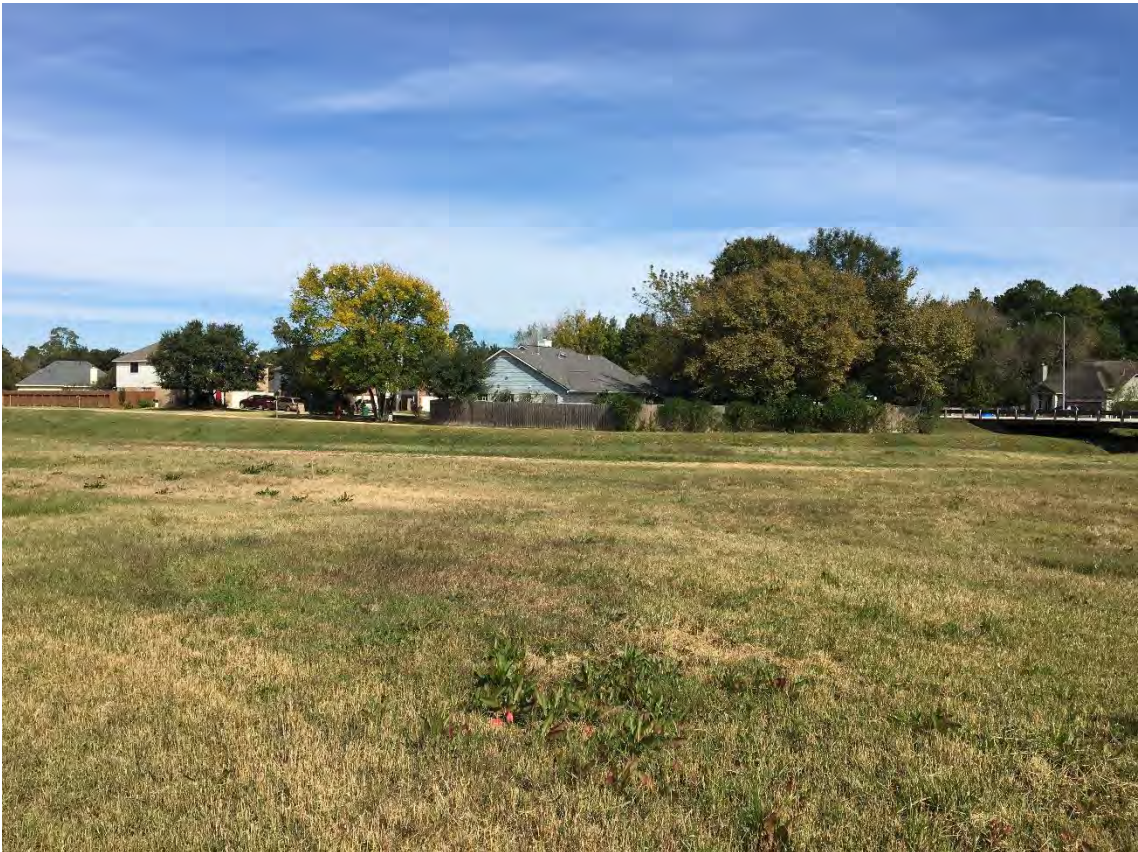
4. A northeastward view of the northern abutting properties (unimproved land and tributary of Spring Creek) and adjacent properties (single-family residential area) from the northwestern corner of the site.

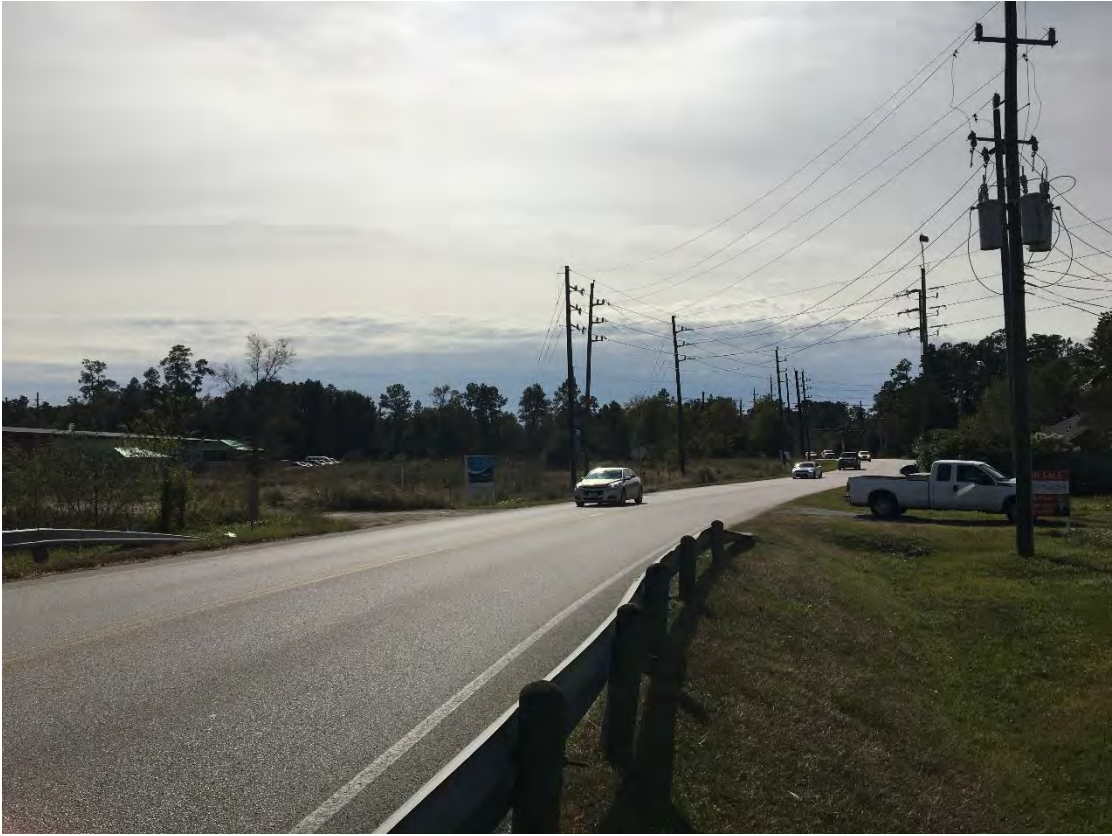
5. A southeastward view of the eastern abutting property (Hanna Road) and adjacent property (vacant land) from the northeastern corner of the site.

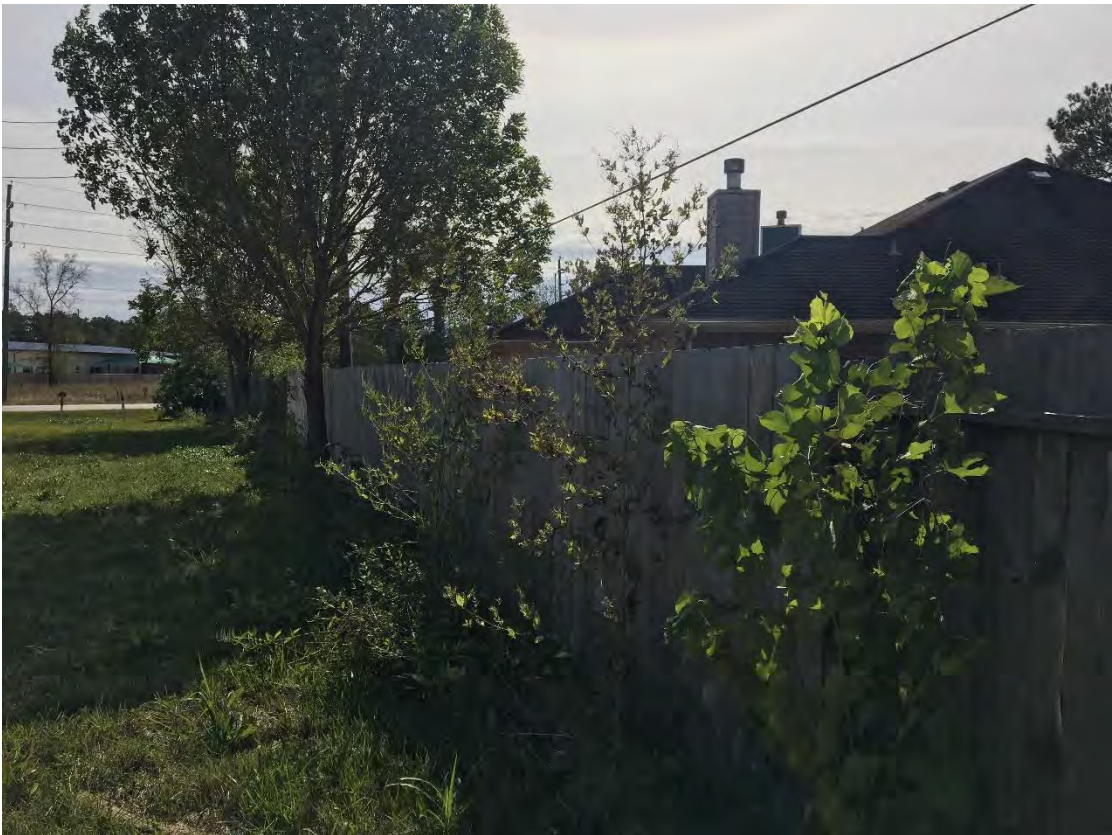
6. A southwestward view of the western/southern abutting properties (single-family residential area) from the northwestern corner of the site.

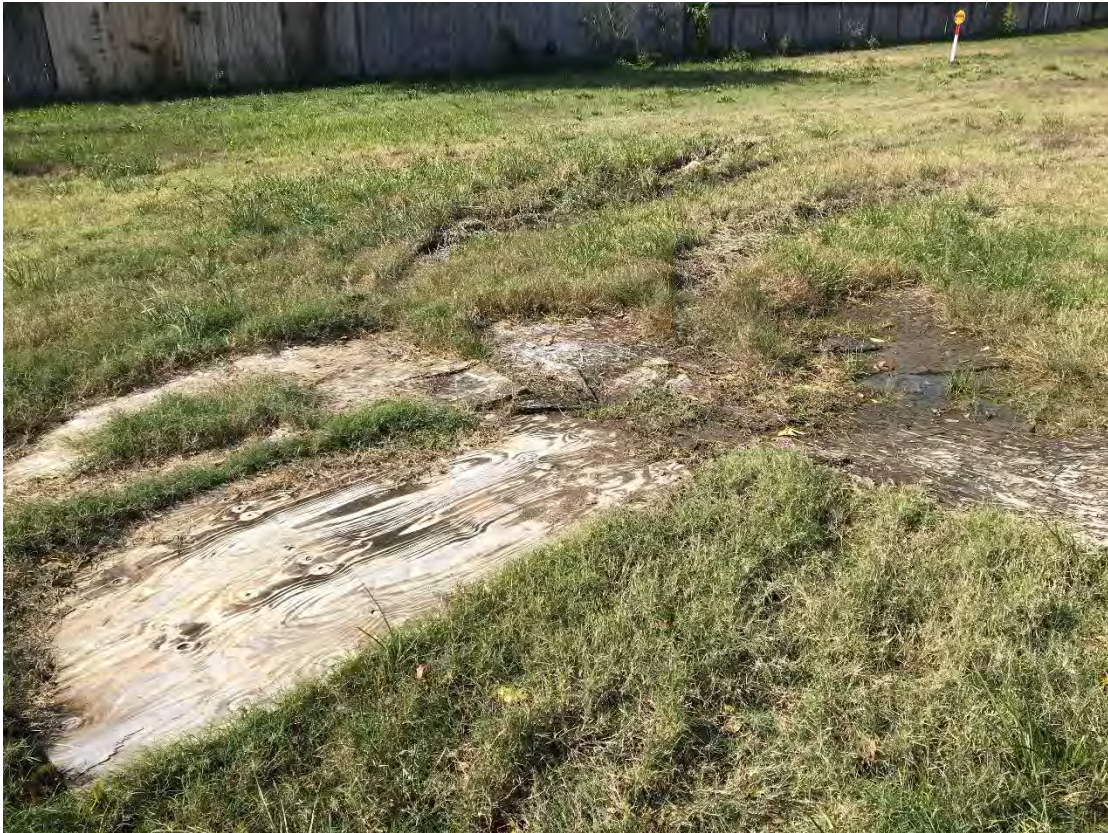
A few wooden boards, wooden planks, and some general household garbage were observed throughout the site. No staining or stressed vegetation was observed around the wooden debris or household garbage.

7. A view of some of the solid waste (wooden debris) that was observed throughout the subject site.

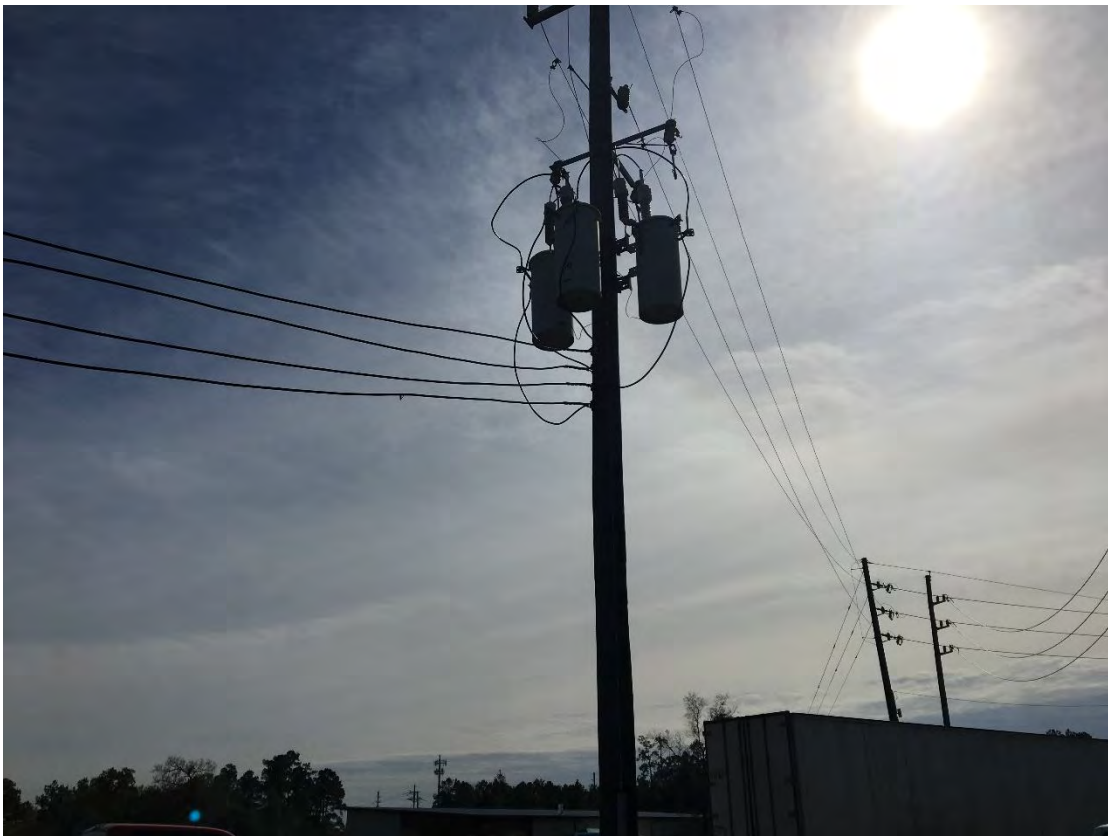
With the exception of three pole-mounted electric transformers that were located along the eastern property boundary of the subject site, no source of suspected polychlorinated biphenyls (PCB's) was observed on the site. No evidence of leakage or staining was noted below the transformers. The presence of the transformers should be of no concern to the subject site.

8. A view of the three pole-mounted electrical transformers observed near the eastern boundary of the subject site. No visible staining or leakage was observed.

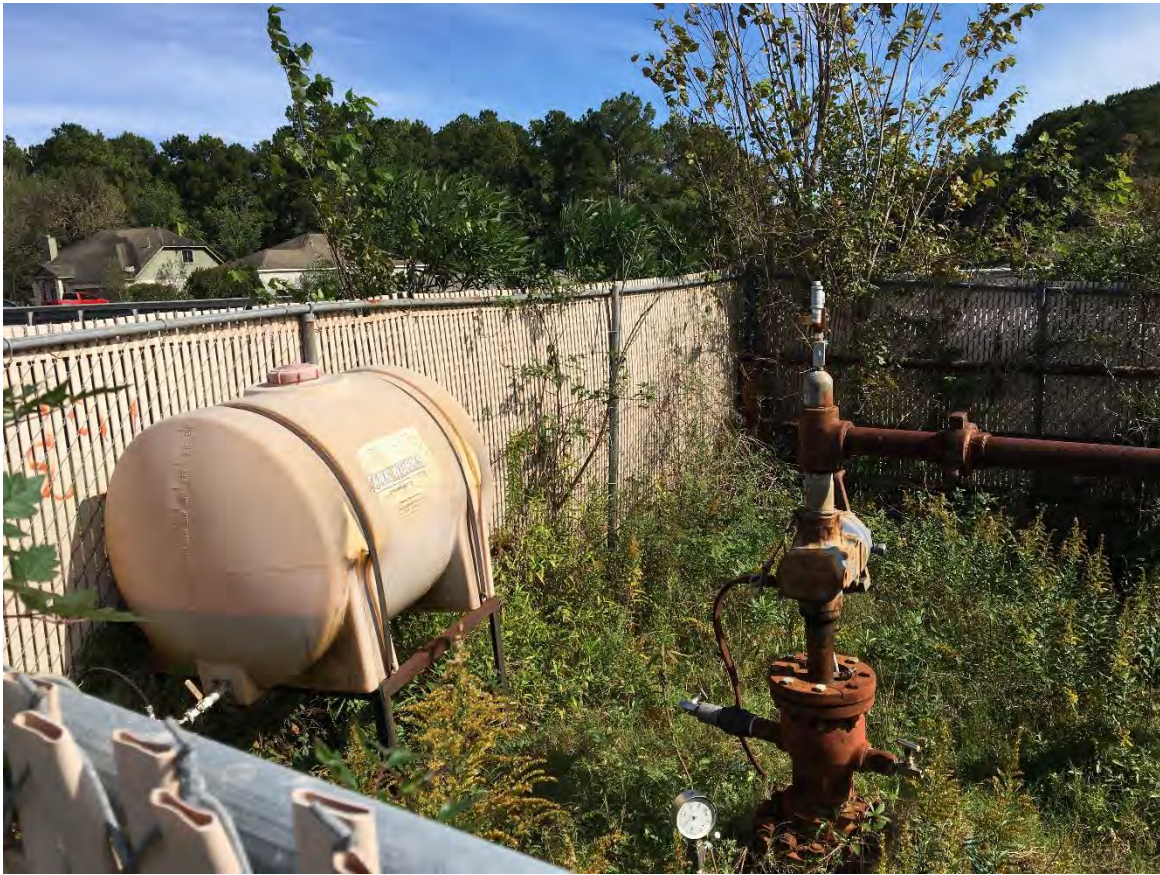
One 130-gallon plastic Aboveground Storage Tank (AST) containing waste oil was observed near the northeastern corner of the subject site. The AST was located inside an area surrounded by chain-link fencing, and no staining or spillage was observed around or underneath the AST.

An oil exploration well with an accompanying 130-gallon AST was observed in an enclosed area near the northeastern corner of the subject site. Documentation obtained by the client indicated that the well was installed on October 6, 1990 and was subsequently plugged on June 8, 2011. However, observations made on November 12, 2019 indicated that the well appeared to be abandoned and not plugged, as the well was still attached to a pressure control valve and associated fixtures. No spillage, stressed vegetation, or staining were observed in the vicinity of the well and AST. Additionally, a refined liquid product transmission pipeline easement was observed running northwest to southeast through the western portion of the subject site. According to the Railroad Commission of Texas (RRC), no spills or environmental incidents were on record for the pipeline.

9. A view of AST and plugged oil well located on the subject site. Rusting is visible, but no leakage, stressed vegetation, or staining were observed underneath.

- An oil exploration and production well with an accompanying 130-gallon AST was observed near the northeastern corner of the site in an enclosed area surrounded by chain-link fencing. Documentation provided by the client indicated that the well was installed on October 6, 1990 and was plugged in June 9, 2011. However, observations made on November 12, 2019 indicated that the well appeared abandoned and not plugged. No signs of stressed vegetation, staining, or spillage were observed near the well or AST.

**Recommendations:** Based upon the information obtained during this investigation and the intended current and future usage of the site, the site appears to have medium risk with respect to human health and environments. Based on these investigations, certain RCRA Metals, Total Petroleum Hydrocarbons, or Volatile Organic Compounds may be present on the site. Geo Environmental Consultants, Inc. recommends the following additional investigations:
