Property Inspection Report #5/16/2022 1111 Honey Rose Court
8616 Daffodil St. Houston, TX 77063

PROPERTY INSPECTION REPORT FORM

1111 Honey Rose Court , Richmond, TX 77406

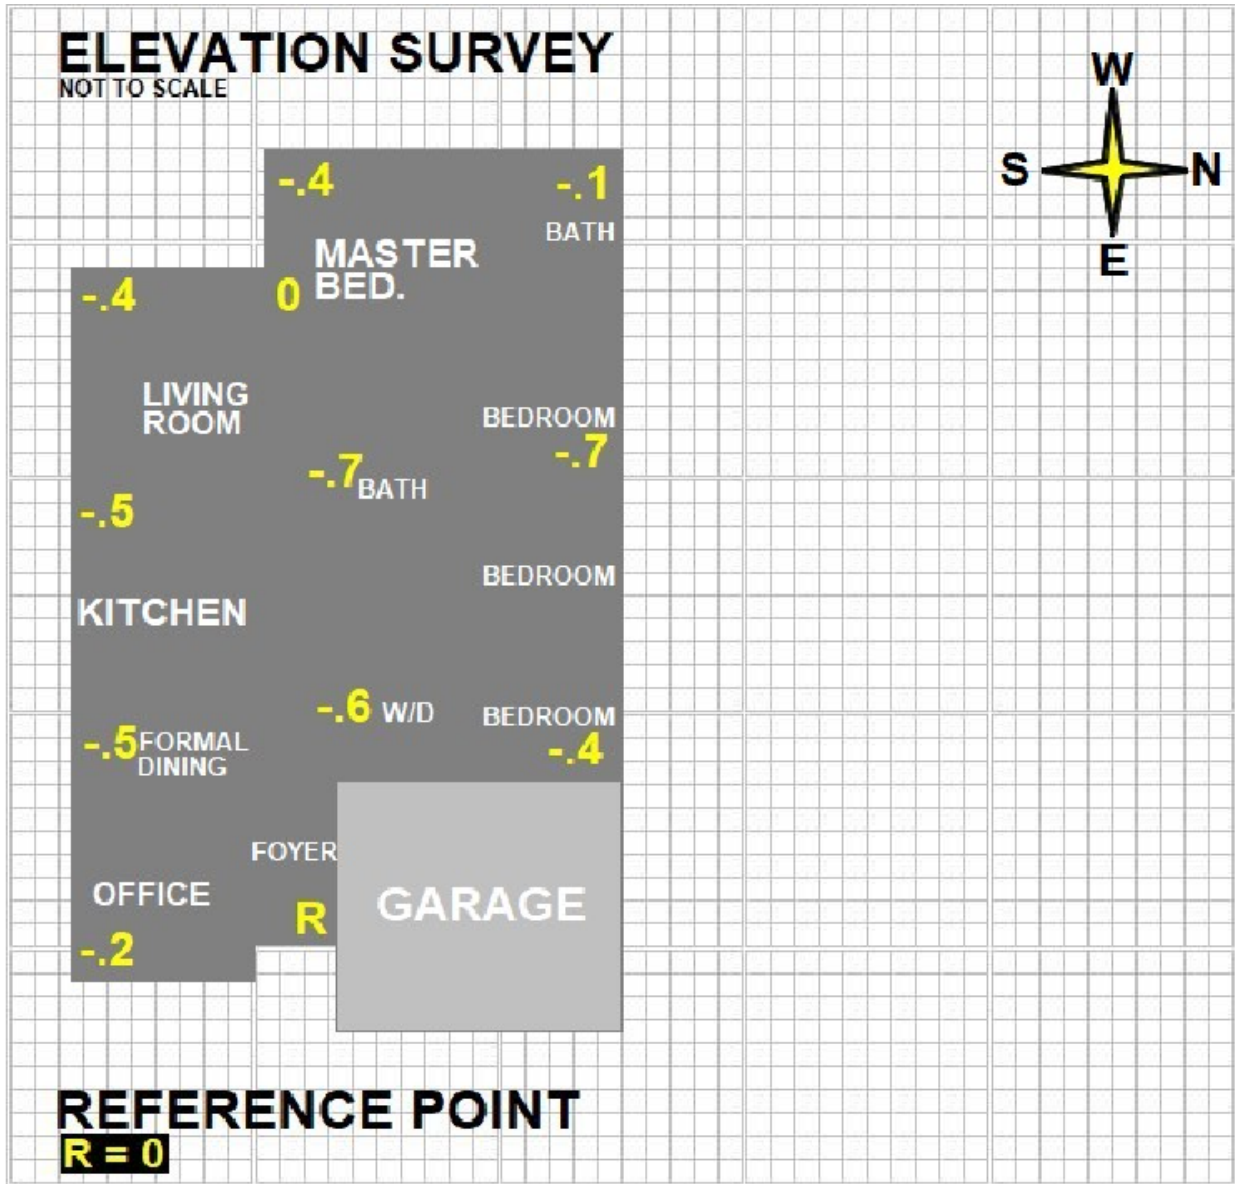
Foundation Variation: .7"

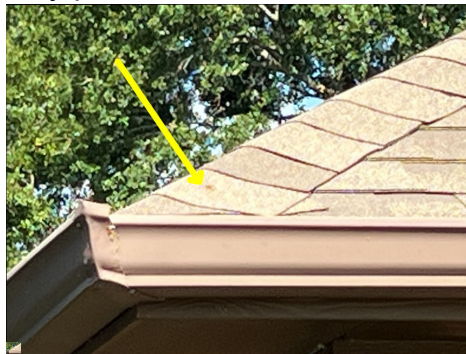
Exposed staples/nail-heads/fasteners observed on the roof are not properly sealed. Water entry possible.

Exposed nail heads observed at one or more locations on the roof.

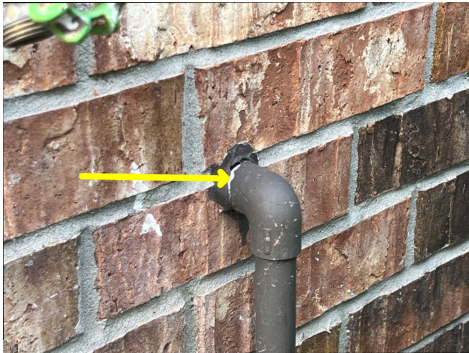
Seal all exterior penetrations.

Need sealing/caulking around all holes and exterior siding penetrations on top and both sides, (leave the bottom open) to prevent water entry. Including but not limited to dryer, bath and range top vents, light fixtures, etc.

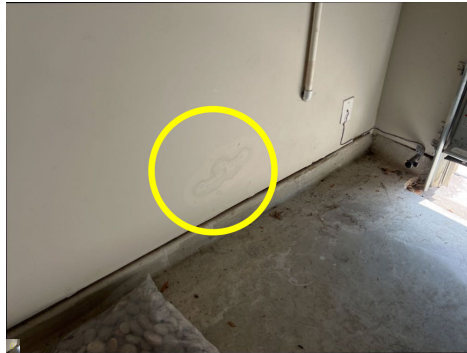
Water penetration observed at the following location(s): North interior garage wall.

Water stain on the north interior garage wall.

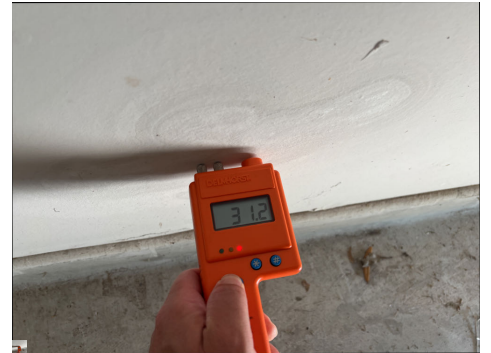
Water stain on the north interior garage wall was wet at the time of inspection.

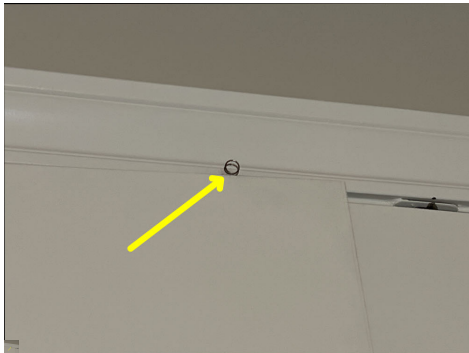
Latch ball on top of door observed to be damaged/ missing / defective; NW guest bedroom closet.

Ball latch damaged at the top of one or more doors.

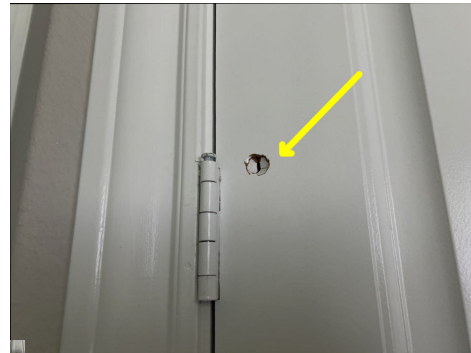
Door damaged; master water closet.

Door damaged at the master water closet

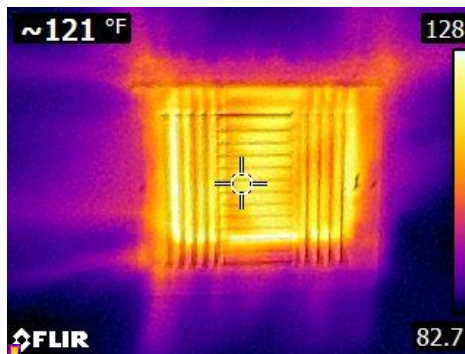
ADDRESSED. The house heater operated as intended at the time of the gas re-inspection.

HEATER UNIT: Carrier 2017

House heater in operation during the gas re-inspection.

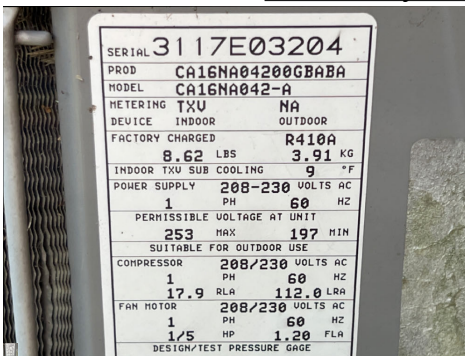
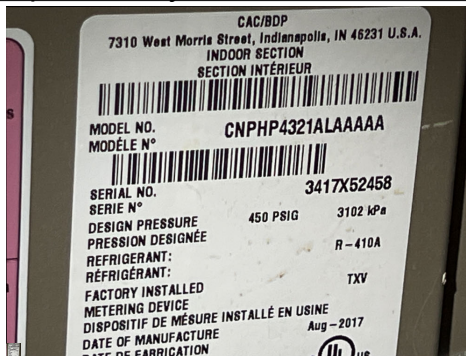
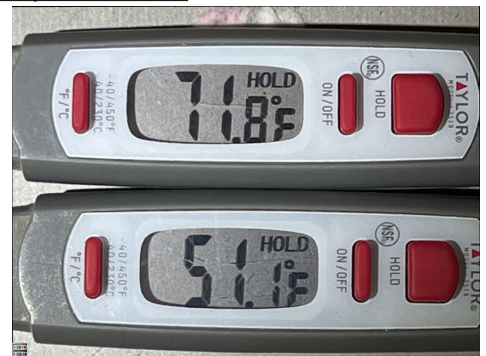
Condenser unit: Carrier 3.5-ton 2017 R-410A

Evaporator unit: Carrier 3.5-ton 2017

AC temperature split: 20.7°

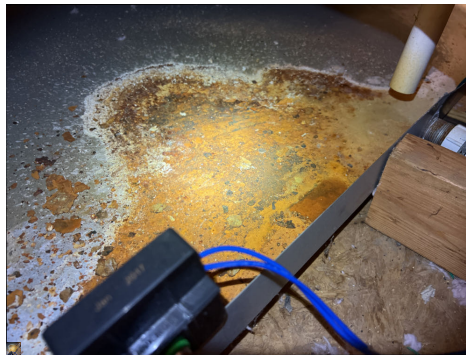
Secondary drain pan is very rusted, recommend replacement.

Recommend replacement of severely rusted evaporator coil drain pan.

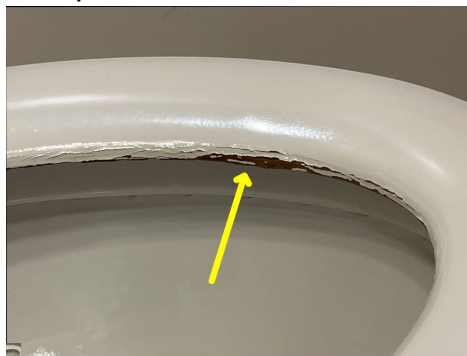
Commode seat damaged at both bathrooms.

Observed damage to both commode seats.

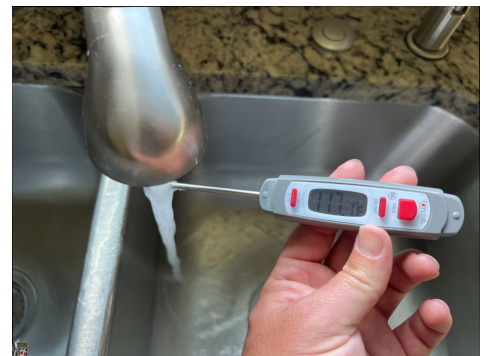
ADDRESSED. Water heater provided adequate hot water to all fixtures at the time of the gas reinspection.

Hot water temperature test during the gas reinspection.

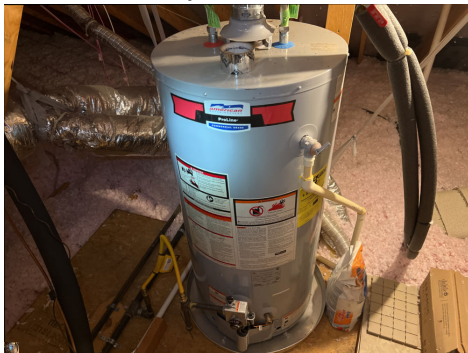
ADDRESSED. Water heater operating as intended at the time of the re-
 inspection.

Water heater unit: American Water Heaters 2017

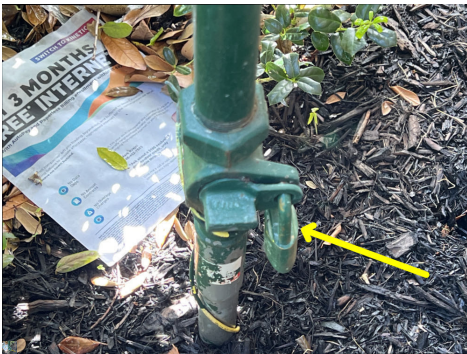
Gas service was locked in the off position at the time of inspection.

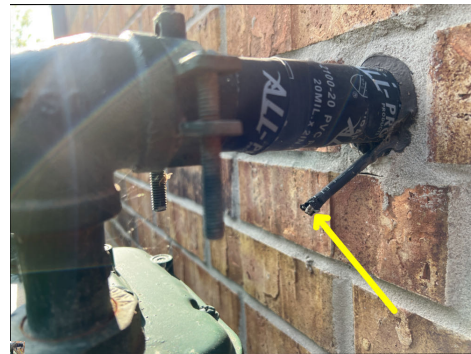
Unable to determine if above ground gas lines are properly bonded as required by 2006 IRC/G2411.1 (310). Recommend further evaluation by qualified contractor.

Gas bond wire has been disconnected.

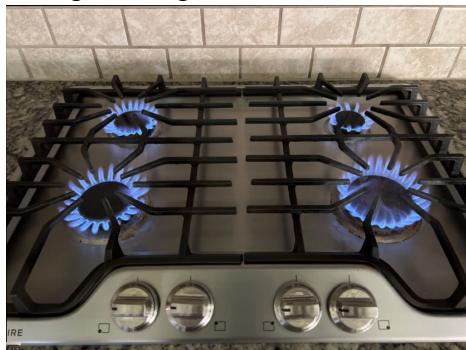
ADDRESSED. The gas range works as intended.

Gas cooktop in operation during the gas re-inspection.

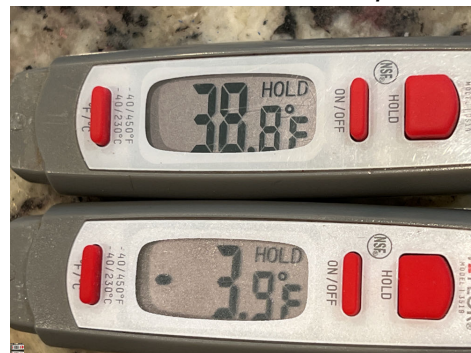
Refrigerator and freezer temperature readings.

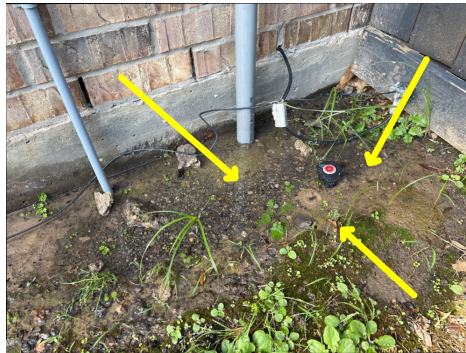
Possible damaged water line/water gusher near the exterior garage wall. Observed ponding water upon arrival to the inspection at this location. Recommend further review/repair.

Ponding water around a sprinkler head on the exterior wall of the garage.
