## RESIDENTIAL INSPECTION

26626 Daylily Grove St  
Katy, TX 77493

# PROPERTY INSPECTION REPORT FORM

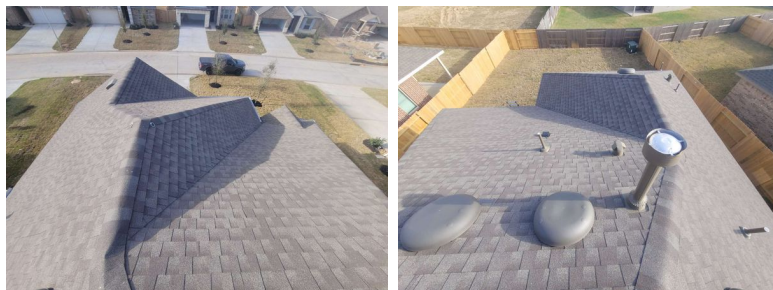
*Roof Condition:* Good Condition

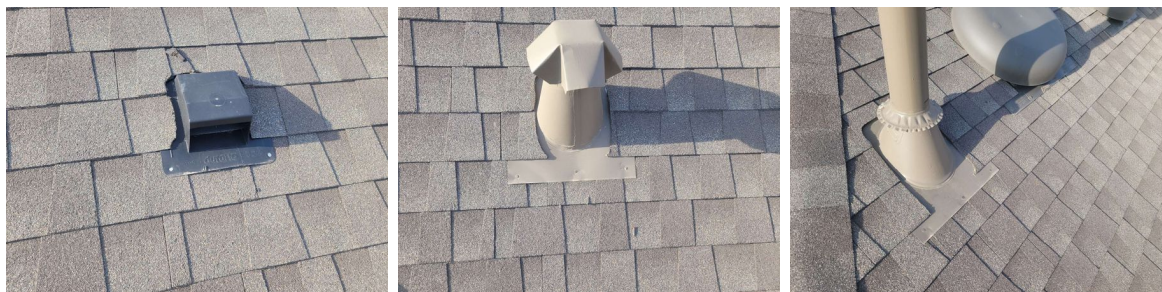
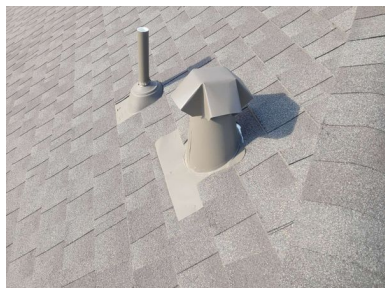
**1: Shingles - Exposed Fasteners**

Roof fasteners (nails and/or staples) were observed to be exposed and should be properly sealed at the flashing areas.

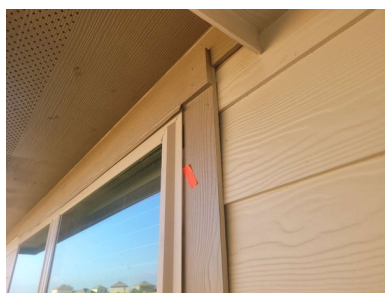
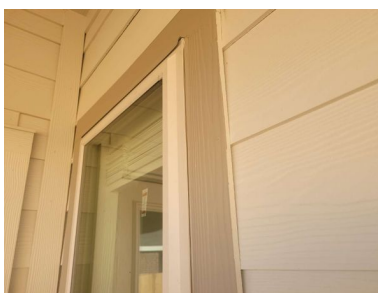
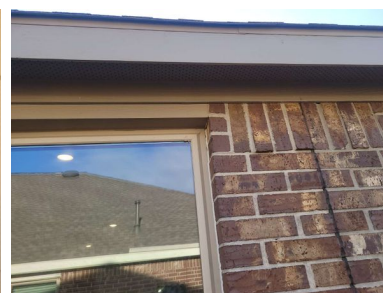
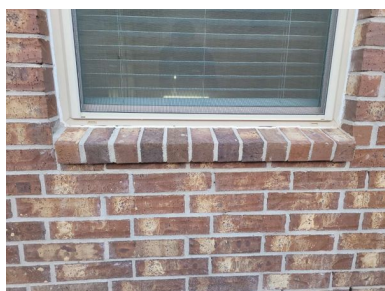
**1: Exterior Walls - Sealant Around Windows**

Sealant improvements are recommended for the area between the exterior siding and the window frames. It is recommended to use elastomeric sealant.

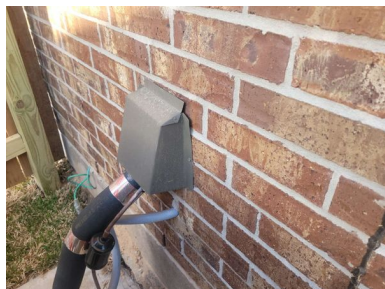
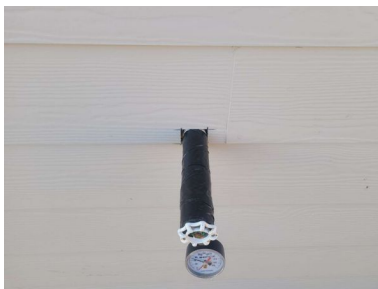
**2: Exterior Walls - Sealant Around Wall Penetrations**

The area between the exterior siding and all of the wall penetrations/openings need to be properly sealed.

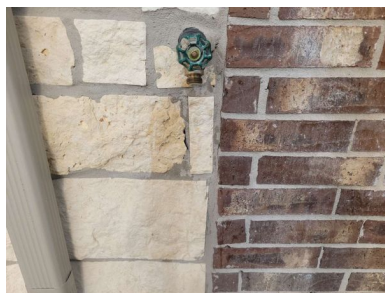
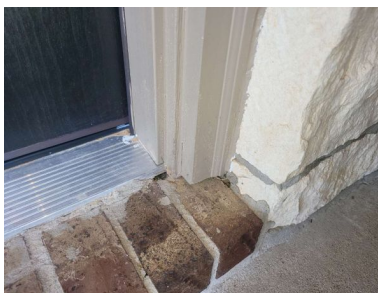
**3: Exterior Walls - Mortar Needs Improvement**

Mortar improvements are recommended for the exterior brick veneer.

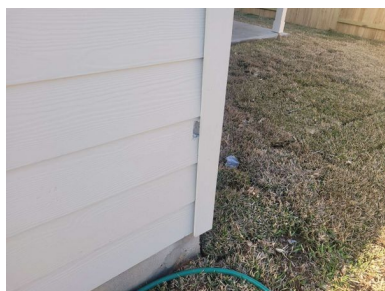
**4: Exterior Walls - Damage**

The exterior siding has some damage.

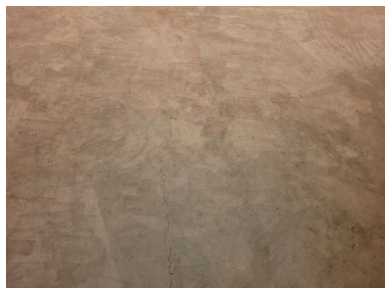
**1: Floors - Shrinkage Cracks Observed In Garage**

The garage floor had common shrinkage cracks. These cracks are not a structural concern.

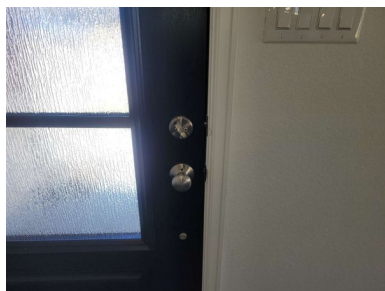
**1: Exterior Doors - Deadbolt Does Not Align**

The exterior door deadbolt did not align correctly with the hole in the strike plate, making the deadbolt difficult to operate.

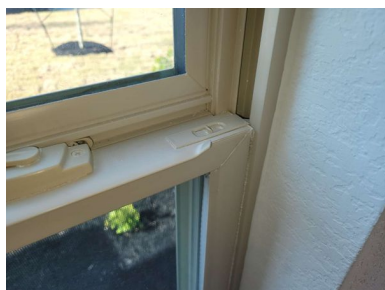
**1: Windows - Damage**

Living Room

The window frame is damaged.

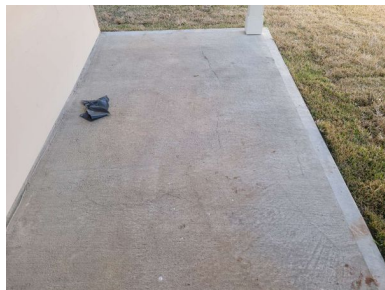
**1: Porch/Patio - Minor Cracks**

Minor cracks and/or deficiencies were observed on the patio.

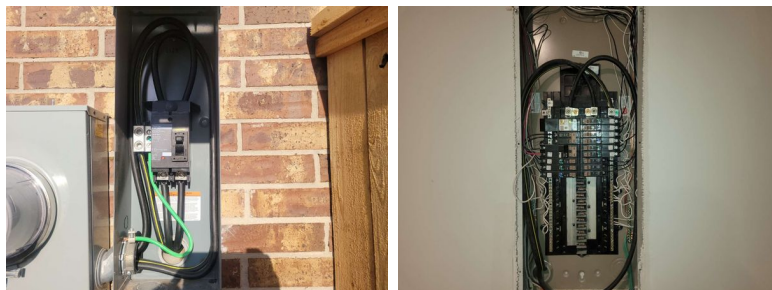
*Electrical Panel/s Uncovered For Inspections:*

The main electrical service entrance and service panel were inspected according to today's Texas Standards of Practice and were performing as intended at the time of the inspection.

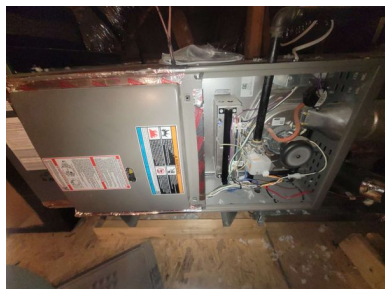
*Heating Equipment Location w/Photo:* Attic

The heating equipment was inspected according to today's Texas Standards of Practice and was performing as intended at the time of the inspection.

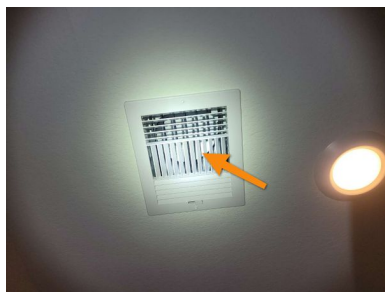
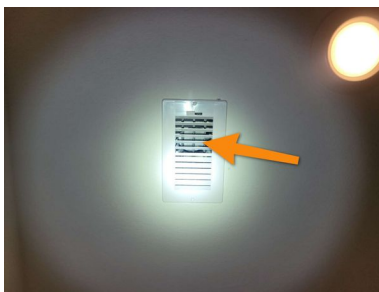
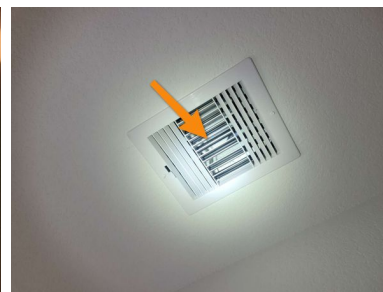
**1: Register - Damper Not Open**

Multiple Locations

The damper inside the air supply register is in a closed position. The damper should be removed or opened to allow for proper air flow.

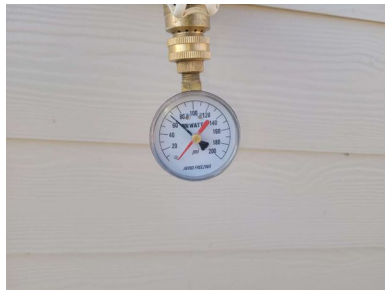
*Static Water Pressure Reading:* 60 to 70 PSI

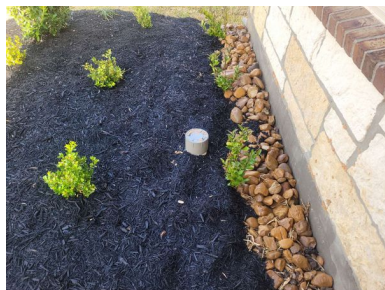
The drains, wastes and vents were inspected according to today's Texas Standards of Practice and were performing as intended at the time of the inspection.

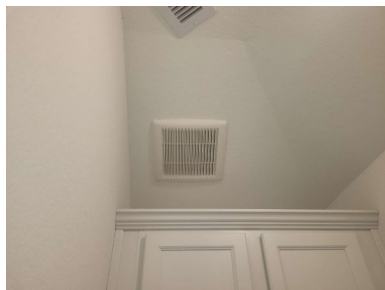
**1: Operation - Noisy Fan**

Master Bathroom

The mechanical exhaust vent fan was unusually noisy

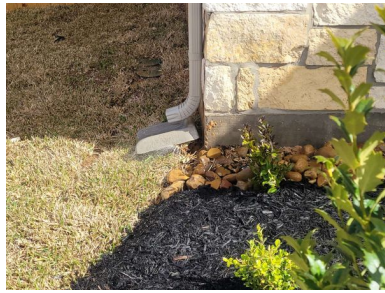
Zone 3

The sprinkler head is obstructed and does not disperse water properly

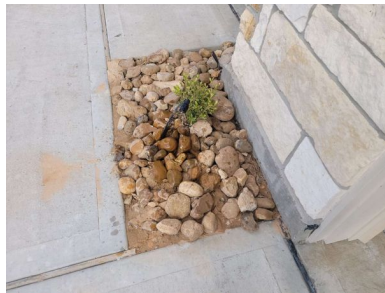
**2: Sprinkler - Low Water Pressure @ Head**

Zone 1

Low water pressure was observed at the sprinkler head. The cause and remedy should be further evaluated and corrected as necessary.
