Inspection Report

Property Address:
2212 Francis St
Houston Texas 77004

PROPERTY INSPECTION REPORT

By: Timothy J Hilsher Texas Professional Home Inspector / Hilsher Group LLC 12/22/
2016

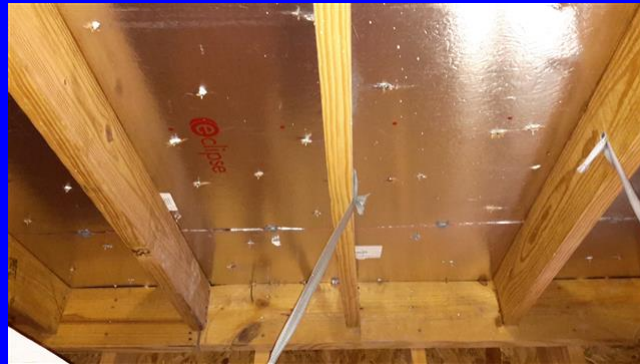
2x6 rafters stick built with radiant barrier decking

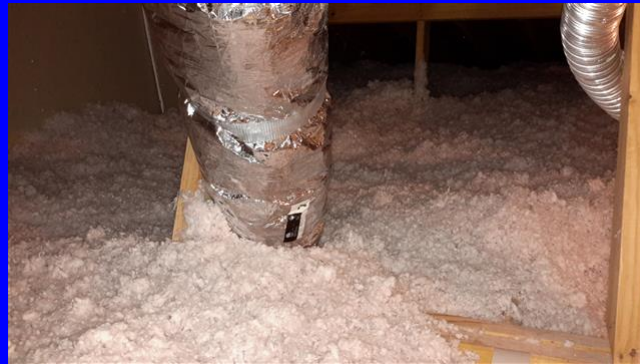
12 inches blown insulation

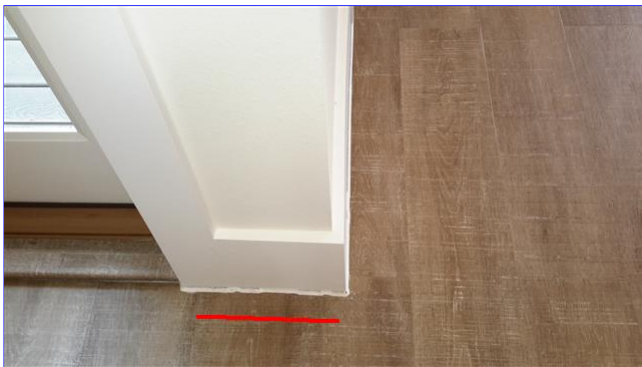
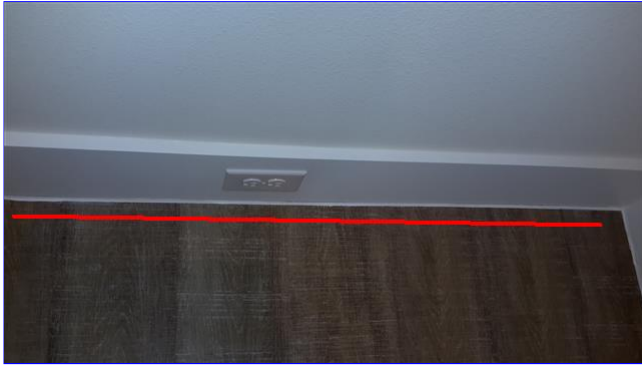
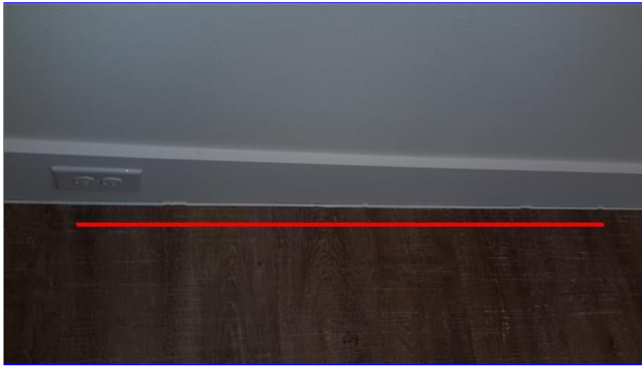
- (1) Baseboards have some separation and deterioration of caulking. I recommend having a qualified person make repairs of needed.

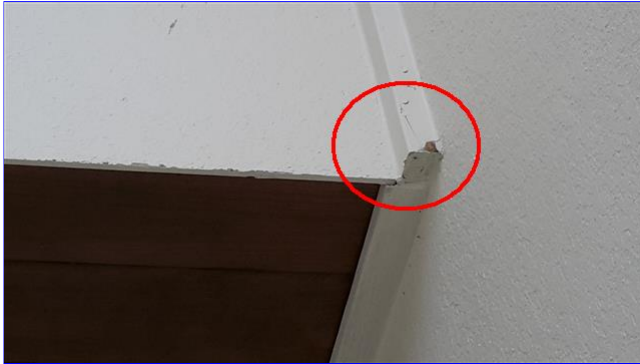
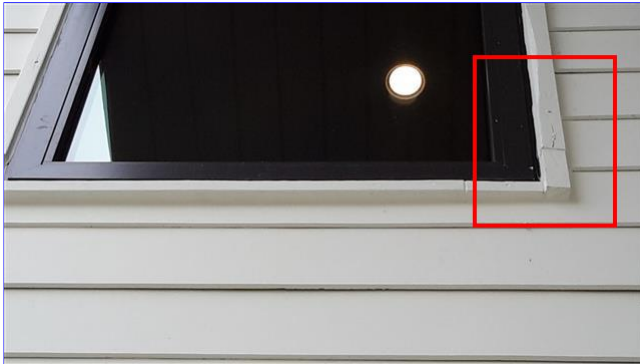
(2) The Trim at the exterior damaged. Deterioration can eventually occur if not corrected. A qualified person should repair or replace as needed.

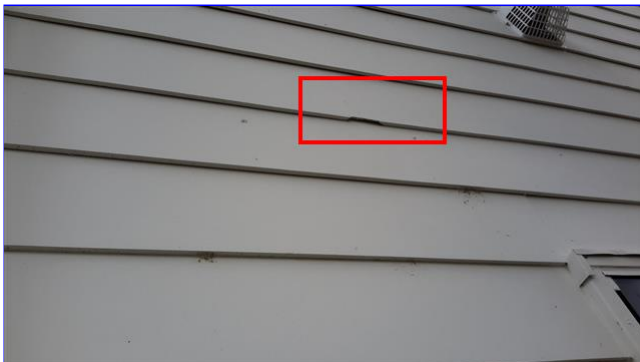
E. Item 9(Picture) Rear of home

(3) The Siding at the exterior damaged. Further deterioration can occur if not corrected. A qualified person should repair or replace as needed.

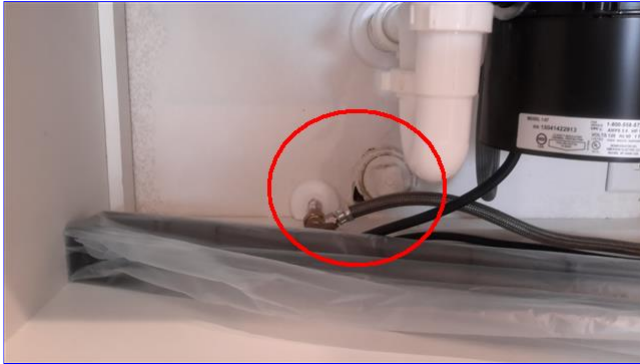
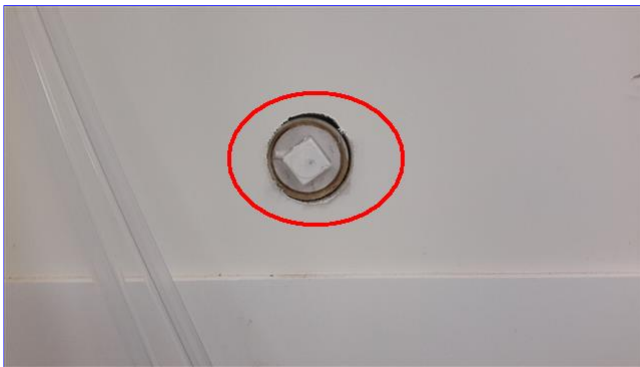
(4) Area's where wiring or piping passes through walls should be sealed. I recommend having a qualified person seal as needed.

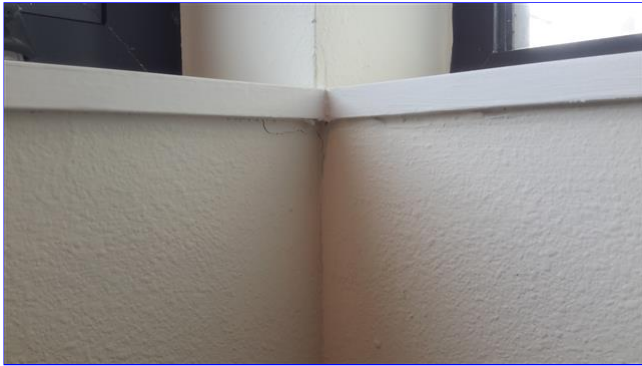
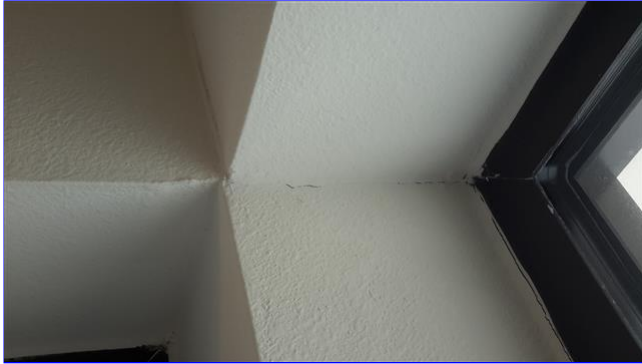
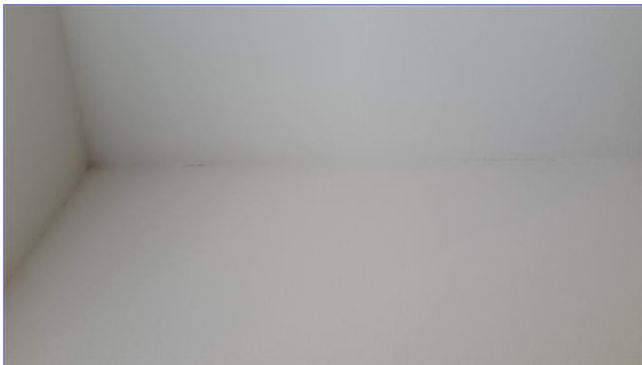
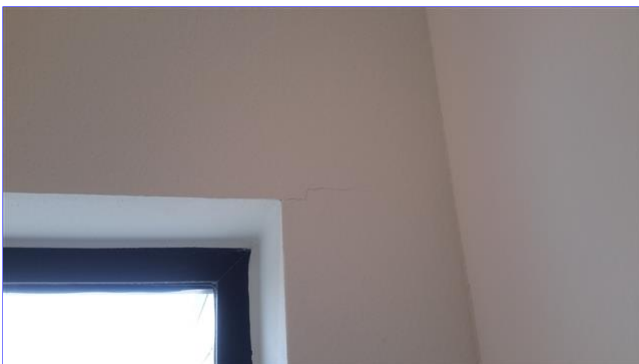
(5) The drywall on the wall reveals tape and nail bed areas (cosmetic). A qualified person should repair or replace as needed.

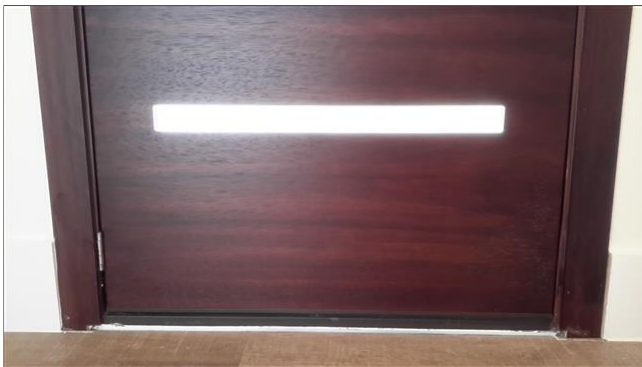
(6) Caulking is deteriorated or missing. I recommend having a qualified person make repairs as needed.

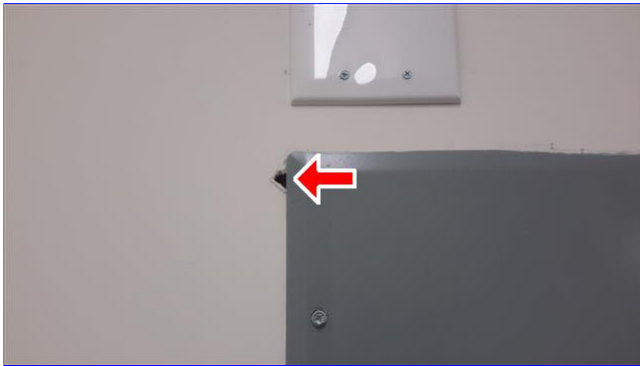
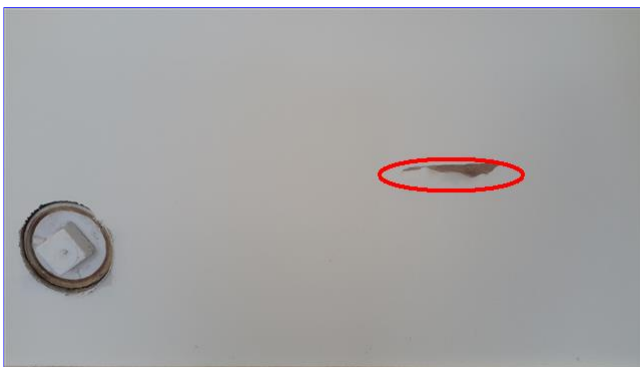
(7) The drywall is damaged. I recommend having a qualified person make repairs as needed.

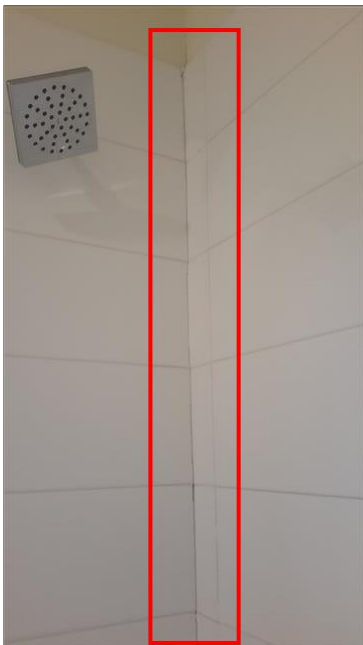
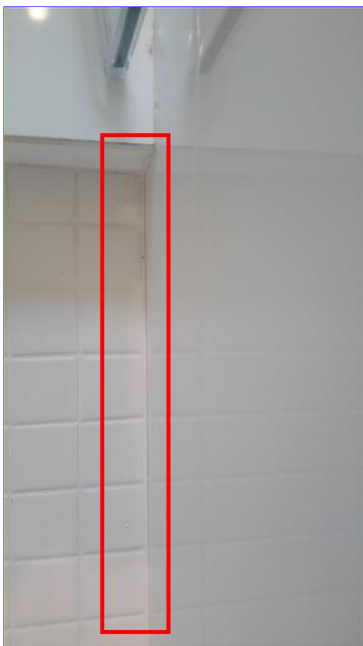
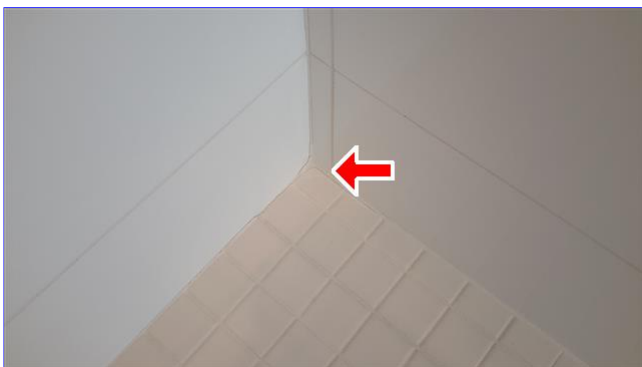
(8) The tile surround at the bathtub/shower wall is deteriorated and needs repair or replacement. I recommend repair or replace using a qualified contractor.

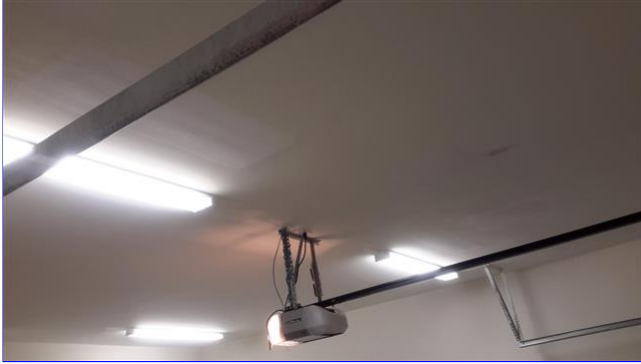
F. Item 2(Picture) garage

(2) The drywall shows signs of previous repair. I recommend having a qualified person repair as needed.

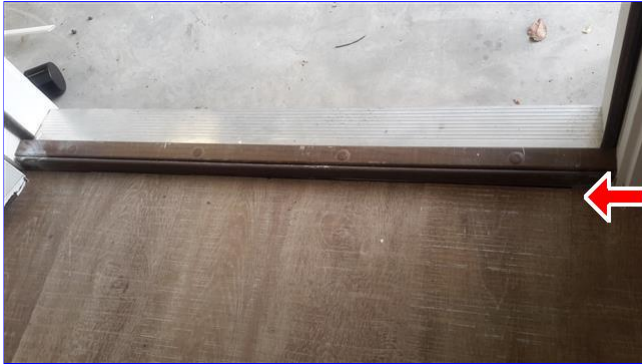
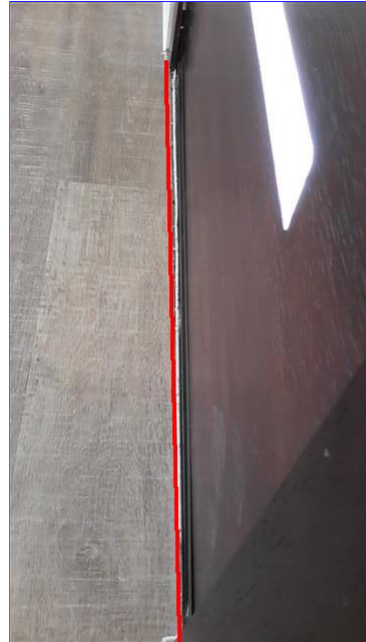
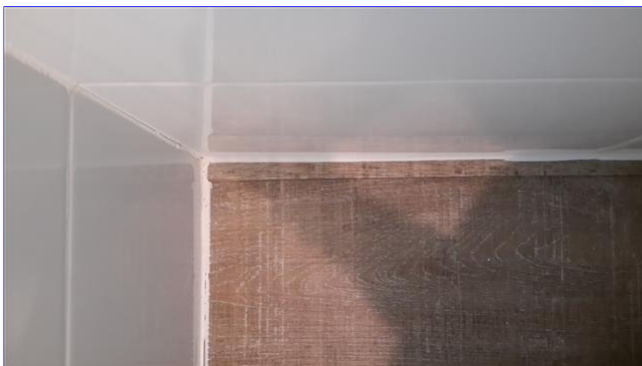
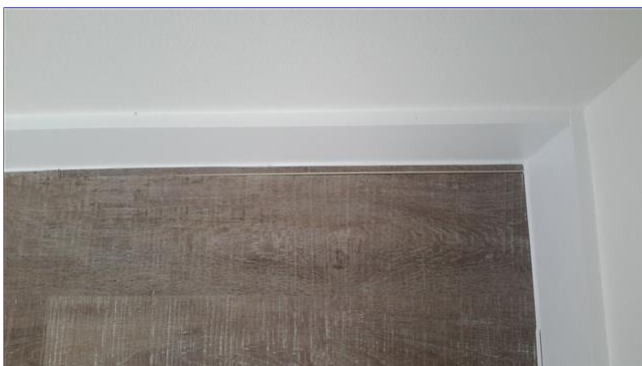
(3) The flooring is incomplete. I recommend having a qualified person make repairs as needed.

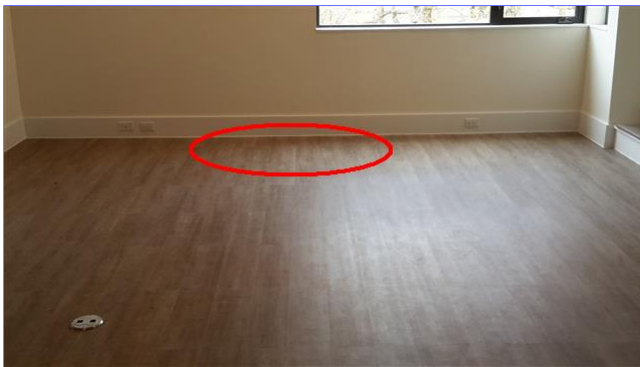
F. Item 8(Picture)

(5) The Living room front wall has slight dip in flooring. I recommend having a qualified person make repairs as needed.

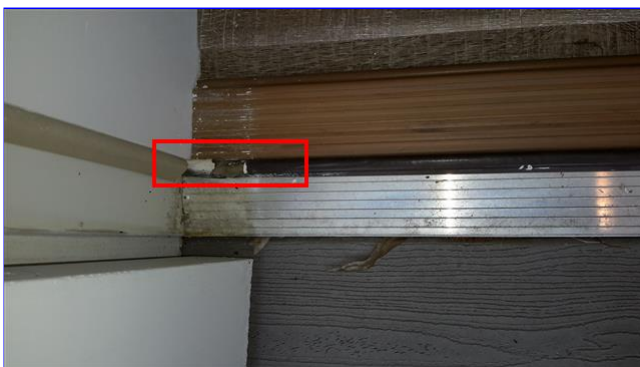
(1) The front of home upper level Deck needs weather-stripping repaired or replaced. This is a maintenance issue and is for your information. A qualified person should repair or replace as needed.

G. Item 1(Picture) damaged weather stripping second floor patio

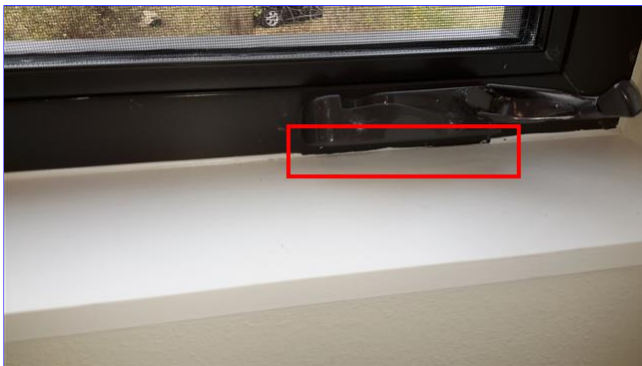
There are window frames that are not properly sealed. This can cause energy loss. I recommend having a qualified person seal and repair as needed,

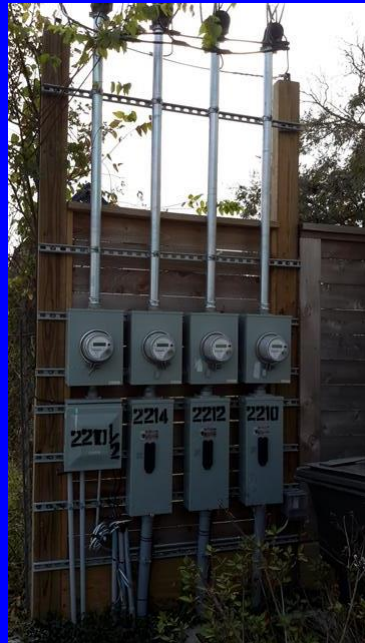
Above ground service with 150 amp disconnect

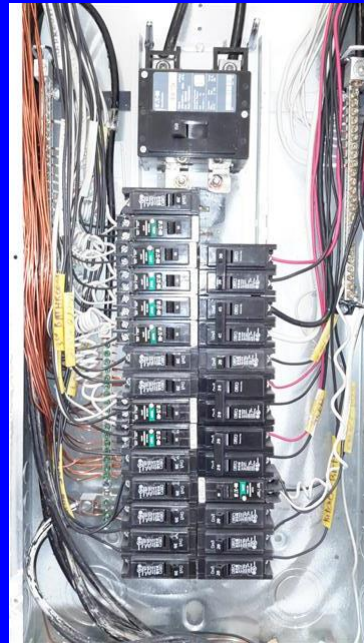
150 amp main panel located in garage

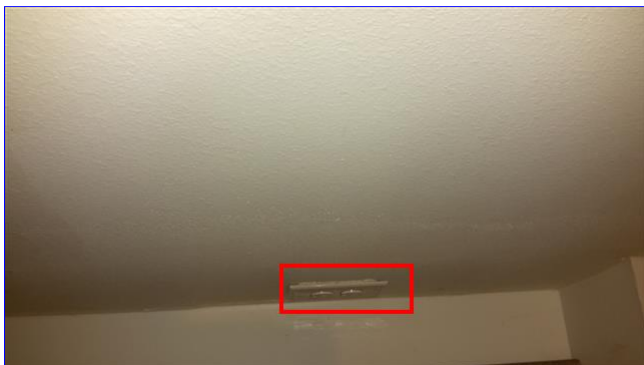
B. Item 1(Picture) Loose outlet stairs to second floor

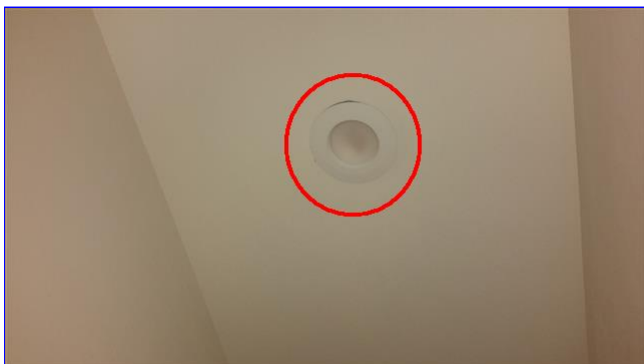
B. Item 3(Picture) 3rd floor rear bedroom closet

(3) The light fixture is loose at the upstairs 2nd bedroom closet. Electrical issues are considered a hazard until repaired. A qualified licensed electrical contractor should perform repairs that involve wiring.

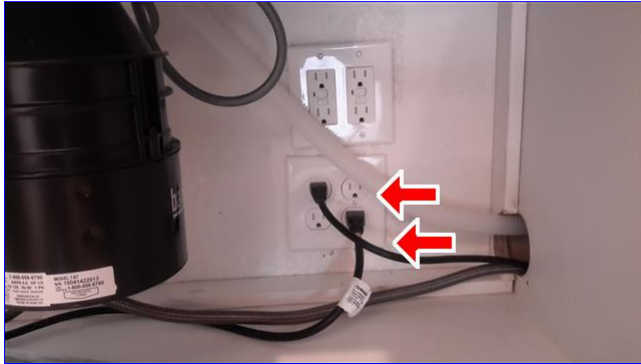
B. Item 4(Picture)

(4) There are no GFCI protected circuits in required area's. This is not considered to be today's standard. I recommend having a qualified electrician make repairs as needed.

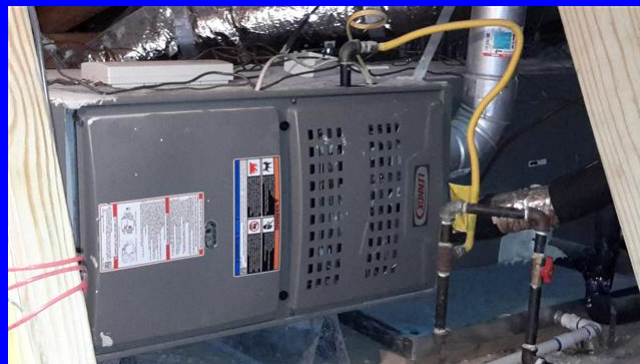
Lennox gas furnace

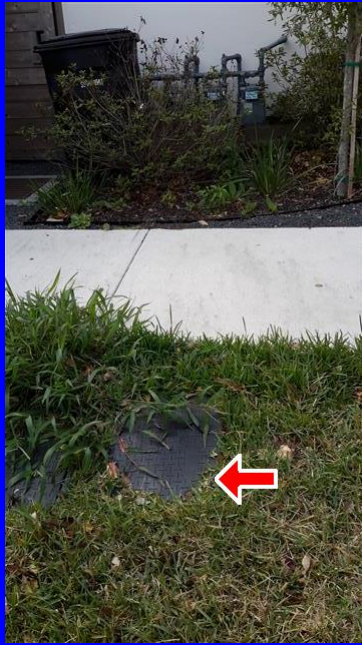
Water meter at street

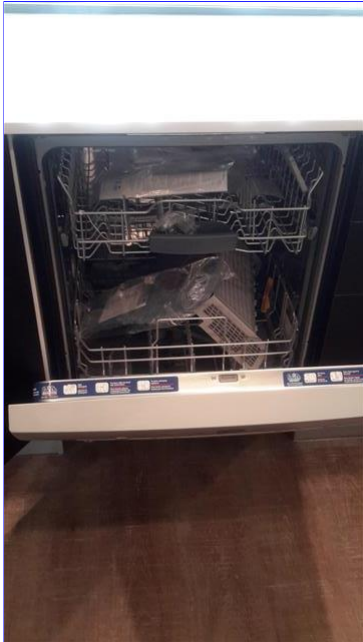
A. Item 1(Picture)

(1) The dishwasher is loose and needs securing to the underside of countertop (using a proper length screw). The unit is not fully installed. I recommend repair as necessary.

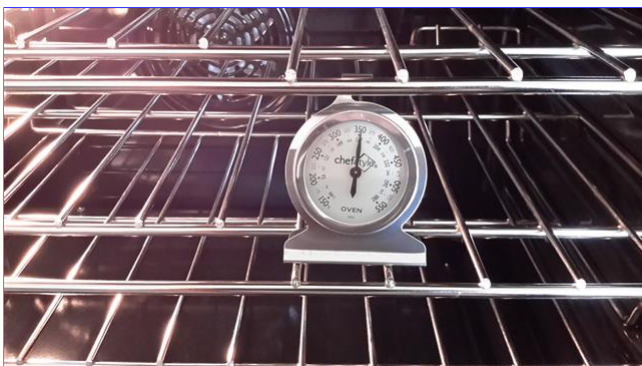
Tested and working properly at the time of inspection.

D. Item 1(Picture) Tested set at 350 (f)

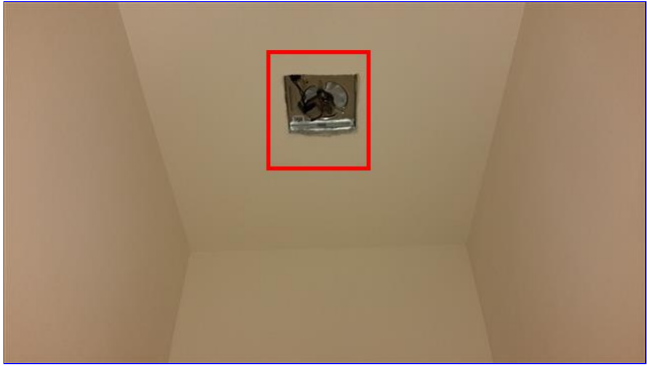
F. Item 1(Picture) half bath

The Exhaust fan is missing cover at the half bath. This is a safety issue that needs repair. A qualified person should repair or replace as needed.
