SELLER'S DISCLOSURE NOTICE

CONCERNING THE PROPERTY AT 3502 Hidden Creek DR SugarLand
 (Street Address and City)

SUMMARY
3502 Hidden Creek Dr, Sugar Land, TX
77479
Thao Bul
May 10, 2022

Arthur Guzman
Certified Professional Inspector
TREC#23407
Fort Bend Inspections
832-250-0135
info@fortbendinspections.com

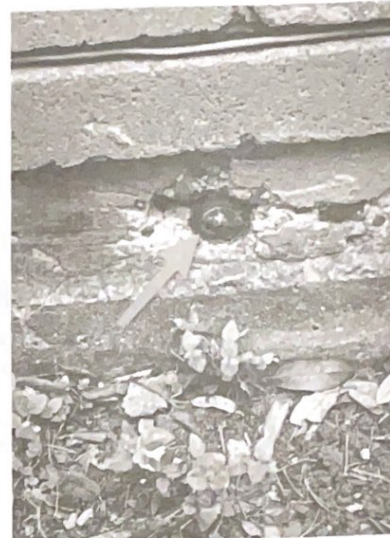
2.1.2 A. Foundations
EXPOSED REBAR

Exposed rebar observed. Recommend filling with concrete filler.

Recommendation
Contact a qualified professional.

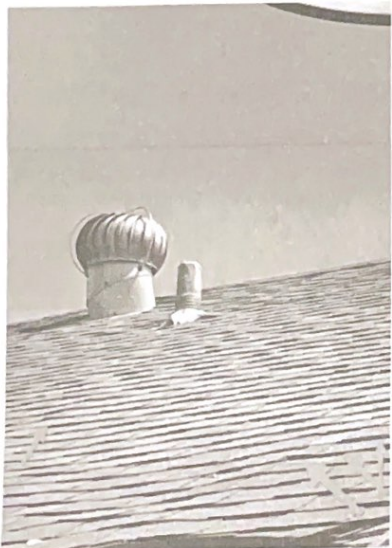
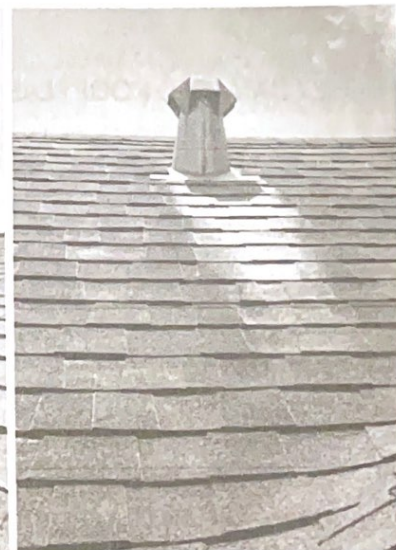
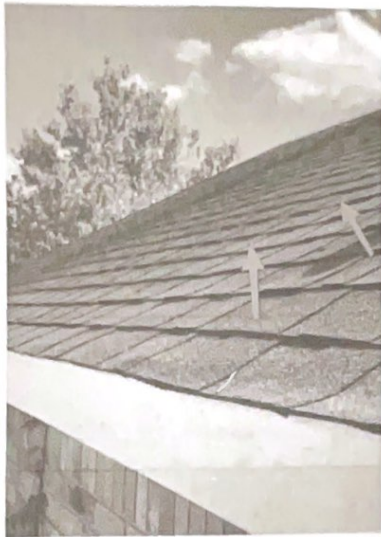
2.3.1 C. Roof Covering Materials
RAISED SHINGLES

Observed raised shingles. Recommend roofer to repair so that it prevents roof leaks, water damage, pest entry, etc.

Recommendation
Contact a qualified roofing professional.

- lifted shingles will be fixed
- Repair damaged flashing

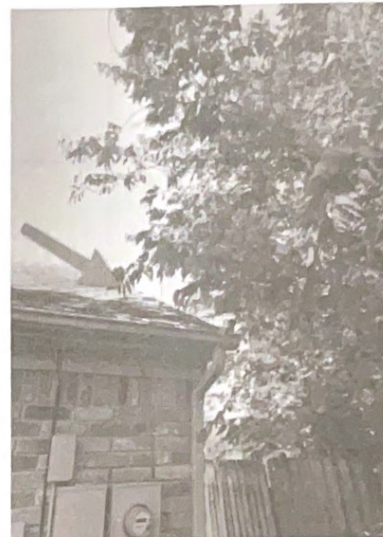
2.3.2 C. Roof Covering Materials
*** TREE BRANCHES OVERHANGING**

Limbs hanging over a home are a threat to the rooftop and the entire property. As branches scrape against roof shingles on windy days, they can strip off layers of asphalt. ... Even worse, if the tree is damaged or diseased, a storm can cause limbs to fall onto your home. This is also a pathway for termites, and unwanted pests to get into home.

Recommendation
 Contact a qualified professional.

→ trim tree branches touching roof

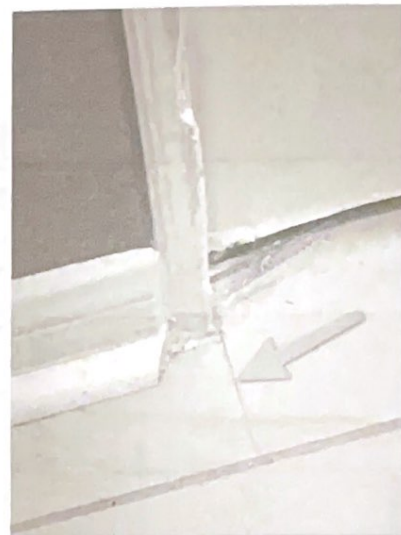
2.6.1 F. Ceilings and Floors

MINOR CRACK

Observed Minor crack ceilings at one or more areas. There appears to be no signs of structural movement although I would recommend repainting, re texturing and monitoring.

Recommendation
Contact a qualified professional.

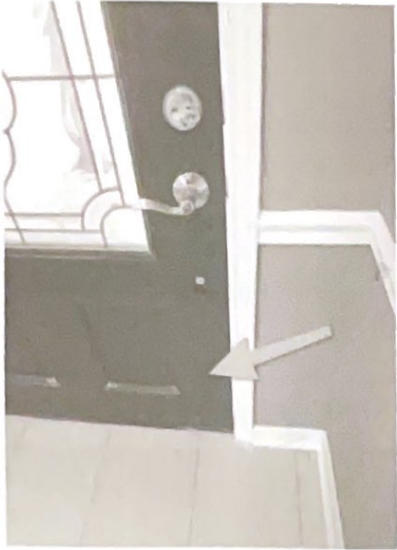
2.7.1 G. Doors (Interior and Exterior)

DOOR STICKS

Door sticks and is tough to open. Recommend sanding down offending sides.

Recommendation
Recommended DIY Project

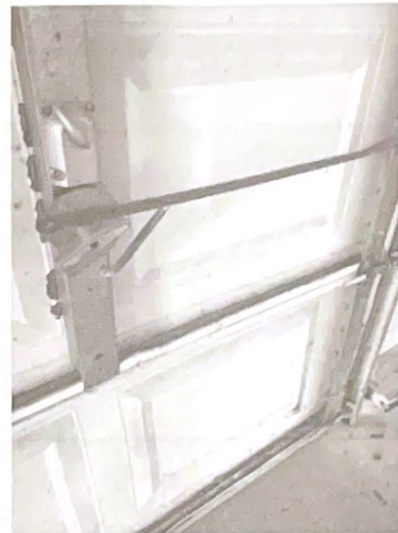
2.7.2 G. Doors (Interior and Exterior)

GARAGE DOOR LOCK NOT DISABLED

With an automatic garage door opener installed, the garage door lock should be disabled to prevent damage if raised automatically with the door locked.

Recommendation
Contact a qualified professional.

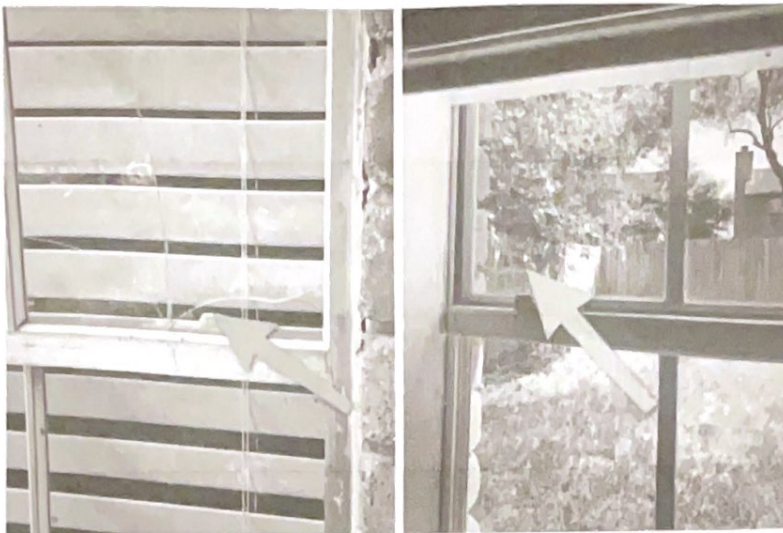
2.8.1 H. Windows

BROKEN OR CRACKED WINDOW

REAR LEFT WINDOW

Recommendation
Contact a qualified professional.

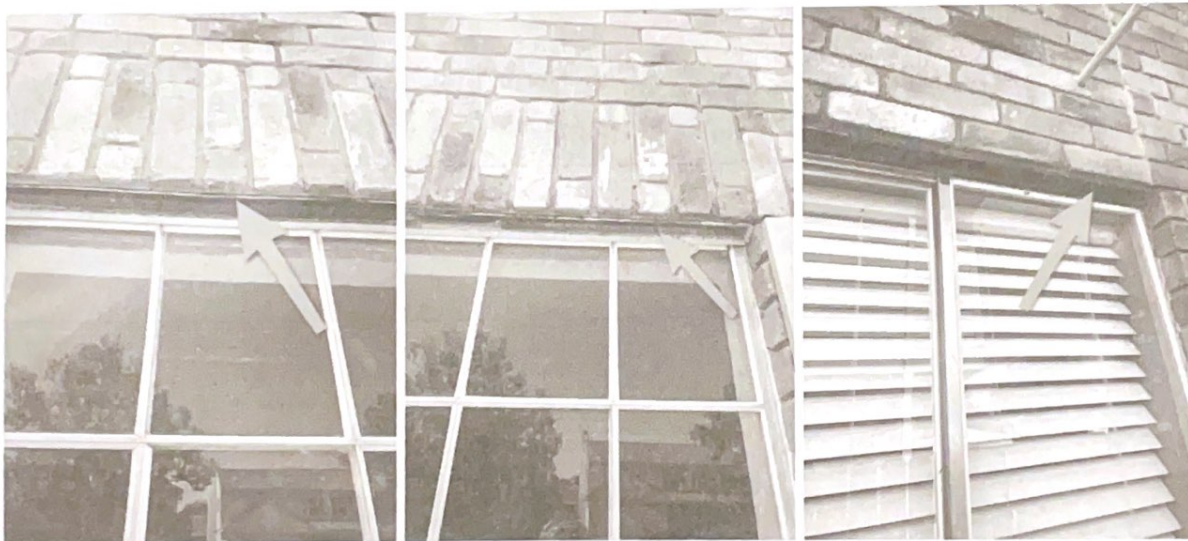
2.8.2 H. Windows

RUSTED WINDOW LINTEL

Observed Rusted door lintel exposed to water and moisture in one or more areas. Recommend sealing to prevent lintel from rusting out further and expanding causing issues in the future. Recommend properly sealing and monitoring .

Recommendation
Contact a qualified professional.

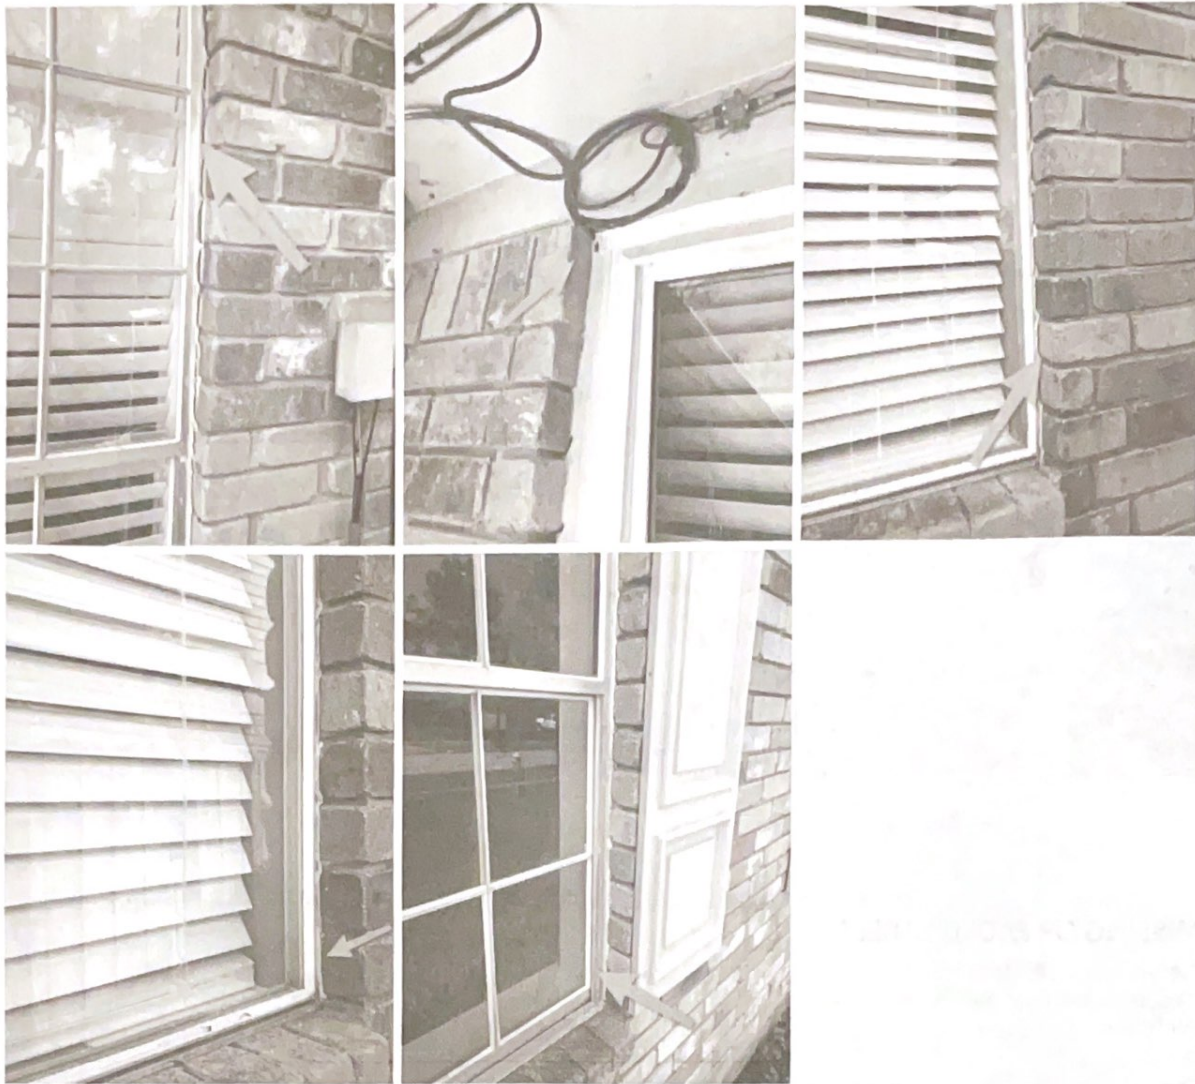
2.8.3 H. Windows

CAULKING IMPROVEMENTS NEEDED

Observed caulking improvements needed around several windows

Recommendation
Contact a qualified professional.

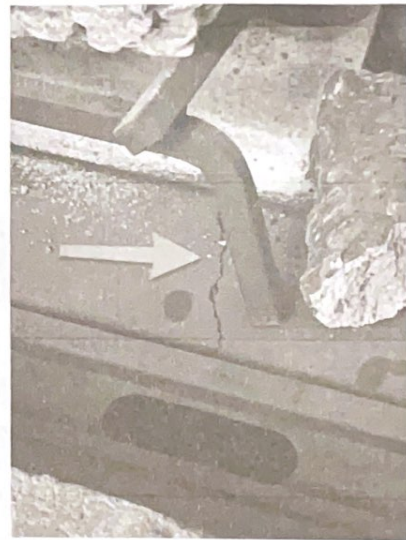
2.10.1 J. Fireplaces and Chimneys

HEARTH NEEDS REPAIR

CRACK IS ON THE HEARTH INSIDE OF THE CHIMNEY.

Contact a qualified professional.

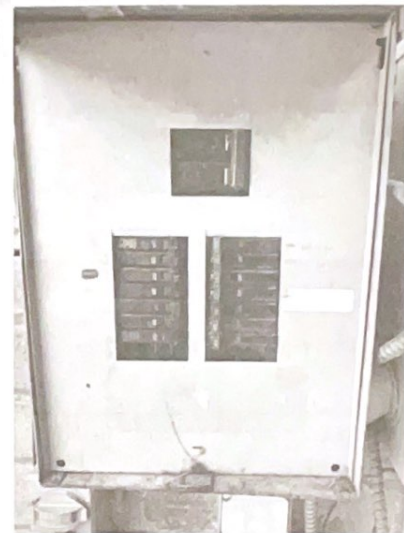
3.1.1 A. Service Entrance and Panels
MISSING OR FADED LABELS

Electrical panel does not have labels or labels are too faded to read. Recommend a qualified electrician test and properly label all switches.

Recommendation
Contact a qualified electrical contractor.

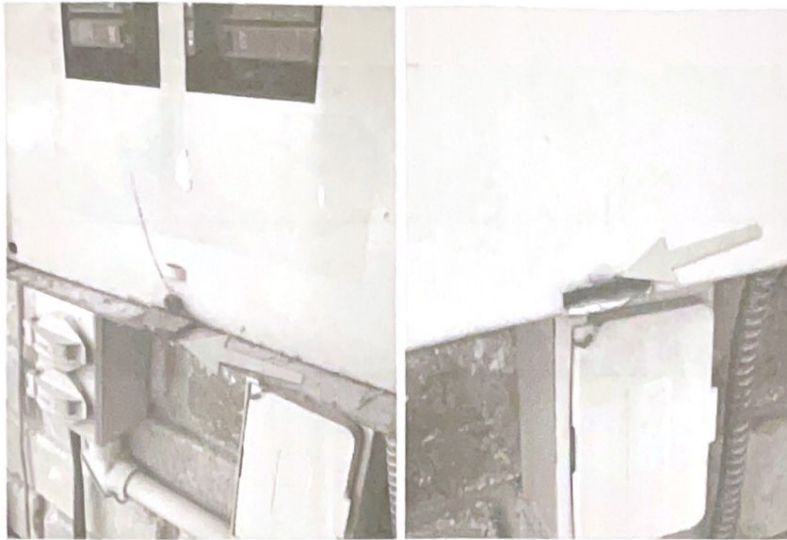
3.1.2 A. Service Entrance and Panels
PANEL DAMAGED

Electrical panel is damaged. Recommend a qualified electrician evaluate and repair.

Recommendation
Contact a qualified electrical contractor.

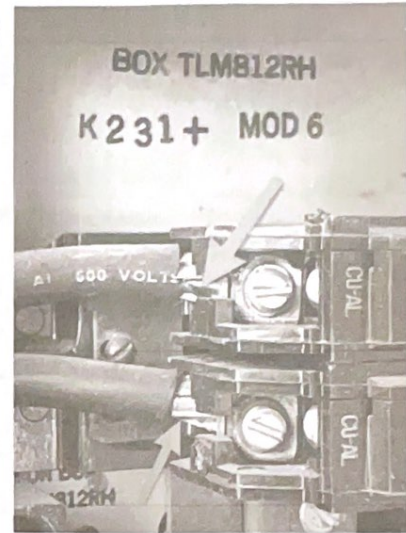
3.1.3 A. Service Entrance and Panels
NO ANTI OXIDANT GEL

Anti-oxidant compound did not appear to be present on the main service connectors. The Texas Real Estate Commission (TREC) recommends that Anti-oxidant compound be applied to all aluminum wires in the main panel.

Recommendation
Contact a qualified electrical contractor.

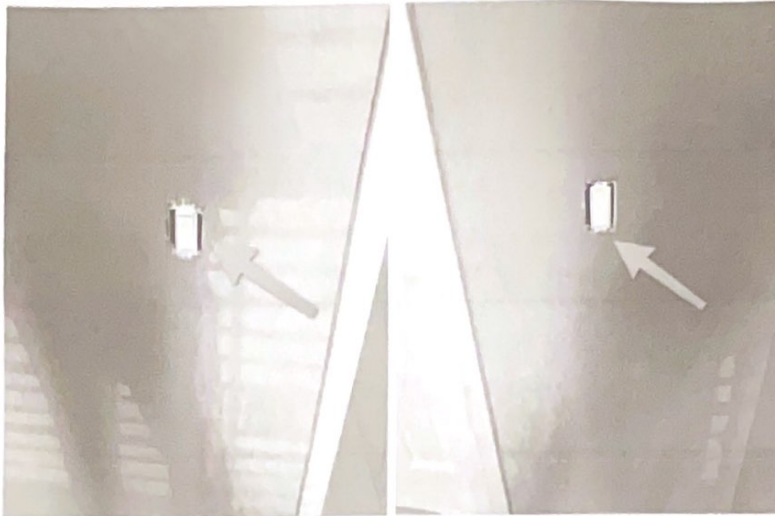
3.2.1 B. Branch Circuits, Connected Devices, and Fixtures

COVER PLATES MISSING

One or more receptacles are missing a cover plate. This causes short and shock risk. Recommend installation of plates.

Recommendation
Contact a qualified electrical contractor.

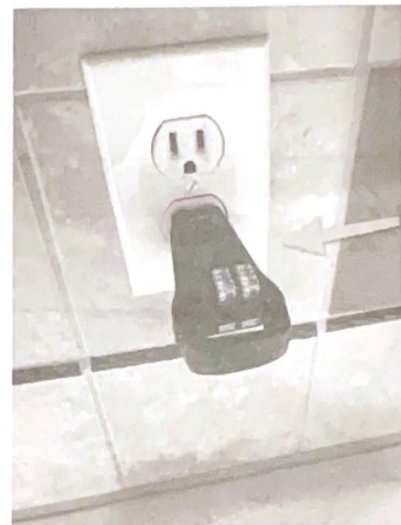
3.2.2 B. Branch Circuits, Connected Devices, and Fixtures

NO GFCI PROTECTION

KITCHEN

No GFCI protection present in the following locations:

Recommend licensed electrician upgrade by installing ground fault receptacles in all locations.

Recommendation
Contact a qualified electrical contractor.

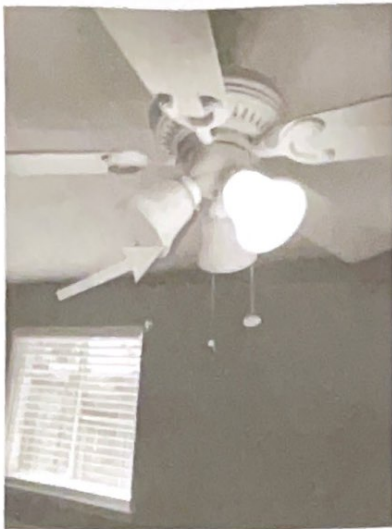
3.2.3 B. Branch Circuits, Connected Devices, and Fixtures

MISSING LIGHT BULBS

Recommendation
Contact a handyman or DIY project

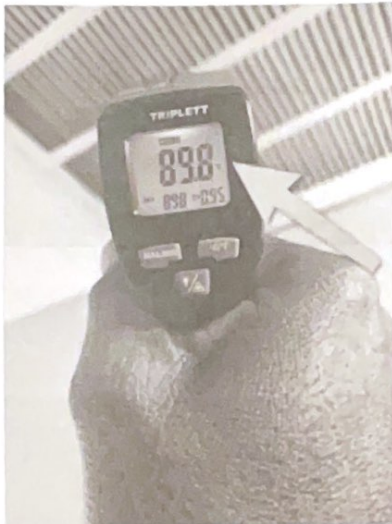
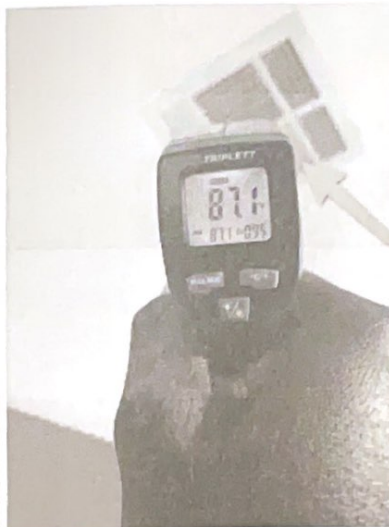
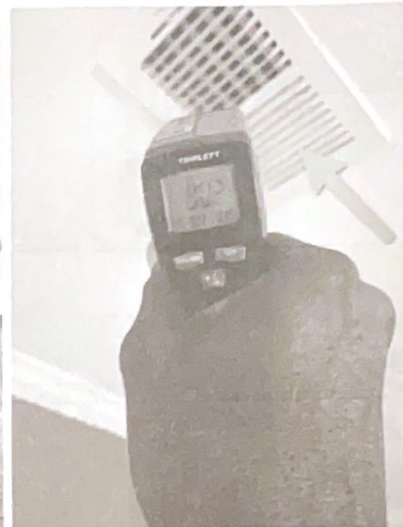
4.2.1 B. Cooling Equipment
FAILED TO PRODUCE COLD AIR

The air conditioner was functional but did not produce cold air. Recommend licensed HVAC contractor evaluate.

Return Register

Living Room Register

Fireplace Room

→ Service was done after inspection was done. Invoice'll be provided

Recommendation
Contact a qualified HVAC professional.

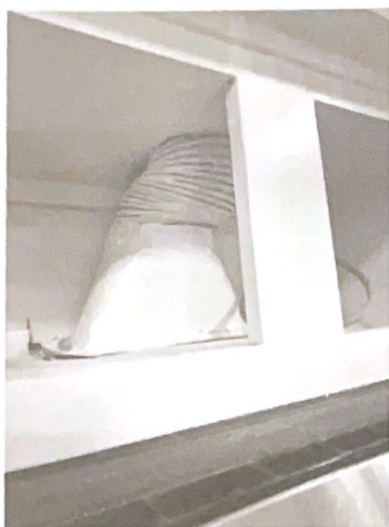
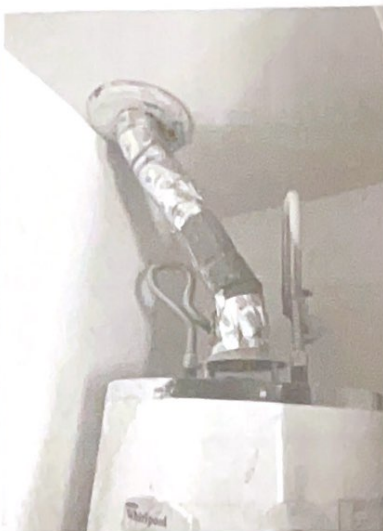
4.3.1 C. Duct Systems, Chases, and Vents

IMPROPER VENTING

One or more areas had improper or substandard venting, which can lead to inefficient heating/cooling.

Contact a qualified professional.

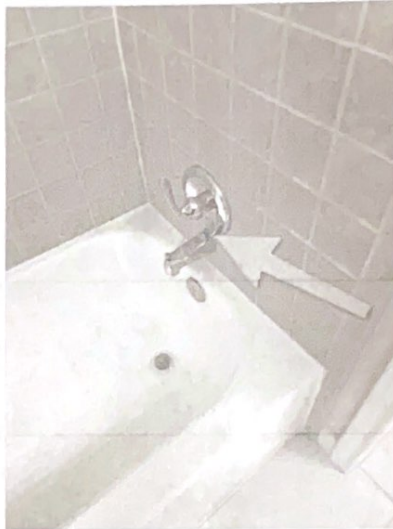
5.1.1 A. Plumbing Supply, Distribution Systems, and Fixtures

***PLUMBING PRESSURE TOO LOW**

MASTER BEDROOM TUB

Faucet pressure extremely low, Recommend plumber. DEFICIENT

Contact a qualified professional.

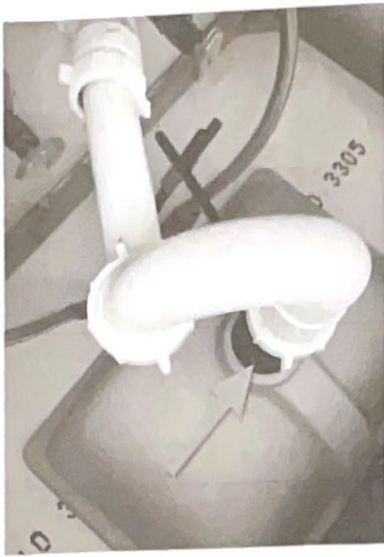
5.1.2 A. Plumbing Supply, Distribution Systems, and Fixtures

***LEAK OBSERVED**

Contact a qualified professional.

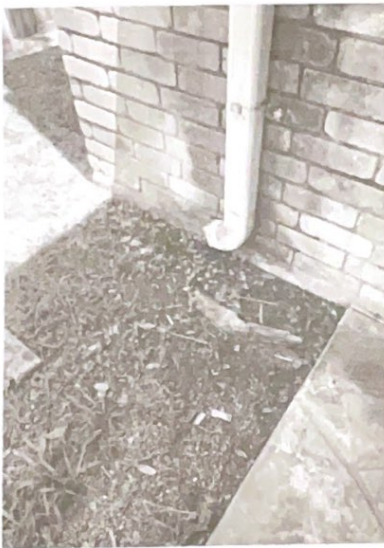
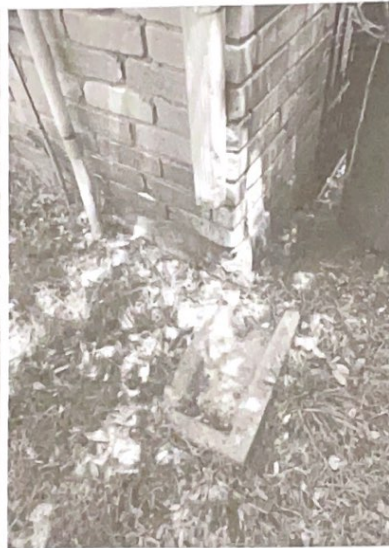
5.2.1 B. Drains, Wastes, and Vents

DOWNSPOUT EXTENSION DRAIN TOO CLOSE TO SBUILDING ENVELOPE.

Downspouts are recommended to discharge a minimum of 4-6ft away from home to prevent water damage to the structure and foundation of the home.

Contact a qualified professional.

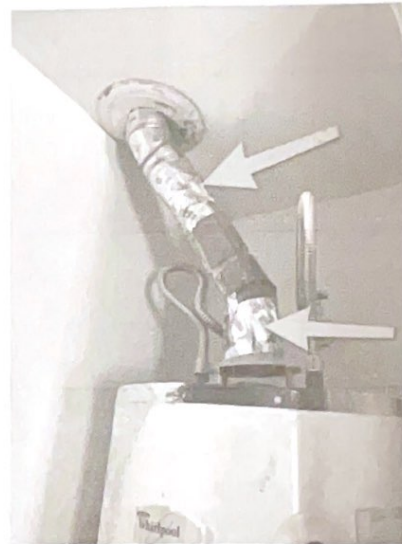
5.3.2 C. Water Heating Equipment

TAPE SHALL NOT BE USED AT GAS FLUE

Observed airtight foil tape typically used for HVAC work taped around gas water heater vent.

Contact a qualified professional.

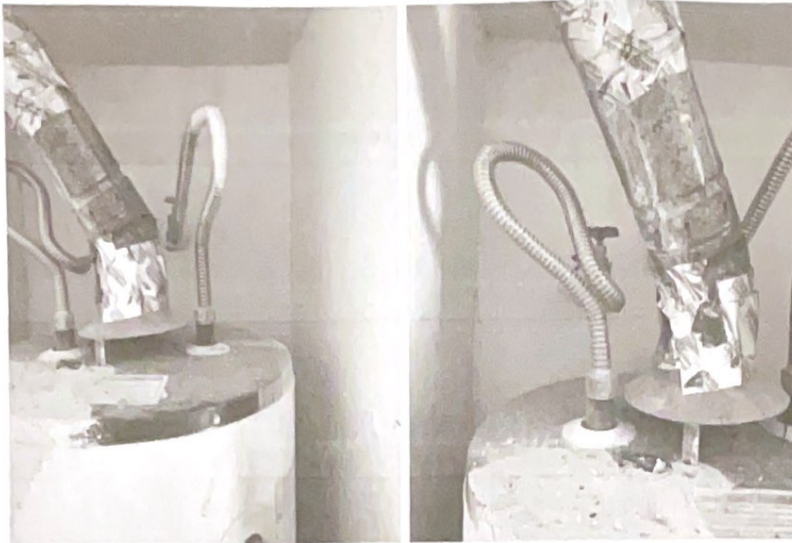
5.3.3 C. Water Heating Equipment

NOT BONDED

Observed water heater not properly bonded. It appears that the bonding wire is loose and needs to be re-fastened

Contact a qualified professional.

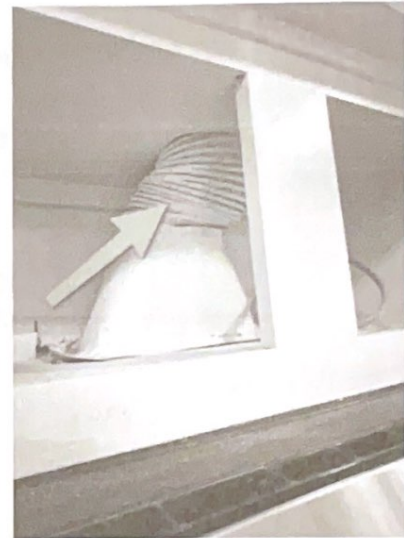
6.6.1 F. Mechanical Exhaust Vents and Bathroom Heaters

IMPROPER VENTING

Improper venting practices were noted. Recommend a qualified contractor evaluate and remedy.

Recommendation
Contact a qualified professional.
