Inspection Report

Property Address:
3521 Pearl Mill Ln
Conroe TX 77301

PROPERTY INSPECTION REPORT

By: Reevis Coleman Schultz Texas Professional Home Inspector / Hilsher Group LLC
1/6/2022
(Name and License Number of Inspector) (Date)

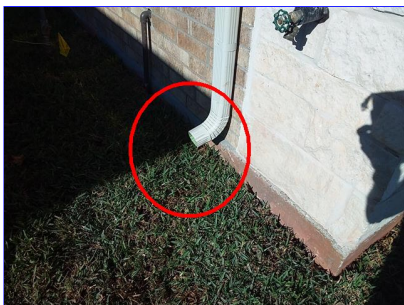
B. Item 1(Picture) left side of home x2

(1) The gutter downspout(s) missing deflector(s) at the exterior. Erosion can continue or become worse if not corrected. A qualified contractor should inspect and replace as needed.

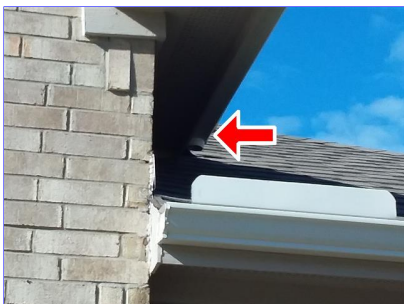
B. Item 2(Picture) roof line areas

(2) Downspouts discharges onto roofing surface in areas of the roof. Deterioration could occur if not corrected. I recommend having a qualified contractor make repairs as needed.

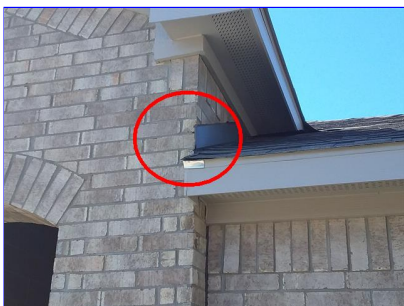
C. Item 2(Picture)

(3) Kick out flashing is missing in areas of the roof. This is not considered today's standard. I recommend having a qualified roofing company make repairs as needed.

Re-inspected 01/18/2022 The repairs do NOT appear to be adequate. The repair is either incomplete or has not been done according to standard workmanlike practice. It is recommended after a proper repair is performed that you obtain a copy of the repair contract from the seller(s). Our company does not guarantee repairs from contractors. We only re-inspect to determine whether or not repairs were performed.

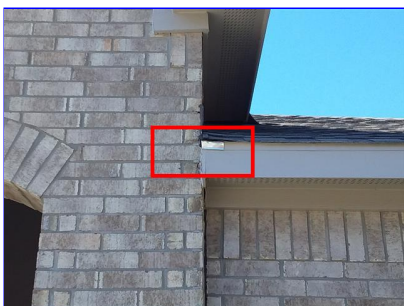
C. Item 3(Picture) front of home

(4) The metal drip edge not painted along rake/eave at the exterior areas. Deterioration may occur if not corrected. A qualified contractor should inspect and repair as needed. Gutters have been installed. Area was not visible at time of re inspection.

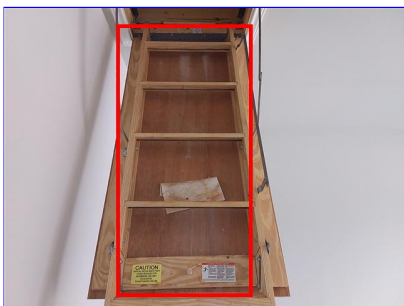
D. Item 1(Picture) garage access

(2) There is inadequate fire blocking. This is a safety hazard and should be corrected. I recommend having a qualified person repair or replace as needed.

Re-inspected 01/18/2022 The repairs do NOT appear to be adequate. The repair is either incomplete or has not been done according to standard workmanlike practice. It is recommended after a proper repair is performed that you obtain a copy of the repair contract from the seller(s). Our company does not guarantee repairs from contractors. We only re-inspect to determine whether or not repairs were performed.

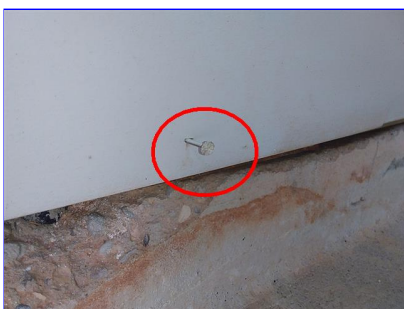
E. Item 1(Picture) inside garage

(1) Nails are protruding from drywall in areas. This is a cosmetic issue. I recommend repairs as needed.

Re-inspected 01/18/2022 The repairs do NOT appear to be adequate. The repair is either incomplete or has not been done according to standard workmanlike practice. It is recommended after a proper repair is performed that you obtain a copy of the repair contract from the seller(s). Our company does not guarantee repairs from contractors. We only re-inspect to determine whether or not repairs were performed.

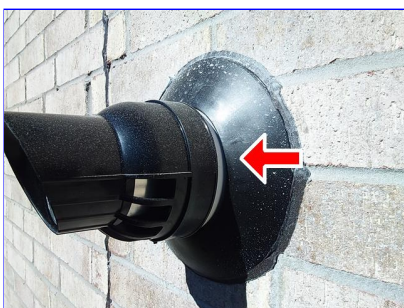
E. Item 3(Picture) left side of home

(3) Areas where wiring or piping passes through walls should be sealed. I recommend having a qualified person seal as needed.

Re-inspected 01/18/2022 The repairs do NOT appear to be adequate. The repair is either incomplete or has not been done according to standard workmanlike practice. It is recommended after a proper repair is performed that you obtain a copy of the repair contract from the seller(s). Our company does not guarantee repairs from contractors. We only re-inspect to determine whether or not repairs were performed.

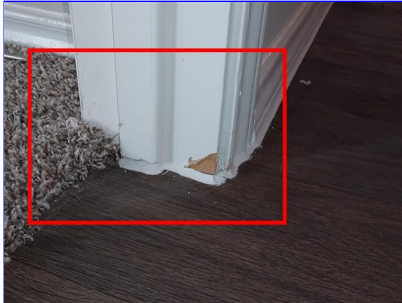
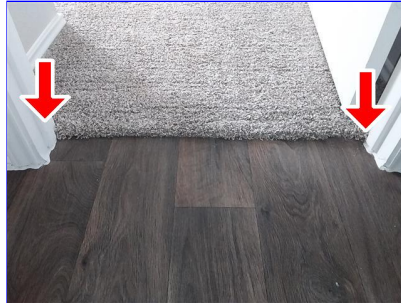
The entry door has a damaged door jamb. This is a maintenance issue and is for your information. A qualified contractor should inspect and repair as needed.

Re-inspected 01/18/2022 The repairs do NOT appear to be adequate. The repair is either incomplete or has not been done according to standard workmanlike practice. It is recommended after a proper repair is performed that you obtain a copy of the repair contract from the seller(s). Our company does not

guarantee repairs from contractors. We only re-inspect to determine whether or not repairs were performed.

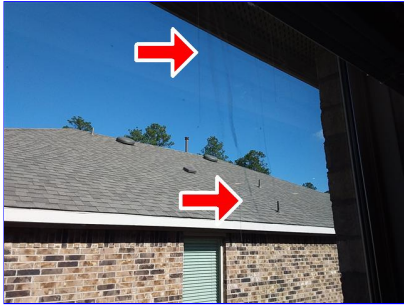
H. Item 2(Picture) living room

(2) The glazing between glass panes appear to be failing at some windows causing cloudy glass (If there are multiple windows that are the same age and style it is safe to assume others will soon start to fail as well). I recommend having a qualified person make repairs as needed.

Re-inspected 01/18/2022 The repairs do NOT appear to be adequate. The repair is either incomplete or has not been done according to standard workmanlike practice. It is recommended after a proper repair is performed that you obtain a copy of the repair contract from the seller(s). Our company does not guarantee repairs from contractors. We only re-inspect to determine whether or not repairs were performed.

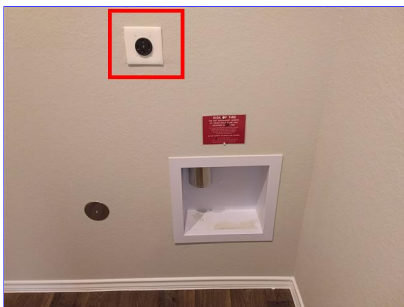
L. Item 1(Picture) laundry room

(1) Laundry room only has option for electric dryer. No gas line. This is for your information.

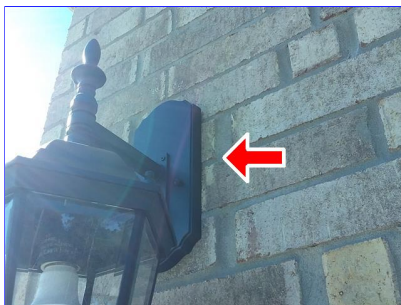
(2) Areas of the home have caulking or grout missing or damaged. Deterioration could occur if not corrected. I recommend having a qualified contractor inspect and make repairs as needed.

Re-inspected 01/18/2022 **The repairs do NOT appear to be adequate. The repair is either incomplete or has not been done according to standard workmanlike practice. It is recommended after a proper repair is performed that you obtain a copy of the repair contract from the seller(s). Our company does not guarantee repairs from contractors. We only re-inspect to determine whether or not repairs were performed.**

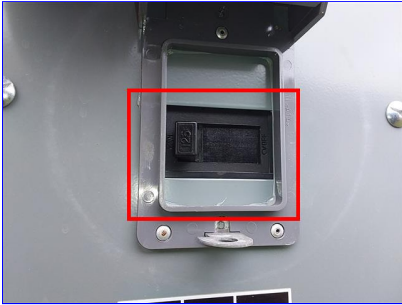
A. Item 1(Picture) 125 amp

(1) The main panel box is located at the outside. However, the main disconnect (shut-off) is outside at meter base panel (for your information).

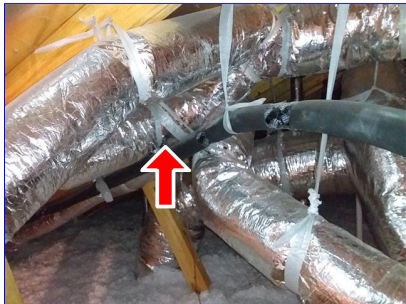
C. Item 1(Picture) multiple areas

(2) Duct piping appears to be in contact with one another in the attic space. Condensation could occur if not corrected. I recommend having a qualified HVAC contractor further evaluate and make repairs as needed.

Re-inspected 01/18/2022 The repairs do NOT appear to be adequate. The repair is either incomplete or has not been done according to standard workmanlike practice. It is recommended after a proper repair is performed that you obtain a copy of the repair contract from the seller(s). Our company does not guarantee repairs from contractors. We only re-inspect to determine whether or not repairs were performed.

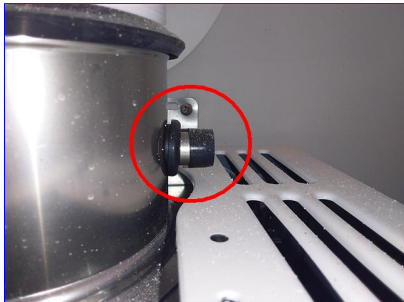
C. Item 2(Picture)

(2) Condensation drain line is not installed at time of inspection process. I recommend having a qualified plumber inspect and repair as needed.

Re-inspected 01/18/2022 **The repairs do NOT appear to be adequate. The repair is either incomplete or has not been done according to standard workmanlike practice. It is recommended after a proper repair is performed that you obtain a copy of the repair contract from the seller(s). Our company does not guarantee repairs from contractors. We only re-inspect to determine whether or not repairs were performed.**

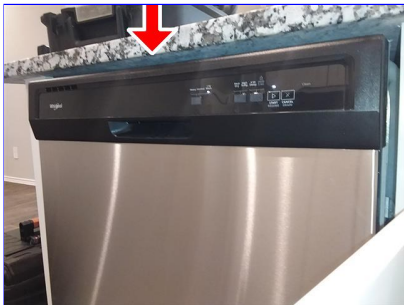
A. Item 1(Picture)

- (1) Tested and working properly at the time of inspection.
- (2) The dishwasher does not have a wall switch to prevent children from operating. I recommend repair as necessary.

Re-inspected 1/18/2022 The repairs do NOT appear to be adequate. The repair is either incomplete or has not been done according to standard workmanlike practice. It is recommended after a proper repair is performed that you obtain a copy of the repair contract from the seller(s). Our company does not guarantee repairs from contractors. We only re-inspect to determine whether or not repairs were performed.

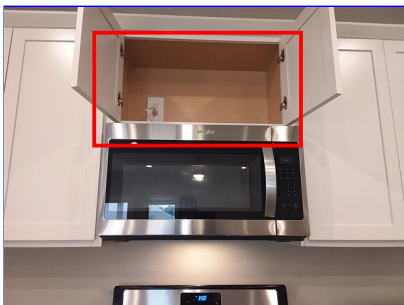
C. Item 1(Picture)

The kitchen vent hood does not vent to the outdoors. This is not considered to be today's standard.

Re-inspected 01/18/2022 The repairs do NOT appear to be adequate. The repair is either incomplete or has not been done according to standard workmanlike practice. It is recommended after a proper repair is performed that you obtain a copy of the repair contract from the seller(s). Our company does not guarantee repairs from contractors. We only re-inspect to determine whether or not repairs were performed.

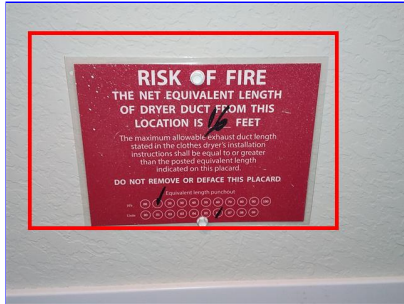
H. Item 1(Picture) laundry room

The dryer vent piping is long and vertical which can trap lint at elbow. Vent pipes should be cleaned regularly if they are longer than normal (10 feet or more) or vented vertically. I recommend repair as needed.
