RESIDENTIAL INSPECTION REPORT

18331 Enchanted Rock Trail
Humble, TX 77346

PROPERTY INSPECTION REPORT

Concerning: 18331 Enchanted Rock Trail, Humble, TX 77346

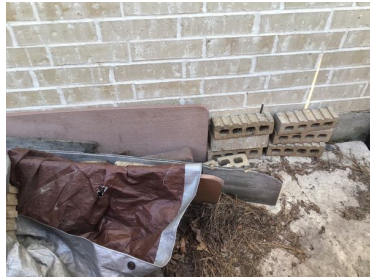
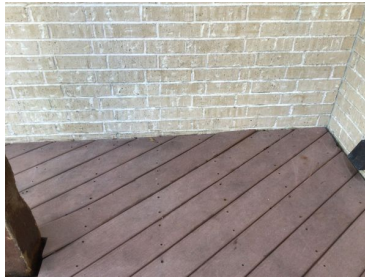
1: Slab: Shear Cracks

Note: Shear cracking ("corner pops") observed at foundation corners is not normally associated with structural movement or deficiencies.

Recommendation: Contact a handyman or DIY project

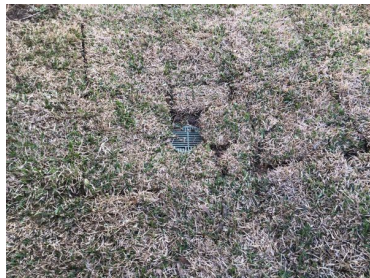
1: Gutters & Downspouts: Missing Splash Blocks

A splash block placed beneath the downspout elbow helps to disperse water away from the foundation and to prevent soil erosion. Remedy as needed.

Recommendation: Recommended DIY Project

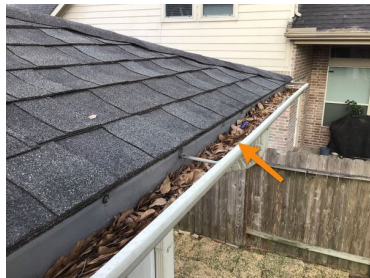
2: Gutters & Downspouts: Clogged

Clear gutters of debris to improve drainage. Badly clogged gutters can cause water to back up under the roof covering and cause damage.

DONE as per Seller

Recommendation: Contact a qualified landscaping contractor

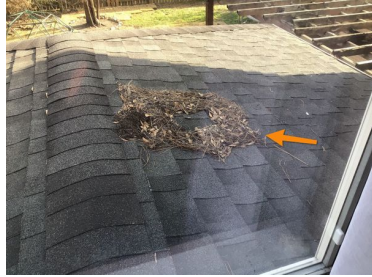
2: Debris on roof

Debris was present on roof surface. The condition of the roof covering underneath could not be determined. Removal of debris and evaluation of the roofing materials underneath is recommended.

Recommendation: Contact a qualified professional.

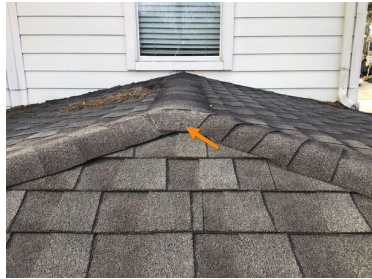
3: Exposed fasteners

Exposed fasteners were observed. Seal as needed to prevent moisture intrusion.

DONE as per seller

Recommendation: Contact a qualified roofing professional.

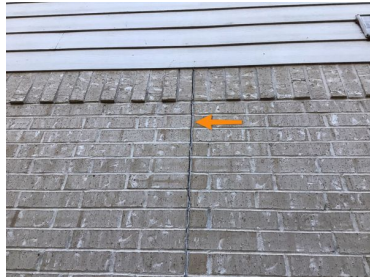
2: Exterior Masonry: Seal Expansion Joints

Sealant in the expansion joints is missing or has deteriorated. Remedy as needed.

Recommendation: Contact a qualified masonry professional.

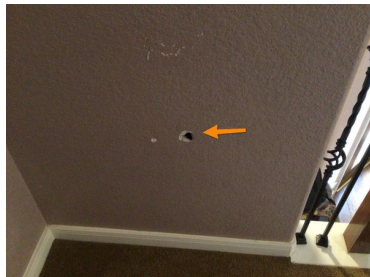
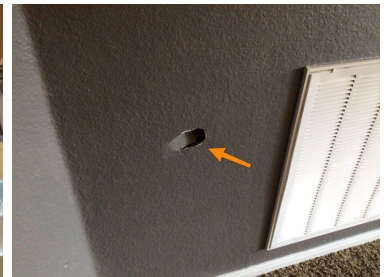
3: Interior: Damaged Drywall (or other wall covering)

Damaged Drywall (or other wall covering) was observed. Remedy as needed to prevent pest intrusion and energy loss.

DONE as per seller

Recommendation: Contact a qualified professional.

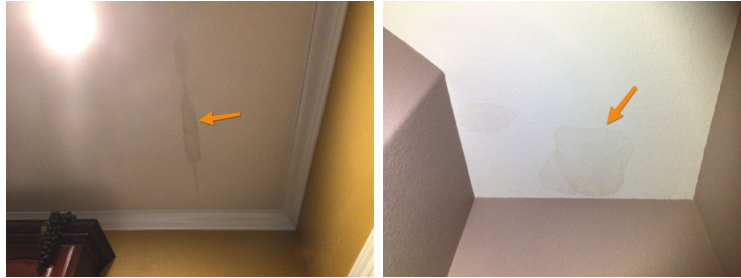
1: Ceiling: Evidence of Previous Moisture Contact

Wall structure showed signs of previous water intrusion. Tested negative for moisture at the time of the inspection. Evaluate and remedy as needed.

Recommendation: Contact a qualified professional.

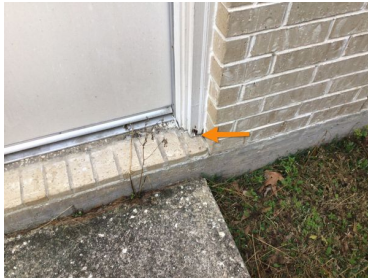
1: Door: Wood Rot at Base of Frame

Wood rot was observed at the base of a door frame. Remedy as needed.

Recommendation: Contact a qualified handyman.

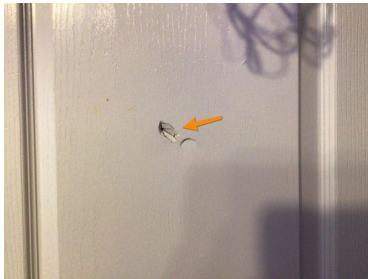
2: Door: Damaged

Evaluated and remedy as needed

DONE as per seller

Recommendation: Contact a qualified door repair/installation contractor.

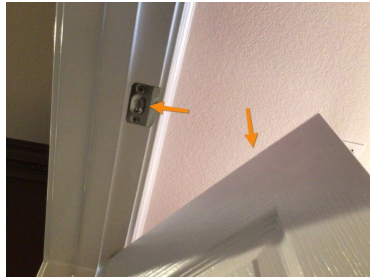
9: Garage Door into Living Space: Self-Closing Mechanism not Present/Operable

Entry door between the garage and living space should have a functioning self-closing mechanism.

Recommendation: Contact a qualified professional.

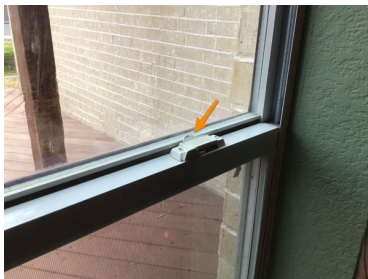
3: Hardware: Missing or Damaged

Window hardware was missing or damaged. Remedy as needed.

Recommendation: Contact a qualified window repair/installation contractor.

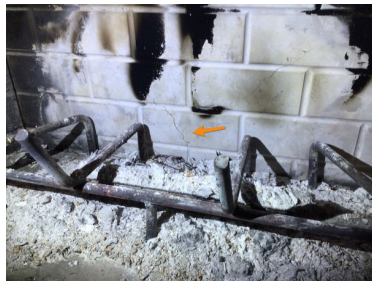
2: Firebox: Masonry Deterioration

Masonry at the firebox was cracked, damaged, and/or deteriorated.

Recommendation: Contact a qualified professional.

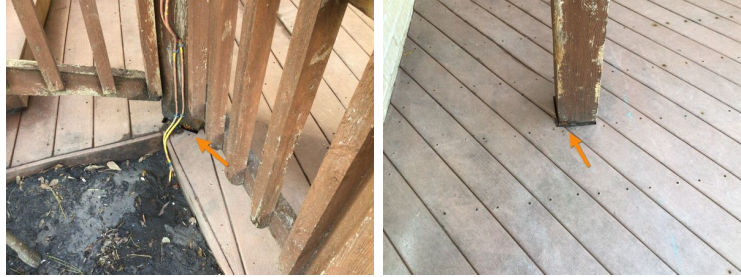
One or more deck boards are rotted. Evaluation and/or repair by a qualified deck contractor is recommended.

Recommendation: Contact a qualified deck contractor.

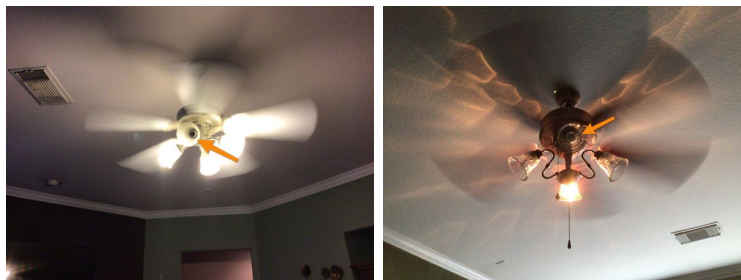
3: Light: Inoperable

One or more light fixtures were not operating at time of inspection. Cause was not determined. Remedy as needed.

DONE as per seller

Recommendation: Contact a qualified electrical contractor.

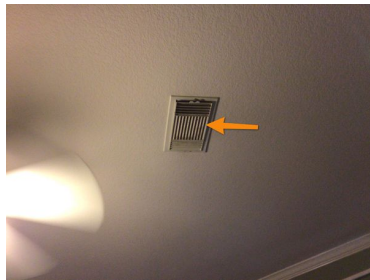
3: Visible substance observed on Supply Register **DONE** as per seller.
 Recommendation Full house dust cleaning performed

A dark substance was observed on an air supply register in the home. Servicing and cleaning of the system by a qualified HVAC contractor is recommended, as this can be a result of excessive water vapor/humidity in the conditioned air.

Recommendation: Contact a qualified HVAC professional.

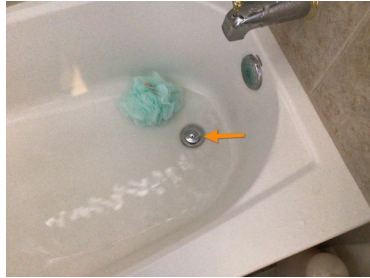
2: Drain piping: Slow Drains

Poor/slow drainage was observed at time of inspection. Evaluation and/or remediation by a licensed plumber is recommended.

Recommendation: Contact a qualified plumbing contractor.

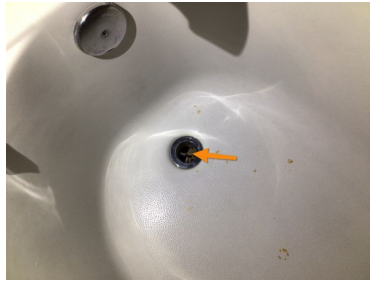
3: Damaged drain

2nd Floor Right Bathroom

Recommendation: Contact a qualified professional.

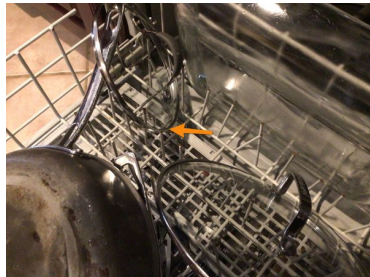
1: Rusted Dish Racks

There is evidence of rust on dishwasher racks. Evaluate and remedy as needed.

Recommendation: Contact a qualified professional.

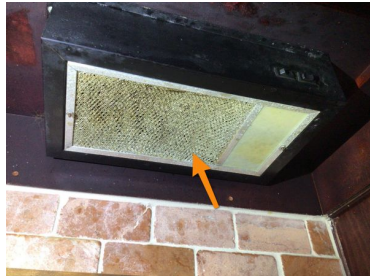
Kitchen exhaust filter had excessive grease build-up. Clean and/or replace as needed.

DONE as per seller. Replaced

Recommendation: Contact a qualified professional.

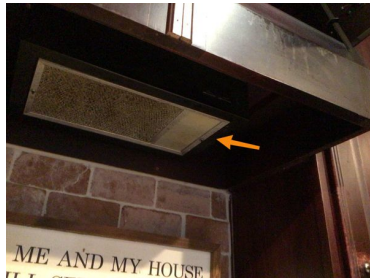
2: Exhaust Light Out

The light did not function at the kitchen exhaust. This may be the result of a bad bulb. Replace and test or remedy as needed.

DONE as per seller. Replaced

Recommendation: Contact a qualified professional.

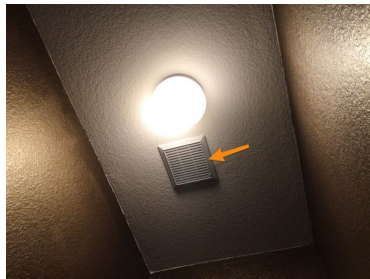
Vent fan was noisy during operation. Evaluate and remedy as needed.

Recommendation: Contact a qualified professional.

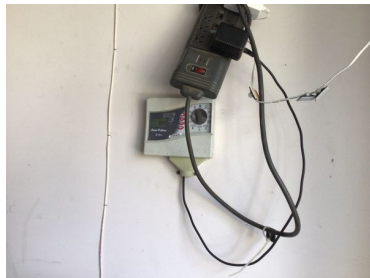
Irrigation System Equipment Photos:

Control Location: Garage

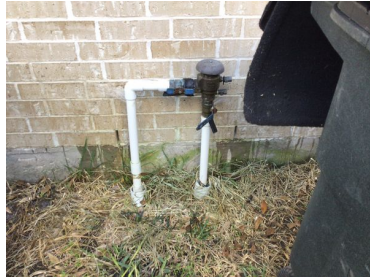
Rain sensor: Not present/Not located
Shut Off Location: At backflow prevention device
Vacuum Breaker/Backflow Preventer: Installed

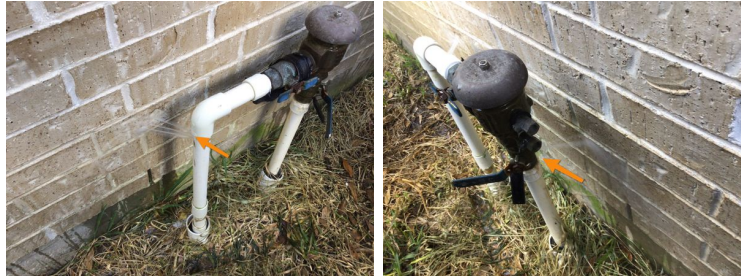
1: Leaks

Unable to operate sprinkler system due to leak:

Recommendation: Contact a qualified professional.

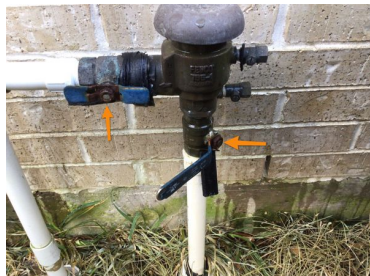
2: Rusted valve handles

One or more valve handles were rusted. Remedy as needed.

Recommendation: Contact a qualified professional.
