DOES IT ALL HOME INSPECTION, PLLC

# PROPERTY INSPECTION REPORT FORM

Michael Yaulten <i>Name of Client</i>	05/18/2022 8:00 am <i>Date of Inspection</i>
19 Cider Mill Ct, Spring, TX 77382 <i>Address of Inspected Property</i>	
Jernard McCray <i>Name of Inspector</i>	TREC #22734 <i>TREC License #</i>
<i>Name of Sponsor (if applicable)</i>	<i>TREC License #</i>

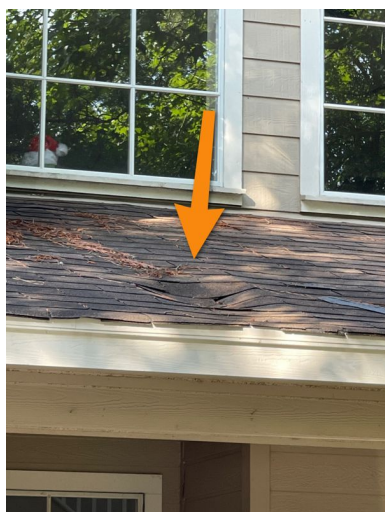
Above the front entrance of the home

Observed one or more areas of the roof that appears to be sagging.

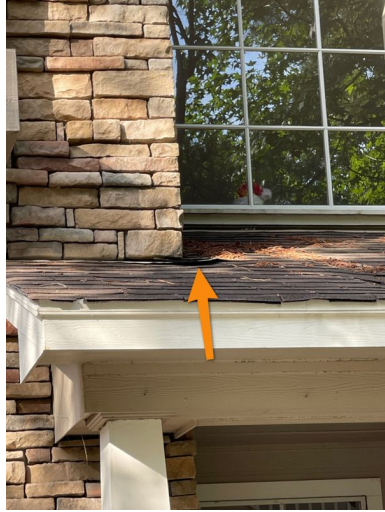
**7: Granule loss**

Deficiency

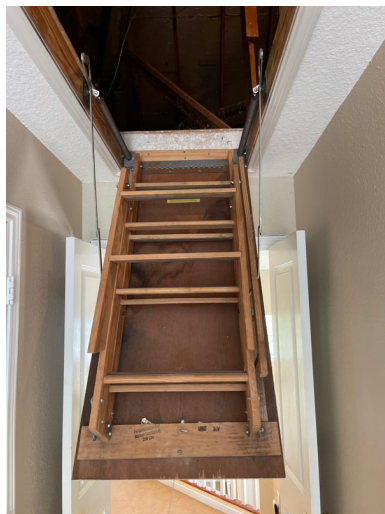
Observed the attic stairs are not properly insulated and/or weather stripped to seal when closed.

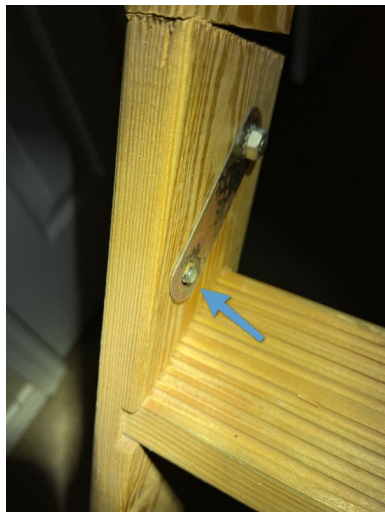
Observed loose/missing nuts, bolts or fasteners in the hinges and steps of the folding attic stairs.

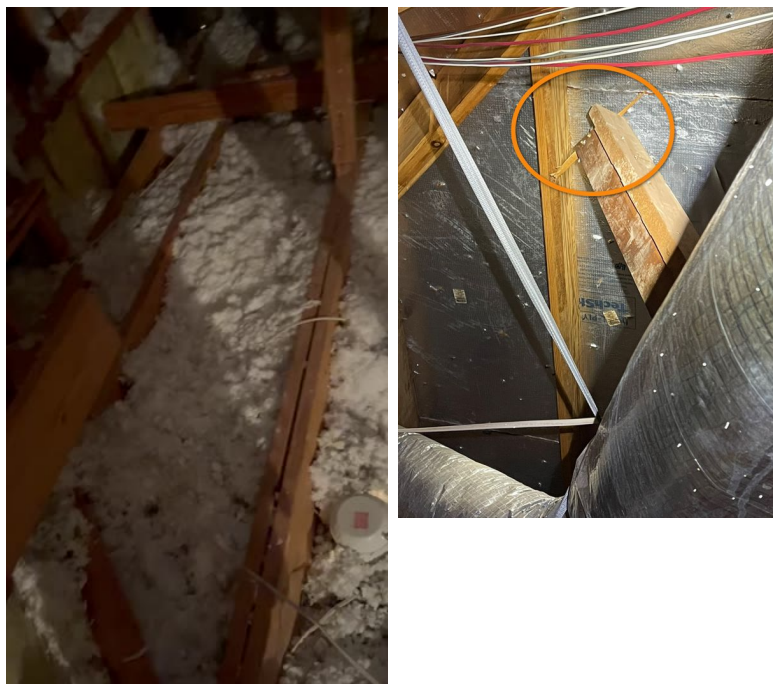
Observed at least one cracked, broken, or otherwise damaged rafters of the roof structure/framing

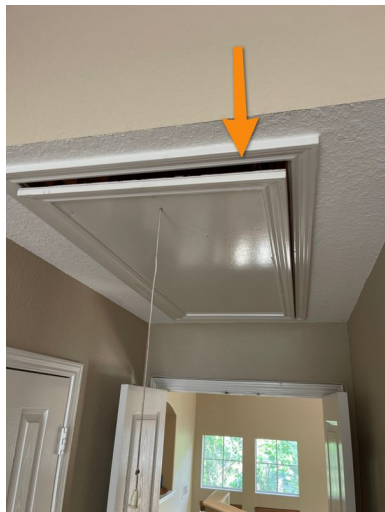
**7: Improper fasteners being used at the access ladder opening**

🚩 Deficiency

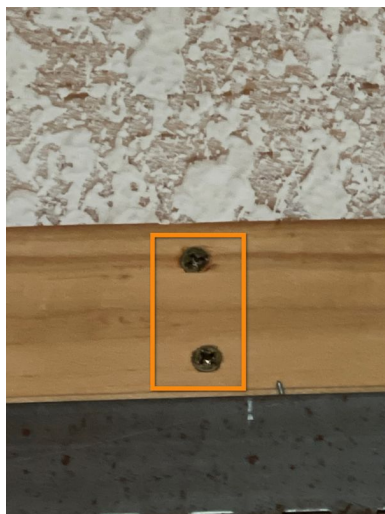
Improper fasteners being used at the access ladder opening. The recommended fasteners to be used in this area should be lag bolts or 16 D penny nails

Recommendation: Contact a qualified professional.

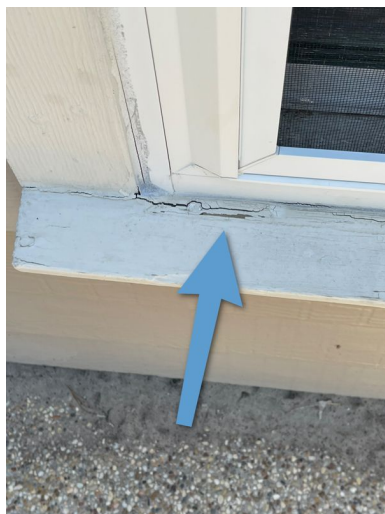
Observed one or more areas of the exterior walls where the paint is chipping or peeling.

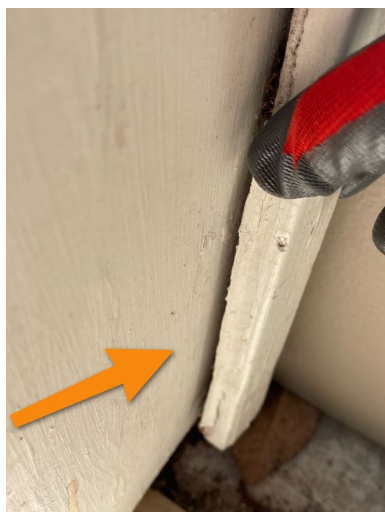
Overhead garage door frame

Loose siding/trim was observed on the exterior of the home. Recommend repairs as necessary

Recommendation: Contact a qualified handyman.

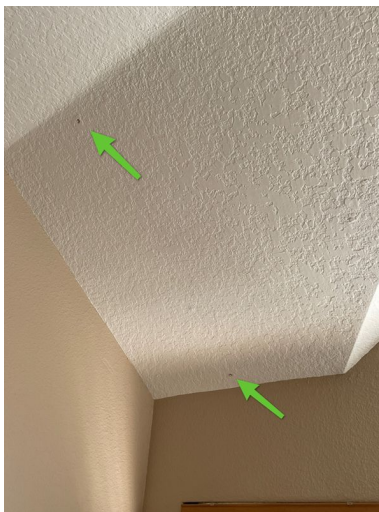
Gameroom

**1: Ceiling damage**

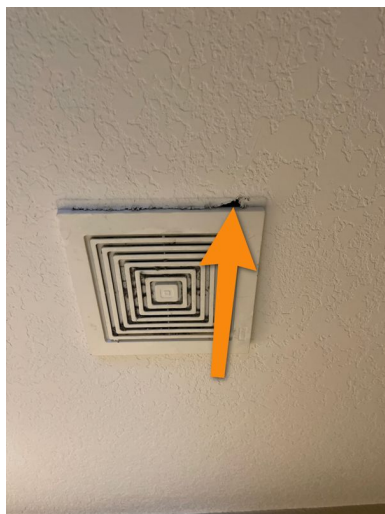
Half bath

Observed holes, cracks, or repaired areas in sheet rock ceilings. Recommend repairs

Recommendation: Contact a qualified professional.

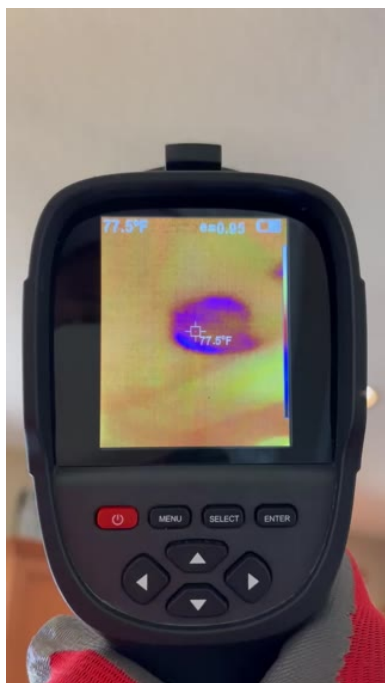
Kitchen

Observed what appears to be a water stain in the sheet rock ceiling. The stained area tested wet with a moisture meter at the time of this inspection.

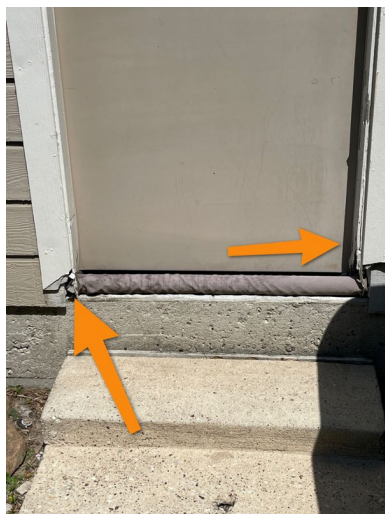
Left side

Observed wood rot in the door jam and/or casing of at least one exterior door. Recommend repairs/replacing the damaged door(s) and/or framing

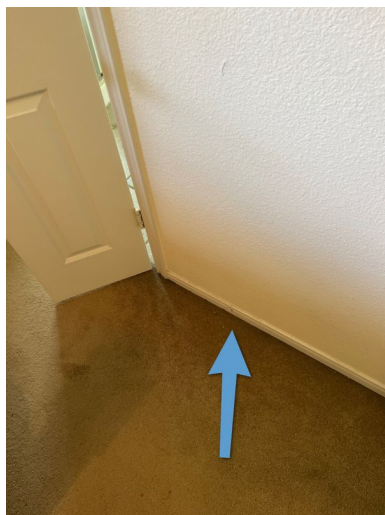
Observed one or more door stops are missing, out of place, or over ridden by the door.

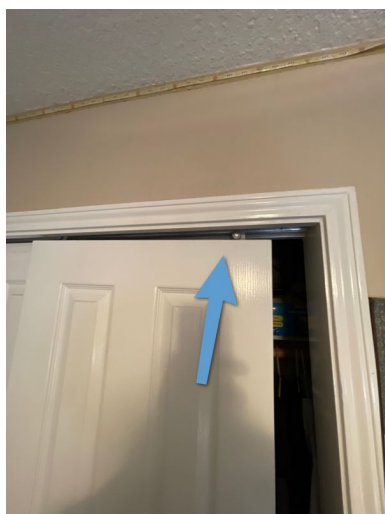
Upstairs Front Left Bedroom Closet

Closet door off track/ missing flooring assembly

Recommendation: Contact a qualified professional.

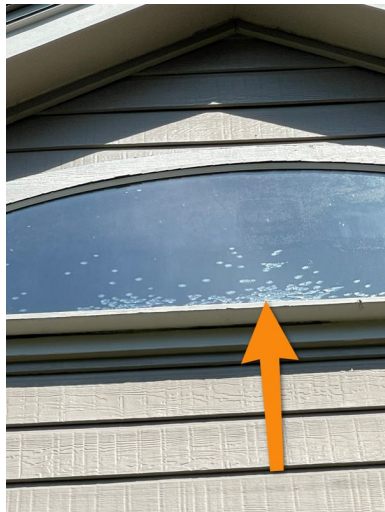
UV film is damaged on the windows. This film when damaged has a rainbow look to it, it does not directly affect the energy efficiency of the window however it make the window be unclear which can be annoying and there is no real way to repair it besides replacing the window that I am aware of.

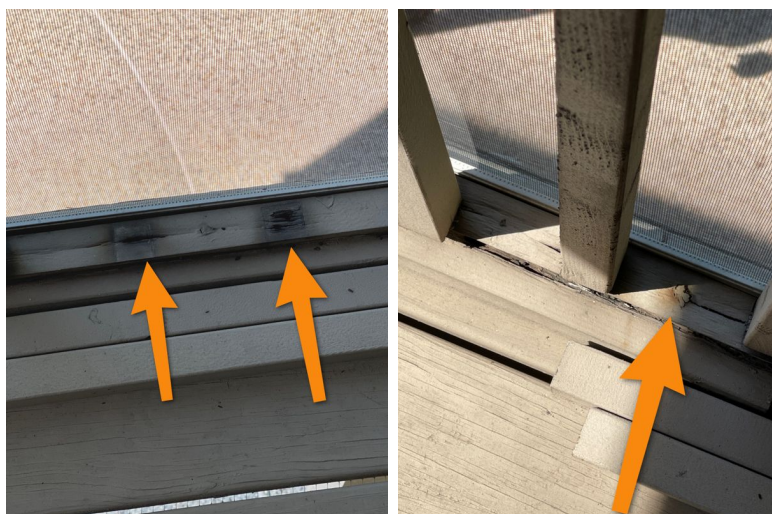
One or more deck boards are showing signs of wood decay/rot. Recommend replacing damaged wood

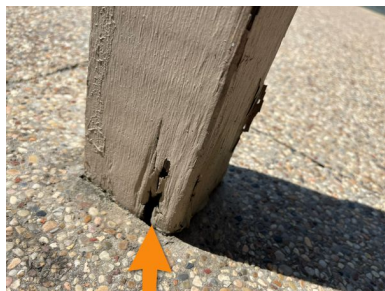
Back Patio

Wood decay was observed on the columns/post. Recommend replacement and/or repairs

Recommendation: Contact a qualified professional.

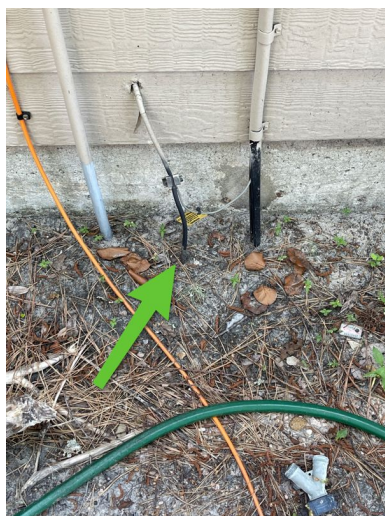
*Type of Feeder Wires found in main and sub panels: Aluminum*  
*Ground connection buried:*  
The connection of the grounding wire to the grounding rod is buried below grade.

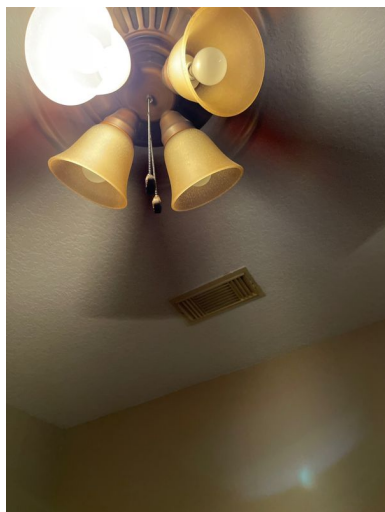
Downstairs Left side room

One or more lights are not operating. New light bulb possibly needed. If changing the bulbs does not fix the problem, recommend further evaluation by a licensed electrician

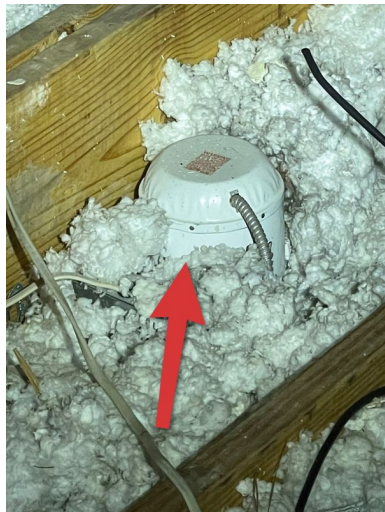
Observed can lights in contact with insulation within the attic. It was not readily apparent if the were rated for contact with insulation. This is a potentially fire hazard and combustible materials should be move back at a minimum of 3” from the light fixture.

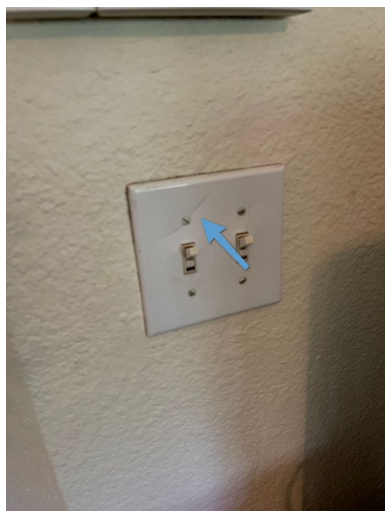
Primary Bedroom

**7: Cover Plates Damaged**

One or more receptacles/switches have a damaged cover plate.

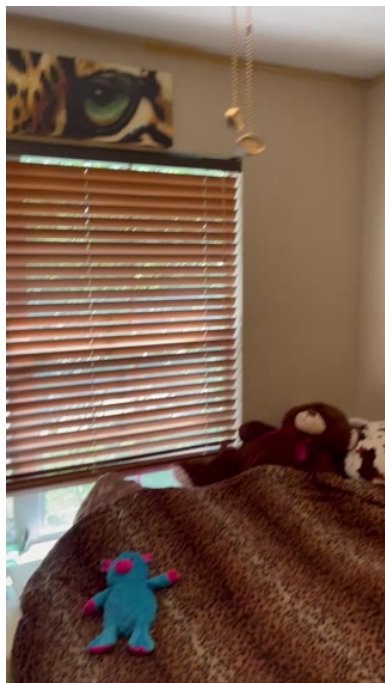
Pull string for light fixture is catching in the home. Recommend repairs to ensure that the light is functioning as intended

Recommendation: Contact a qualified professional.

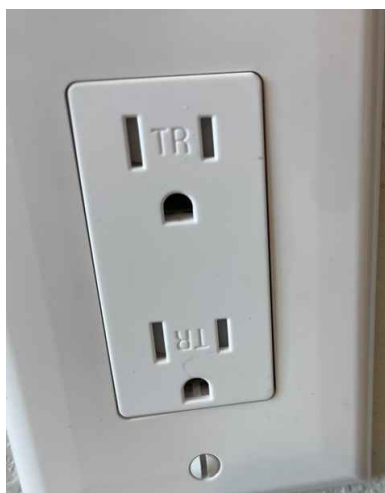
**11: Not all outlets in the home within 5 feet of the flooring are tamper resistant**

Per today’s standards all outlets within 5 feet of the flooring are required to be tamper resistant. This may not have been standard when this home was constructed. One of the ways to identify this type of outlet is by the “TR” embedded on the face of the outlet

Tamper Resistant Outlet With The “TR” Embedded

Recommendation: Contact a qualified professional.

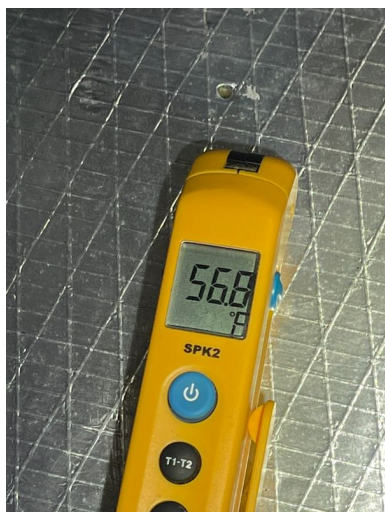
Upstairs

*Temperature Differential Between The Return & Supply Air:* Recommend having the HVAC system cleaned and serviced prior to closing, 13° -  
The temperature differential is normally expected temperature is between 15 and 21 degrees. This is where the inspector is taking a temperature reading from the supply air and subtracting it from the return air to get a total.

An air test was performed on the upstairs unit to determine the difference in temperature between the supply and return air. the recommend range should be in the range of 15 to 22 degrees. The supply air temperature on your system read 57 degrees and the return read 70 degrees. This means that the temperature difference was NOT within the recommended range. Recommend further evaluation by a licensed HVAC professional

Recommendation: Contact a qualified HVAC professional.

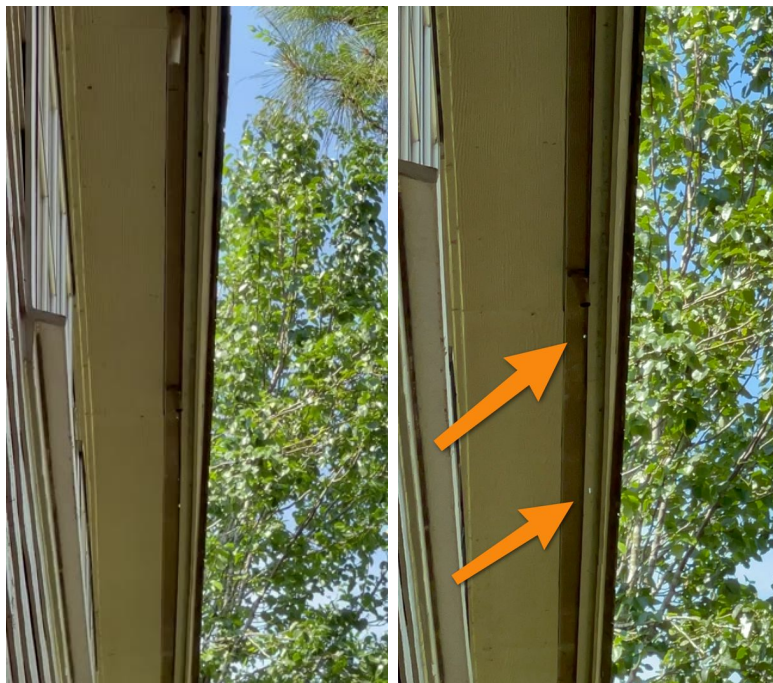
**3: Active leak at the secondary drain line**

There's an active leak on the secondary drain line which terminates on the exterior of the home. This is an indication that there is a issue with the A/C portion of the HVAC equipment. Recommend further evaluation and repairs by a licensed HVAC professional

Recommendation: Contact a qualified professional.

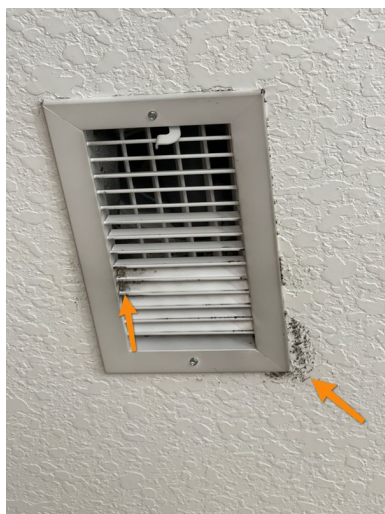
Gameroom

Organic growth was observed on the supply registries in the home. Recommend further evaluation by a licensed HVAC professional

Recommendation: Contact a qualified professional.

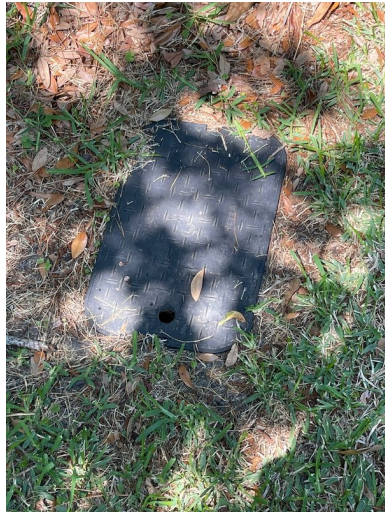
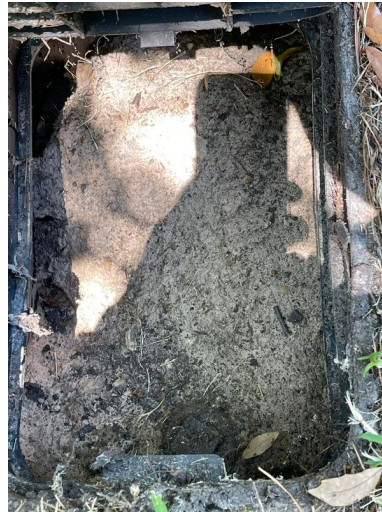
*Location of Main Water Supply Valve : Unknown  
Static Water Pressure Reading: 70 to 75 psi*

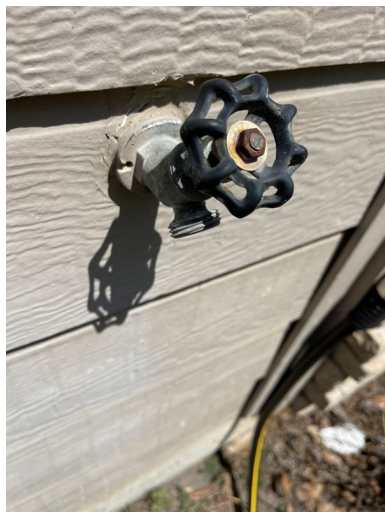
**4: Hose/outside faucet bib leaks**

Observed one or more outside faucets are leaking when turned on.

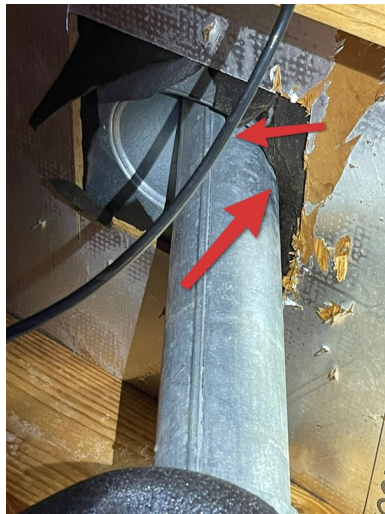
**1: Combustible material near/or in direct contact with the burner compartment**

Combustible material appears to be near/or in direct contact with the burner compartment. Recommend removing to prevent the potential of a fire hazard

Recommendation: Contact a qualified professional.

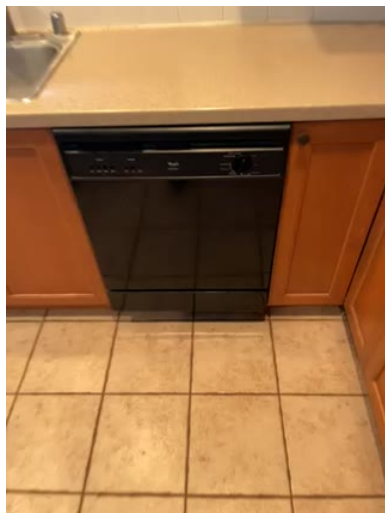
**1: Rust**

Observed the unit has rust on the racks.

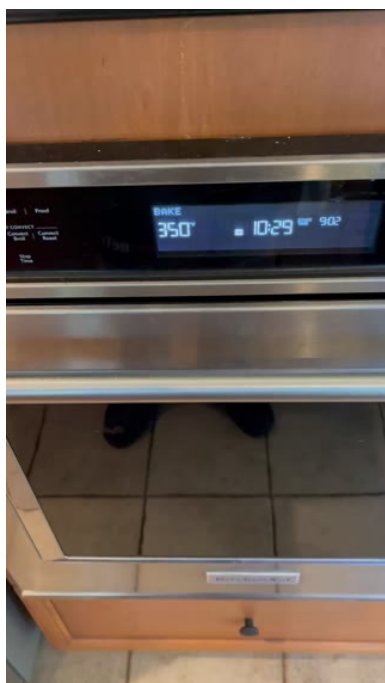
Oven temperature when set to 350 degrees: 330° -

The oven is set for 350° and a temperature reading is taking from that oven. Per standards as long as the oven reaches temperature differential within 25° it is acceptable.

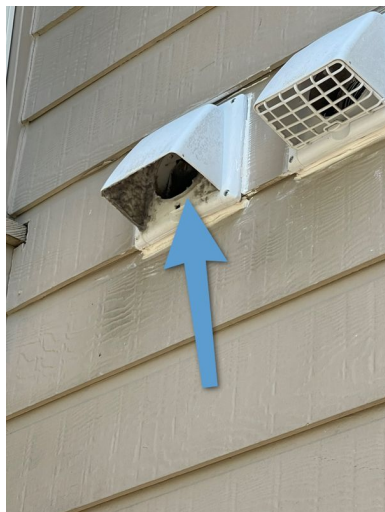
Damper flap missing and/or damaged on the exterior of the dryer vent cover. Recommend installing

Recommendation: Contact a qualified professional.

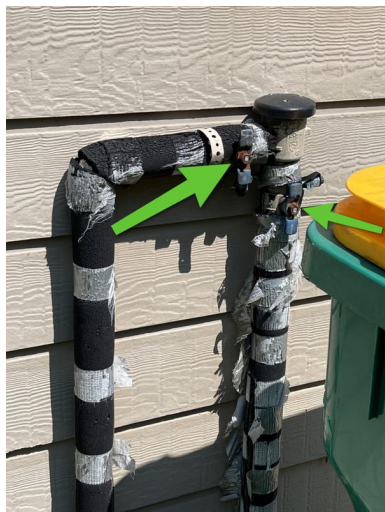
**1: Broken Sprinkler**

The sprinkler system water supply was shut off. Operation could not be tested on the day of the inspection. Recommend having the system serviced prior to closing to ensure functionality

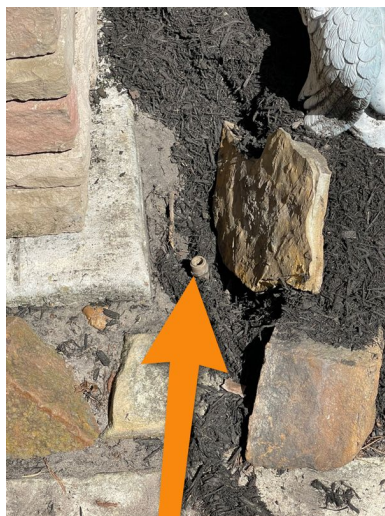
Front

Broken sprinkler/ not functioning properly heads noted on one or more zones.
