# Inspection Report

**Property Address:**  
7 Grey Birch Place  
The Woodlands TX 77381

# PROPERTY INSPECTION REPORT

**By:** Ryan Vance TREC# 21238 / Hilsher Group LLC 10/13/2020

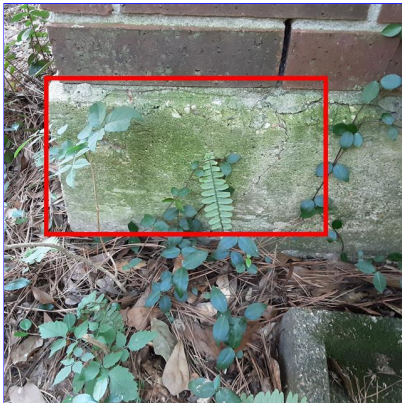
A. Item 1(Picture) Front right corner

- (1) This is not an engineering report, but is only an opinion based on observation of conditions known to be related to foundation performance, using the knowledge and experience of the inspector.
- (2) The foundation has large corner pop(s) that are larger than 4 inches. Further deterioration will occur if not corrected. I recommend having a qualified person make repairs as needed.

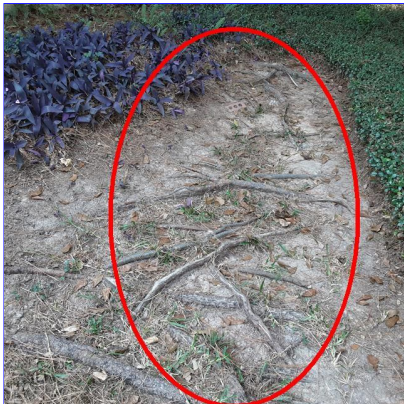
A. Item 3(Picture) Front

- (3) There are trees roots too close to the foundation. I recommend removal or the use of root diverters.

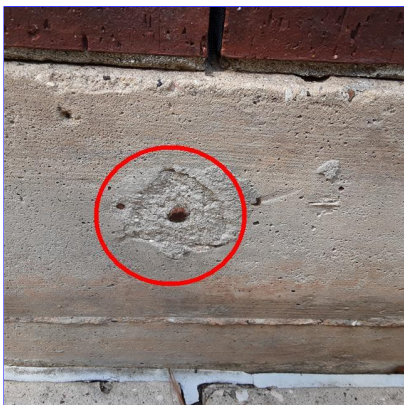
A. Item 4(Picture) Multiple on left side

(4) The foundation is poured on grade with post tension cables and appears to be performing as designed.  
(5) The post tension foundation has exposed cable ends that are starting to show signs of deterioration. This is a maintenance issue. Further deterioration will occur if not corrected. I recommend having a qualified person make repairs as needed.

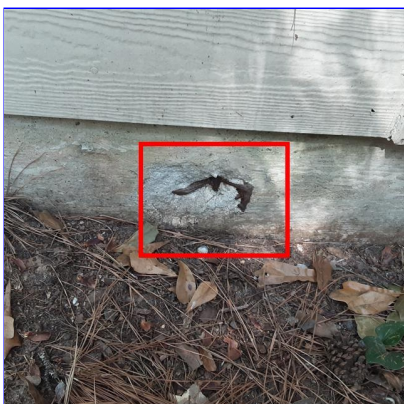
A. Item 5(Picture) Back

(6) Observed exposed steel at foundation in one or more areas. A qualified contractor should inspect further and repair or replace as needed.

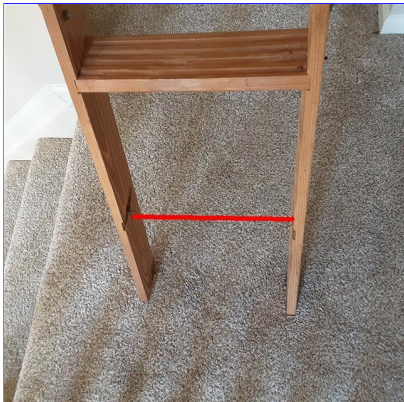
D. Item 1(Picture) Bottom step

(1) The pull down stairs missing a step and could be a tripping hazard. Injury could result if not repaired. This is a small repair. A qualified contractor should inspect and repair as needed.

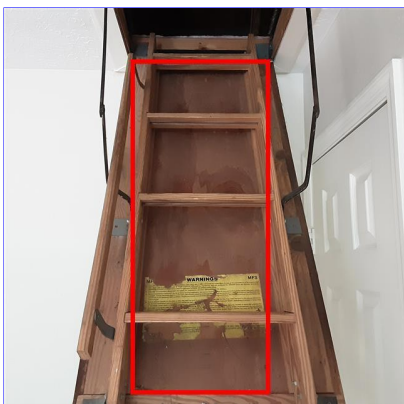
D. Item 2(Picture) Pull down stairs

(2) The pull down stairs are not properly insulated. This can cause some heat loss in winter and loss of cool air in summer if not corrected. I recommend repair as desired.

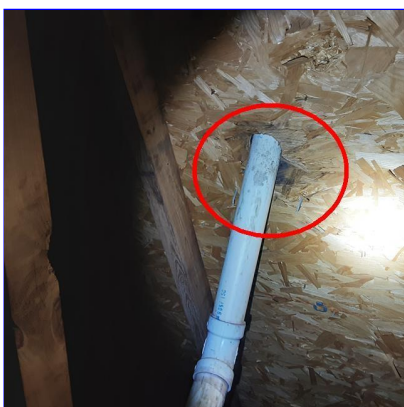
(3) Observed a water stain on roof decking in attic in one or more areas. A qualified contractor should inspect further and repair or replace as needed.

D. Item 3(Picture) Attic, east side at disconnected plumbing vent

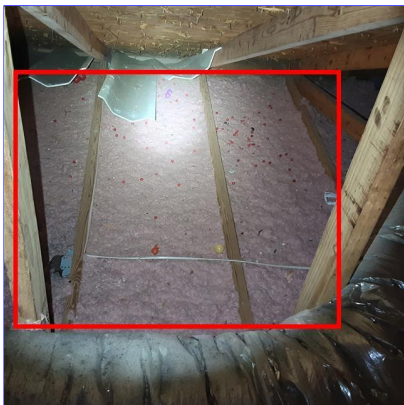
D. Item 4(Picture) Attic

(4) The attic space has area's of thin insulation. This is causing energy loss and is not today's standard. I recommend having a qualified person evaluate and add insulation as needed. Not all areas are pictured.

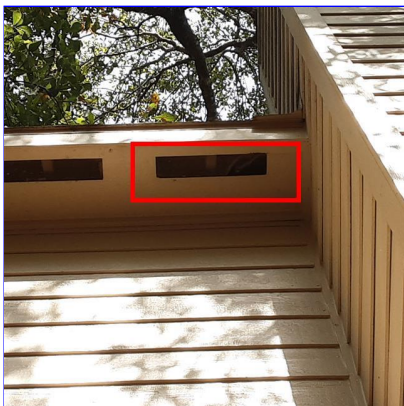
D. Item 5(Picture) Left of chimney

(5) Observed damage to soffit vent screen in one or more areas. A qualified contractor should inspect further and repair or replace as needed.

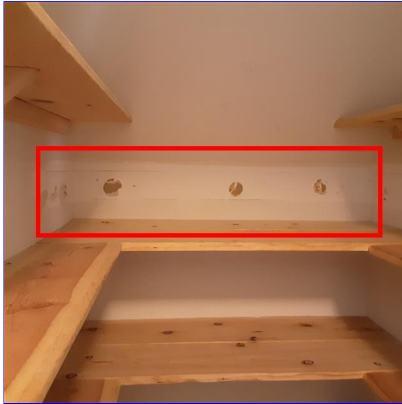
E. Item 1(Picture) Foyer closet

(1) Observed damage to one or more interior walls. A qualified contractor should inspect further and repair or replace as needed.

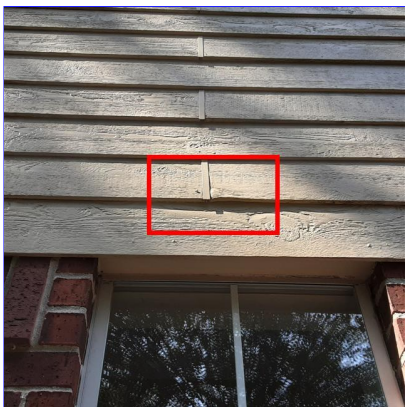
E. Item 2(Picture) Left side above bathroom window

(2) Observed wood rot or deterioration to siding in one or more areas. Further deterioration may occur if not repaired. A qualified contractor should inspect further and repair or replace as needed.

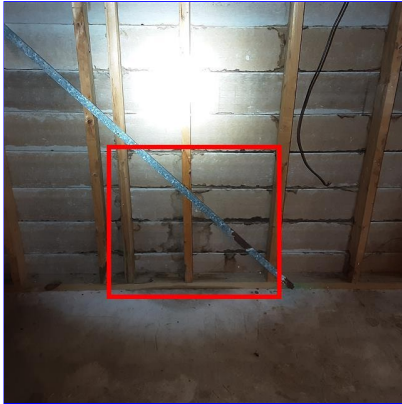
E. Item 7(Picture) Garage

(3) Observed water stains on interior walls in garage in one or more areas. Unable to determine if areas still leak. A qualified contractor should inspect further and repair or replace as needed.

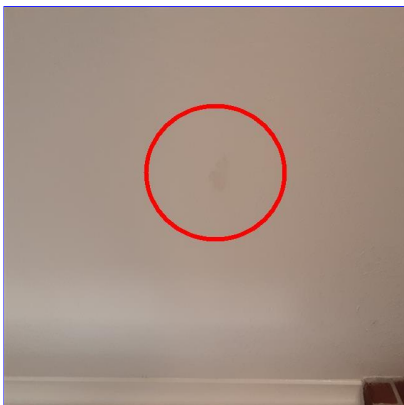
F. Item 1(Picture) Living room above exterior door

Observed a water stain on the ceiling in one or more areas. Area was dry at time of inspection when tested with thermal imaging camera and moisture detecting equipment. A qualified contractor should inspect further and repair or replace as needed.

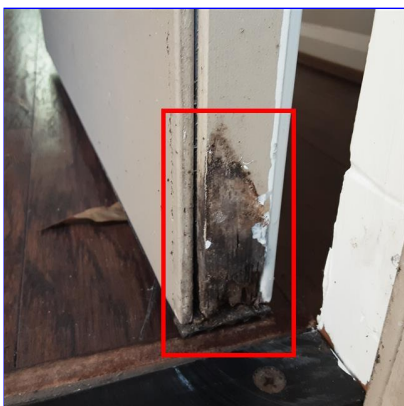
G. Item 1(Picture) Back door at living room

(1) Observed wood rot or deterioration to one or more exterior doors, jambs or frames. Further deterioration may occur if not repaired. A qualified contractor should inspect further and repair or replace as needed.

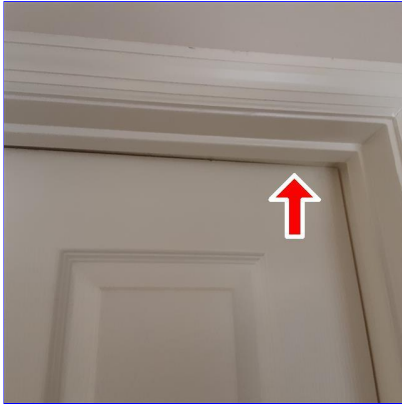
G. Item 2(Picture) 2nd floor NE guest bedroom

(2) The Privacy door needs adjustment rubs at top when closing in areas. This is a small repair. A qualified contractor should inspect and repair as needed.

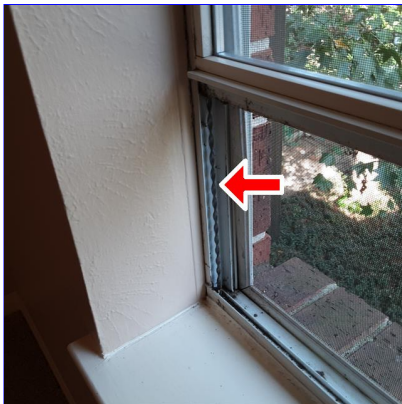
H. Item 1(Picture) Master bedroom, left window

- (1) Windows have damaged or missing screens. This is not considered to be today's standards. I recommend having a qualified person make repairs as needed.
- (2) One or more window springs are damaged. A qualified contractor should inspect further and repair or replace as needed.

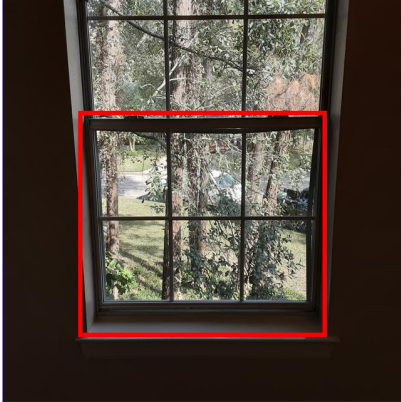
H. Item 2(Picture) Master bedroom, left window

- (3) One or more windows will not stay open. A qualified contractor should inspect further and repair or replace as needed.

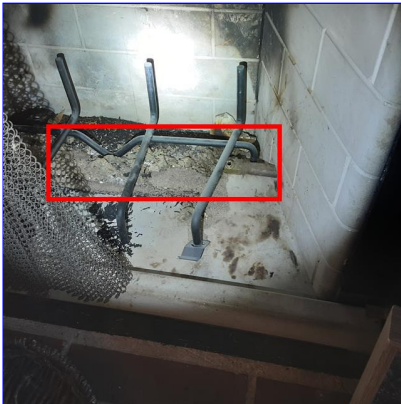
J. Item 1(Picture) Fireplace

No gas bar installed at fireplace. Unable to test operation of fireplace. A qualified contractor should inspect further and repair or replace as needed.

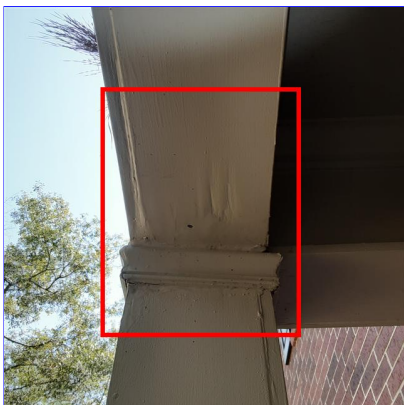
K. Item 1(Picture) Left of front door

(2) Observed wood rot or deterioration to patio cover in front. Further deterioration may occur if not repaired. A qualified contractor should inspect further and repair or replace as needed.

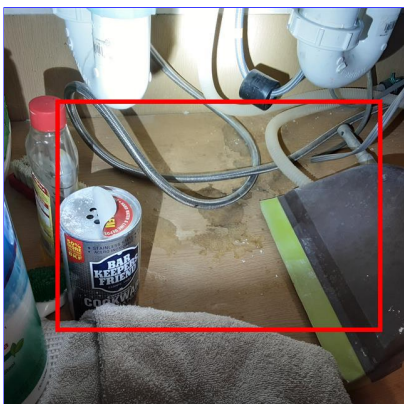
L. Item 1(Picture) Under kitchen sink

Evidence of previous water leak under sink. The stain appears old. I recommend having a qualified person repair as needed,

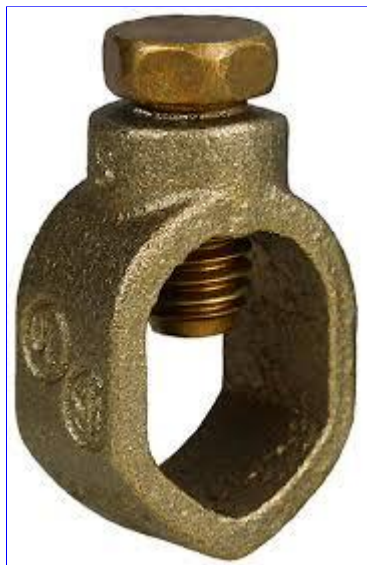
A. Item 1(Picture)

(2) The grounding rod near meter is using improper clamp for grounding of main panel (solid brass clamp is recommended). This is not considered to be today's standard. I recommend having a qualified person replace with proper clamp to assure proper grounding.

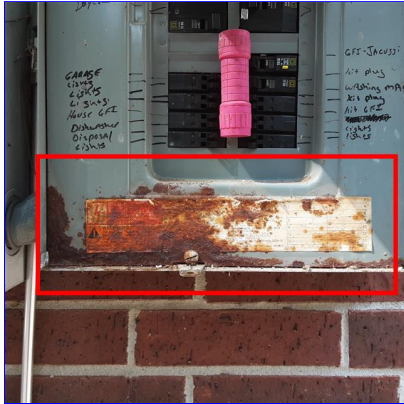
A. Item 3(Picture) Main panel

(3) Observed rust and corrosion to main panel in one or more areas. Further deterioration may occur if not repaired. A qualified contractor should inspect further and repair or replace as needed.

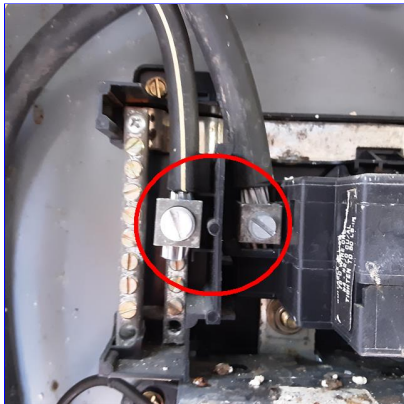
A. Item 4(Picture) Main panel

(4) There is no antioxidant on aluminum conductors feeding panel. This is not considered to be today's standard. I recommend having a qualified electrician evaluate make repairs as needed.

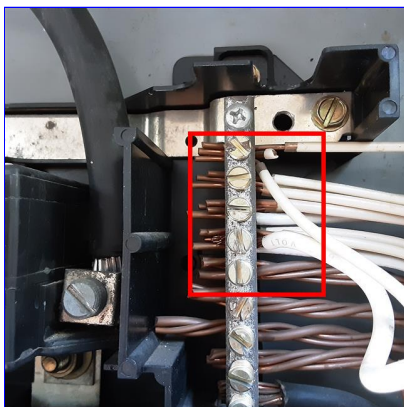
A. Item 5(Picture) Main panel

(5) Observed more than one neutral wire per screw on bus bar. A qualified electrician should inspect further and repair or replace as needed.

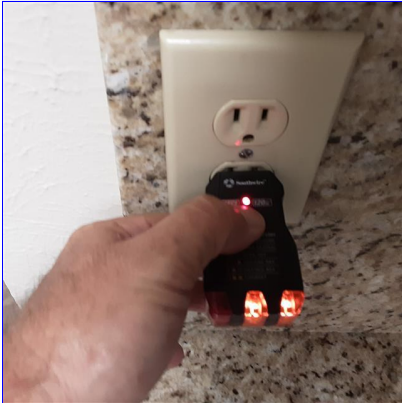
B. Item 1(Picture) Not all kitchen counter outlets

(2) There are no GFCI protected circuits in required area's. This is not considered to be today's standard. I recommend having a qualified electrician make repairs as needed.

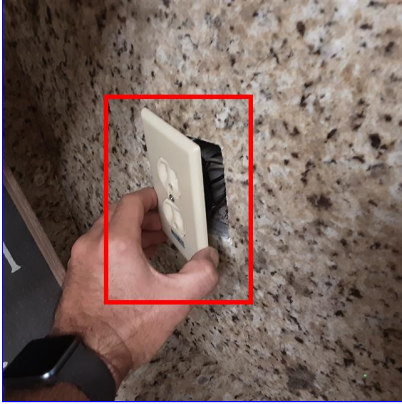
B. Item 4(Picture) Kitchen counter

(3) One or more electrical outlets are loose in the wall. A qualified electrician should inspect further and repair or replace as needed.

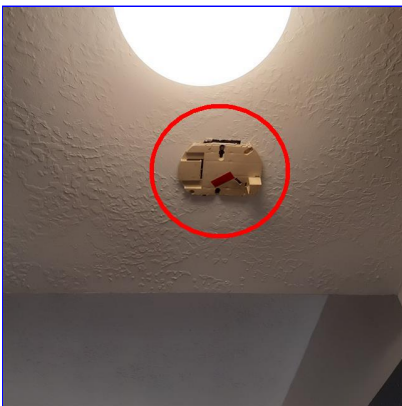
B. Item 7(Picture) 1st floor

(4) One or more smoke detectors are missing or damaged. A qualified contractor should inspect further and repair or replace as needed.

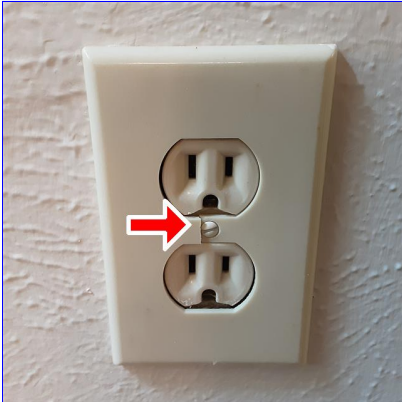
B. Item 9(Picture) Living room

(7) One or more electrical outlet cover plates or light switch cover plates are missing, damaged or missing screws. A qualified contractor should inspect further and repair or replace as needed.

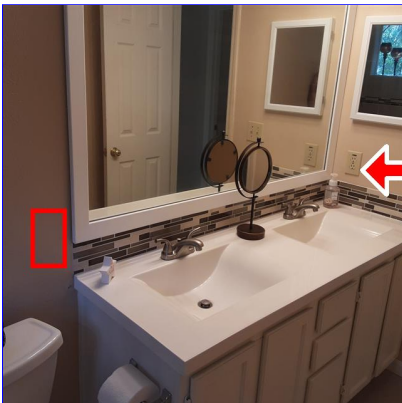
B. Item 10(Picture) 2nd floor guest bathroom

(8) Observed double vanity sinks with only one electrical outlet. Should have outlets at each sink or one outlet between both sinks. A qualified electrician should inspect further and repair or replace as needed.

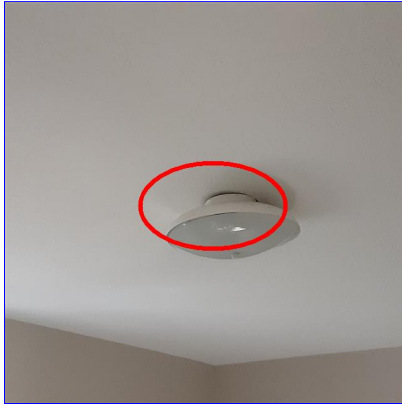
B. Item 12(Picture) 2nd floor SW guest bedroom

(9) One or more light fixtures appear to be loose at the ceiling. A qualified electrician should inspect further and repair or replace as needed.

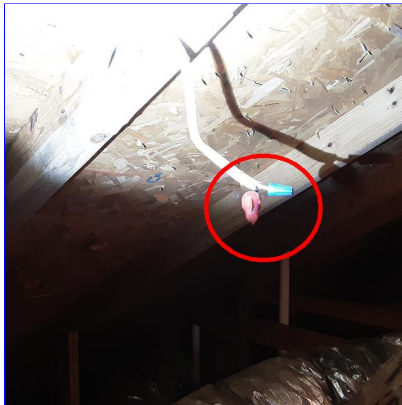
B. Item 13(Picture) Attic

(10) Observed improperly terminated wires in one or more areas. A qualified electrician should inspect further and repair or replace as needed.

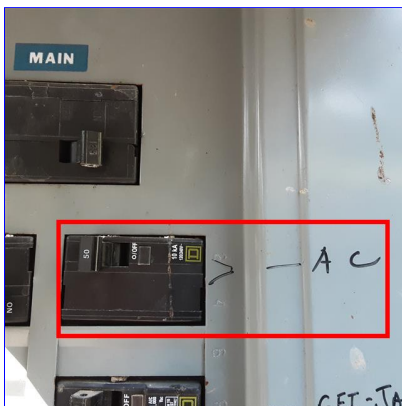
(11) Breaker for AC is over amped. Manufacturer for HVAC states max circuit breaker is 45 amps. Breaker for AC in main panel is 50 amps. A qualified electrician should inspect further and repair or replace as needed.

B. Item 14(Picture) 50 amp breaker for AC in main panel

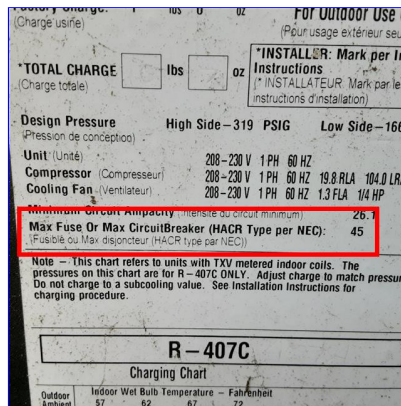
B. Item 15(Picture) Manufacturer states max 45

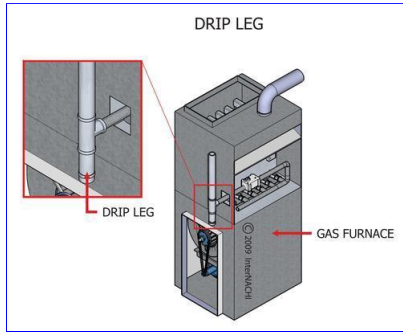
A. Item 1(Picture) dripleg

- (1) It is recommend to have heating systems serviced annually.
- (2) The gas furnace is installed without the recommended sediment trap or "drip leg" that is designed to extend the life of the unit. This is not considered to be today's standard. I recommend having a qualified person make repairs as needed.

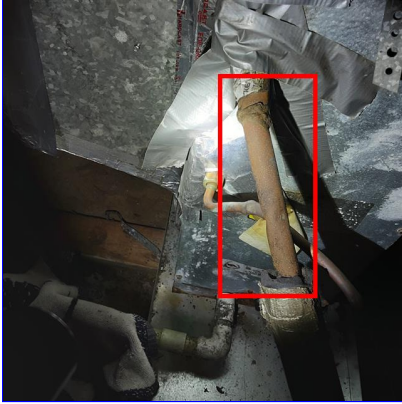
B. Item 1(Picture) At evaporator coil in attic

(2) The suction line is missing foam sleeve in area(s). Missing foam on suction line can cause energy loss and condensation. A licensed HVAC contractor should service or repair unit.

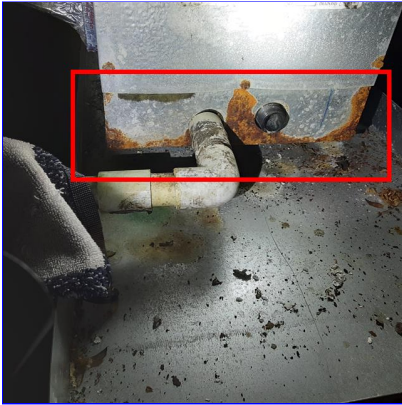
B. Item 3(Picture) Evaporator coil

(3) Observed rust and corrosion to bottom of evaporator coil in attic. Further deterioration may occur if not repaired. A qualified contractor should inspect further and repair or replace as needed.

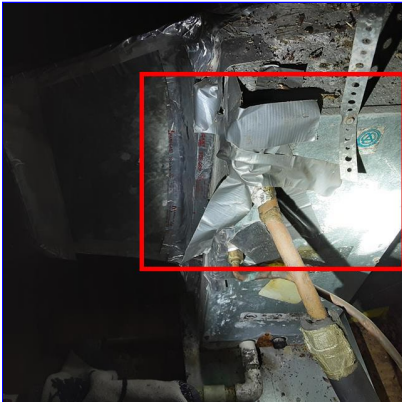
B. Item 4(Picture) At evaporator coil

(4) Observed improper duct tape on HVAC equipment in areas. A qualified contractor should inspect further and repair or replace as needed.

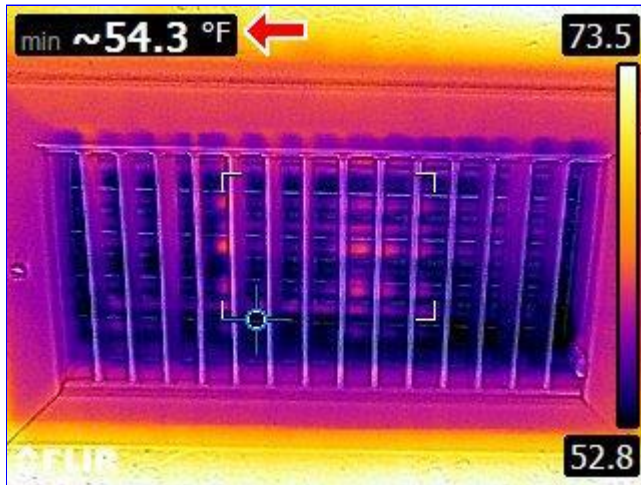
B. Item 5(Picture) Supply

(5) The ambient air test was performed by using infrared thermal equipment at the supply vents of Air conditioner to determine if the difference in temperatures of the supply and return air are between 14 degrees and 22 degrees which indicates that the unit is cooling as intended. The supply air temperature on your system read 54 degrees, and the return air temperature was 72 degrees. This indicates the range in temperature drop is normal.

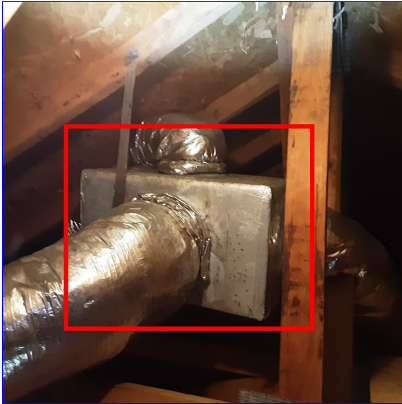
C. Item 1(Picture) In attic

(2) Observed a supply plenum that is loose in attic and needs to be secured with more straps. A qualified contractor should inspect further and repair or replace as needed.

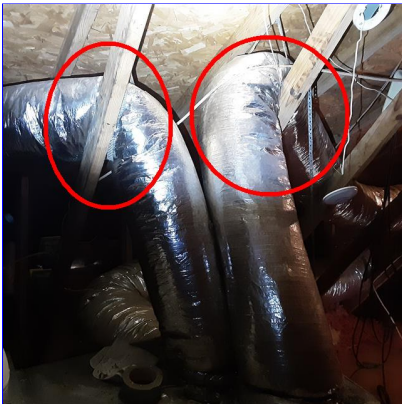
C. Item 2(Picture) In attic

(3) Observed sharp bends in supply ducts in attic. A qualified contractor should inspect further and repair or replace as needed.

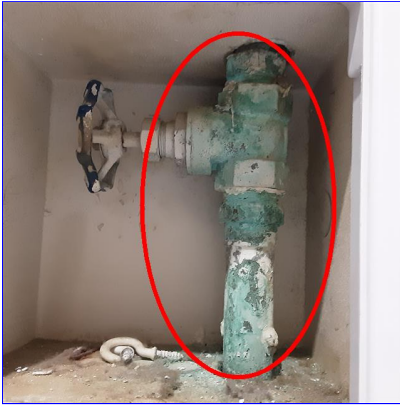
A. Item 1(Picture) Main water shutoff

(1) Observed corrosion to main water shutoff in laundry room. Further deterioration may occur if not repaired. Does not appear to be leaking at time of inspection. A qualified contractor should inspect further and repair or replace as needed.

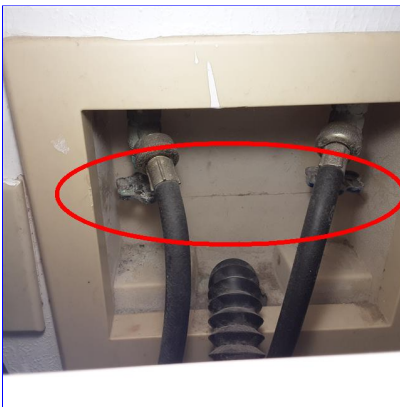
A. Item 2(Picture) Laundry connections

(2) Laundry connections should be colored red for hot and blue for cold. A qualified contractor should inspect further and repair or replace as needed.

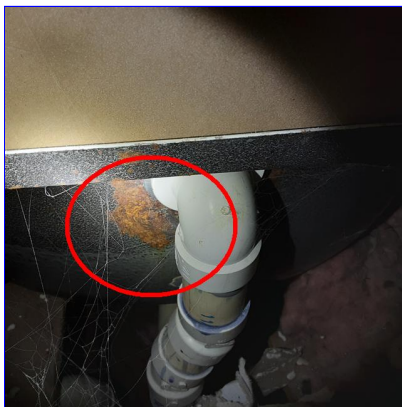
A. Item 5(Picture) 2nd floor guest bathroom tub

(4) Observed rust and corrosion to exterior of guest bathroom tub at emergency overflow drain connection. Further deterioration may occur if not repaired. A qualified contractor should inspect further and repair or replace as needed.

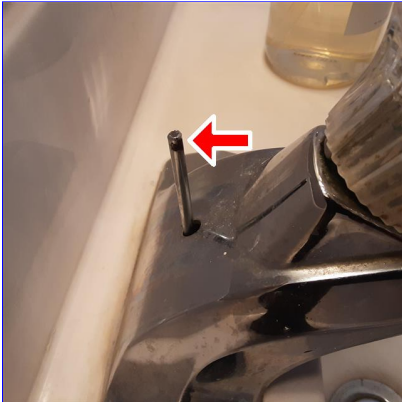
B. Item 1(Picture) 1st floor powder room

(1) One or more drain stoppers are missing, damaged or need adjustment to work properly. A qualified contractor should inspect further and repair or replace as needed.

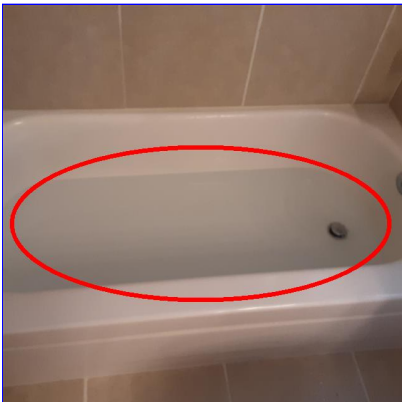
B. Item 2(Picture) 2nd floor guest bathroom tub

(2) Observed one or more slow drains. A qualified contractor should inspect further and repair or replace as needed.

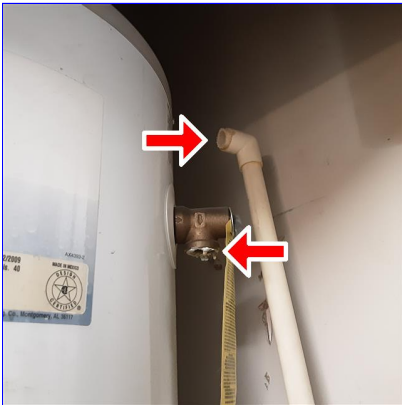
C. Item 1(Picture) T&P piping

(1) T&P piping is not connected at water heater. This is a safety hazard. A qualified contractor should inspect further and repair or replace as needed.

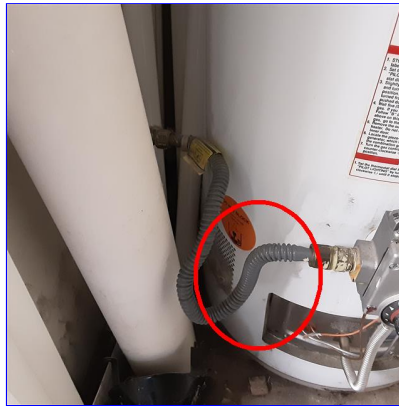
C. Item 3(Picture) No drip leg

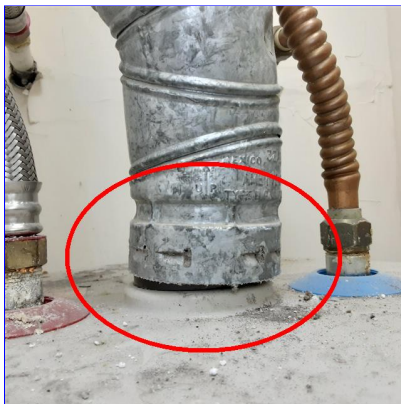
C. Item 4(Picture) Top

(3) The gas water heater has improper venting. The draft hood is not being used. This is a safety hazard until corrected. I recommend having a qualified plumber evaluate and make repairs as needed.

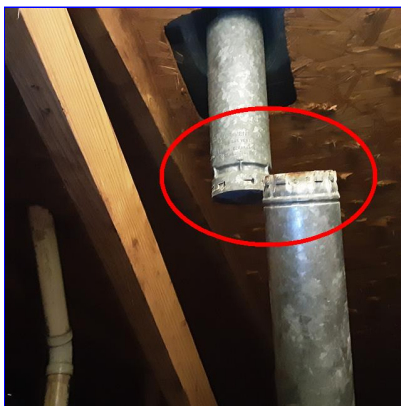
C. Item 5(Picture) In attic

(5) Water heater exhaust vent duct is disconnected in attic and venting into attic. This is a safety hazard until repaired. A qualified contractor should inspect further and repair or replace as needed.

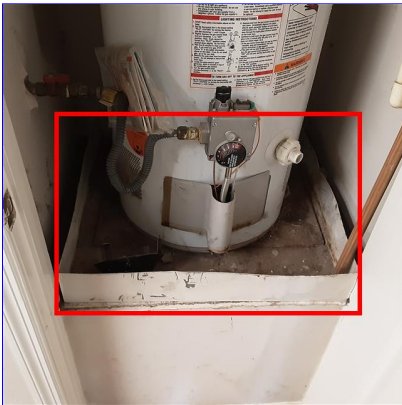
(6) Water heater does have an emergency overflow pan, but does not drain to outside. A qualified contractor should inspect further and repair or replace as needed.

C. Item 6(Picture) Does not drain outside

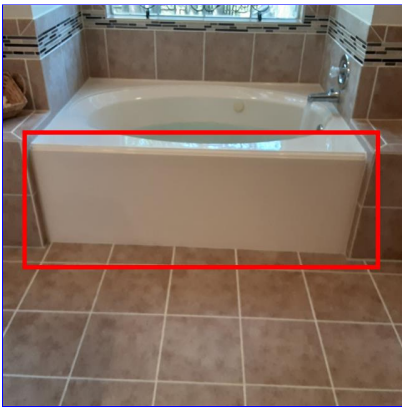
(1) No motor access for spa tub. A qualified contractor should inspect further and repair or replace as needed.

D. Item 1(Picture) No motor access

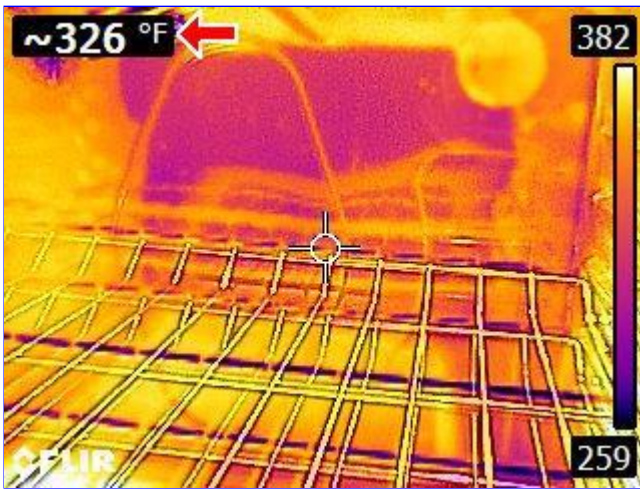
D. Item 2(Picture) When set to 350

(2) Oven heats to approximately 326 degrees when set to 350 degrees. A qualified contractor should inspect further and repair or replace as needed.
