# Inspection Report

**Property Address:**  
1101 Autumn Brook St.  
Seabrook TX 77586

# PROPERTY INSPECTION REPORT

**By:** Ryan Vance TREC# 21238 / Hilsher Group LLC 1/26/2019

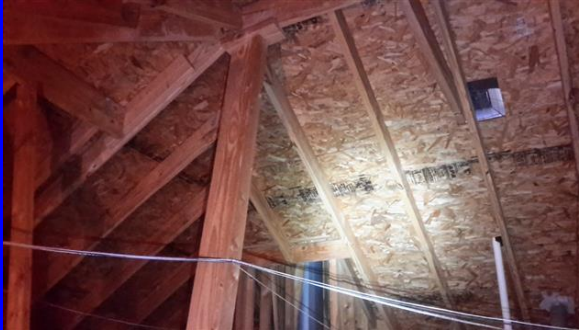
Stick built 2x6 rafters

**Roof Structure:** Stick-built, 2 X 6 Rafters

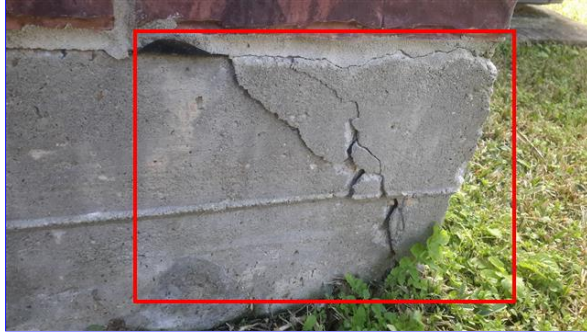
A. Item 1(Picture) Back corner near AC unit

(2) The foundation is poured on grade with post tension cables that appears to be performing as designed.  
(3) The foundation has large corner pop(s) that are larger than 4 inches. Further deterioration will occur if not corrected. I recommend having a qualified person make repairs as needed.

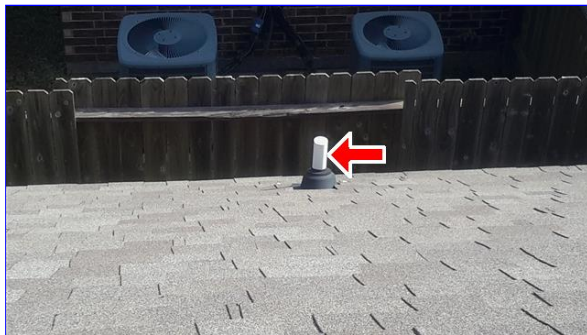
C. Item 1(Picture) Right side

(2) The plumbing and appliance venting at roof level does not have adequate weather coating (Paint) to prevents premature deterioration. This is not considered to be today's standard. I recommend having a qualified person make repairs as needed.

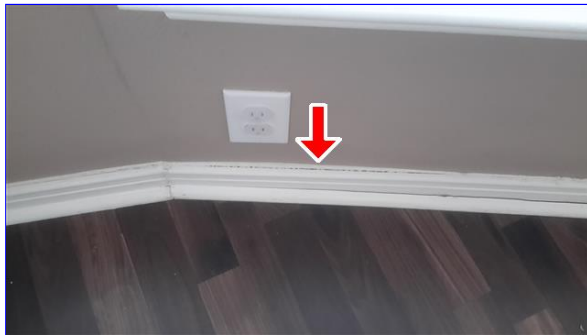
E. Item 1(Picture) Living room

(1) Baseboards have some separation and deterioration of caulking. I recommend having a qualified person make repairs of needed.

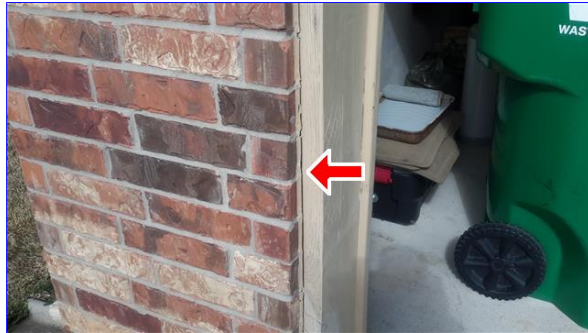
E. Item 4(Picture) Around garage door

(3) Recommend caulking all vertical trim boards to prevent water entry during wind driven rains.

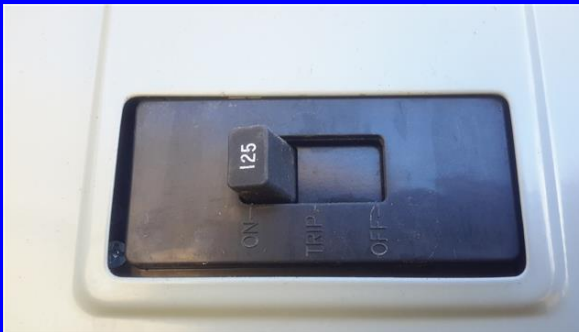
125 amp main service disconnect

**Panel Capacity:** 125 AMP

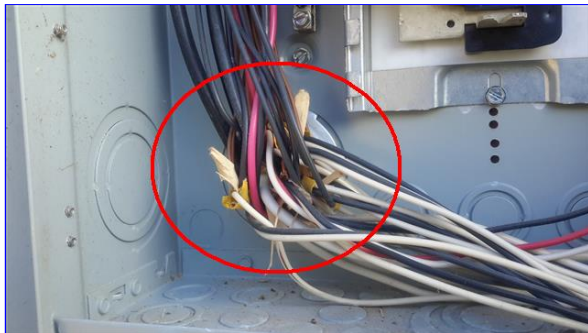
A. Item 1(Picture) Main panel

(1) The electrical panel has branch circuit wires bundled together that are entering the panel through one to two entry points. This is not considered today's standard. It is recommended that each sheathed wire enter the panel independently and be sealed for fire blocking purposes. I recommend having a qualified electrician evaluate and make repairs as needed.

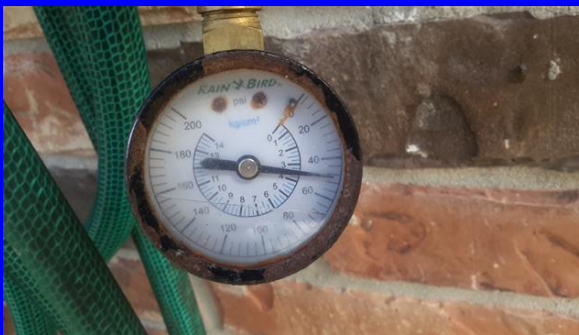
48 psi

**Static water pressure reading:** 48 pounds/square inch

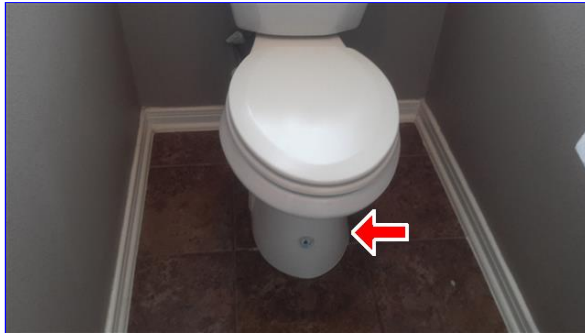
B. Item 1(Picture) Master bathroom

One or more toilets are loose at the floor. Recommend repair or replace as needed.

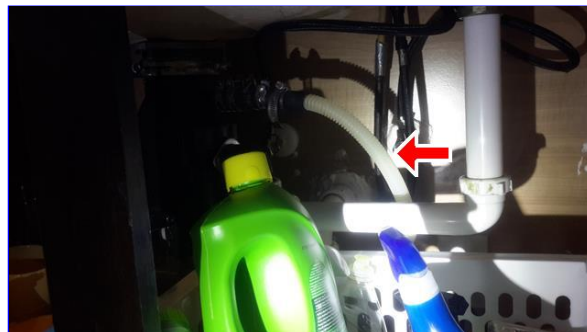
A. Item 1(Picture)

The dishwasher drain hose did not perform a loop to create a trap under sink. I recommend repair as necessary.
