Inspection Report

19928 Sutton Falls Dr
Cypress TX 77433

HG Home Inspection / Hilsher Group LLC

**Kenneth Linnett Texas Professional Home Inspector
2020 N Loop W Ste 150
Houston, TX 77018
281-782-7451**

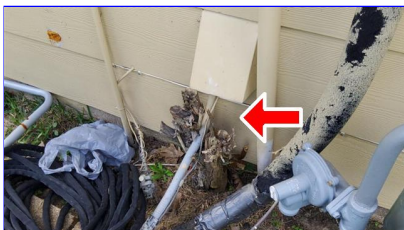
A. Item 1 (Picture) Rear

- (1) This is not an engineering report, but is only an opinion based on observation of conditions known to be related to foundation performance, using the knowledge and experience of the inspector.
- (2) There are trees roots too close to the foundation. I recommend removal or the use of root diverters.

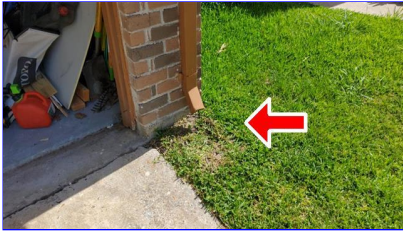
B. Item 2 (Picture) Front

(3) The gutter is deteriorated at the exterior. Loose or leaking gutters can cause deterioration of fascia, soffit or roof edge. It can also cause gutters to pull loose and lead to possible water intrusion. A qualified contractor should inspect and repair as needed.

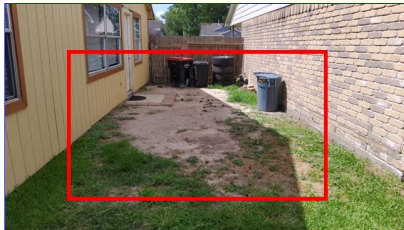
B. Item 5 (Picture) Side yard

(4) Grading on the lot does not appear to drain water properly. I recommend having a qualified person grade lot properly.

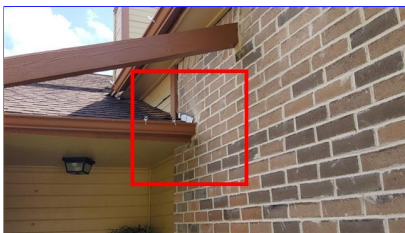
C. Item 1 (Picture) Front

(2) Kick out flashing is missing in areas of the roof. This is not considered today's standard. I recommend having a qualified roofing company make repairs as needed.

(3) Flashing appears to be improperly installed. I recommend having a qualified person evaluate and make repairs as needed.

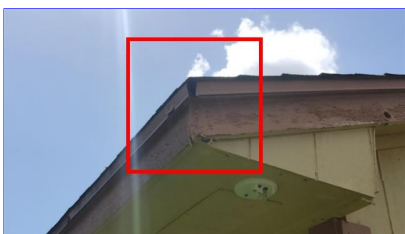
C. Item 2 (Picture) Left rear

(4) The ridge shingles are showing excessive wear in areas. I recommend having a qualified person make repair or replace as needed.

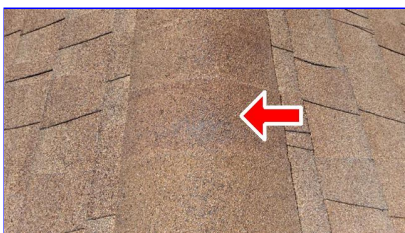
C. Item 3 (Picture) Roof

(5) The roof covering is damaged in areas. These areas may need replacement and or periodic maintenance. A qualified roofing contractor should inspect and repair as needed.

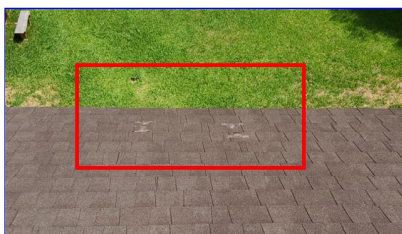
C. Item 5 (Picture) Rear, old satellite dish mount?

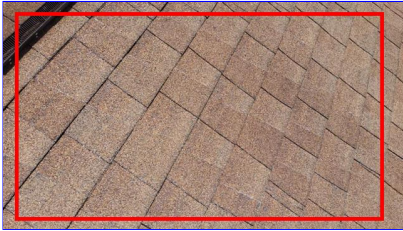
C. Item 6 (Picture)

(6) The roof shingles showing wear and granular loss. (Granules provide UV protection for shingles. Once the granules erode away the sun is able to deteriorate the asphalt and shortens the life of the roofing

material.) I recommend consulting with a roofing professional.. A qualified person should repair or replace as needed.

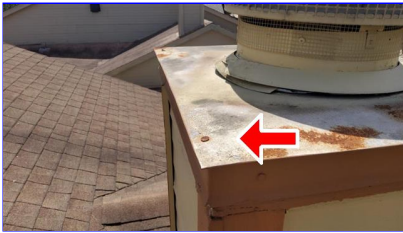
C. Item 7 (Picture) Chimney

(7) The roofing surface has exposed nail heads that are showing signs of deterioration. Further deterioration will occur if not corrected. I recommend having a qualified person repair or replace as needed.

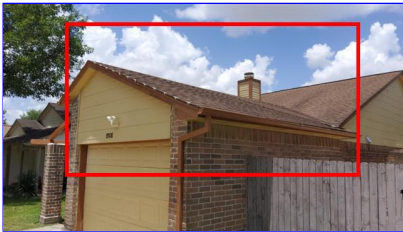
(8) Ventilation was not added, when the most recent roof covering was installed. I recommend increasing the ventilation to promote life expectancy of covering.

C. Item 8 (Picture) Garage attic, add Gable or ridge vent when possible

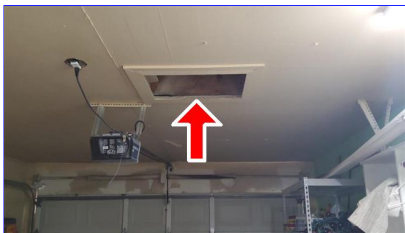
D. Item 1 (Picture) Garage

- (1) Attic inspection is limited to visibility from service decking that is safely accessible at the time of inspection.
- (2) Attic space inspected with limited access. This is for your information.
- (3) The attic space is missing a hatch door. This is not considered to be today's standard. I recommend having a qualified person install hatch.

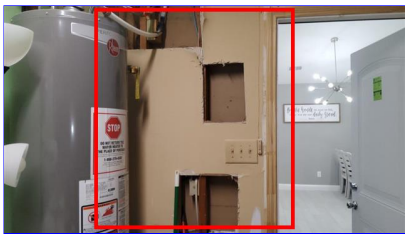
- (4) The attic space has area's of missing insulation. This is causing energy loss and is not today's standard. I recommend having a qualified person evaluate and add insulation as needed.

D. Item 2 (Picture) Wall at kitchen needs insulation and drywall repairs

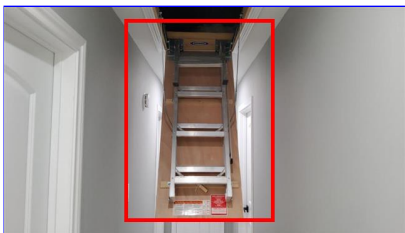
D. Item 5 (Picture) Attic

- (5) The pull down stairs are not properly insulated or weather-stripped. This can cause some heat loss in winter and loss of cool air in summer if not corrected. I recommend repair as desired.

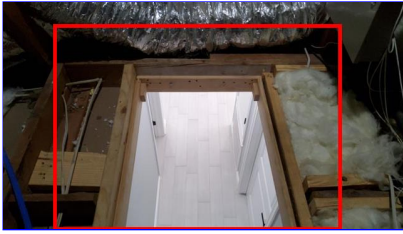
(6) The pull down stairs were not installed according to workmanlike practices. Injury could result if not repaired. A qualified person should repair or replace as needed.

D. Item 6 (Picture) Framing not doubled

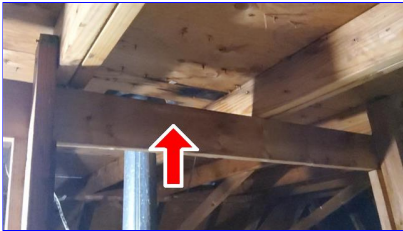
D. Item 7 (Picture) Near furnace vent

(7) The roof structure in the attic has water stain indicating a leak did or still exists in areas. Due to recent dry weather, I am unable to determine if the leak still exists. A qualified contractor should inspect and repair as needed.

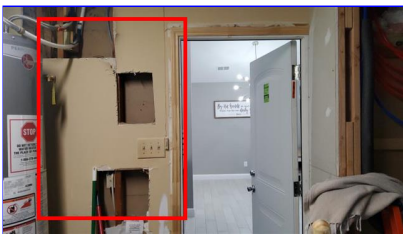
E. Item 1 (Picture) Garage

(1) The fire protection wall that separates garage from heated space is damaged. This is considered unsafe until corrected. A qualified person should correct for safety.

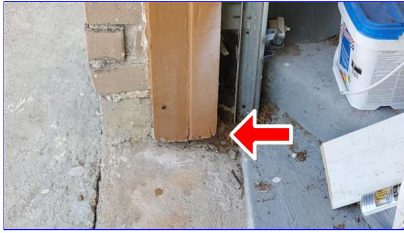
E. Item 2 (Picture) Garage

(2) The exterior siding and trim is deteriorated in areas. Further deterioration will occur if not corrected. A qualified contractor should inspect and repair as needed.

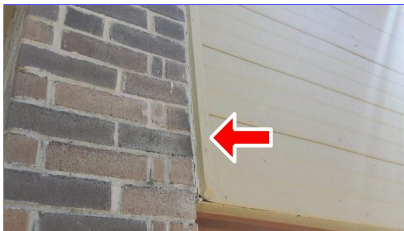
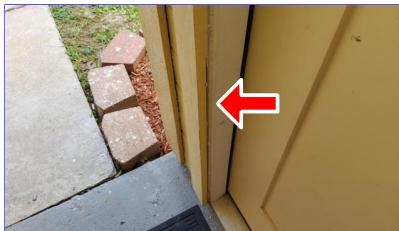
(3) The siding exterior has caulking that is weathered or missing and some lifted nails. Deterioration can eventually occur if not corrected. A qualified person should repair as needed.

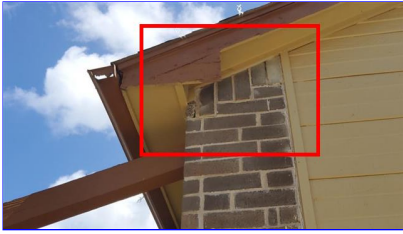
E. Item 11 (Picture) Front

(4) The Brick siding at the exterior has step cracks caused from settlement. Deterioration can eventually occur if not corrected. A qualified contractor should inspect and repair as needed.

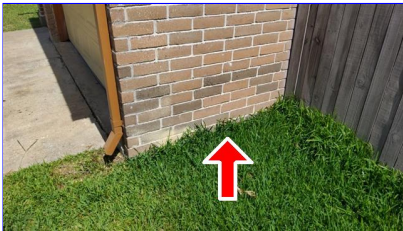
E. Item 12 (Picture) Right side

(5) Siding in contact with ground. Because the siding is in contact with ground it is possible for framing to be deteriorated. We did not inspect behind this siding. Recommend a ground clearance of six to eight inches where possible.

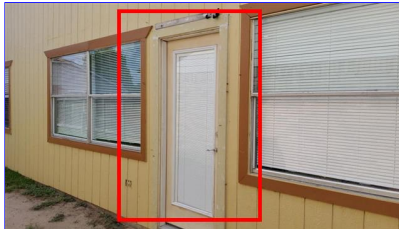
(6) Bare siding needs primer and paint at exterior in areas. I recommend having a qualified person make repairs as needed.

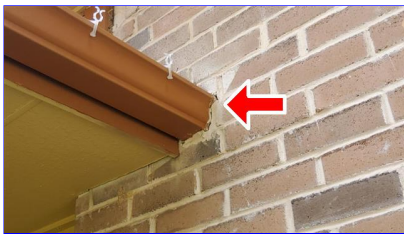
E. Item 16 (Picture) Front entry

(7) The brick siding was improperly repaired in areas. Water intrusion may occur if not corrected. A qualified contractor should inspect and repair as needed.

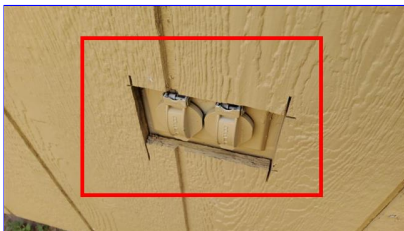
E. Item 17 (Picture) Left side

(8) The exterior siding was installed improperly or not according to standard workmanlike practices in areas. Further deterioration can occur if not corrected. A qualified contractor should inspect and repair as needed.

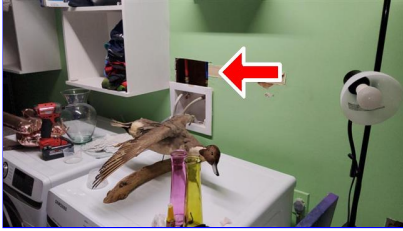
E. Item 23 (Picture) Garage

(9) The drywall on the wall is damaged. While this damage is cosmetic, it needs to be repaired. A qualified person should repair or replace as needed.

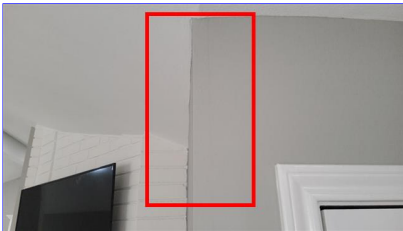
E. Item 24 (Picture) Front entry

(10) The drywall on the wall reveals tape lines and nail bed areas (cosmetic). While this damage is cosmetic, it needs to be repaired. A qualified person should repair or replace as needed.

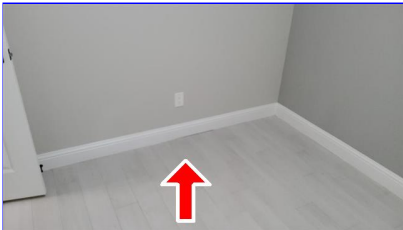
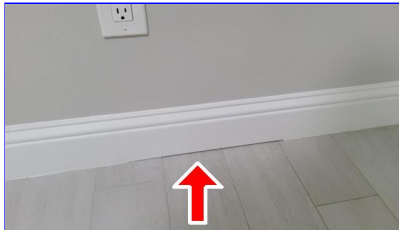
(11) Baseboards have some separation and deterioration of caulking. I recommend having a qualified person make repairs of needed.

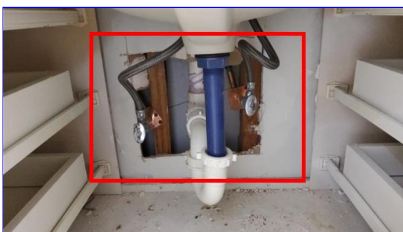
E. Item 27 (Picture) Hall bath

(12) Areas where wiring or piping passes through walls should be sealed. I recommend having a qualified person seal as needed.

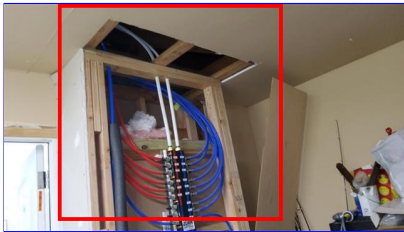
F. Item 1 (Picture) Garage

(1) The Drywall on the ceiling is damaged garage. Repairs are needed. A qualified contractor should inspect and repair as needed.

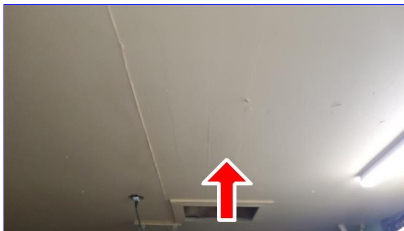
F. Item 2 (Picture) Garage

(2) The Drywall on the ceiling reveals tape line and nail bed areas (cosmetic). This damage is considered cosmetic. A qualified contractor should inspect and repair as needed.

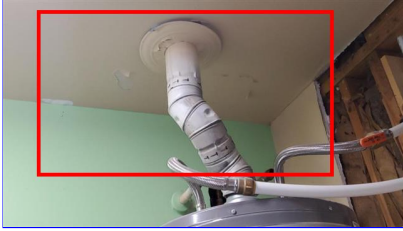
F. Item 4 (Picture) Garage

(3) The Drywall on the ceiling is peeling in areas and needs prep and paint. This is a cosmetic issue for your information. I recommend prep and paint using a qualified contractor.

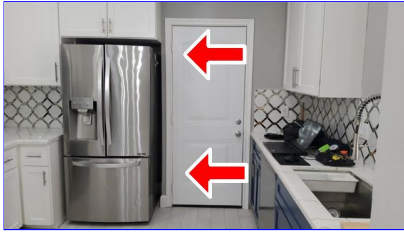
G. Item 1 (Picture) Garage

(1) The interior garage door does not have the required self closing hinge. This is not considered to be today's standard. I recommend having a qualified person make repairs as needed.

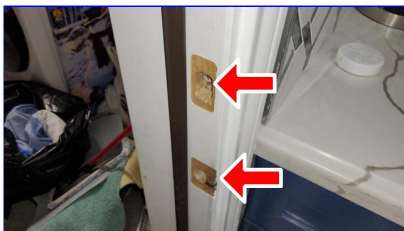
(3) The interior door does not shut and latch properly. This is a maintenance issue and is for your information. A qualified contractor should inspect and repair as needed.

G. Item 3 (Picture) Garage,
missing hardware

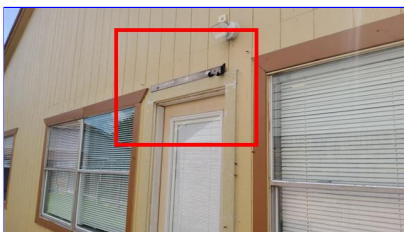
G. Item 4 (Picture)

(4) The side entry door missing head flashing. Water intrusion may occur if not repaired. A qualified contractor should inspect and repair as needed.

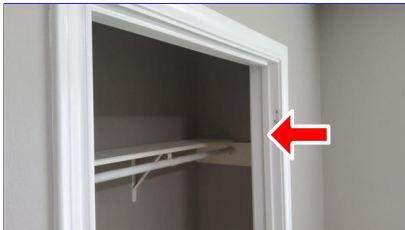
G. Item 5 (Picture) Front left bedroom

(5) Closet doors were missing in areas. A repair or replacement is needed. A qualified person should repair or replace as needed.

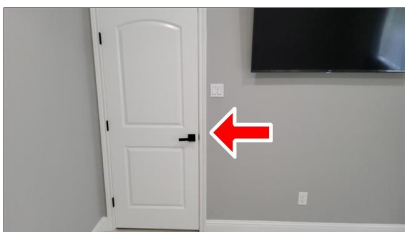
G. Item 7 (Picture) Master bedroom

(6) An interior door needs strike and latch adjustment to shut tight at Master Bedroom. This is a small repair. A qualified person should repair or replace as needed.

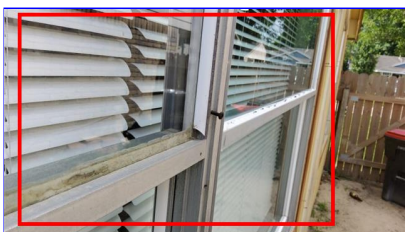
(1) There are window frames that are not properly sealed. This can cause energy loss and potential water intrusion. I recommend having a qualified person seal and repair as needed.

H. Item 1 (Picture) Most plastic dividers were damaged or missing

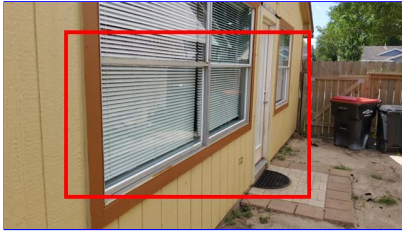
(2) Windows have damaged or missing screens. This is not considered to be today's standards. I recommend having a qualified person make repairs as needed.

H. Item 5 (Picture) Left side, 3 missing

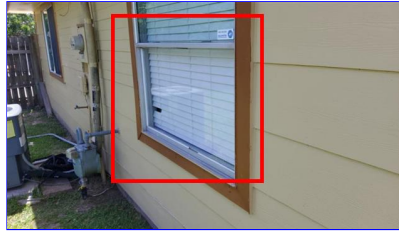
H. Item 6 (Picture) Rear, 1 missing

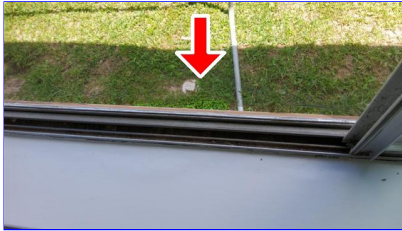
H. Item 7 (Picture) Master bedroom, damaged

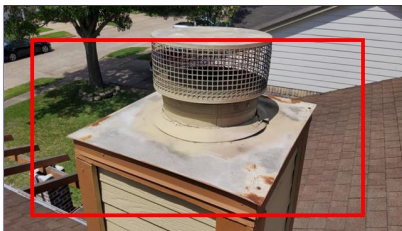
J. Item 1 (Picture) Chimney

- (1) I do not inspect the shape of fireplace or the design to determine if your fireplace has a proper air draw.
- (2) Metal rain cap on chimney crown is rusting. A qualified contractor should inspect and repair or replace as needed.

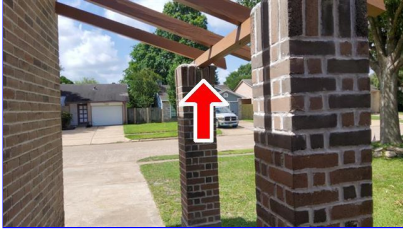
K. Item 1 (Picture) Front entry

- (1) The weight load capabilities are not part of this inspection.
- (2) The wooden support beam at the front entry shows signs of movement. A possible injury could occur if not secured. A qualified contractor should inspect and repair as needed.

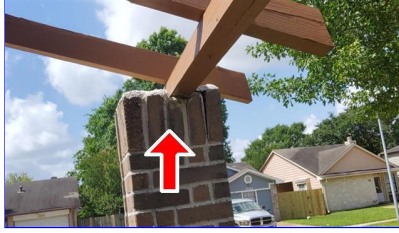
K. Item 2 (Picture) Beam has rolled

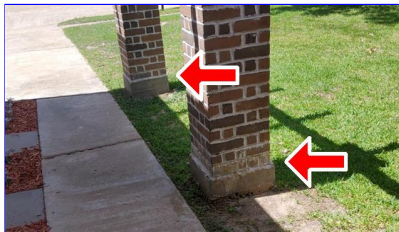
K. Item 4 (Picture) Front entry

(3) Columns at front entry were not capped off and did not have weep holes at bottom to let water out. Further deterioration will occur if not corrected. I recommend having a qualified contractor repair or replace as needed.

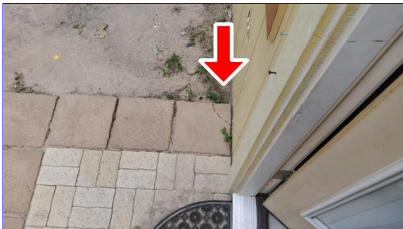
K. Item 5 (Picture) Side patio

(4) The brick floor on the patio at the left side of home has cracked in some areas (which are cosmetic). I recommend repair as desired.

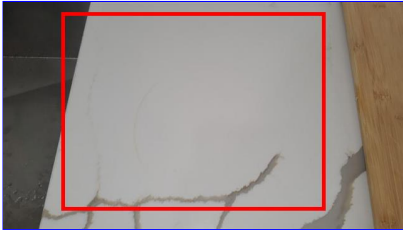
L. Item 2 (Picture) Right of kitchen sink

(2) Countertops were stained in areas. I recommend repair as needed.

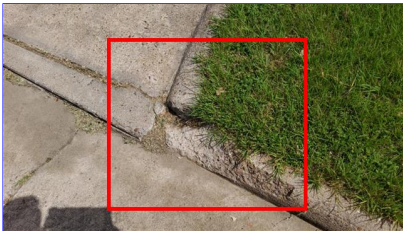
L. Item 3 (Picture) Curb

(3) The concrete drive at the front of home deteriorated in areas and has settlement cracks. Further deterioration can occur if not repaired. A qualified contractor should inspect and repair as needed.

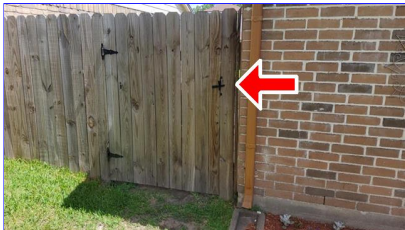
(4) Fence is deteriorated/damaged in area's. Recommend repair or replace by a qualified contractor.

L. Item 6 (Picture) Gate was difficult to operate/latch

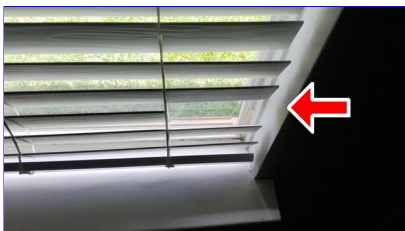
L. Item 8 (Picture) Left rear bedroom

(5) Window blinds are damaged in areas. I recommend repairs as needed.

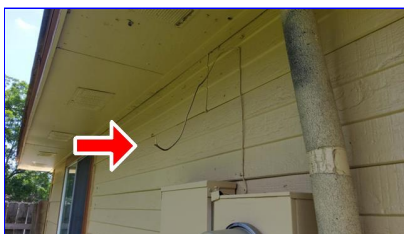
A. Item 1 (Picture) Rear

(1) The grounding wire did not appear to be properly grounded at meter. I recommend having a qualified electrician repair and/or replace.

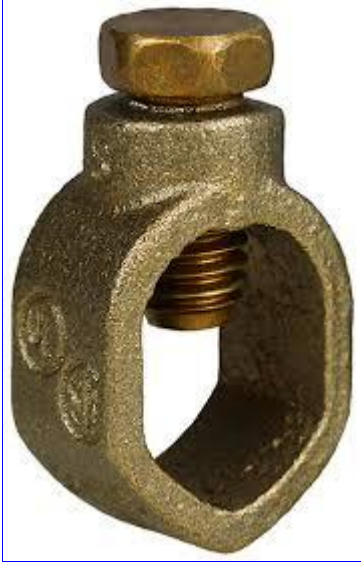
A. Item 2 (Picture)

(2) The grounding rod near meter is using improper clamp for grounding of main panel (solid brass clamp is recommended). This is not considered to be today's standard. I recommend having a qualified person replace with proper clamp to assure proper grounding.

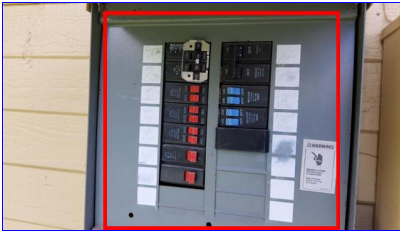
A. Item 4 (Picture) Electrical panel

(3) Some labels are present, but are illegible or confusing. I recommend correcting for safety reasons.

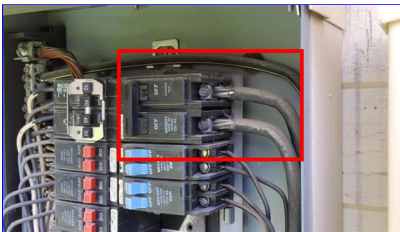
A. Item 5 (Picture) Electrical panel

(4) There is no antioxidant on aluminum conductors feeding panel. This is not considered to be today's standard. I recommend having a qualified electrician evaluate make repairs as needed.

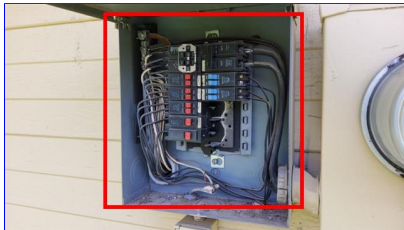
A. Item 6 (Picture) Electrical panel

(5) The main panel does not have a whole house surge protector. This is not today's standards. Recommend a licensed electrician to repair as needed.

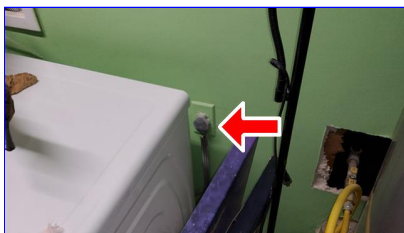
B. Item 3 (Picture) Garage

- (3) A three prong outlet for dryer is present in laundry room. This is not considered today's standard. Today's standard requires a four prong outlet be installed. I recommend having a qualified electrician to inspect and make repairs as needed.

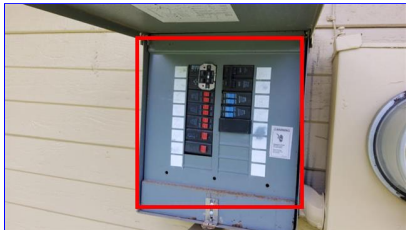
B. Item 4 (Picture) Electrical panel

- (4) Arc fault breakers are not in required areas of home at electrical panel. This is not considered today's standard. I recommend having a qualified electrician inspect and make repairs as needed.

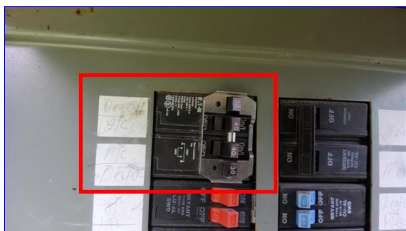
(5) At least two circuit breakers in main panel are of a different brand than panel manufacturer. The manufacturer requires that in order for the panel to be safe, only their brand is allowed to be used inside the panel. Even though these circuit breakers are all "UL approved," they are not approved to be used in panels of different manufacturers unless so indicated on the panel label.

B. Item 5 (Picture) Eaton breakers in Bryant panel

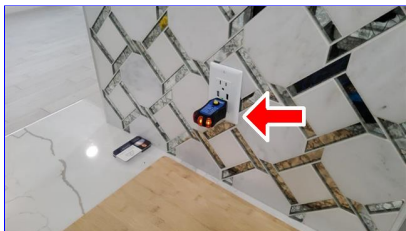
B. Item 6 (Picture) Kitchen

(6) There are no GFCI protected circuits in required area's. This is not considered to be today's standard. I recommend having a qualified electrician make repairs as needed.

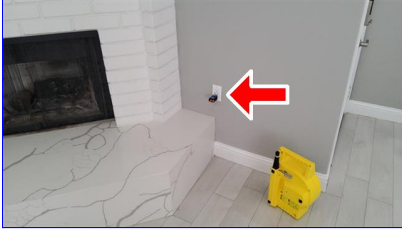
B. Item 10 (Picture) Living room

(7) One "three-prong" outlet is clogged or obstructed with paint or debris in the living room. Electrical issues are considered a hazard until repaired. A qualified licensed electrical contractor should perform repairs that involve wiring.

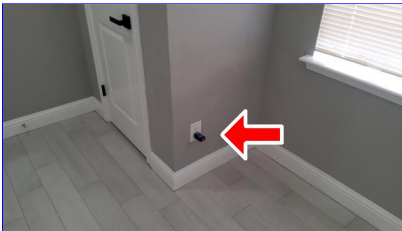
B. Item 11 (Picture) Living room

(8) At least one "three-prong" outlet is loose in wall in most if not all rooms. Electrical issues are considered a hazard until repaired. A qualified licensed electrical contractor should perform repairs that involve wiring.

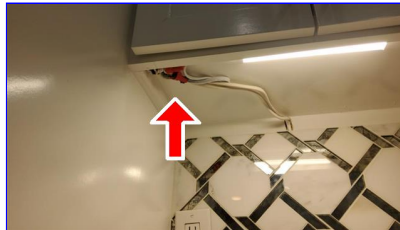
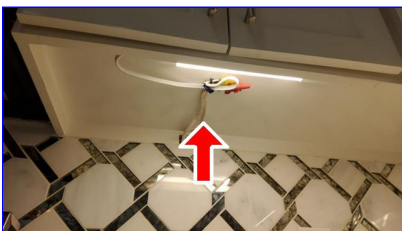
(9) Several open splices need placing in boxes with cover-plates in the kitchen. A qualified licensed electrical contractor should perform repairs that involve wiring.

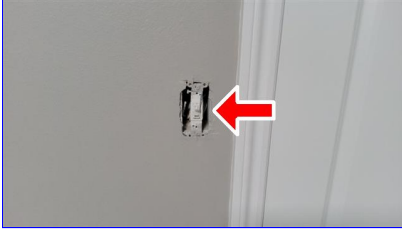
B. Item 15 (Picture) Left front bedroom

(10) The wall switch is missing "cover-plate" at the Small bedroom. Electrical issues are considered a hazard until repaired. A qualified licensed electrical contractor should perform repairs that involve wiring.

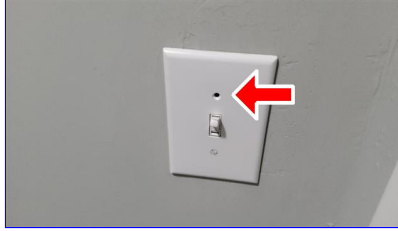
B. Item 16 (Picture) left rear bedroom closet, missing screw

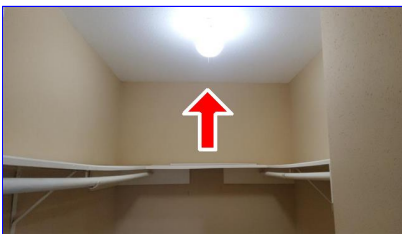
B. Item 17 (Picture) Master closet

(11) The light fixture at the master closet was controlled by a pull chain. This is not considered today's standard. I recommended repair as desired. A qualified licensed electrical contractor should perform repairs that involve wiring.

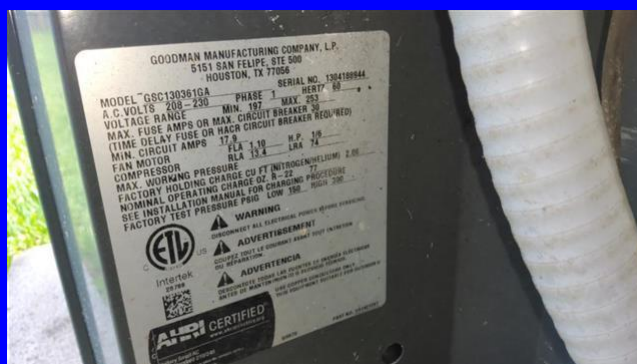
Condenser data plate

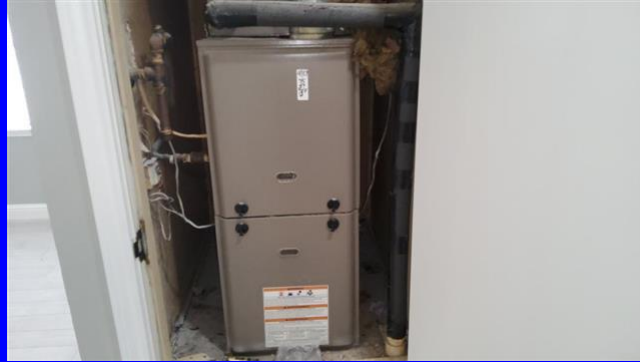
Gas furnace

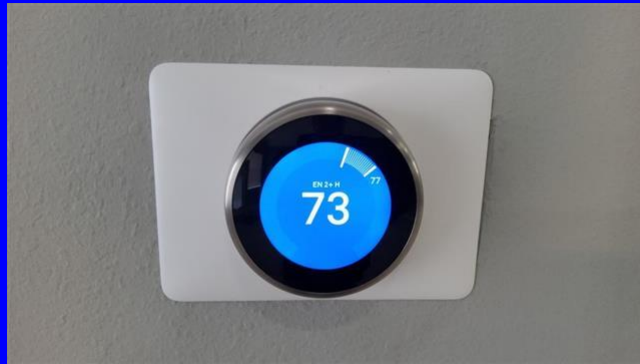
Thermostat

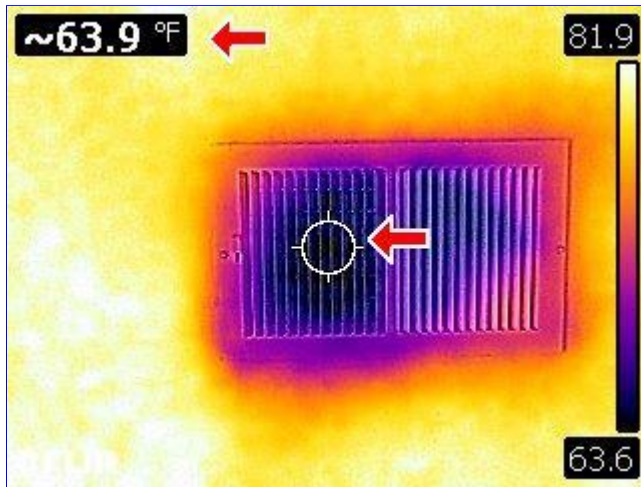
B. Item 1 (Picture) Supply

(2) The ambient air test was performed by using infrared thermal equipment at the supply vents of Air conditioner to determine if the difference in temperatures of the supply and return air are between 15 degrees and 22 degrees which indicates that the unit is cooling as intended. The supply air temperature on your system read 63 degrees and the return air temperature was 81 degrees. This indicates the range in temperature drop is normal.

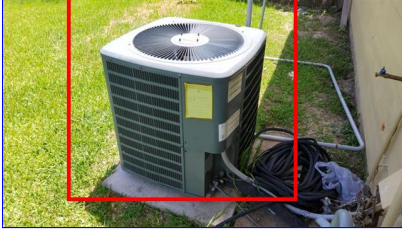
(3) The condenser outside (AC unit) is very old and may last a few years more, but maybe not. I have seen units fail shortly after a home inspection during the seasonal change from mild to hot weather. I cannot determine how long your AC will last before a replacement is necessary.

B. Item 3 (Picture) Approximately 9 years old

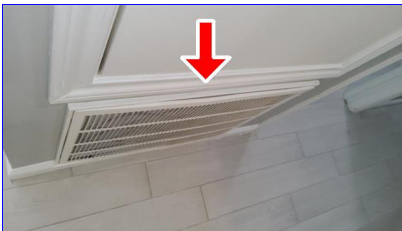
(2) The return air grill in wall is bent. This item is a cosmetic issue for your information. I recommend service or repair as needed.

C. Item 1 (Picture) Hallway

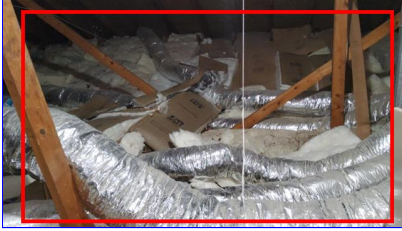
(3) The duct pipe needs support straps in the attic. . A qualified HVAC person should inspect further and repair or replace as needed.

C. Item 2 (Picture) Attic

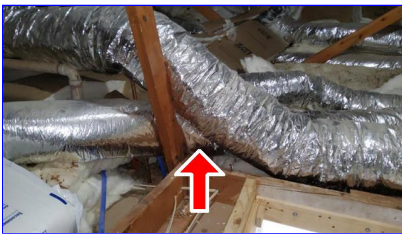
C. Item 3 (Picture) Attic

(4) Duct piping appears to be in contact with one another in the attic space. Condensation could occur if not corrected. I recommend having a qualified HVAC contractor further evaluate and make repairs as needed.

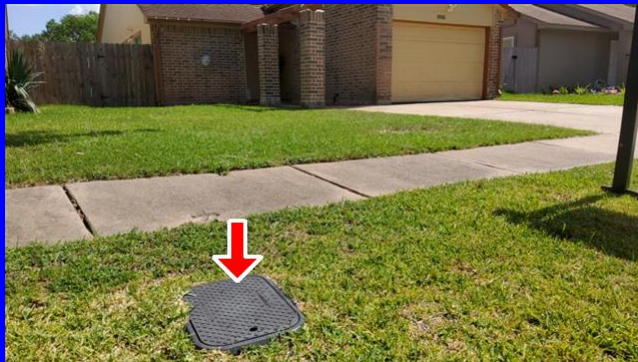
Water meter located in front yard

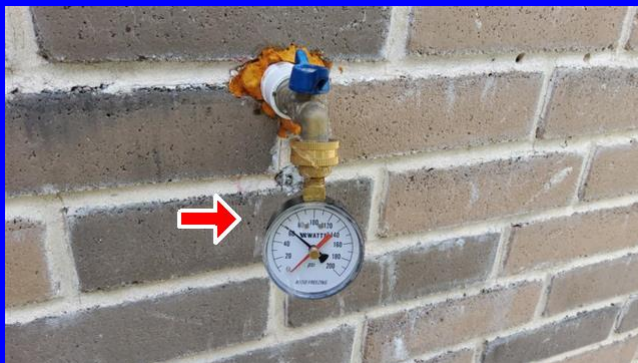
Water pressure 62 psi

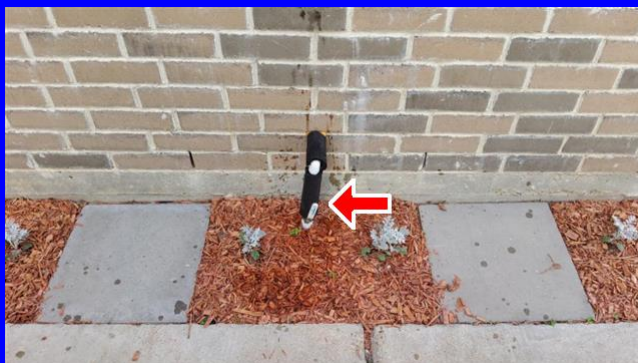
Main water shutoff

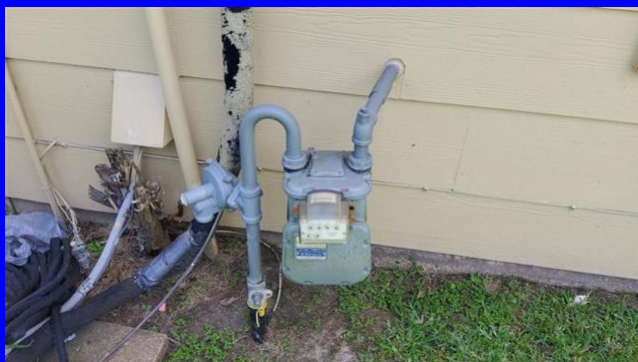
Gas meter

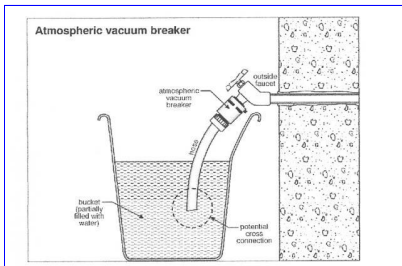
A. Item 1 (Picture)

(1) There is no Anti Siphon device installed on exterior faucet(s). This is not considered to be today's standard. I recommend having a qualified person make repairs as needed.

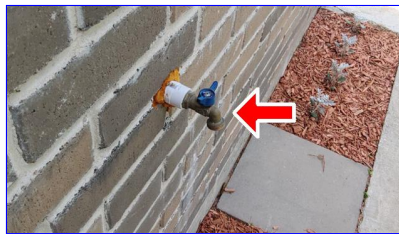
A. Item 2 (Picture) Exterior faucets

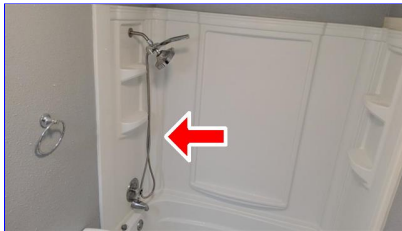
(3) Hose for shower wand was too long and may allow a cross connection (bath water could potentially enter potable water supply). This is potential health hazard until corrected. I recommend a qualified person repair as needed.

A. Item 3 (Picture) Shower wand can reach below bath water line

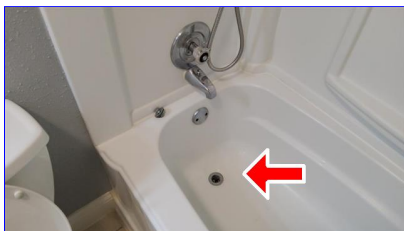
The bathtub stopper mechanism is not working properly. I recommend repairs as needed.

B. Item 1 (Picture) Hall bath

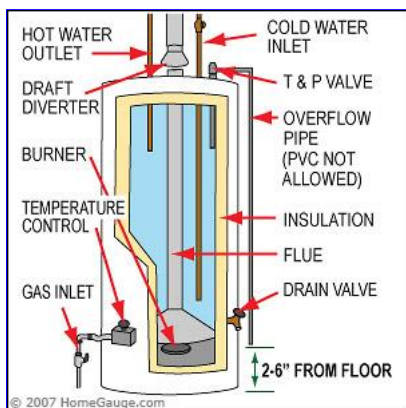
C. Item 2 (Picture) Garage

(1) The T&P (Test and Pressure) valve on water heater needs a 3/4 threaded pipe to extend within 6 inches of floor for safety. (PVC is not approved for hot water use). I recommend repair by a qualified person.

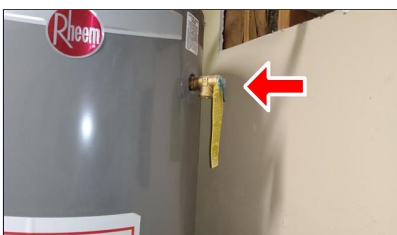
(2) The water heater is installed without the recommended sediment trap or "drip leg" that is designed to extend the life of the unit. This is not considered to be today's standard. I recommend having a qualified plumber make repairs as needed.

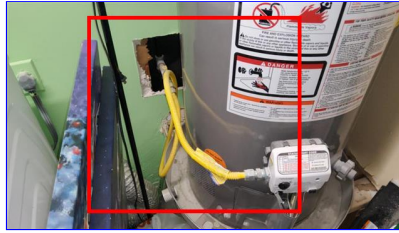
C. Item 4 (Picture) Garage

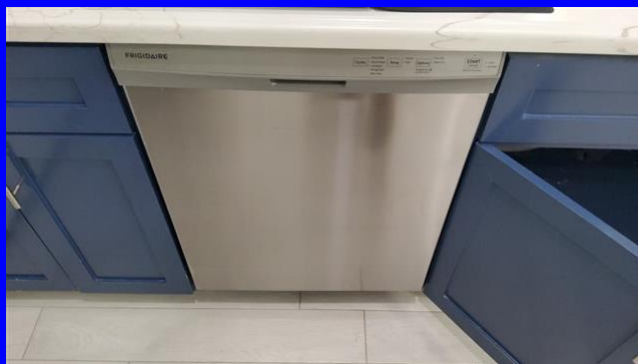
Dishwasher

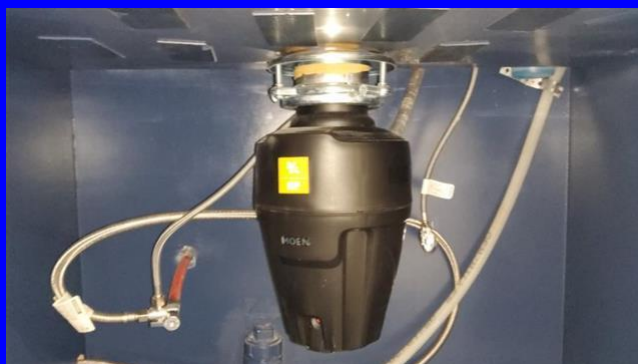
Food waste disposer

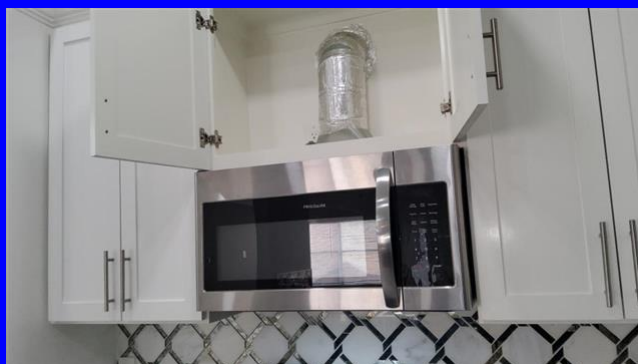
Built-in microwave and range hood combo

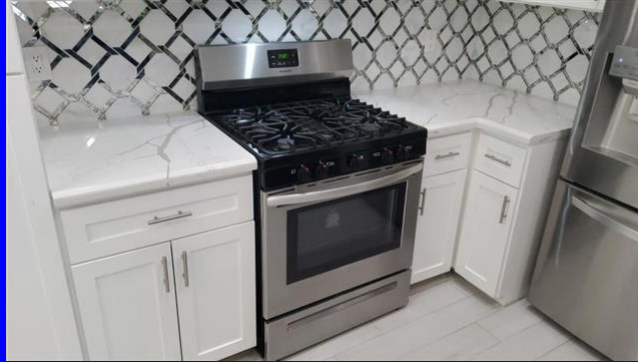
Gas range and oven

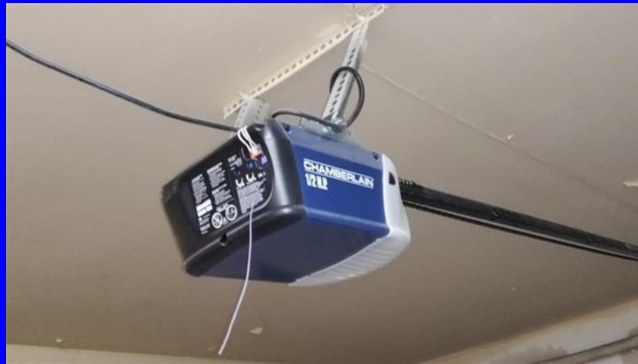
Garage opener

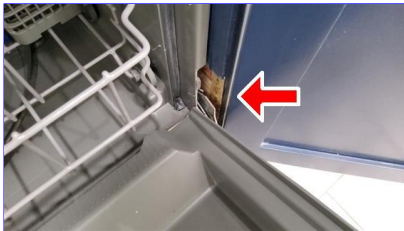
(1) The dishwasher door hinges were unusually noisy and may need maintenance or adjustment. I recommend repair as necessary.

A. Item 1 (Picture) Kitchen

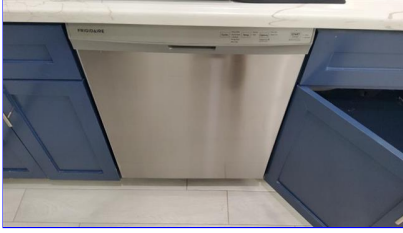
A. Item 2 (Picture) Kitchen

(2) Tested and working properly at the time of inspection.

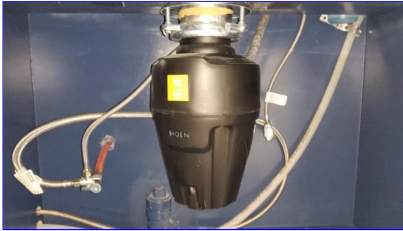
B. Item 1 (Picture) Kitchen

Tested and working properly at the time of inspection.

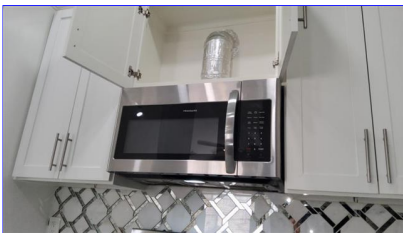
C. Item 1 (Picture) Kitchen

Tested and working properly at the time of inspection.

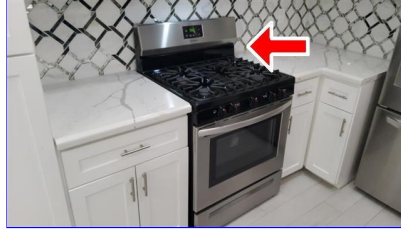
D. Item 2 (Picture) Kitchen

(2) The left two burners for range did not work when tested, would not ignite properly. I recommend repair as needed.

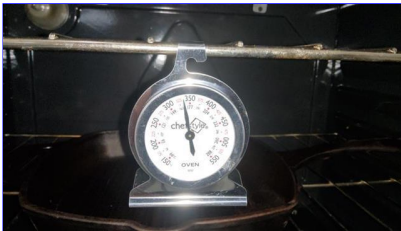
(3) Tested and working properly at the time of inspection.

D. Item 4 (Picture) Oven

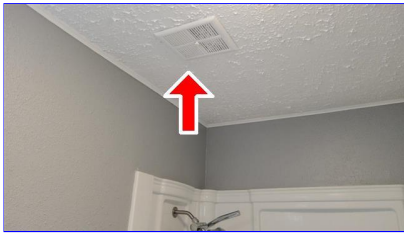
F. Item 1 (Picture) Hall bath

(1) The Exhaust fan is old and noisy at the hall bath. This is for informational purpose to you. A qualified person should repair or replace as needed.

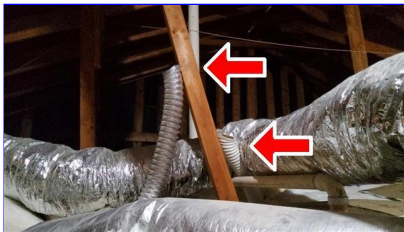
F. Item 2 (Picture) Attic

(2) The bathroom exhaust fans did not properly vent to the outside. Vent pipes that terminate in attic space can sometimes cause moisture that can lead to mold or cause condensation. A qualified contractor should inspect and repair as needed.
