Inspection Report

Property Address:
9226 Portal Dr
Houston TX 77031

PROPERTY INSPECTION REPORT FORM

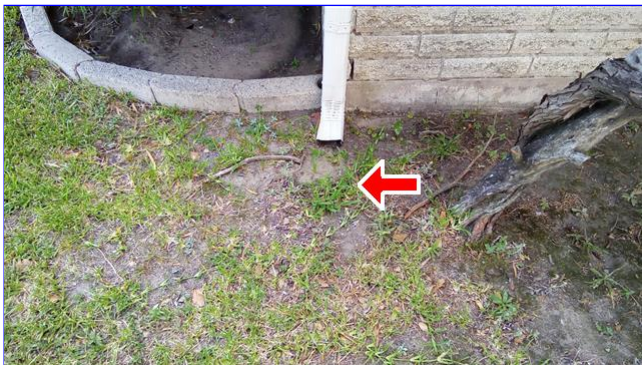
B. Item 1(Picture) at multiple locations

- (1) The gutter downspout(s) missing deflector(s) at the exterior. Erosion can continue or become worse if not corrected. A qualified contractor should inspect and replace as needed.

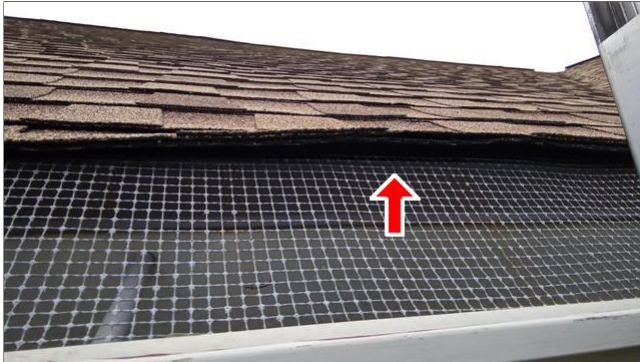
B. Item 2(Picture)

(2) The gutter on the front of the home does not appear to be installed correctly. The shingles are being pushed upward. Recommend having a qualified contractor inspect and make all necessary repairs and

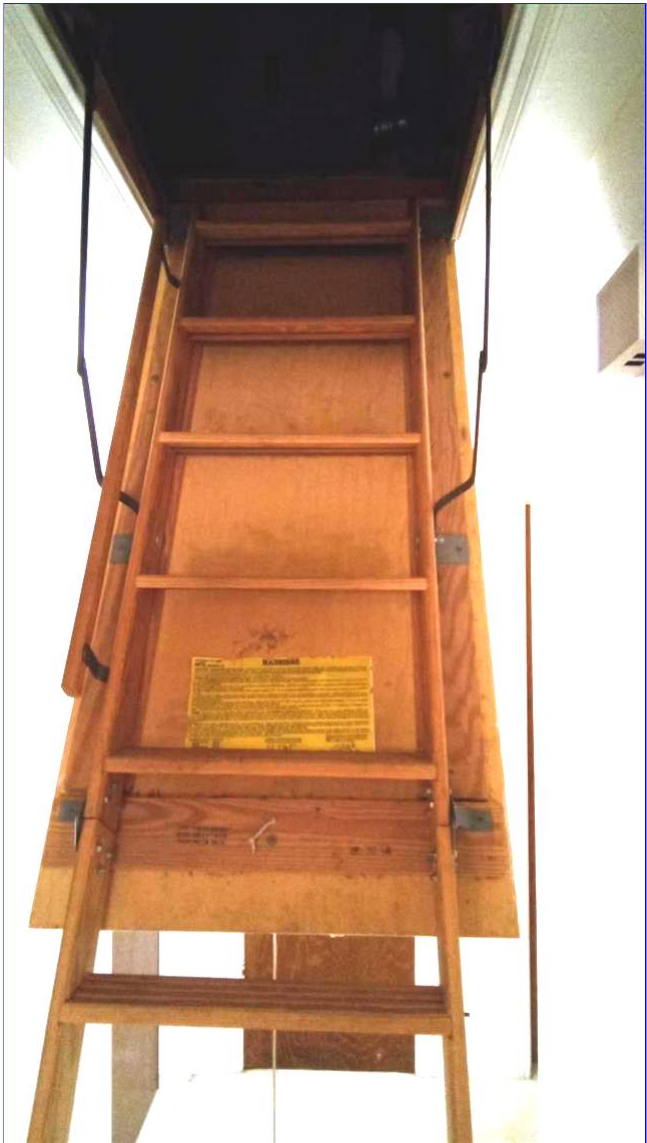
D. Item 1(Picture)

(2) The pull down stairs are not properly insulated. This can cause some heat loss in winter and loss of cool air in summer if not corrected. I recommend repair as desired.

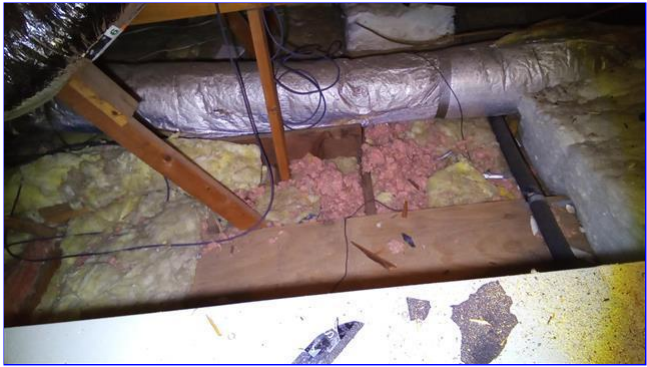
D. Item 2(Picture) additional insulation needed

(3) The attic space has area's of thin insulation. This is causing energy loss and is not today's standard. I recommend having a qualified person evaluate and add insulation as needed.

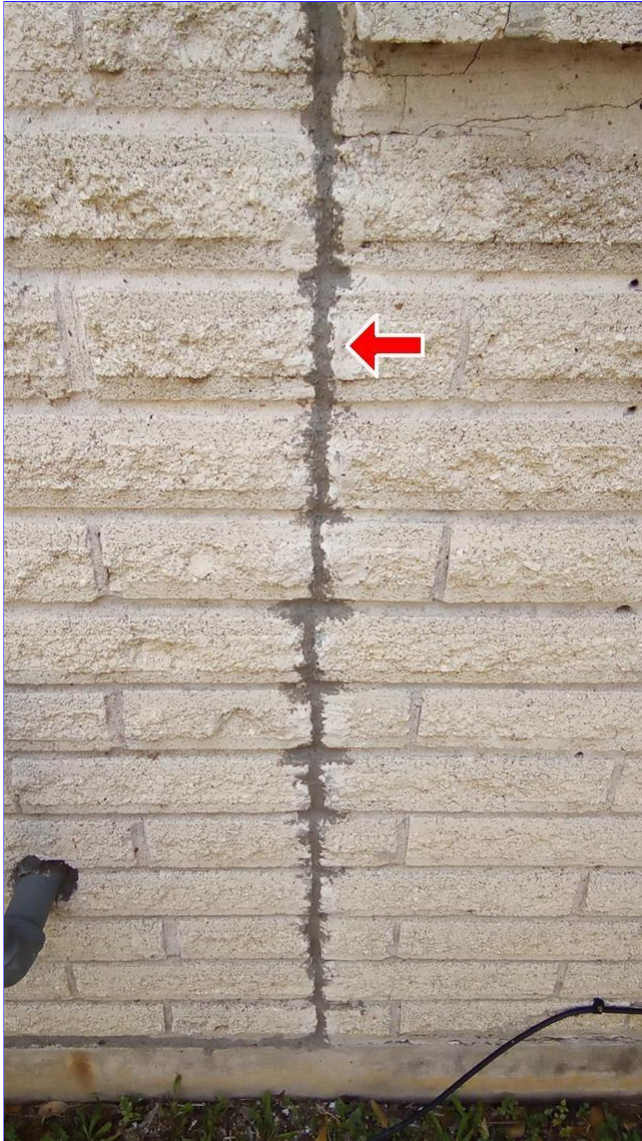
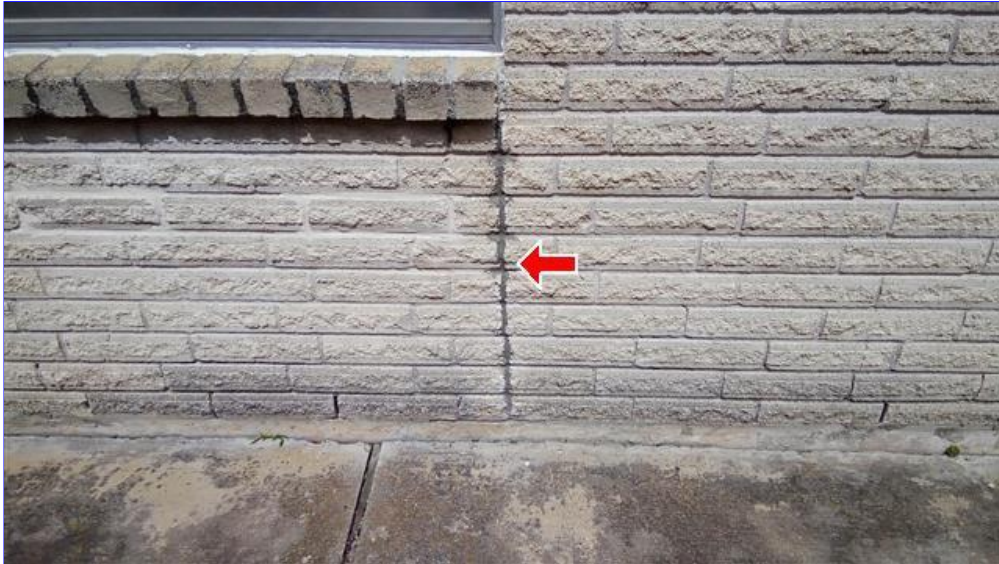
E. Item 1(Picture) right side of the home

(1) The brick expansion joints around the home have been sealed with mortar. This is not considered to be today's standard. Recommend having a qualified contractor inspect and make all necessary repairs.

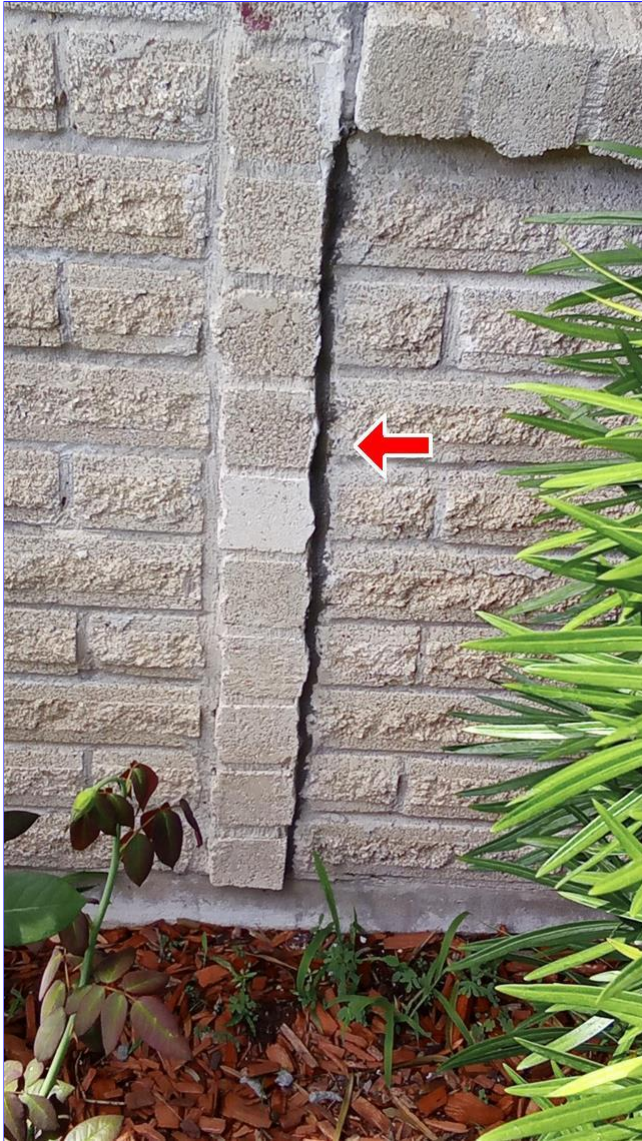
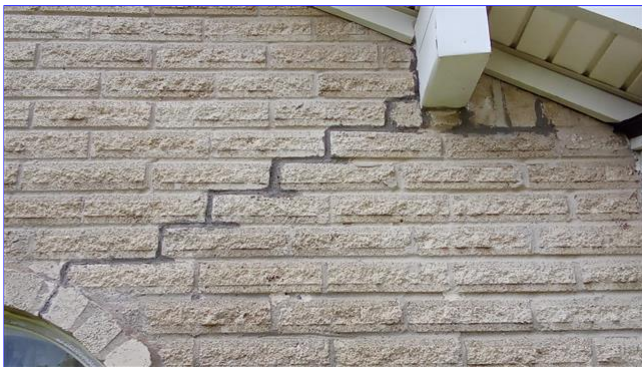
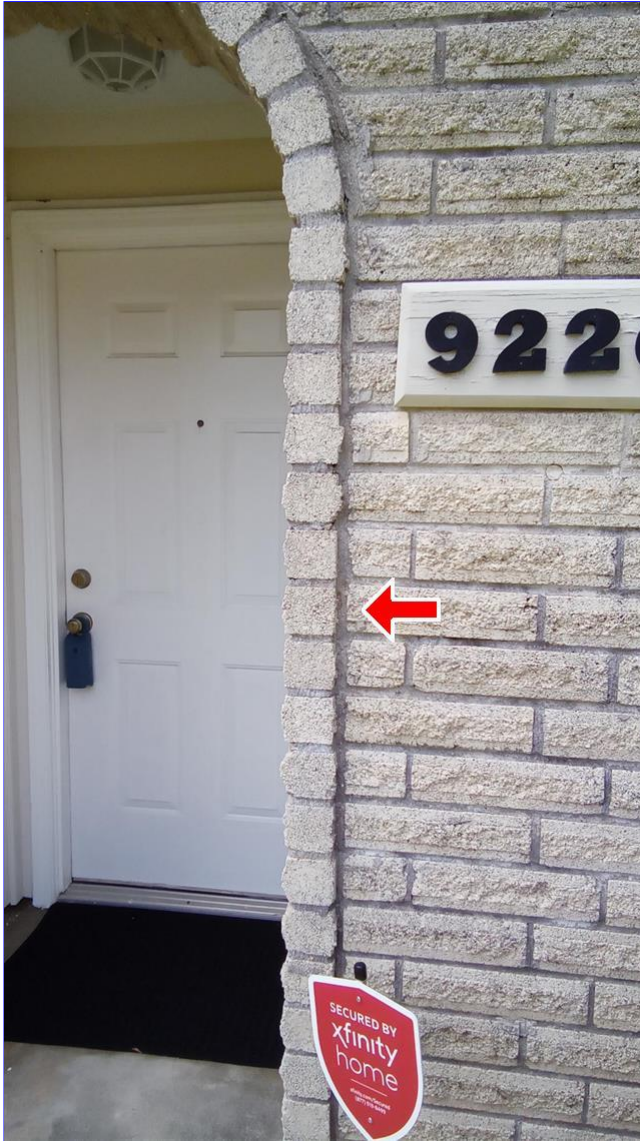
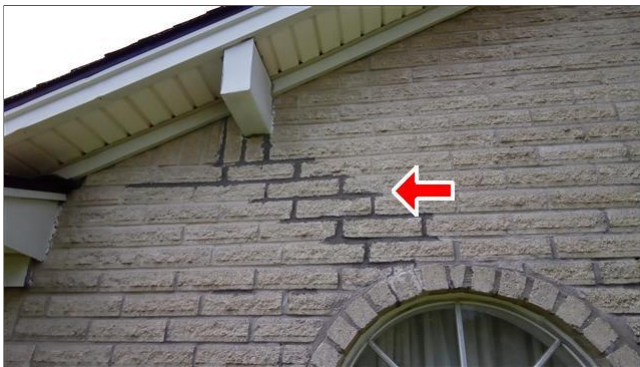
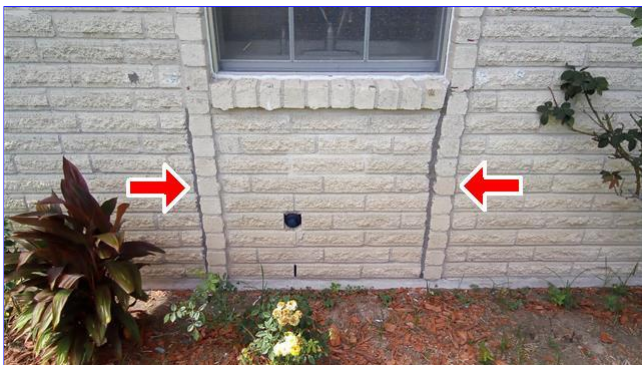
E. Item 3(Picture) front OK f home on right.

(2) The brick walls have been repaired in multiple locations. This is most likely due to settlement. This is for your information.

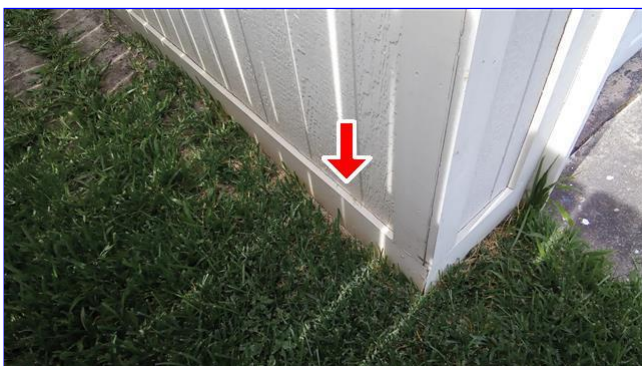
E. Item 8(Picture) around the garage

(3) Siding in contact with ground. Because the siding is in contact with ground it is possible for framing to be deteriorated. We did not inspect behind this siding. Recommend a ground clearance of six to eight inches where possible.

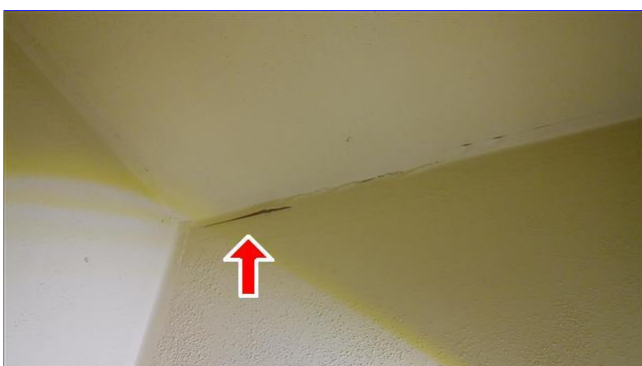
F. Item 1(Picture) top of master bedroom closet

The Drywall on the ceiling reveals tape line and nail bed areas (cosmetic). This damage is considered cosmetic. A qualified contractor should inspect and repair as needed.

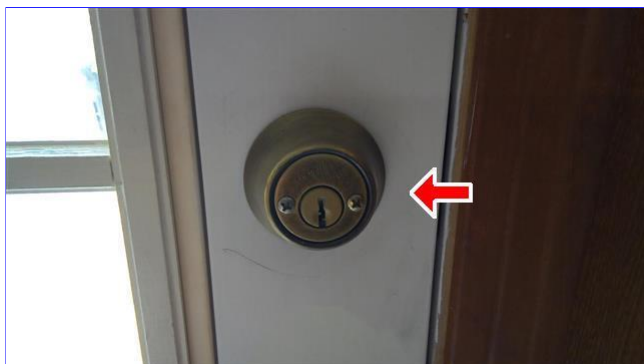
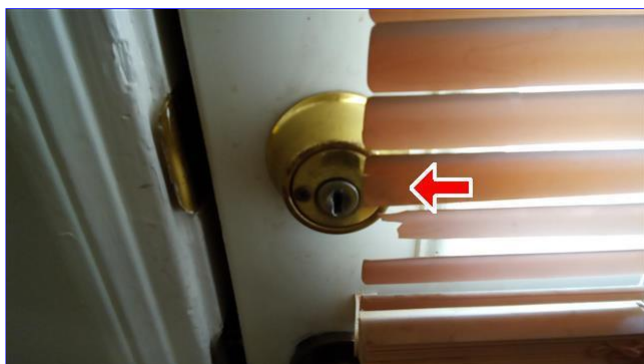
G. Item 1(Picture) rear living room door

(1) The exterior door has keyed dead bolt lock. This prevents proper egress and is a safety hazard until repaired. I recommend having a qualified person make repairs as needed.

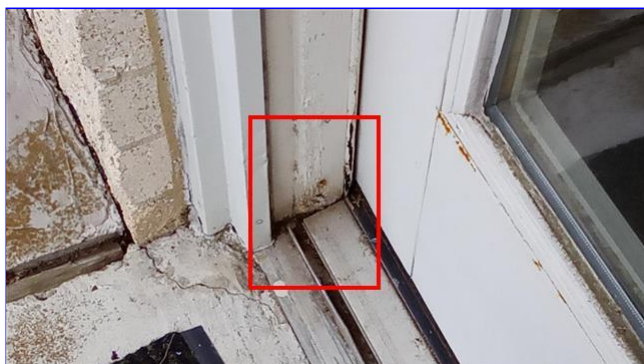
G. Item 3(Picture) right living room rear door at jamb

(2) The entry door deteriorated at bottom of jamb (s). Further deterioration may occur if not repaired. A qualified person should repair or replace as needed.

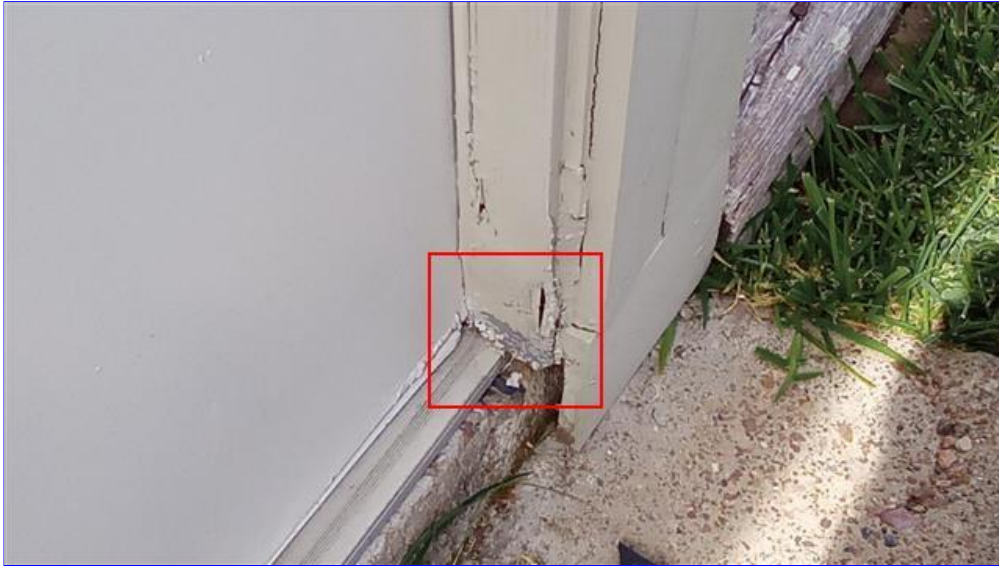
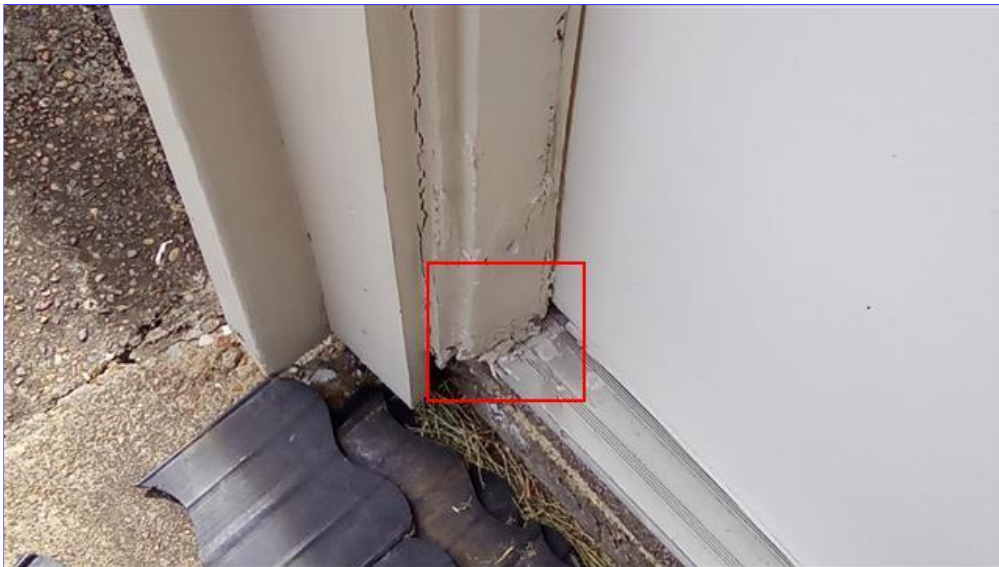
G. Item 4(Picture) right jamb

(3) The garage access door is deteriorated at bottom of jamb (s). A repair or replacement is needed. A qualified contractor should inspect and repair as needed.

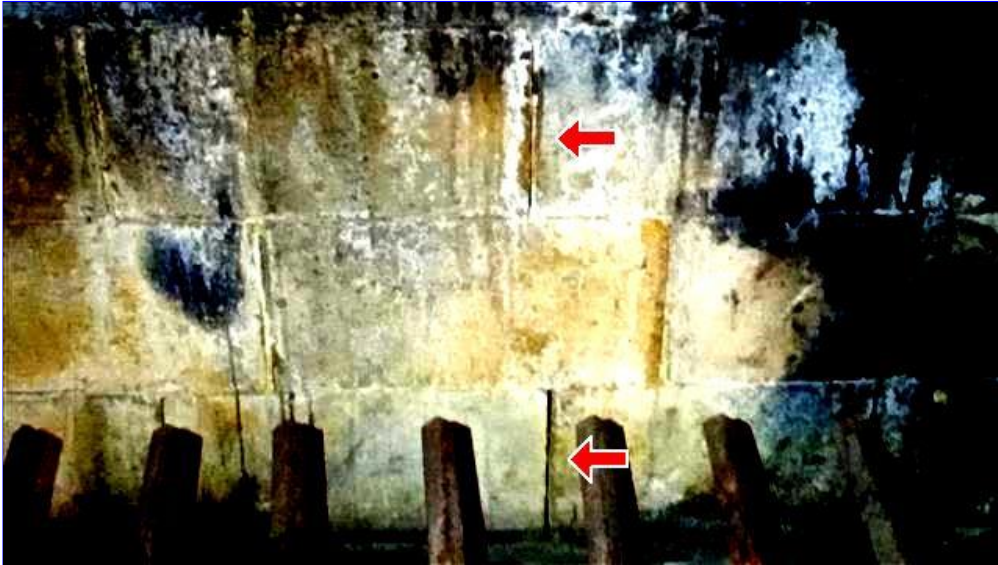
J. Item 1(Picture)

(2) The (Burn Area) for the fireplace is not properly sealed. This burn area should be fireproof. Any repairs should be performed according to the manufacturer's specifications.

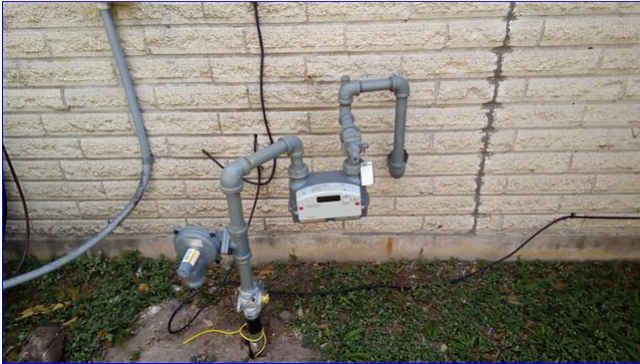
A. Item 1(Picture) at gas meter

(1) There is a bond wire to the metal plumbing but it is not within 5 feet from where plumbing line enters home. It would be safer if the above direction is observed. If you choose to correct, there should only be one bond wire to the metal plumbing so the one in wrong location should be removed. I recommend an electrical contractor install a ground wire and clamp on metal plumbing line within five feet from where plumbing line enters home and remove the old location.

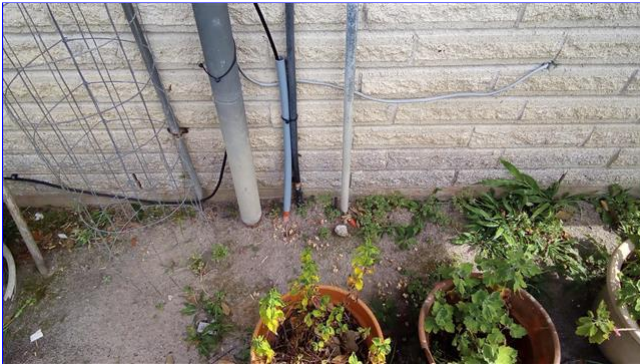
A. Item 2(Picture)

(2) I could not locate the ground wire. The ground wire may not be present or could be hidden from view by construction materials. I recommend an electrical contractor verify or install a ground wire.

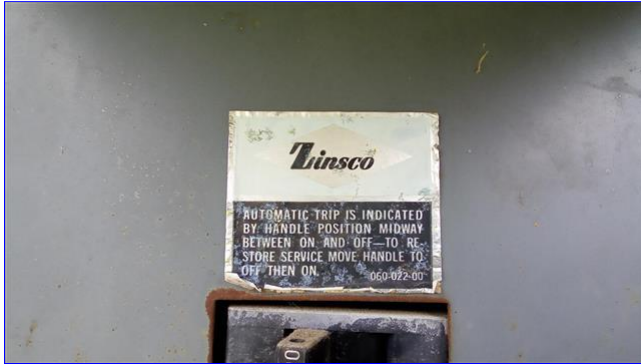
A. Item 3(Picture)

(3) You have a Zinsco-Sylvania panel which is legal, but there is a possibility that the circuit breakers may not trip when shorted possibly causing an electrical hazard. Opinions by most licensed electrical contractors on this panel is that it is unsafe. I recommend you consult a licensed electrical contractor for replacement.

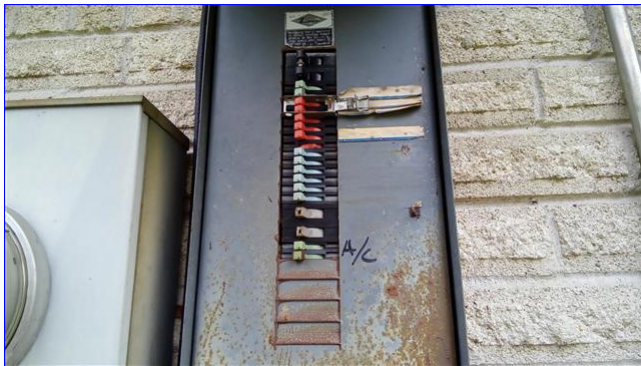
A. Item 4(Picture) clear labeling needed

(4) Some labels are present, but are illegible or confusing. I recommend correcting for safety reasons.

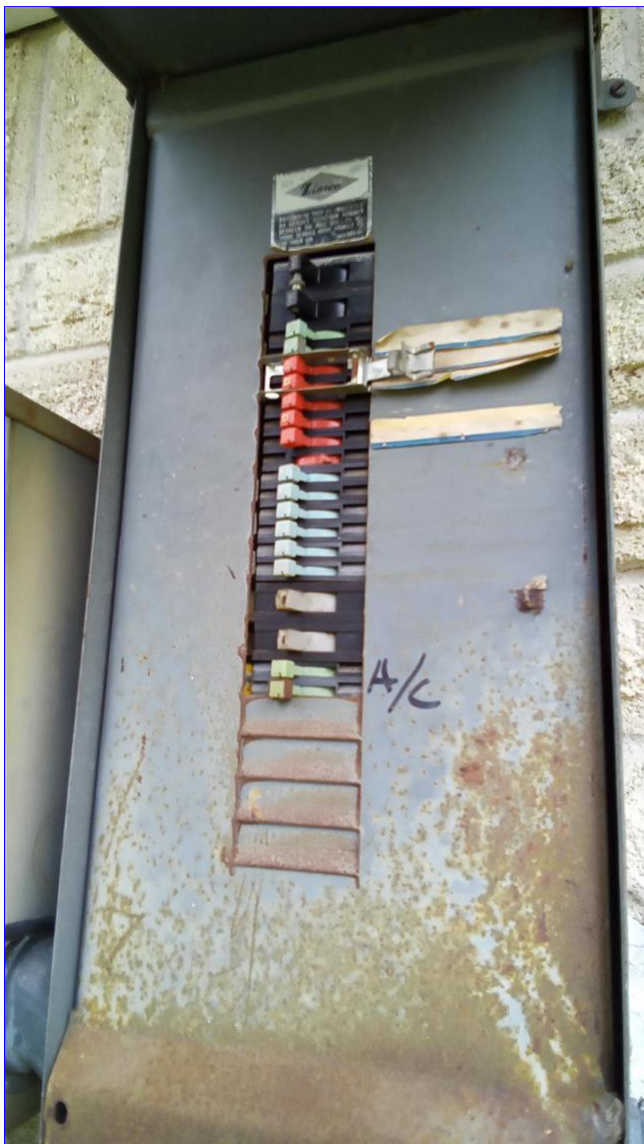
A. Item 5(Picture) no surge protector

(5) The main panel does not have a whole house surge protector. This is not today's standards. Recommend a licensed electrician to repair as needed.

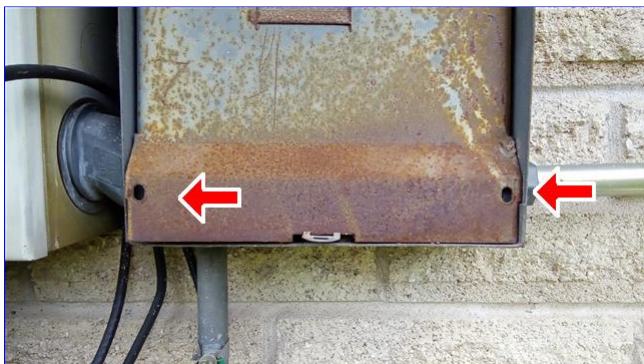
A. Item 6(Picture)

(6) The panel is missing cover screw(s). **This is a safety issue.** I recommend having a qualified person repair as needed.

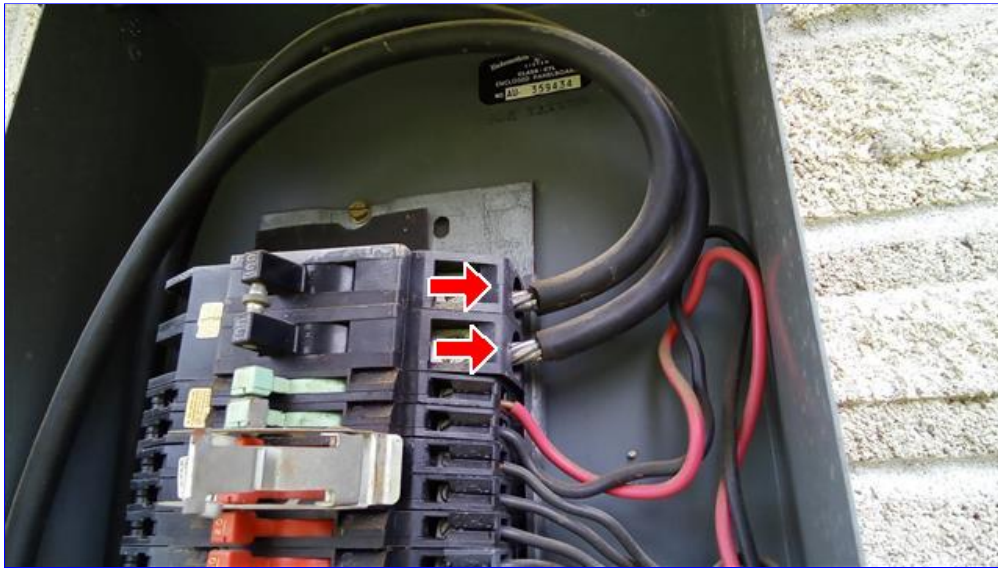
A. Item 7(Picture)

(7) There is no anti-oxidant on aluminum conductors feeding panel. This is not considered to be today's standard. I recommend having a qualified electrician evaluate make repairs as needed.

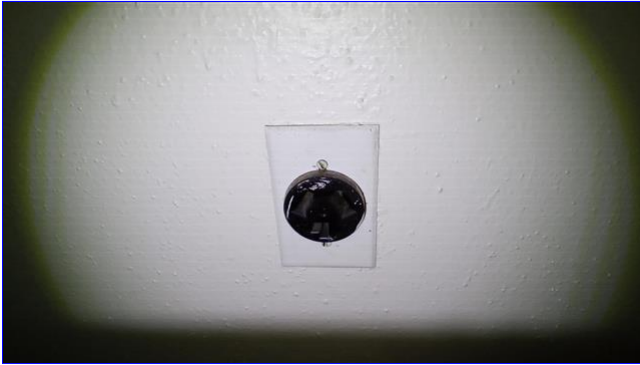
B. Item 5(Picture)

(3) A three prong outlet for dryer is present in laundry room. This is not considered today's standard.

Today's standard requires a four prong outlet be installed. I recommend having a qualified electrician to inspect and make repairs as needed.

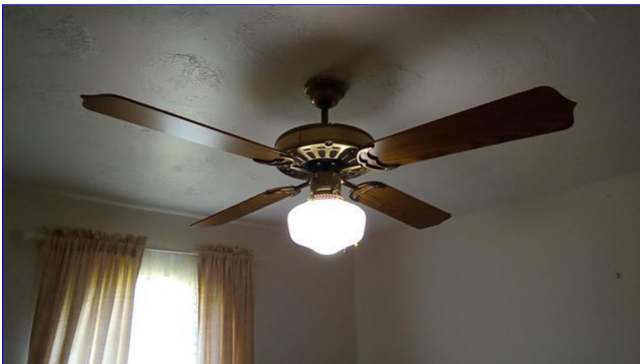
B. Item 6(Picture)

(4) The ceiling fan does not work in the front left bedroom. Electrical issues are considered a hazard until repaired. A qualified licensed electrical contractor should perform repairs that involve wiring.

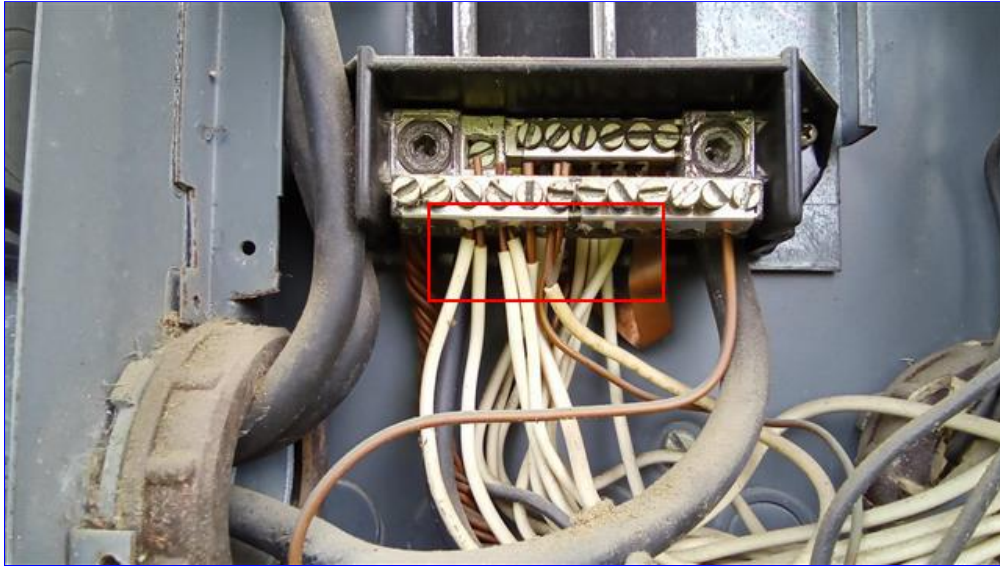
B. Item 8(Picture) doubled neutral wires

(9) Problem(s) discovered with Branch Circuits such as amateur wiring installation, doubled wiring at neutral/grounding bar, and any other problems that an electrical contractor may discover while performing repairs need correcting. I recommend a licensed electrical contractor inspect further and correct as needed.

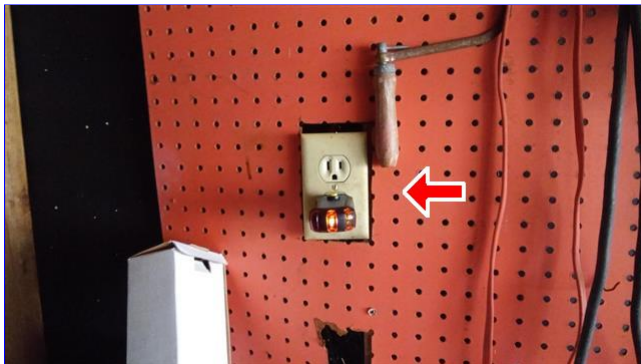
B. Item 9(Picture)

(10) The electrical outlet located inside the garage on the right wall is wired with an open ground. This is a possible shock hazard. Recommend having a licensed electrician make all the necessary repairs.

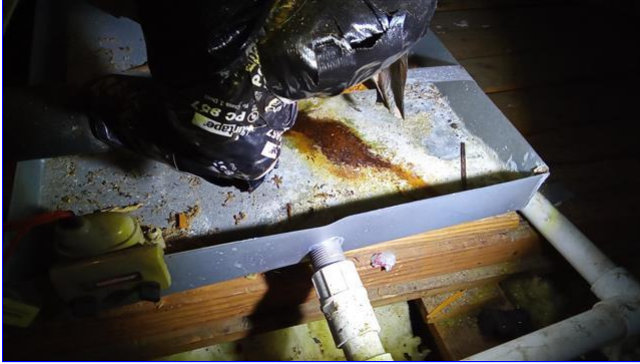
B. Item 3(Picture)

- (3) The emergency overflow drain pan for the HVAC system is showing signs of deterioration. Further deterioration may occur if not corrected. I recommend having a qualified person make repairs as needed.

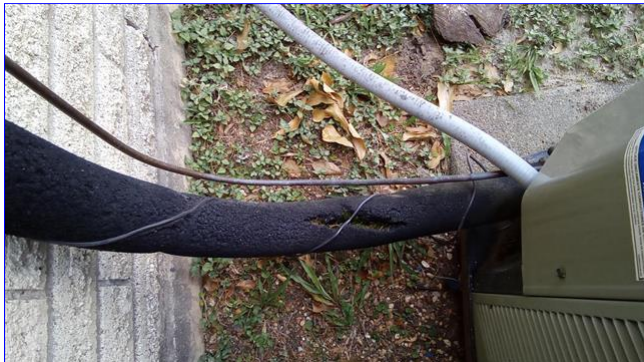
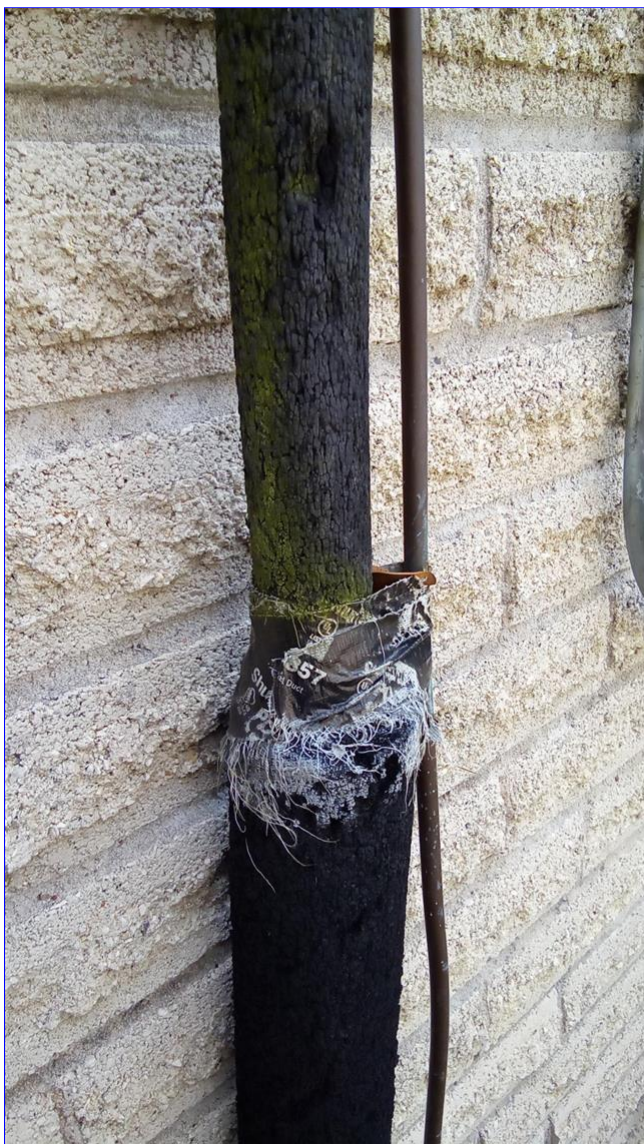
B. Item 4(Picture)

(4) The foam sleeve on suction line is deteriorated. A replacement is needed. A licensed HVAC contractor should service or repair unit.

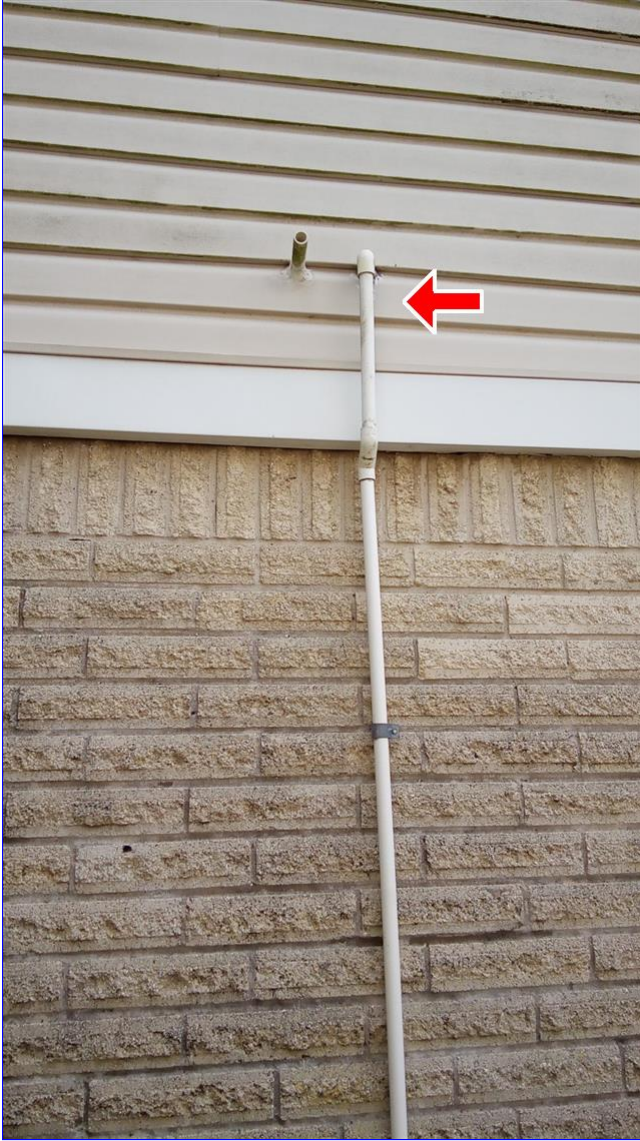
B. Item 6(Picture)

(5) The evaporator secondary drain pan line should terminate over a window per today's standard. Recommend having a qualified HVAC technician inspect and make all necessary repairs.

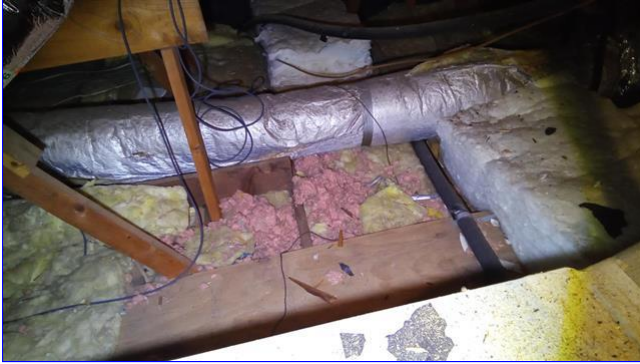
C. Item 1(Picture) straps needed

- (1) I recommend changing all HVAC filters upon move in.
- (2) The supply needs support straps in the attic. Energy loss is occurring. A licensed HVAC contractor should service or repair unit.

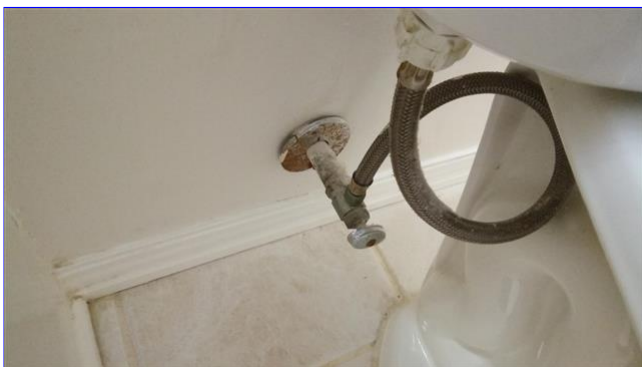
A. Item 1(Picture)

The water pipe ran in the home is galvanized steel pipe. Galvanized pipe is only rated for 35 to 40 years. The pipe has exceeded its life expectancy. This is for your information.

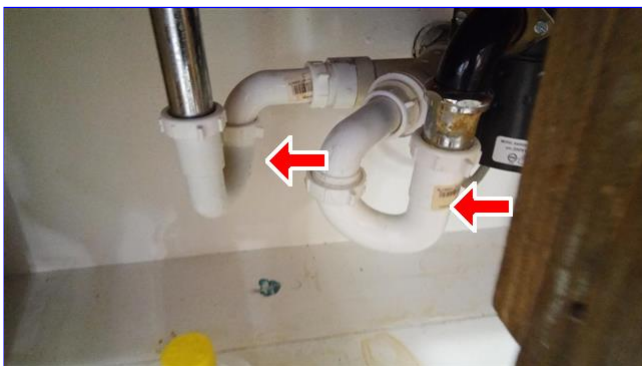
B. Item 1(Picture)

(1) The p-trap on waste line is "double trapped" which can create an air lock at the Kitchen sink. This is not considered up to today's standard. A qualified licensed plumber should repair or correct as needed.

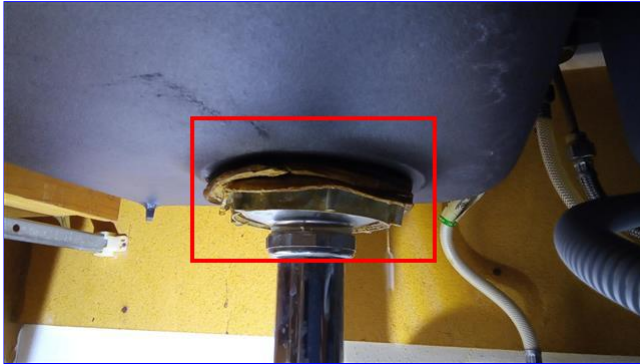
B. Item 2(Picture)

(2) The basket strainer is leaking at the Kitchen sink. Repairs are needed. A qualified licensed plumber should repair or correct as needed.
