PROPERTY INSPECTION REPORT

Concerning: 9009 Richmond Ave 104, Houston TX 77063

12/31/2021 9:00 am

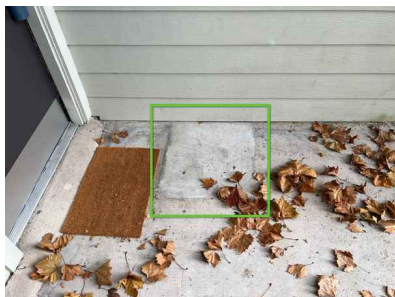
Foundation not performing as intended :

Indications of previous foundation repair were observed at the time of inspection. It is recommended to refer to the structural engineer's report (if available) for further information of repairs, warranty and maintenance of the foundation. A sewer scope inspection is also recommended to determine the condition of the underground drain/waste piping, which can be disturbed during foundation movement such as repairs.

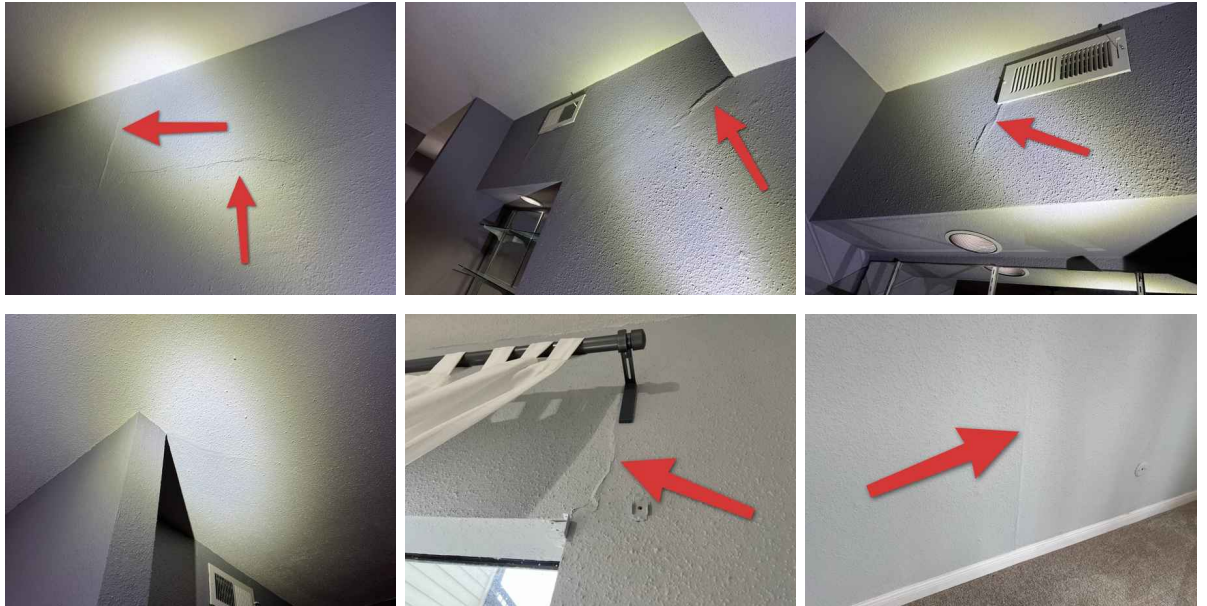
1: Evidence of Structural Damage

Evidence of structural damage was found in the wall structure. Recommend a structural engineer evaluate and advise on how to repair.

Recommendation: Contact a qualified structural engineer.

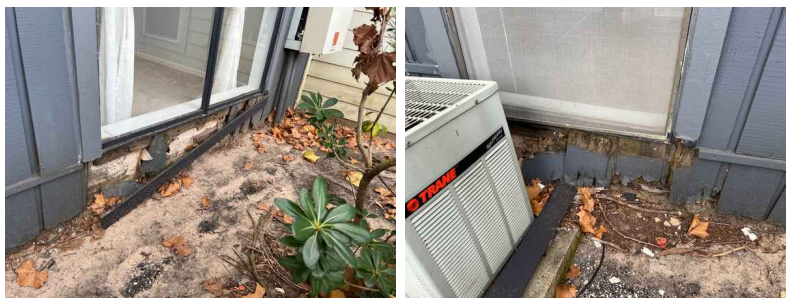
2: Exposed wall framing

Wall framing was observed exposed to the outdoors. This can cause moisture intrusion, rot, and potentially damaging the structural strength of the wall.

Recommendation: Contact a qualified professional.

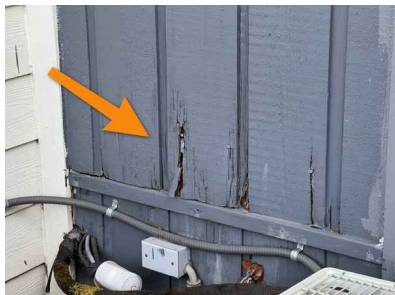
4: Exterior wall rot

Rot was observed in a few areas in the exterior walls. Recommend to replace the areas with new material.

Recommendation: Contact a qualified professional.

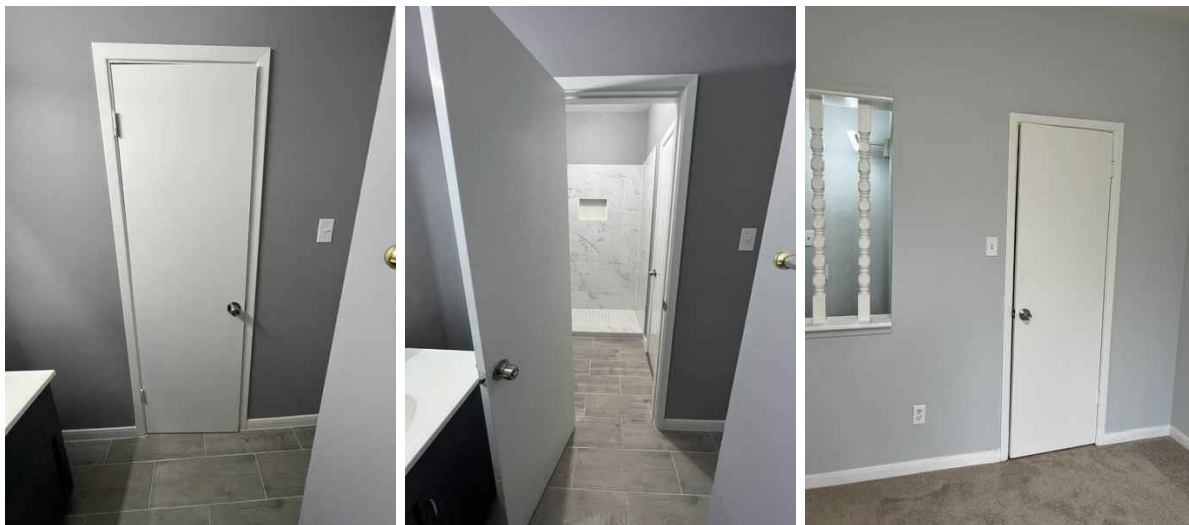
1: Out of square/ twisted door/doorframe

Adjustment is needed in the second bathroom door. It closes but with special maneuvering.

Closet door, primary bedroom

Recommendation: Contact a qualified professional.

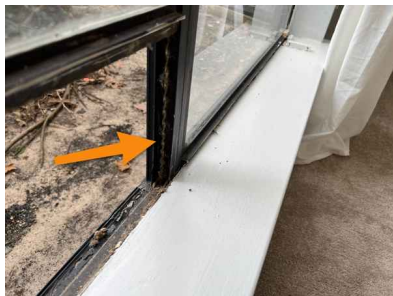
1: Channel balance out of track

The channel balance in one or more windows was observed out of track. Recommend for a window contractor to make adjustments.

Recommendation: Contact a qualified professional.

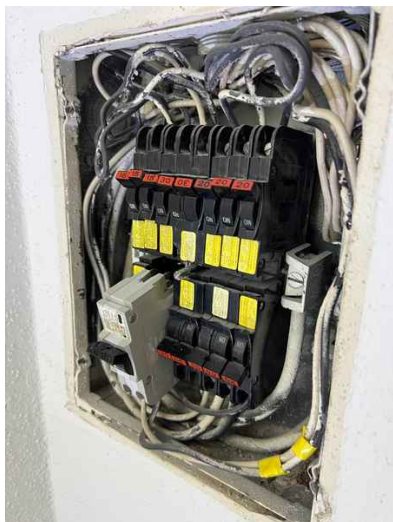
1: Breakers - not fully inserted/seated

Two breakers were observed not fully inserted. This loose contact is a fire hazard and should be repaired by a licensed electrician.

Recommendation: Contact a qualified professional.

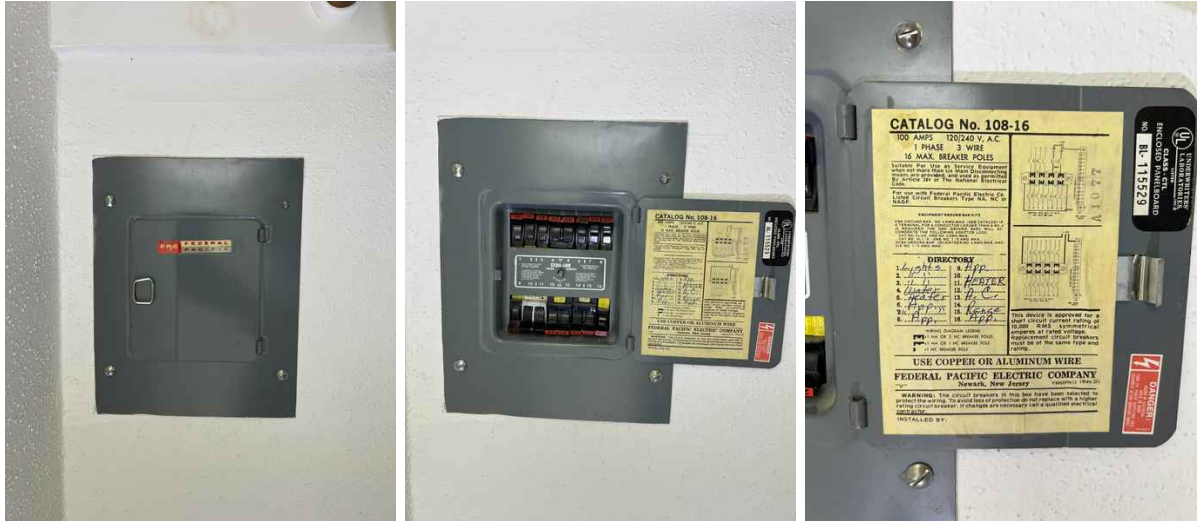
2: *RECALL*PANEL UPGRADE NEEDED

If your home was built between 1950 and 1990 and is equipped with a Federal Pacific Electric (FPE) circuit breaker panel with Stab-Lok circuit breakers, you run a significant risk of breaker malfunction and fire. If you find you a Federal Pacific panel or Stab-Lok breakers, call a licensed electrician in your area for further information about replacing immediately.

Recommendation: Contact a qualified electrical contractor.

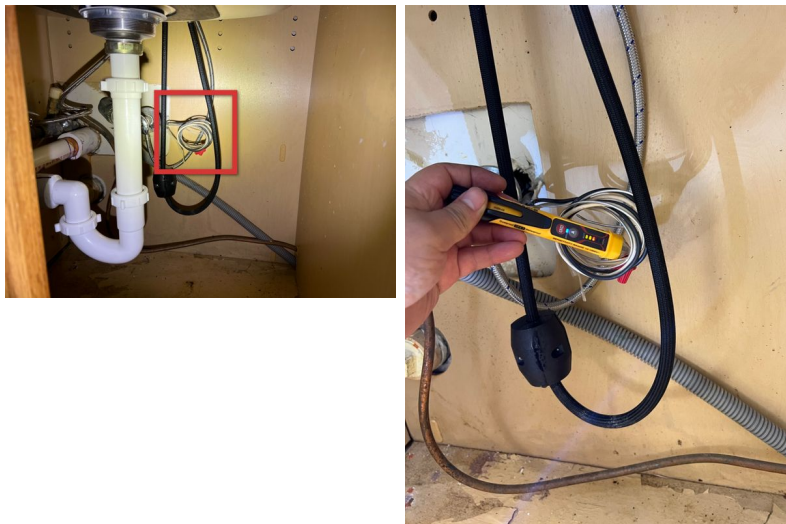
1: Exposed Ends & Splices

All wire connections & charged wires with exposed ends and splices should be covered in junction boxes for safety. Recommend a qualified electrician correct.

Recommendation: Contact a qualified electrical contractor.

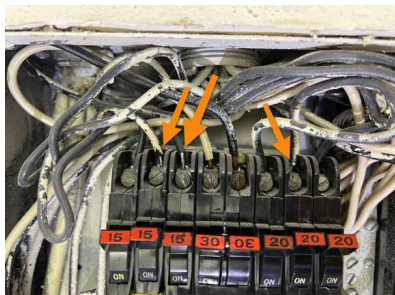
2: Aluminum Branch Circuits

Aluminum wire appears to be installed on branch electrical circuits in the subject premises. These single strand, branch circuit aluminum wires were used widely in houses during the mid 1960s and 1970s. According to the U.S. Consumer Product Safety Commission, problems due to expansion can cause overheating at connections between the wire and devices (switches and outlets) or at splices, which has resulted in fires. For further information on aluminum wiring contact the U.S. Consumer Product Safety

Commission via the Internet at <http://www.cpsc.gov/> . It is recommended that the electrical system be evaluated by a licensed electrician.

Recommendation: Contact a qualified electrical contractor.

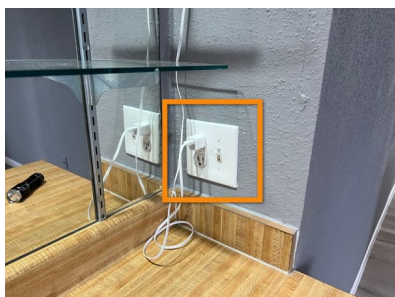
3: Loose receptacle

A loose receptacle was observed. Recommend for an electrician to tighten receptacles attachment.

Recommendation: Contact a qualified professional.

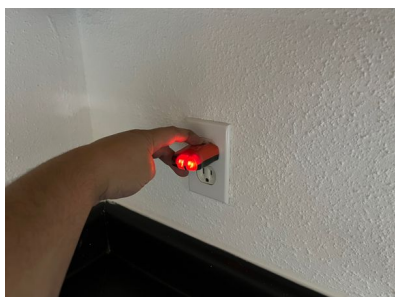
4: No GFCI

Kitchen

No ground fault circuit interrupter (GFCI) protection of electrical receptacles was provided in the home. Although GFCI protection may not have been required at the time the home was built, for safety reasons, the Inspector recommends that the home electrical system be upgraded to meet modern safety standards. All work should be performed by a qualified electrical contractor.

Recommendation: Contact a qualified electrical contractor.

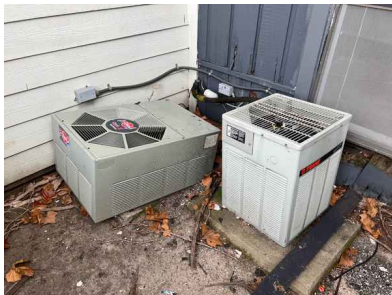
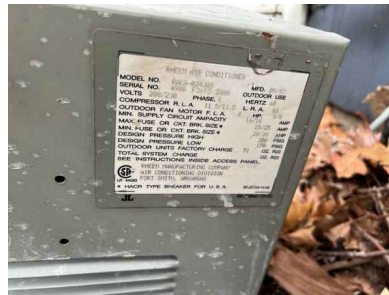
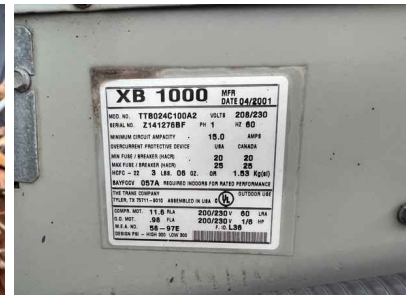
1: AC: end of useful life

The air-conditioner was old and appeared to be at the end of its useful life. The Inspector recommends that before the expiration of your Inspection Objection Deadline you consult with a qualified HVAC contractor to discuss options and costs for replacement.

Manufactured in 1993/2001

Recommendation: Contact a qualified professional.

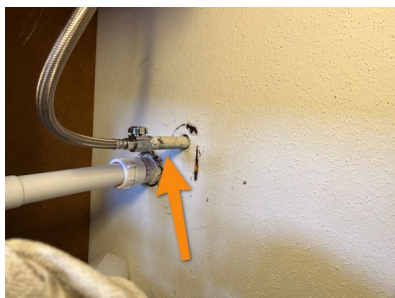
1: Water supply pipes: 1/2" and 3/4" Galvanized steel

Water distribution pipes in the home were a combination of half-inch and three quarter-inch galvanized steel. These pipes are old, and of a material no longer installed for this purpose due to bore shrinkage from accumulation of interior corrosion that over time reduces water flow. These pipes may need to be replaced soon. The Inspector recommends that before the expiration of your Inspection Objection Deadline you consult with a qualified contractor to discuss the necessity, options and costs for replacement.

Recommendation: Contact a qualified professional.

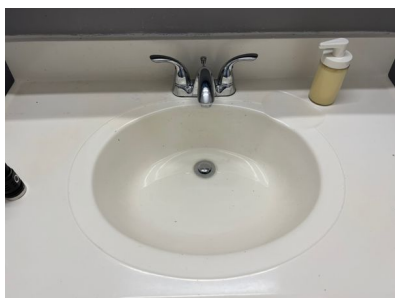
1: Poor/Slow Drainage

Poor/slow drainage was observed at time of inspection. Recommend a qualified plumber evaluate and repair.

Recommendation: Contact a qualified plumbing contractor.

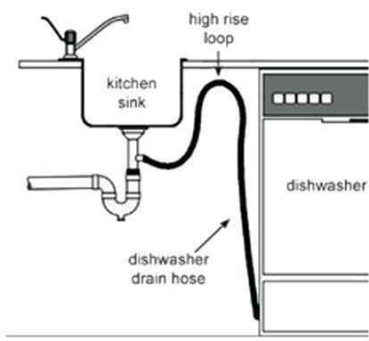
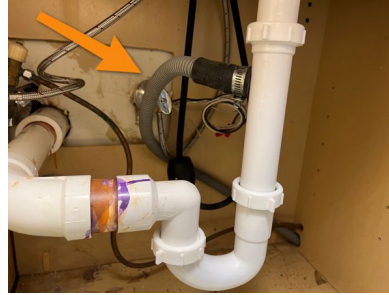
1: Improperly installed drain hose

No high loop was observed in the dishwasher drain hose. The purpose of a dishwasher high drain loop is to prevent back flow of water. The water can flow back into the dishwasher which will leave water in the bottom of the dishwasher. The high drain loop is also there to prevent improper drainage of water while the dishwasher is running.

Recommendation: Contact a qualified handyman.
