Home Inspection Report

3519 Fern Footpath Ln, Richmond , TX 77406

Inspection Date:

Wednesday, October 20, 2021

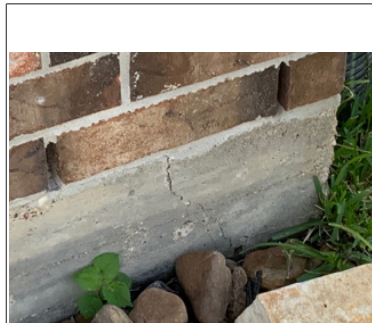
Comments: Corner(s) of foundation were broken at time of inspection. The corners for brick walls provide a ledge for the bricks to rest on. Corner broken off can possibly lead to brick damage during settlement of home. It is recommended that the corner(s) be structurally repaired and not a cosmetic cover up. Failure to repair correctly may result in structural damage to home.

Broken right front corner

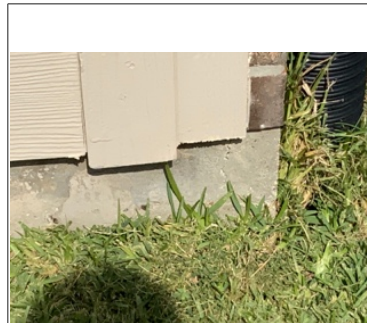
Broken left rear corner

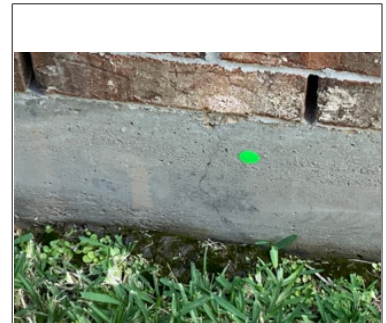
Minor vertical cracking was observed in the foundation. This type of cracking is usually the result of shrinkage of the concrete as it cures. Shrinkage cracks are very common and should not be cause for alarm.

Shrinkage crack on right side

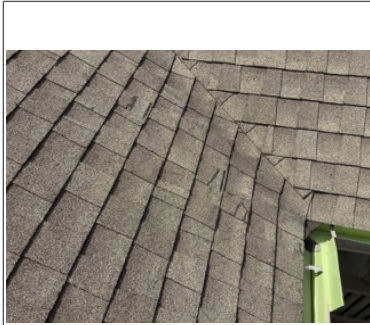
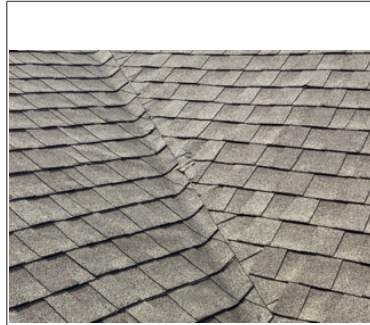
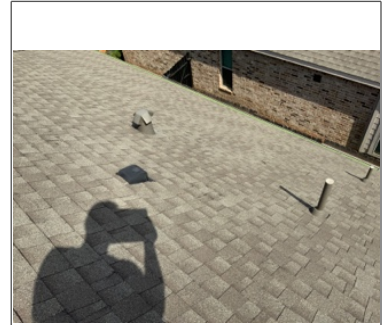
Comments: Damaged and or missing shingles noted. These areas could possibly become a water leak if not replaced or repaired.

Damaged shingles

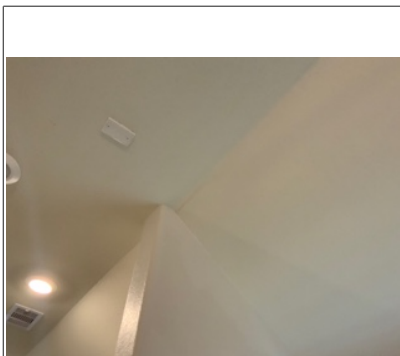
Comments: Seam failure(s) and or joint failures are a common failures due to settlement. Trim boards may need new seals.

Seam failures in family room and kitchen

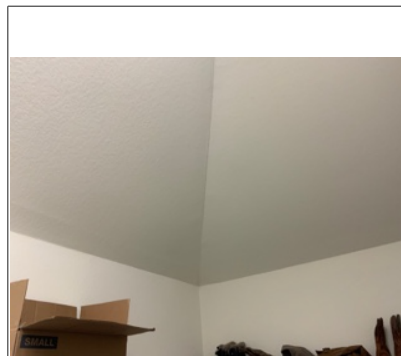
Seam failures in primary closet

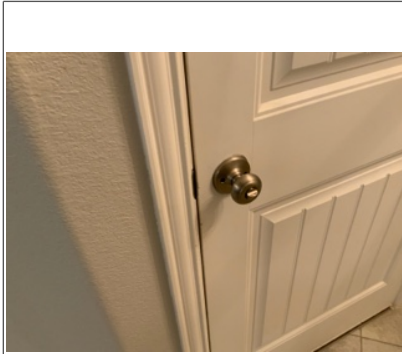
Comments: Missing hardware prevent proper operation.

Missing hardware to garage door

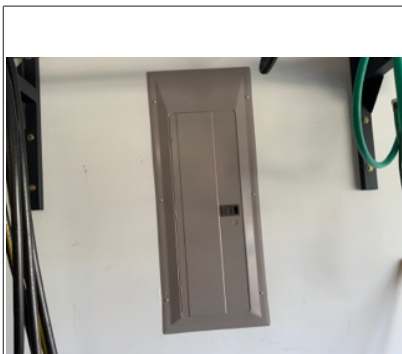
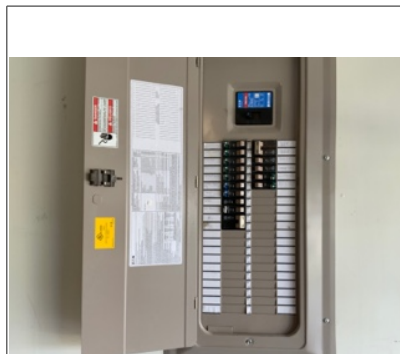
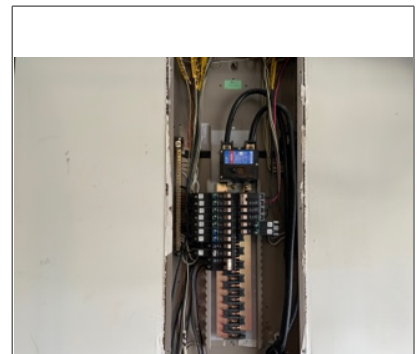
Ref photo

- A. Service Entrance and Panels**
*Comments: You have 125 amp service to your house.
Home is supplied with aluminum service wires.
Aluminum service wires are recommended to have a anti oxidant or anti corrosion compound applied. This prevents the aluminum wire from oxidation. Oxidation will cause poor connection and lead to overheating, possibly fire.*

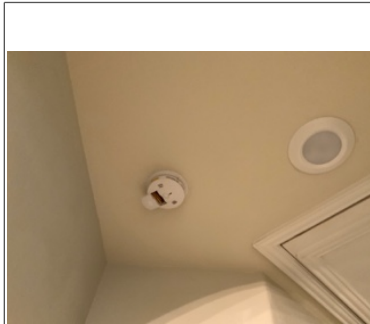
Comments: Smoke detectors are chirping which indicates new batteries are needed at all smoke detectors in the home. All batteries should be changed annually.

Replace all smoke detector batteries

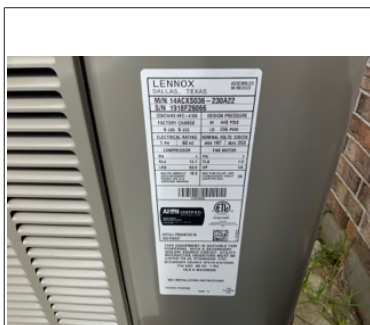
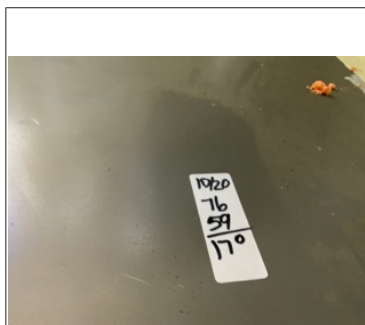
Ref differential temperature

Comments: At time of inspection temperatures were monitored at the coil(s) of the unit(s). The recommended temperature(s) drop at coil(s) is 15 -21 degrees. The system(s) operated within these standards.

30 max

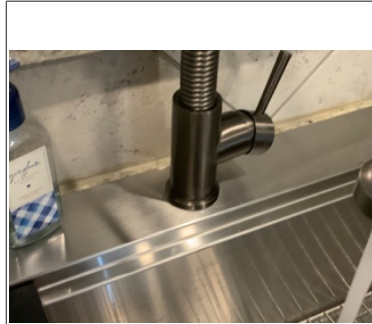
Comments: Safe water temperature of 120 degrees in recommended for safety
The faucet is loose and should be tightened.

Loose faucet

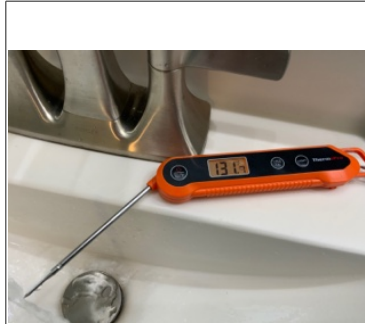
Recommend safe water temperature of 120 degrees

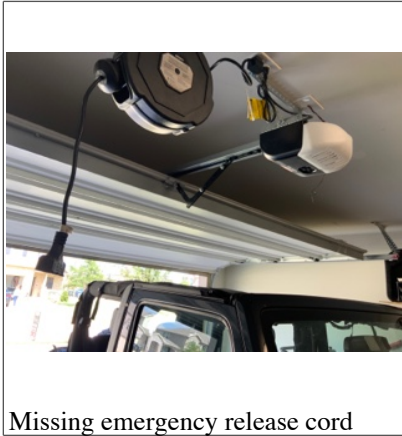
Comments: Emergency release cord needs replacing for added safety.
