PROPERTY INSPECTION REPORT

Concerning: 12727 Braewood Glen Ln, Houston, TX 77072
(Address or Other Identification of Inspected Property)

By: Raul Ramirez - TREC# 21863 09/09/2022 10:00 am
(Name and License Number of Inspector) (Date)

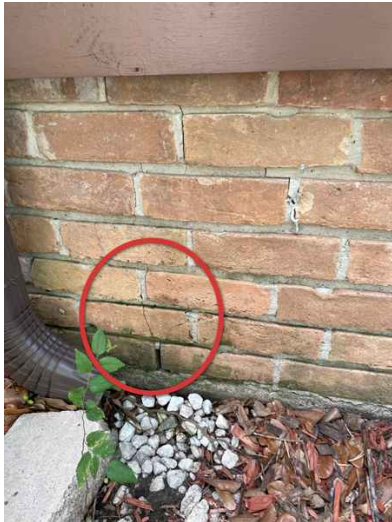
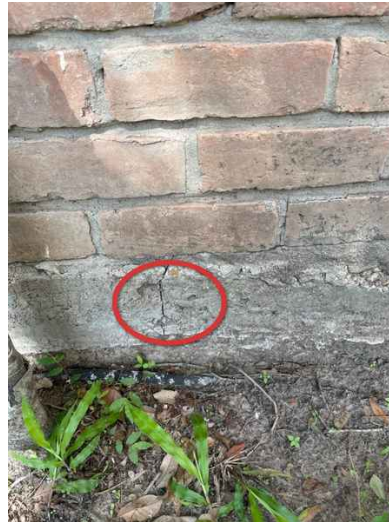
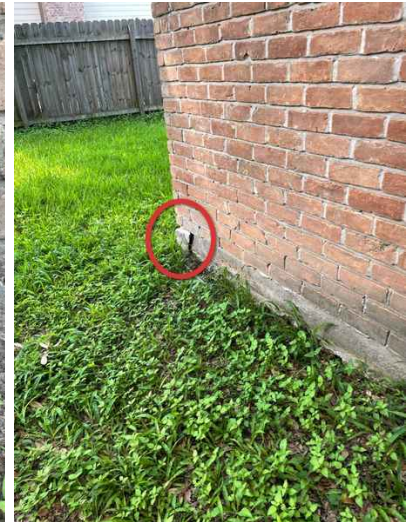
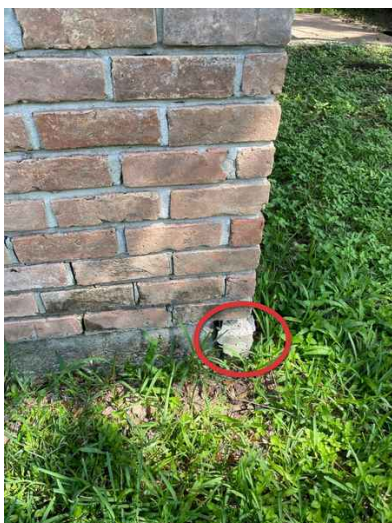
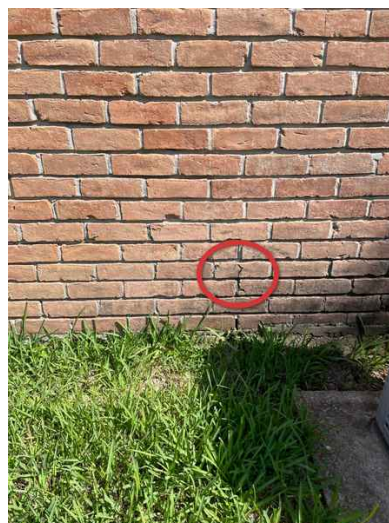
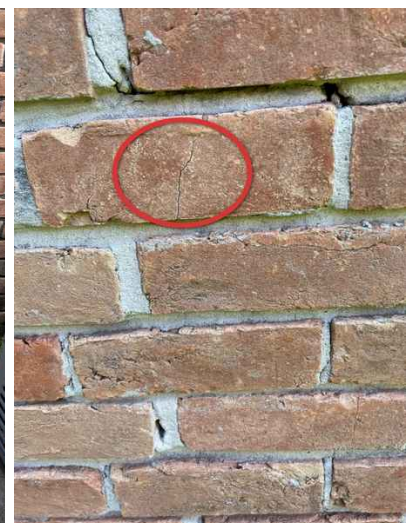
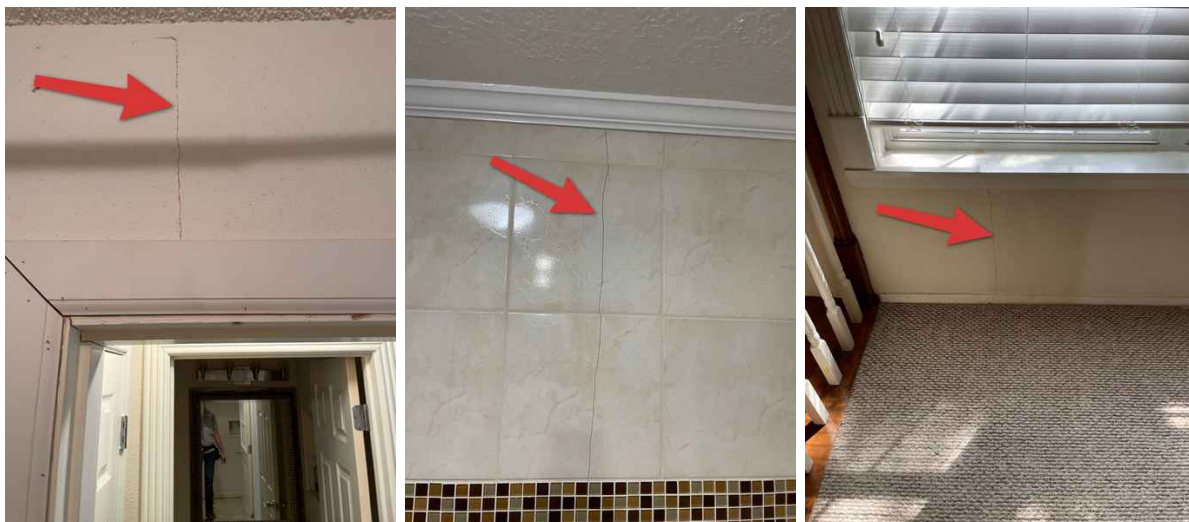
1: Foundation Cracks - Major

Severe cracking noted at the foundation. This is typically consistent with soil movement and could lead to serious damage to structural components, foundation and/or slabs. Recommend a structural engineer evaluate and provide a report on course of action and remedy.

Recommendation: Contact a qualified structural engineer.

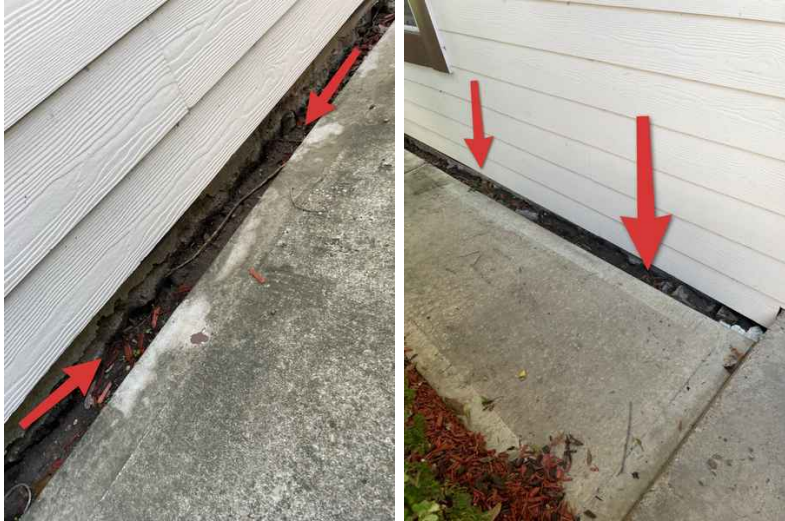
2: Negative Grading

Grading is sloping towards the home in some areas. This could lead to water intrusion and foundation issues. Recommend qualified landscaper or foundation contractor regrade so water flows away from home.

Water is getting stuck along front right elevation. Water should travel away from home.

Recommendation: Contact a qualified landscaping contractor

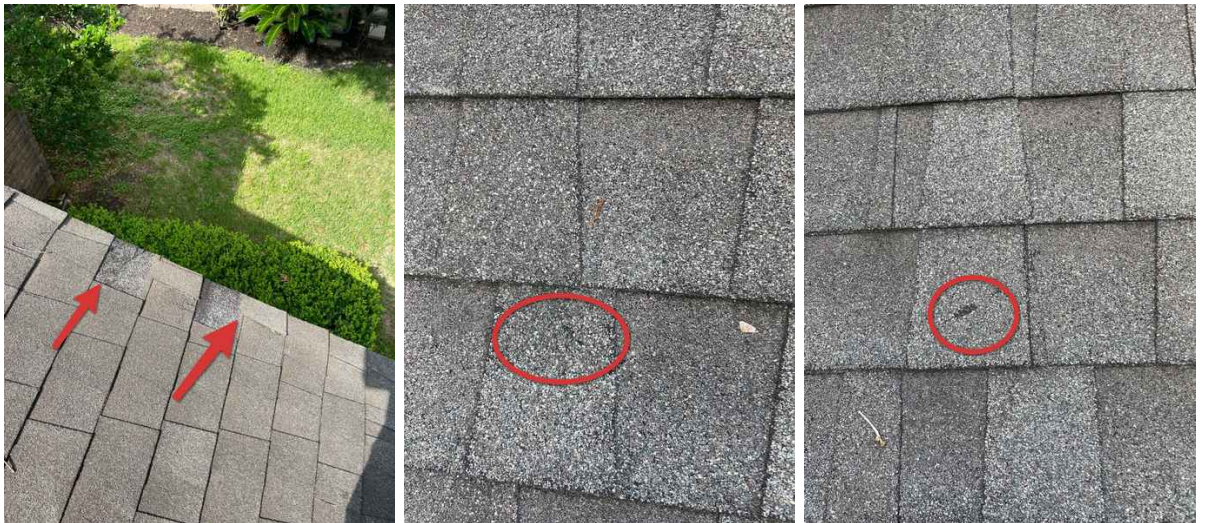
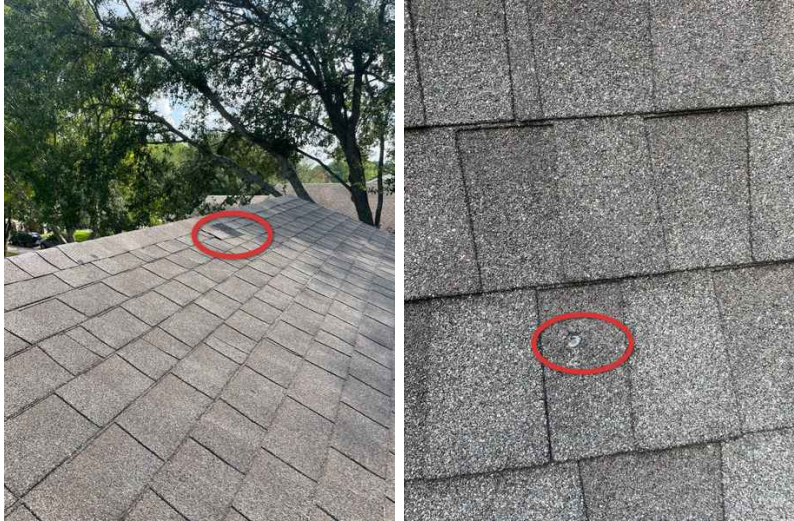
1: Damaged Coverings

Roof coverings exhibited general damage that could affect performance. Recommend a qualified roofer evaluate and repair.

Missing Shingles

Recommendation: Contact a qualified roofing professional.

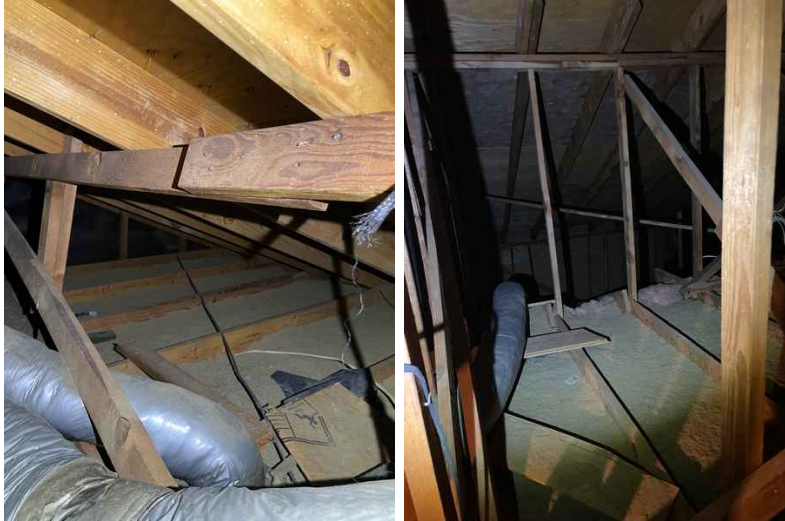
1: Insufficient Insulation

Insulation depth was inadequate. Recommend a qualified attic insulation contractor install additional insulation.

Recommendation: Contact a qualified insulation contractor.

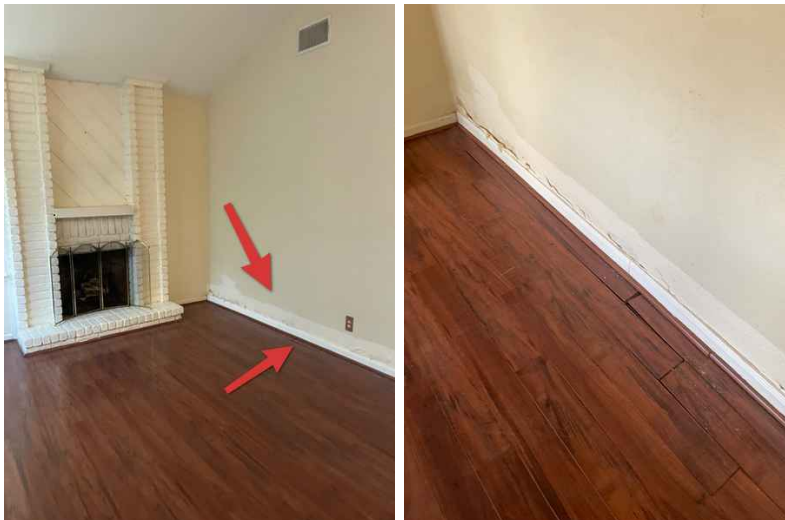
1: Evidence of Water Intrusion

Wall structure showed signs of water intrusion, which could lead to more serious structural damage. Recommend a qualified contractor identify source or moisture and remedy.

Recommendation: Contact a qualified structural engineer.

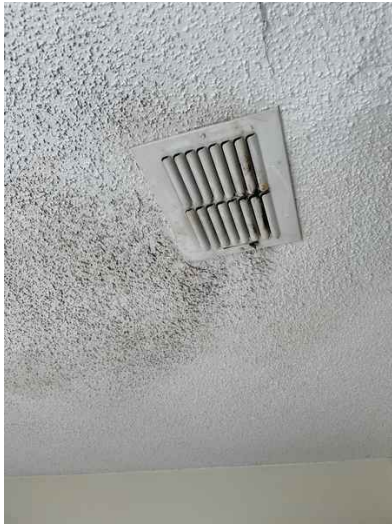
1: Ceiling - Minor Damage

Minor damage or deterioration to the ceiling was visible at the time of the inspection.

Upstairs bedroom

Recommendation: Contact a qualified drywall contractor.

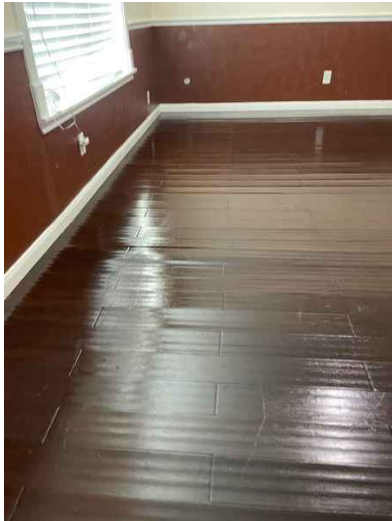
2: Uneven Floors

Uneven engineered wood floors, possibly due to expansion.

Master bedroom

Recommendation: Contact a qualified professional.

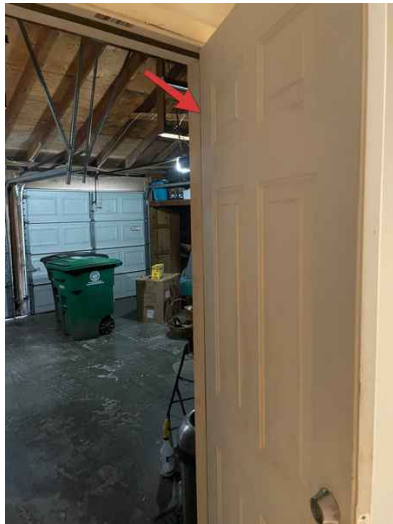
2: No re-tracting hinge

Garage door that leads to home needs to retract to prevents fumes from entering home

Recommendation: Contact a handyman or DIY project

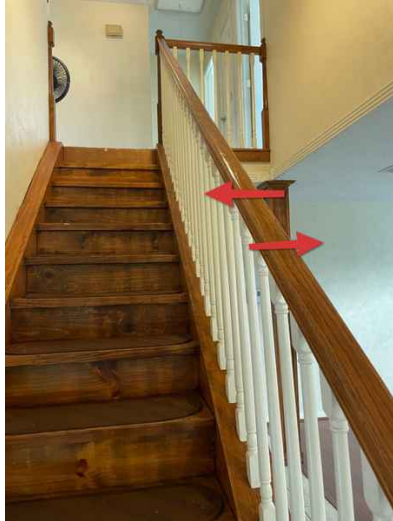
1: Loose Balusters/Handrail

Handrail balusters were loose. This could pose a safety hazard. Recommend a qualified handyman evaluate and fasten.

Recommendation: Contact a qualified handyman.

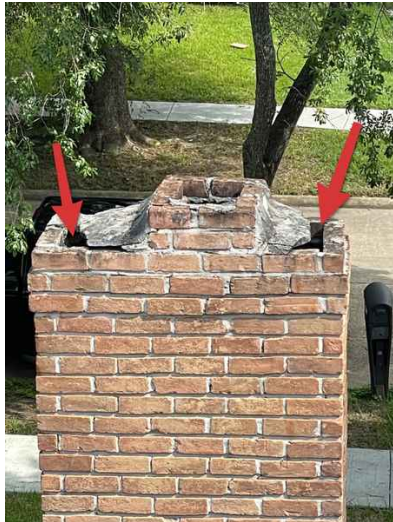
1: Damage Chimney Stack

Recommend further evaluation to prevent water penetration.

Water penetration points. Can lead to structural damage.

Recommendation: Contact a qualified professional.

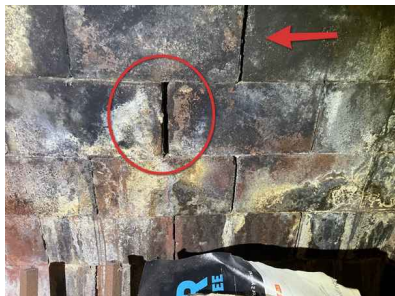
2: Firewall Cracked

The brick lining of the fireplace was cracked in one or more places, which could lead to chimney damage or toxic fumes entering the home. Recommend a qualified fireplace contractor evaluate and repair.

Recommendation: Contact a qualified fireplace contractor.

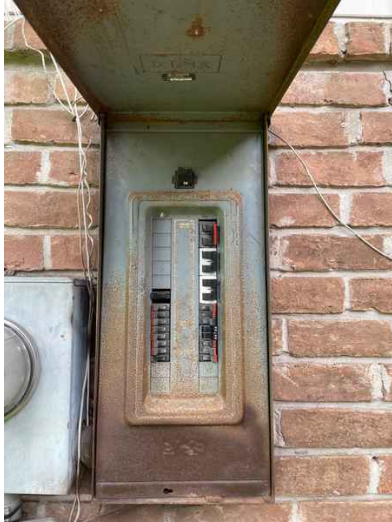
1: Panel Missing Labels

Electrical panel does not have labels. Recommend a qualified electrician test and properly label all switches.

Recommendation: Contact a qualified electrical contractor.

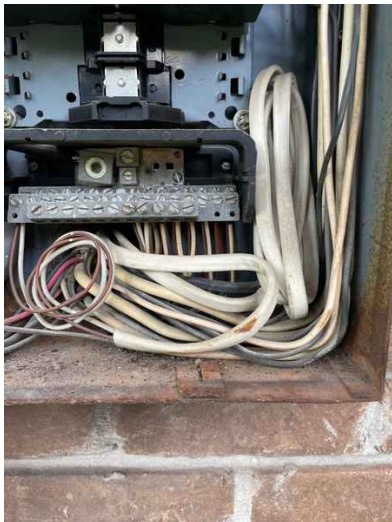
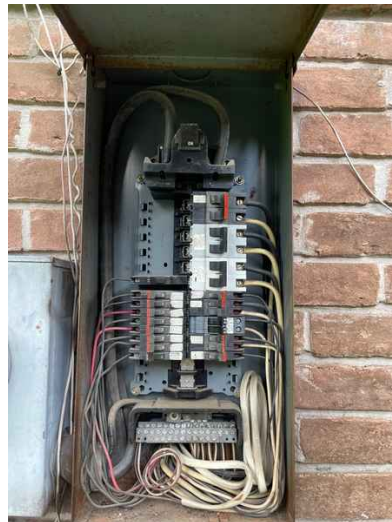
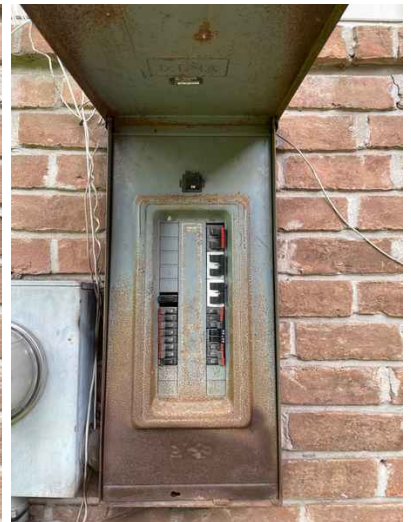
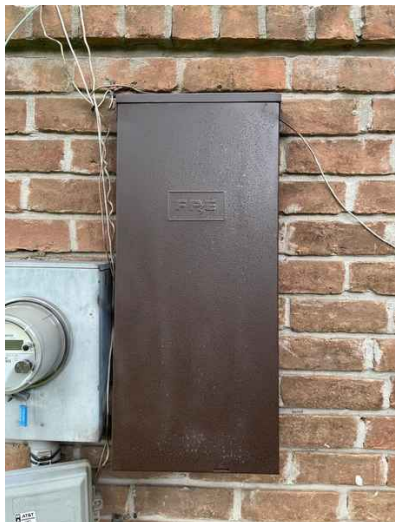
2: Panel Upgrade-Federal Pacific

Federal Pacific panels are known to fail and become a safety issue. See related article.

Recommendation: Contact a qualified professional.

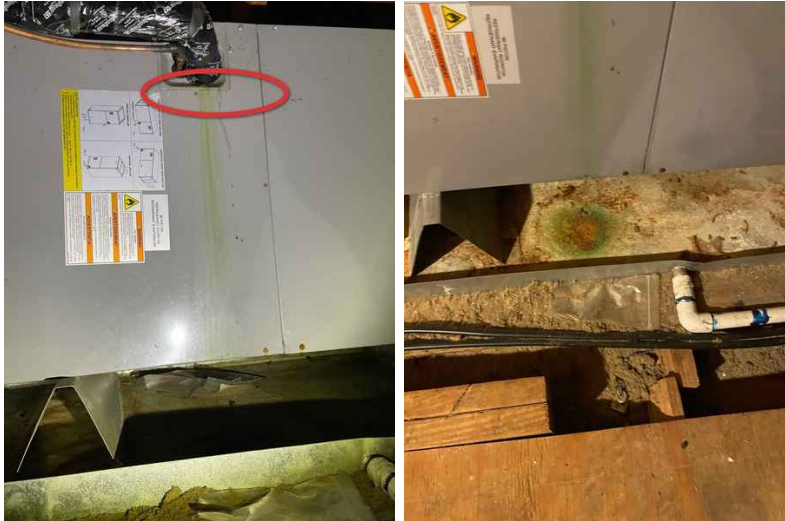
1: Water leak

Small water leak on AC condensation drain line.

Recommendation: Contact a qualified HVAC professional.

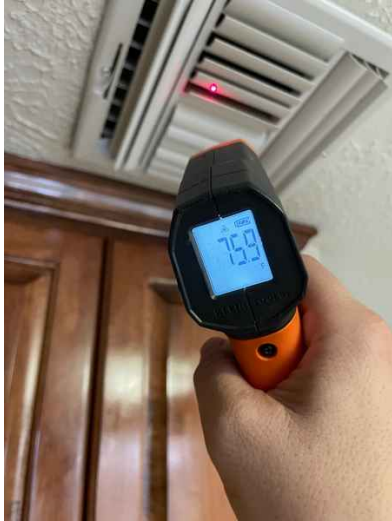
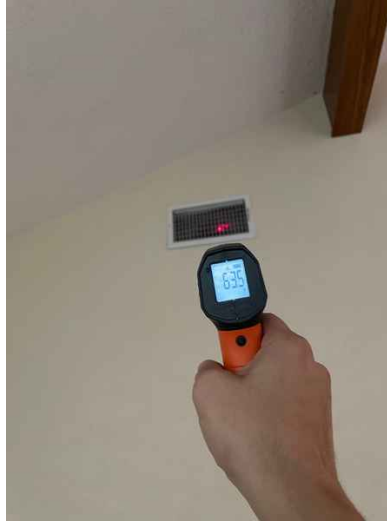
1: Return Air System Missing/Insufficient

Return air registers were missing or insufficient. This can result in poor heating efficiency. Recommend a qualified HVAC contractor evaluate and remedy.

No cold air was being registered at kitchen and living room grills

Recommendation: Contact a qualified HVAC professional.

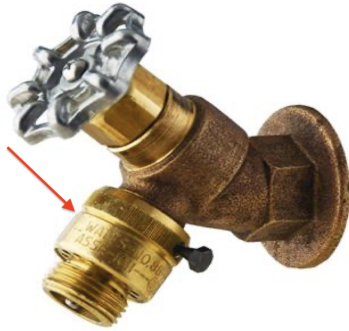
1: Missing anti siphon device hose bib

Anti-siphon devices protect against the possibility of a low water-pressure event in the supply line sucking contaminated water back into the potable water supply

Recommendation: Contact a qualified plumbing contractor.

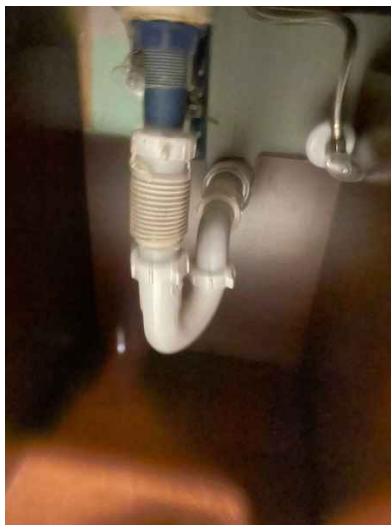
1: Accordion P-Trap

The major problem accordion pipe has is the collection of grime, hair, dirt, and other small items which may fall in the drain. The design of the pipe allows for debris to easily collect in the waste line. With the collection of all the goop, the drain begins to slowly clog and not drain properly.

Recommendation: Contact a qualified plumbing contractor.

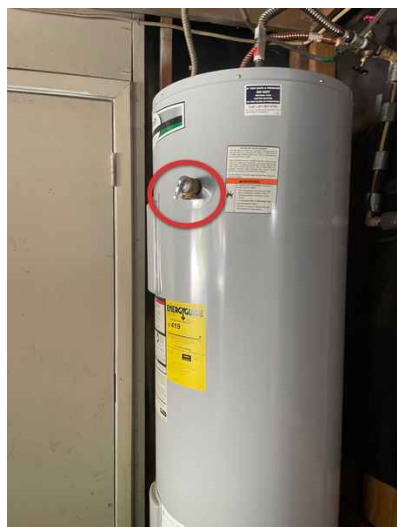
1: Improper termination of TP&R Valve drain line.

Drain line needs to terminate to exterior.

Recommendation: Contact a qualified professional.

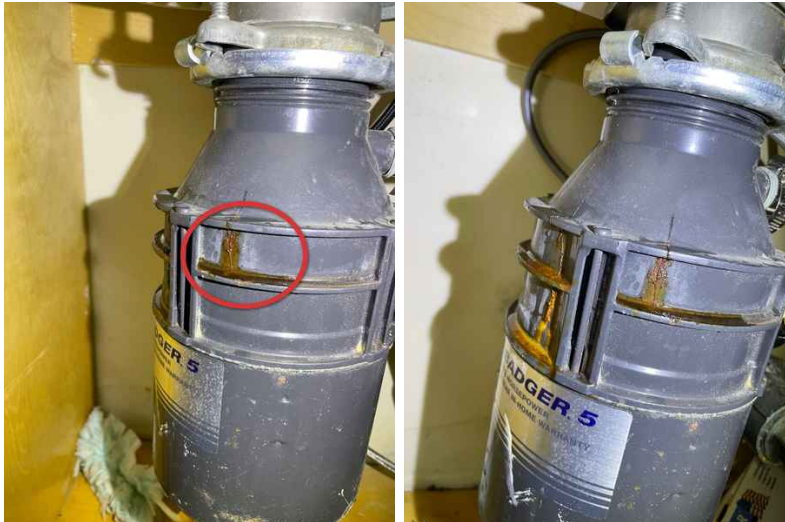
1: Leaking disposal

Recommend replacing disposal before use.

Recommendation: Contact a qualified plumbing contractor.

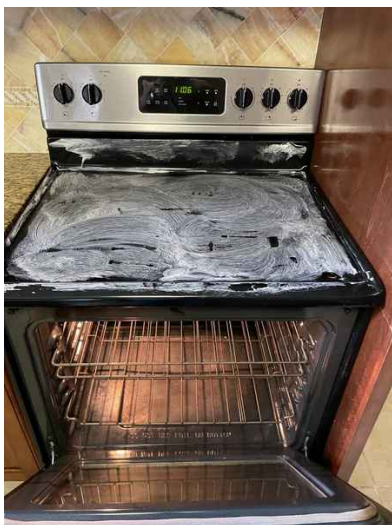
Unable to inspect due to chemicals/cleaning agent still applied
