JP's Real Estate Inspections

LICENSED PROFESSIONAL INSPECTOR'S CERTIFIED REPORT

Andrew & Dora Iremhinmhen

Additional Comments: The property is a pre-owned two-story single-family dwelling, built in 1977 on a slab on grade foundation with brick veneer, hardi plank siding with trim and composition shingle roof. The house has 2,069 Square of total living space with three bedrooms, two full and a half bathroom with a two-car attached garage. The house was vacant during the time of inspection. The buyer's son was present during the time of inspection.

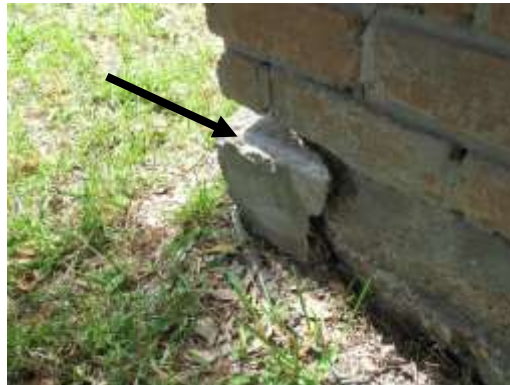
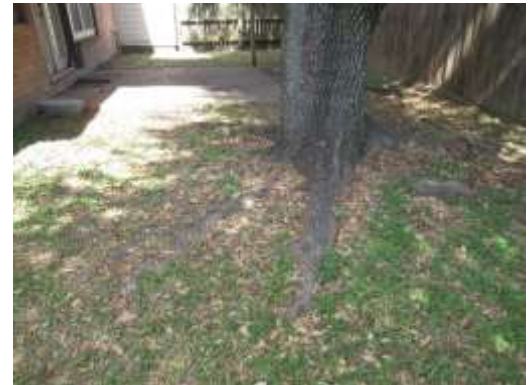
Inspectors’ Closing Comment: I recommend the foundation to be checked by a foundation company because it shows signs settlement conditions. The tree in the back yard needs to be removed, because the roots are causing damage.

- 1. I recommend the foundation to be checked by a foundation company because it shows signs settlement conditions. The tree in the back yard needs to be removed, because the roots are causing damage.**

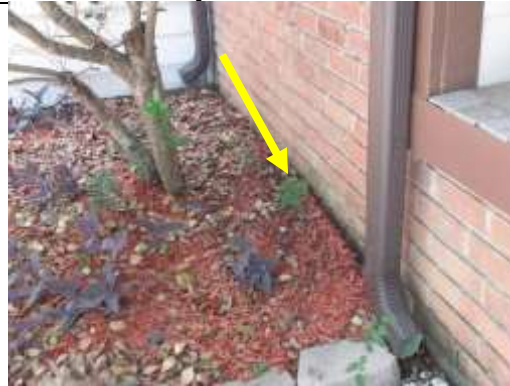
Inspectors’ Closing Comment: The grading and drainage around the house appeared to be in good condition during the time of inspection, but the soil level is too high in front of the house, and it needs to be removed to allow the weep holes to be exposed.

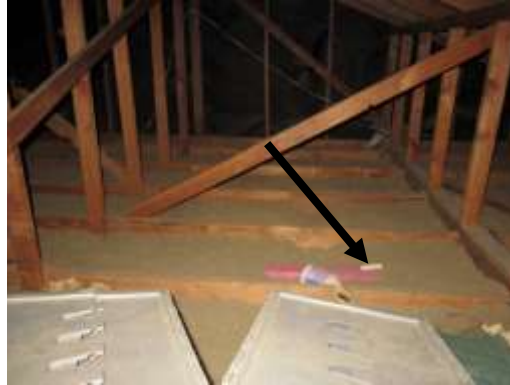
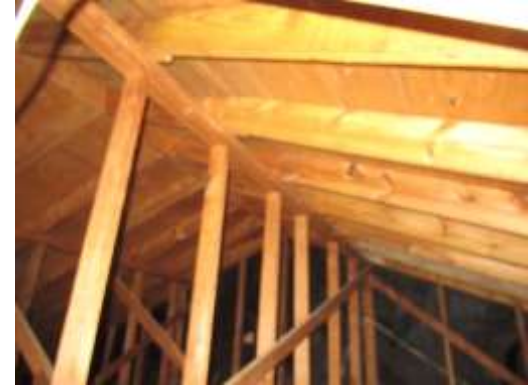
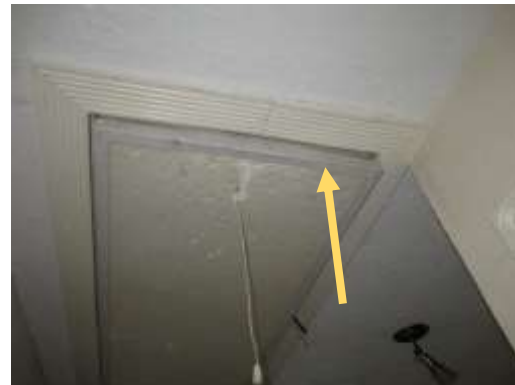
Inspectors' Closing Comment: The roof structure appeared to be in good condition during the time of inspection, but there needs to be new insulation installed inside

the attic because the insulation that is present is below the rafters and not energy efficient. The attic door needs to be repaired because it is not closing properly.

- 4. There needs to be new insulation installed inside the attic because the insulation that is present is below the rafters and not energy efficient. The attic door needs to be repaired because it is not closing properly.**

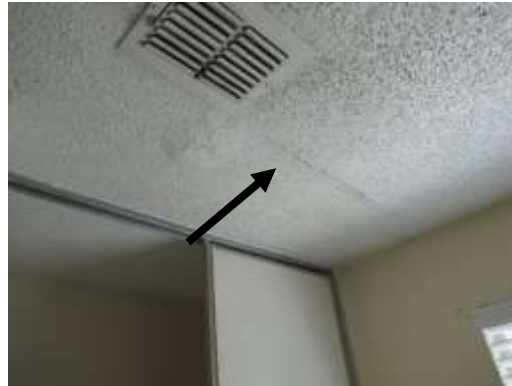
Inspectors' Closing Comment: The exterior walls appeared to be in good condition during the time of inspection, but the interior walls show signs of settlement showing.

Comments: Signs of ceiling cracks in some areas: Yes
Signs of structural settling: Yes
Water stains on ceiling: No
Floor cracks: No

Inspectors' Closing Comment: The ceiling in the bedroom upstairs needs to be repaired. The tile floors throughout the house downstairs appears to be in fair condition during the time of inspection.

- 5. The ceiling in the bedroom upstairs needs to be repaired.**

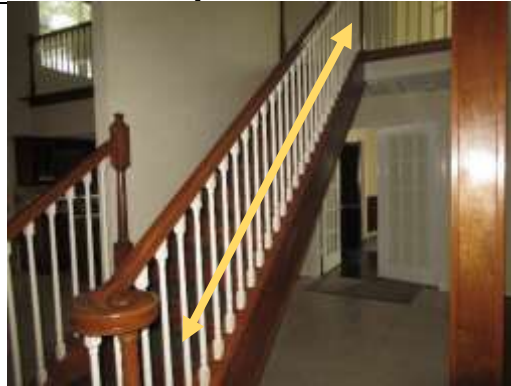
Inspectors Closing Comments: The stairway railing needs to be made sturdier because it shows signs of weakness.

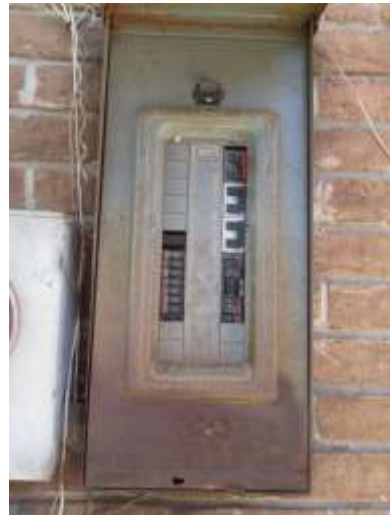
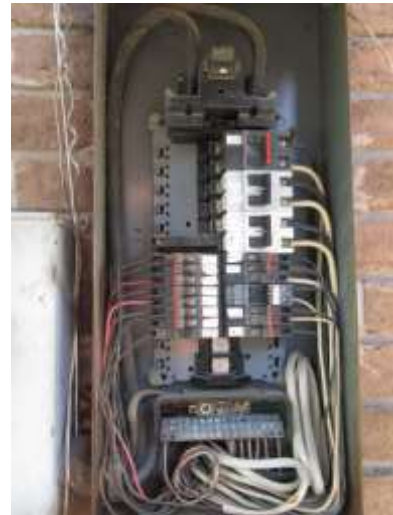
Inspectors' Closing Comment: It is mandated by the National Electrical Code to replace an electrical panel if it has been in service for 30 years or more. I recommend an electrical company to inspect it and make a determination if it needs to be replaced soon.

- 8. It is mandated by the National Electrical Code to replace an electrical panel if it has been in service for 30 years or more. I recommend an electrical company to inspect the breaker box and to make a determination if it needs to be replaced soon.**

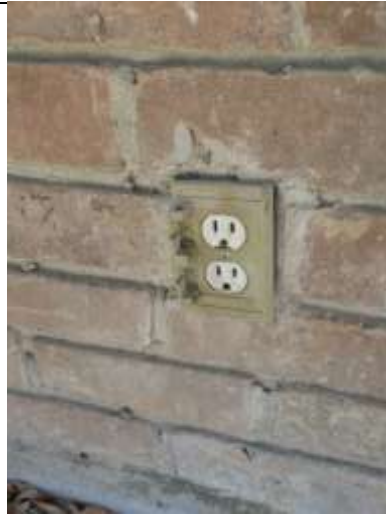
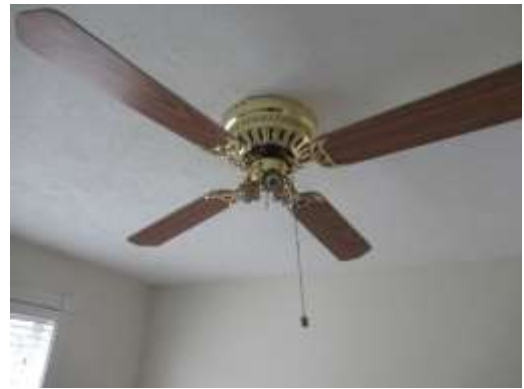
Inspectors' Closing Comment: There are several outlets need to be replaced throughout the house because the tension is very weak. There need to be GFCI outlets installed in all wet locations such as on the front and rear porch, on the counter near the kitchen sink, bathrooms and inside the garage because there are none present during the time of inspection. The ceiling fan inside the bedroom upstairs needs to be replaced because it did not work during the time of inspection.

- 9. There are several outlets need to be replaced throughout the house because the tension is very weak. There need to be GFCI outlets installed in**

all wet locations such as on the front and rear porch, on the counter near the kitchen sink, bathrooms and inside the garage because there are none present during the time of inspection. The ceiling fan inside the bedroom upstairs needs to be replaced because it did not work, and the ceiling fan inside the family room make noise during the time of inspection.

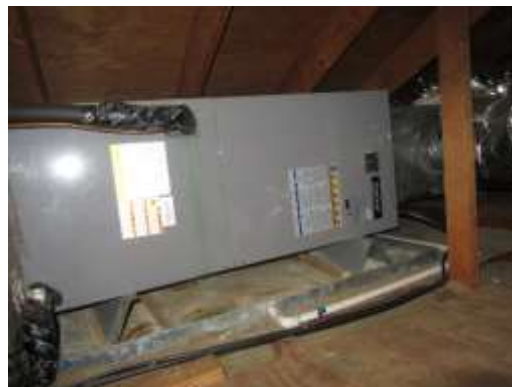
Inspectors' Closing Comment: The furnace inside the attic was operated for a short period and appeared to be functioning as intended during the time of inspection.

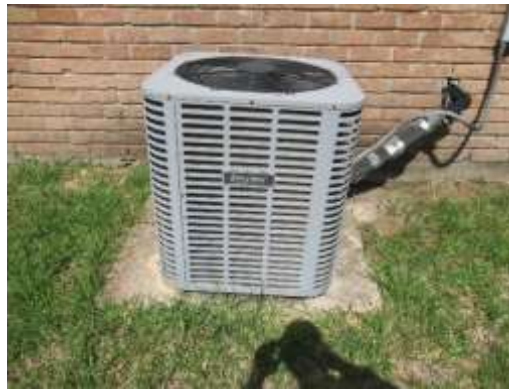
Inspectors' Closing Comment: The ac unit appeared to be functioning as intended during the time of inspection, but I recommend it to be checked by a license HVAC repair person because the rooms upstairs were very warm.

10. The ac unit appeared to be functioning as intended during the time of inspection, but I recommend it to be checked by a license HVAC repair person because the rooms upstairs were very warm.

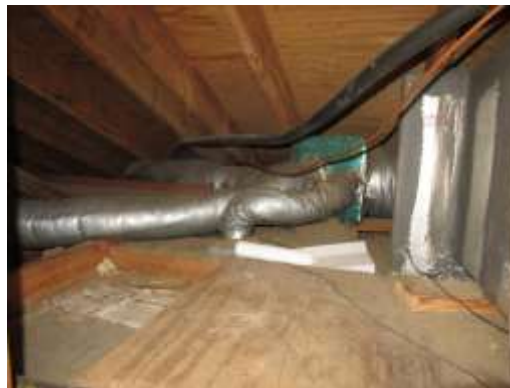
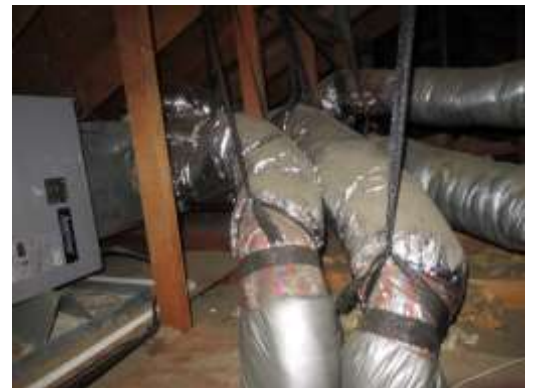
Inspectors' Closing Comment: There are several ducts inside the attic need to be replaced because they are very old, and there are rooms upstairs with no air flow coming from the vents.

11. There are several ducts inside the attic need to be replaced because they are very old, and there are rooms upstairs with no air flow coming from the vents.

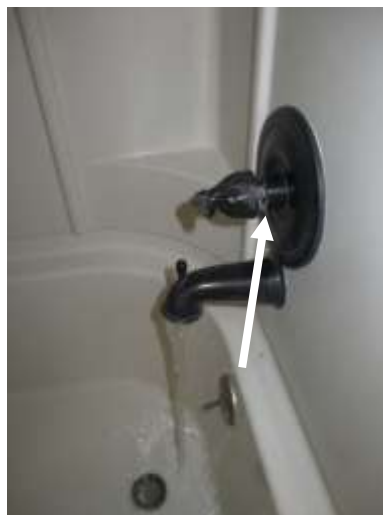
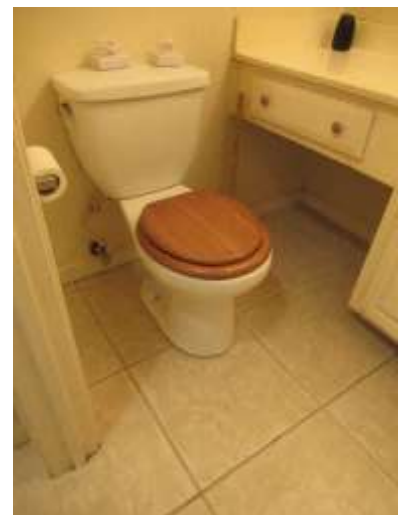
Inspectors’ Closing Comment: The plumbing system appeared to be in good condition during the time of inspection, but the faucet on the bathtub needs to be repaired inside the master bathroom because the shower is not working properly. The toilet inside the half bathroom needs a new flush kit installed because it is not flushing.

12. The faucet on the bathtub needs to be repaired inside the master bathroom because the shower is not working properly. The toilet inside the half bathroom needs a new flush kit installed because it is not flushing.

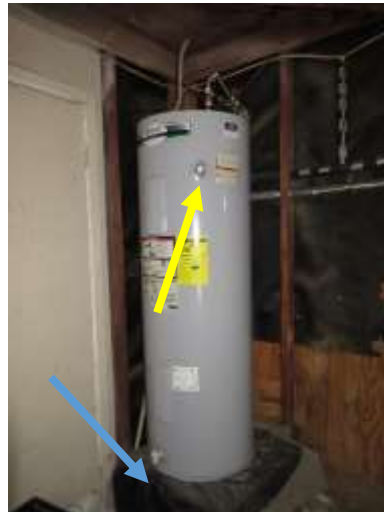
Inspectors' Closing Comment: The water heater appeared to be functioning as intended during the time of inspection, but it needs to be properly sitting inside a drain pan. There needs to be a 3/4-inch PVC pipe installed on the T&P valve on the side of the water heater and terminated outside because there is not one present.

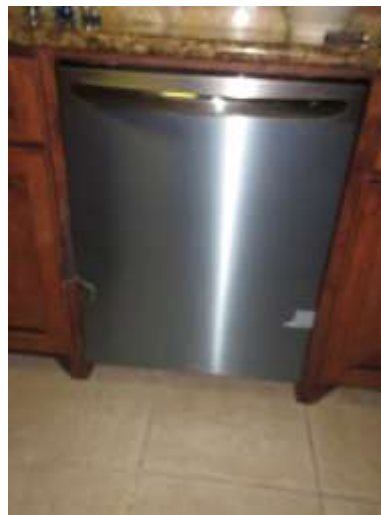
Inspectors' Closing Comment: **The dishwasher needs to be repaired because it did not work during the time of inspection.**

14. The dishwasher needs to be repaired because it did not work during the time of inspection.

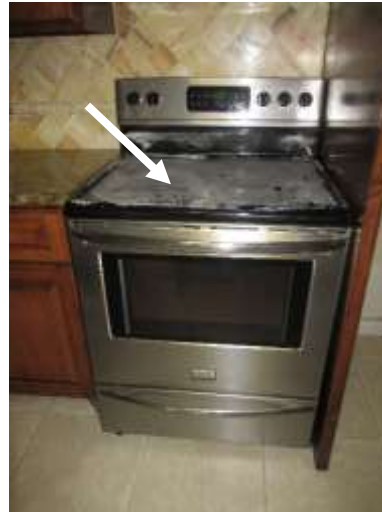
Inspectors' Closing Comment: The oven appeared to be functioning as intended during the time of inspection, but the cooktop needs to be cleaned and evaluated by an appliance repair person because it was not operated because of the white solution that was present.

15. The cooktop needs to be cleaned and evaluated by an appliance repair person because it was not operated because of the white solution that was present.

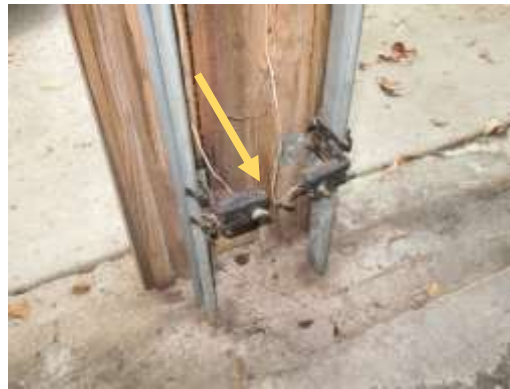
Comments: Auto reverse block test acceptable: Yes
 Electric eye reverse test acceptable: Yes
 Improper sensor height: (More than six inches above garage floor) Yes

Inspectors' Closing Comment: The garage door operator appeared to be functioning as intended during the time of inspection, but the motion sensors need to be lowered because they are too high off the garage floor.
