Vested Property Inspection

**Professional Inspector
Trusted Inspector
TREC# 22088**

Address
12727 Braewood Glen Ln
Houston Tx 77072

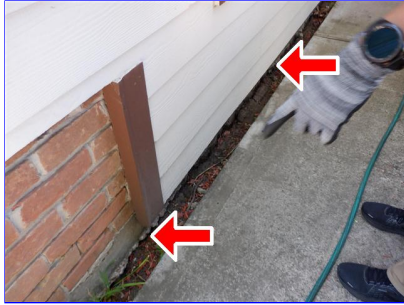
- ⊘ (3) There was an issue with foundation movement at the time of inspection, this type of foundation shifting\movement can cause foundation crack, interior\exterior wall separates due to structure shifting (ie. brick wall, window, corner wall, floor & ceiling). Have a qualified foundation contractor to evaluate for further information.

Foundation separation from soil level all around the house

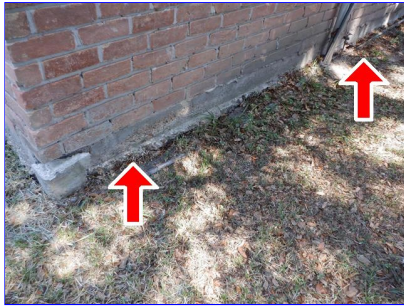
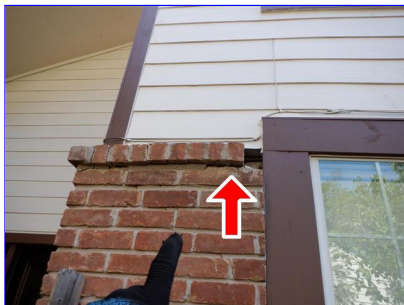
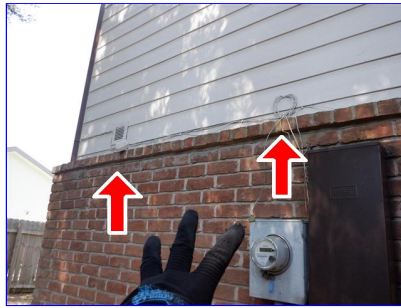
Brick wall & brick mortar separation all around the house brick walls

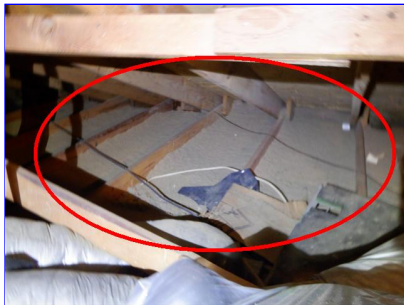
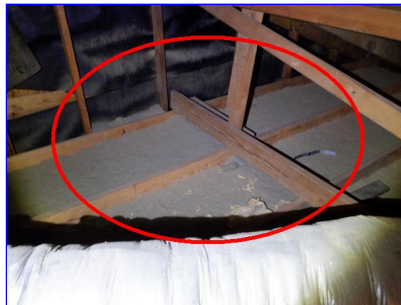
- ⊘ (5) Attic insulation missing at several ceiling locations. Have qualified contractor to replace all missing or depleted insulation due to older home.

Attic insulation thickness @1"

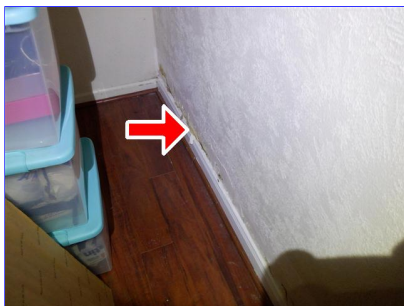
Family wall

- ⊘ (5) There was sign of stain on wall surface at the time of inspection. Ask owner if any previous damaged/repair.

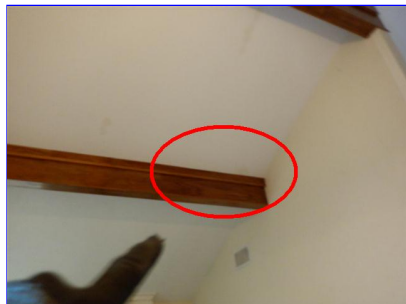
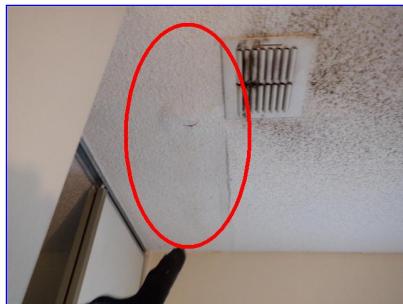
Upstair bedroom ceiling

- ⊘ (3) Ceiling stain indicated at certain interior room, this stain could result from previously damaged, check with owner for more information. Have a qualified plumber, roofer to evaluate and repair/repaint.

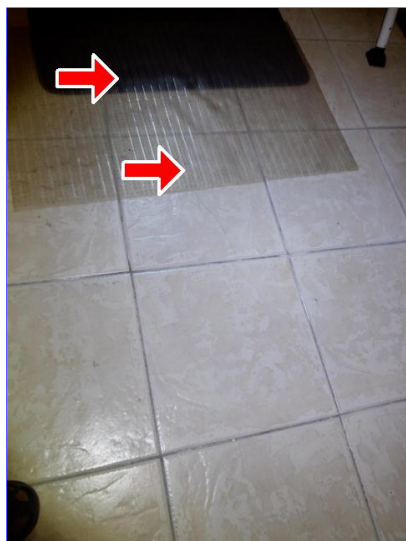
- ⊘ (4) Tile cracked. Have a qualified floor technician to evaluate and repair.

Front entrance tile crack

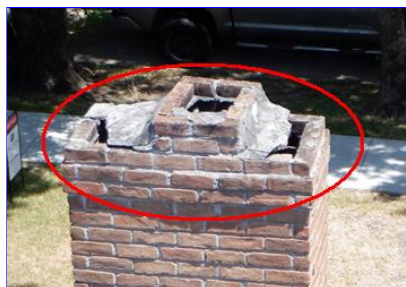
- ⊘ (1) Unable to inspect family gas log fire place at the time of an inspection due to house hold object blockage. Have a qualified chimney contractor to evaluates before closing.
- ⊘ (2) Chimney cap surface damaged at the time of an inspection. Have a qualified chimney contractor to evaluates and repair.

Chimney cap surface

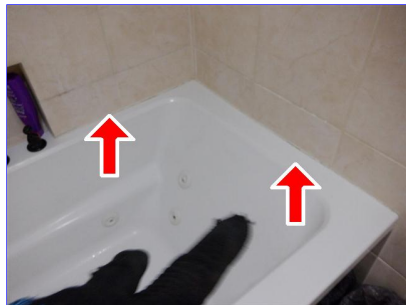
Master shower wall

- ⊘ (2) Shower wall needs to be sealant/caulk, this will cause water/moisture siphon behind shower wall and cause deterioration over period of time.

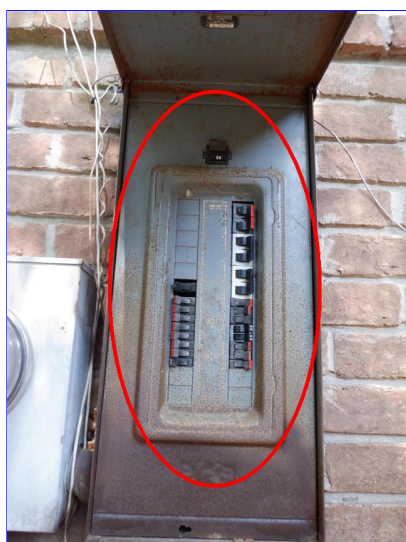
- ⊘ (4) You have a Federal Pacific panel which is legal, but there is a possibility that the circuit breakers may not trip when shorted possibly causing an electrical hazard. Opinions by licensed electrical contractors on this panel varies between safe and unsafe. I recommend you consult a licensed electrical contractor for an opinion and correct if necessary.

Outside main elect panel Stab
Loc- FPE

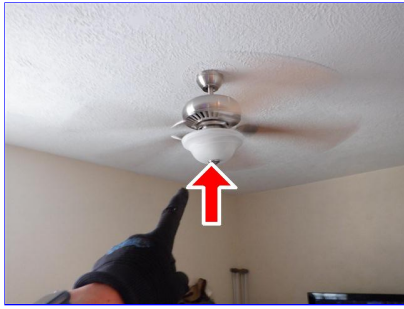
- ⊘ (3) Lighting bulb burnt out. This is usually just a case of burned out bulb. Recommend replacing bulb before closing as needed. If fixtures are still not functioning, then a licensed electrician should diagnose for deficiencies.

Upstairs sitting room lighting

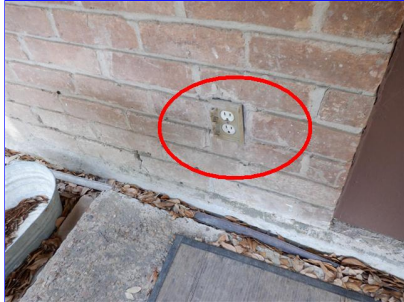
Patio elect outlet

- ⊘ (6) Electrical outlet cover plate missing or loose. Have qualified electrician to repair/replace all missing and damaged electrical outlet covers.

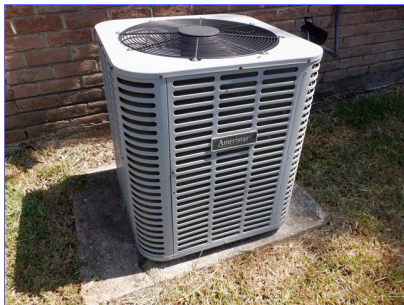
- ⊘ (4) An average life of inside and outside A/C unit approximately between 12-14 years base on the usage and surround environmental. At the moment outside & inside units are at it last third of it useful life unable to determent the remaining service life of the system. Have a license HVAC to evaluating both outside and inside unit.

Outside AC unit,suspect
2013,9yrs old

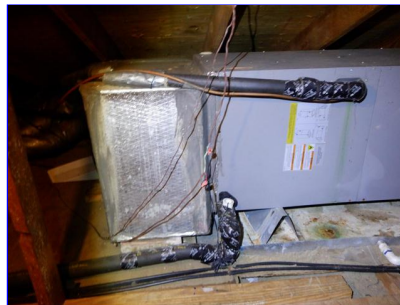
Attic evaporator unit,2013,9yrs
old

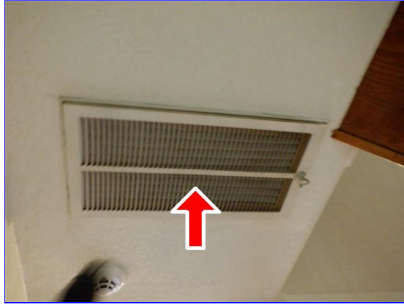
- ⊘ (3) The disposable filter was clogged and dirty. Recommend filter to be replace by a qualified technician.

Downstair hallway air return filter replacement

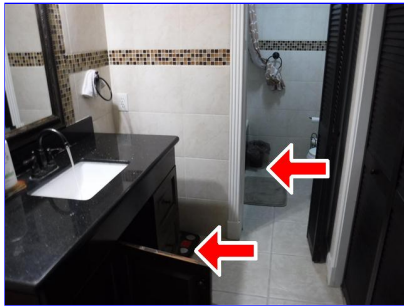
Master bathroom sink & bathtub

- ⊘ (5) There was water leakage during the water testing, inspector was unable to determine where was the leakage came from but it happened between the master bathroom sink and master bathtub during the water testing, that's including Hydro massager unit testing. Have a qualified plumber to evaluates for more information.

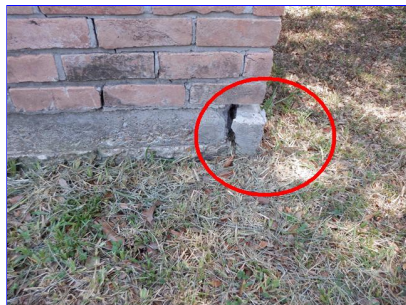
(2) Corner cracks were observed at the corners of the slab foundation. Cracks of this nature are typical and occur when the exterior veneer is warmed by the sun and the wall expands. Have a qualified foundation contractor to repair and prevent further separation.

Rear foundation corner crack

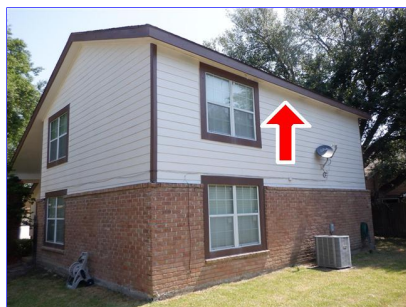
(2) Additional gutter and downspout need to be install around the upper and lower roof eaves, this will reducing water splashing against the extended concrete pavement, shingle, and soil onto the foundation, bricks or wood siding as the same creating dirt, erosion and algae/moss over the period of time. Recommended qualified gutter contractor to add on gutter to areas as needed.

Rear of home

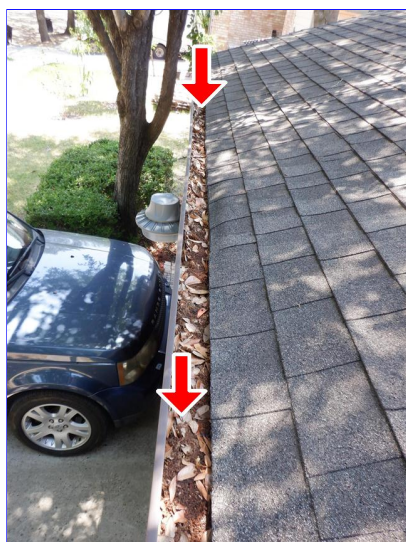
(3) Debris was observed in the gutters. This condition prevents proper drainage of water off and away from structure. Debris in gutters can conceal rust, deterioration or holes that are not visible until cleaned. Recommended to be clean by qualified general laborer.

Front gutter

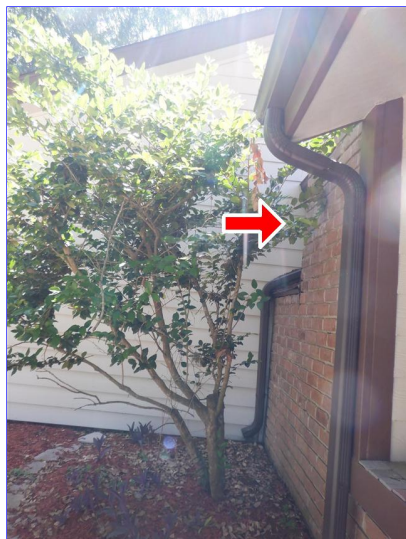
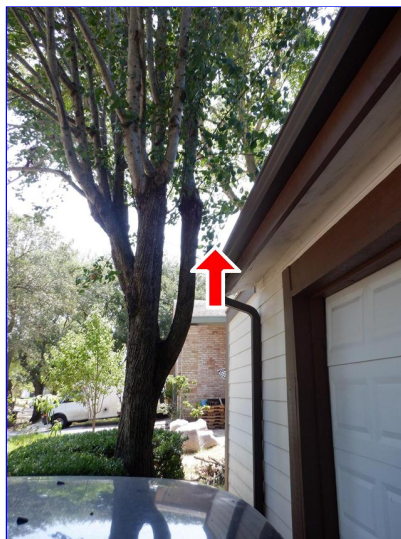
(4) The tree limbs that are in contact with roof or hanging near roof should be trimmed back 3-5 feet. These limbs can creating debris inside gutter, pest infestation and tree root penetrated into foundation, areas damaged by limb contact should be repaired. Recommended a qualified general landscaper to evaluates.

Front of home tree branches

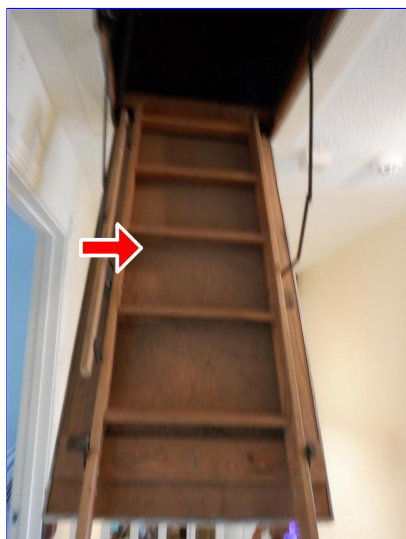
(4) [Missing attic stair insulation. Recommended insulation to be installed on attic stair to reduce loss of energy.](#)

Attic stairway access

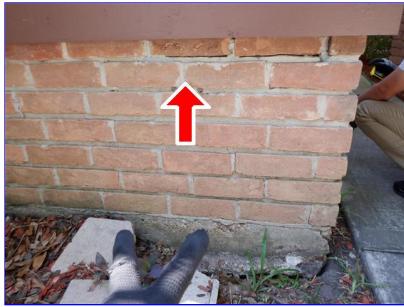
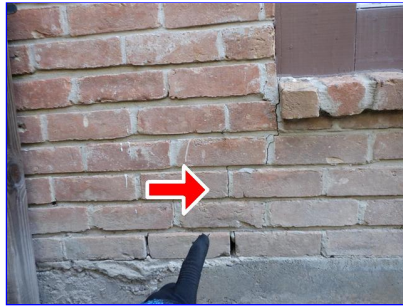
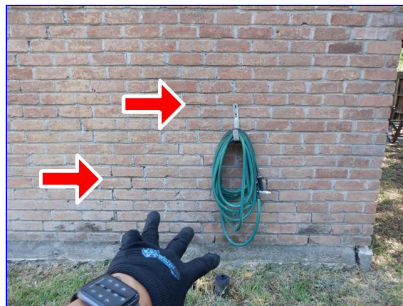
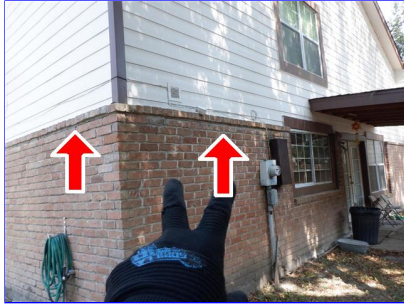
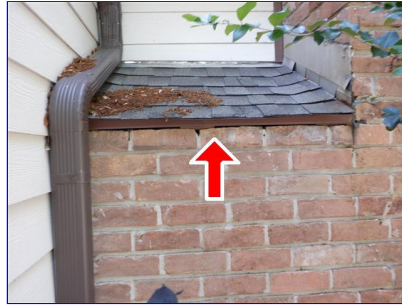
(3) [Brick,stone mortar, siding, brick control joints require sealant\caulking to prevented water incursion into wall space, this is due to weathering wear or foundation movement and structure shifting. Have a qualified general contractor to repair\sealant brick,stone\siding joints at all locations.](#)

All around the brick walls & mortar walls

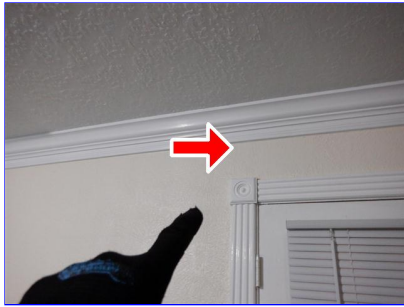
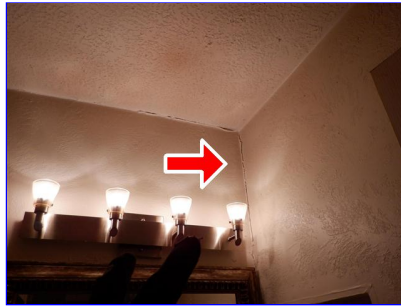
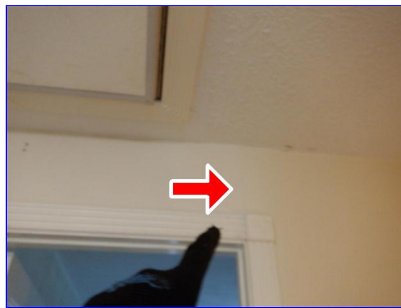
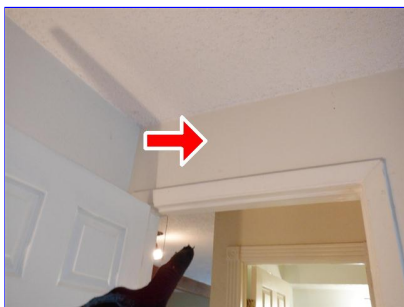
(4) There are areas of the interior window\door & wall, that have corner cosmetic cracked this is due to structure shifting. Have a qualified painter to repair, sealant, and paint at all necessary interior corner windows, walls and doors.

Family,bedroom, closet walls

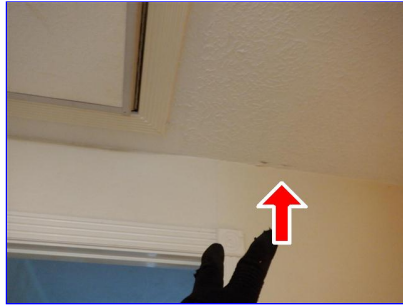
(2) There are areas of the interior corner ceiling that have corner cosmetic hair line cracked, this was due to structure shifting. Have a qualified general contractor to evaluate, repair, sealant, and paint at all necessary interior corner(s) ceiling.

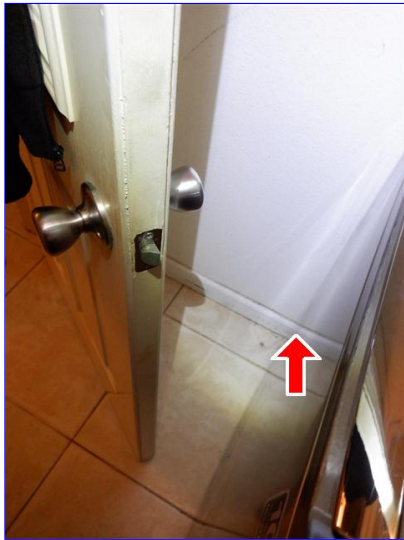
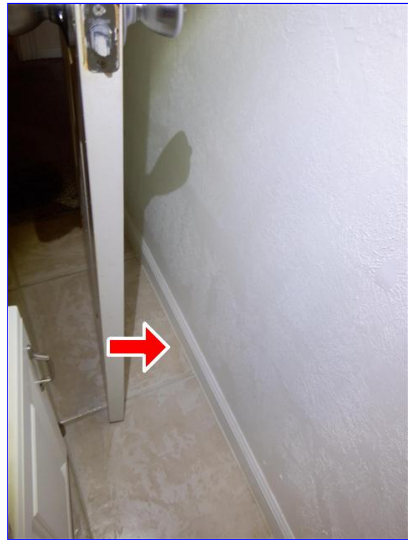
(3) Missing door stopper/knob plate protector throughout the house. Have a qualified general contractor to evaluate and install components to prevent door knob jam against the wall when excessive opening force..

Bedroom doors

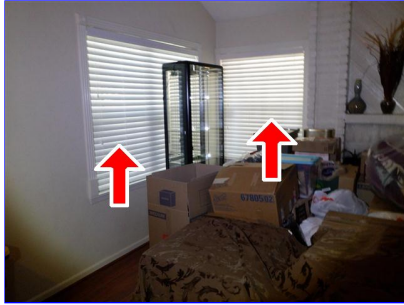
Family, bedroom windows

(2) Unable to open and observe windows due to items blocking. Be sure to test windows operational at the time moving in.

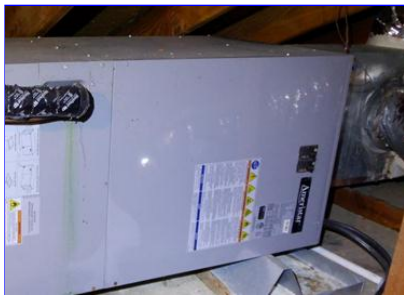
Attic WH unit

(3) Due to today's outside temperature, the non-seasonal cycle of the heat pump(s) was not tested at the moment outside temperature @98F. Industry standards recommend not running the heating cycle in warm seasons or the cooling cycle in cold weather. Typically, a satisfactory test in either the heating or cooling mode verifies all of the major components of the system are functioning, with the exception of the refrigerant reversing valve. Have a qualified HVAC to evaluate for more information.

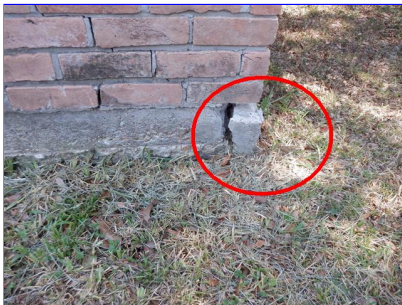
(2) Corner cracks were observed at the corners of the slab foundation. Cracks of this nature are typical and occur when the exterior veneer is warmed by the sun and the wall expands. Have a qualified foundation contractor to repair and prevent further separation.

Rear foundation corner crack

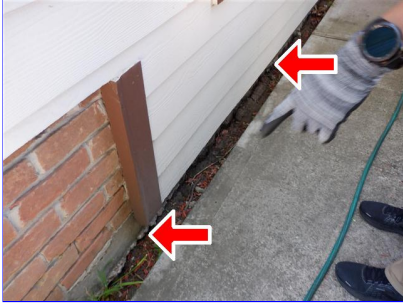
(3) There was an issue with foundation movement at the time of inspection, this type of foundation shifting\movement can cause foundation crack, interior\exterior wall separates due to structure shifting (ie. brick wall, window, corner wall, floor & ceiling). Have a qualified foundation contractor to evaluate for further information.

Foundation separation from soil level all around the house

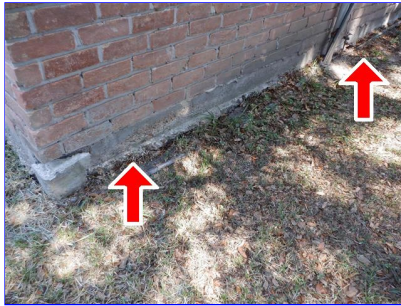
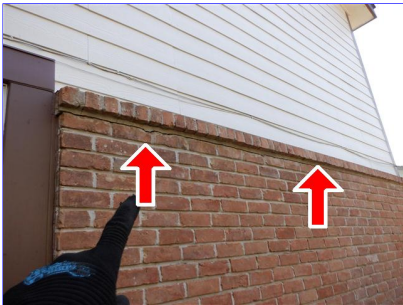
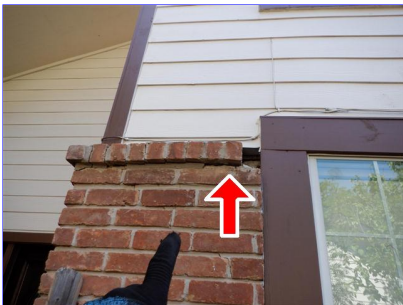
Brick wall & brick mortar separation all around the house brick walls

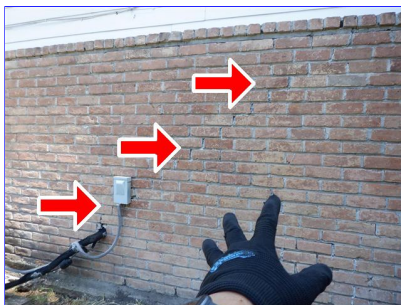
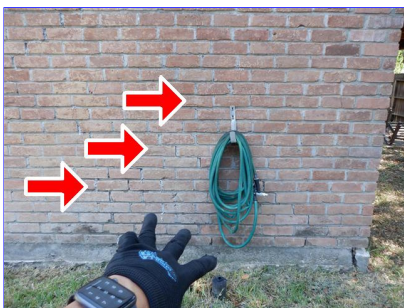
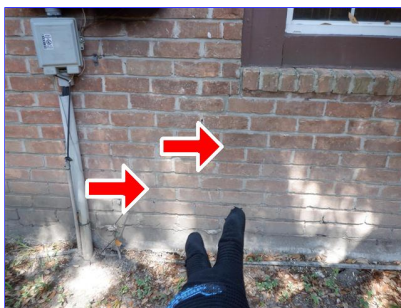
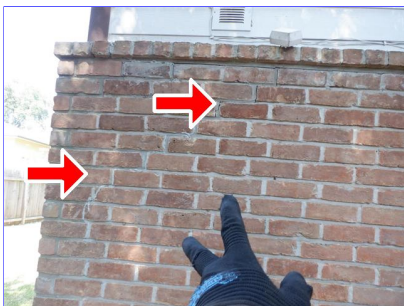
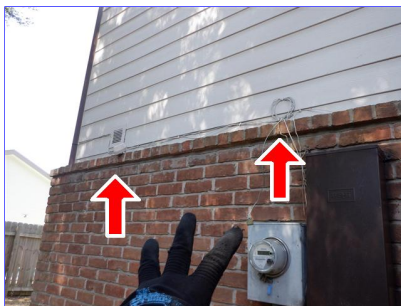
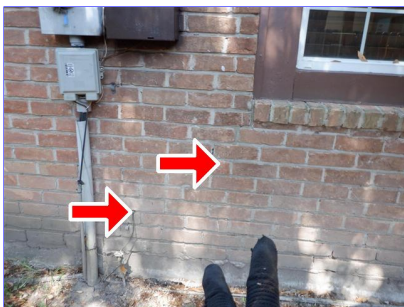
⊘ (4) Previous repairs to the foundation have been disclosed and/or were detected. Refer to the seller for any documentation and possible warranties for further information or have a qualified foundation contractor to evaluate for more info.

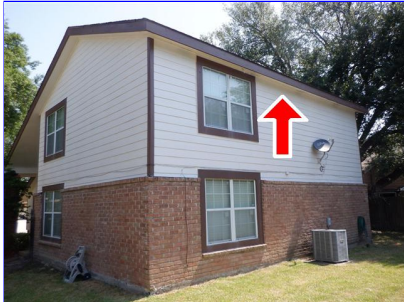
Rear of home

(2) Additional gutter and downspout need to be install around the upper and lower roof eaves, this will reducing water splashing against the extended concrete pavement, shingle, and soil onto the foundation, bricks or wood siding as the same creating dirt, erosion and algae\moss over the period of time. Recommended qualified gutter contractor to add on gutter to areas as needed.

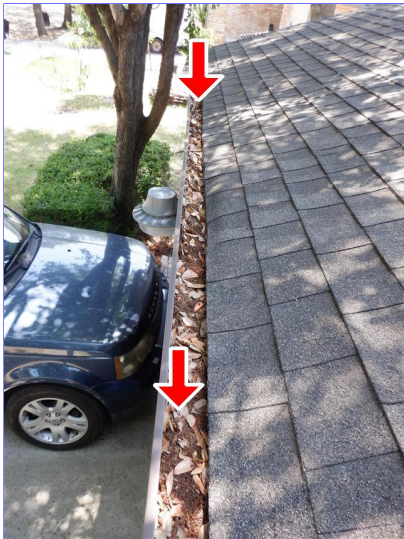
(3) Debris was observed in the gutters. This condition prevents proper drainage of water off and away from structure. Debris in gutters can conceal rust, deterioration or holes that are not visible until cleaned. Recommended to be clean by qualified general laborer.

Front gutter

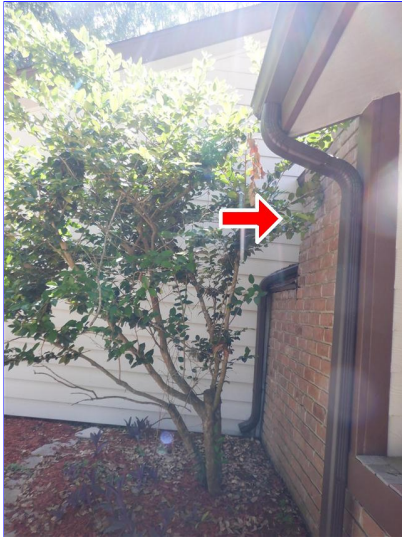
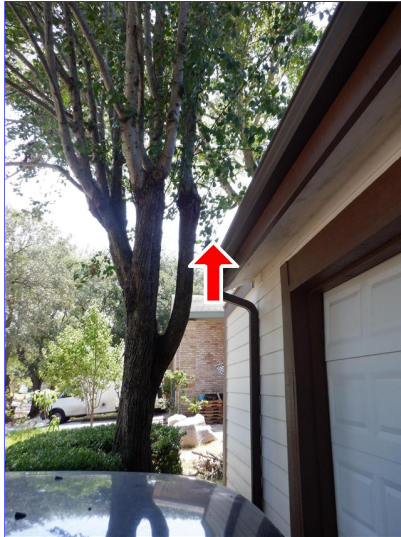
(4) The tree limbs that are in contact with roof or hanging near roof should be trimmed back 3-5 feet. These limbs can creating debris inside gutter, pest infestation and tree root penetrated into foundation, areas damaged by limb contact should be repaired. Recommended a qualified general landscaper to evaluates.

Front of home tree branches

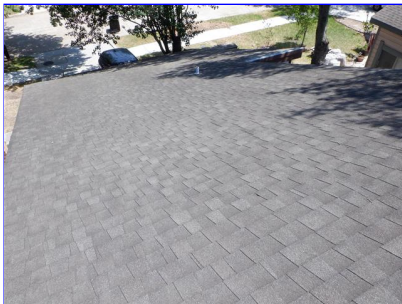
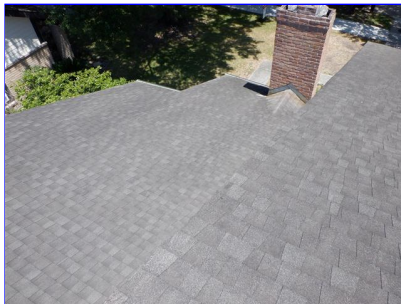
Front roofing

(2) The roof covering appeared in good condition at time of inspection. Shingles appeared to be properly fastened.

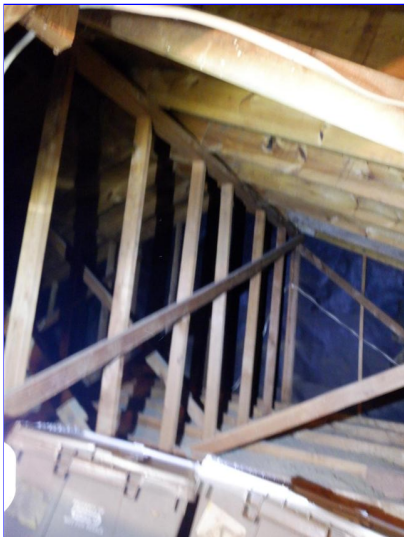
Attic structures

- (1) Only areas of the attic determined accessible by the inspector are inspected.
- (2) The structure was in good condition. However, the following exceptions were observed:

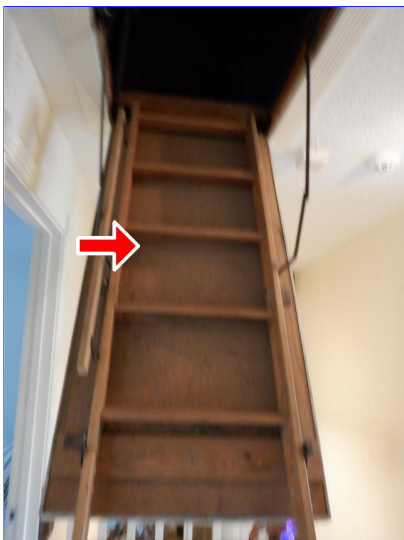
(4) **Missing attic stair insulation. Recommended insulation to be installed on attic stair to reduce loss of energy.**

Attic stairway access

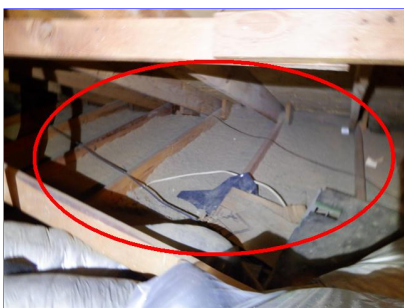
⊘ (5) Attic insulation missing at several ceiling locations. Have qualified contractor to replace all missing or depleted insulation due to older home.

Attic insulation thickness @1"

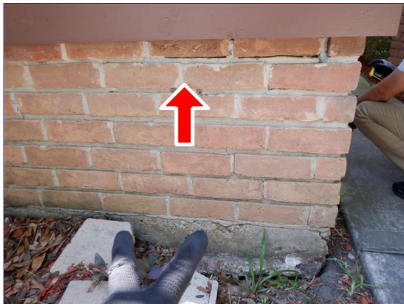
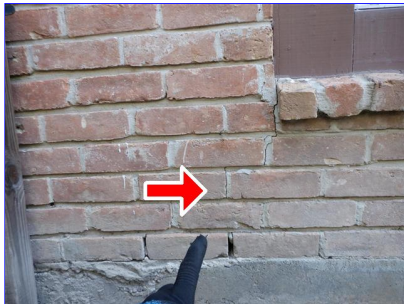
(3) [Brick,stone mortar, siding, brick control joints require sealant\caulking to prevented water incursion into wall space, this is due to weathering wear or foundation movement and structure shifting. Have a qualified general contractor to repair\sealant brick,stone\siding joints at all locations.](#)

All around the brick walls & mortar walls

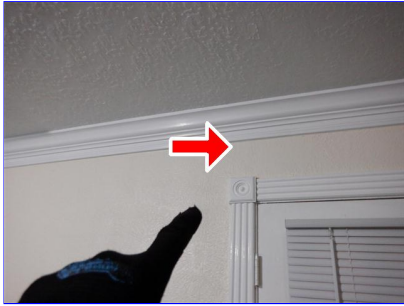
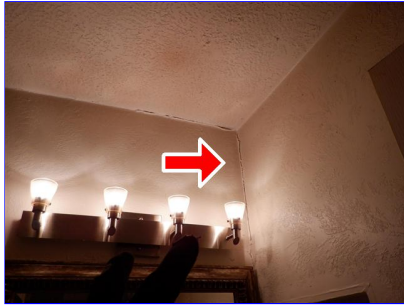
Family,bedroom, closet walls

(4) There are areas of the interior window\door & wall, that have corner cosmetic cracked this is due to structure shifting. Have a qualified painter to repair, sealant, and paint at all necessary interior corner windows, walls and doors.

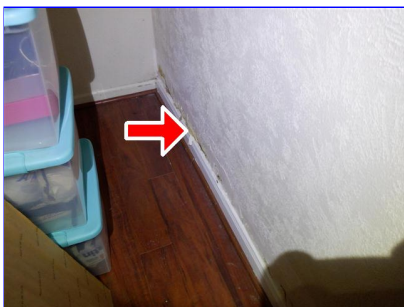
Family wall

⊘ (5) There was sign of stain on wall surface at the time of inspection. Ask owner if any previous damaged/repair.

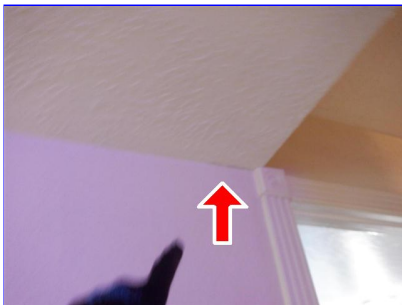
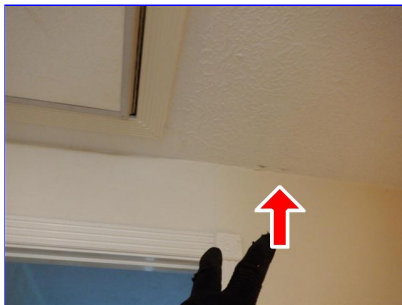
(2) There are areas of the interior corner ceiling that have corner cosmetic hair line cracked, this was due to structure shifting. Have a qualified general contractor to evaluate, repair, sealant, and paint at all necessary interior corner(s) ceiling.

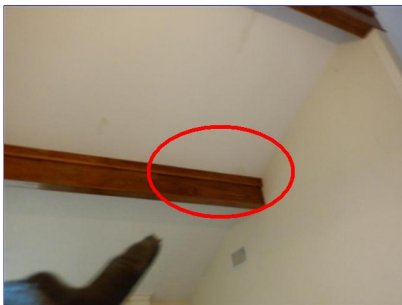
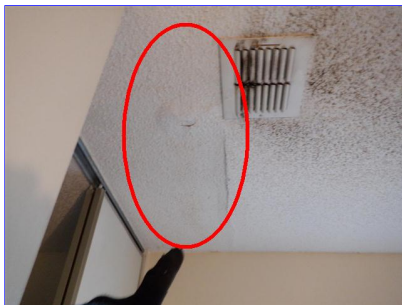
Upstairs bedroom ceiling

(3) Ceiling stain indicated at certain interior room, this stain could result from previously damaged, check with owner for more information. Have a qualified plumber, roofer to evaluate and repair/repaint.

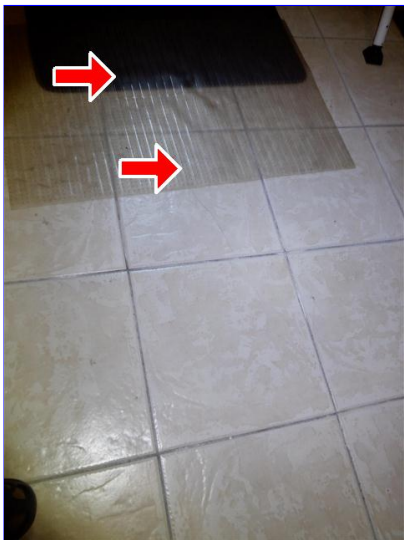
⊘ (4) Title cracked. Have a qualified floor technician to evaluate and repair.

Front entrance tile crack

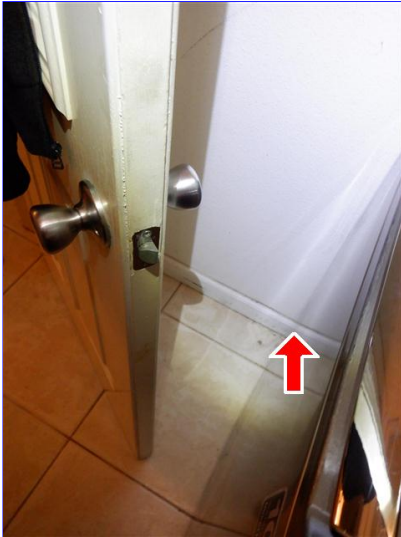
Bedroom doors

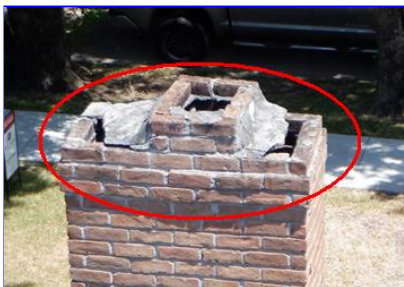
⊘ (2) Chimney cap surface damaged at the time of an inspection. Have a qualified chimney contractor to evaluates and repair.

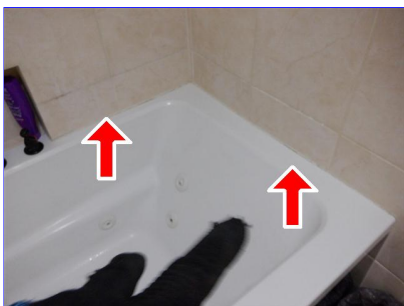
Master shower wall

⊘ (2) Shower wall needs to be sealant/caulk, this will cause water/moisture siphon behind shower wall and cause deterioration over period of time.

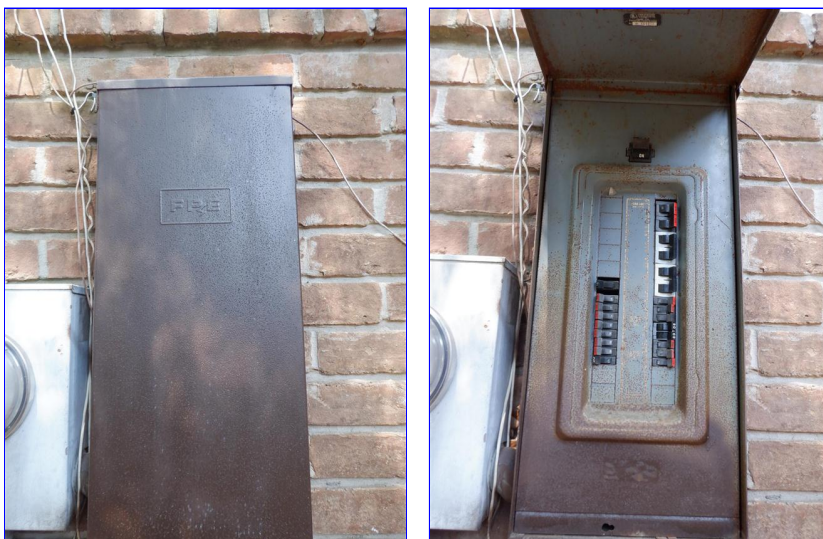
Federal Pacific, 100amp, main elect panel

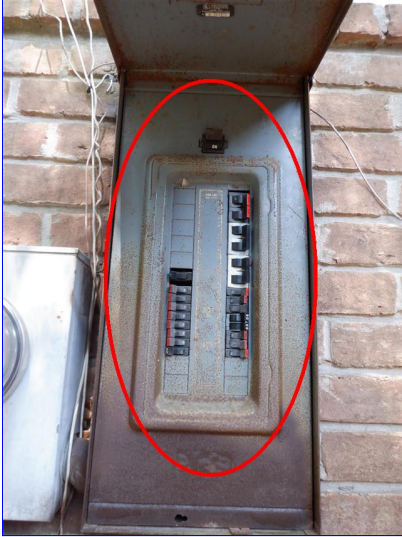
⊘ (4) You have a Federal Pacific panel which is legal, but there is a possibility that the circuit breakers may not trip when shorted possibly causing an electrical hazard. Opinions by licensed electrical contractors on this panel varies between safe and unsafe. I recommend you consult a licensed electrical contractor for an opinion and correct if necessary.

Outside main elect panel Stab
Loc- FPE

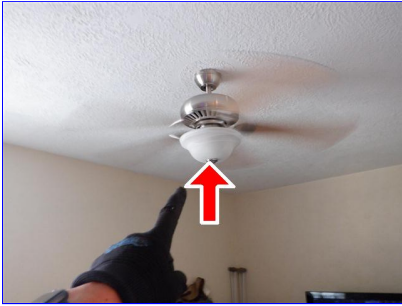
Upstairs sitting room lighting

⊘ (3) **Lighting bulb burnt out. This is usually just a case of burned out bulb. Recommend replacing bulb before closing as needed. If fixtures are still not functioning, then a licensed electrician should diagnose for deficiencies.**

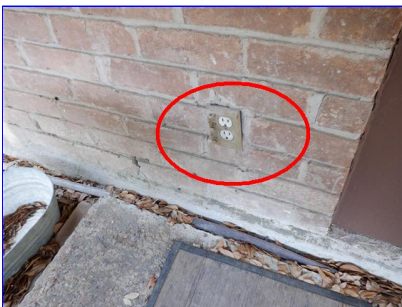
Patio elect outlet

⊘ (6) Electrical outlet cover plate missing or loose. Have qualified electrician to repair/replace all missing and damaged electrical outlet covers.

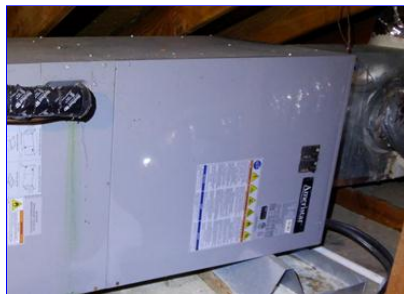
Attic WH unit

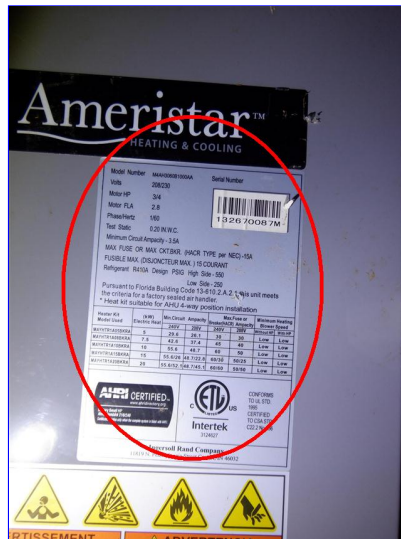
AmeriStar,elect240V,2013

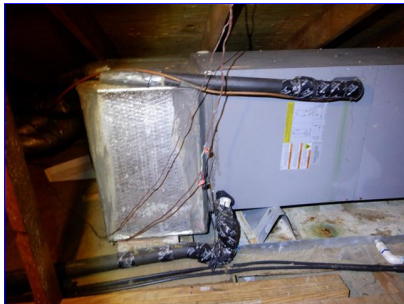
Attic evaporator unit

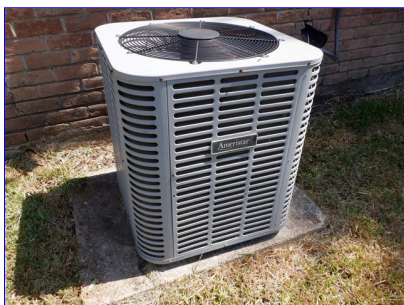
Outside AC unit

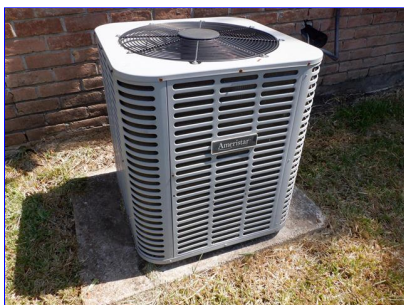
⊘ (4) An average life of inside and outside A/C unit approximately between 12-14 years base on the usage and surround environmental. At the moment outside & inside units are at it last third of it useful life unable to determent the remaining service life of the system. Have a license HVAC to evaluating both outside and inside unit.

Outside AC unit,suspect 2013,9yrs old

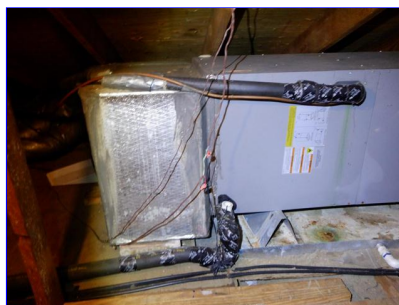
Attic evaporator unit,2013,9yrs old

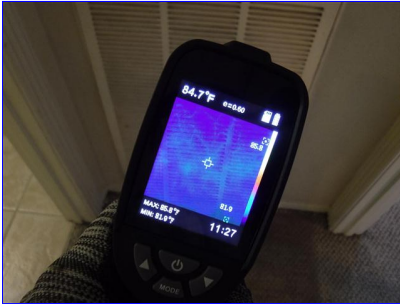
(5) The ambient air test was performed by using thermometers on the air handler of both Air conditioners to determine if the difference in temperatures of the supply and return air are between 12 degrees and 20 degrees which indicates that the unit is cooling as intended. The supply air temperature on your system

read 48 degrees, and the return air temperature was 84 degrees. This indicates the range in temperature drop is normal.

Hallway air return @84F

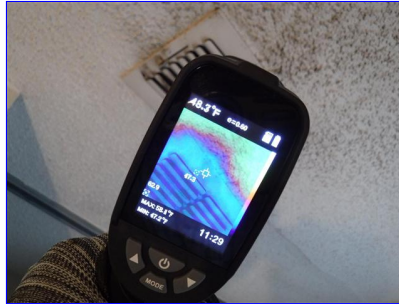
Bedroom @48F

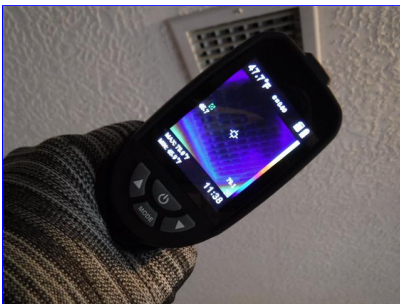
Bedroom @47F

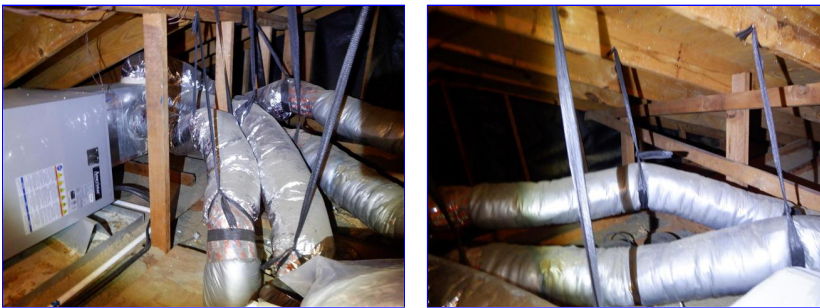
(2) Ducts and ventilation system appeared serviceable.

Attic registry & return duct lines

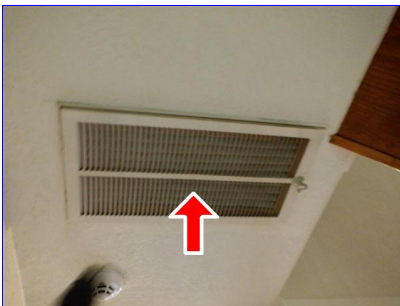
⊘ (3) The disposable filter was clogged and dirty. Recommend filter to be replace by a qualified technician.

Downstair hallway air return filter replacement

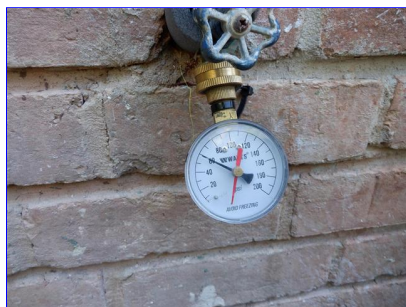
(2) Standard water pressure normally is about 45psi to 75psi with fixtures functional, flow acceptable. The toilets flushed on the day of the inspection.

Water pressure @60psi

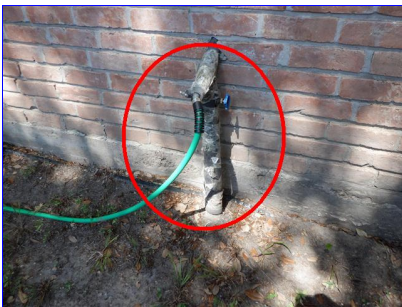
Left siding main water shut off valve

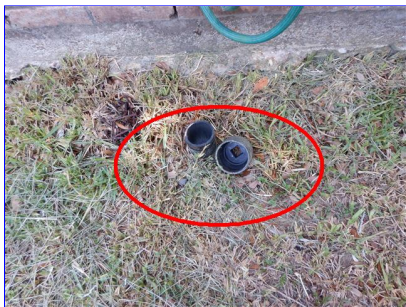
Rear main sewer drainage line

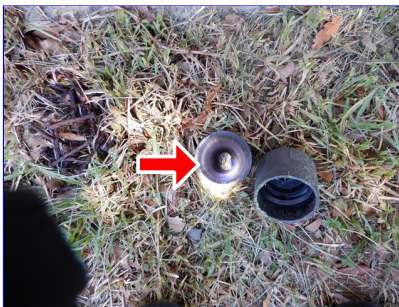
Normal drainage

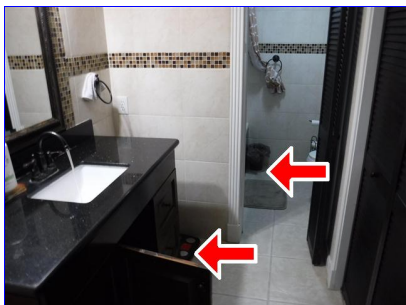
(5) There was water leakage during the water testing, inspector was unable to determine where the leakage came from but it happened between the master bathroom sink and master bathtub during the water testing, that's including Hydro massager unit testing. Have a qualified plumber to evaluates for more information.

Master bathroom sink & bathtub

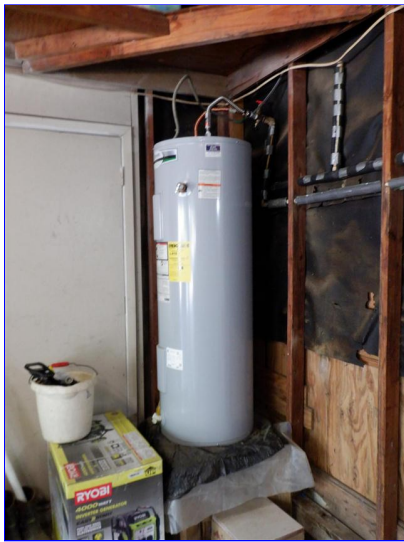
(3) Water heater is functions at the time of inspection

AO Smith,40gal,elect240V,2018

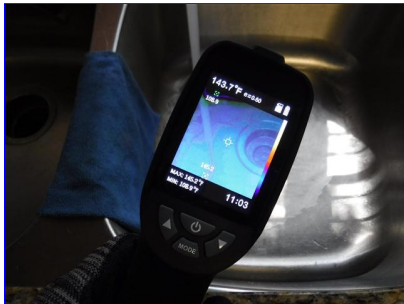
Hot water temperature Kitchen @143F

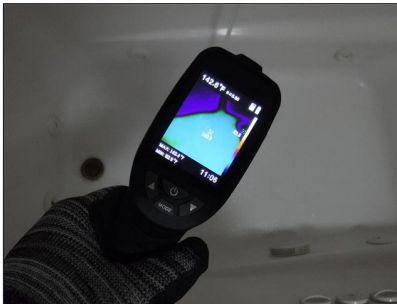
Bathtub @142F

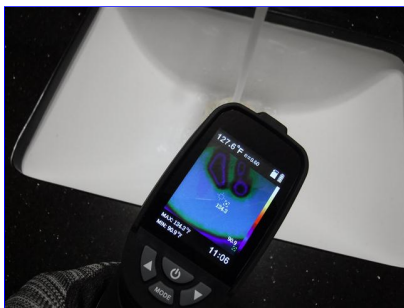
Bath sink @127F

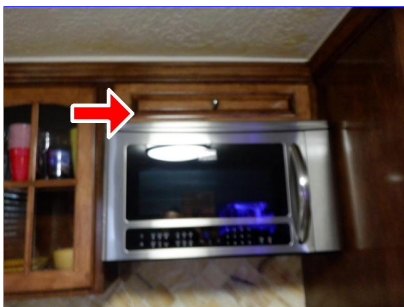
Kitchen exhaust vent functions at the time of inspection and vented NOT to exterior.

Kitchen exhaust vented NOT to exterior

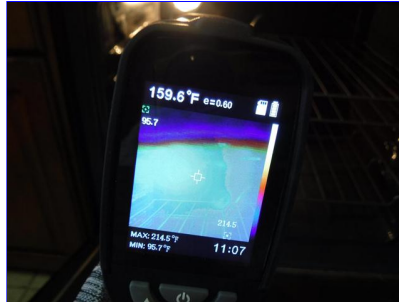
(2) Cook top and oven function normally within 25 degree Fahrenheit at the time of inspection.

Oven set @175F read @174F

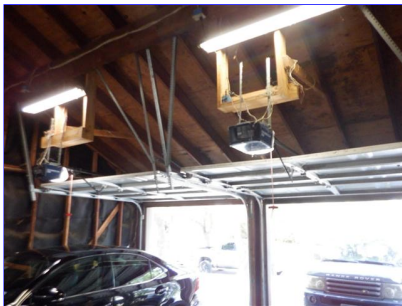
Garage door functions at auto-reverse when IR beam obstructed and downward pressure not test due to unknown and sensitive mechanical failure due to not maintenance over the years. Have seller sure to check before move in.

Garage two doors auto
