TREC REI 7-6
13906 Britoak Ln
Houston, TX 77079

PROPERTY INSPECTION REPORT FORM

Allison Higbie <i>Name of Client</i>	04/26/2022 9:00 am <i>Date of Inspection</i>
13906 Britoak Ln, Houston, TX 77079 <i>Address of Inspected Property</i>	
Beau Evetts <i>Name of Inspector</i>	TREC#10434 <i>TREC License #</i>
<i>Name of Sponsor (if applicable)</i>	<i>TREC License #</i>

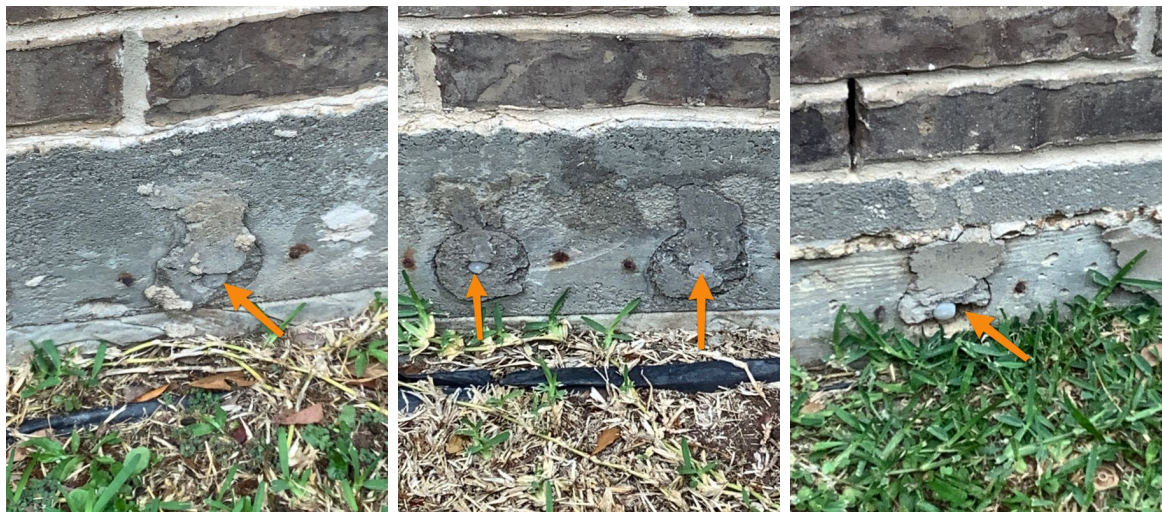
Ends of some post tension cables were exposed. These should be properly repaired and sealed to avoid further deterioration.

Recommendation: Contact a qualified professional.

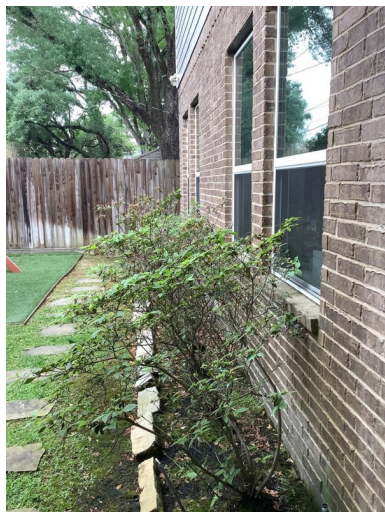
Excessive vegetation was noted in some areas of the home. In our opinion vegetation should be cleared at least 12" from the exterior walls.

Recommendation: Contact a qualified professional.

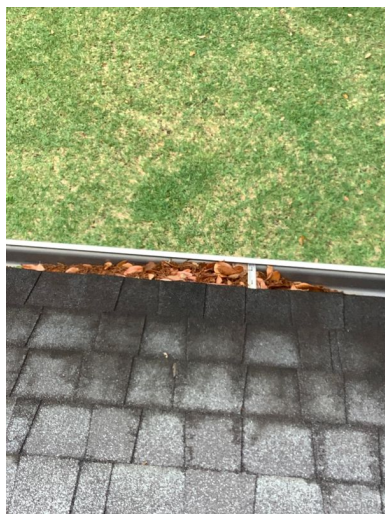
2: Gutter Debris

Gutters should be cleared to allow for proper drainage.

Recommendation: Contact a qualified professional.

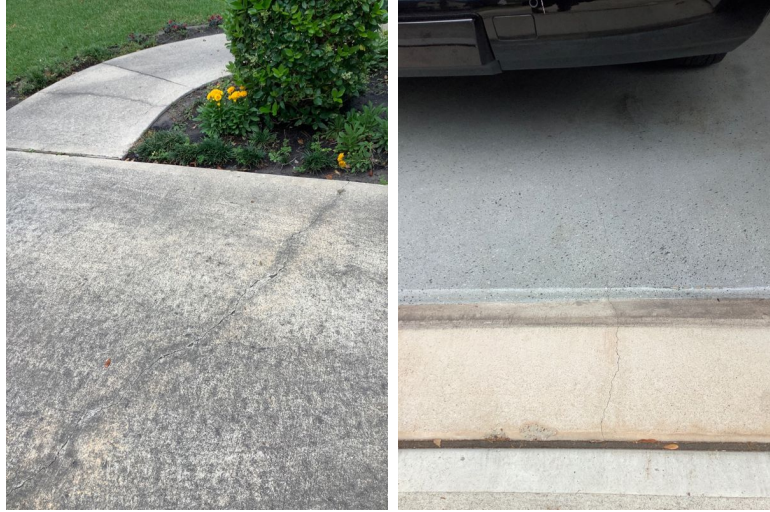
3: Cracked Flatwork

There were some cracks on flat work around the home and in the garage.

Recommendation: Contact a qualified professional.

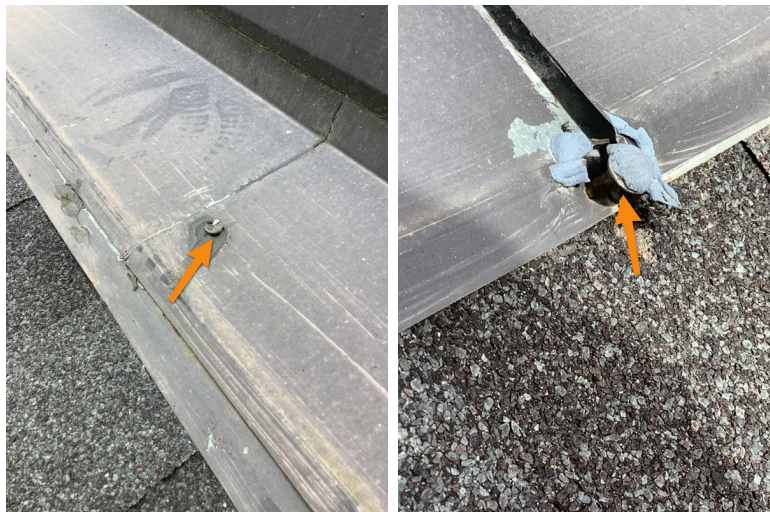
Exposed nails were noted at some roof penetration flashings. These should be properly sealed.

Recommendation: Contact a qualified professional.

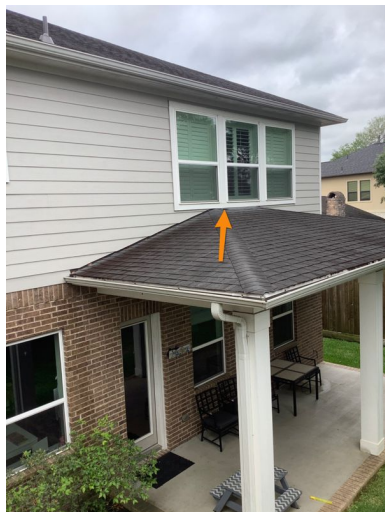
Flashing was not flush with the roof surface.

Recommendation: Contact a qualified professional.

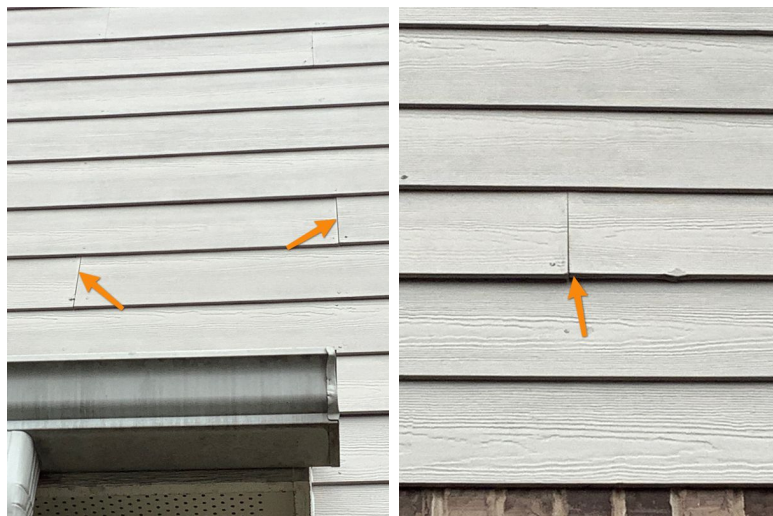
Wall gaps were observed. Most notably at siding seams and/or nail heads. Fiber cement siding manufacturers recommend all gaps be sealed. All exterior wall penetrations, changes of materials and direction should be properly sealed to prevent water and pest intrusion.

Recommendation: Contact a qualified professional.

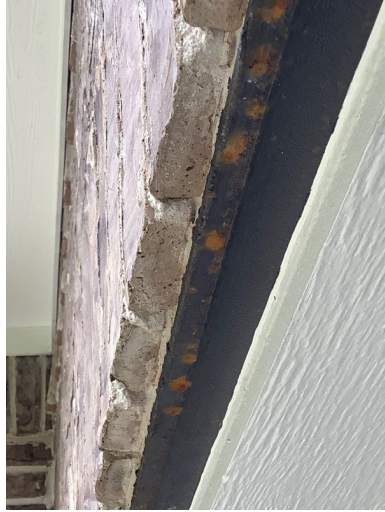
2: Rust at Lintels

Lintels around the home showed signs of possible rust. These should be properly sealed.

Recommendation: Contact a qualified professional.

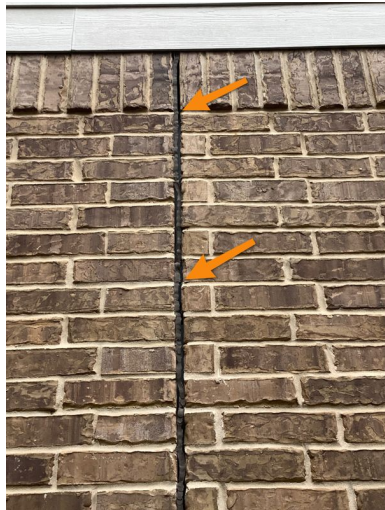
3: Expansion Joint Filler

Expansion joint filler showed signs of deterioration. There as evidence of some possible settlement at the rear joint. Expansion joints should be properly sealed around the home.

Recommendation: Contact a qualified professional.

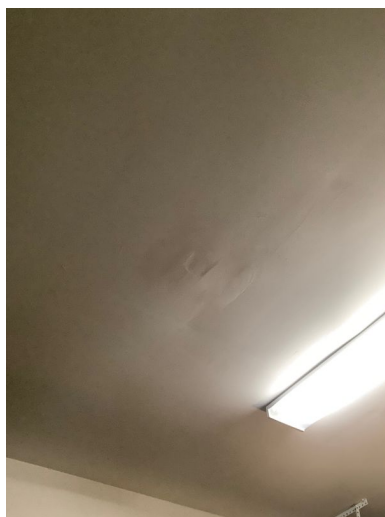
1: Drywall Repairs

Evidence of possible drywall repairs were observed around the home.

Recommendation: Contact a qualified professional.

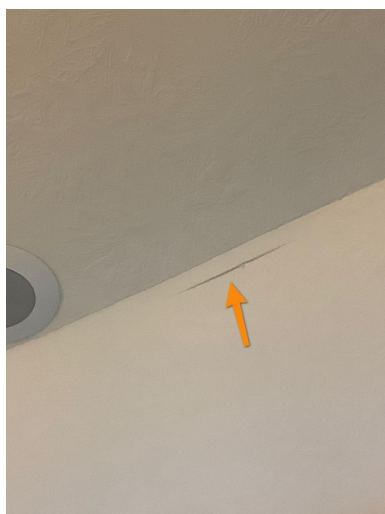
2: Drywall Cracks

Some drywall cracks were observed around the home. These should be sealed and monitored.

Recommendation: Contact a qualified professional.

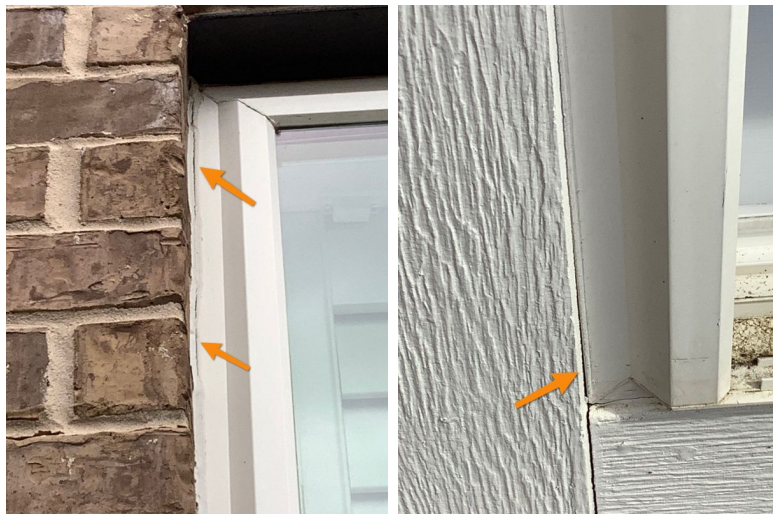
Some windows were not completely sealed around the exterior framing.

Recommendation: Contact a qualified professional.

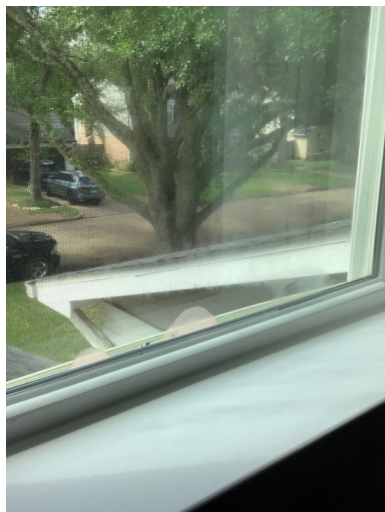
2: Window Seal Compromised

Window(s) appeared to be stained on the interior of the window between the panes. This may indicate that the window seal has been compromised. Recommend further evaluation by a window professional.

Recommendation: Contact a qualified professional.

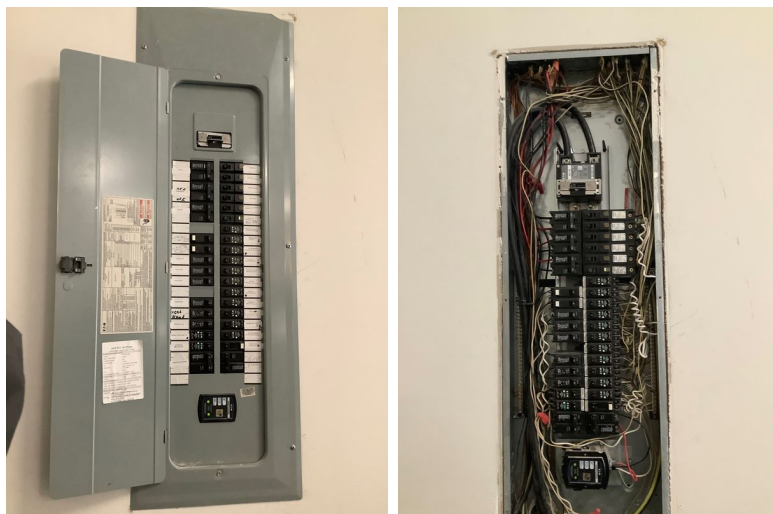
3 wire 120/240v service feeds electrical panel with 4/0 AWG aluminum wire which is rated for 200 amps. The main disconnect breaker was 200 amps. The cabinet (rated for 200 amps) appeared to be grounded and neutrals/grounds bonded. Trip ties appeared to be installed properly. It appeared that AFCI circuits were partially installed.

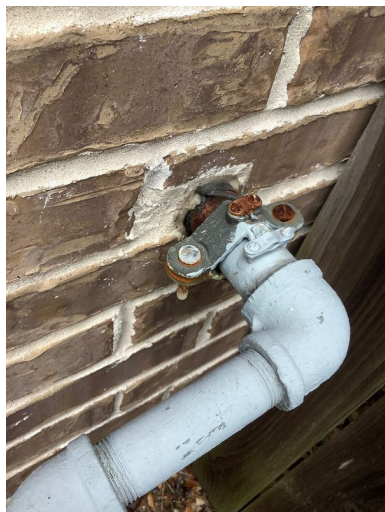
Proper grounding/bonding was not completely visible or verifiable on all metal water/gas piping and appliances. Many areas were concealed and not accessible or visible. Visible bonding was observed at the exterior gas piping. We recommend proper grounding/bonding of applicable systems, water heater and appliances be verified by a qualified licensed electrician.

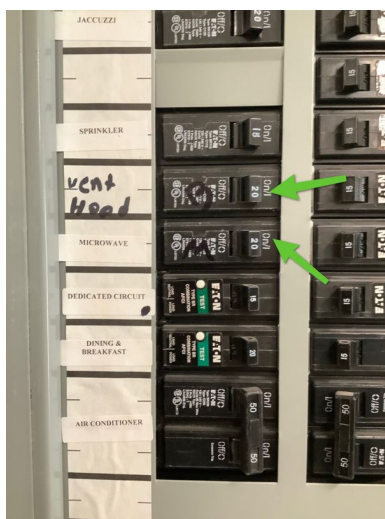
AFCI breakers were not completely installed. Per the 2015 NEC (National Electric Code) AFCI breakers are required in most 15 and 20 amp circuits supplying power to household outlets and devices including kitchens and laundry room. They are not typically required in exterior, garage or bathroom circuits. Typically homes prior to 2006 did not have any form of AFCI protection as a part of the original construction.

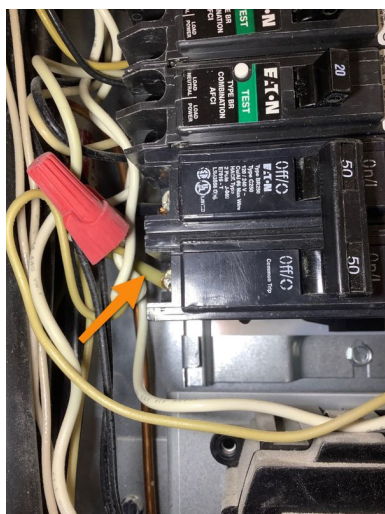
1: White Hot Wires

There were white wires connected to breakers that appeared to be used as hot wires in the panel. Typically white wires should be designated as neutral only.

Recommendation: Contact a qualified professional.

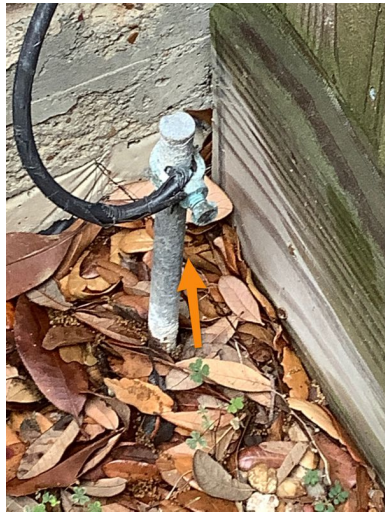
3: Grounding Rod Above Grade Level

Grounding rod was well above grade level. This could indicate that the rod was not driven the required 8' into the Earth. Grounding rod should be driven to grade level.

Recommendation: Contact a qualified professional.

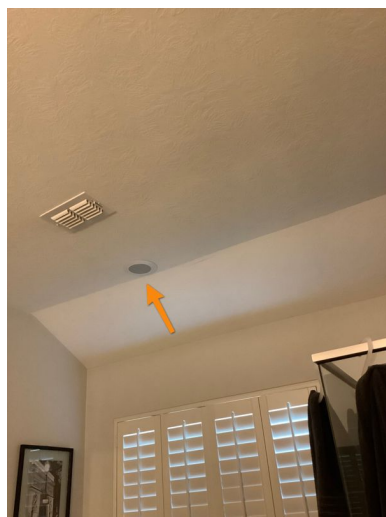
Fixture(s) did not appear to be functioning around the home.

Recommendation: Contact a qualified professional.

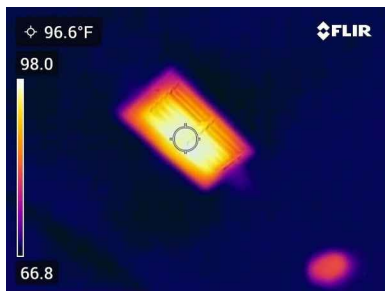
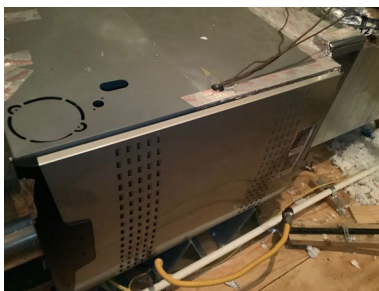
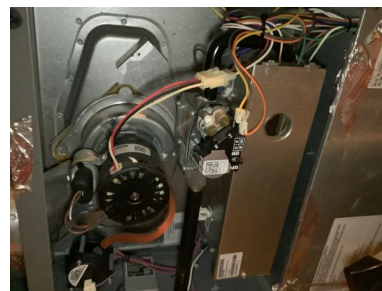
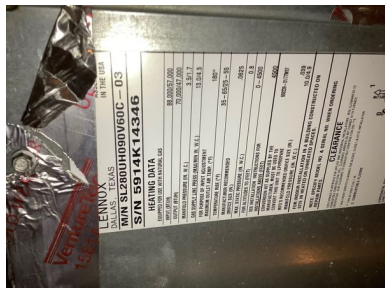
Furnace appeared to be manufactured by Lennox in 2014. Furnace was operated, access panel was removed and interior was observed. Appeared to be functioning as intended.

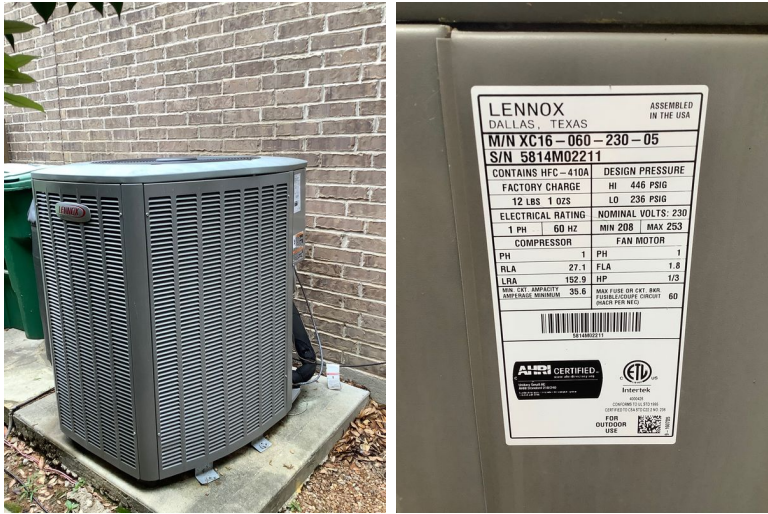
Condensing unit appeared to be manufactured by Lennox in 2014. Unit appeared to be 5 ton. Per the manufacturer's label, max amps on breaker should be 60. Per the labeling on the electrical panel, AC was connected to a 50 amp breaker.

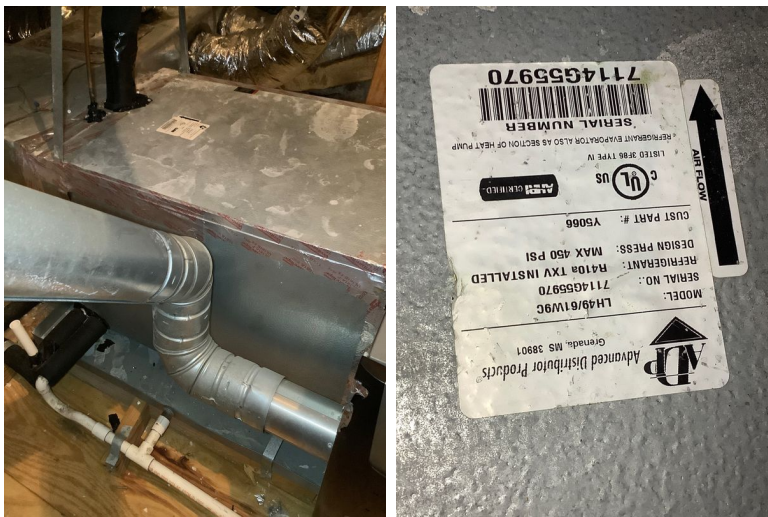
Evaporator unit appeared to be manufactured by ADP in 2014. Unit appeared to be 5 ton.

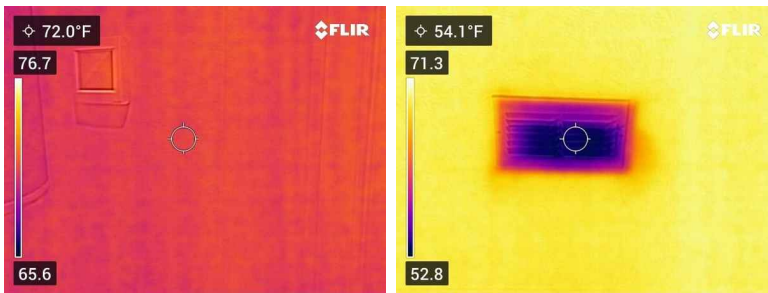
AC appeared to be cooling properly. Temperature differential measured 18 degrees between air supply and registers. Typical range should be 15 to 20 degrees.

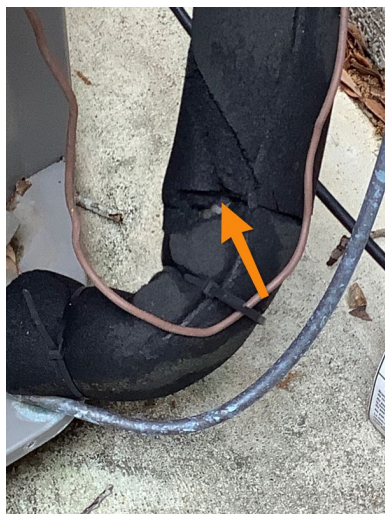
1: Insulation Deteriorated

Insulation was deteriorated on the exterior suction lines.

Recommendation: Contact a qualified professional.

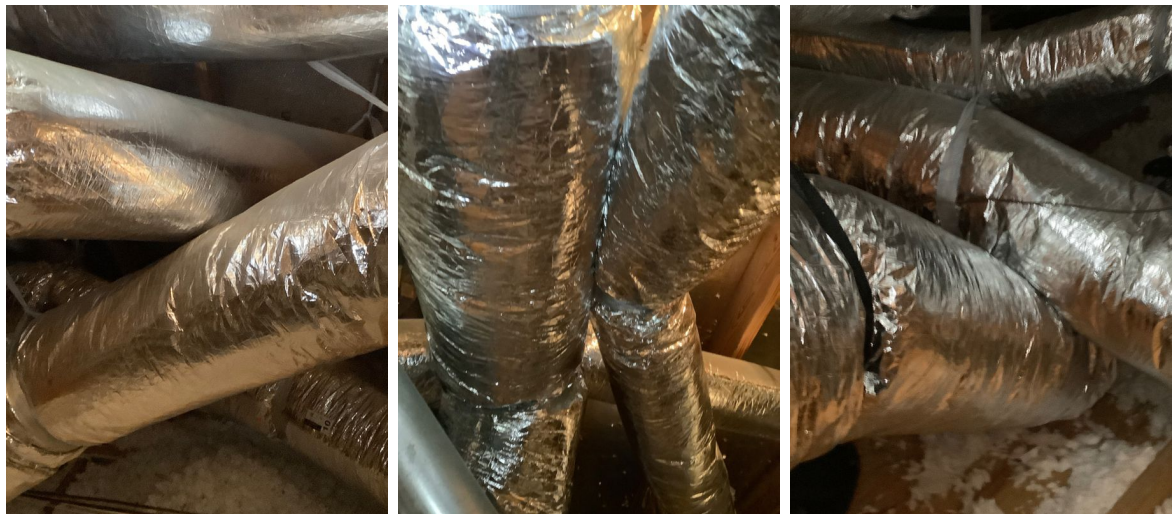
1: Unsupported/touching Ducts

Some air ducts did not appear to be properly supported and were laying on insulation and/or contacting other ducts.

Recommendation: Contact a qualified professional.

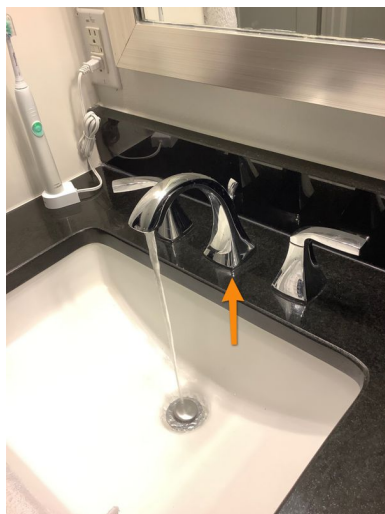
1: Loose Plumbing Fixture

Loose plumbing fixture(s) were observed.

Recommendation: Contact a qualified professional.

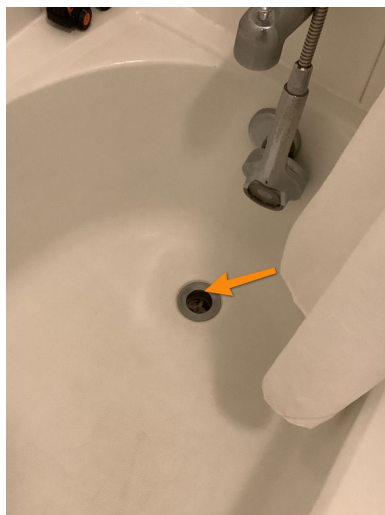
Tub stopper(s) were not operable in the home.

Recommendation: Contact a qualified professional.

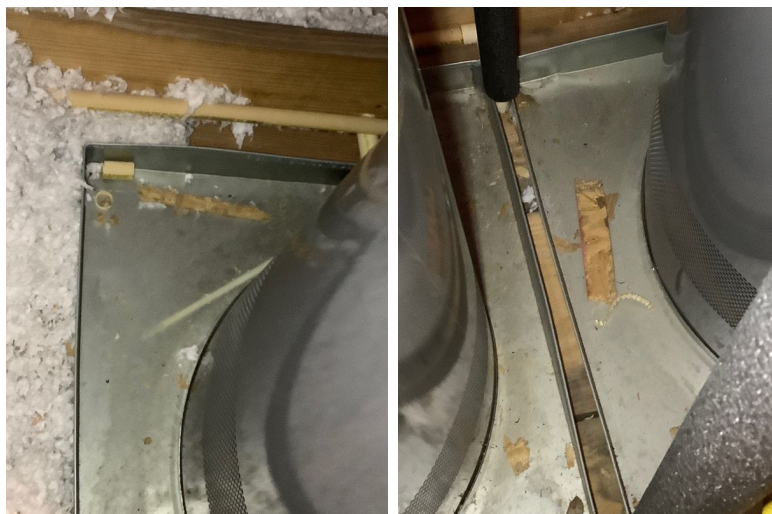
2: Debris in Pan(s)

There was debris in the water heater drain pan(s). This should be cleared to allow for proper drainage.

Recommendation: Contact a qualified professional.

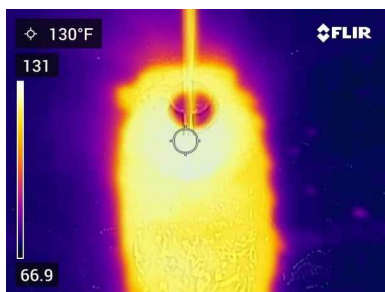
4: Hot Water Too Hot

In our opinion, hot water was too hot. Suspect this could be corrected by turning down the thermostats.

Recommendation: Contact a qualified professional.

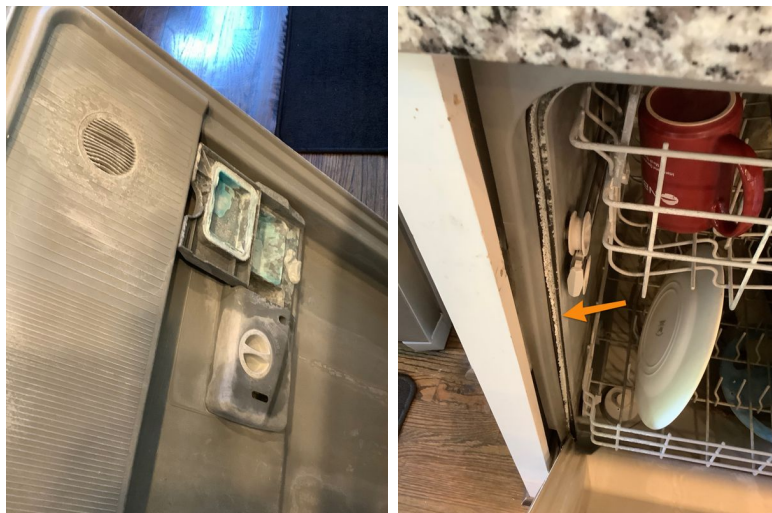
There was some soap/mineral buildup visible.

Recommendation: Contact a qualified professional.

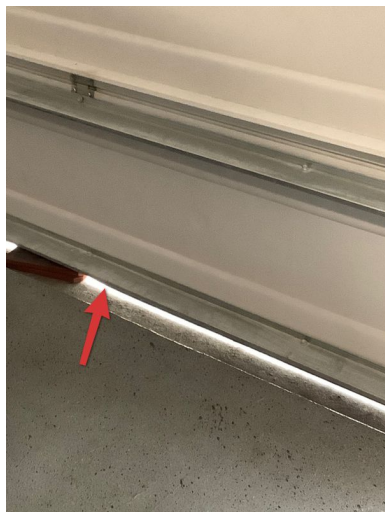
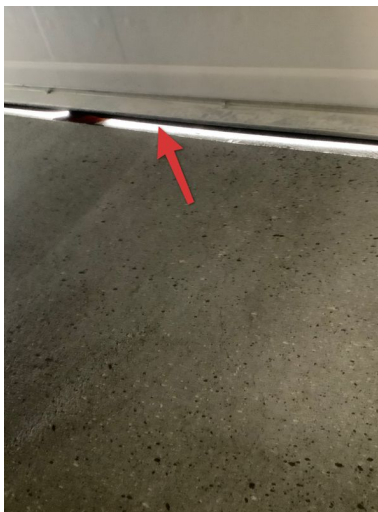
Garage door opener auto reverse features were not functioning.

Recommendation: Contact a qualified professional.

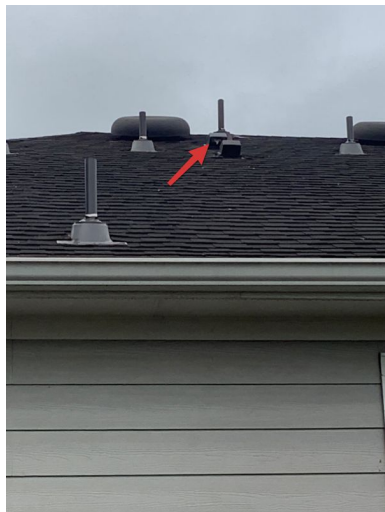
There were signs of lint buildup in the dryer vent.

Recommendation: Contact a qualified professional.
