**3322 Orchard Mill Ln Pearland Tx 77581**

## REDSTAR RESIDENTIAL INSPECTION

3322 Orchard Mill Ln  
Pearland TX 77584

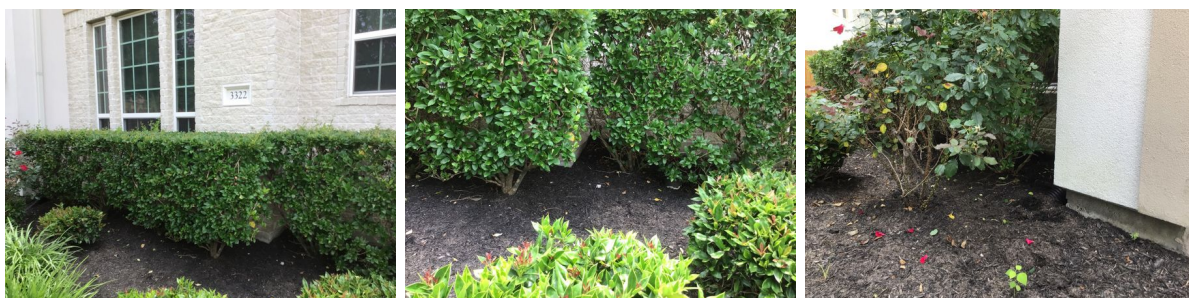
**2: Landscaping: High Soil**

High soil conditions observed at the various locations around the structure. The soil level should be reduced to allow for a minimum of 2-4" of foundation exposure, while still providing positive drainage away from the home. Recommend correction.

Recommendation: Contact a qualified landscaping contractor

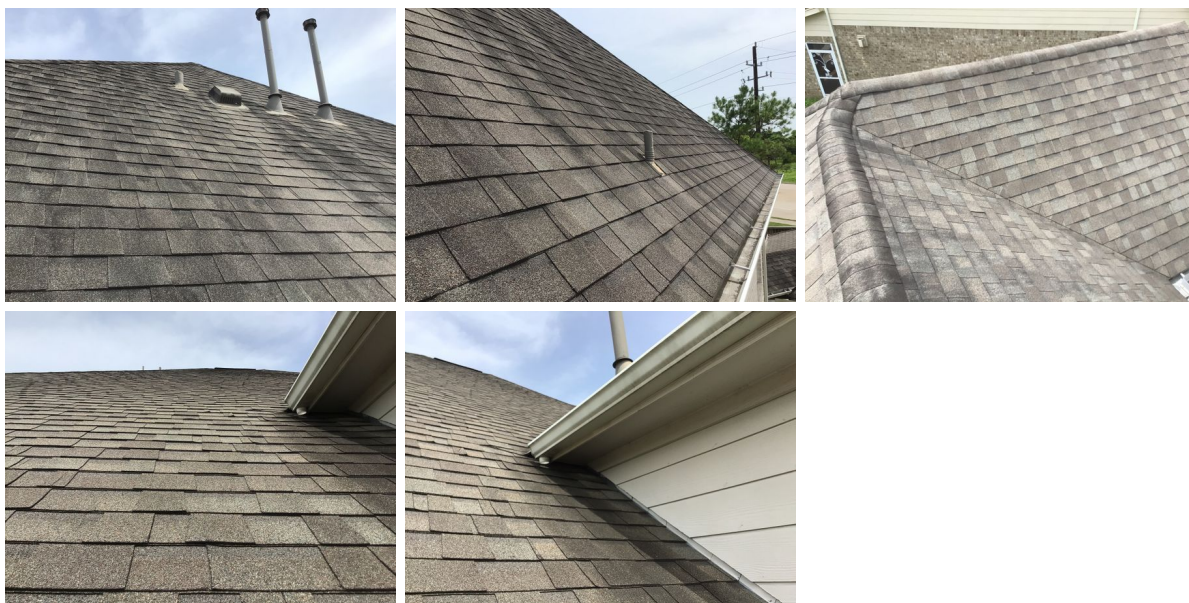
*General Photos:*

The roof covering shows multiple issues that require further evaluation to determine the extent of necessary repairs. A Certified Roofing Company should be consulted for further evaluation.

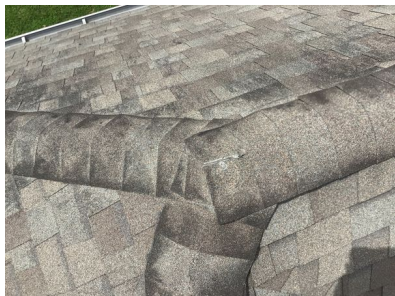
Several locations where the nail heads are exposed and need sealed. These locations include around vent jacks, flashings, and hip and ridge caps. Recommend correction as needed to prevent moisture penetration over time.

Recommendation: Contact a qualified roofing professional.

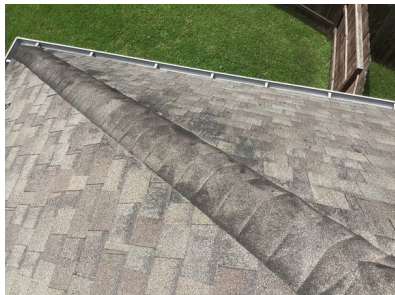
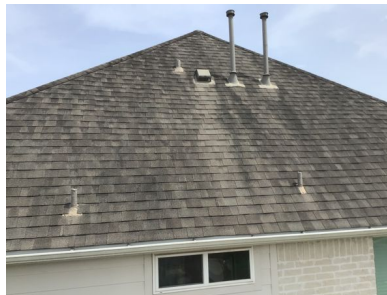
## **2: Shingles: Granule Loss Noted**

Moderate granule loss of the asphalt roofing shingles was observed at some locations. This condition is typical for an aging roof, and does not seem to be affecting the performance of the roof covering at this time. Recommend regular monitoring and inspection of this condition. Consult with roofing contractor if you desire further evaluation of this condition.

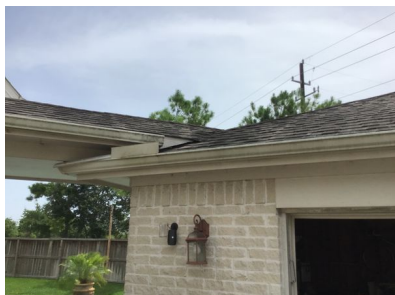
## **3: Flashing: Deteriorated Sealant**

Deteriorated sealant was observed around plumbing and other flashing components. It is vital to maintain these locations to ensure performance of the covering. Recommend correction to avoid further deterioration or potential moisture intrusion issues.

Recommendation: Contact a qualified roofing professional.

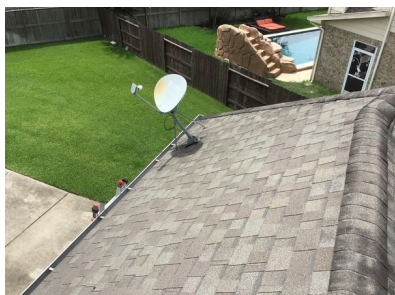
## **4: Satellite Dish(es) on Roof**

A satellite dish was observed to be secured to the roof covering. This installation is prone to leaking over time, I recommend you consider further evaluation and repair or removal.

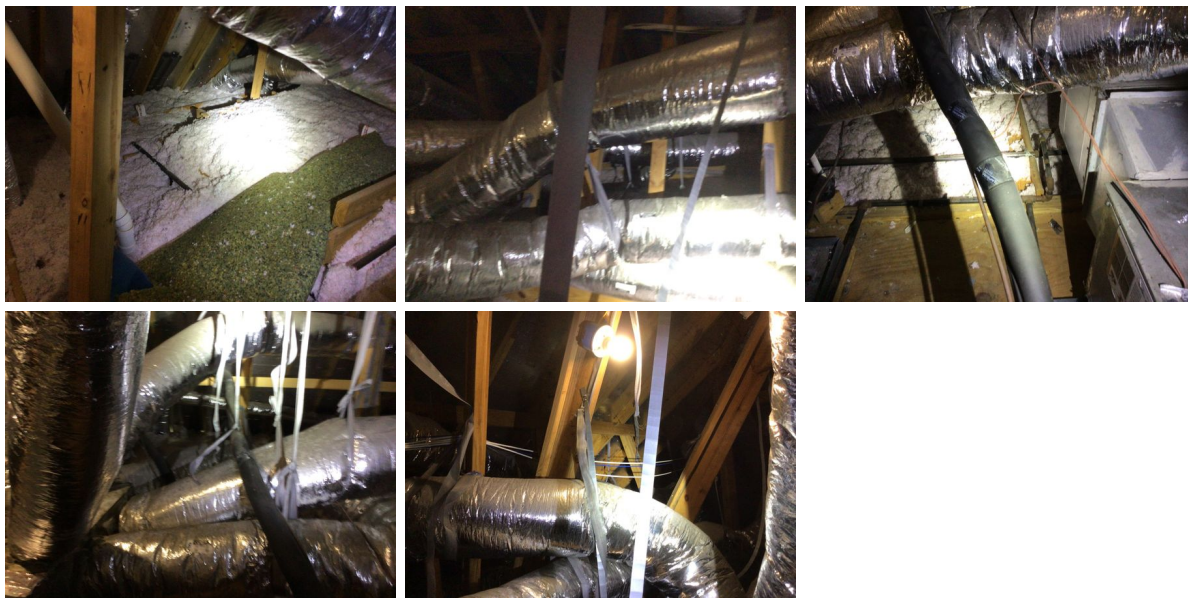
*General Photos:*

*Type of Insulation Material: Blown Fiberglass, Batt Fiberglass*

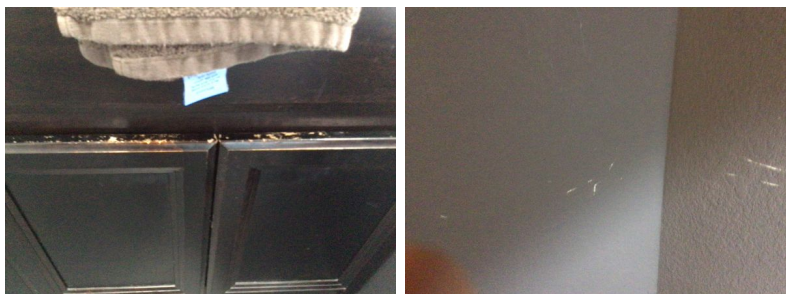
Paint finish damaged or worn, Paint touch up needed -  
The paint and caulk touch up at windows and door frames was observed. These items are related to cosmetic issues or maintenance due to expected wear and tear. Recommend you budget for repair of these issues for cosmetic reasons, or to avoid further deterioration.

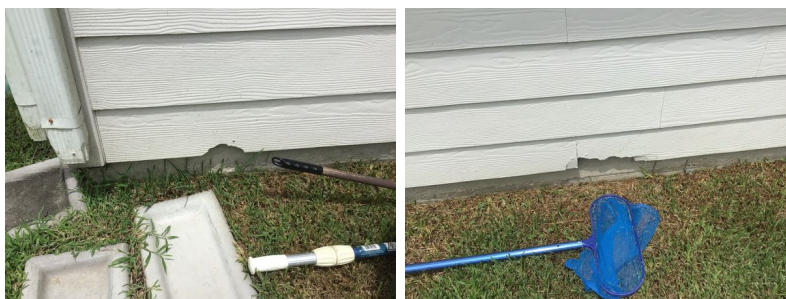
The siding displayed sections with minor damage or maintenance issues. Common maintenance items include: minor damage, separation at joints and trim, finishes that are worn, etc. While these conditions do not appear to be contributing to any larger issues, I recommend you consider correction to avoid further deterioration and as apart of normal maintenance.

Recommendation: Contact a qualified handyman.

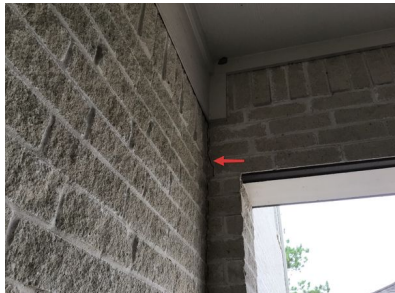
Moderate cracks and/or separations were observed in the masonry walls around the exterior of the home. Common areas of issues include around windows, doors, and/or expansion joints. These cracks and separations are excessive and I recommend further evaluation to determine extent of necessary repairs.

Recommendation: Contact a qualified masonry professional.

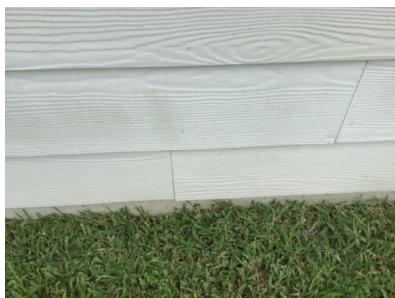
#### 5: Siding: Loose sections

Lapped siding was observed to be damaged/loose at multiple locations around the home. Repair as needed.

Recommendation: Contact a qualified professional.

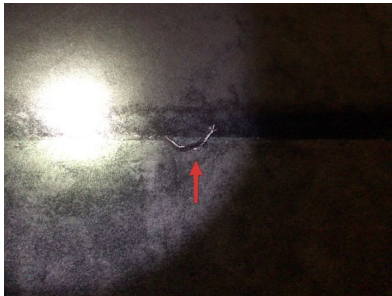
The floor covering was observed to be damaged in one or more areas. Further evaluation is needed and repair or replace as needed

Recommendation: Contact a qualified professional.

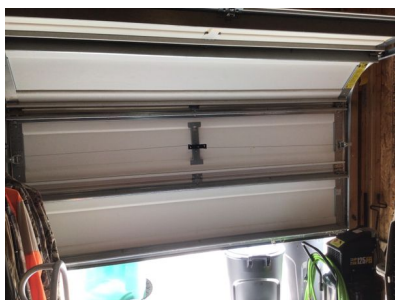
**4: Small garage door**

Inspector observed the smaller detached garage door to be quite difficult to operate. Recommend correction.

Recommendation: Contact a qualified professional.

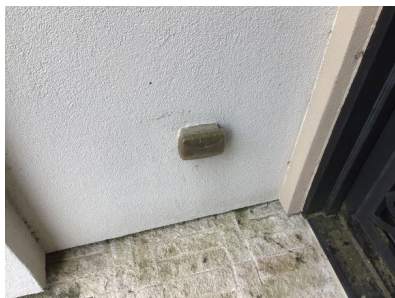
Open ground was observed on 3-prong outlets installed at various locations around the home. This condition presents a false sense of a ground being present, and is a code violation. This is common with older homes. Recommend further evaluation and correction as needed.

Recommendation: Contact a qualified electrical contractor.

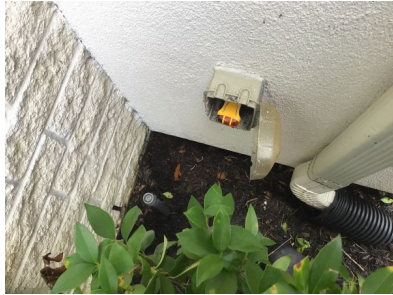
Outlet had no power at the time of the inspection. Recommend further evaluation by an electrician.

Recommendation: Contact a qualified electrical contractor.

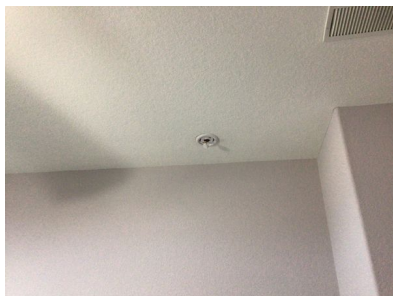
The inspector observed one or more smoke alarms missing in the home. Evaluate and replace as needed.

Recommendation: Contact a qualified professional.

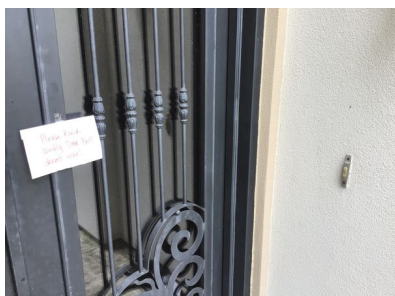
### 6: Doorbell

Inspector observed the front doorbell to not be operable. Recommend correction.

Recommendation: Contact a qualified professional.

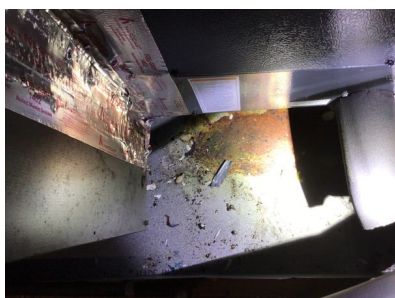
Rust was observed in the secondary drain pan, this indicates there may have been a continuous issue with the primary drain line. Recommend inquiring as to if any repairs have been made to the equipment and if the unit has been serviced within the last year.

Recommendation: Contact a qualified professional.

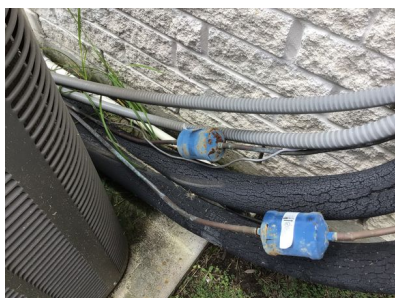
**2: Refrigerant Lines: Rust on Filter**

Observed rust on the exterior of the refrigerant filter. Recommend to have an HVAC contractor evaluate further to ensure no failure is possible.

Recommendation: Contact a qualified HVAC professional.

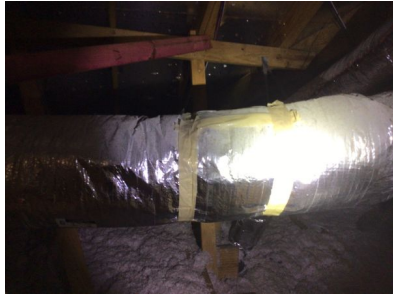
Duct tape was observed on the ducts, despite its name duct tape is not proper use for ducts. Remedy as needed.

Recommendation: Contact a qualified professional.

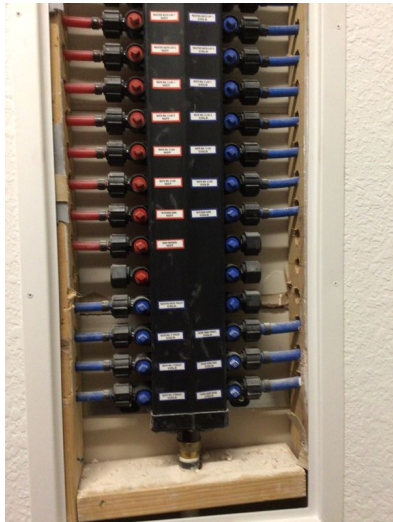
*Photo of Plumbing Manifold:*

*Type of Piping::* PEX

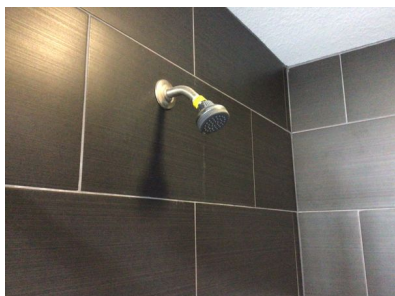
## 2: Showerhead leaking

Inspector observed the master shower to be continuously leaking during the inspection. Recommend evaluation and correction by qualified plumber.

Recommendation: Contact a qualified professional.

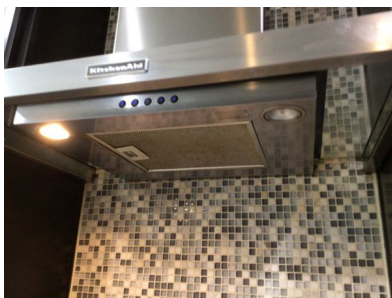
**1: Exhaust Light is Out**

The range hood light did not function, it appears to be bulb related. Repair as needed.

Recommendation: Contact a qualified professional.

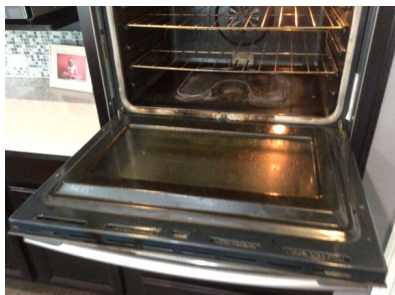
Recommend cleaning the oven unit for sanitary and safety purposes.

Recommendation: Contact a qualified professional.

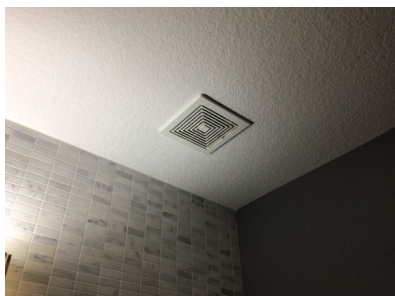
One or more vent covers were observed to be dirty. Recommend to clean as needed.

Recommendation: Contact a qualified professional.

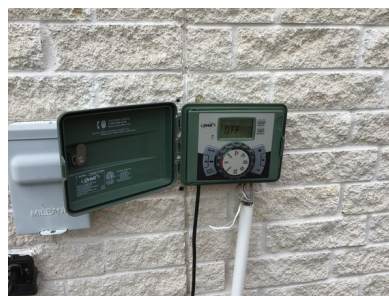
**1: Valve Control not secure to wall**

The valve controls at the vacuum breaker was observed not to be secured properly to the wall. Recommend properly to prevent damage.

Recommendation: Contact a qualified professional.

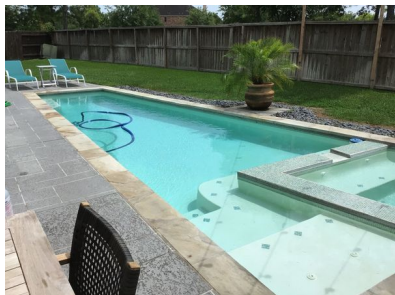
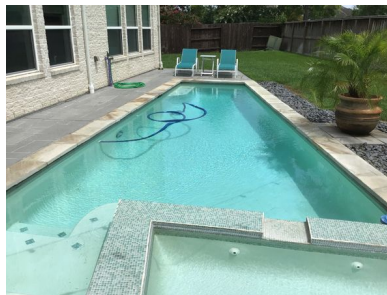
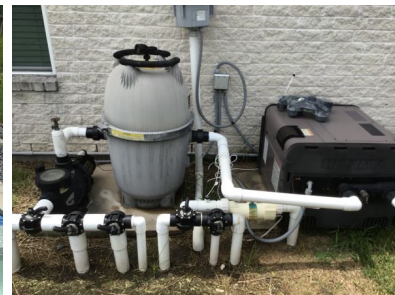
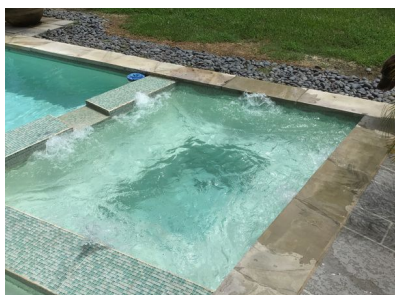
*Pool and Equipment Photos:*

The pool and related equipment was shown to be in need of several repairs and displayed various issues that require further evaluation by a qualified contractor. Recommend a licensed, competent pool contractor be consulted to further evaluate and perform the necessary repairs.

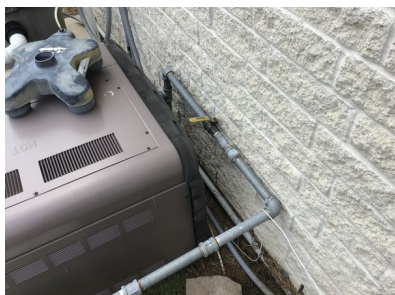
There was no gas supply to the heater is the time of inspection. The valve was in the off position. Recommend evaluation and correction by a qualified pool contractor if desired.

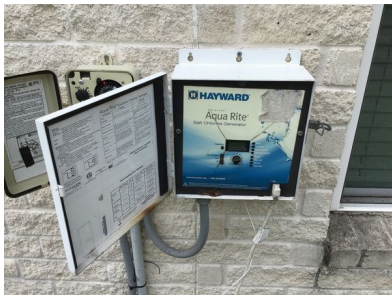
#### **5: Chlorine generator**

Inspector observed the chlorine generator to not be functioning at the time of inspection. Recommend evaluation by a qualified pool contractor.

Recommendation: Contact a qualified professional.

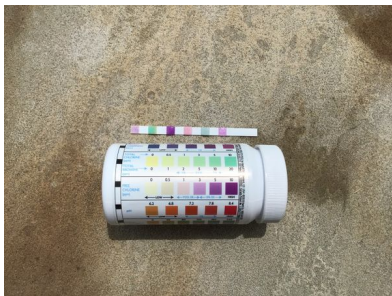
#### **6: Pool chemistry**

High chlorine, high hardness, high alkalinity, High cyanuric acid

Recommendation: Contact a qualified professional.
