## RESIDENTIAL INSPECTION

3966 Belle Park Dr,  
Houston , Tx 77072

# PROPERTY INSPECTION REPORT FORM

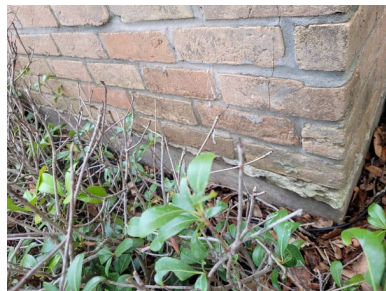
East

Two or more of the foundation perimeter beam corners were sheared off ( corner pop ). This is a common condition and is due to the thermal expansion and contraction of the different materials. This does not adversely affect the foundation's performance. However, some cosmetic improvements may be necessary. Traditionally the exterior of condominiums is maintained by the HOA. It is advisable to check the governing documents for how repairs, and maintenance, should be handled. Look for anything that defines the lines of responsibility and repair policies. Mold remediation, roof maintenance, and any rules regarding multi-unit issues may be referenced in addition to general repair guidelines.

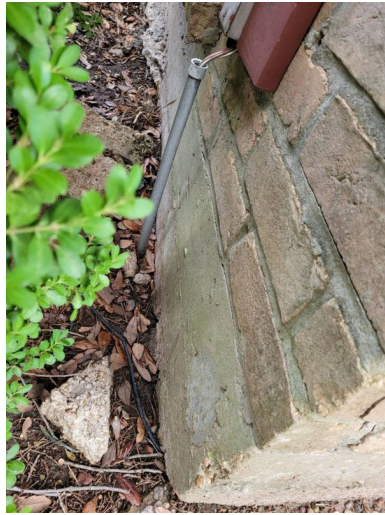
South

Minor cracking was noted at the foundation. This is common as concrete ages and shrinkage surface cracks are normal. Recommend monitoring for more serious shifting/displacement.

Recommendation: Contact a qualified structural engineer.

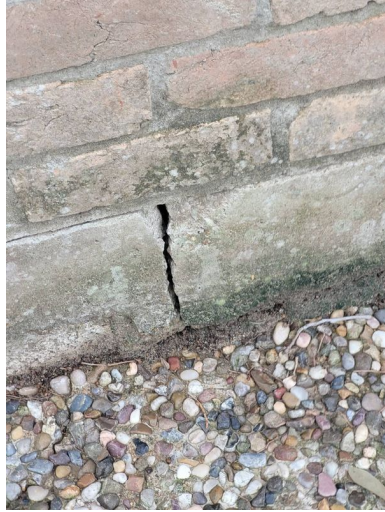
East

The floor slab shows movement/settling due to soil movement. This can compromise the structural integrity of the home. Recommend a qualified structural engineer evaluate and advise on how to remedy.

Recommendation: Contact a qualified structural engineer.

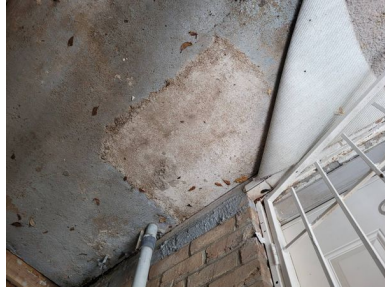
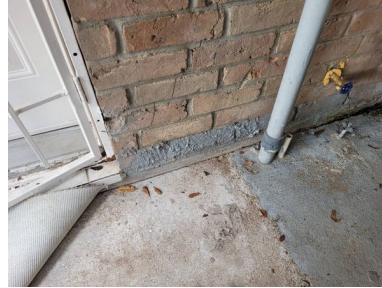
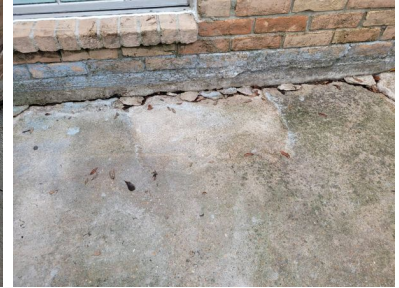
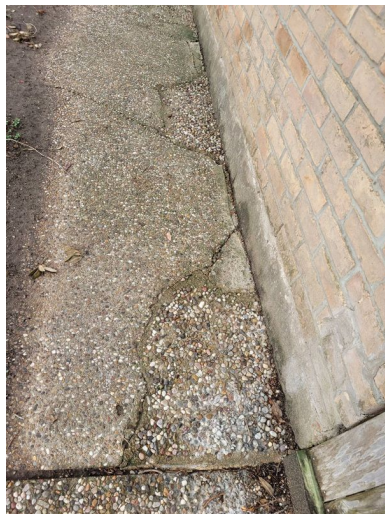
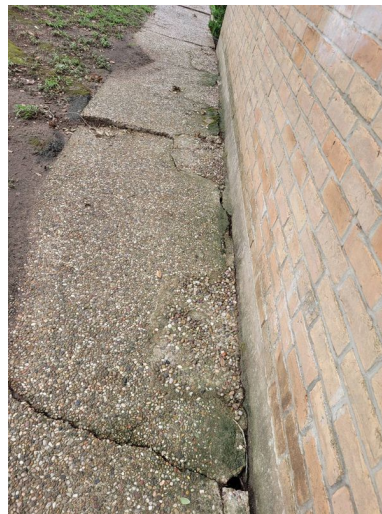
Previous repairs were noted

Recommendation: Contact a qualified professional.

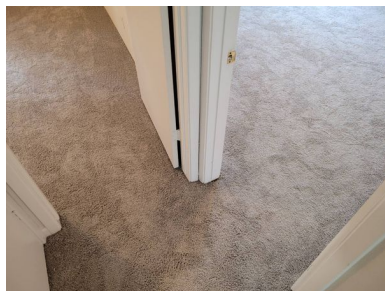
Hallway, Bedroom, Master Bedroom

The floor in those areas are sloping slightly. I recommend a flooring contractor to evaluate and advise on a course of action.

Recommendation: Contact a qualified professional.

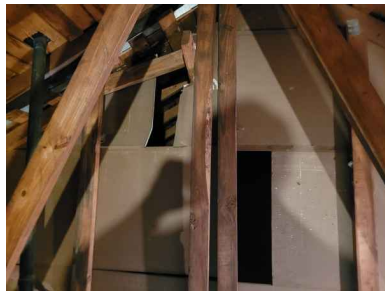
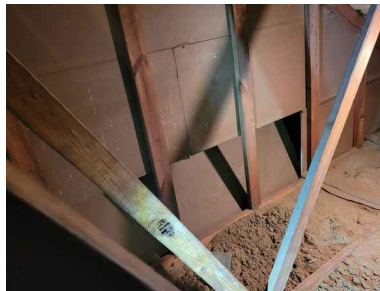
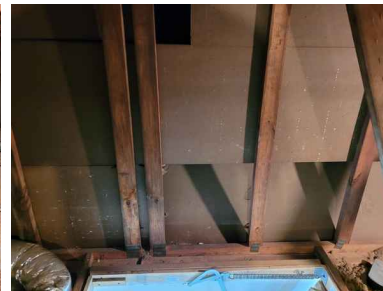
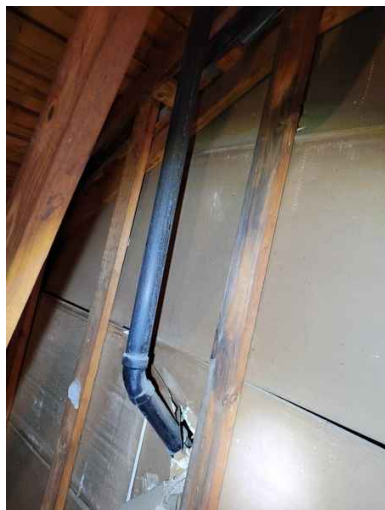
Fire code today for multiple unit buildings, such as condos and townhomes requires that a fire "partition" be built all the way to the roofline. The "partition" should have a 1-hour fire rating or a ½-hour fire rating for buildings that are sprinkled. I recommend a general contractor evaluate and repair

Recommendation: Contact a qualified professional.

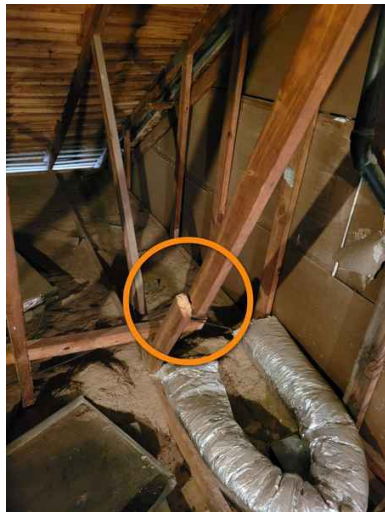
Broken web

I observed damaged and broken truss assemblies. When a roof truss becomes stressed beyond its load capacity, it may buckle, crack, or break. Atypical loading events or additional loading after the original construction can cause roof truss failure. I recommend a structural engineer to evaluate and repair.

Recommendation: Contact a qualified professional.

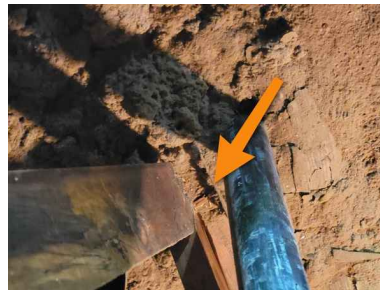
Web runners separated from the joints

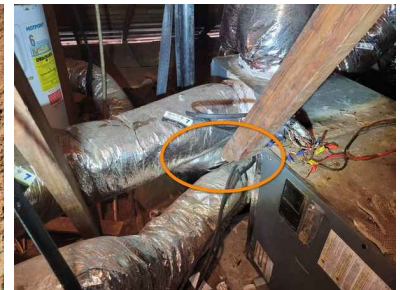
Cut web

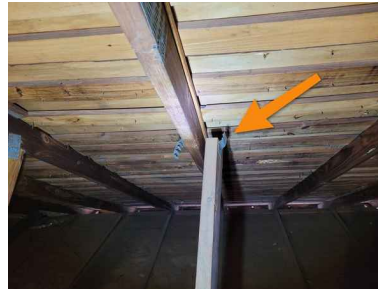
Web runners separated from the joints

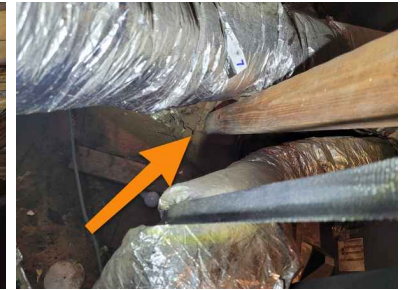
Web runners separated from the joints

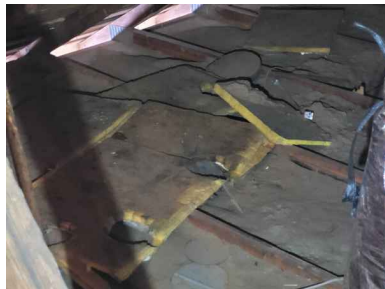
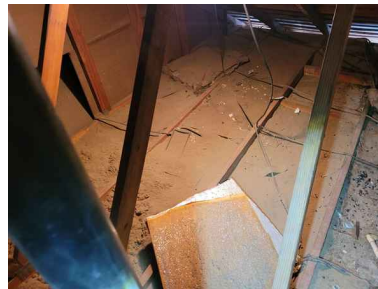
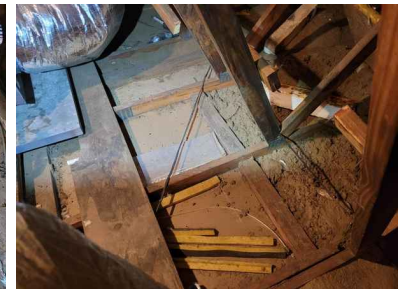
-The insulation is insufficient in areas of the attic. I recommend a qualified technician evaluate and repair

Recommendation: Contact a qualified insulation contractor.

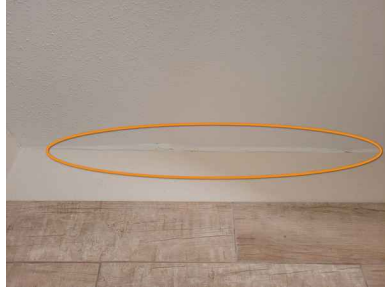
2nd Floor Bathroom

Cracked paint or caulking in a bathroom wall is usually due to the underlying substrate (plaster or drywall) deteriorating or flexing with temperature and humidity changes but also the settlement of the house. Bathrooms exhibit the same settlement cracks as the rest of the house, plus the environment can be hostile for paint and caulking because of the high moisture levels. I recommend a qualified te

Recommendation: Contact a qualified professional.

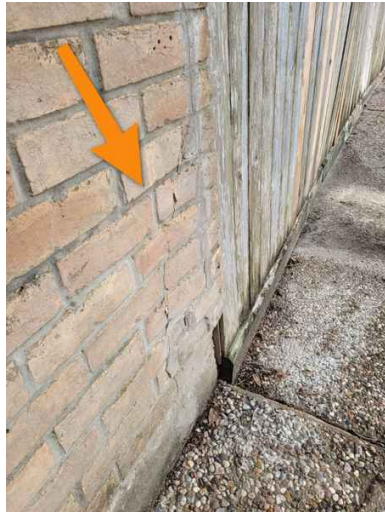
Northeast

A bowing problem could be a result of poor structural design or excessive lateral pressure from the soil surrounding and underneath the home. Inadequate drainage, too much soil compaction, and poor waterproofing all can contribute to the pressure that leads to bowed walls. I recommend a structural engineer to evaluate and advise on a course of action.

Recommendation: Contact a qualified professional.

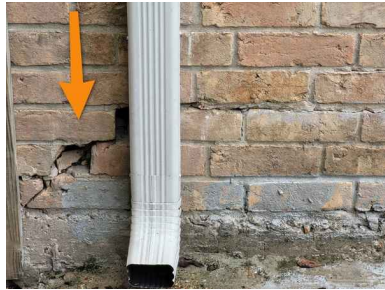
Northeast

Major cracking observed in wall structure. This could be from moisture intrusion at the structure and/or soil movement. Recommend a qualified structural engineer evaluate and advise on course of action.

Recommendation: Contact a qualified structural engineer.

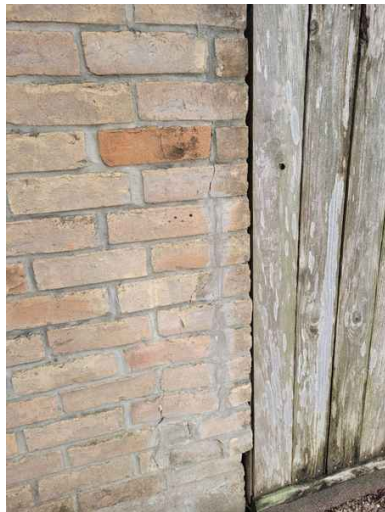
Northeast

Minor cracking was observed in wall structure. This is common in homes this age. Recommend monitoring.

Recommendation: Recommended DIY Project

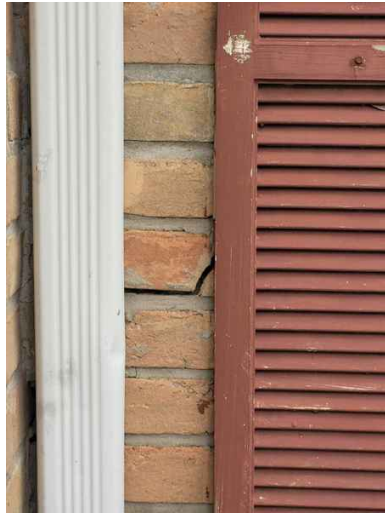
South

The Wall structure showed signs of water intrusion, at a previous time. Recommend a qualified contractor to evaluate and repair

Recommendation: Contact a qualified structural engineer.

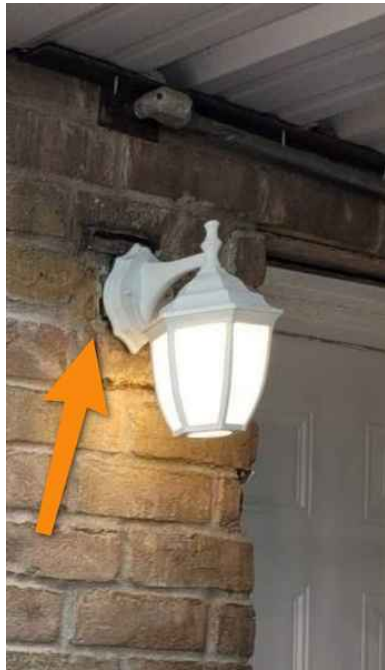
North

Rain and moisture will often find their way into a wall if the exterior light fixture is not properly caulked. Therefore, proper caulking will help prevent water from entering into a wall; helping prevent damage to the wiring, the fixture, and the growth of mold inside the wall

Recommendation: Contact a qualified professional.

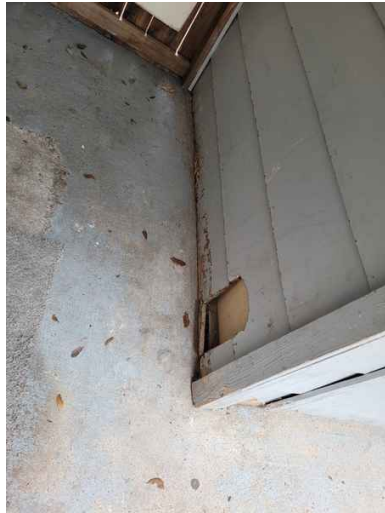
Storage shed

Holes in the walls need to be repaired to prevent moisture intrusion. I recommend a qualified technician evaluate and repair

Recommendation: Contact a qualified professional.

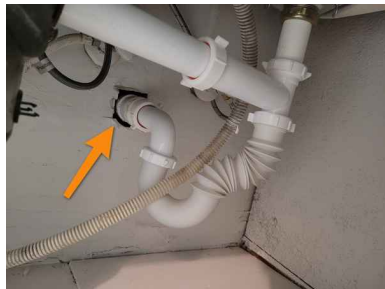
Kitchen

It is recommended to air seal around all plumbing and piping installed through walls, ceilings, and flooring to keep conditioned air from leaking into unconditioned space.

Recommendation: Contact a qualified professional.

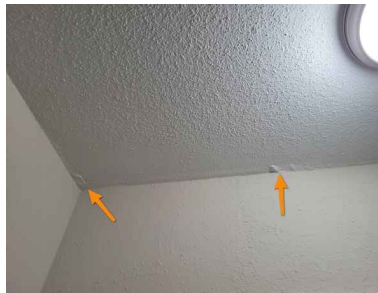
Master Bathroom

**2: Ceiling - Minor Damage**

Minor damage or deterioration to the ceiling was visible at the time of the inspection. I recommend a qualified technician evaluate and repair

Recommendation: Contact a qualified drywall contractor.

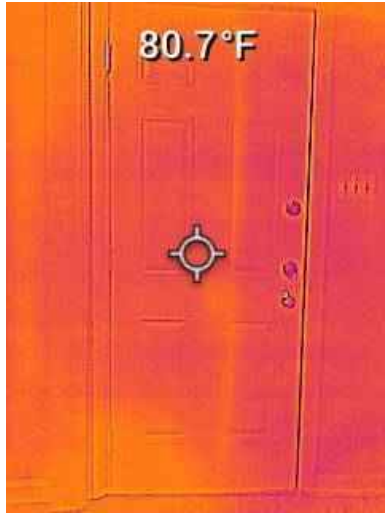
Some conditioned air loss from the back door

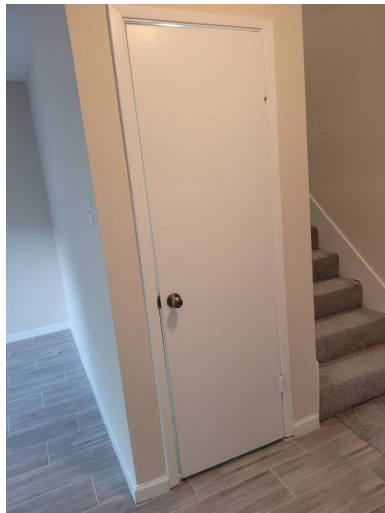
1st Floor storage door

Door doesn't latch properly. Recommend handyman repair latch and/or strike plate.

Recommendation: Contact a qualified handyman.

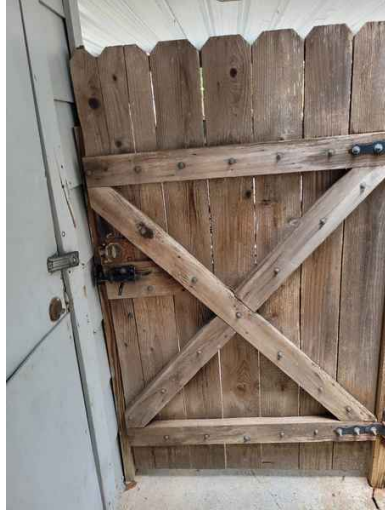
General damage

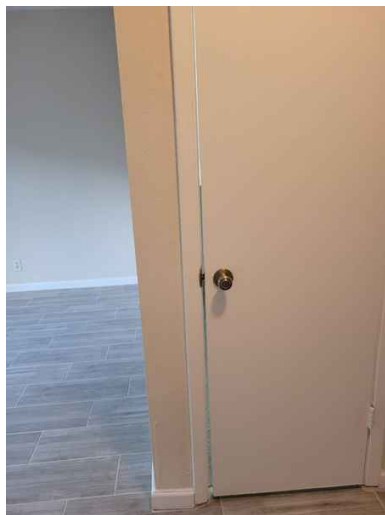
1st Floor storage door

One or more gaps could result in energy loss. Recommend handyman or door contractor evaluate.

Recommendation: Contact a qualified door repair/installation contractor.

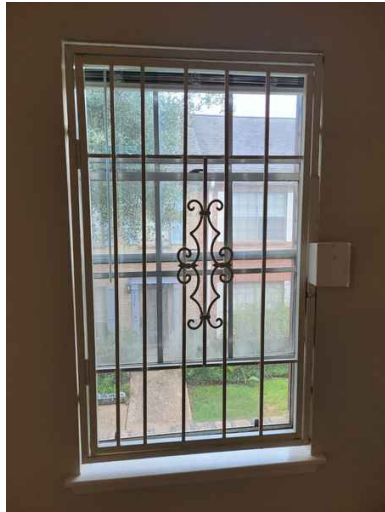
## 2: Evidence of moisture damage

Some window sills have evidence of moisture damage. I recommend a qualified technician to evaluate and repair. Cracks that are in only the trim around the doors and windows are often from humidity causing material, especially wood, to swell and contract. If that happens enough, the trim can crack near its edge and create a gap. These cracks are merely cosmetic, but you'll want to fill them.

Recommendation: Contact a qualified professional.

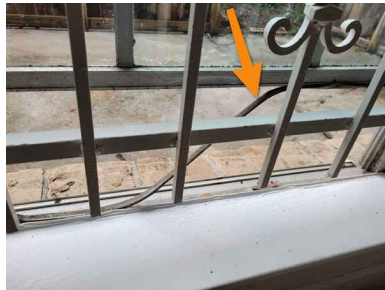
Dining Room

### 3: Failed weatherstrips

I recommend replacing the bottom rail weatherstrip to prevent loss of conditioned air and moisture intrusion.

Recommendation: Contact a qualified professional.

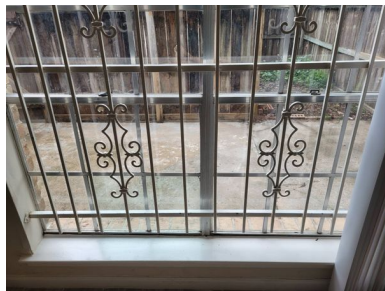
Dining Room

### 4: Missing Screen(s)

One or more windows are missing a screen. Recommend replacement. They are the barrier that keeps insects from coming into your house when you open your windows up to let the fresh air in. And they keep a whole range of potential pests from using your windows as a doorway into your home. Screens are important.

Recommendation: Contact a qualified window repair/installation contractor.

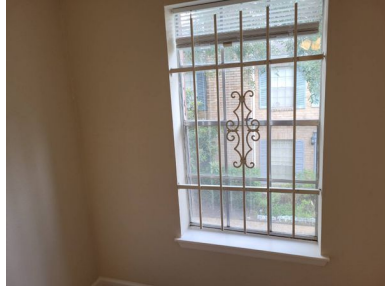
Master Bedroom

Window inoperable

Recommendation: Contact a qualified professional.

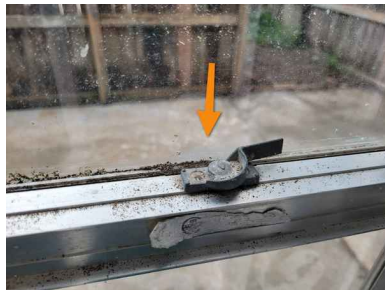
Dining Room

**6: Window not locking**

Recommendation: Contact a qualified window repair/installation contractor.

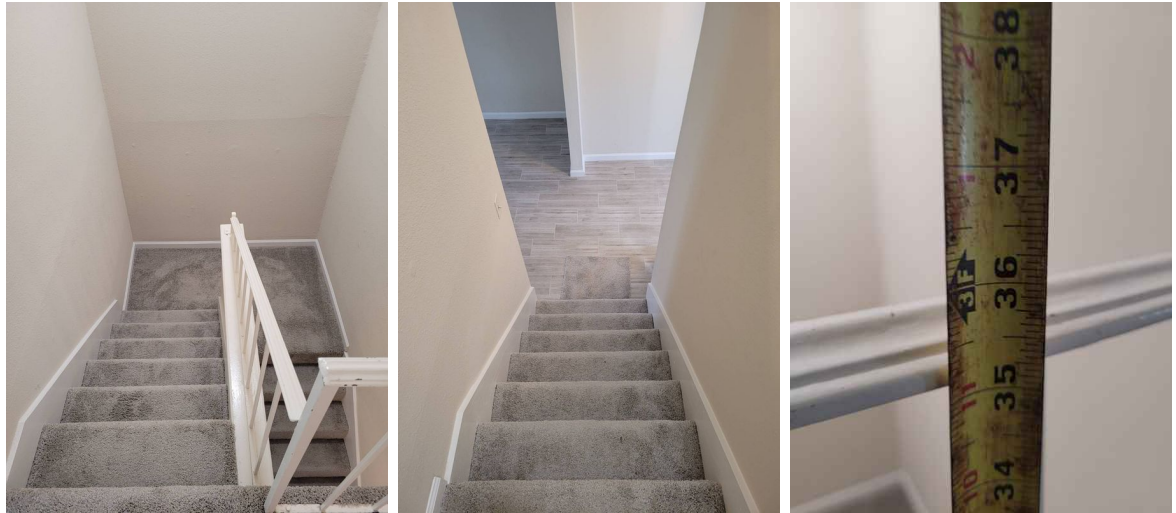
Proper guard rail height

**1: Baluster Gap Too Wide**

The baluster space is not up to modern safety standards. The space between balusters should not allow passage of a 4 3/8-inch sphere for child safety. Recommend a qualified handyman or original installer repair and bring up to code.

Recommendation: Contact a qualified handyman.

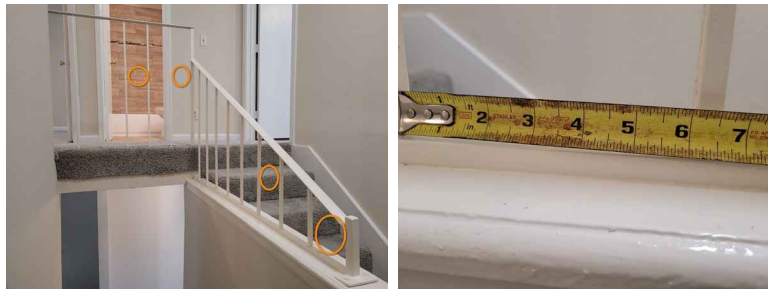
The baluster gap

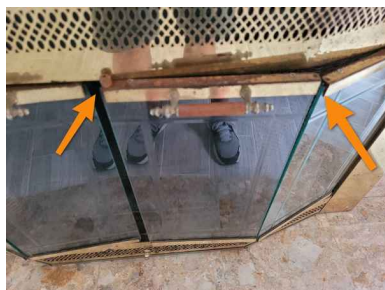
**2: Cabinet doors damaged**

I observed the fireplace cabinet door on the right side to be damaged. I recommend a qualified technician evaluate and repair

Recommendation: Contact a qualified professional.

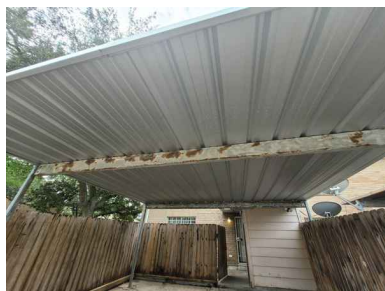
**1: Carport leaking**

I observed the carport leaking water at the time of the inspection. I recommend caulking the problem areas

Recommendation: Contact a qualified professional.

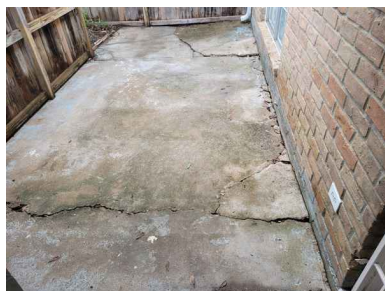
North Patio

**2: Cracked Exterior Floor**

Porch or balcony exterior flooring shows signs of foundation cracking. Recommend a concrete contractor evaluate and repair.

Recommendation: Contact a qualified concrete contractor.

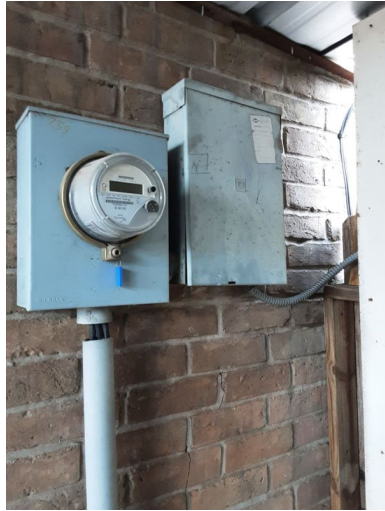
North

The components of the electrical service panel, service entrance cables, breakers, connections, wiring, and grounding, appear to perform as it was intended at the time of the inspection, however, there were some deficiencies.

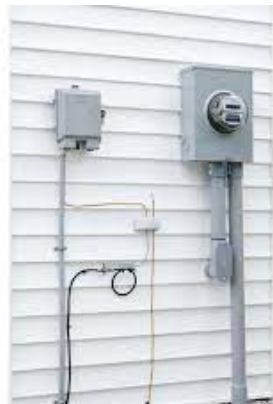
The electrical panel/system is the heart of the home. Electrical current is being distributed from the panel(s) to the receptacles, fixtures, appliances, and elsewhere around the property. breakers become weak and wear out, connections can become loose. It is recommended every few years to have a qualified licensed electrician inspect and evaluate the service panel for any service or repair that may be needed.

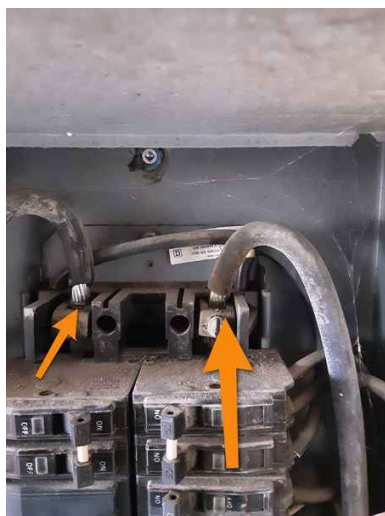
North

The oxygen in the air reacts to the aluminum wire. The resulting oxidation causes extra resistance to the electrical current. Applying an antioxidant to the aluminum wiring makes it safer.

Recommendation: Contact a qualified professional.

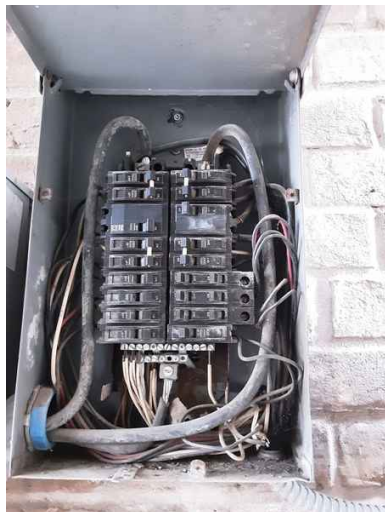
Panel

I recommend a certified electrician evaluate and advise on a course of action

Recommendation: Contact a qualified professional.

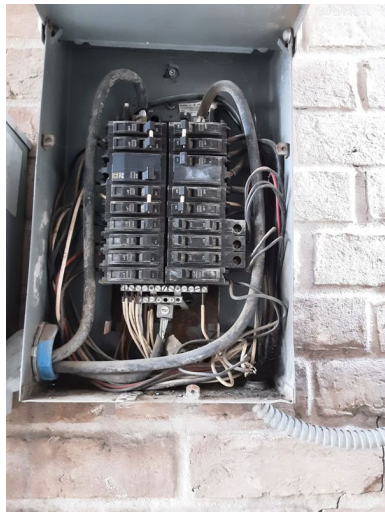
North

The electrical panel does not have labels. Recommend a qualified electrician to test and properly label all switches. Labeling the electrical panel can be an essential time-saving step when things go south at home. When a circuit trips, a label will help identify the culprit and keep confusion to a minimum.

Recommendation: Contact a qualified electrical contractor.

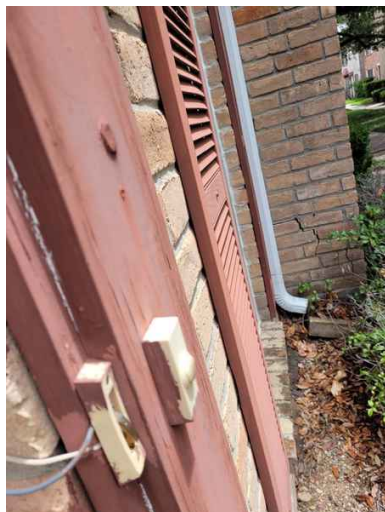
South Inoperable

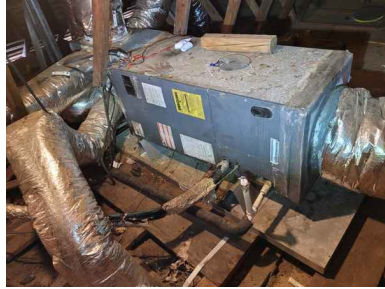
Attic

The heating equipment appears to be functioning as intended at the time of the inspection. The MFG is March 2009

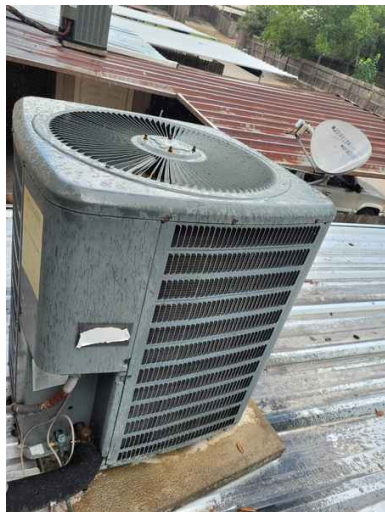
North

The A/C appears to perform as intended at the time of the inspection. The refrigerant used for both units is R 22, and as of January 2020, has been banned in the USA. If your AC or heat pump system needs a repair that involves refrigerant, you may have to decide between a hefty refrigerant bill reaching \$110 plus per pound, and very rare to find, or a system replacement

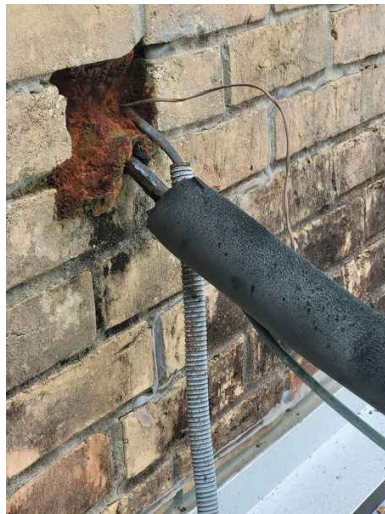
North

Missing or damaged insulation on refrigerant line can cause energy loss and condensation.

Recommendation: Contact a qualified HVAC professional.

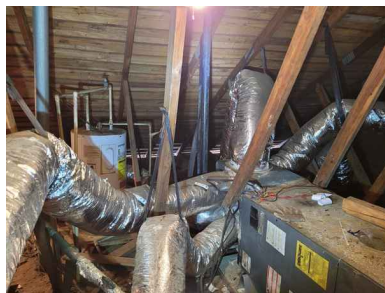
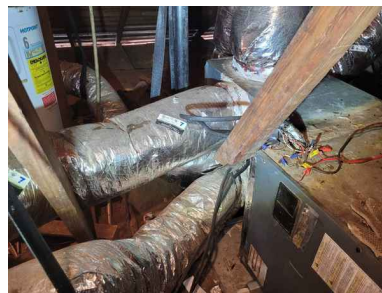
The ducting system appears to be functioning as intended at the time of the inspection, however, there are some deficiencies

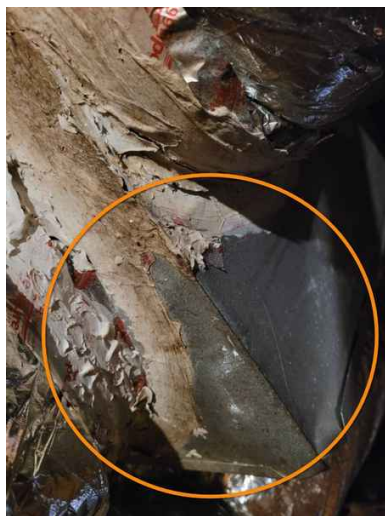
Attic

The main causes for condensation occurring on the HVAC include the temperature difference between the outside air and AC vent, improperly sealed AC ducts, and lack of insulation around these ducts. However, ductwork sweating can also be aggravated by factors like too much air moisture, or a dirty air filter.

Recommendation: Contact a qualified professional.

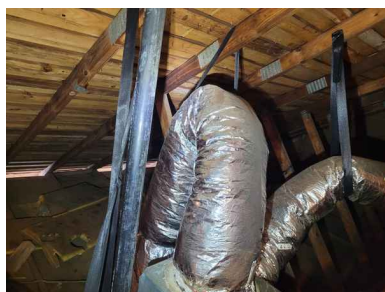
Attic

Ducts which have been improperly routed and are crimped, crushed, or have excessive bends can reduce cool air flow in an otherwise properly functioning system.

Recommendation: Contact a qualified professional.

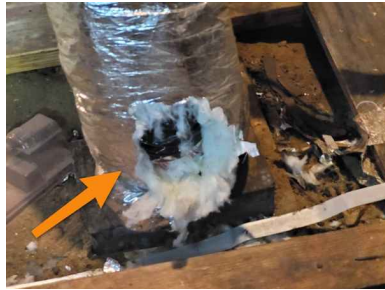
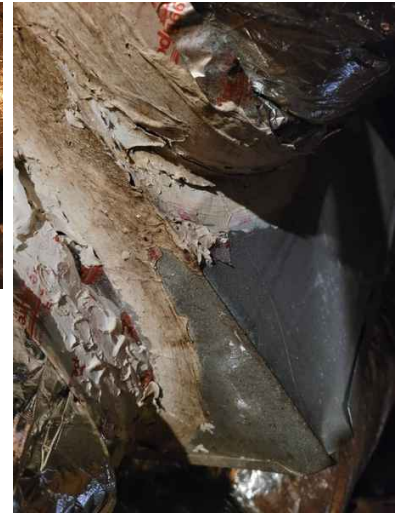
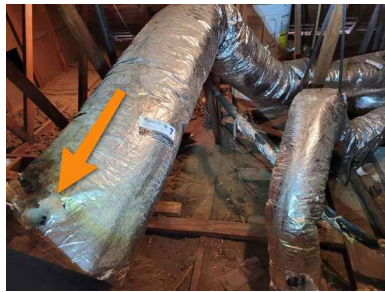
Air supply duct was damaged. Recommend a qualified HVAC contractor repair.

Recommendation: Contact a qualified HVAC professional.

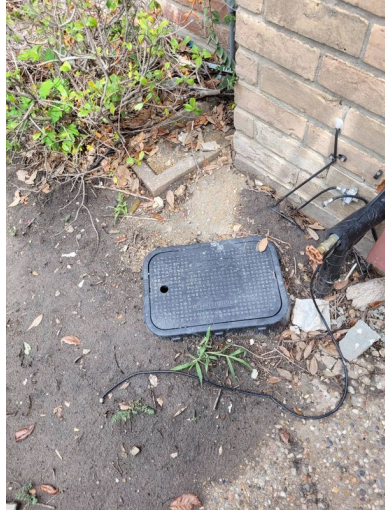
South

Static Water Pressure Reading: 55

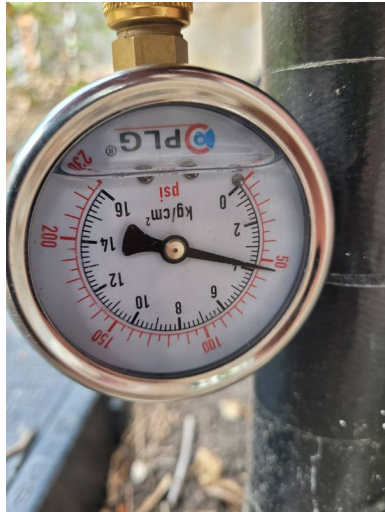
Type of Supply Piping Material: PVC/CPVC

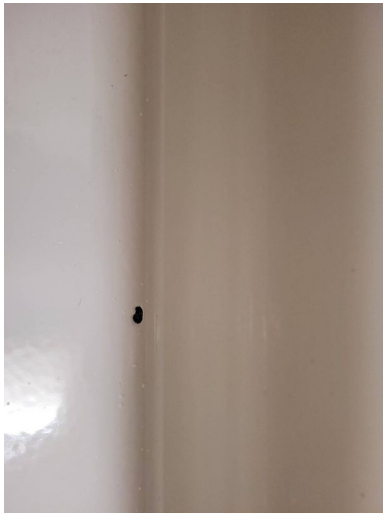
2nd Floor Bathroom

There was a small chip in the bathtub. I recommend a qualified professional evaluate and advise on a course of action.

Recommendation: Contact a qualified professional.

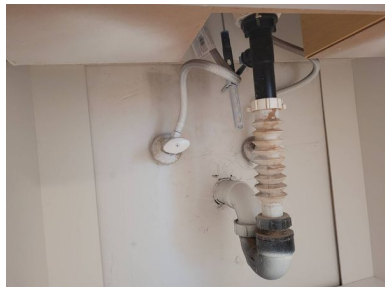
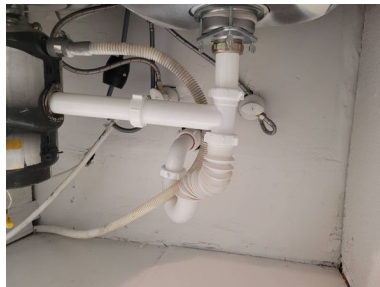
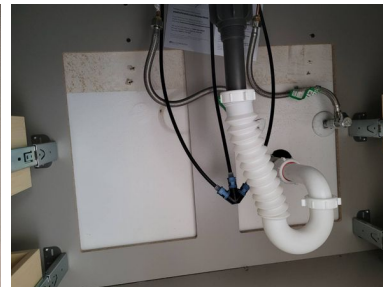
The major problem with them is that they collect the dirt and grime that's supposed to flow down the drain. Making matters worse, since they slow down the flow of water, gunk can easily collect further down the pipe, especially if the pipe already isn't 100% clear.

Recommendation: Contact a qualified professional.

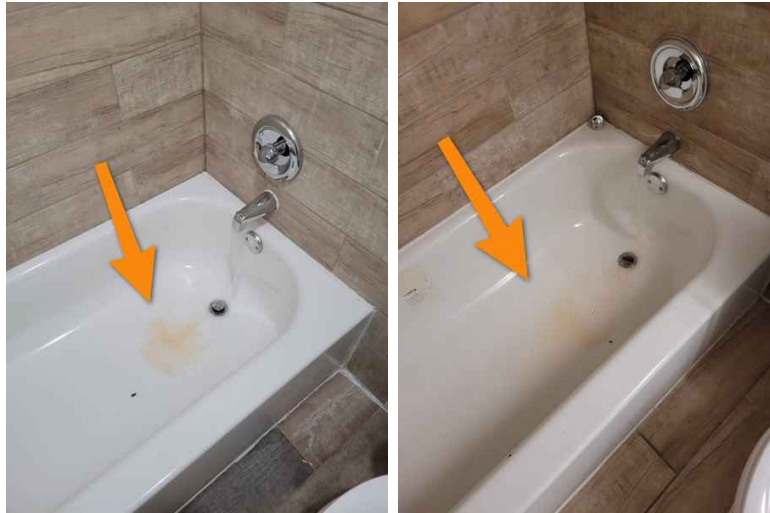
**2: Galvanic corrosion**

Galvanic corrosion happens when two different metals are connected together.

Recommendation: Contact a qualified professional.

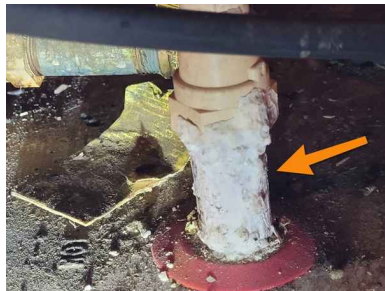
#### 4: Calcification

Those are water deposits where there is enough water to be a leak, then the water evaporates, leaving the minerals behind, and it builds up as crystals.

Recommendation: Contact a qualified professional.

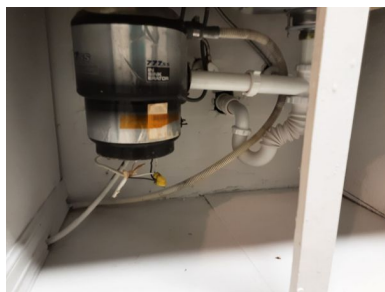
**1: Missing Anti-syphon loop**

The dishwasher drain is missing an anti- siphon loop. The purpose of a dishwasher air gap or anti-siphon is to prevent the siphoning and back flow of water. The water can flow back into the dishwasher which will leave water in the bottom of the dishwasher. The air gap or anti-siphon prevents siphoning if sinks are drained simultaneously.

Recommendation: Contact a qualified professional.

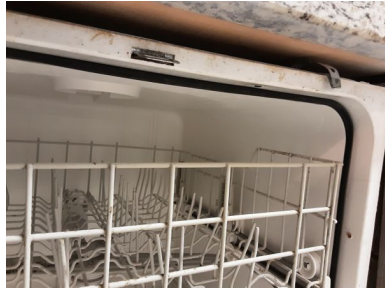
**2: Not secured**

The dishwasher is not secured to the counter. I recommend a handyman secure it to the counter, so it does not move around, and to prevent it from tipping while it is in use

Recommendation: Contact a qualified professional.

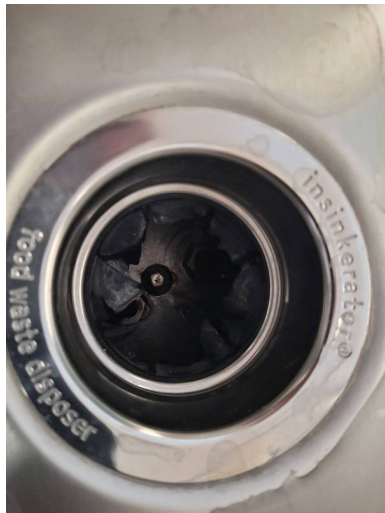
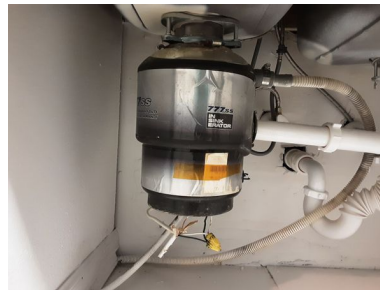
Kitchen

**1: Improper wiring**

Waste disposal cord connected with no connector and a conduit. I recommend a qualified technician to evaluate and repair

Recommendation: Contact a qualified professional.

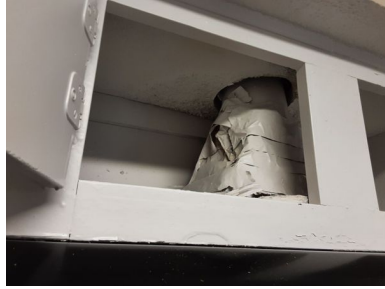
Kitchen

**1: Exhaust fan needs sealing**

The space between the exhaust fan and the surrounding drywall must be sealed so that large amounts of the conditioned air does not leak through, which can lead to energy loss and moisture problems.

Recommendation: Contact a qualified professional.

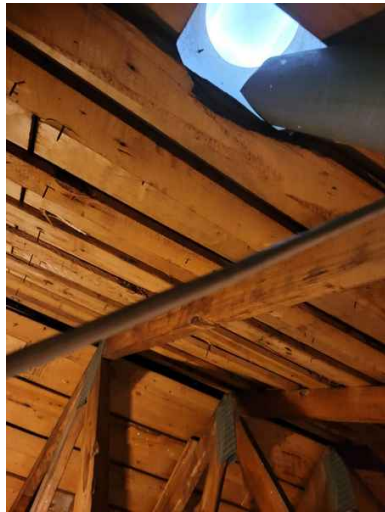
Attic

When you see light come in through these areas, it means that water can also get in, so the problem needs to be addressed immediately.

Recommendation: Contact a qualified professional.

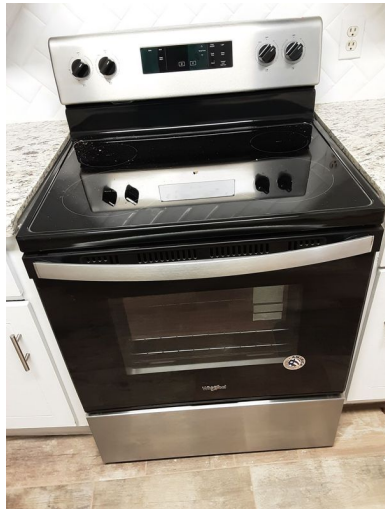
Kitchen

### 2: Range Not Fastened

Range was not fastened to the floor. This poses a safety hazard to children. Recommend a qualified contractor secure range so it can't tip.

Recommendation: Contact a qualified handyman.

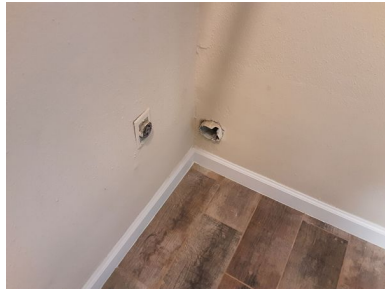
**1: Missing vents in bathroom and laundry room**

Laundry room ventilation is important as it can be a major source of contaminants in your house. A poorly ventilated laundry room will have moisture buildup. During the hotter summer months, this is a recipe for mold growth, bacteria, and dust mites. Washers emit a great deal of humidity, particularly when running on the spin cycle. Concentrated water vapor in the air condenses on walls and other surfaces and can trigger mold growth as well as consequences such as deteriorated structural materials. Dryers require specific venting for fire safety as well as air quality protection. Lint produced by driers is a proven fire hazard when not properly vented. Released into the household environment, airborne lint can present health issues if inhaled.

Recommendation: Contact a qualified professional.

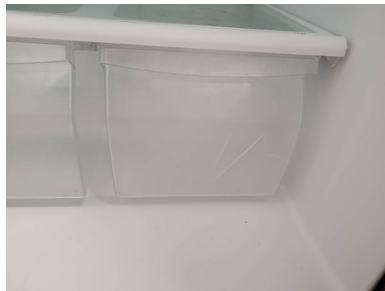
**1: Broken shelf**

I observed a broken shelf on the refrigerator door.

Recommendation: Contact a qualified professional.

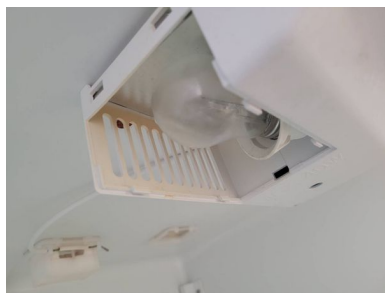
**2: Light not on**

Recommendation: Contact a qualified professional.
