**SUMMARY**  
7723 Ellis Dr, Missouri City, TX 77489  
Jincy Jose  
August 24, 2022

Arthur Guzman  
Certified Professional Inspector  
TREC#23407  
Fort Bend Inspections  
832-250-0135  
[info@fortbendinspections.com](mailto:info@fortbendinspections.com)

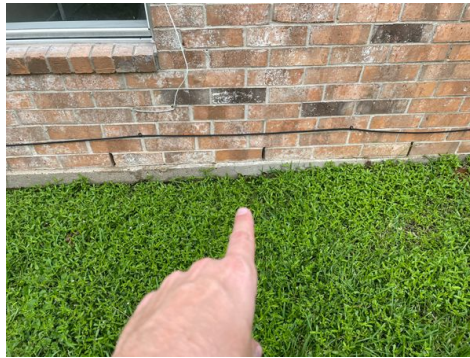
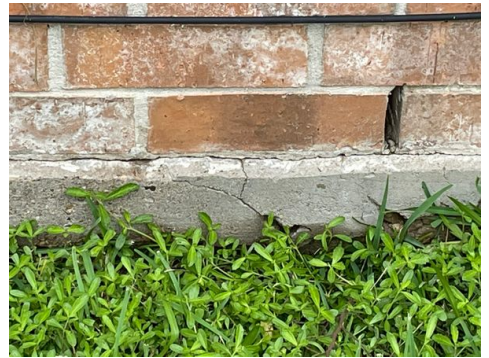
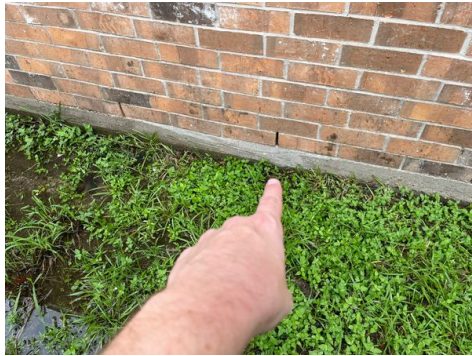
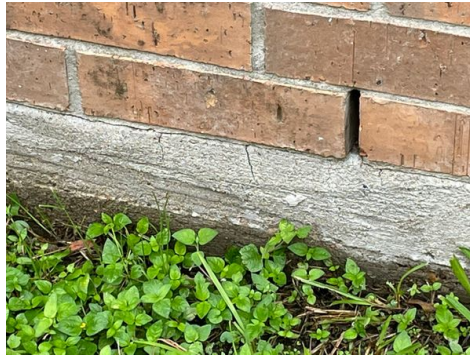
**FOUNDATION CRACKS - MINOR**

Minor cracking was noted at the foundation. This is common as concrete ages and shrinkage surface cracks are normal. Recommend monitoring for more serious shifting/displacement.

Recommendation  
Contact a foundation contractor.

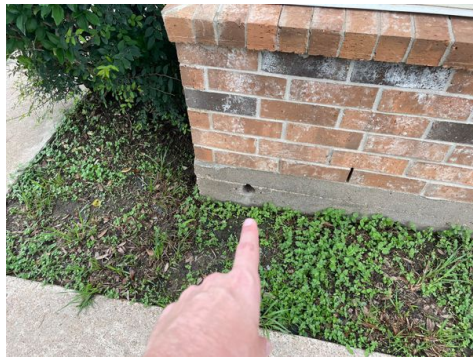
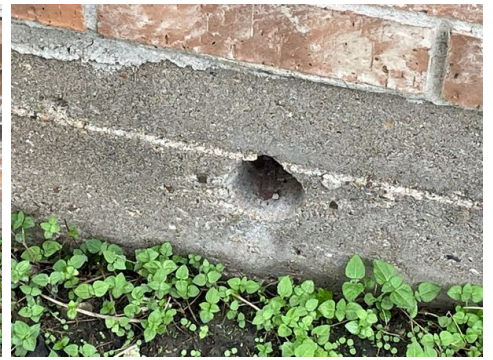
**EXPOSED REBAR**

Exposed rebar observed. Recommend filling with concrete filler. If left expose, future expansion of rebar will cause more cracking and spalling to concrete slab. Recommend sealing with masonry sealant or fresh concrete.

The corrosion cycle of steel begins with the rust expanding on the surface of the bar and causing cracking near the steel/concrete interface. As time marches on, the corrosion products build up and cause more extensive cracking until the concrete breaks away from the bar, eventually causing spalling.

Recommendation  
Contact a qualified professional.

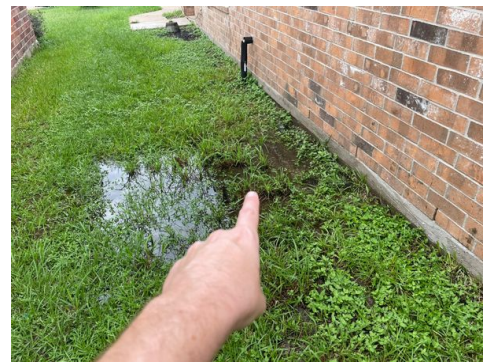
### 2.2.1 B. Grading and Drainage **STANDING WATER**

Standing water observed, which could indicate poor drainage and/or grading. Recommend monitor and/or have landscaper correct.

Recommendation  
Contact a qualified landscaping contractor

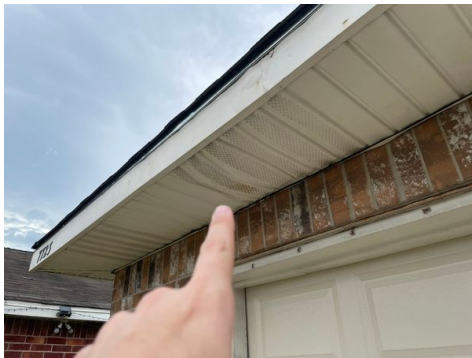
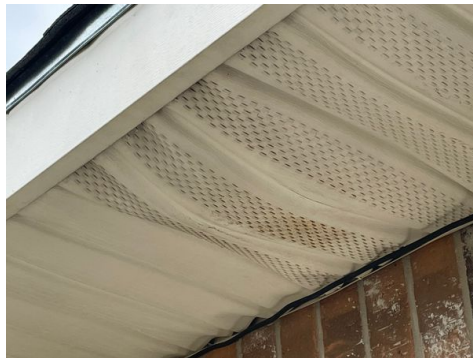
### 2.3.1 C. Roof Covering Materials **DAMAGED SOFFIT**

Observed area of soffit that was damaged. Recommend qualified contractor to evaluate and repair

Recommendation  
Contact a qualified professional.

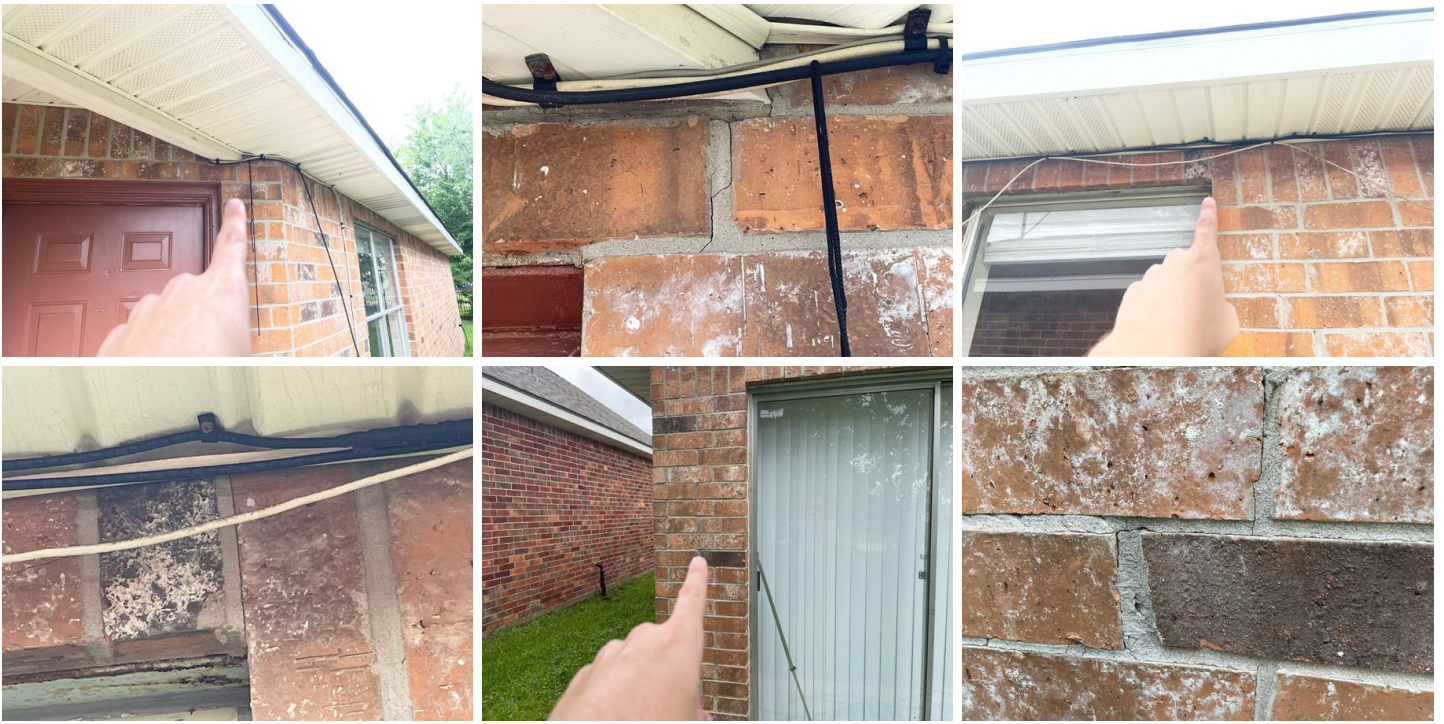
### 2.5.1 E. Walls (Interior and Exterior) **CRACKS, MINOR - EXTERIOR**

Minor cracking was observed on the exterior siding of the home. The cracks were located in common areas that are not likely to be structural in nature. Recommend monitoring, or if desired have a qualified contractor/or builder to repoint these areas.

Recommendation  
Contact a qualified siding specialist.

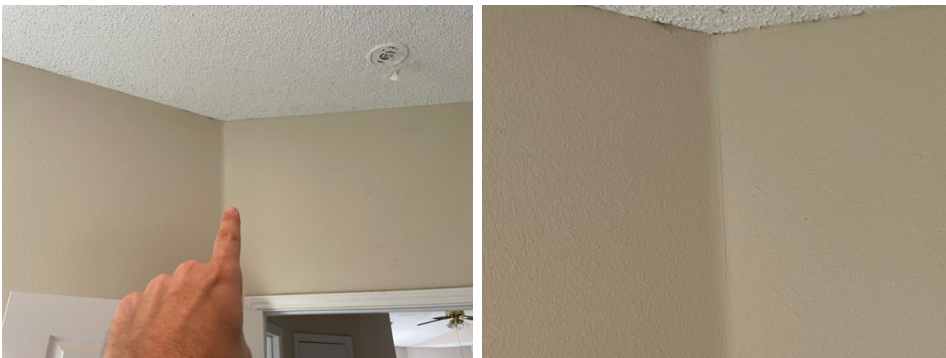
2.5.2 E. Walls (Interior and Exterior)  
**CRACKS, MINOR - INTERIOR**

Minor cracking was observed on the interior finish of the home. The cracks were located in common areas that are not likely to be structural in nature. Recommend monitoring, or if desired have a qualified contractor/or builder to refinish and repaint these areas.

Recommendation  
 Contact a qualified professional.

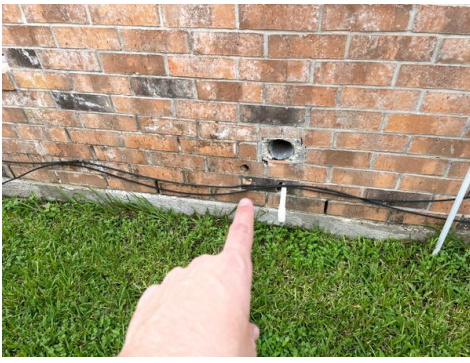
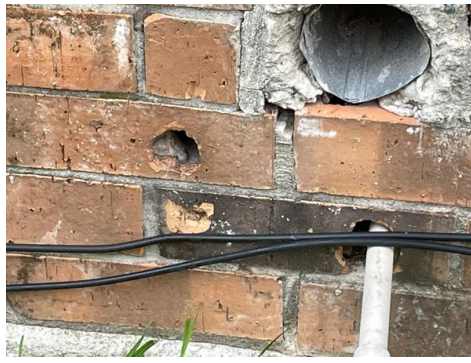
2.5.3 E. Walls (Interior and Exterior)  
**SEALING IMPROVEMENTS - EXTERIOR PENETRATIONS**

Observed areas of the exterior home that have gaps in need of being sealed or filled to Prevent damage to the wall cavity, pests from entering the building, and cool air from possibly freezing pipes. Recommend qualified contractor to reseal these areas

Recommendation  
 Contact a qualified professional.

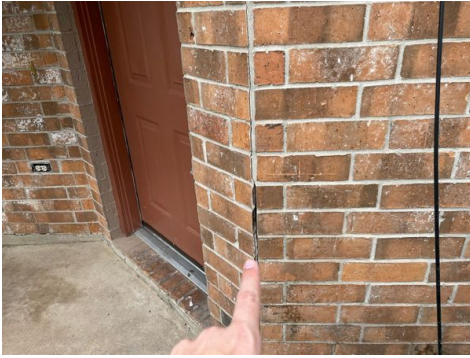
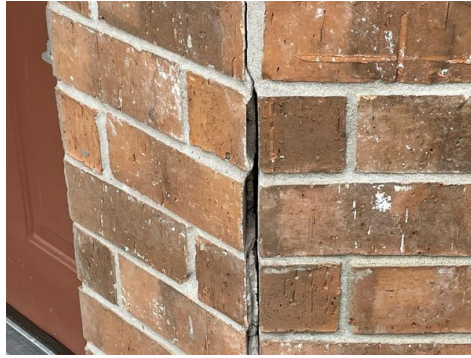
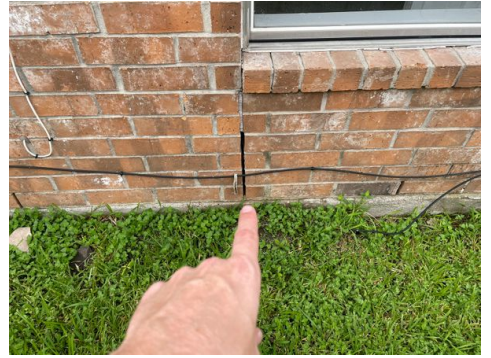
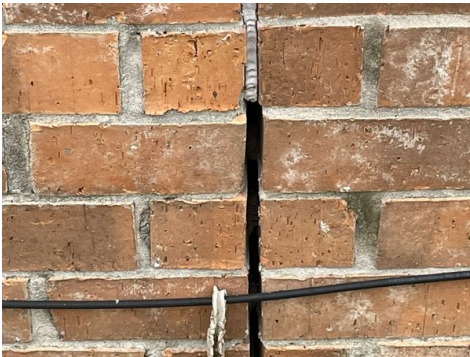
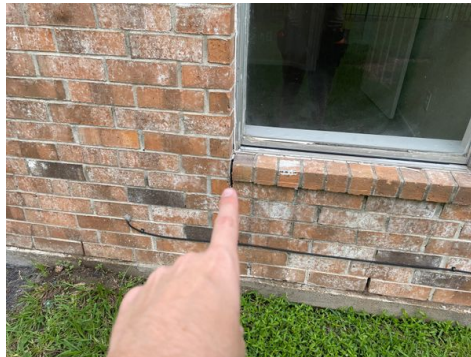
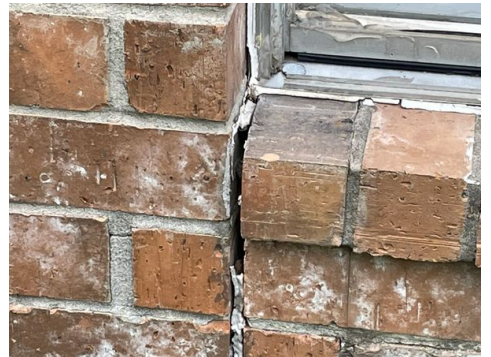
#### 2.5.4 E. Walls (Interior and Exterior) **MISSING MORTAR**

Observed areas of the exterior siding with missing mortar. This is a potential entry point for pests and moisture. Recommend qualified contractor to repair

Recommendation  
Contact a qualified professional.

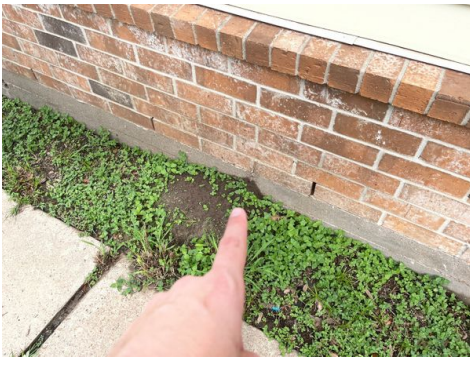
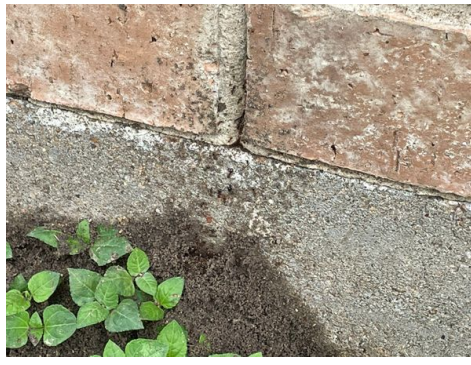
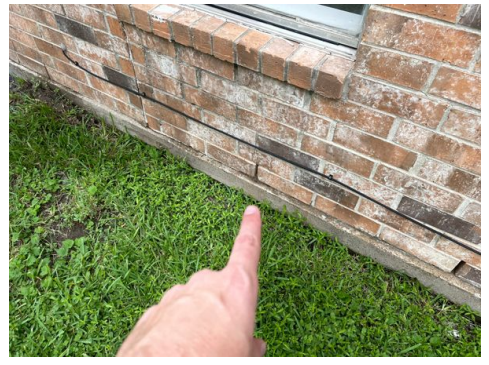
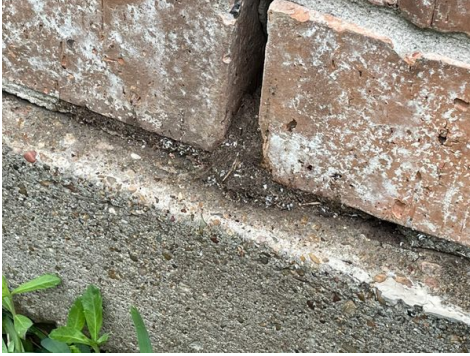
#### 2.5.5 E. Walls (Interior and Exterior) **RECOMMEND PEST CONTROL**

Observed areas of the exterior where what appeared to be ants entering the home. Recommend pest control.

Recommendation  
Contact a qualified professional.

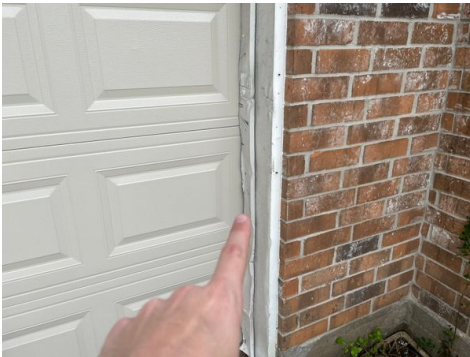
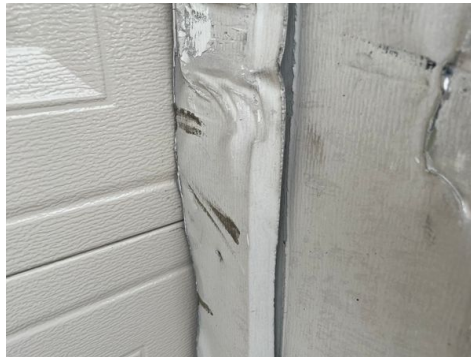
#### **EXTERIOR TRIM DAMAGE**

Observed areas of the exterior garage trim that were damaged. Such damage can reduce the trim's ability to ward off water from entering the wall structure. Recommend qualified contractor to repair

Contact a qualified professional.

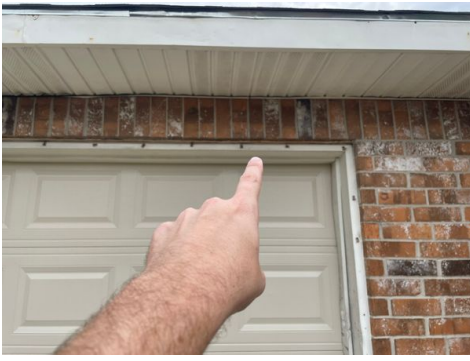
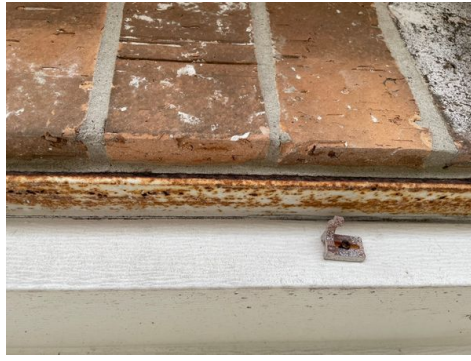
#### **RUSTED GARAGE LINTEL**

Observed lintel over garage that was rusted. This can cause cracking of the surrounding veneer and a loss of support of the masonry above. Recommend qualified contractor to evaluate and repair

Contact a qualified professional.

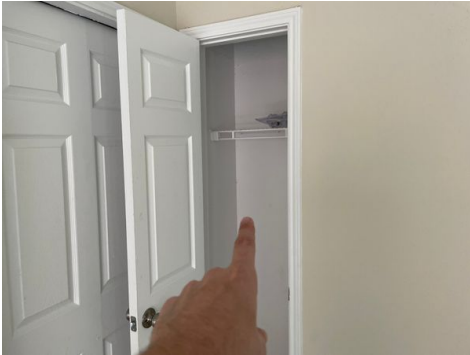
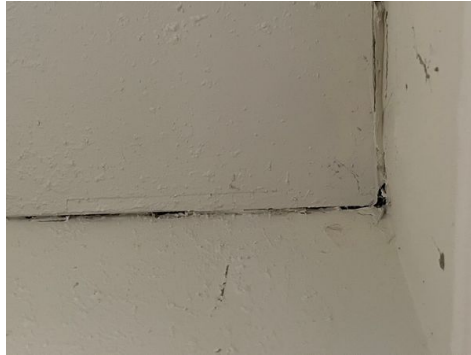
**SEALING IMPROVEMENTS-INTERIOR**

Observed areas of the interior in need of sealing to prevent pest entry and loss of conditioned air. Recommend qualified contractor to repair

Recommendation  
Contact a qualified professional.

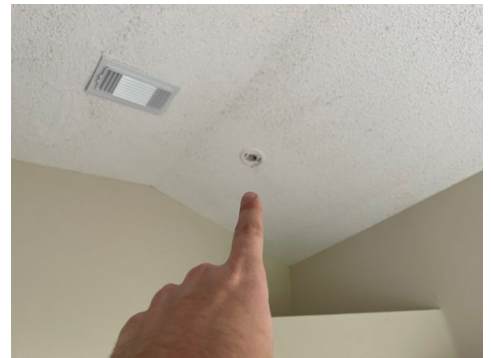
**SMOKE DETECTOR NOT PRESENT IN ROOMS**

The National Fire Protection Association recommends homes should have smoke alarms installed inside every bedroom, outside each sleeping area and on every level of the home

Recommendation  
Recommended DIY Project

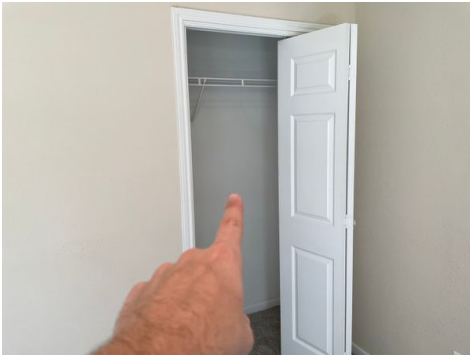
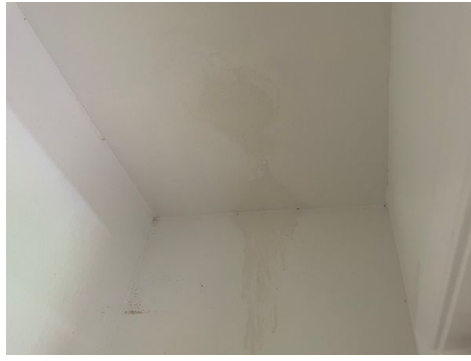
**STAIN ON CEILING**

Observed stain on ceiling in a bedroom closet. Moisture was active and likely from the melt water of the frozen line set. Recommend HVAC issue be resolved first and then having a qualified contractor to repair any water damage to the ceiling

Recommendation  
Contact a qualified professional.

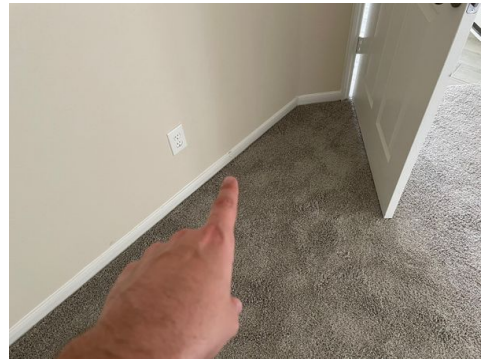
**MISSING DOOR STOPS**

Observe missing doorstops in one or more areas around home. Recommend installing doorstops on all doors lacking them

Recommendation  
Contact a qualified professional.

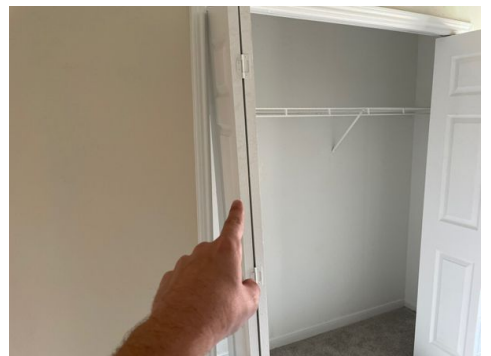
**CLOSET DOOR DETACHED**

Observed door to closet that was detached from the railing. Recommend qualified contractor for repair

Recommendation  
Contact a qualified professional.

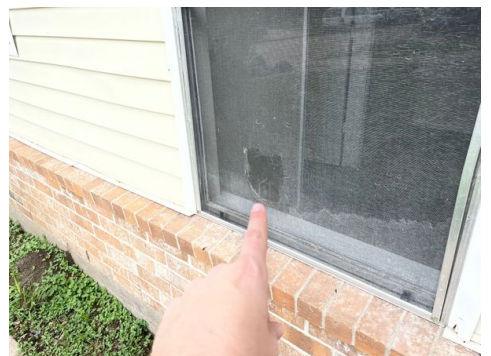
**DAMAGED SCREEN**

One or more window screens were observed to be damaged. Recommend replacement by a qualified contractor

Recommendation  
Contact a qualified professional.

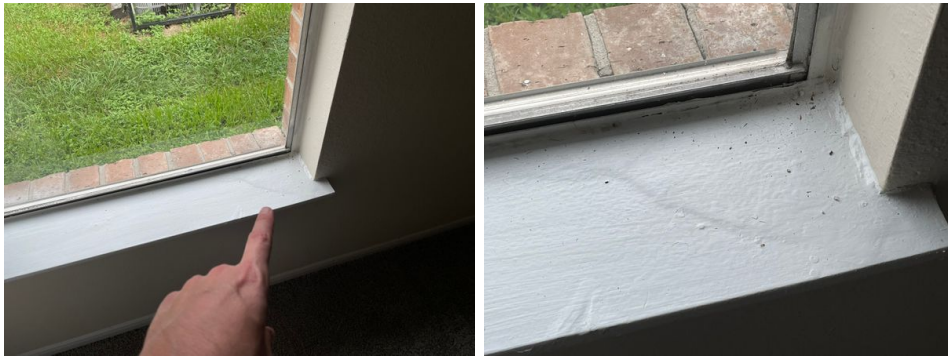
**MOISTURE DAMAGE AROUND WINDOW TRIM**

Observed moisture damage on most of the windows. Recommend qualified contractor to ensure all windows are properly sealed and then monitoring.

Recommendation  
Contact a qualified professional.

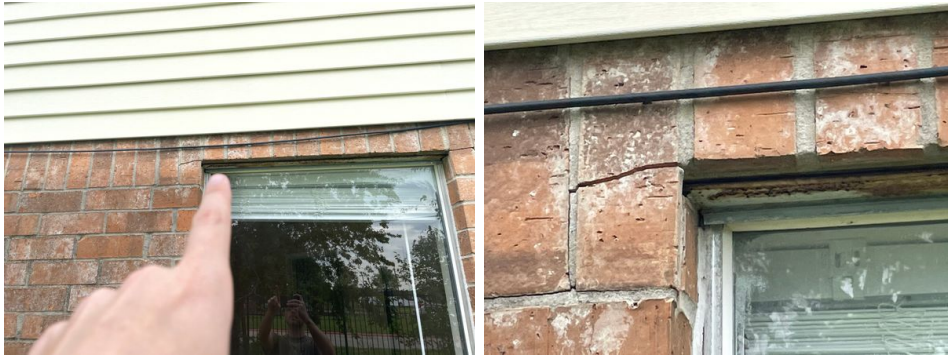
#### **RUSTED WINDOW LINTEL**

Observed Rusted door lintel exposed to water and moisture in one or more areas. Recommend sealing to prevent lintel from rusting out further and expanding causing issues in the future. Recommend properly sealing and monitoring .

Recommendation  
Contact a qualified professional.

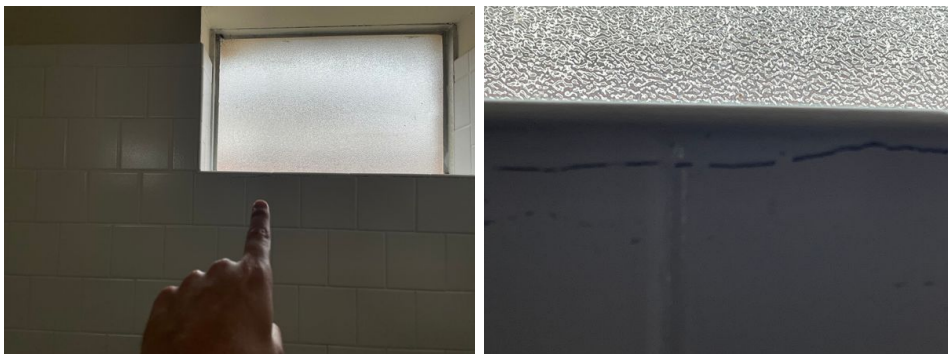
#### **MINOR CRACKING AROUND INTERIOR WINDOW TRIM**

Observed minor cracking around interior window trim. Recommend properly sealing or caulking and re-painting

Recommendation  
Contact a qualified professional.

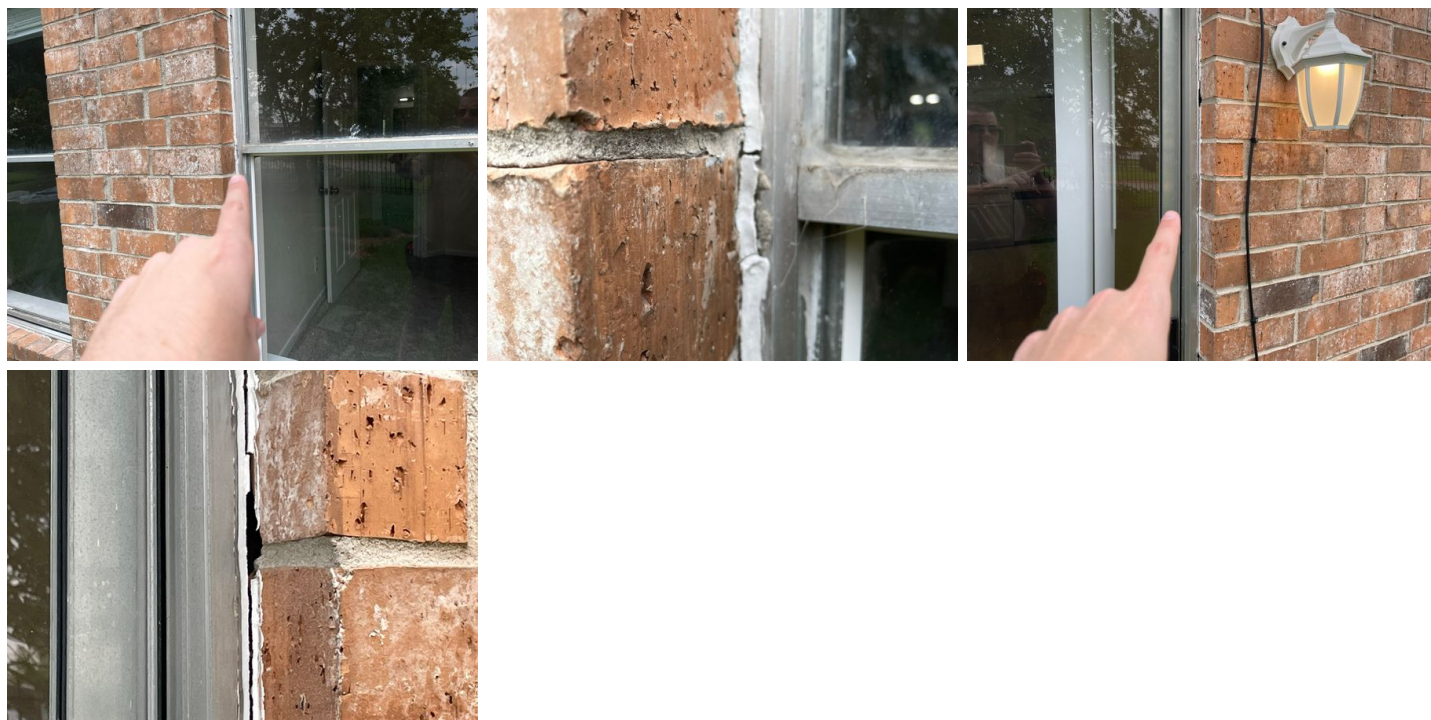
### CAULKING IMPROVEMENTS NEEDED

Observed caulking improvements needed around several windows. Caulking should be replaced every 5 years and monitored yearly. Recommend qualified contractor to repair

Contact a qualified professional.

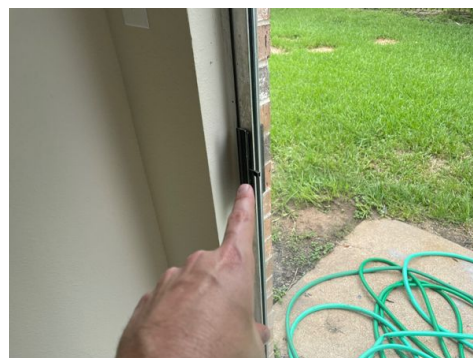
### SLIDING GLASS DOOR NOT LATCHING

Observed sliding glass door that would not latch preventing the door from being locked at the handle. Recommend qualified professional for repair

Contact a qualified professional.

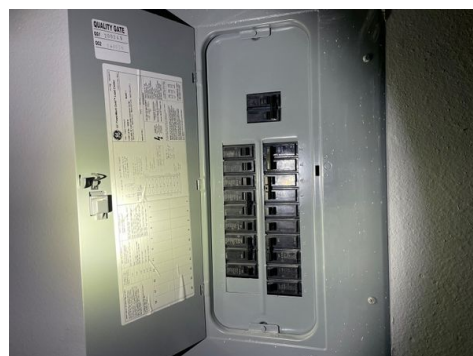
### MISSING OR FADED LABELS

Electrical panel does not have labels or labels are too faded to read. Recommend a qualified electrician test and properly label all switches.

Contact a qualified electrical contractor.

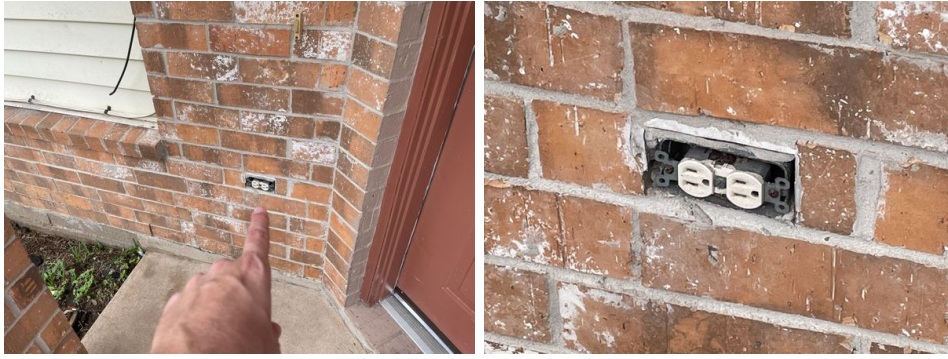
### COVER PLATES MISSING /DAMAGED

One or more receptacles have a damaged or missing cover plate. Recommend replacement.

Contact a qualified electrical contractor.

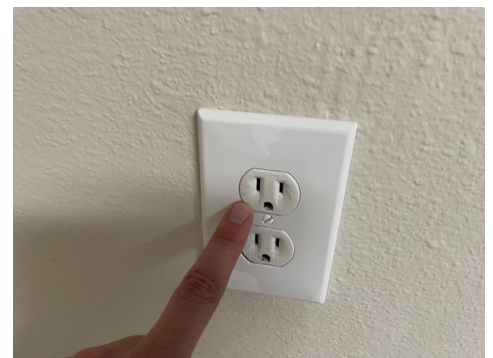
### OUTLETS PAINTED

Paint was observed on all outlets within the home. Any outlets (receptacles) that have been painted over or that have drywall mud on them should be replaced. They should be replaced for safety reasons. Recommend licensed electrician to further evaluate all wiring behind outlets and suggest a course of action.

Contact a qualified professional.

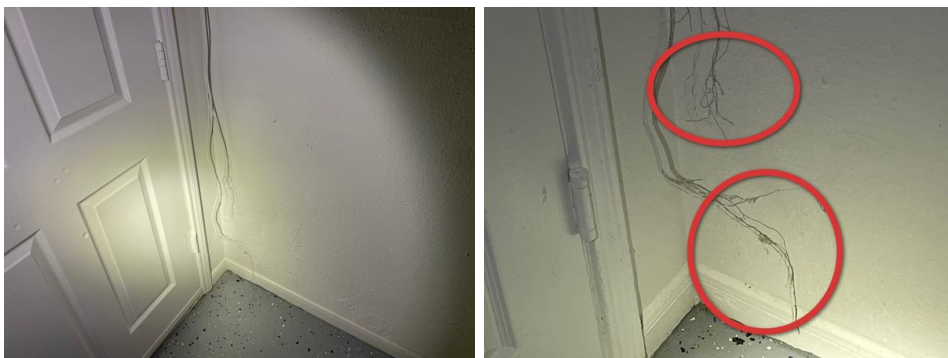
### EXPOSED ENDS & SPLICES

All wire connections & charged wires with exposed ends and splices should be covered in junction boxes for safety. Recommend a qualified electrician correct.

Contact a qualified electrical contractor.

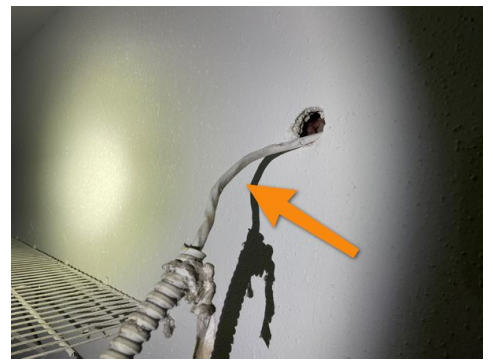
### CONDUCTOR NOT PROTECTED AT WALL PENETRATION

Observed conductor for water heater whose conduit does not extend through the wall. Recommend qualified electrician to install conduit that extends through the wall to protect the conductor from damage

Recommendation  
Contact a qualified professional.

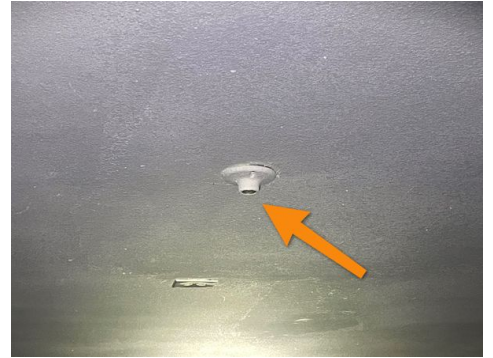
### MISSING LIGHT BULBS

Observed that many of the light fixtures in the home were missing bulbs, preventing verification of their operability. Recommend installing light bulbs on all fixtures lacking them

Recommendation  
Contact a qualified professional.

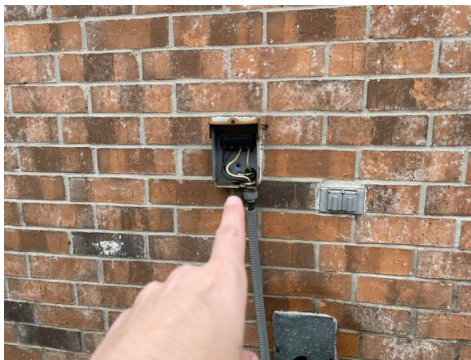
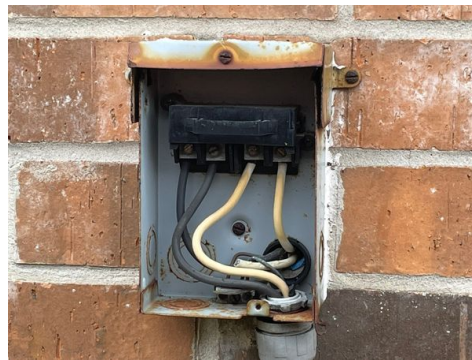
### NO COVER ON EMERGENCY DISCONNECT

Observed lack of cover on AC condenser emergency disconnect. This leaves the wiring and components exposed to the elements. Recommend qualified electrician to install cover

Recommendation  
Contact a qualified professional.

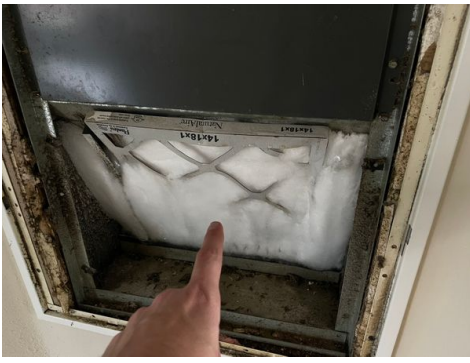
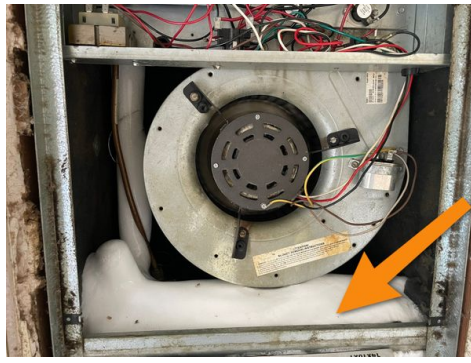
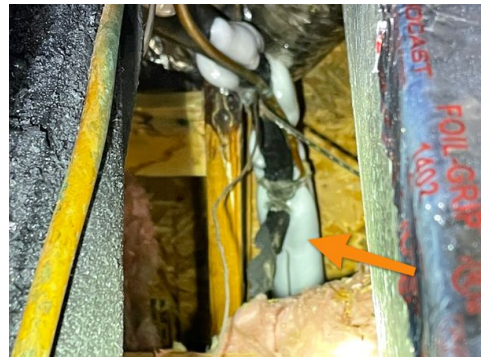
### SYSTEM FROZEN

Observed many of components in the furnace to be frozen solid. Recommend qualified HVAC technician to evaluate and repair IMMEDIATELY

Recommendation  
Contact a qualified professional.

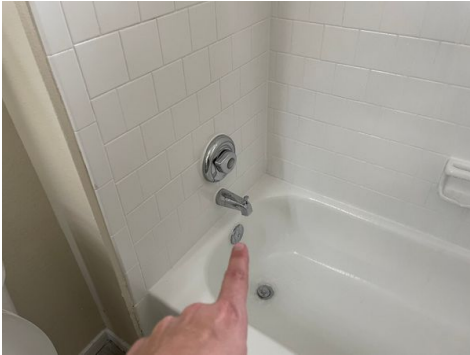
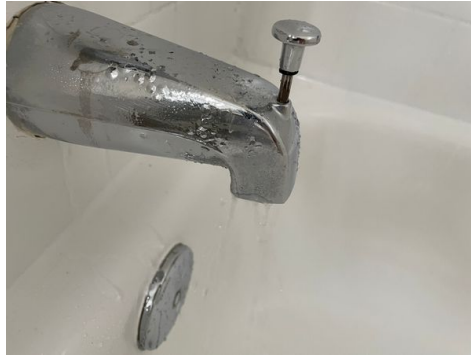
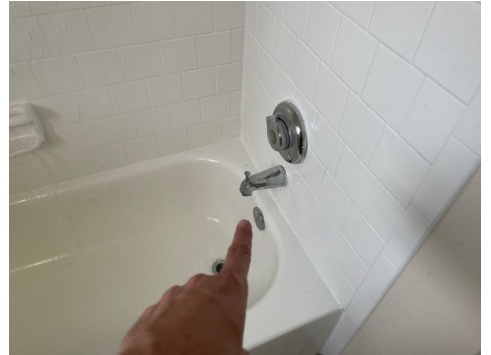
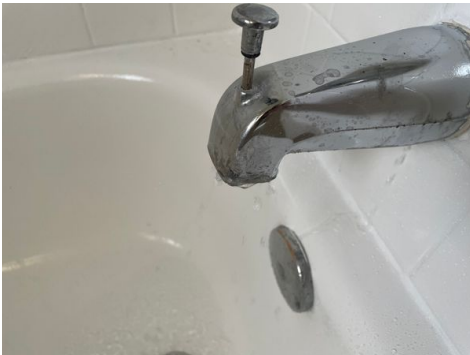
5.1.1 A. Plumbing Supply, Distribution Systems, and Fixtures  
**FAULTY SHOWER DIVERTER**

Observed shower diverter that would not fully direct water to showerhead, causing a loss of pressure for the shower. Recommend qualified plumber for repair

Recommendation  
Contact a qualified professional.

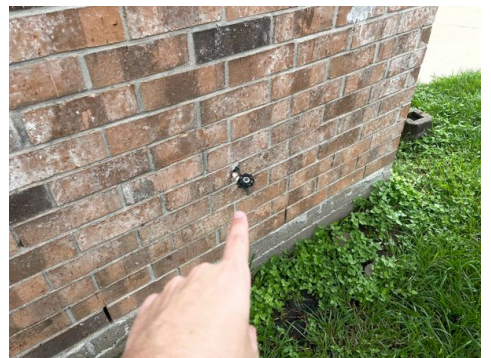
5.1.2 A. Plumbing Supply, Distribution Systems, and Fixtures  
**NO WATER AT FIXTURE**

Observed hose bib with no running water. Recommend qualified plumber to repair

Recommendation  
Contact a qualified professional.

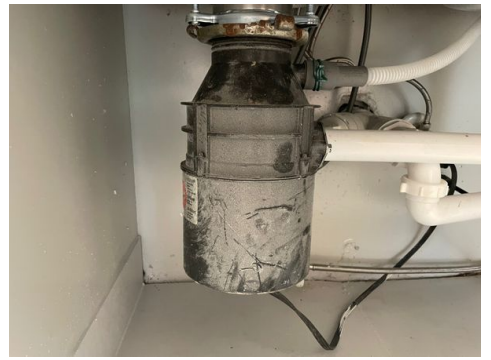
**INOPERABLE**

Garbage disposal was inoperable at the time of inspection.  
Recommend qualified handyman repair.

Recommendation  
Contact a qualified handyman.

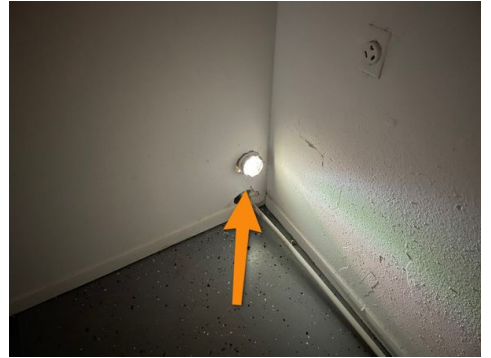
**NO CAP ON VENT**

Observed unused dryer vent that was not capped which is an entry point for pests. Recommend this installing cap on dryer vent until dryer is installed

Recommendation  
Contact a qualified professional.
