Inspection Report

Property Address: 2934 Junction Dr Houston Tx 77045

Steven Bradfute 21353 701 N Loop 336 E, Suite 101 Conroe, Tx 77301 (281) 782-7451

PROPERTY INSPECTION REPORT

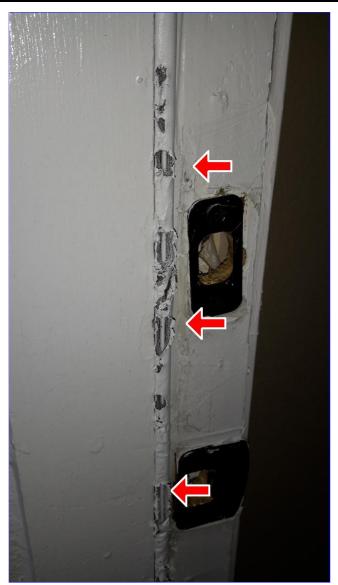
G. Item 1(Picture)

(1) The main entry door damaged at weather-stripping. This can cause some heat loss in winter and loss of cool air in summer if not corrected. A qualified contractor should inspect and repair as needed.

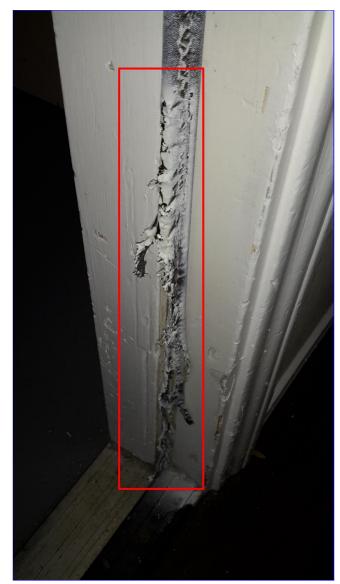
G. Item 2(Picture)

(2) The garage fire door is damaged at weather-stripping. This can cause some heat loss in winter and loss of cool air in summer if not corrected. A qualified contractor should inspect and repair as needed.

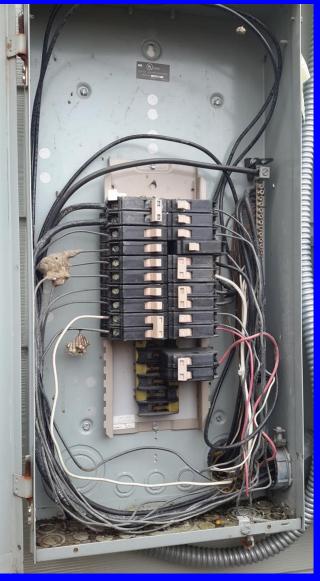
Jnderground electrical service entrance and electrical panel located on the right side of the home

inside the electrical pane

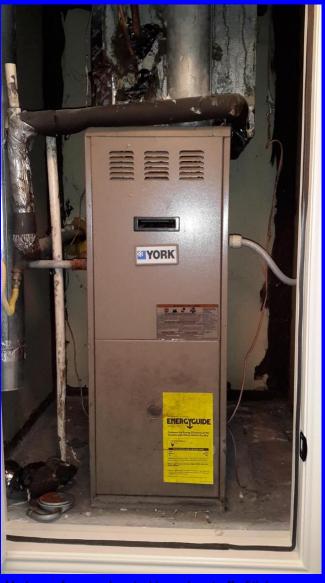
York gas furnace located in a closet off of living room

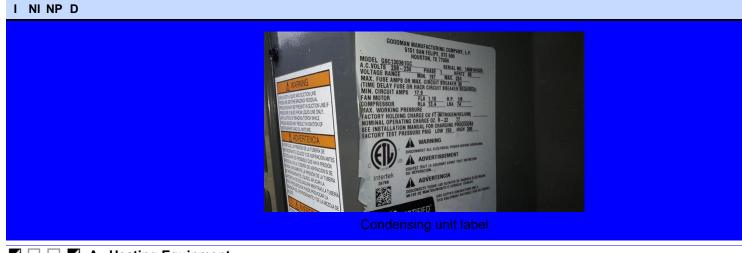
Goodman condensing unit located on the rear of the home

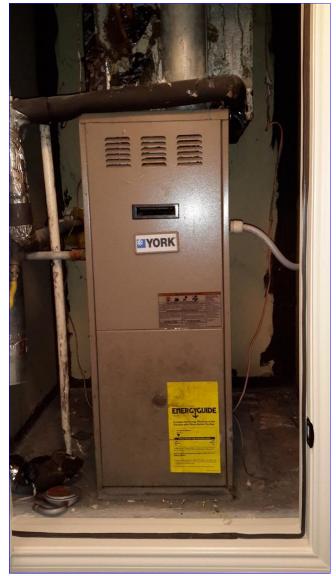
A. Item 1(Picture)

(2) The gas furnace is nonfunctional. Will not heat. Recommend having a licensed HVAC technician inspect and make all necessary repairs.

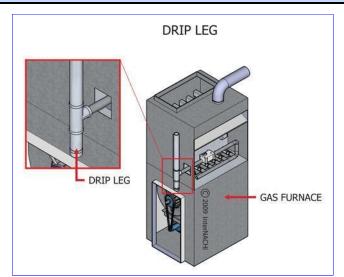
A. Item 2(Picture) dripleg

(3) The gas furnace is installed without the recommended sediment trap or "drip leg" that is designed to extend the life of the unit. This is not considered to be today's standard. I recommend having a qualified person make repairs as needed.

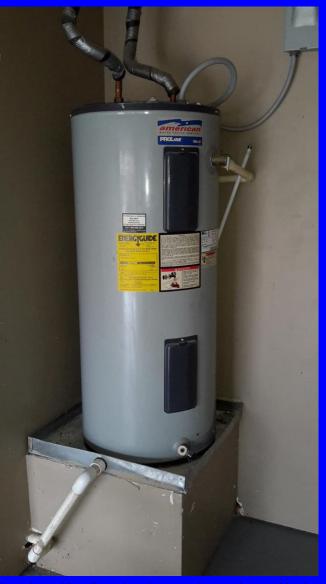
American 40 gallon electric water heater located in the garage
