McShan Home Inspections

INSPECTED FOR
Brenda Townsley
110 Dove Ridge St
Palestine, TX 75801
September 7, 2022

PROPERTY INSPECTION REPORT FORM

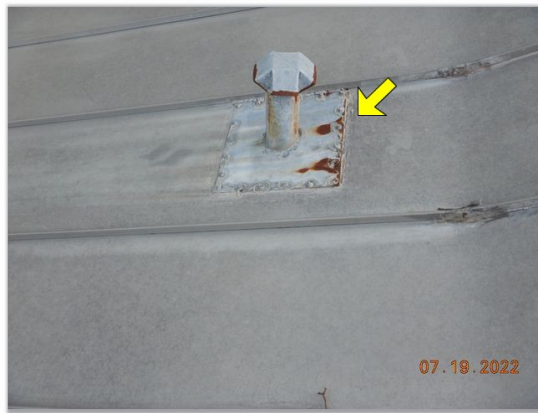
The main structure roof is in generally Good condition.

FYI...You will need to seal around the vent and front and back of structure every few years, to ensure no water penetration into structure FYI...Owner stated they have the vents sealed.

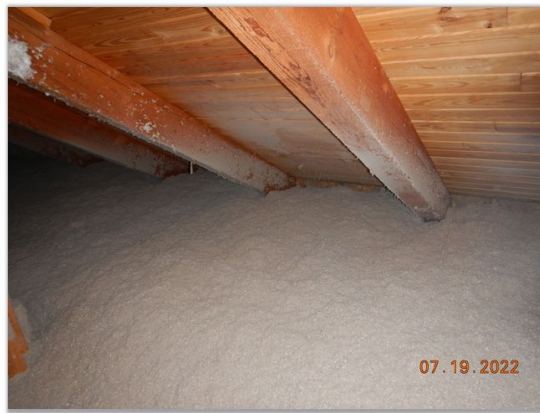
Attic Insulation

Insufficient Insulation. (9-10" Minimum Insulation depth in the attic recommended). Recommend installing blown cellulose insulation. Additional Insulation is recommended. 6 to 8 inches of insulation in attic

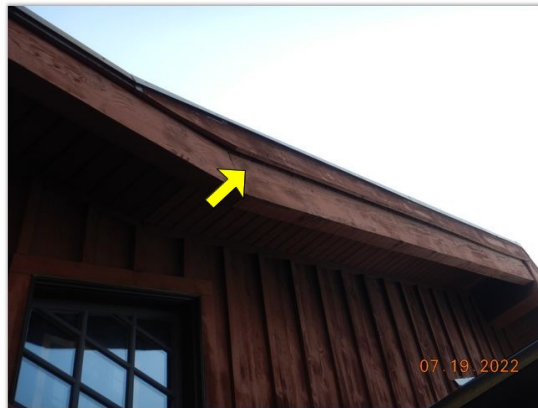
There is some loose trim-- Side of house Recommend reattaching, caulking and repairs as necessary to prevent water penetration and damage to the structure.

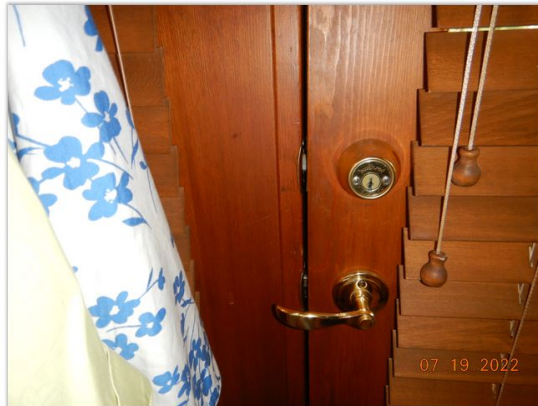
Safety concern using keys on inside of home to lock and unlock dead bolt locks, this could slow your exit down when or if an emergency occurred. recommend replacement of dead bolts

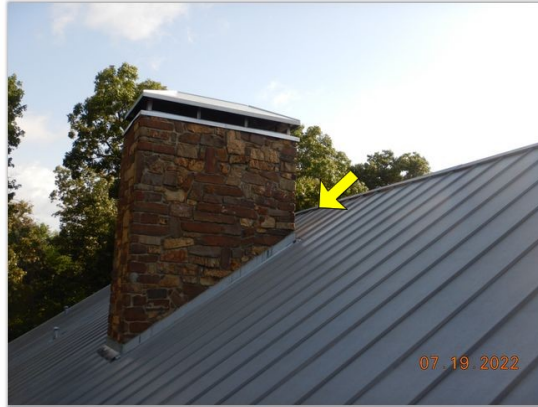
The fireplace chimney does not have a cricket. (sloped roof at the back of the chimney to prevent damming of water behind the chimney) Current Building Practices require a cricket when the chimney is over 30 inches wide. Recommend installing a cricket when reroofing. In the short term monitoring and spot repairs should be done to prevent water penetration.

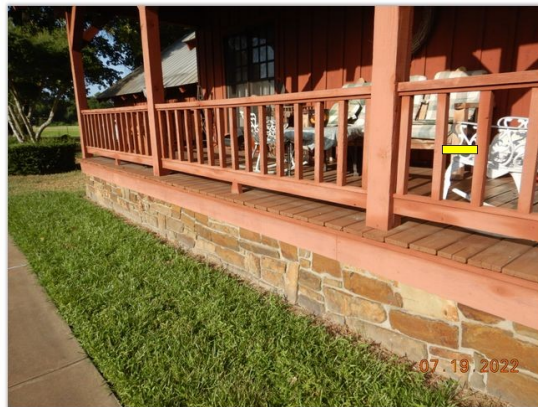
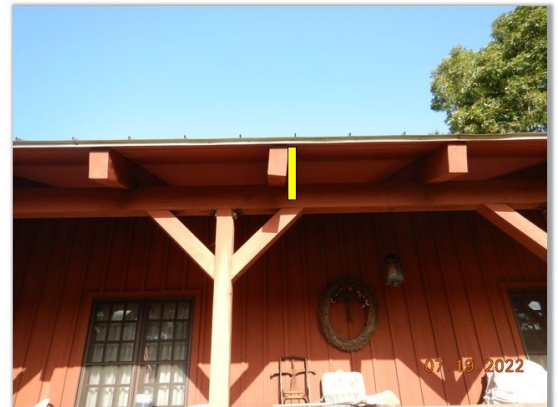
The openings in the railing are large enough to allow an object of 4 inches in diameter to fall through. Recommend Repair.

Twisted beam at front of structure this is a cosmetic issue

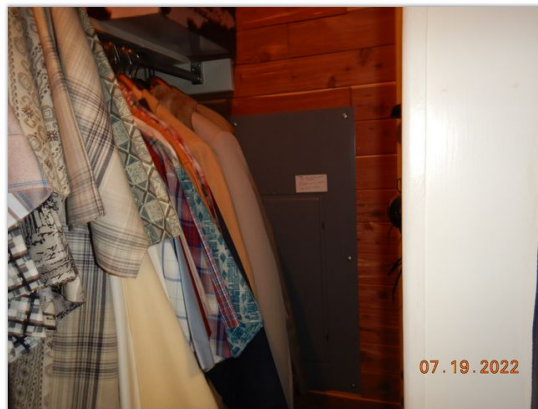
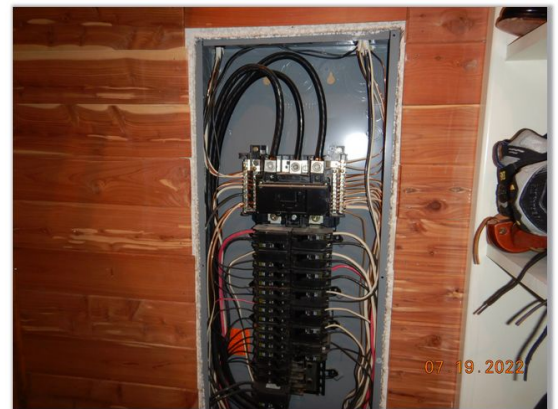
Box Location: Master bedroom clothes closet

The panel box is not located in an appropriate location Bedroom clothes closet. Current building standards do not allow panel boxes to be placed in this area. [Texas Real Estate Standards of Practice now require this item to be marked as deficient.if not present](#)

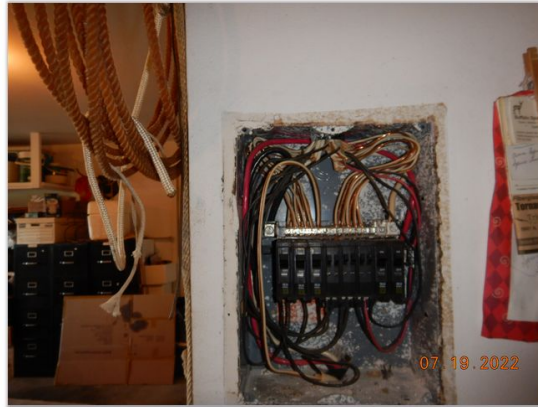
Box Location: Garage Interior

All sub-Panels require a 4 wire system, two hot wires one neutral and a ground wire. The ground wires and neutral wires have to be separated. The ground wires on the ground bus bar can have two wires in each hole, but the neutral bus bar can only have one wire in each hole. I recommend a qualified electrician correct as required. [Texas Real Estate Standards of Practice now require this item to be marked as deficient.if not present](#)

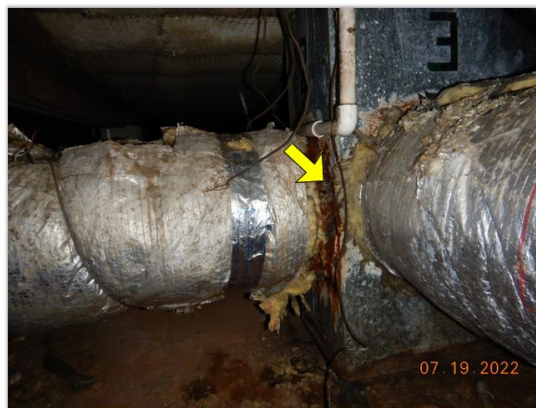
Rust at the/plenum in crawl space, recommend further evaluation and repair if needed

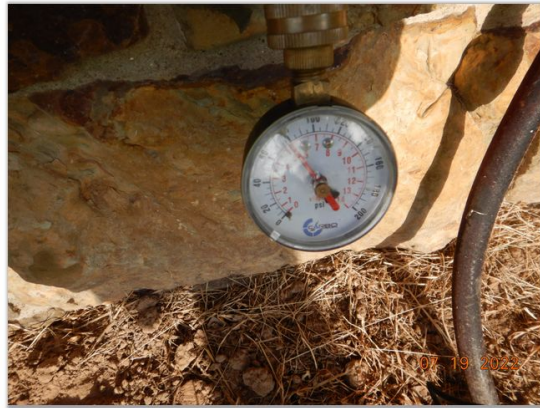
Supply piping

All components were found to be performing and in satisfactory condition on the day of the inspection

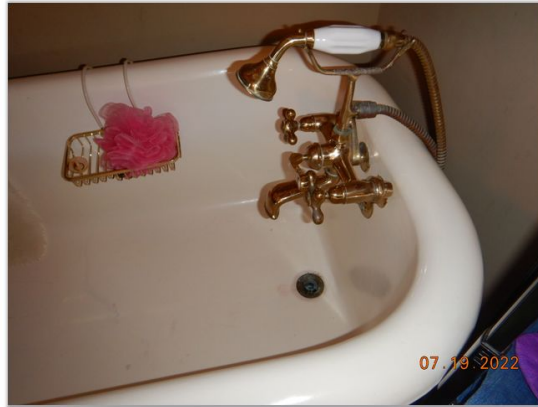
Master Bathroom

The bathtub faucet was found to have a small leak

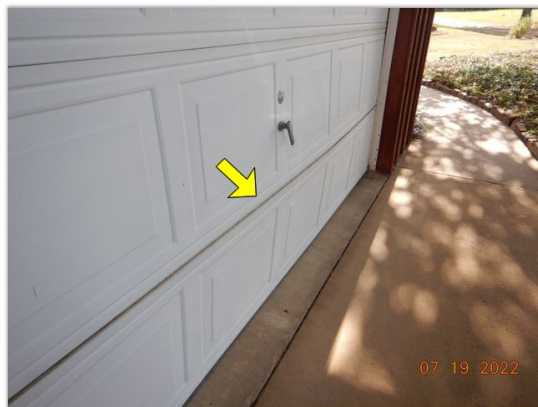
The garage door is damaged. Recommend repair or replacement.
