# FRANCIS HOME INSPECTIONS, PLLC TREC #24926

3107 Snug Harbour Ct  
Katy, TX 77449

# PROPERTY INSPECTION REPORT FORM

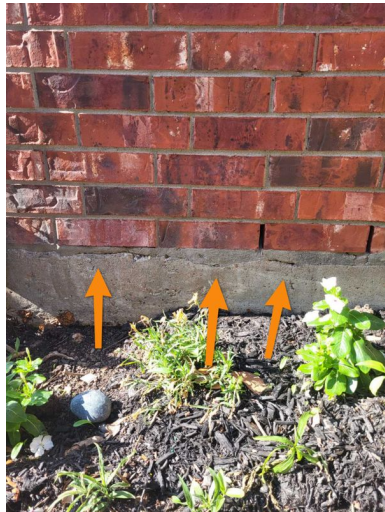
Front entry

### 1: Foundation Cracks - Minor

Minor cracking was noted at the foundation. This is common as concrete ages and shrinkage surface cracks are normal. Recommend monitoring for more serious shifting/displacement.

Recommendation: Recommend monitoring.

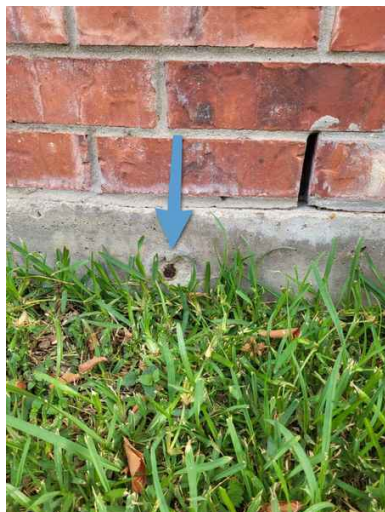
South exterior foundation

Post-tensioned cables exposed due to missing mortar. As cables are exposed to moisture they will rust which causes expansion and eventual corrosion to the cable. Recommend a handyman or DIY

Recommendation: Contact a handyman or DIY project

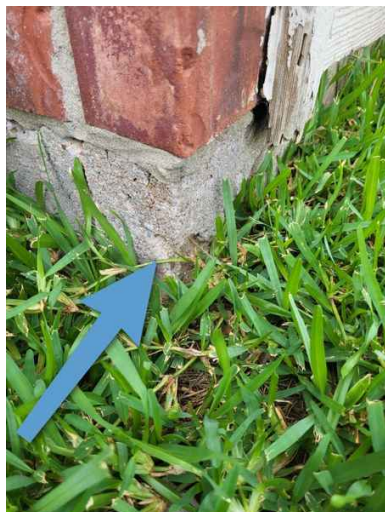
West corner/backyard

### 3: FOUNDATION CRACKS-CORNER POPS

Foundation corner crack(s) observed. Recommend monitoring cracks for future movement as foundation settles.

CORNER WEDGE CRACK

Recommendation: Recommend monitoring.

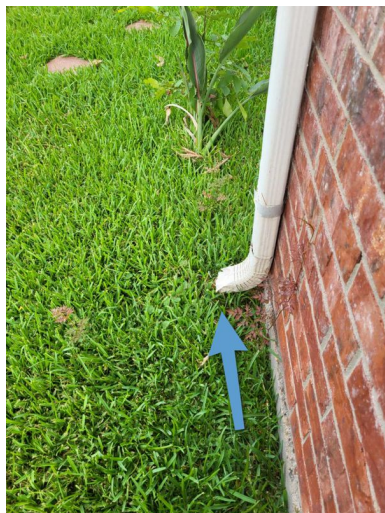
South corner/backyard

**2: SPLASH BLOCK-MISSING**

Observed missing splash blocks at gutter downspouts. Recommend installing splash blocks to prevent possible localized erosion in soil under the foundation.

Recommendation: Contact a handyman or DIY project

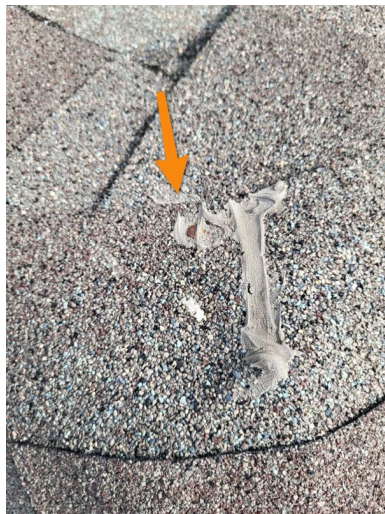
Several exposed roofing nails were noted on the roof. Recommend all exposed nail heads are properly sealed to mitigate potential nail rust/corrosion and roof leaks.

Recommendation: Contact a qualified roofing professional.

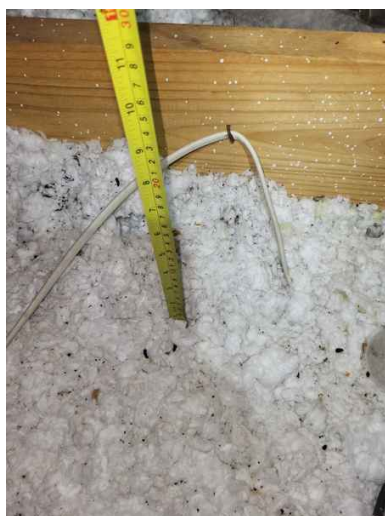
Insulation depth was inadequate. Recommend a qualified attic insulation contractor install additional insulation.

Recommendation: Contact a qualified insulation contractor.

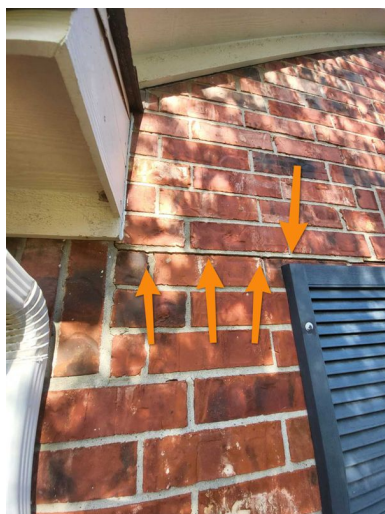
East side(front) of home

**1: Cracks - Minor**

Minor cracking was observed in wall structure. This is common in homes this age. Recommend monitoring and/or having cracks sealed or caulked.

Recommendation: Contact a qualified professional.

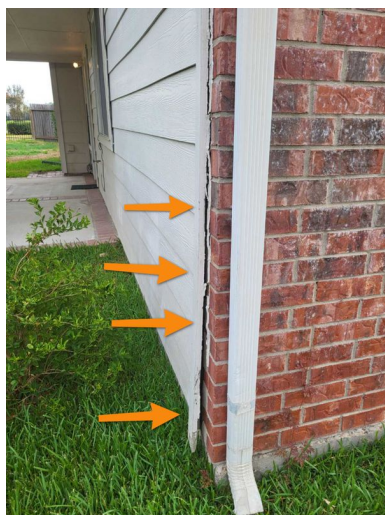
South corner/backyard

**2: DAMAGED SIDING/TRIM**

Observed damaged siding/trim on one or more exterior wall surfaces. Repairing will help prevent potential moisture and/or pest intrusion

Recommendation: Contact a qualified professional.

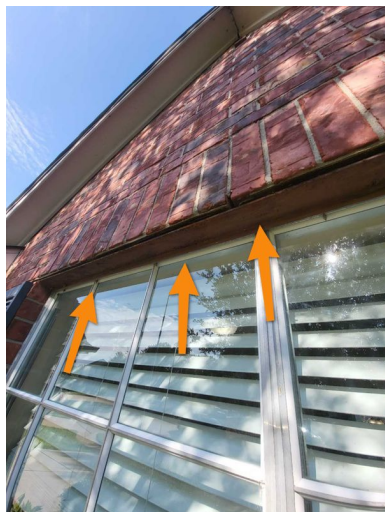
East side(front) of home

### 4: RUSTED/EXPOSED LINTELS

Observed exposed and rust on lintels above windows/doors on exterior wall. Rusting of lintels cause expansion of the steel which may cause further damage to exterior wall structure.

Recommendation: Contact a qualified professional.

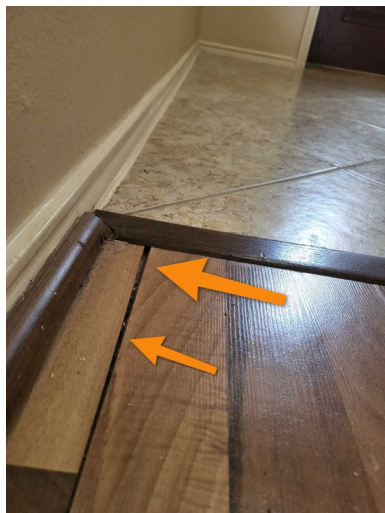
**1: Flooring - Damaged**

The home flooring had general moderate damage visible at the time of the inspection. Recommend evaluation by a qualified flooring contractor.

Floor sounds hollow in area near oven

Recommendation: Contact a qualified professional.

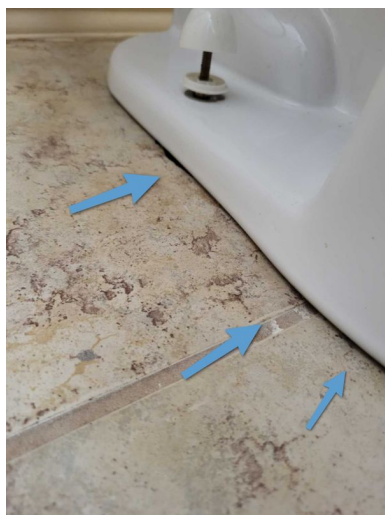
Toilet master bath

**2: MISSING CAULK - FLOOR/TILE AREA**

Missing caulk between base trim and tile/vinyl flooring allowing cleaning water and normal spillage to wick into the unpainted bottom of trim.

Recommendation: Contact a qualified professional.

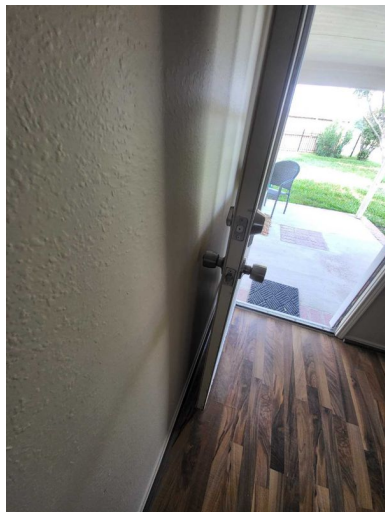
Back door

**1: MISSING DOORSTOP**

Observed missing doorstops in one or more locations.

Recommendation: Contact a handyman or DIY project

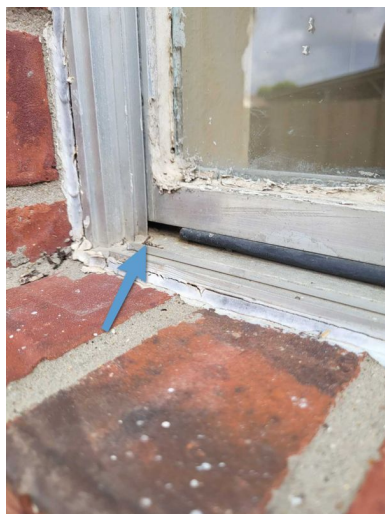
South exterior window

Observation of caulk shrinkage on the exterior of windows allows for the possibility of water penetration. Recommend a qualified professional for further evaluation.

Recommendation: Contact a handyman or DIY project

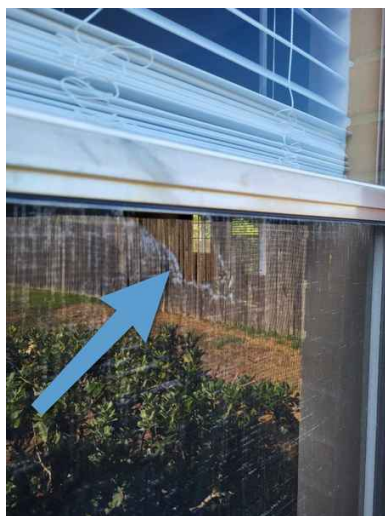
North side of home

**2: MISSING/DAMAGED SCREEN(S)**

Observed one or more windows with damaged or missing window screens.

Recommendation: Contact a qualified window repair/installation contractor.

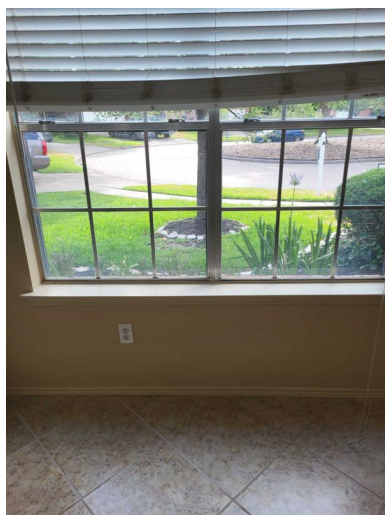
Kitchen windows

Several windows in the home were difficult to open/close. This issue commonly happens when windows are not used and/or serviced on a regular basis. Recommend a window professional inspect, clean, lubricate & adjust/repair windows as necessary.

Recommendation: Contact a qualified window repair/installation contractor.

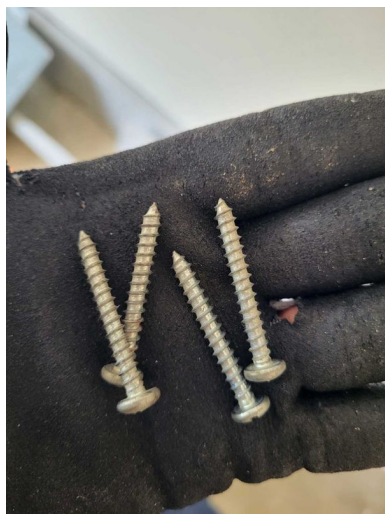
## 2: IMPROPER SCREWS ON DEAD FRONT COVER

Dead front cover had an unapproved screw installed, which prevented removal of the dead front for further inspection. Recommend further evaluation by a qualified electrician. Sharp-pointed metal screws should not be used. These are a potential hazard as they may puncture wire insulation and electrify panel box, becoming a shock or electrocution hazard. These screws should be replaced with approved, flat-tipped screws.

Recommendation: Contact a qualified electrical contractor.

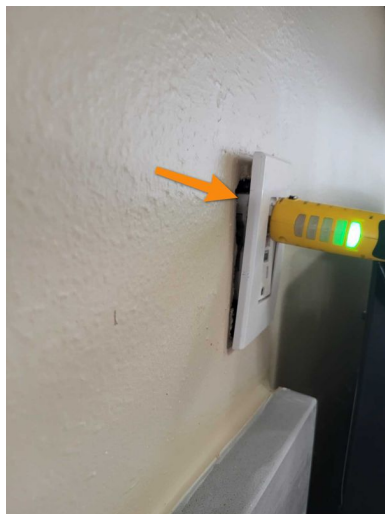
Kitchen counter

**2: LOOSE OUTLET**

Observed loosely fastened outlets. Outlets loosen because they're attached to an electrical box that's installed too far back into the wall. Electrical boxes that are too far back aren't secure enough, which affects the stability of the entire fixture. That instability could bump or joist wires loose, creating even more major problems. Loose, damaged, or disconnected wires are shock hazards and could lead to sparks, fires and other electrical hazards.

Recommendation: Contact a qualified electrical contractor.

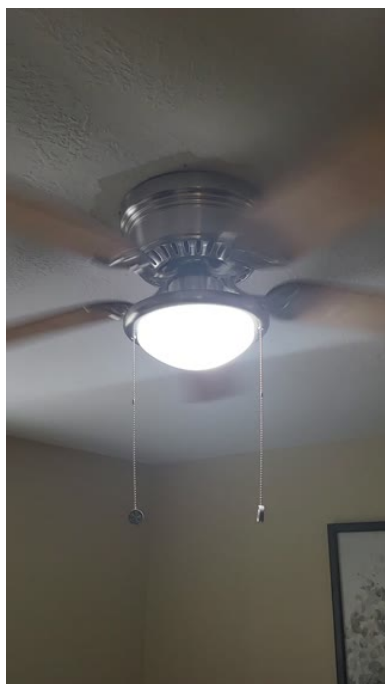
Ceiling fan in master bedroom made more noise during operation than normal. Fan may not have been properly installed. Recommend further evaluation by a qualified professional.

Recommendation: Contact a handyman or DIY project

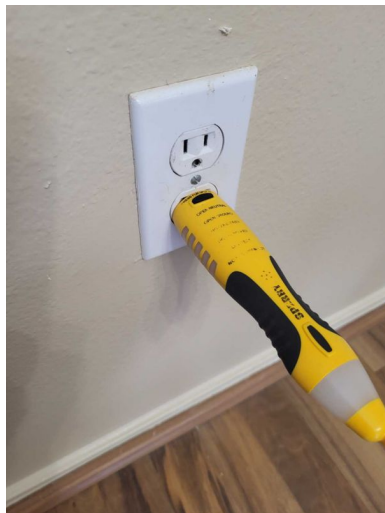
Bar/behind sink

Outlet at bar was inoperable at the time of inspection

Recommendation: Contact a qualified professional.

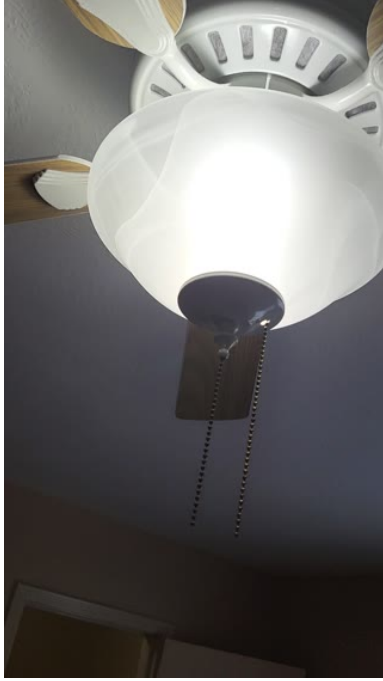
**7: Ceiling fan inoperable/missing remote**

One or more ceiling fans were inoperable missing remotes. This can hinder operation of ceiling fans, sometimes requiring replacement. Recommend replacement of a compatible remote, and/or further evaluation by a qualified professional.

Recommendation: Contact a qualified professional.

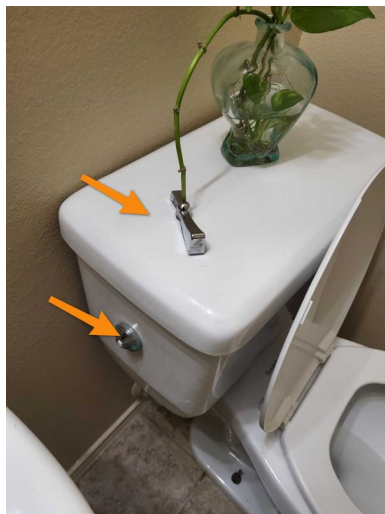
Half bath

**1: Improper Installation**

Fixtures were installed improperly. Recommend a qualified handyman or plumber evaluate and repair.

Recommendation: Contact a qualified plumbing contractor.

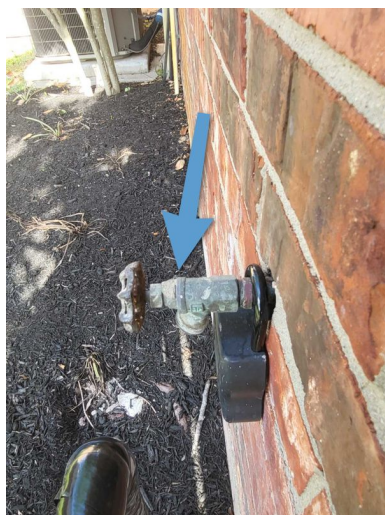
South side of home

**2: MISSING INSULATION**

Observed missing insulation on one or more exterior plumbing fixtures.

Recommendation: Contact a handyman or DIY project

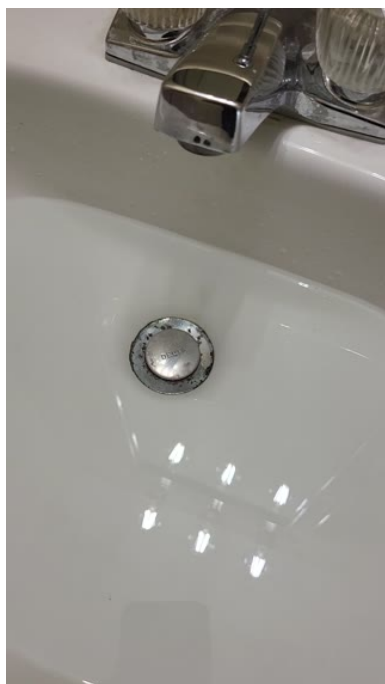
Half bath

Sink stopper not adequately seating or functioning properly in drain orifice.

Recommendation: Contact a handyman or DIY project

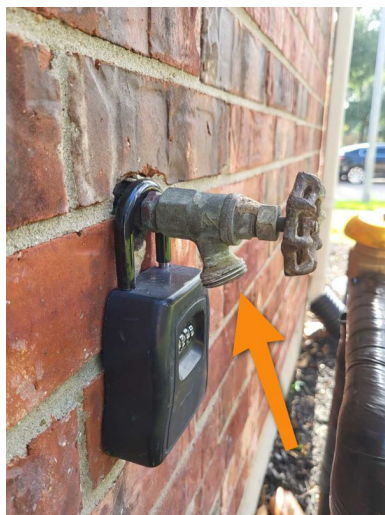
South side of home

### 4: Missing backflow preventor

Recommendation: Contact a qualified professional.

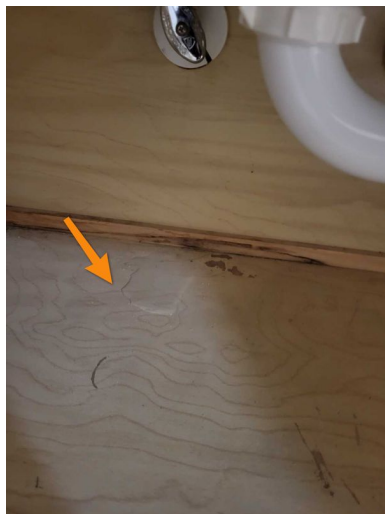
Master bathroom sink

At the time of inspection there was a leak at the 1st sink in master bathroom

Recommendation: Contact a qualified plumbing contractor.

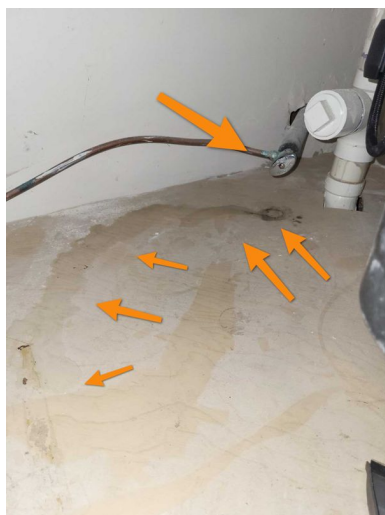
At the time of inspection, dishwasher leaked at water turn on valve.

Leaking at water shut off

Recommendation: Contact a qualified plumbing contractor.

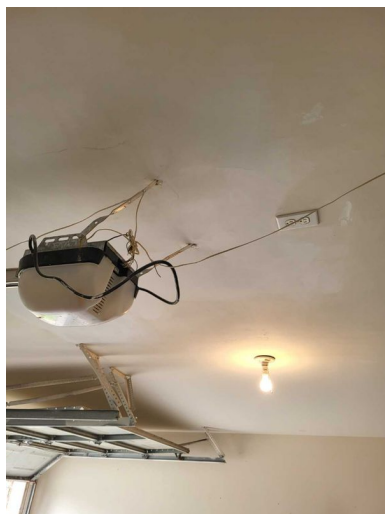
Automatic garage door inoperable at the time of inspection. It's installed but not plugged in.

Recommendation: Contact a qualified garage door contractor.
