Desktop Review for a 6.48-acre site located at the West End of Galveston Island, near San Luis Pass. This site is on Galveston Island. The Galveston CAD shows the present owner of this site is Marc M. Britton. The legal description is: Abstract 121 Hall & Jones Survey Tract 10-1. The ID is 370263.

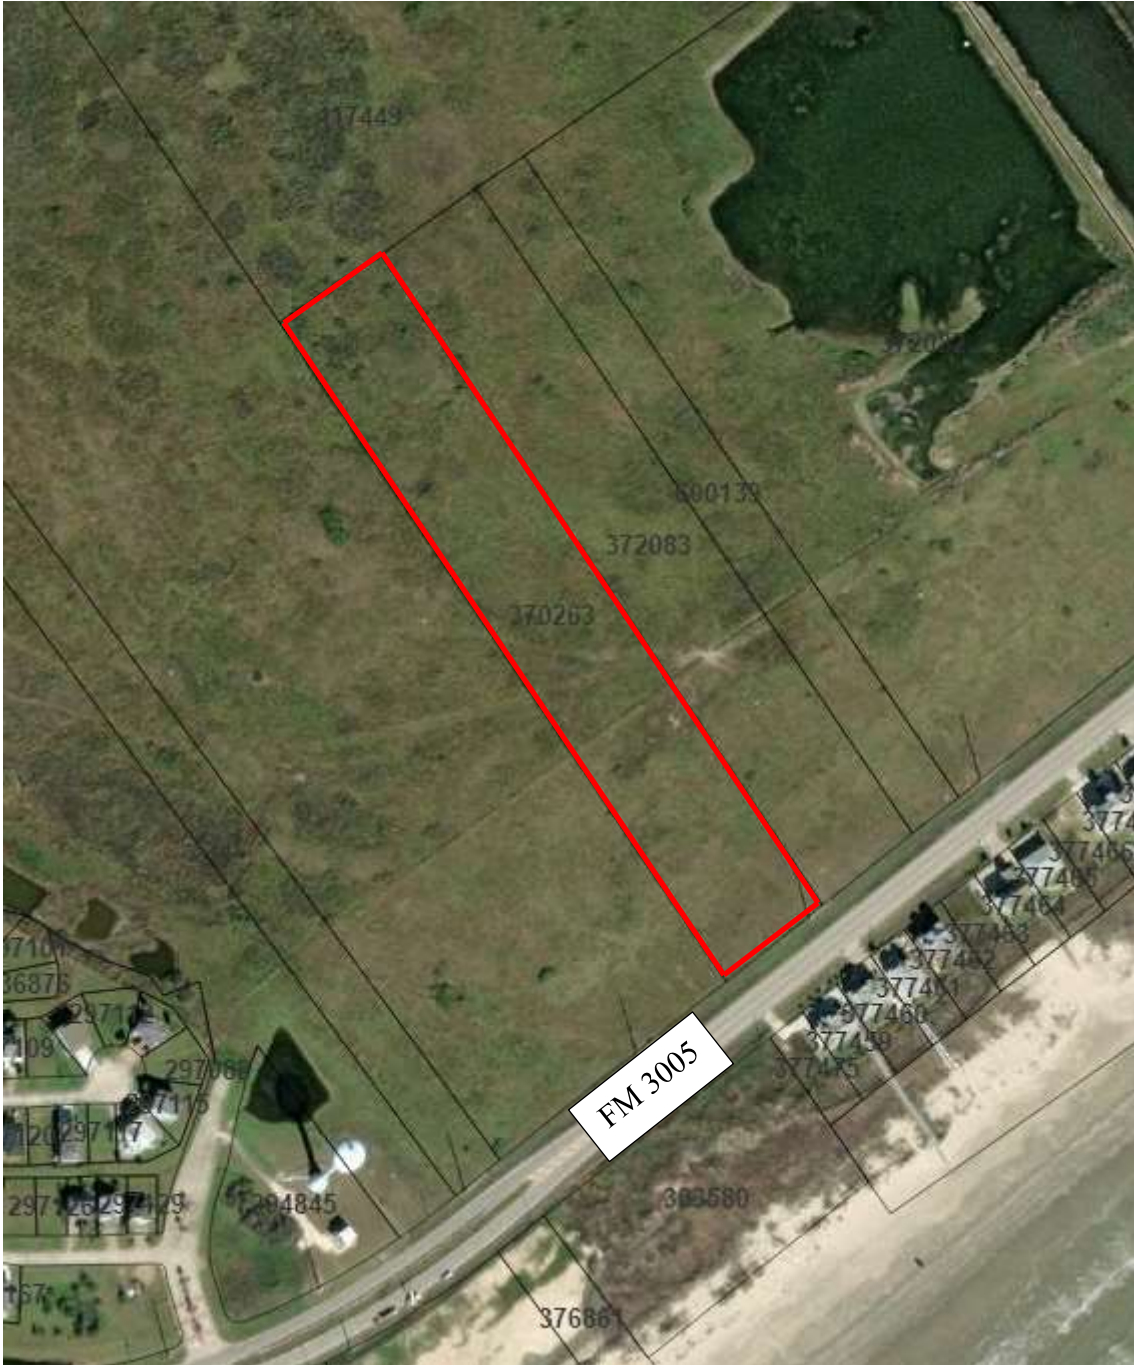
Image from Galveston County Central Appraisal District.

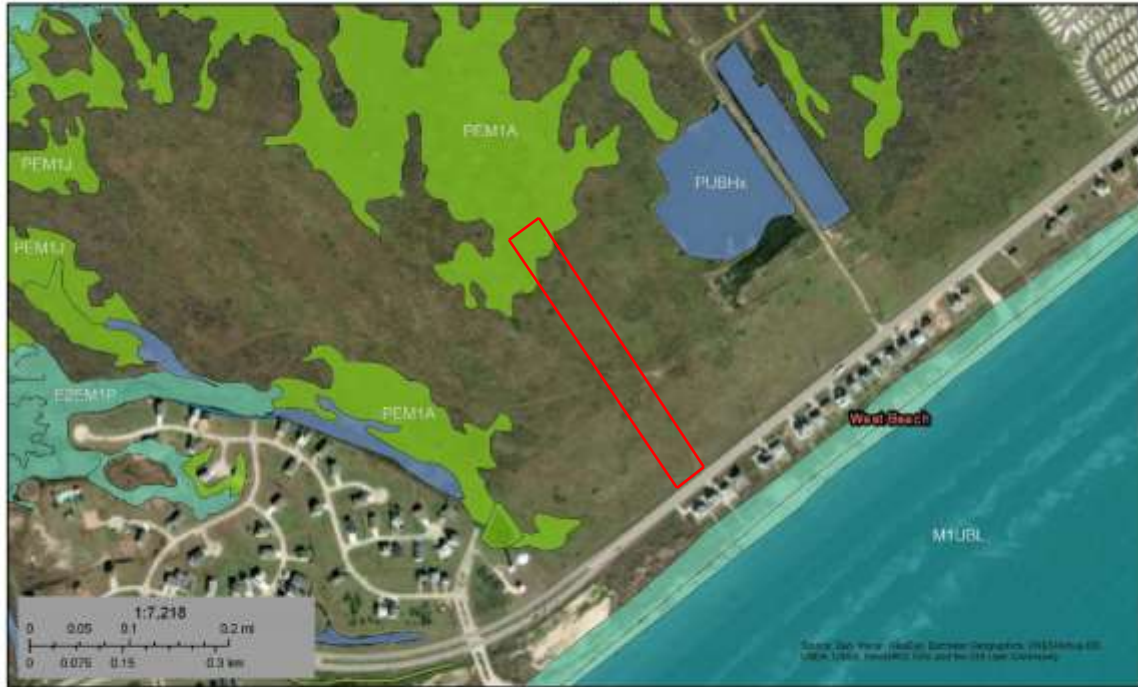
National Wetlands Inventory (2022)
 This page was produced by the FWS mapper.

The National Wetlands Inventory Map was obtained from the U. S. Fish and Wildlife Services web page. It indicates a potential wetland near the North property line. The code for this potential wetland area is PEM1A, Palustrine (P), Emergent (EM), Persistent (1), Temporary Flooded (A).

There is one NWI Mapped Wetland area at the North property line. However, images reviewed indicate wetlands may exist farther South on the site. A site visit will be necessary to determine the extent these potential wetlands.

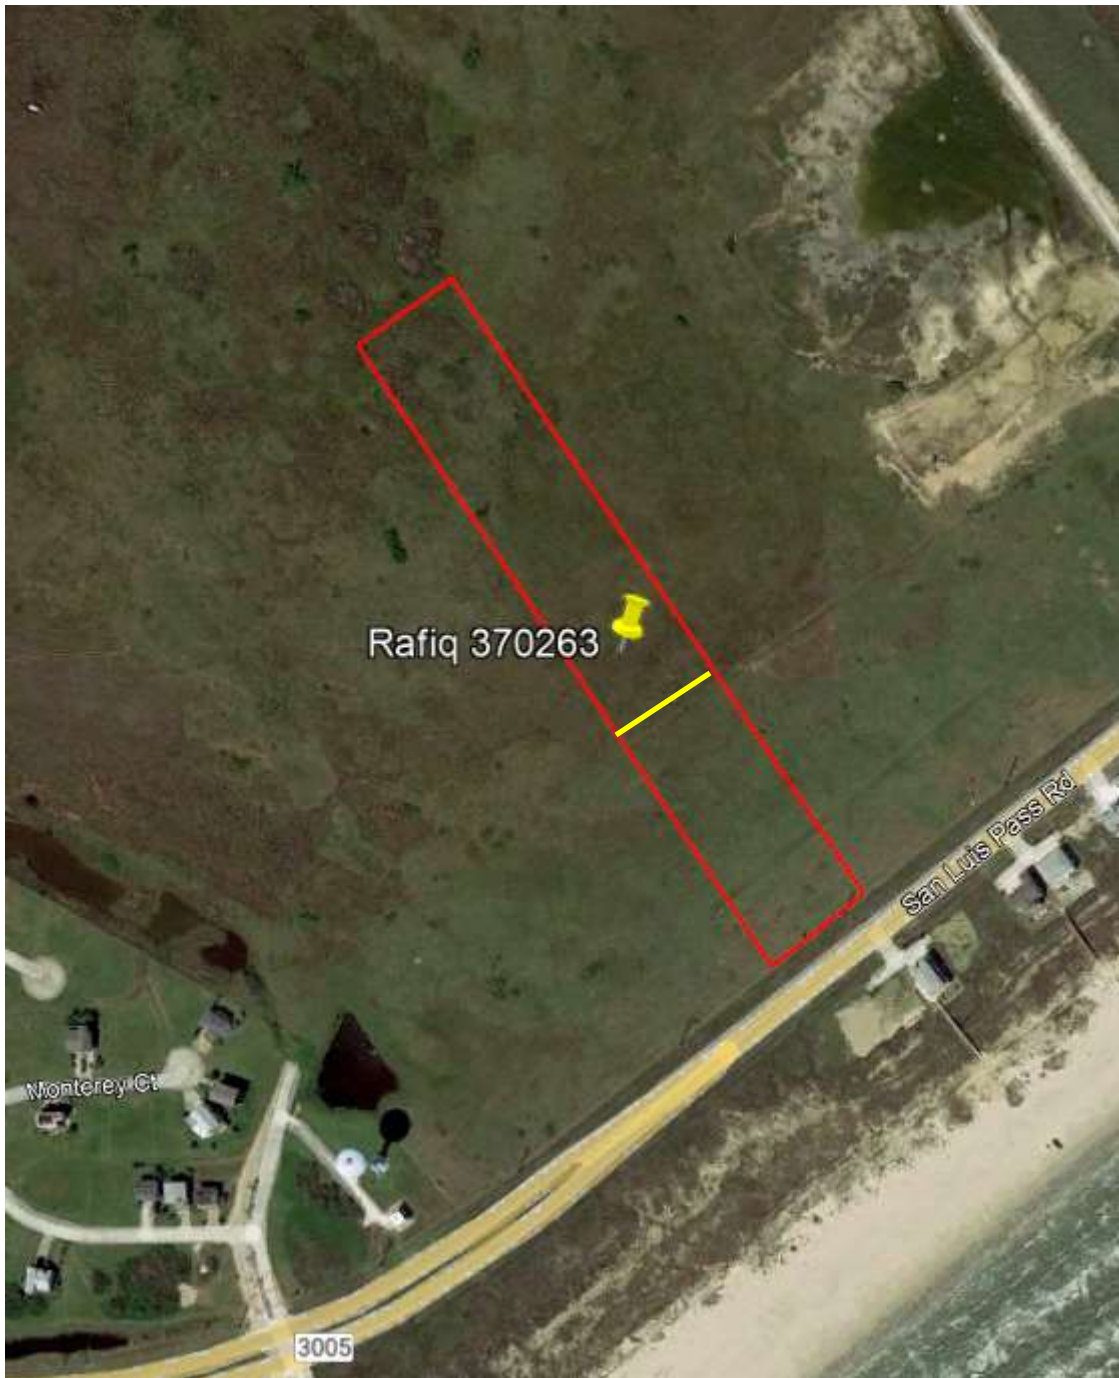
March 3, 2018 Google Earth image. North of the yellow line the image appears to change from upland signature to wetland signature. This area will need further investigation during the site visit.

The northern half of the site may contain wetlands. A site visit will be necessary assess this area.

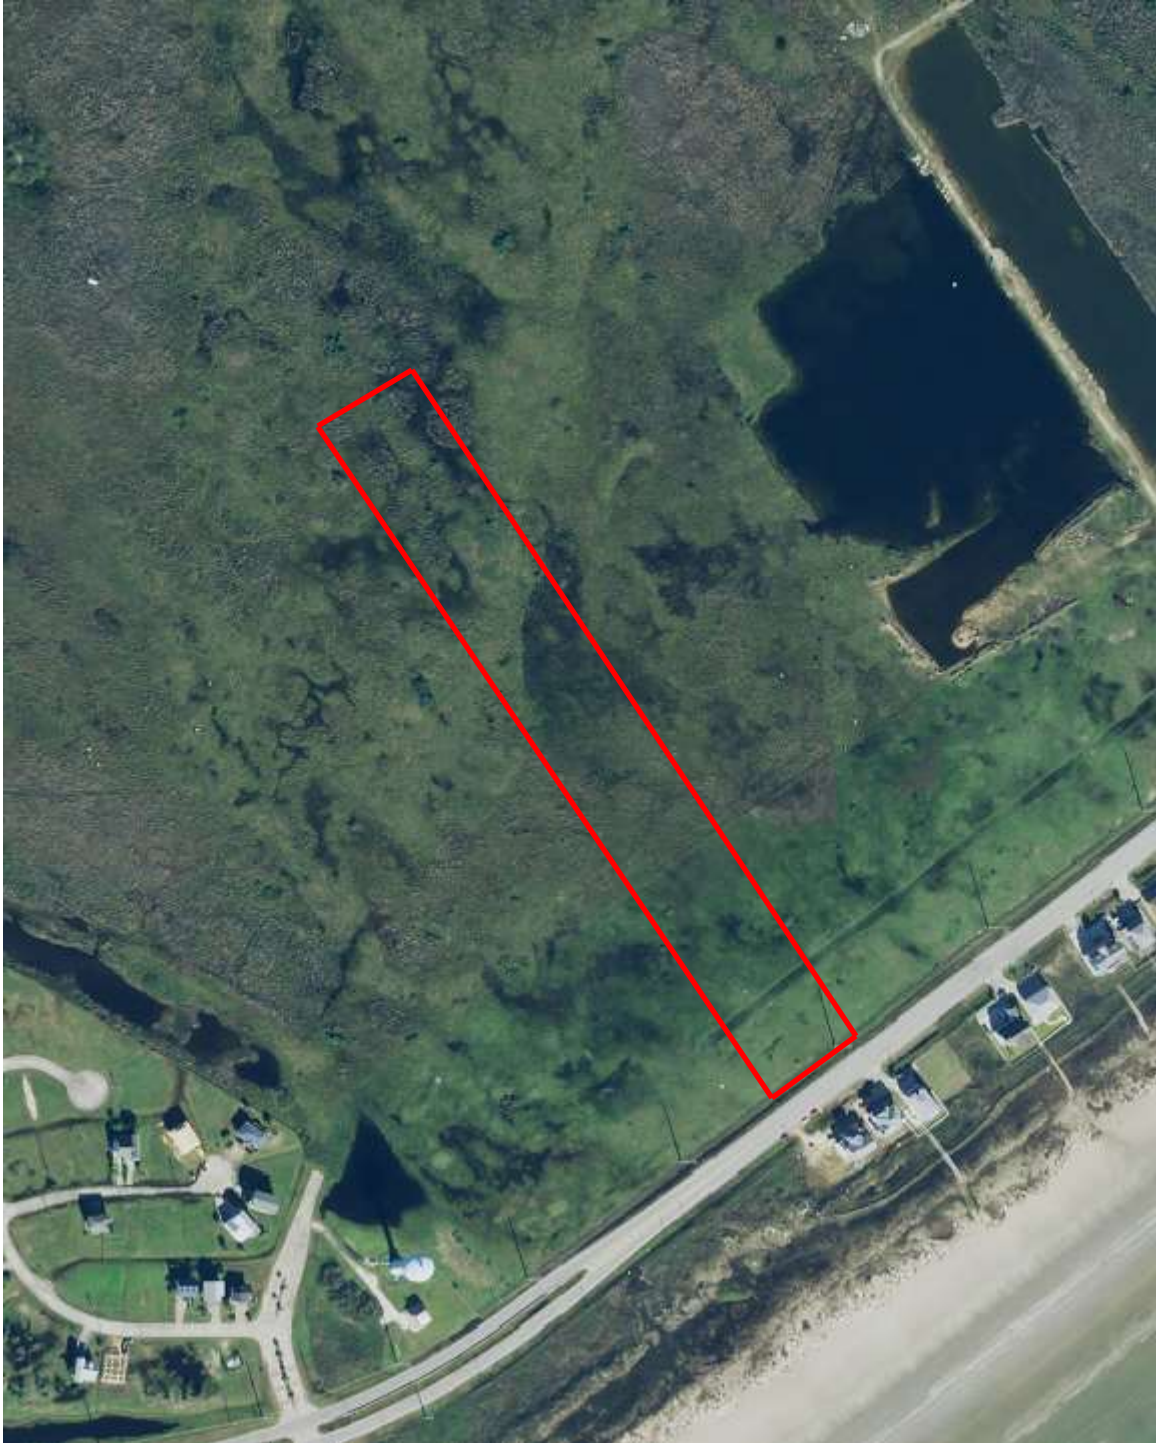
Texas Natural Resources Information System 2018 aerial image of the site. This aerial photograph was taken shortly after it rained. Standing water can be seen in several locations on this site. This could be due to recent rainfall, or these areas could be wetland areas.

Images from the Texas Natural Resources Information System for the year 2018 were taken following rainfall and outline potential wetland areas on the site. Images from 2020 are inconclusive since it appears the area had not received rainfall recently.

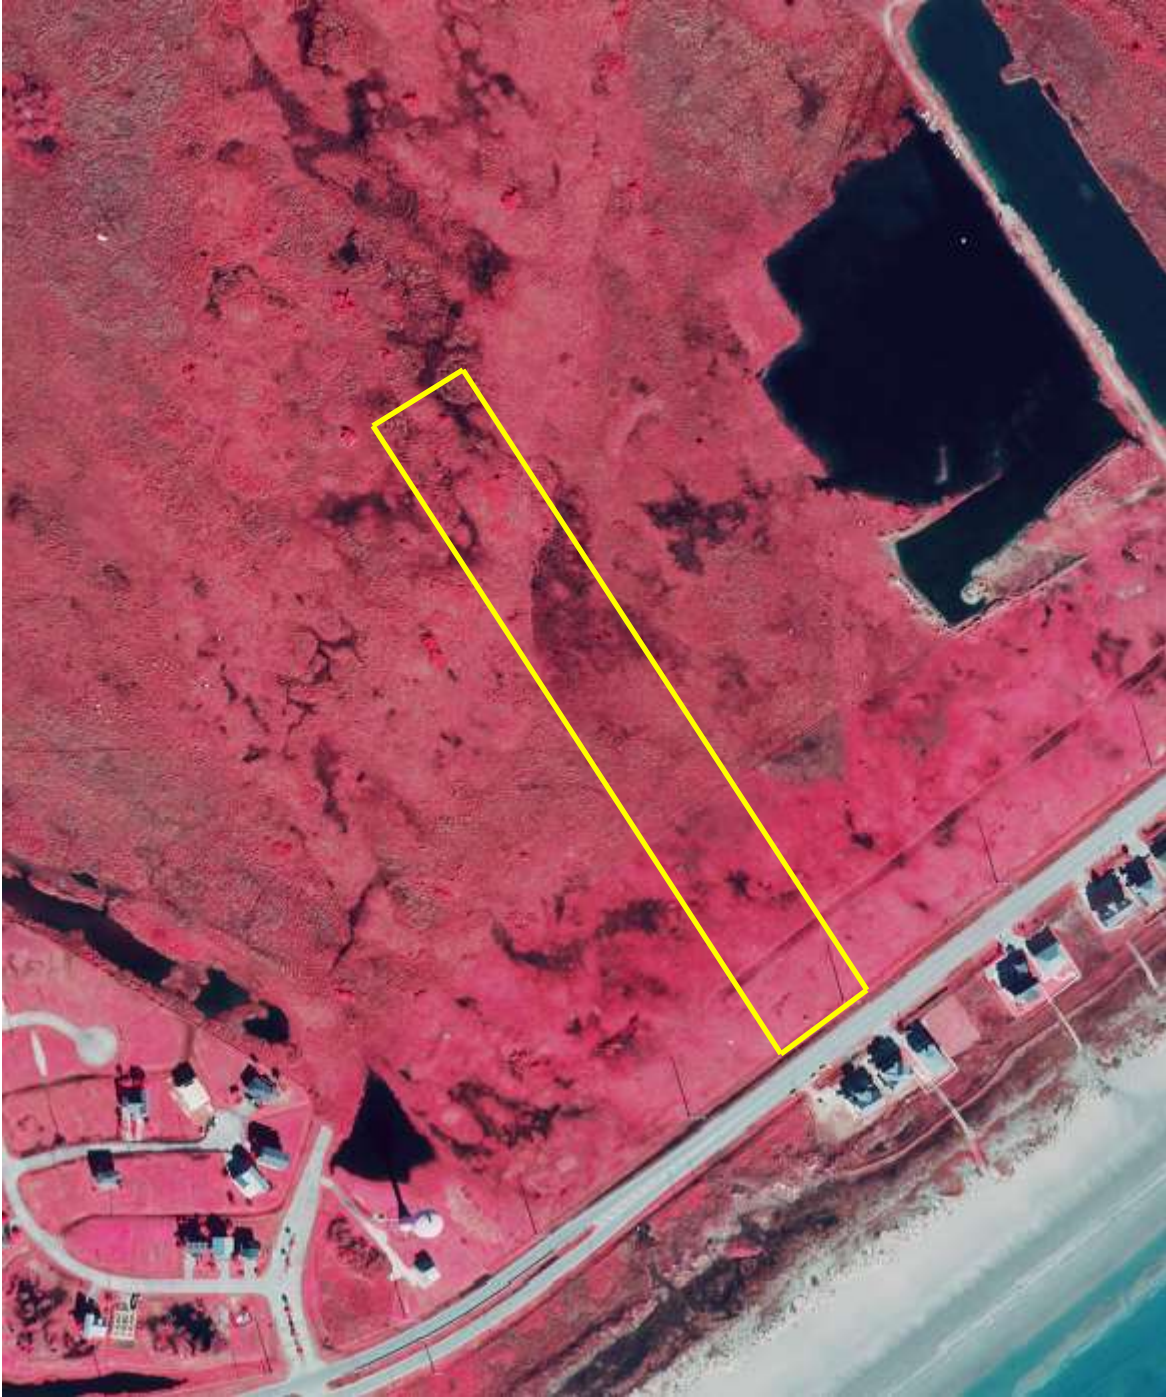
Texas Natural Resources Information System 2018 infrared aerial image of the site. The darker signatures are potential wetland area. Bright reds are probable uplands.

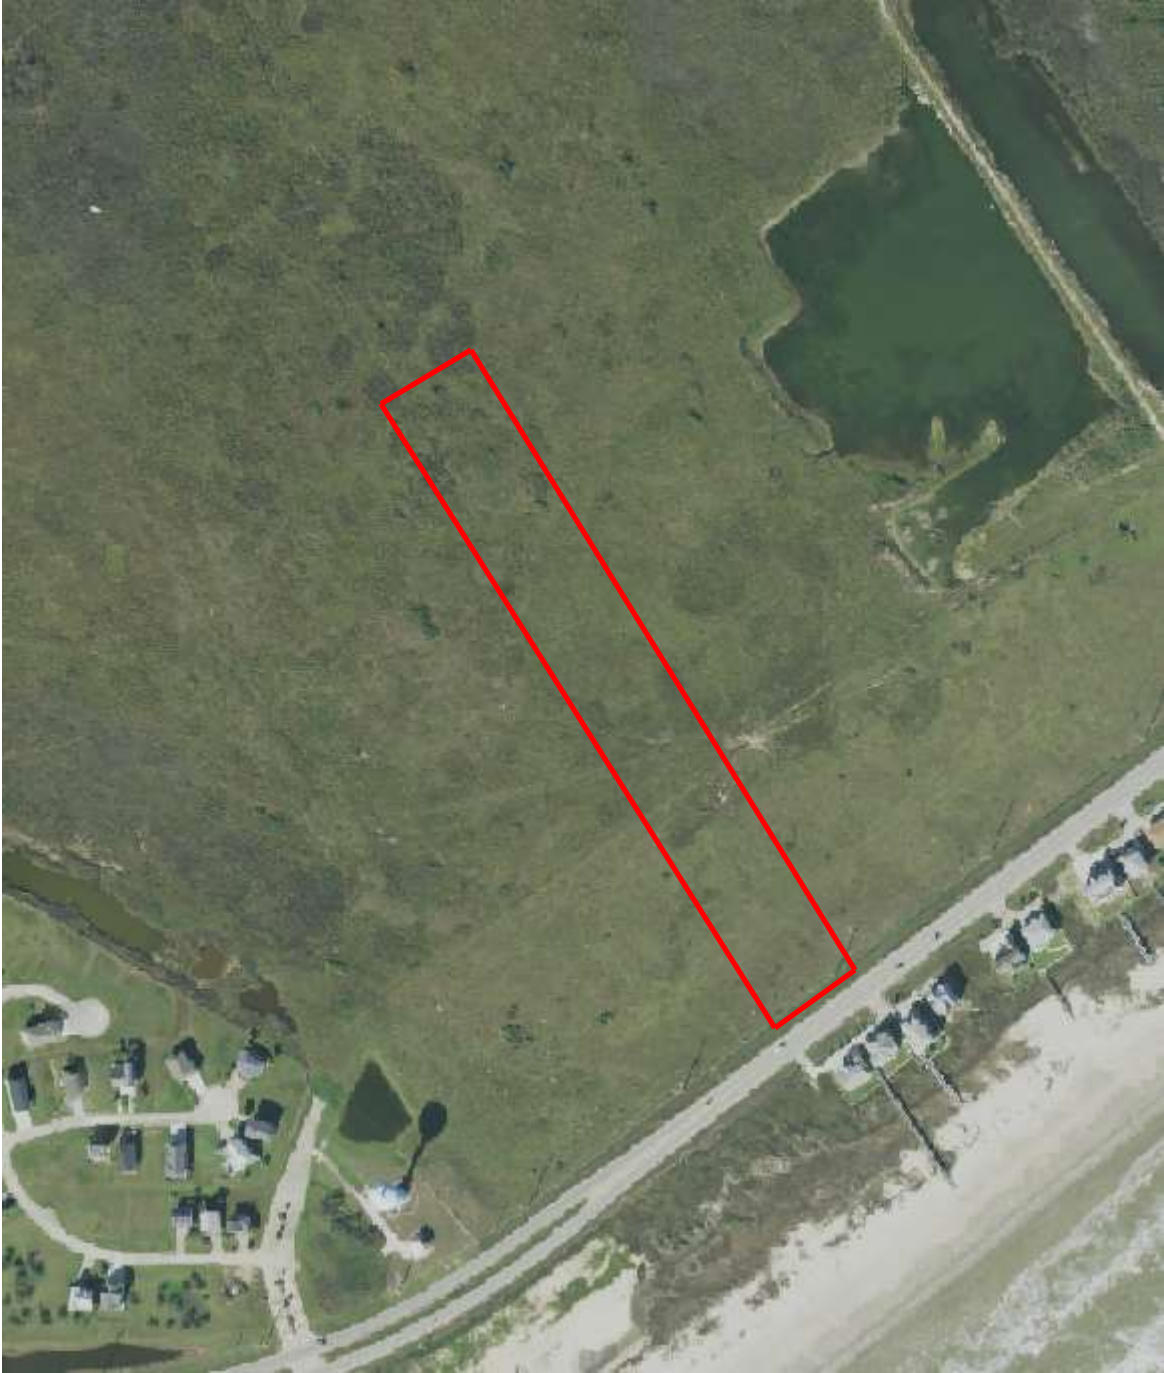
Texas Natural Resources Information System 2020 aerial image of the site. This aerial image does not show the potential wetlands seen in the 2018 aerial image.

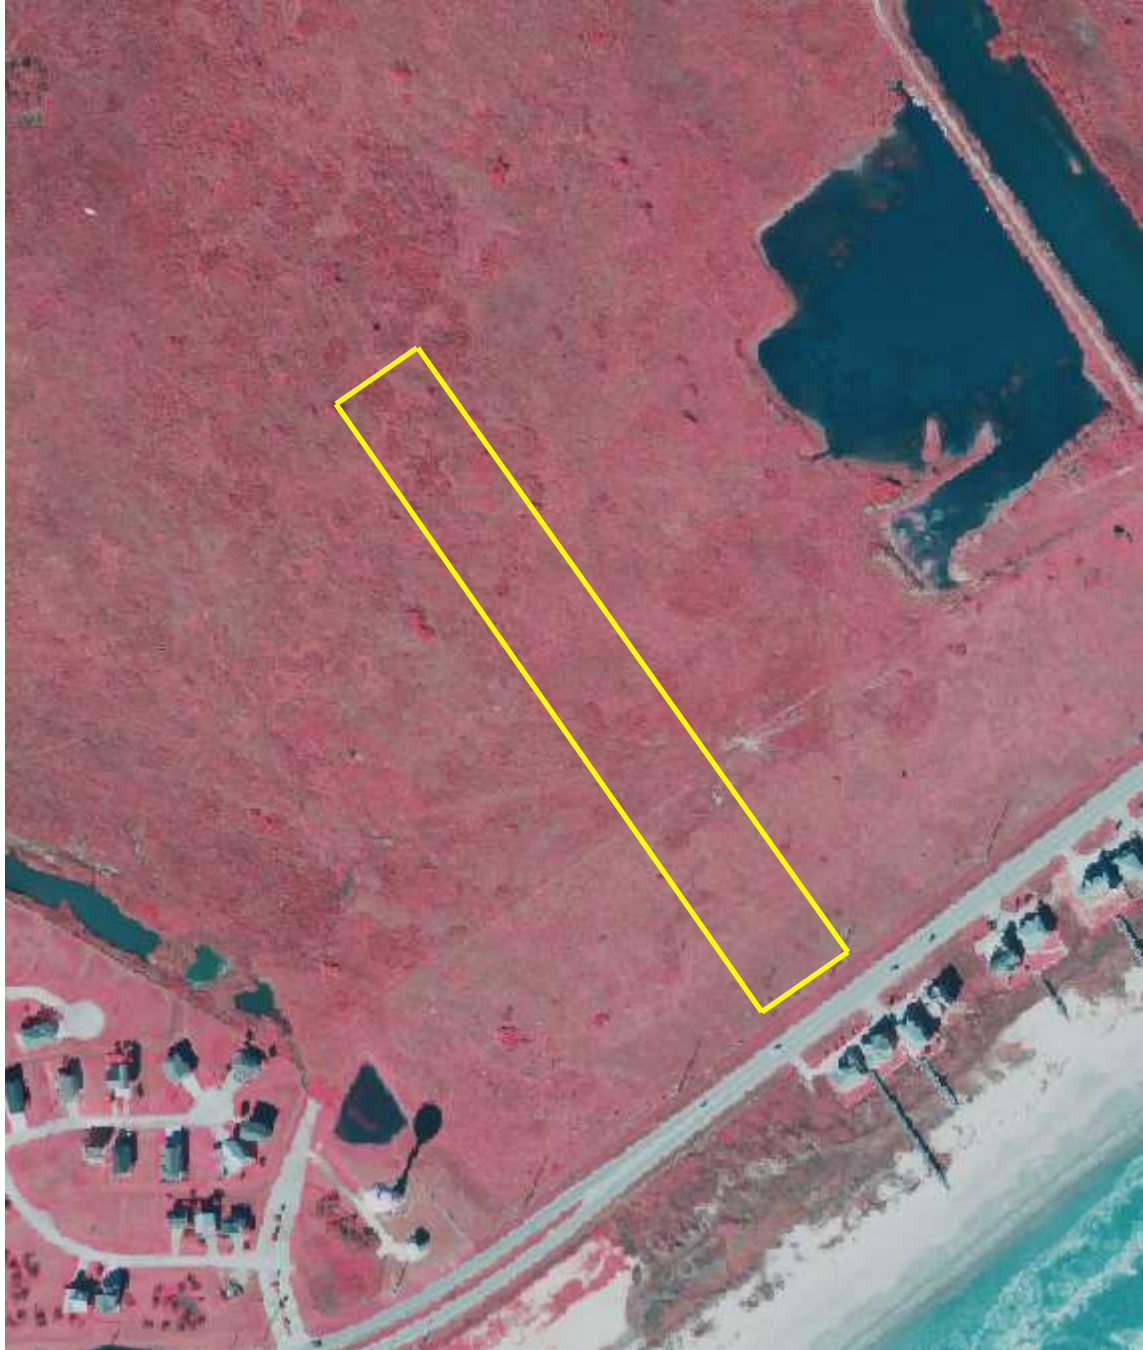
Texas Natural Resources Information System 2020 infrared aerial image of the site. This infrared image is inconclusive since the site appears to lack recent rainfall.

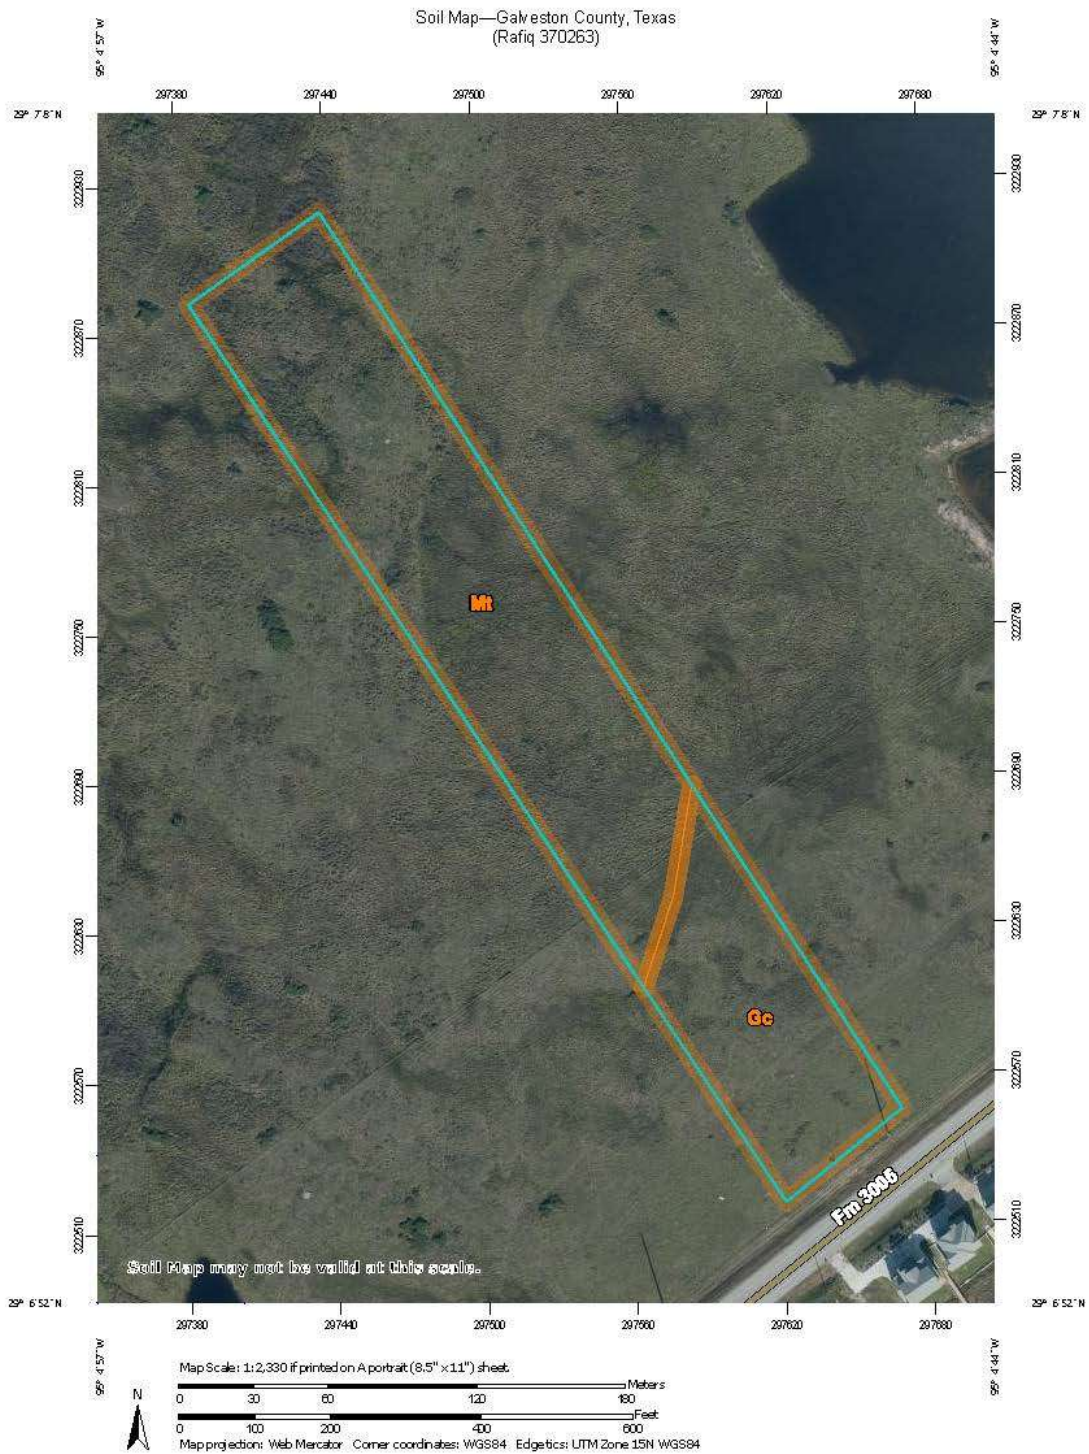
The site consists of two soil types. Mt Mustang-Nass complex, 0 to 1 percent slopes, occasionally flooded, occasionally ponded, and Gc Galveston-Nass occasionally ponded complex, 0 to 4 percent slopes, occasionally flooded.

The site consists of two soil types. Mt Mustang-Nass complex, 0 to 1 percent slopes, occasionally flooded, occasionally ponded, and Gc Galveston-Nass occasionally ponded complex, 0 to 4 percent slopes, occasionally flooded. Both are listed as a fine sandy soil to a depth of 60-70 inches. This would indicate this soil drains fairly quickly and is not conducive to wetland formation.

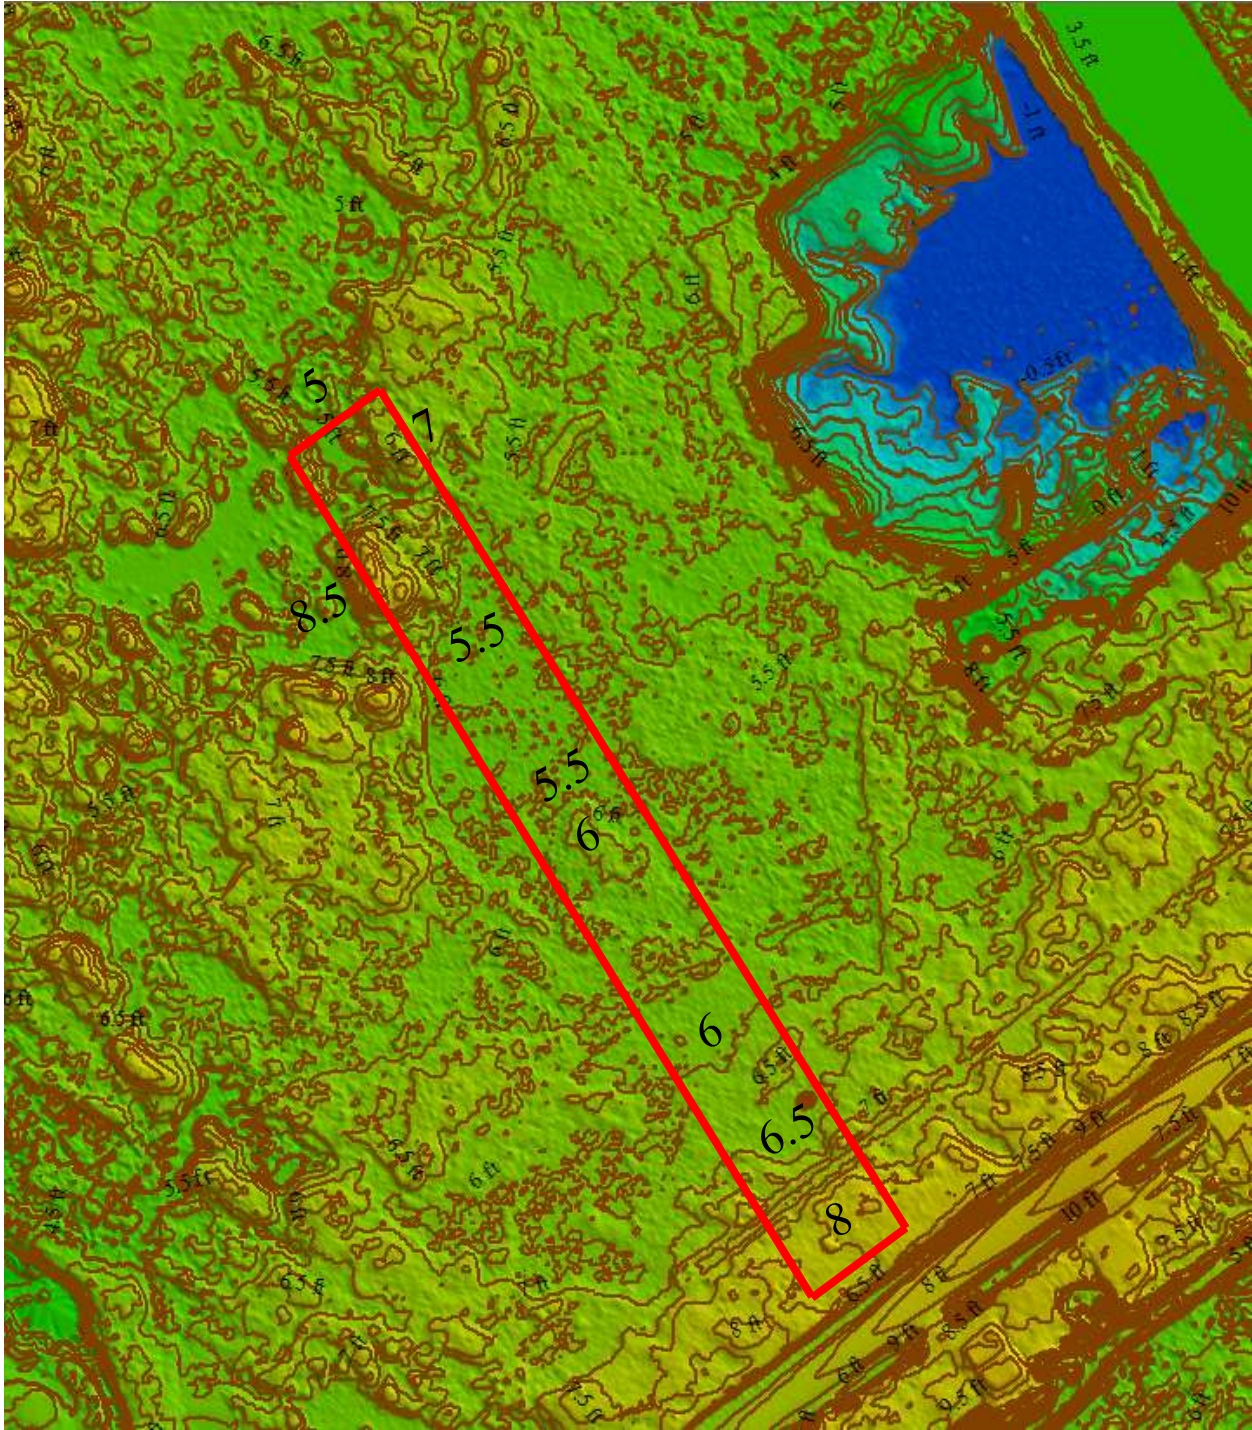
Texas Natural Resources Information System 2018 Upper Coast Lidar. The North property line is at elevation 5 feet. There are two mounds, one at elevation 7 feet and the other at elevation 8.5 feet. South of those mounds the elevation is 5.5 feet. The land gradually increases in elevation to 6.5 feet (North of the South property line). The elevation near FM 3005 is 8 feet.

Upper Coast LIDAR elevations indicate the site varies from elevation 5 feet to elevation 8 feet. It is uneven and contains mounds of sand. The areas between elevation 5 and 6.5 need to be investigated for wetlands.
