**REFERENCE: FOUNDATION INSPECTION**

**FOOTING LOCATION PLAN**

**SITE ADDRESS: 2621 Staton  
Port Neches, Texas**

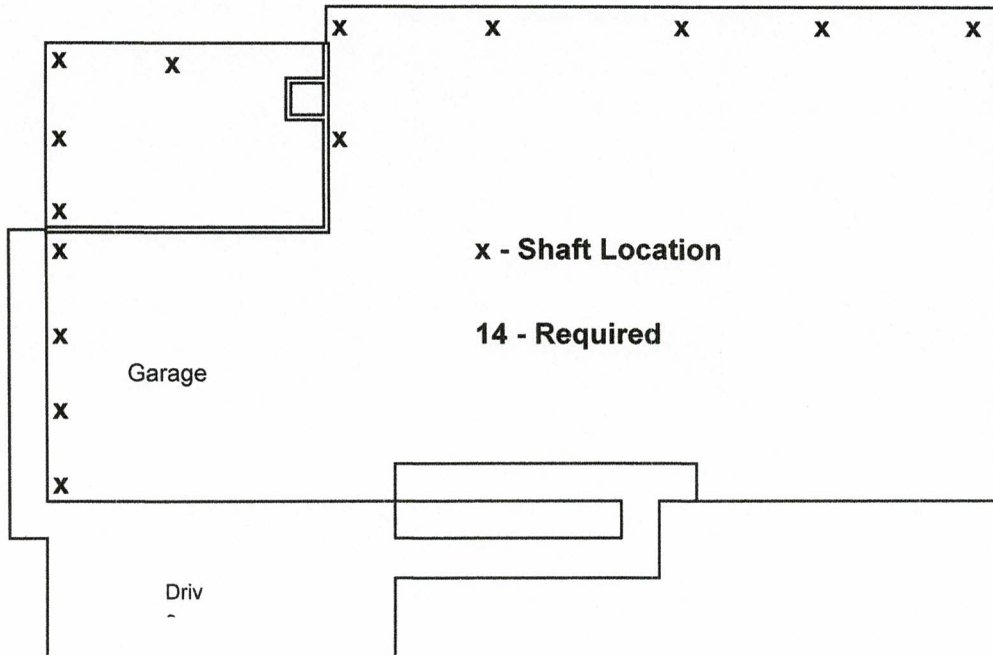
It is my opinion that 14 pressed piers, drilled shafts, or bell footings are required around the affected portion of the foundations. They are more fully described in the attached sketch.

The best course of action is to stabilize that portion of the foundation that has failed and/or is experiencing movement. A failed foundation is more easily susceptible to movement and further damage. The solution to the problem is to install pressed piers, drilled shafts, or bell footings around the affected area for additional support. These supports are installed at a depth below grade where the soil moisture content, generally, is unchanged. In my opinion, this will stabilize the foundation with little or no seasonal movement. Furthermore, once a foundation has failed, it can only be supported to an acceptable level.
