4018 Shackleton Ct

Property Inspection Report

PROPERTY INSPECTION REPORT FORM

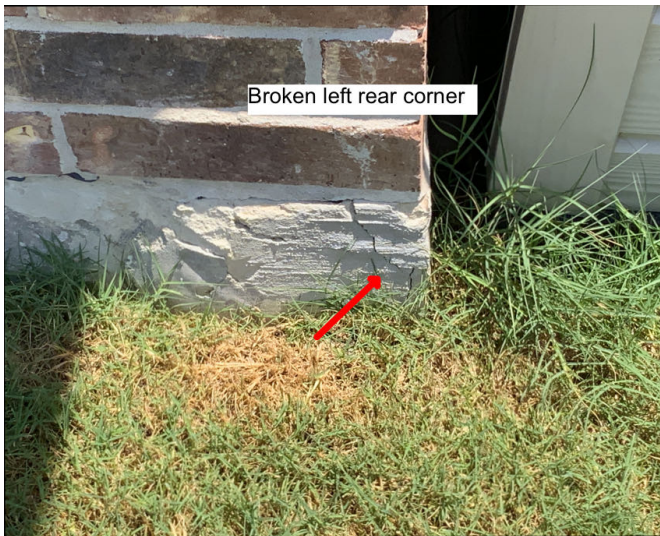
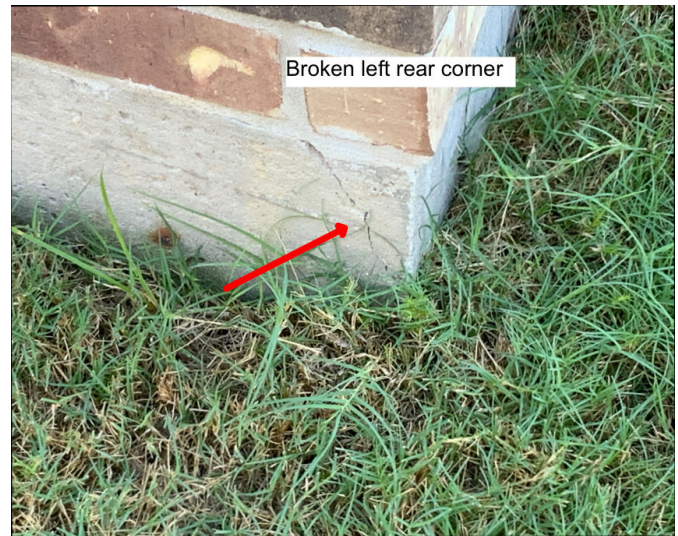
- The Foundation is: In the inspector's opinion, the foundation was found to be performing as intended at the time of inspection, with some notable deficiencies. These deficiencies may or may not require further evaluation by a foundation expert as its not possible to determine full performance on a single inspection. This opinion was formed with a visual evaluation. No measurements, or specialty tools were used while performing the home inspection.
- Corners of the foundation were found to be broken. This is a common deficiency. Correct repairs of the corner(s) is recommended to reduce the risk of further damage to the exterior finish.

Foundation: repair broken corners
 Windows: Replace lost seal windows

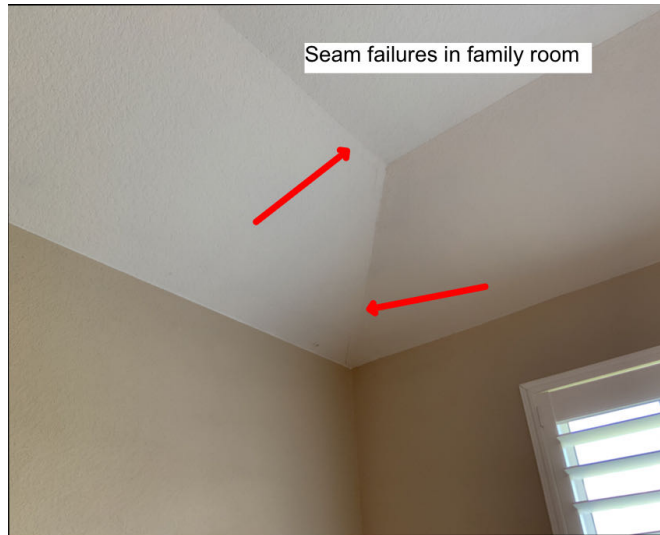
- The inspector reports on all visible deficiencies on the ceilings and floors at the time of inspection. The inspector does not accept responsibility for any deficiencies that may occur in these areas after the time of inspection, as mechanical failures within the walls are unpredictable. The inspector is unable to view within the walls, which may be covering poor connections of water lines, drains, electrical connections, and possibly organic growth.
- Drywall seam failures observed. These are common with settlement deficiencies. Recommend repairs to prevent further damage.

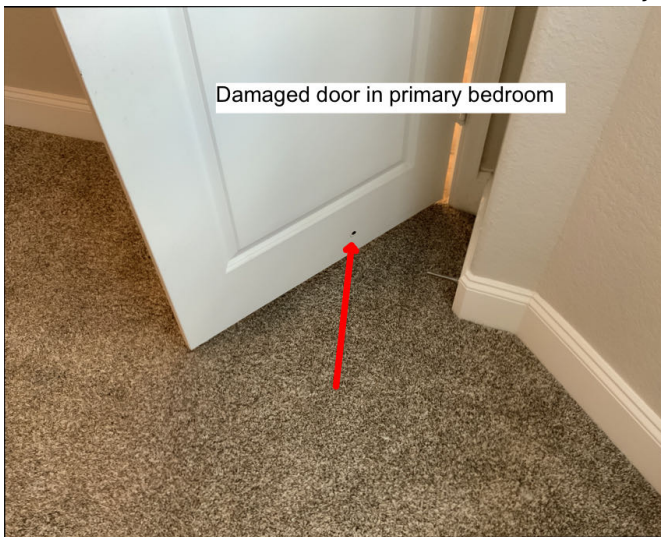
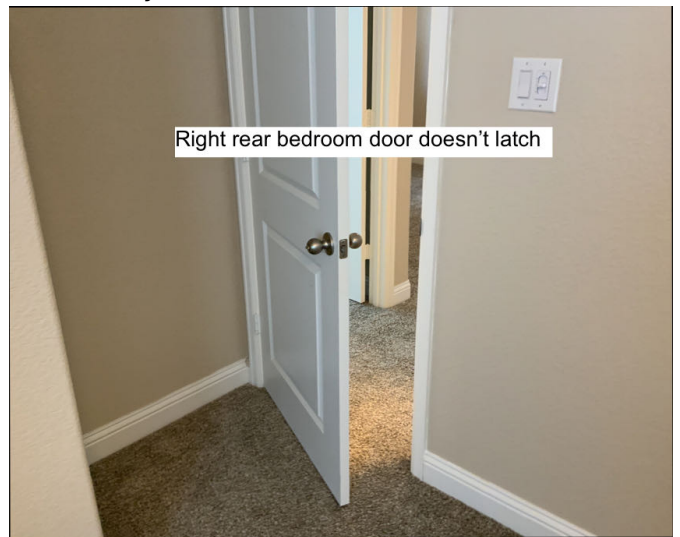
- Door(s) were observed to have damage or decay. Repairs or replacements should be considered.
- Doors should be trimmed or adjusted as necessary to work as intended

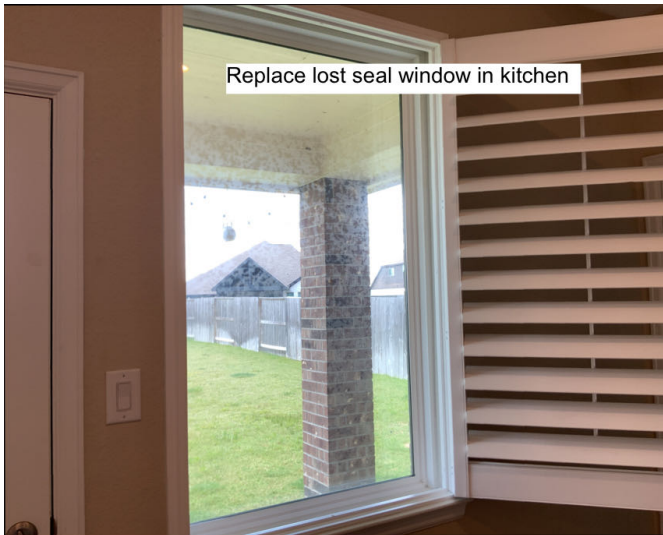
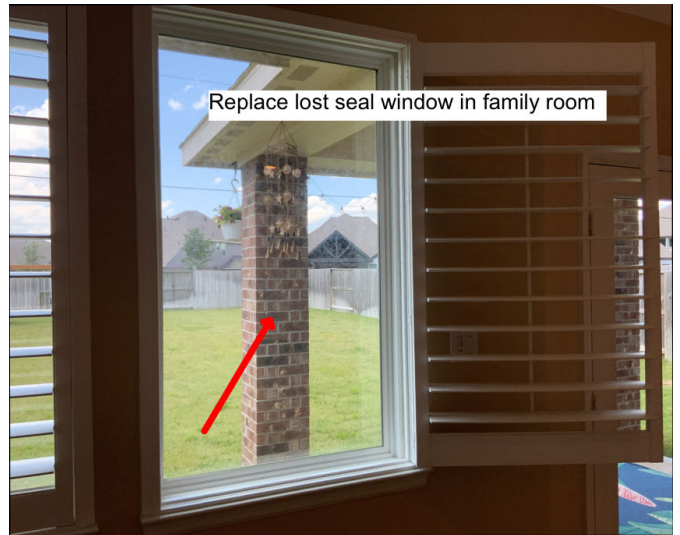
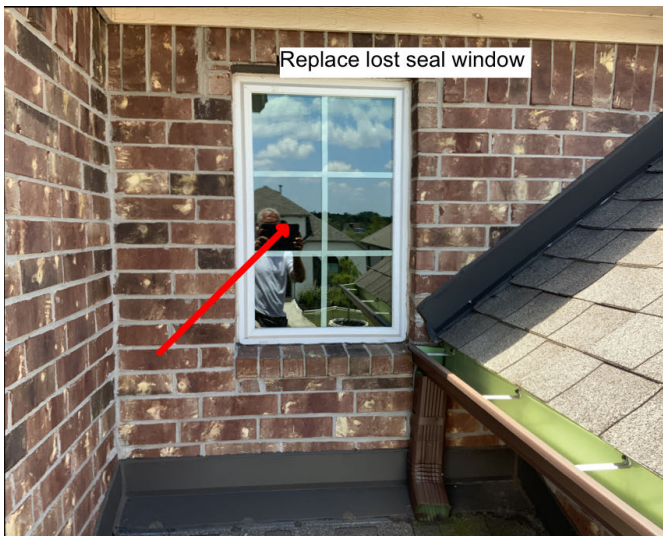
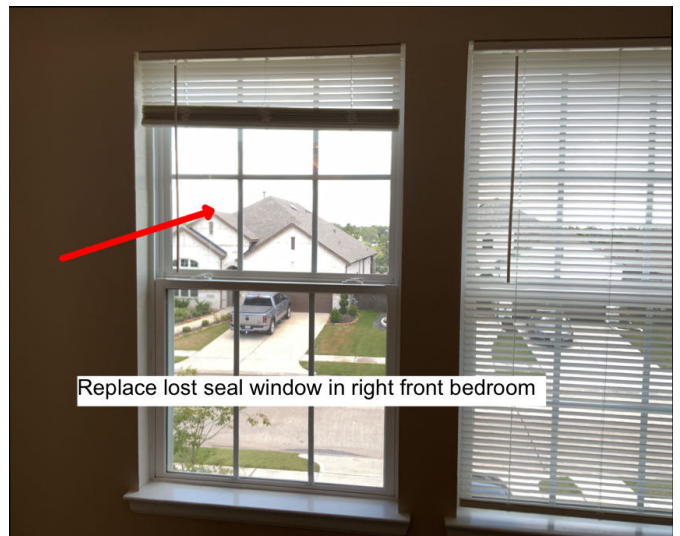
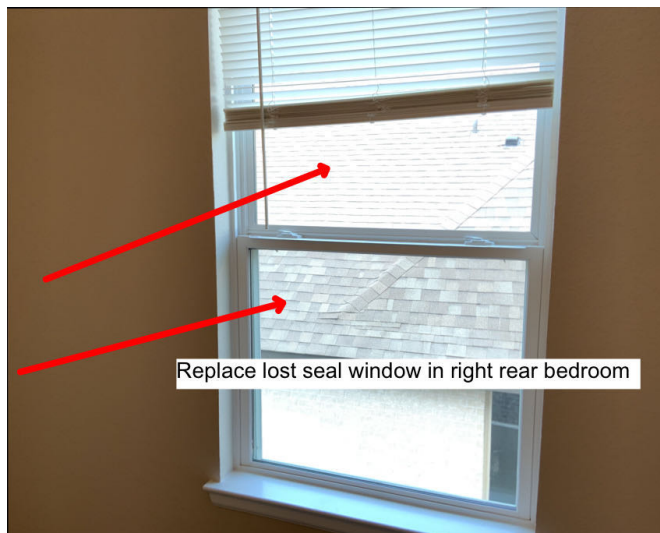
- It is recommended that a two story or high home be equipped with a window escape ladder. Training is always recommended should ladder ever be needed in an emergency situation.
- The window(s) have lost their seal. This has resulted in condensation developing between the panes of glass and can cause the glass to loose it's insulating properties. The glass should be replaced.

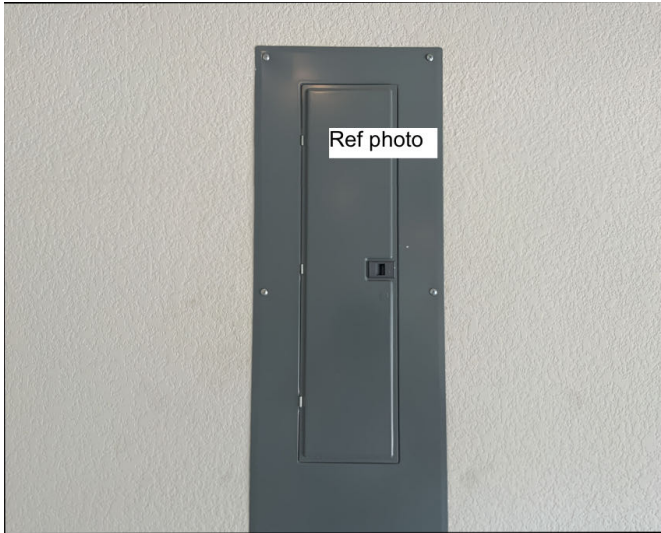
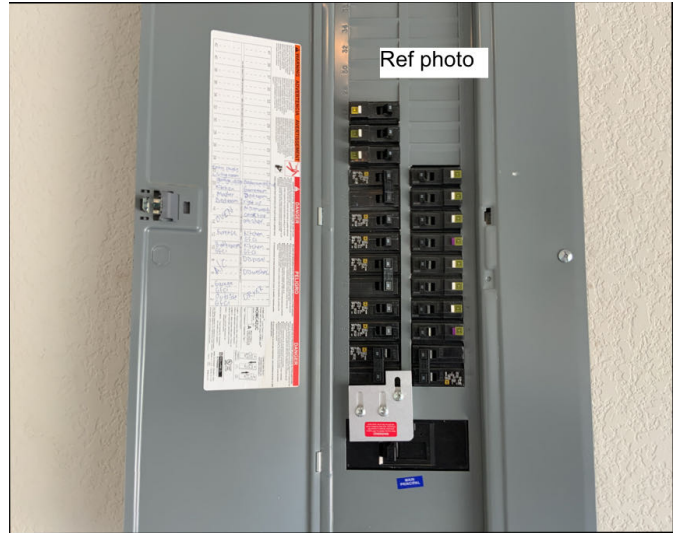
Panel Locations: The main distribution electrical panel is located inside the garage.
Materials and Amp Rating: Aluminum wiring, 150 amp

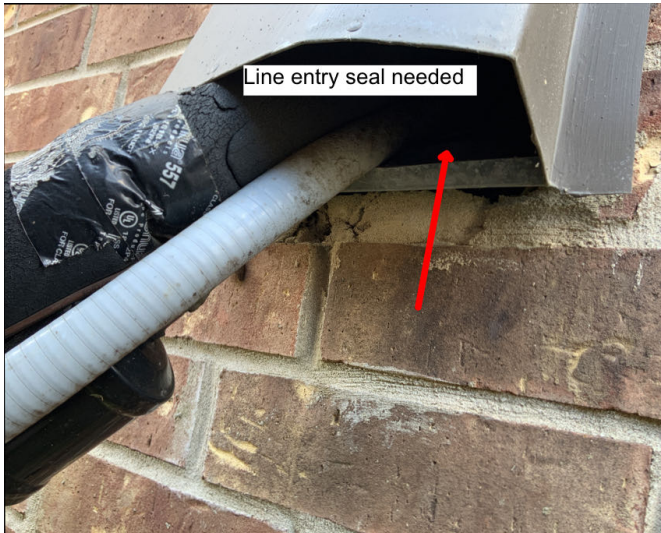
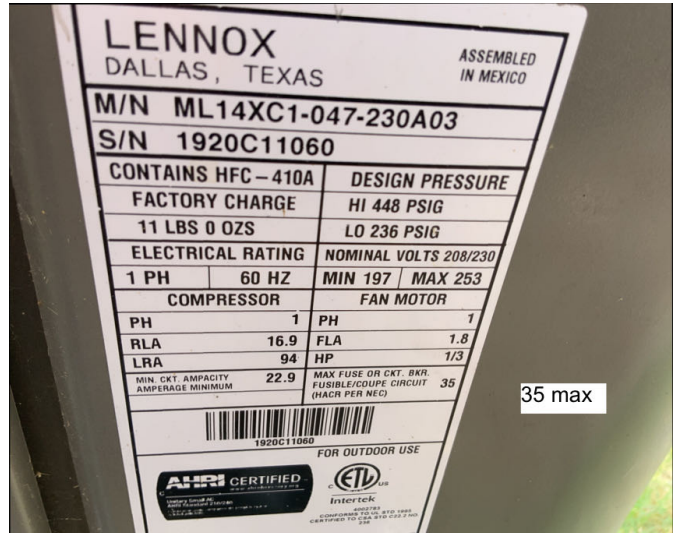
- Seal improvements are needed where service lines enter the home from the condenser unit.
- The temperature differentials measured across the evaporator coil(s) was found to be within range of what is considered typical.

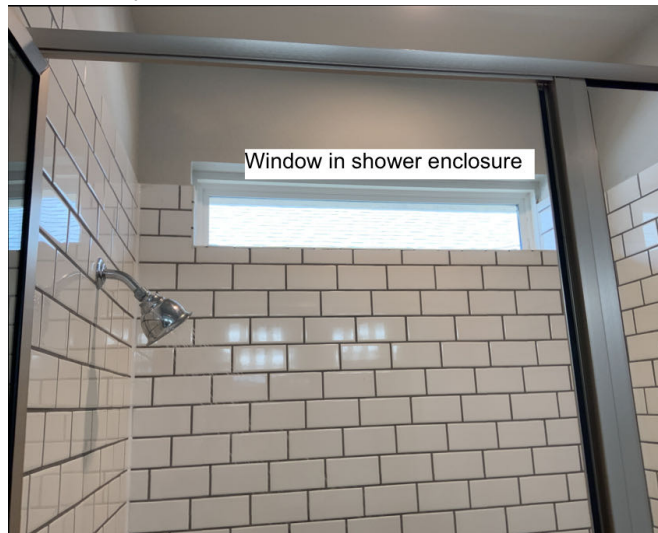
- *Static water pressure reading:* 61 psi
- *Type of supply piping material:* PVC
- The inspector only reports on exposed supply lines visible at the time of inspection. If the inspector feels further evaluation is needed she will recommend a licensed plumber do so. Performance Inspections PLLC and it's employees take no responsibility for connections that are not visible at the time of inspection.
- The window and sill of the shower enclosure should be protected from moisture. A waterproof curtain is usually sufficient. Windows in shower enclosures have a reputation for allowing leakage behind the enclosure, causing damage to the wall, therefore maintaining seals and reducing moisture access is important.
