Fox Residential Pool Services Houston

Swimming Pool Inspection Report

Inspection Date: **May 8, 2020**

Pool Address: **21515 Pebble Pine Court Cypress, TX 77433**

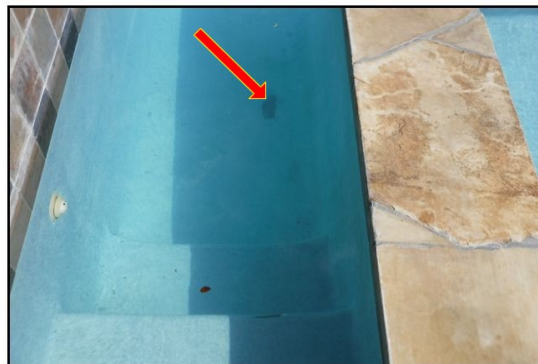
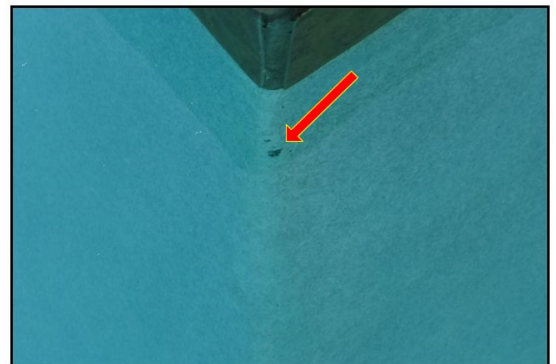
Some discoloration of the pool surface was observed at the time of this inspection. A qualified technician should investigate the cause and remedy of this condition.

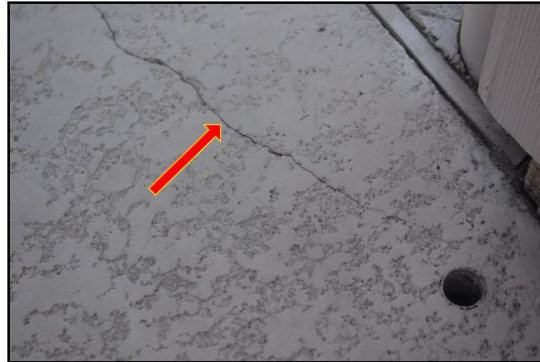
Observed mortar cracking between coping and deck at one or more locations.

Observed settlement / cracks around pool deck.

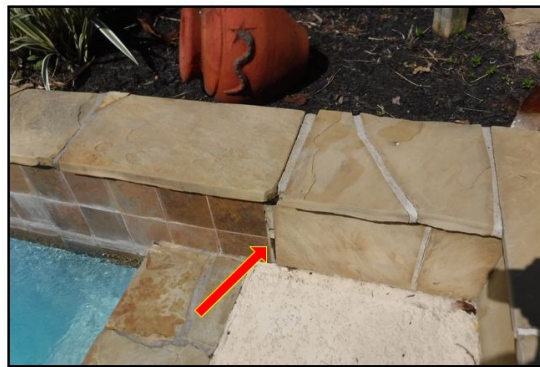
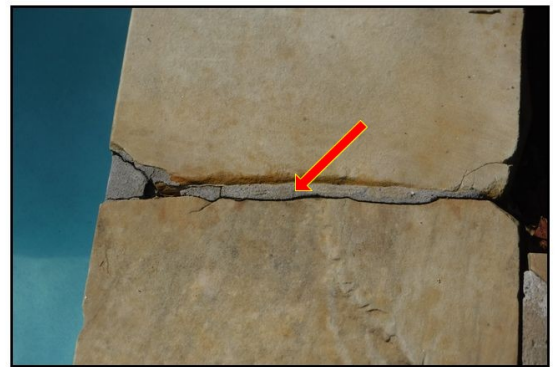
The mortar between some of the coping around the pool and/or spa needs to be improved.

Observed cracks in coping.

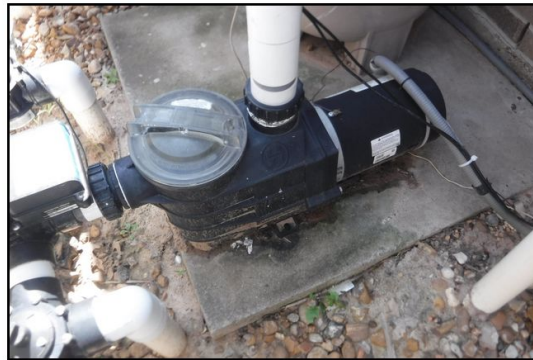
Pool filter pump

Pump bearing noise observed coming from Pool pump which generally indicates imminent failure in the not-too-distant future.

There was a lot of air observed in the plumbing lines. Further evaluation is recommended.

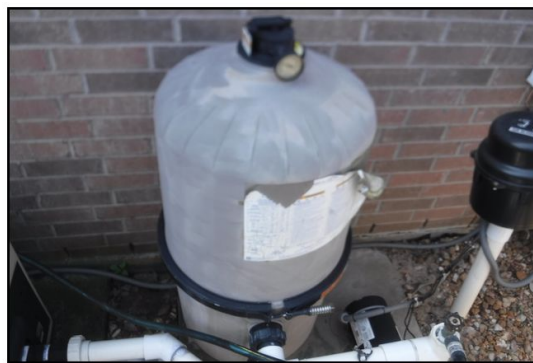
Filter

Disassembly and/or servicing of filter is beyond the scope of this limited visual inspection. Recommend obtaining documentation from seller regarding last servicing of filter. Life expectancy of swimming pool components such as filter is expected to last up to 5-7 years.

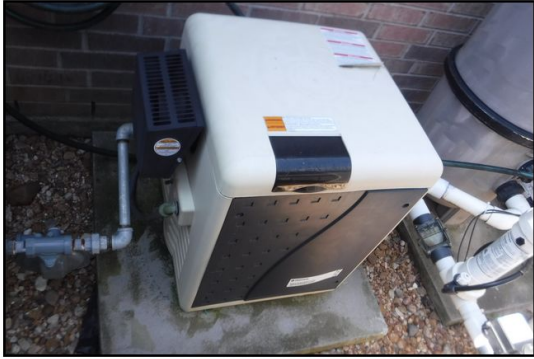
<p>Heater</p>

No significant deficiencies or anomalies observed at the time of inspection.

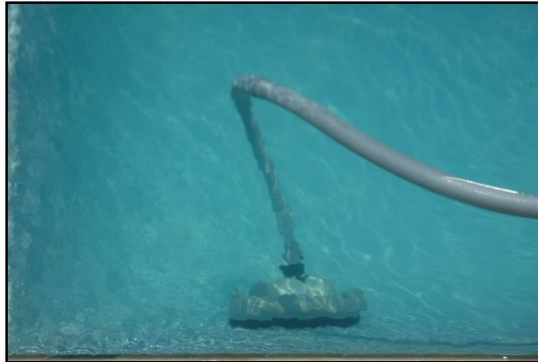
The sweeper does not appear to be performing properly at this time.

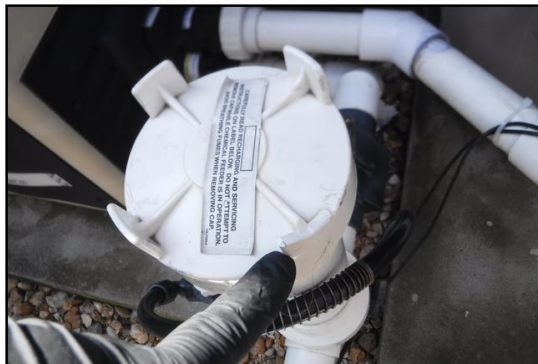
Damage of chlorinator cap observed.

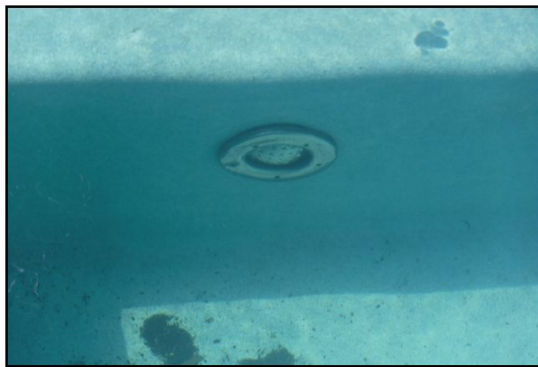
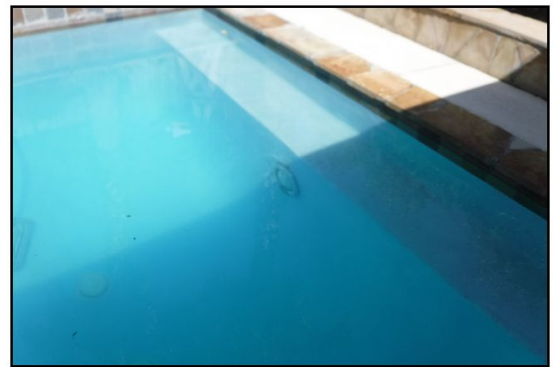
Light not operational, GFCI appears to be operational indicating likelihood light fixture just needs a bulb, spa and pool. Needs further diagnosis to determine true cause and proper remedy.

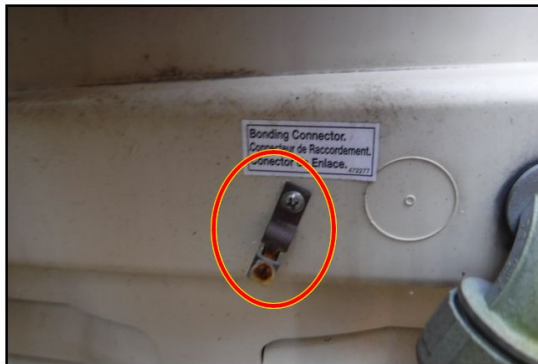
Did not observe proper electrical bonding wire attachment to all pool mechanical equipment. This is required for safety from potential shock hazard.

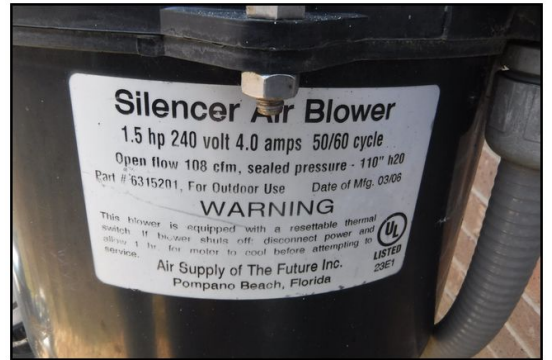
Air blower data plate

No significant deficiencies or anomalies observed at the time of inspection.
