Inspection Report

Property Address:
3831 Supremes Trl
Spring TX 77386

PROPERTY INSPECTION REPORT

By: Reevis Coleman Schultz Texas Professional Home Inspector / Hilsher Group LLC
3/11/2019
(Name and License Number of Inspector) (Date)

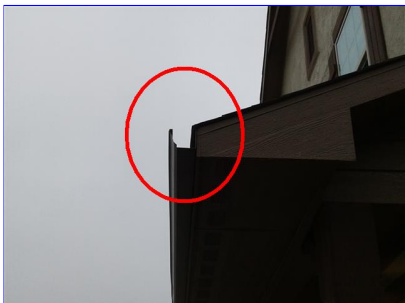
B. Item 1(Picture) right side of the home

(1) End cap is missing on gutter in areas. This is not considered today's standards. I recommend having a qualified contractor inspect and make repairs as needed.

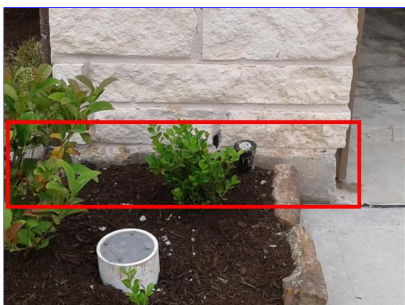
B. Item 2(Picture) front of the home

(2) There is a negative slope towards the exterior areas. This area does not appear to drain water away from home and needs landscaping and drainage corrected to show a minimum of 4 inches of slab.

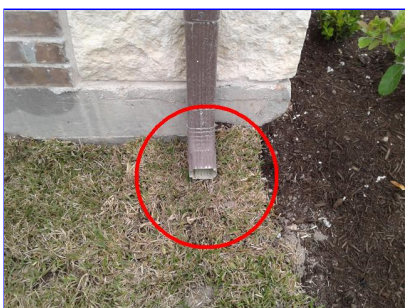
B. Item 3(Picture) left side of the home

(3) The gutter downspout(s) missing deflector(s) at the exterior. Erosion can continue or become worse if not corrected. A qualified contractor should inspect and replace as needed.

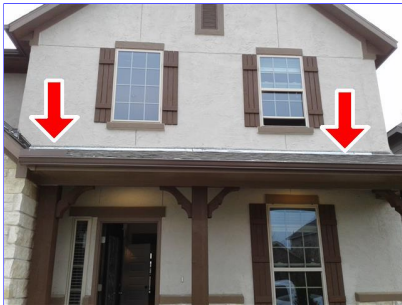
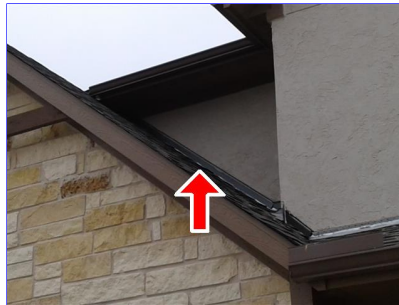
C. Item 1(Picture)

- (1) This inspection does not warrant against roof leaks.
- (2) Flashing appears to be unfinished in multiple areas. This is not considered today's standards. I recommend having a qualified contractor inspect and make repairs as needed.

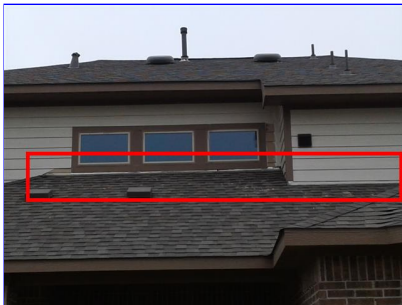
C. Item 3(Picture) multiple areas roof line

- (3) The flashing is not clearly visible and I am unable to verify proper installation and condition. I recommend consulting with a roofing professional to evaluate and make any necessary repairs.

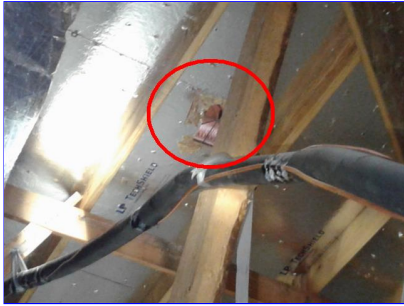
D. Item 1(Picture)

- (1) Attic space inspected with limited access. This is for your information.
- (2) Excess roof sheathing needs to be removed from passive vent in attic space. This is for your information. I recommend having a qualified contractor make repairs as needed.

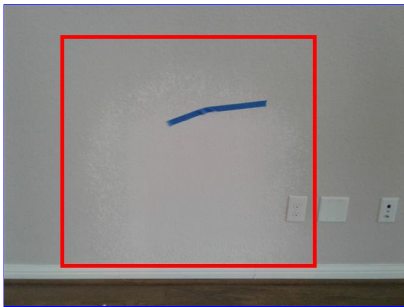
E. Item 1(Picture) multiple areas throughout home

(1) Drywall is being patched or repaired in multiple areas. This is for your information.

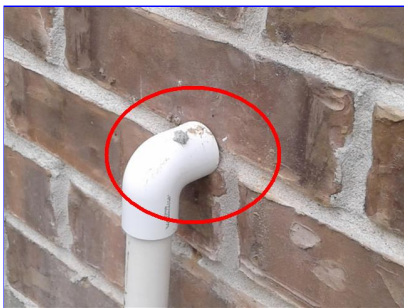
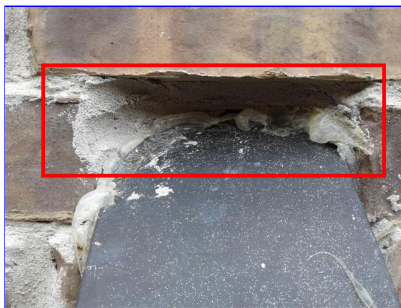
E. Item 2(Picture) left side of the home

(2) Areas where wiring or piping passes through walls should be sealed. I recommend having a qualified person seal as needed.

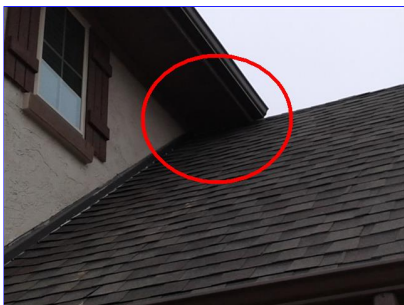
E. Item 4(Picture) multiple areas
roof line

(3) A gap between the fascia and roof sheathing exists which allows insects or bees to enter attic.

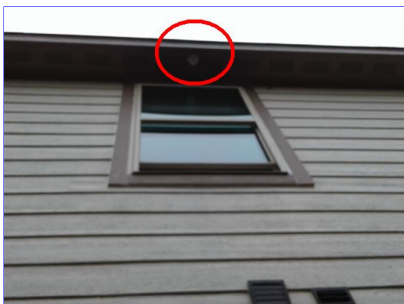
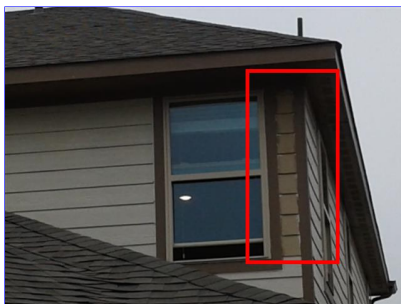
E. Item 5(Picture) left side of the
home

(4) Exterior areas are unfinished or unpainted. This is a cosmetic issue. I recommend having a qualified contractor inspect and make repairs as needed.

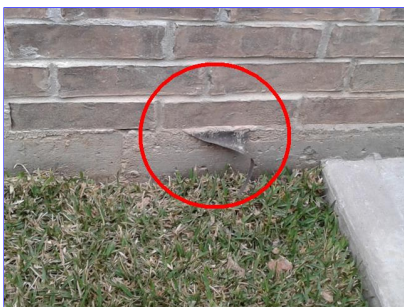
E. Item 7(Picture) left side of the
home

(5) Building materials need to be trimmed in areas. This is for your information.

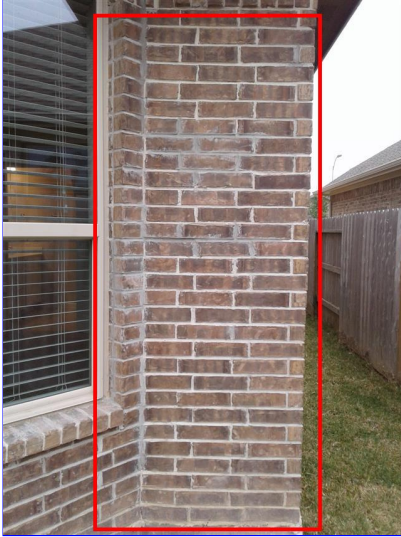
E. Item 8(Picture) multiple areas rear of the home

(6) Different color mortar in areas. This is a cosmetic issue. I recommend having a qualified contractor make repairs as needed.

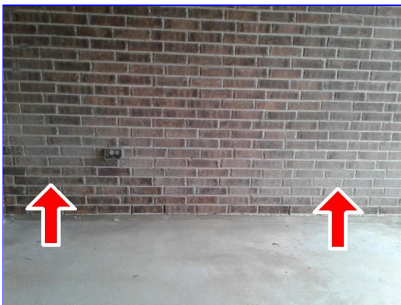
E. Item 11(Picture) multiple areas exterior

(7) Exterior siding is need of cleaning and routine maintenance. I recommend having a qualified person clean and make repairs as needed,

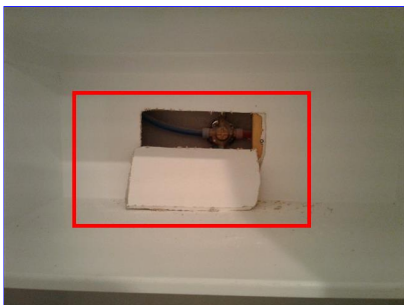
E. Item 12(Picture) upstairs hallway closet

(8) The drywall on the wall is missing piece in areas. While this damage is cosmetic, it needs to be repaired. A qualified contractor should inspect and repair as needed.

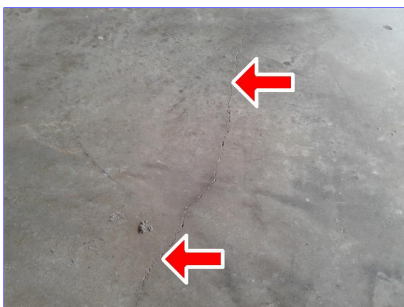
F. Item 1(Picture) multiple areas garage

(1) The concrete floor of garage is cracked in areas. These cracks do not appear significant and seem typical. I recommend a structural engineer inspect to determine the integrity of floor and repair as needed.

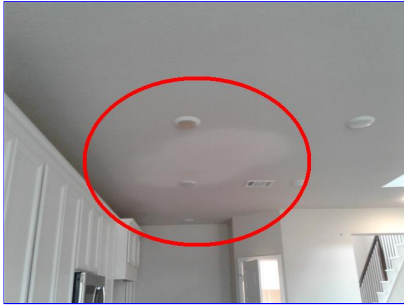
F. Item 3(Picture) kitchen

(3) The Drywall on the ceiling shows repair signs in areas. While this damage is cosmetic, it needs to be repaired. A qualified contractor should inspect and repair as needed.

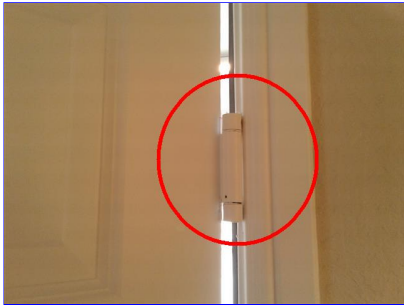
G. Item 1(Picture) garage door

(1) The interior garage door does not have the required self closing hinge. This is not considered to be today's standard. I recommend having a qualified person make repairs as needed.

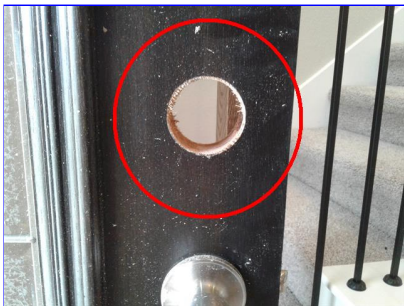
G. Item 2(Picture) front door

(2) The main entry door is missing locking hardware . This is a maintenance issue and is for your information. A qualified contractor should inspect and repair as needed.

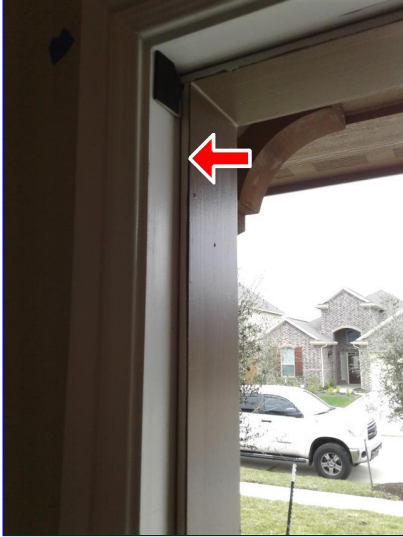
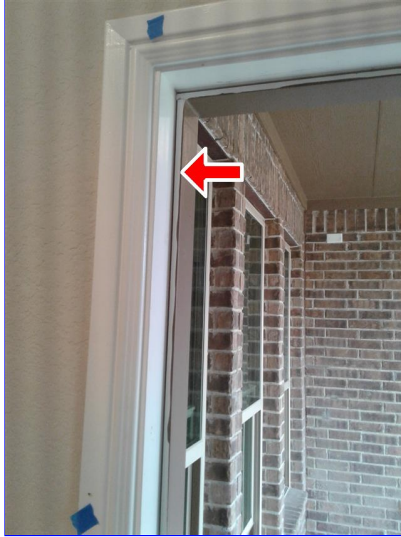
G. Item 3(Picture) front door

(3) The entry door missing weather-stripping. This is a maintenance issue and is for your information This can cause some heat loss in winter and loss of cool air in summer if not corrected. A qualified contractor should inspect and repair as needed.

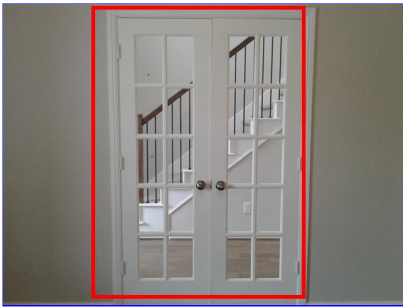
G. Item 5(Picture) study

(4) The Entry door needs adjustment in areas. This is a maintenance issue and is for your information. A qualified contractor should inspect and repair as needed.

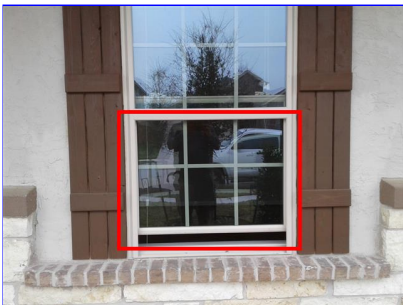
H. Item 1(Picture) All windows

Windows have damaged or missing screens. This is not considered to be today's standards. I recommend having a qualified person make repairs as needed.

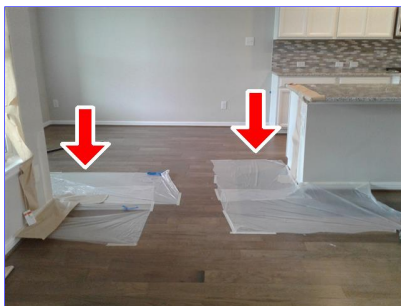
L. Item 1(Picture) multiple areas being repaired

(1) Drywall crew is present at time of inspection process. Multiple areas are taped off throughout home. This will limit the ability of the thermal camera in areas. This is for your information.

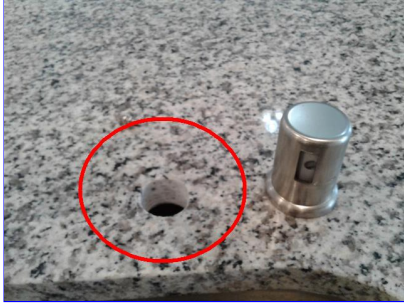
L. Item 3(Picture) kitchen

(2) Soap dispenser is not installed. However the hole is drilled. This is for your information.

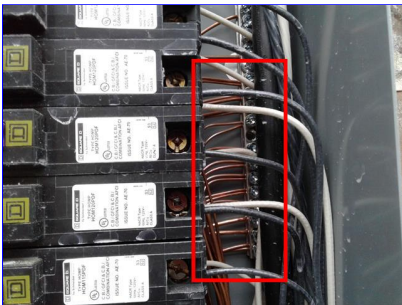
B. Item 1(Picture)

(2) Problem(s) discovered with Branch Circuits such as amateur wiring installation, doubled wiring at neutral/grounding bar, and any other problems that an electrical contractor may discover while performing repairs need correcting. I recommend a licensed electrical contractor inspect further and correct as needed.

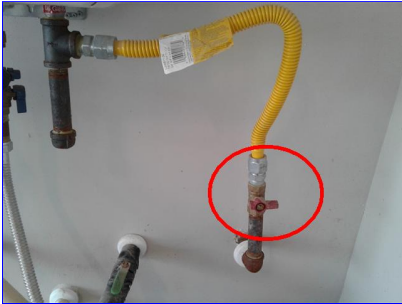
A. Item 1(Picture)

(1) The hot water was not on for inspection. I did not inspect condition of faucets, fixtures, plumbing, pressure or volume. There is an additional charge for a separate trip to return and inspect plumbing.

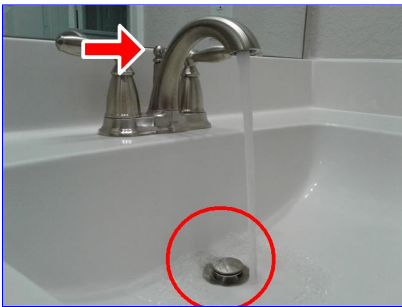
A. Item 2(Picture) guest bath upstairs left

(2) The stop-valve and linkage does not work properly at the . This is not considered up to today's standard Repairs are needed. A licensed plumber should troubleshoot further to determine cause or remedy.

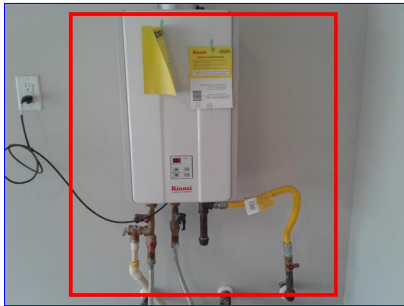
C. Item 1(Picture)

(1) Unable to test. The gas meter issues are present.

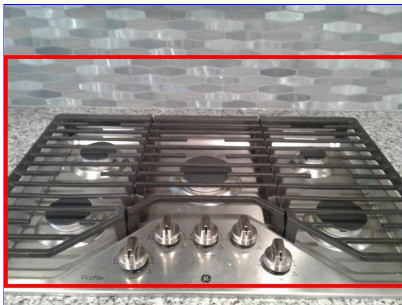
D. Item 1(Picture)

(1) No gas at cooktop. Appliance not function tested. This is for your information.

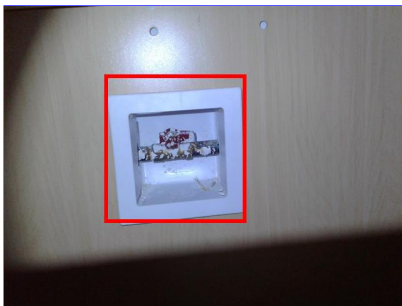
D. Item 2(Picture)

(2) Gas shut off valve is located behind a pull out drawer to right of oven. This can make shutoff in an emergency difficult. This is for your information.

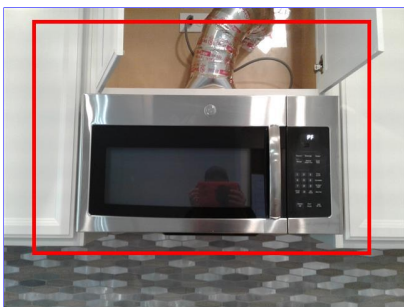
E. Item 1(Picture)

Appliance not working properly at time of inspection. This is not considered today's standards. I recommend having a qualified contractor inspect and make repairs as needed.

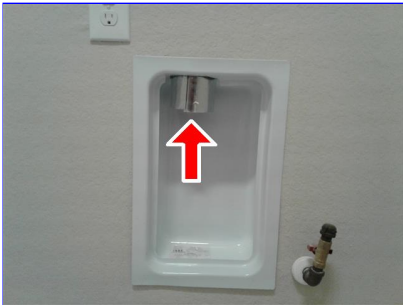
H. Item 1(Picture) laundry room

The dryer vent piping is long and vertical which can trap lint at elbow. Vent pipes should be cleaned regularly if they are longer than normal (10 feet or more) or vented vertically. I recommend repair as needed.

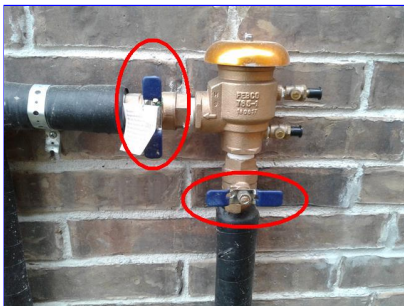
A. Item 1(Picture)

Sprinkler system has been disabled and was not tested.
